AS-BUILT REPAIR QUANTITY TABLE

PROJECT NO. HB-0017
DARE COUNTY
 BRIDGE NO. 270009

STATE OF NORTH CAROLINA
 DEPARTMENT OF TRANSPORTATION
 RALEIGH

BENT 157 & BENT 158

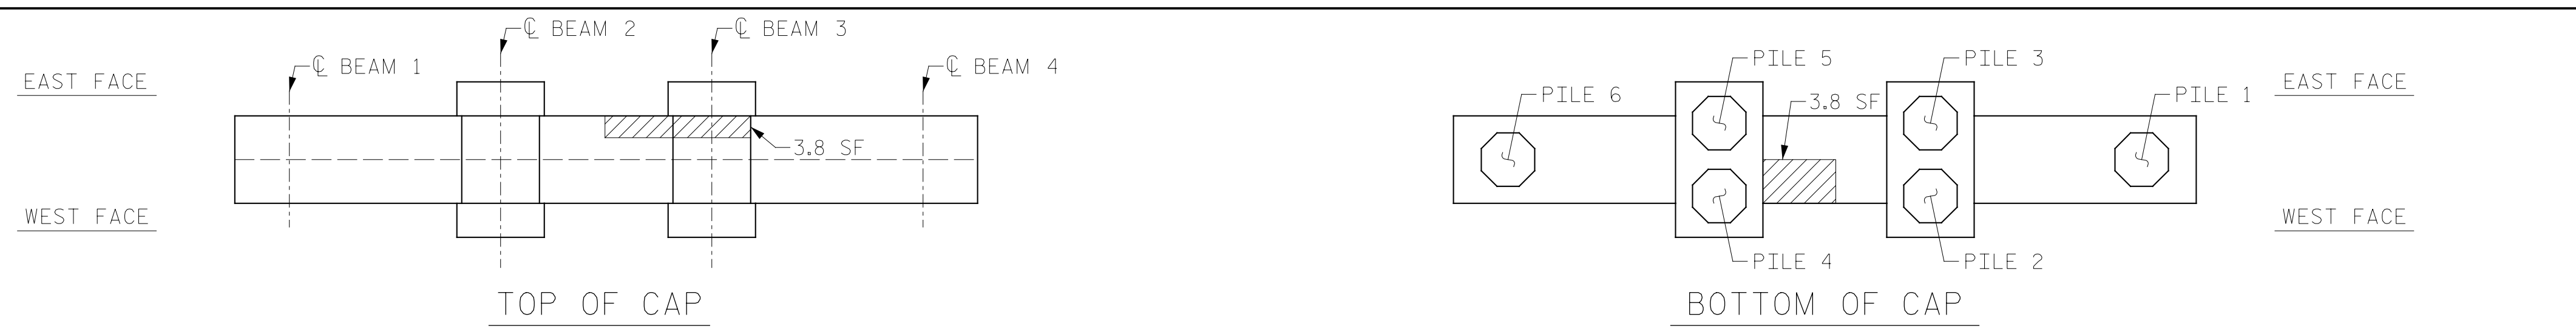
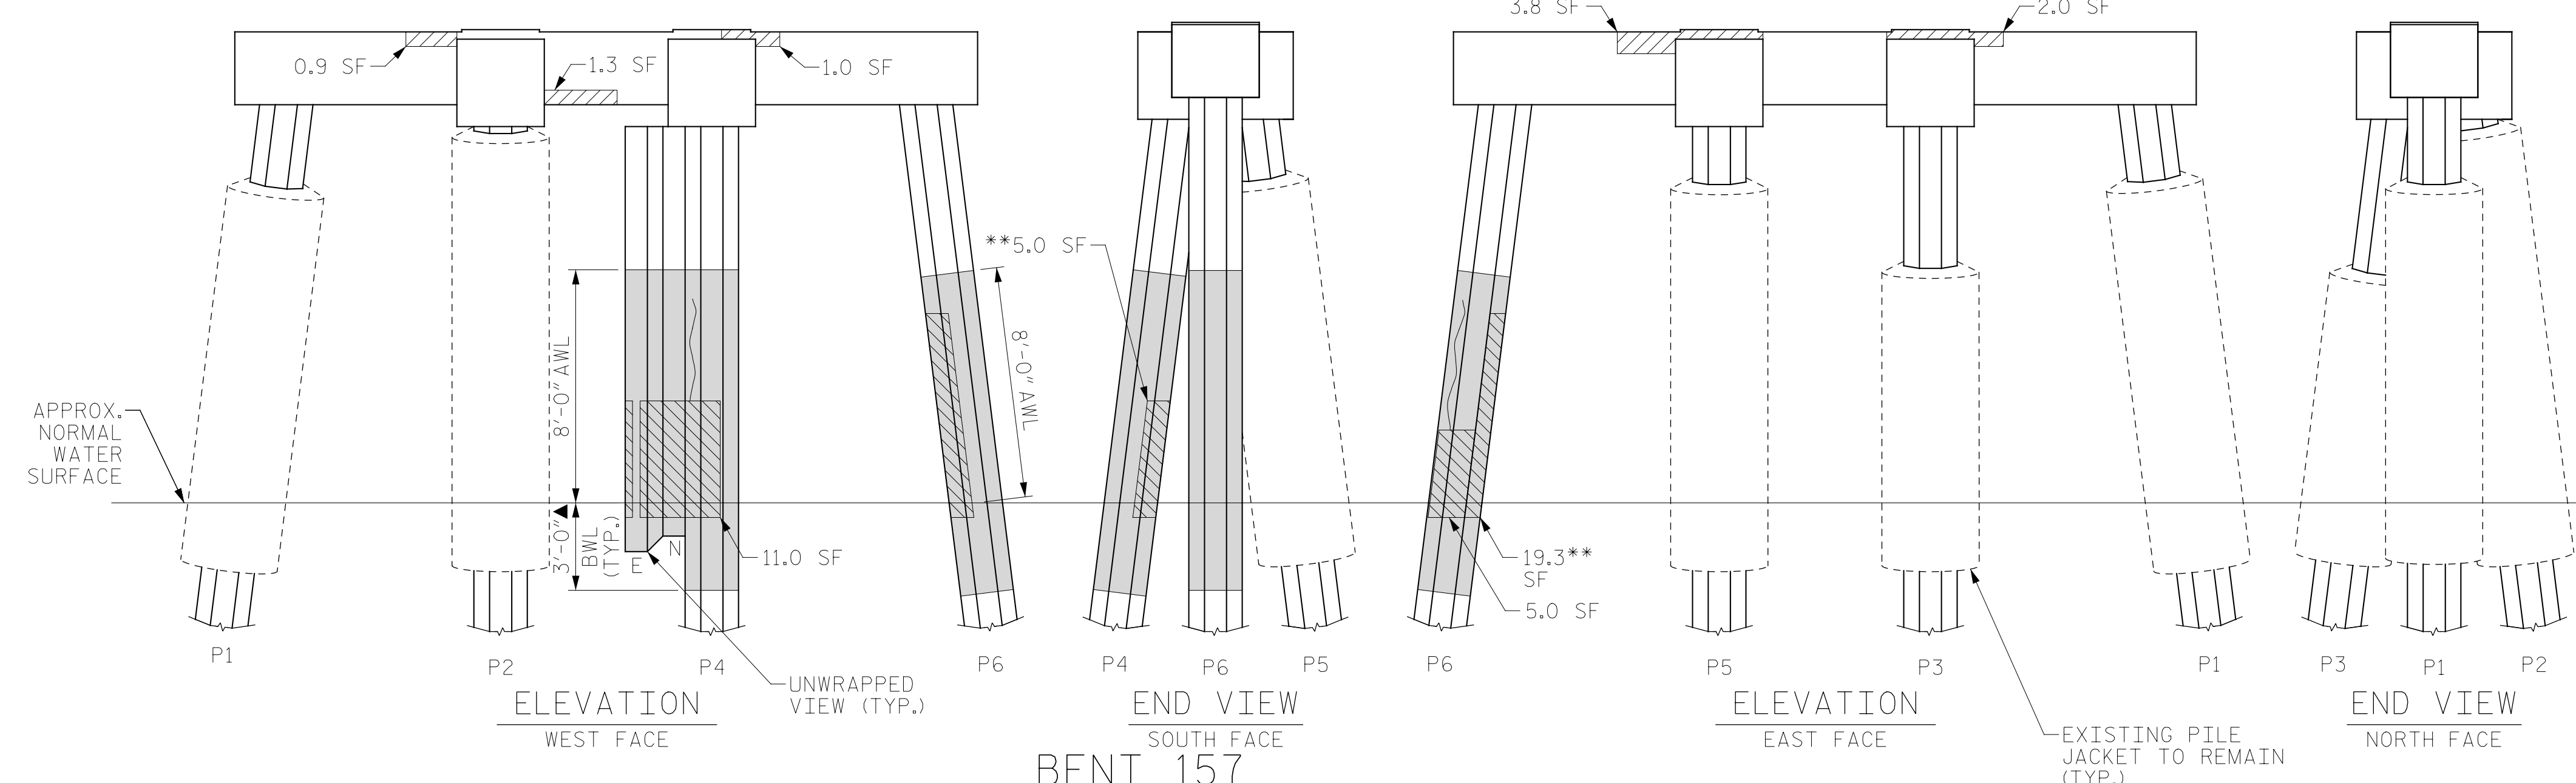
BENT 157

CAP REPAIRS			
SHOTCRETE REPAIRS	16.6 SF	6.6 CF	SF CF
EPOXY RESIN INJECTION	- LF		LF
PILE REPAIRS			
PILE CONCRETE RESTORATION	40.3 SF	15.6 CF	SF CF
FRP PROTECTIVE SYSTEM AWL	97.6 SF		
FRP PROTECTIVE SYSTEM BWL	36.6 SF

(AWL = ABOVE WATERLINE)
 (BWL = BELOW WATERLINE)
 (**QUANTITY INCLUDES ADJACENT REPAIRS)

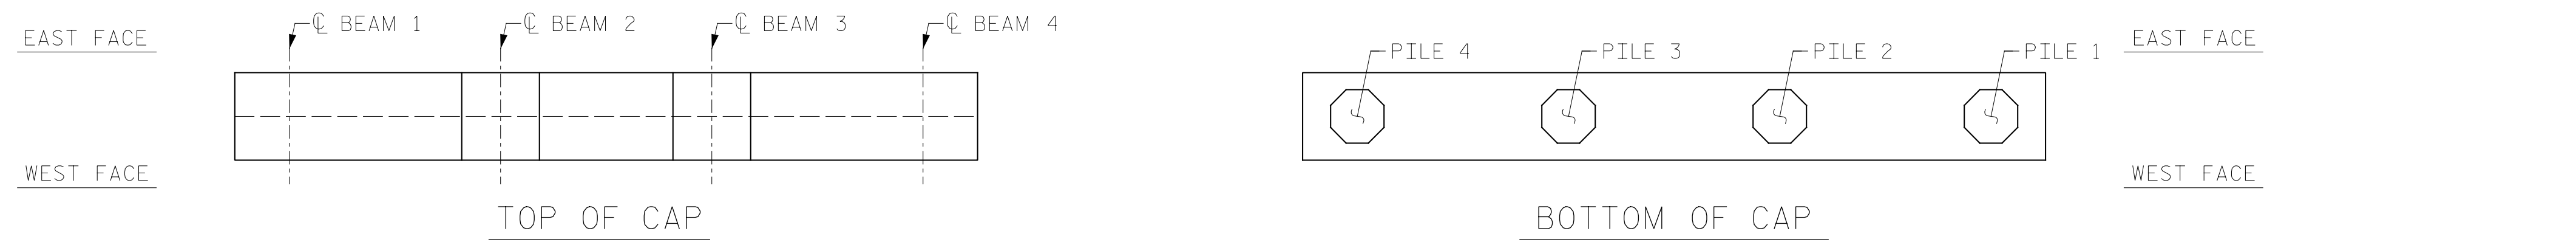
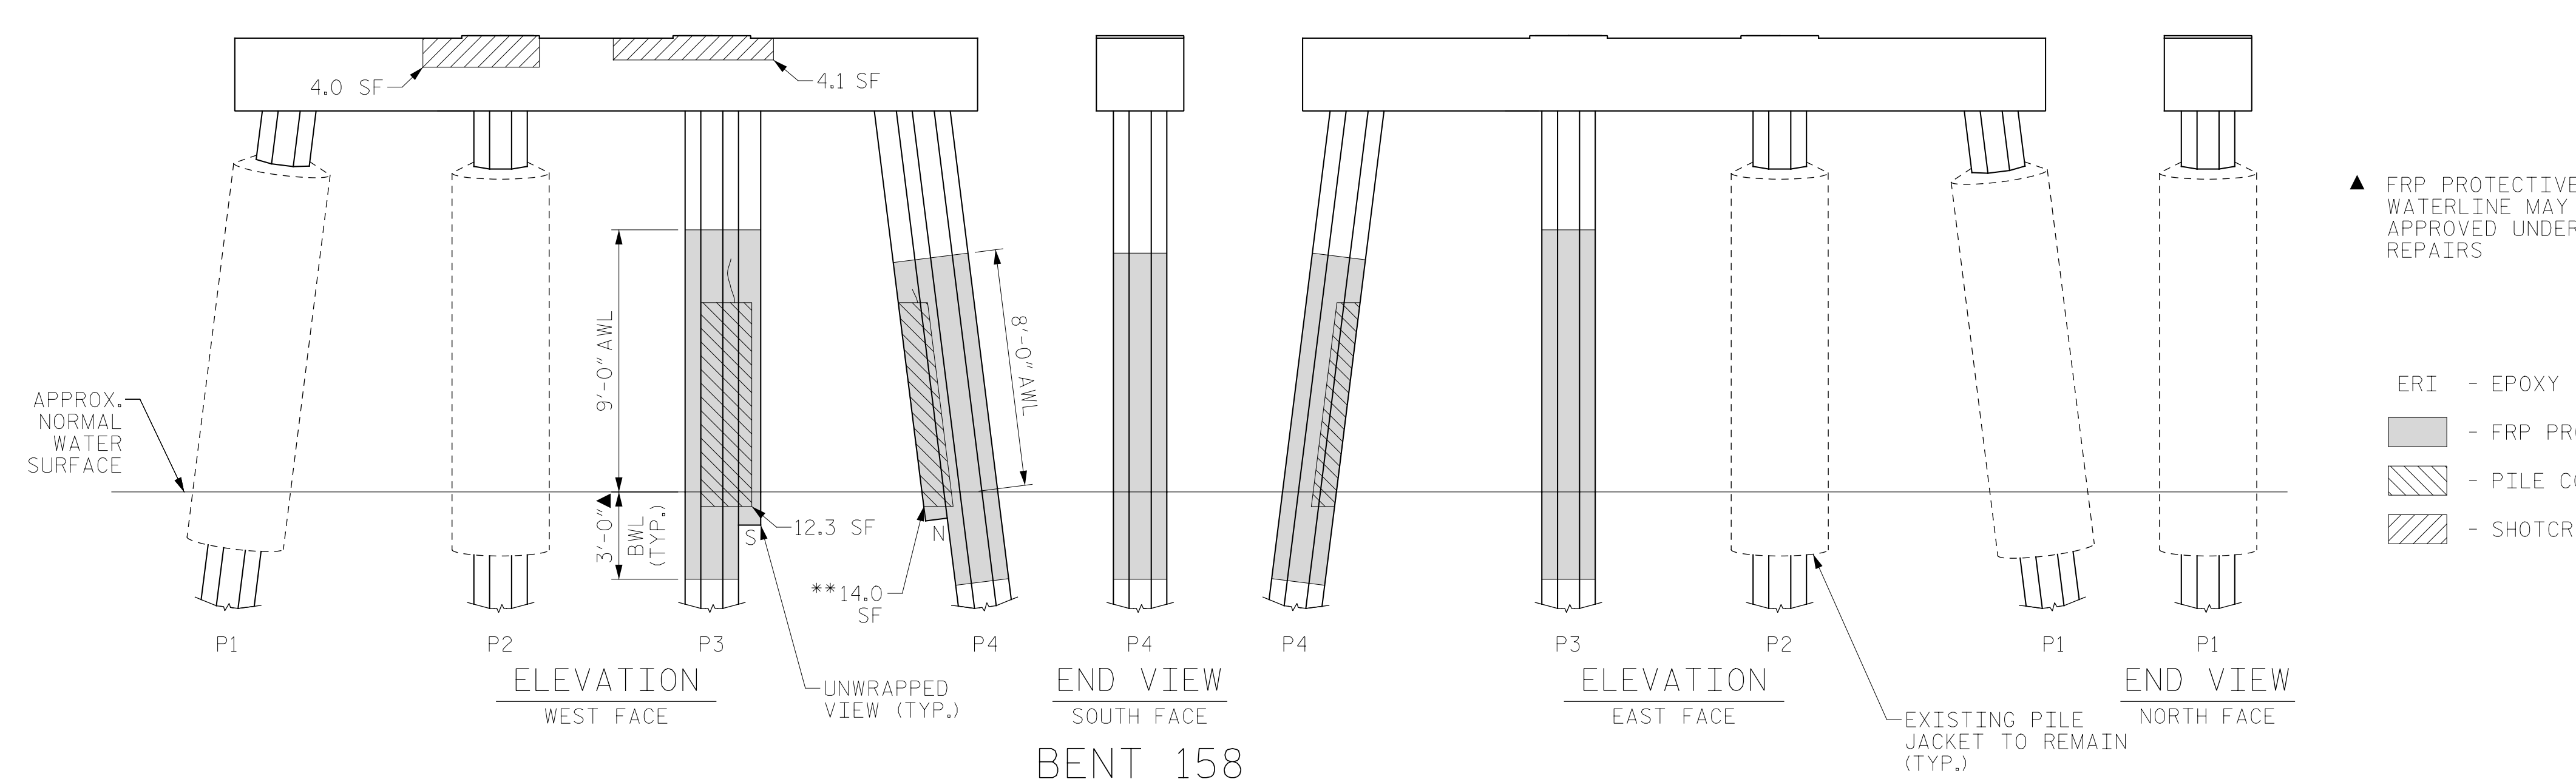
BENT 158

CAP REPAIRS			
SHOTCRETE REPAIRS	8.1 SF	4.1 CF	SF CF
EPOXY RESIN INJECTION	- LF		LF
PILE REPAIRS			
PILE CONCRETE RESTORATION	26.3 SF	10.6 CF	SF CF
FRP PROTECTIVE SYSTEM AWL	103.7 SF		
FRP PROTECTIVE SYSTEM BWL	36.6 SF

(AWL = ABOVE WATERLINE)
 (BWL = BELOW WATERLINE)
 (**QUANTITY INCLUDES ADJACENT REPAIRS)
