AS-BUILT REPAIR QUANTITY TABLE

PROJECT NO. HB-0017  
DARE COUNTY  
BRIDGE NO. 270009

STATE OF NORTH CAROLINA  
DEPARTMENT OF TRANSPORTATION  
RALEIGH  
BENT 185 & BENT 186

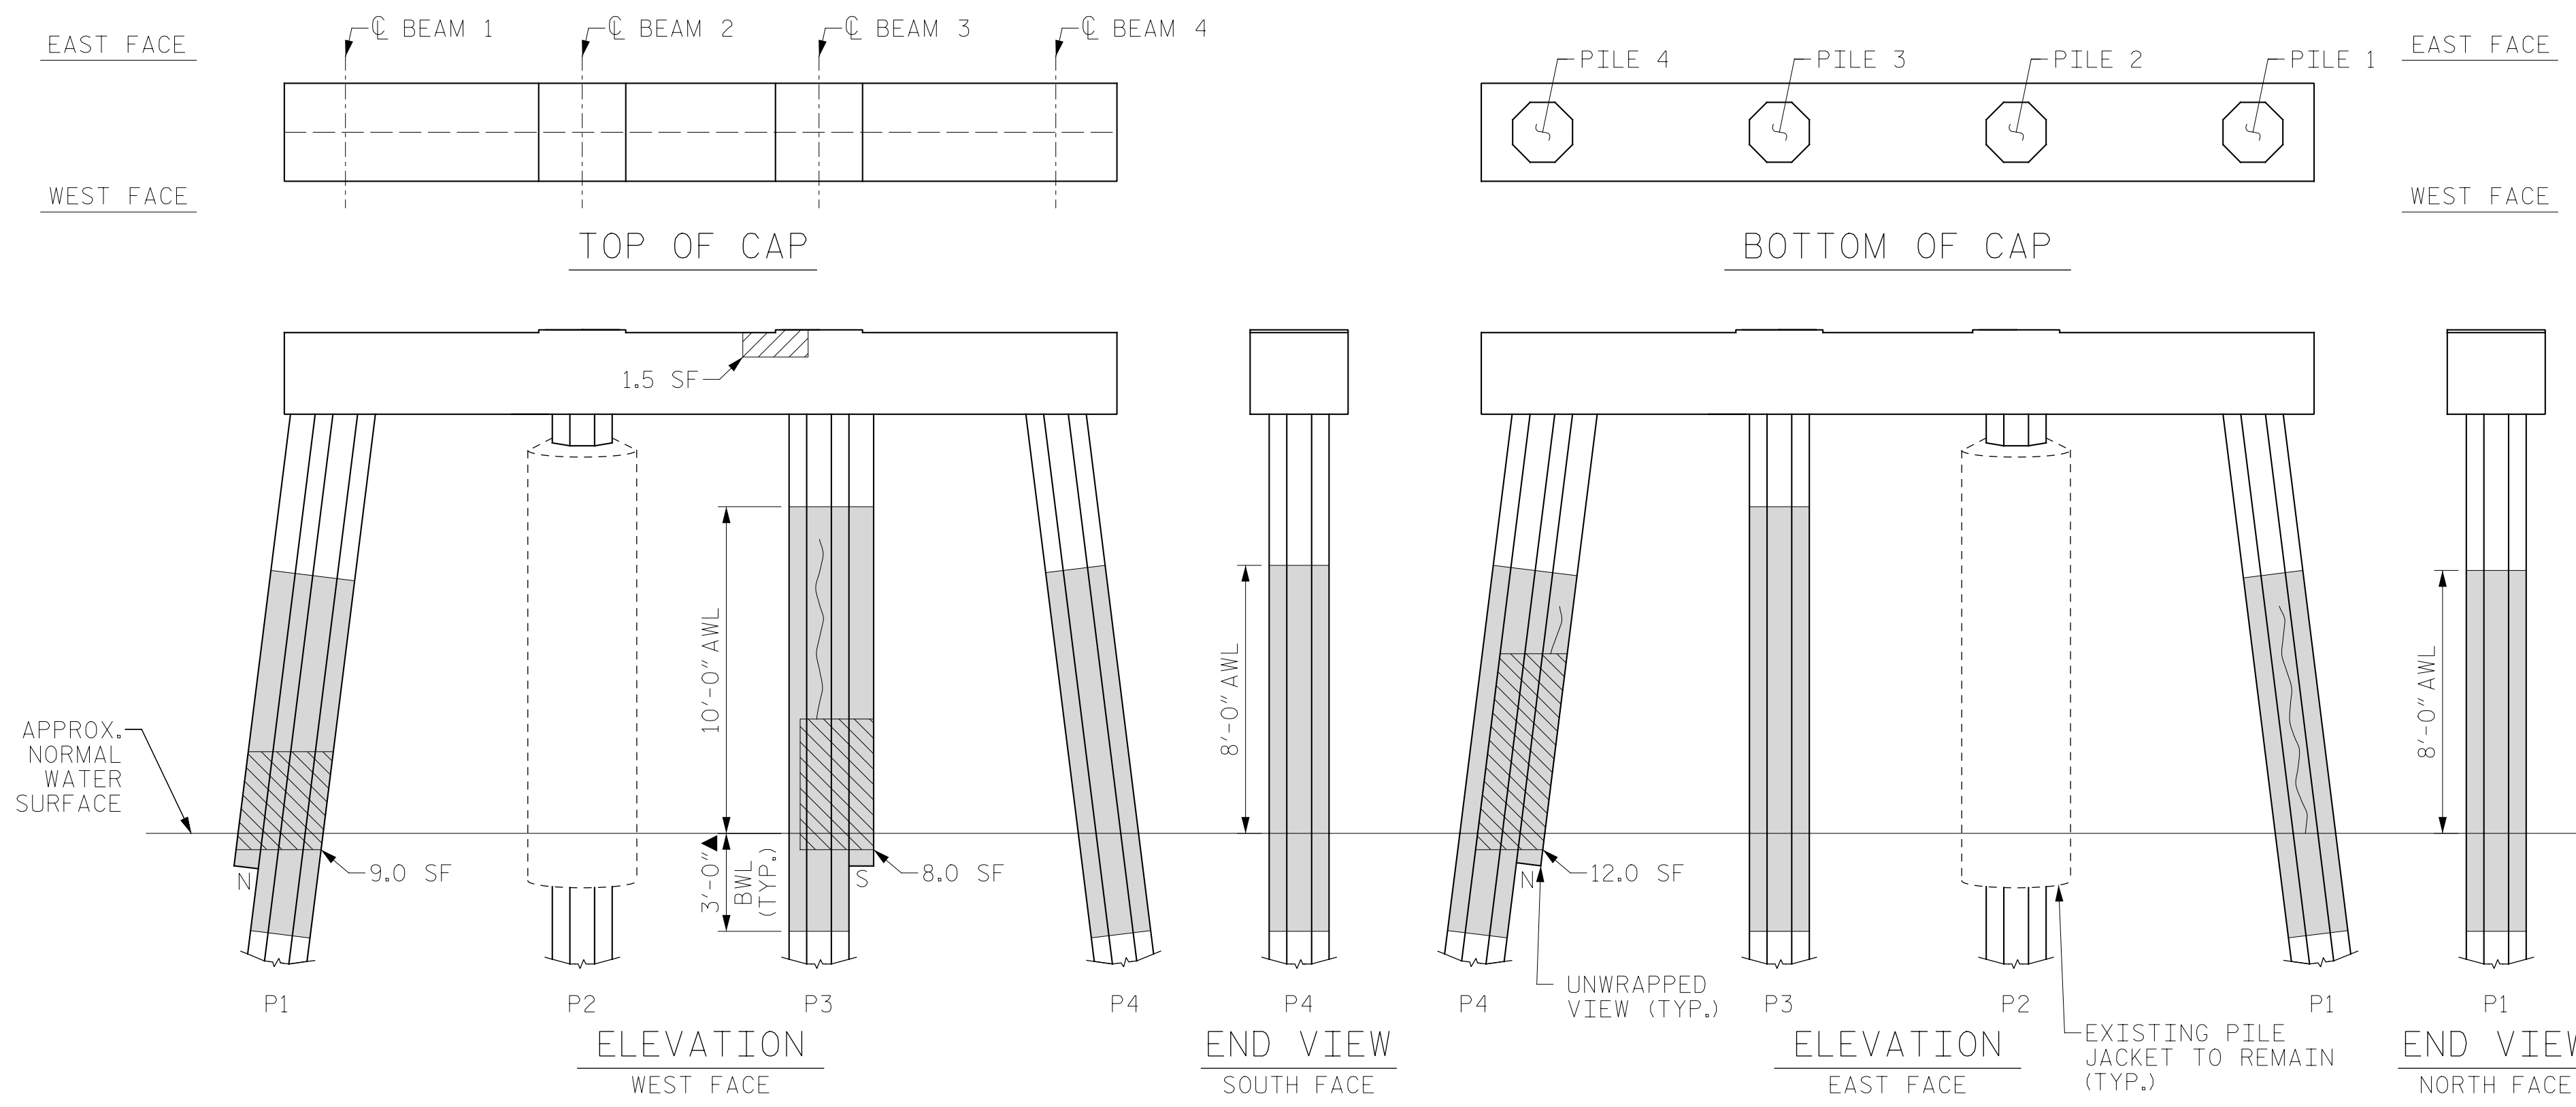
BENT 185

CAP REPAIRS			
SHOTCRETE REPAIRS	1.5 SF	0.8 CF	SF CF
EPOXY RESIN INJECTION	- LF		LF
PILE REPAIRS			
PILE CONCRETE RESTORATION	28.3 SF	11.2 CF	SF CF
FRP PROTECTIVE SYSTEM AWL	158.6 SF		
FRP PROTECTIVE SYSTEM BWL	54.9 SF

(AWL = ABOVE WATERLINE)  
(BWL = BELOW WATERLINE)  
(\*\*QUANTITY INCLUDES ADJACENT REPAIRS)

FOR CAP REPAIRS: VALUES IN CHART REPRESENT ESTIMATED REPAIR TOTALS AFTER REMOVAL OF UNSOUND CONCRETE, MIN. OF 1" BEHIND REBAR AND MIN. 2" CL. TO SAWCUT. SEE REPAIR DETAILS.

▲ FRP PROTECTIVE SYSTEM BELOW WATERLINE MAY INCLUDE APPROVED UNDERWATER MORTAR REPAIRS

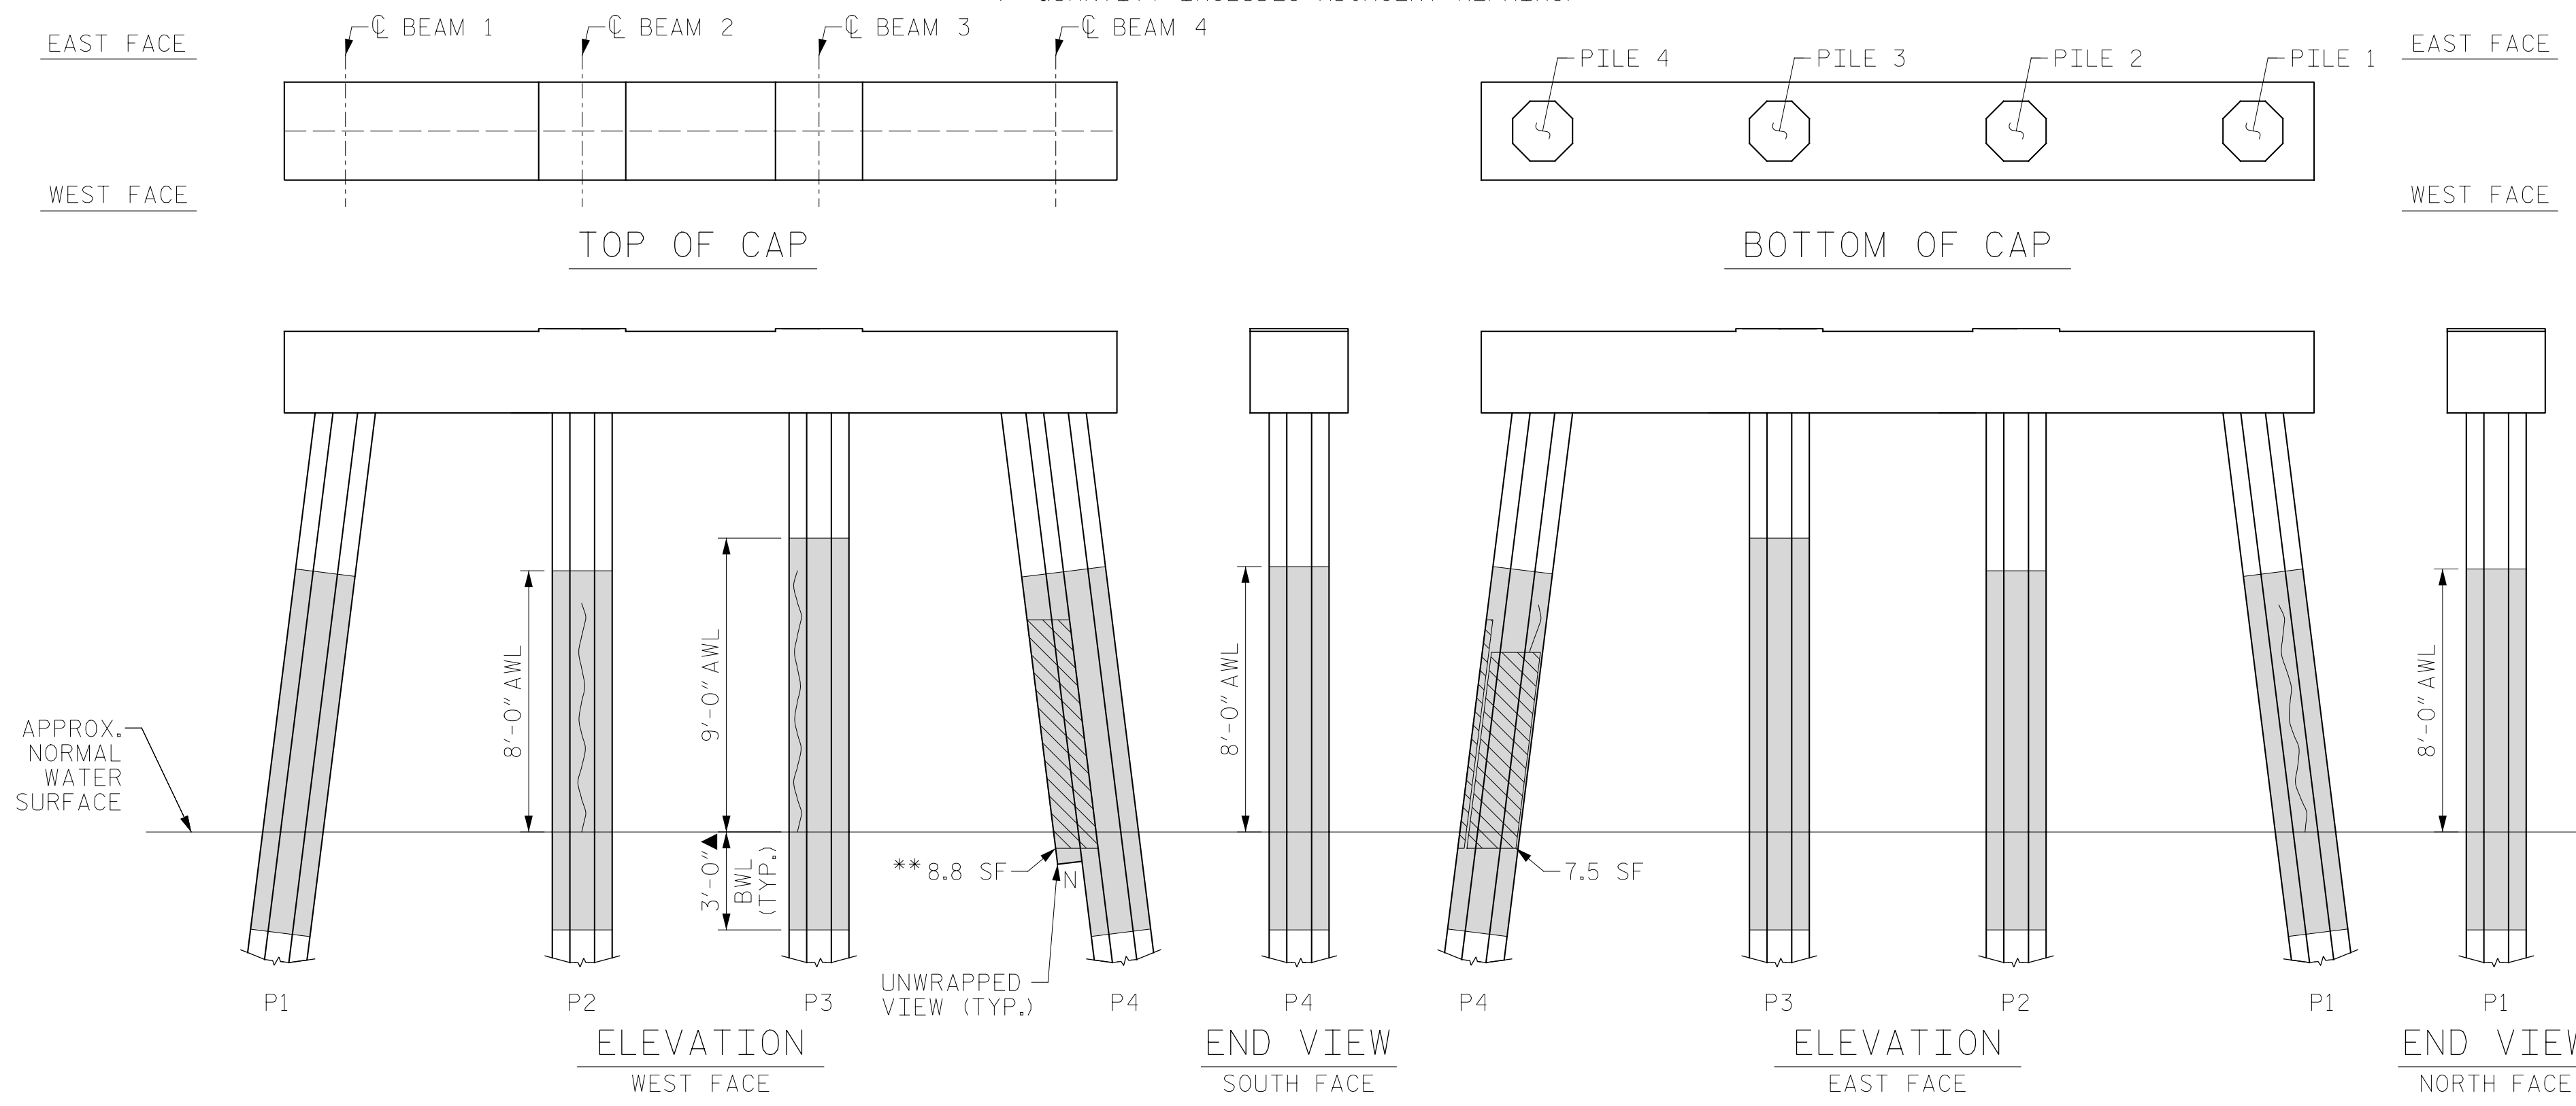
BENT 186

CAP REPAIRS			
SHOTCRETE REPAIRS	- SF	- CF	SF CF
EPOXY RESIN INJECTION	- LF		LF
PILE REPAIRS			
PILE CONCRETE RESTORATION	16.3 SF	6.9 CF	SF CF
FRP PROTECTIVE SYSTEM AWL	201.3 SF		
FRP PROTECTIVE SYSTEM BWL	73.2 SF

(AWL = ABOVE WATERLINE)  
(BWL = BELOW WATERLINE)  
(\*\*QUANTITY INCLUDES ADJACENT REPAIRS)
