AS-BUILT REPAIR QUANTITY TABLE

PROJECT NO. HB-0017
DARE COUNTY
BRIDGE NO. 270009

BENT 187 & BENT 188

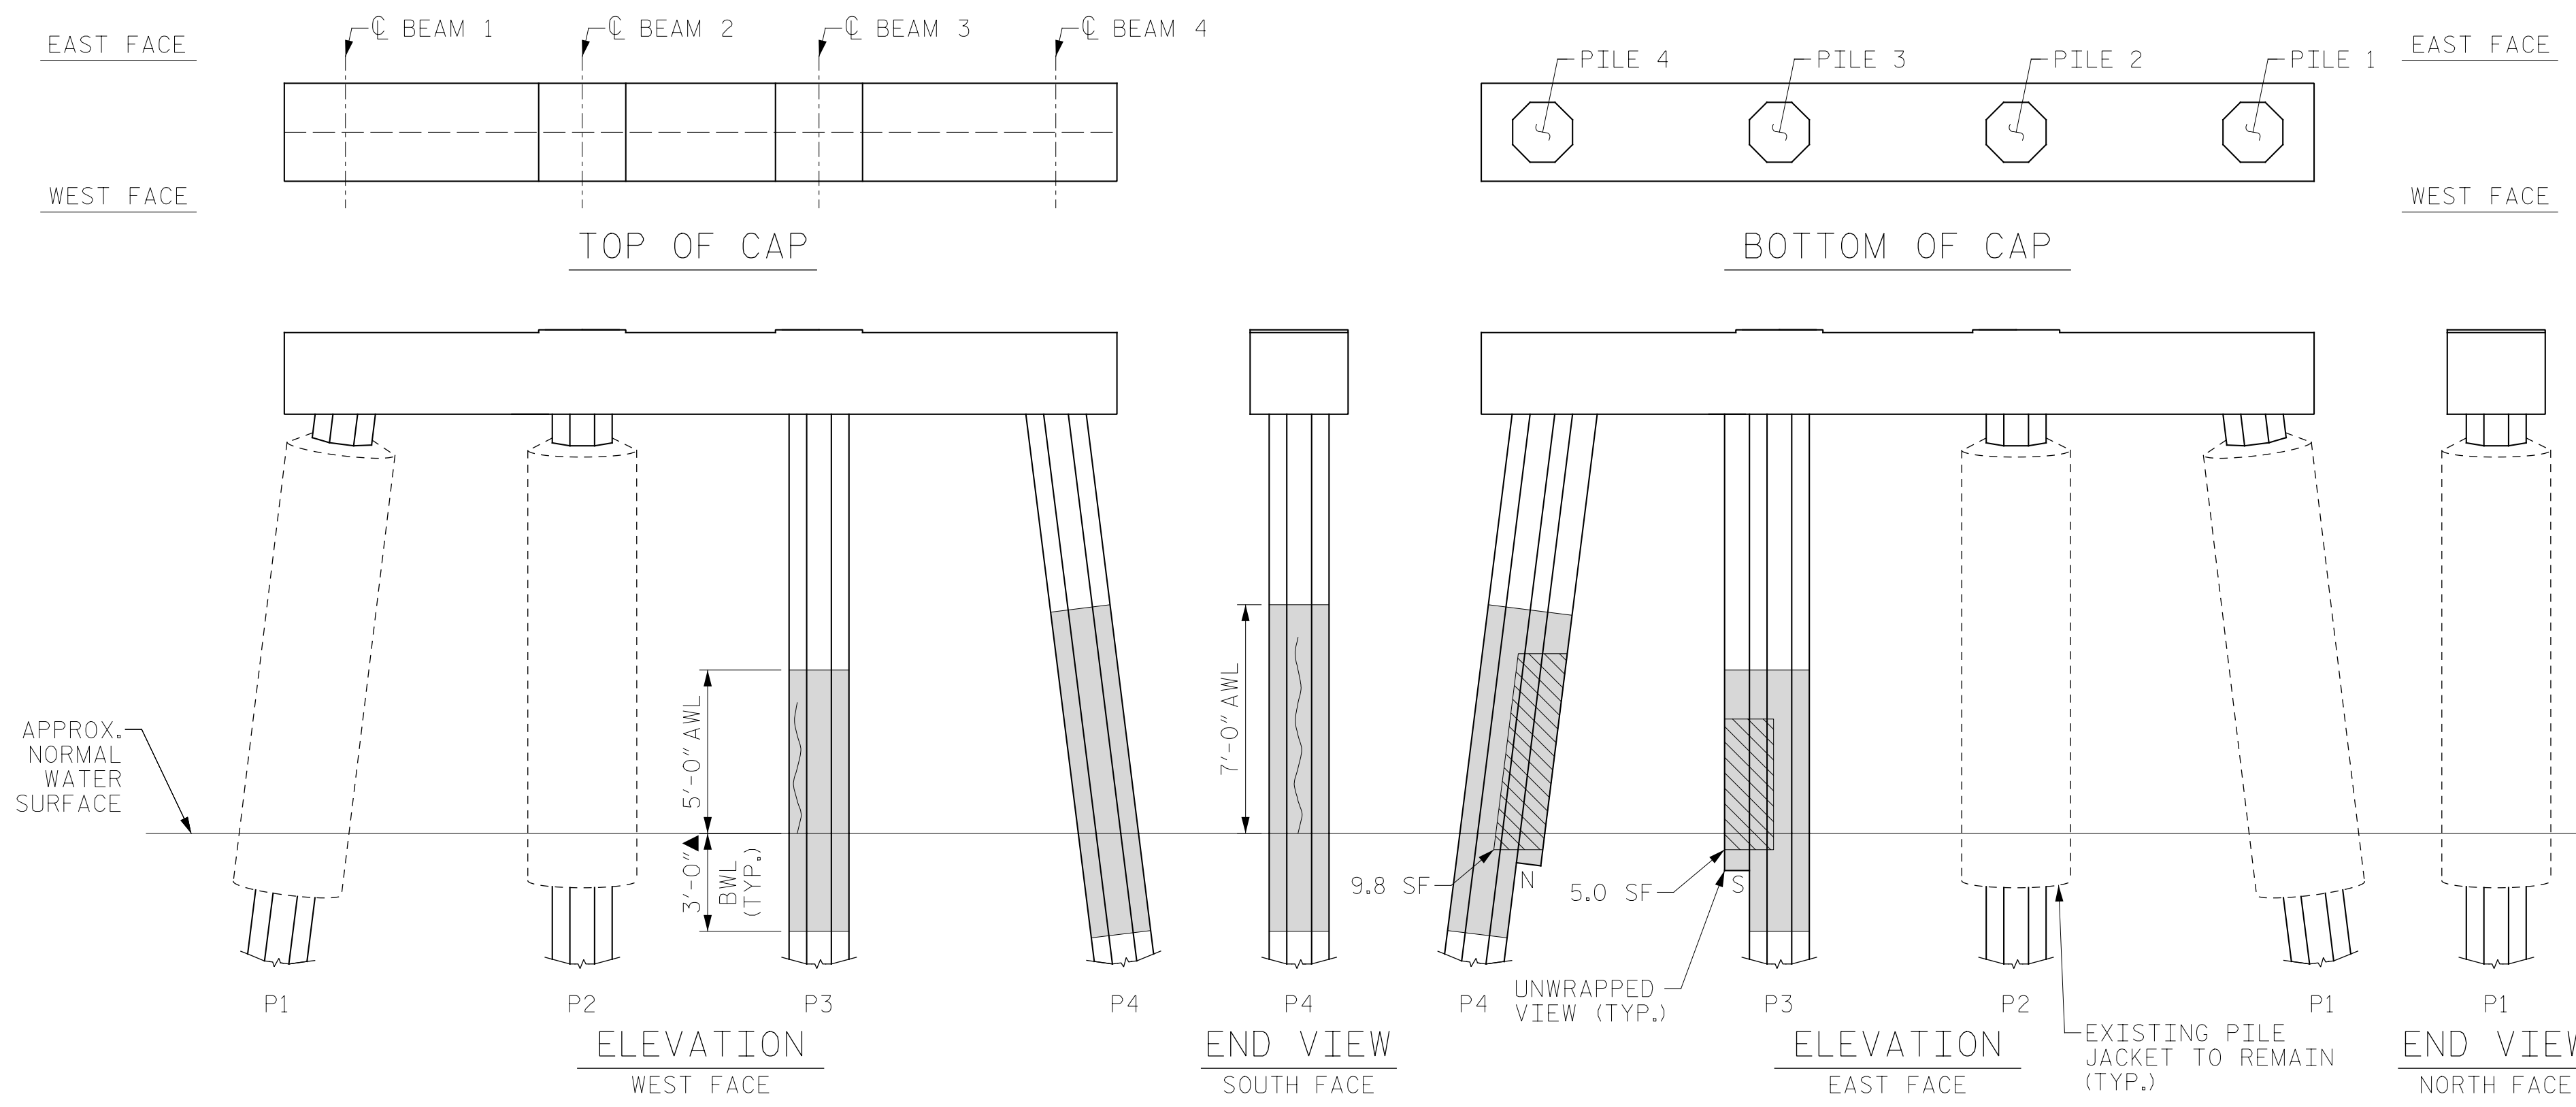
BENT 187

CAP REPAIRS			
SHOTCRETE REPAIRS	- SF	- CF	SF CF
EPOXY RESIN INJECTION	- LF		LF
PILE REPAIRS			
PILE CONCRETE RESTORATION	14.8 SF	6.5 CF	SF CF
FRP PROTECTIVE SYSTEM AWL	73.2 SF		
FRP PROTECTIVE SYSTEM BWL	36.6 SF

FOR CAP REPAIRS: VALUES IN CHART REPRESENT ESTIMATED REPAIR TOTALS AFTER REMOVAL OF UNSOUND CONCRETE, MIN. OF 1" BEHIND REBAR AND MIN. 2" CL. TO SAWCUT. SEE REPAIR DETAILS.

FOR SHOTCRETE REPAIRS, SEE SPECIAL PROVISIONS.
FOR CONCRETE REPAIR DETAILS, SEE "TYPICAL CAP, COLUMN & UNDERDECK REPAIR DETAILS" & "PILE CONCRETE RESTORATION DETAILS" SHEETS.
FOR PILE CONCRETE RESTORATION, SEE SPECIAL PROVISIONS.
FOR FRP PROTECTIVE SYSTEM, SEE SPECIAL PROVISIONS.
FOR FRP PROTECTIVE SYSTEM DETAILS AND UNDERWATER MORTAR REPAIRS, SEE "PILE FRP PROTECTIVE SYSTEM DETAILS" SHEET.

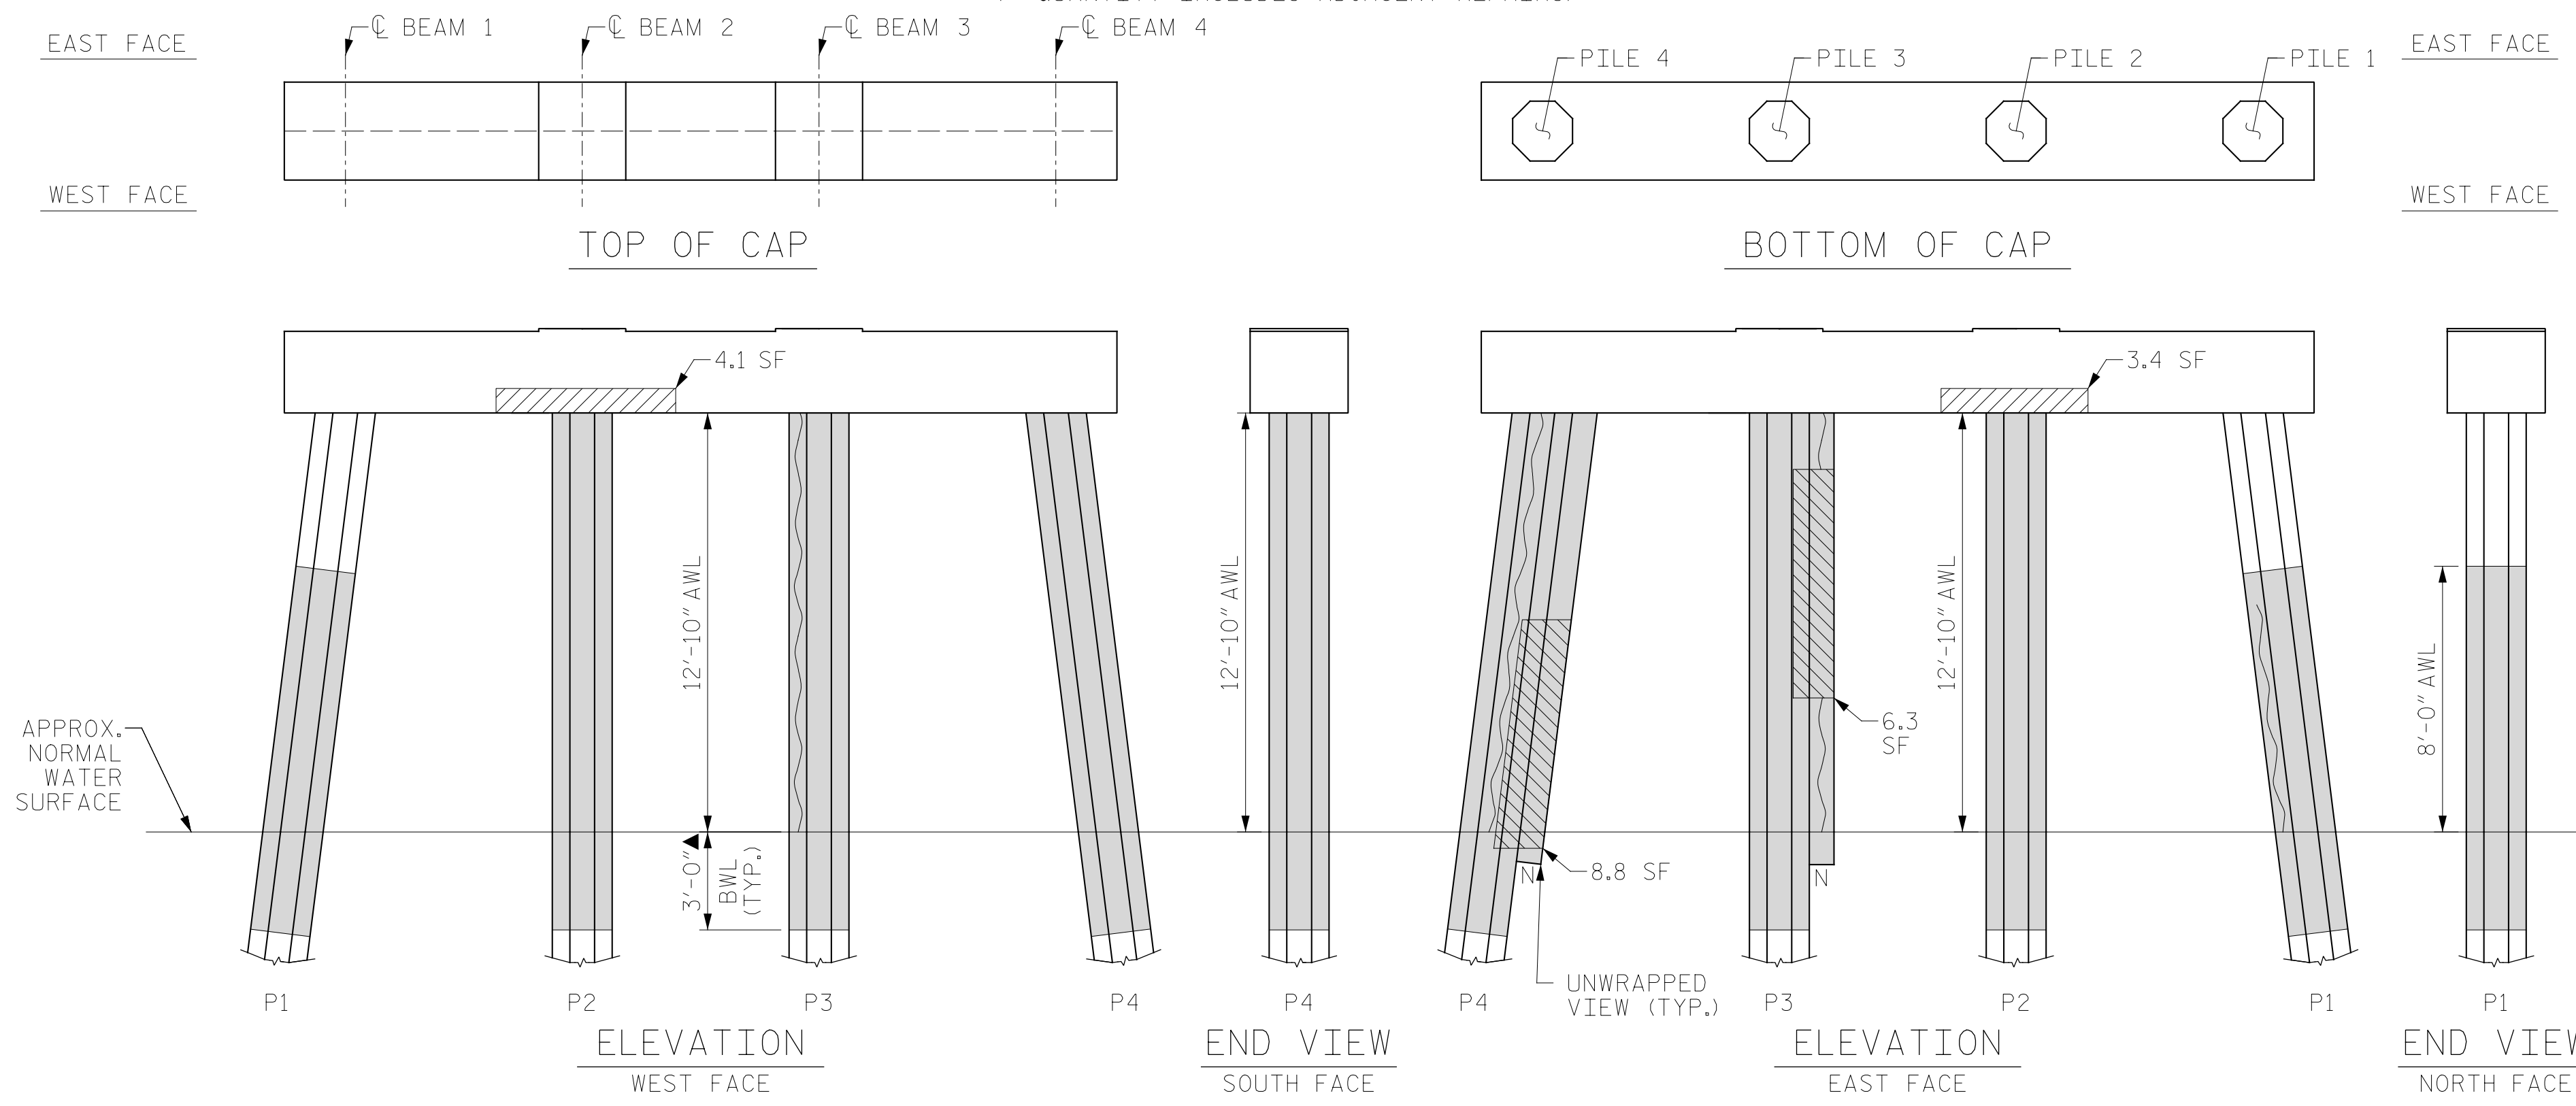
BENT 188

CAP REPAIRS			
SHOTCRETE REPAIRS	7.5 SF	3.8 CF	SF CF
EPOXY RESIN INJECTION	- LF		LF
PILE REPAIRS			
PILE CONCRETE RESTORATION	15.0 SF	6.4 CF	SF CF
FRP PROTECTIVE SYSTEM AWL	283.7 SF		
FRP PROTECTIVE SYSTEM BWL	73.2 SF
