AS-BUILT REPAIR QUANTITY TABLE

PROJECT NO. HB-0017
DARE COUNTY
 BRIDGE NO. 270009

BENT 201 & BENT 202

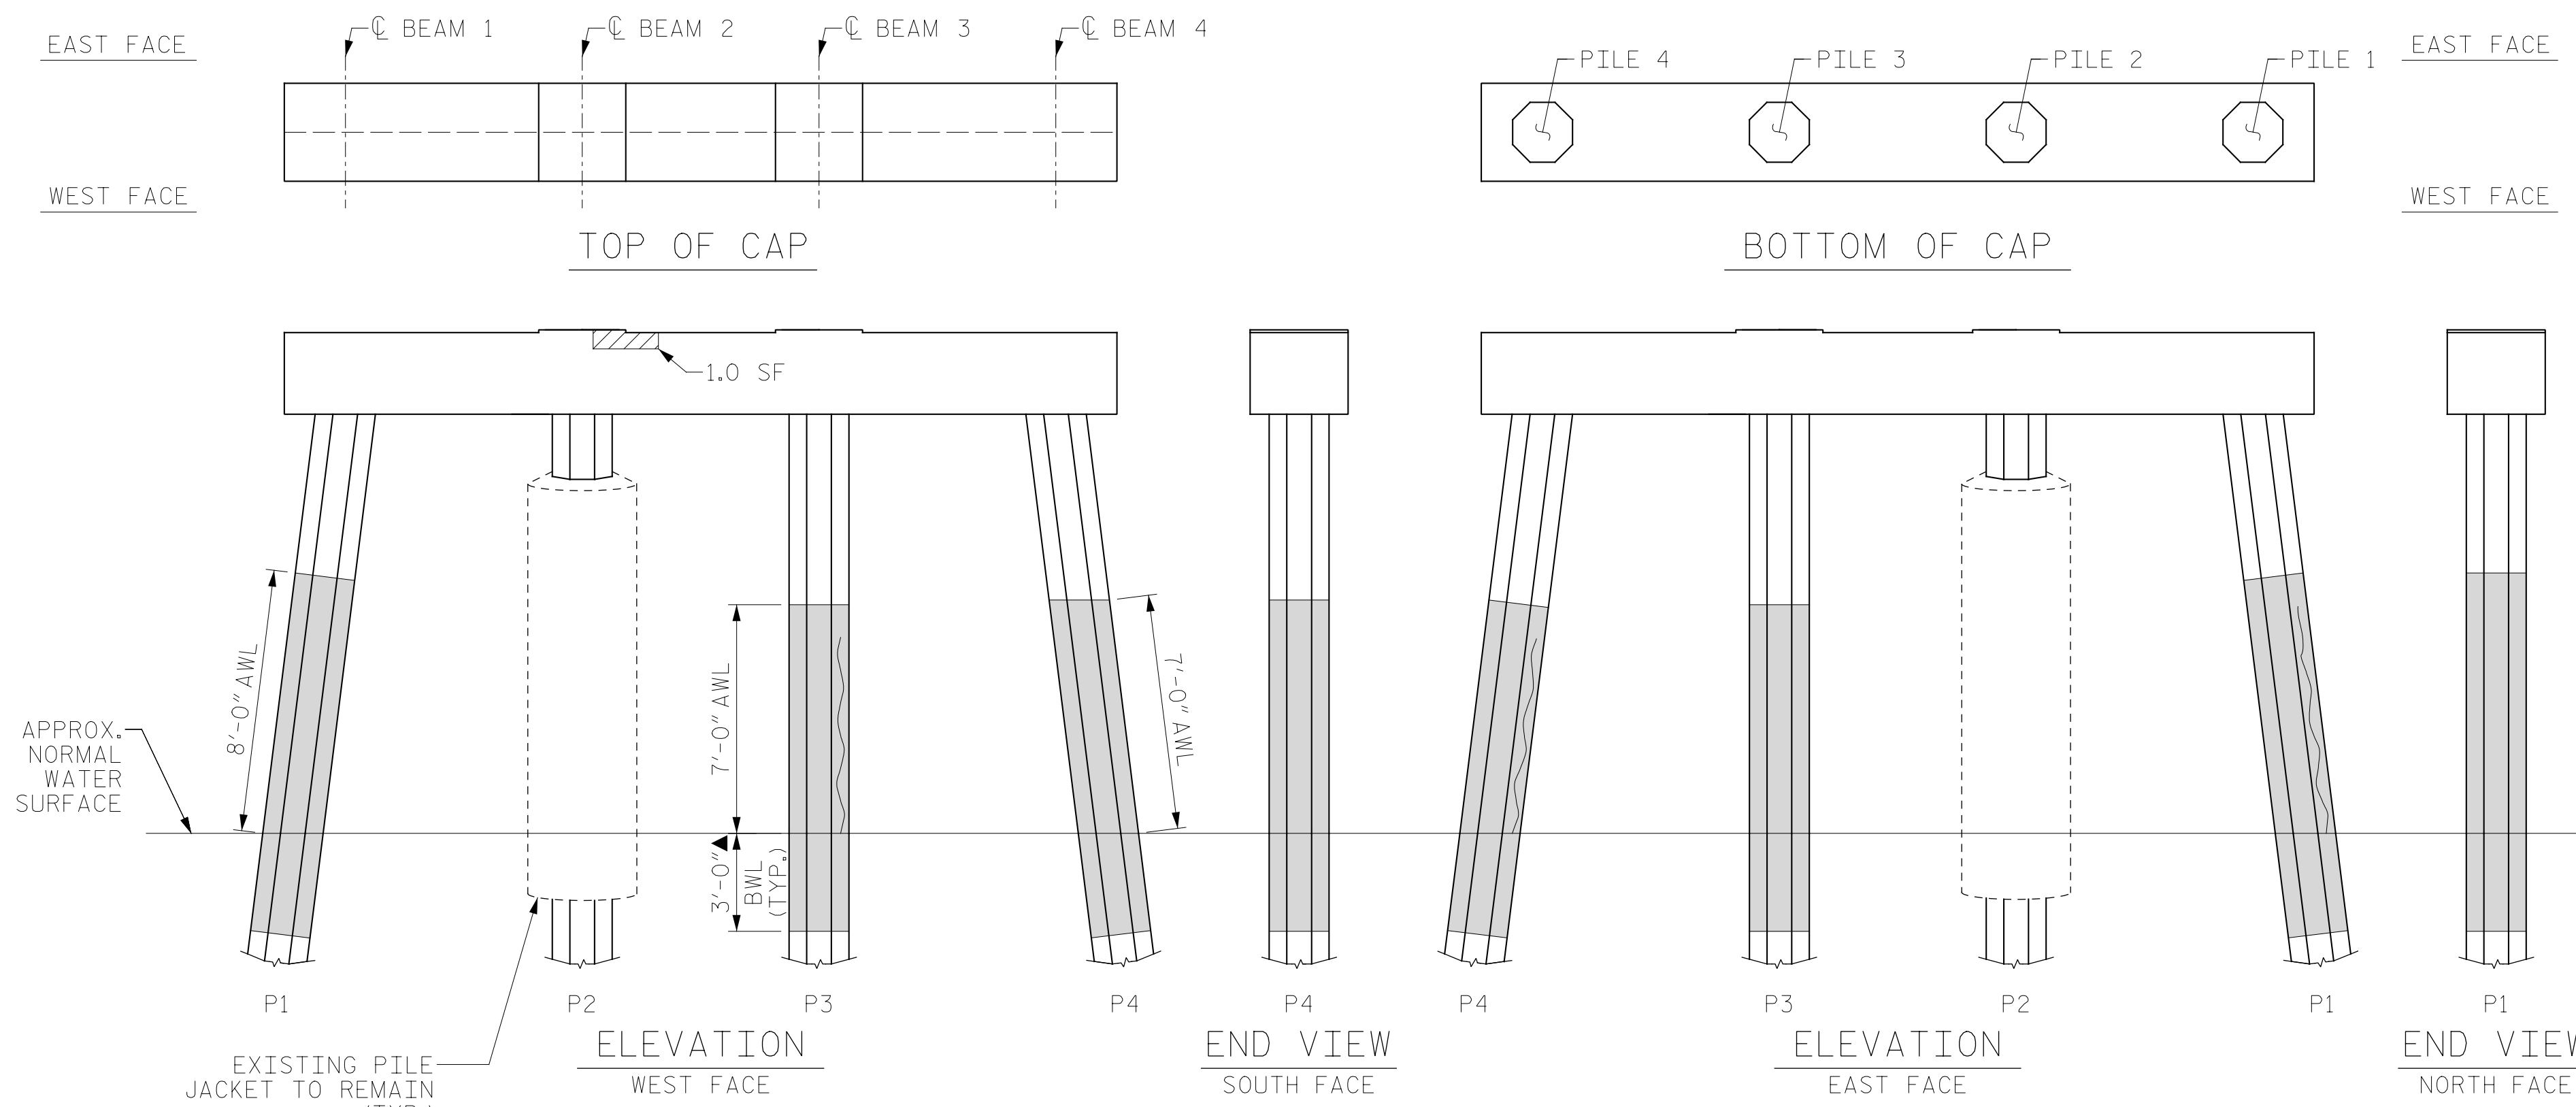
BENT 201

CAP REPAIRS				
SHOTCRETE REPAIRS	1.0 SF	0.5 CF	SF	CF
EPOXY RESIN INJECTION	- LF			LF
PILE REPAIRS				
PILE CONCRETE RESTORATION	- SF	- CF	SF	CF
FRP PROTECTIVE SYSTEM AWL	140.3 SF			
FRP PROTECTIVE SYSTEM BWL	54.9 SF

(AWL = ABOVE WATERLINE)
(BWL = BELOW WATERLINE)
(*QUANTITY INCLUDES ADJACENT REPAIRS)

FOR CAP REPAIRS: VALUES IN CHART REPRESENT ESTIMATED REPAIR TOTALS AFTER REMOVAL OF UNSOUND CONCRETE, MIN. OF 1" BEHIND REBAR AND MIN. 2" CL. TO SAWCUT. SEE REPAIR DETAILS.

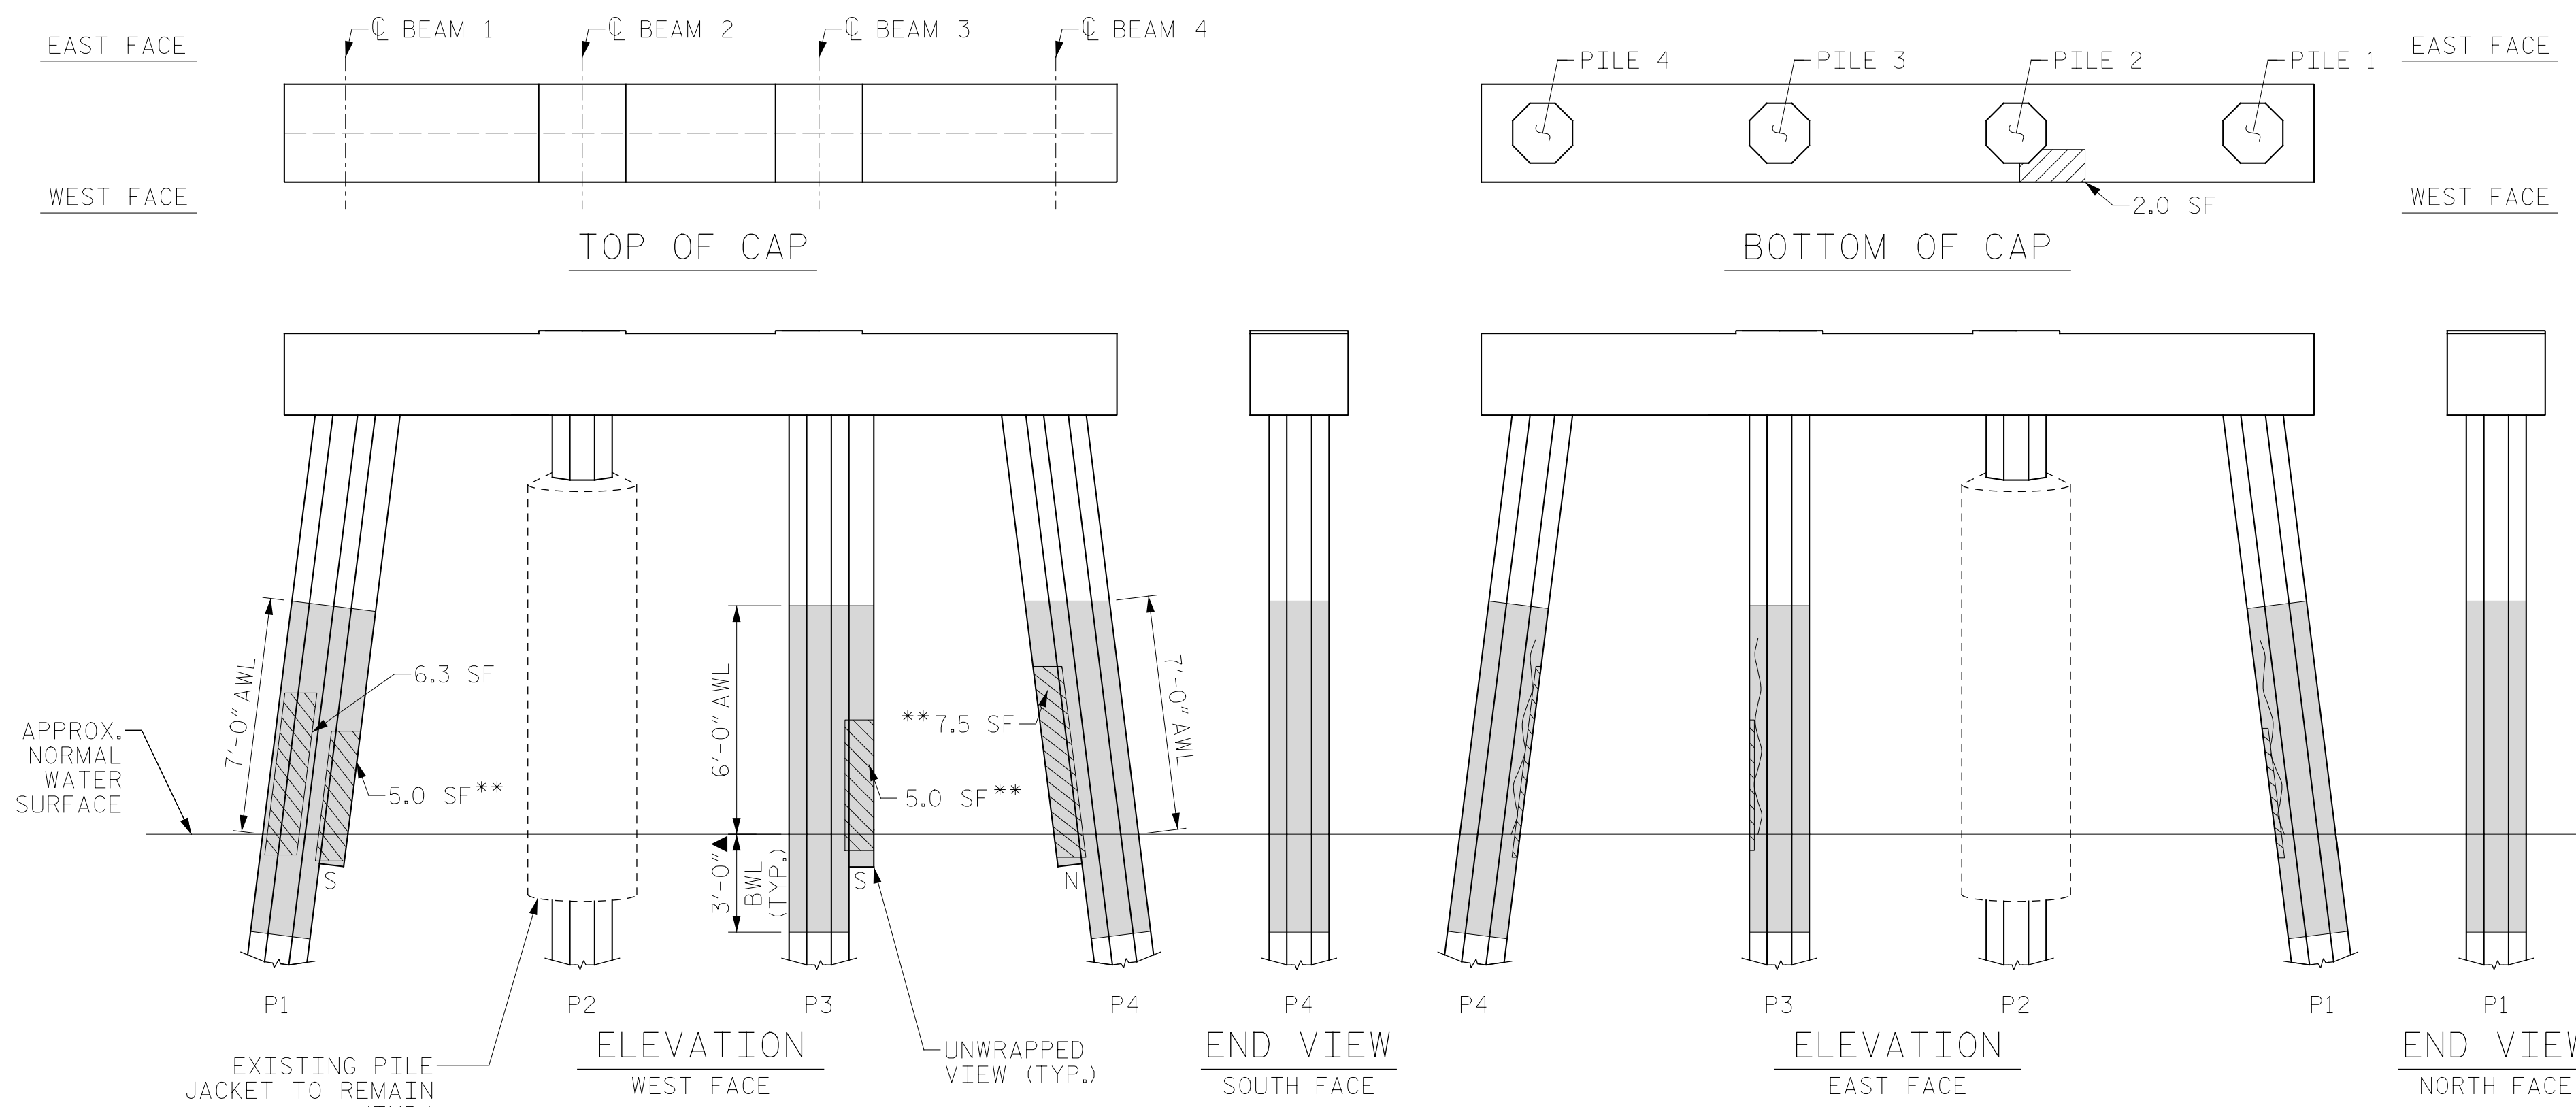
BENT 202

CAP REPAIRS				
SHOTCRETE REPAIRS	2.0 SF	1.0 CF	SF	CF
EPOXY RESIN INJECTION	- LF			LF
PILE REPAIRS				
PILE CONCRETE RESTORATION	23.8 SF	10.1 CF	SF	CF
FRP PROTECTIVE SYSTEM AWL	122.0 SF			
FRP PROTECTIVE SYSTEM BWL	54.9 SF

(AWL = ABOVE WATERLINE)
(BWL = BELOW WATERLINE)
(*QUANTITY INCLUDES ADJACENT REPAIRS)
