AS-BUILT REPAIR QUANTITY TABLE

PROJECT NO. HB-0017
DARE COUNTY
 BRIDGE NO. 270009

BENT 207 & BENT 208

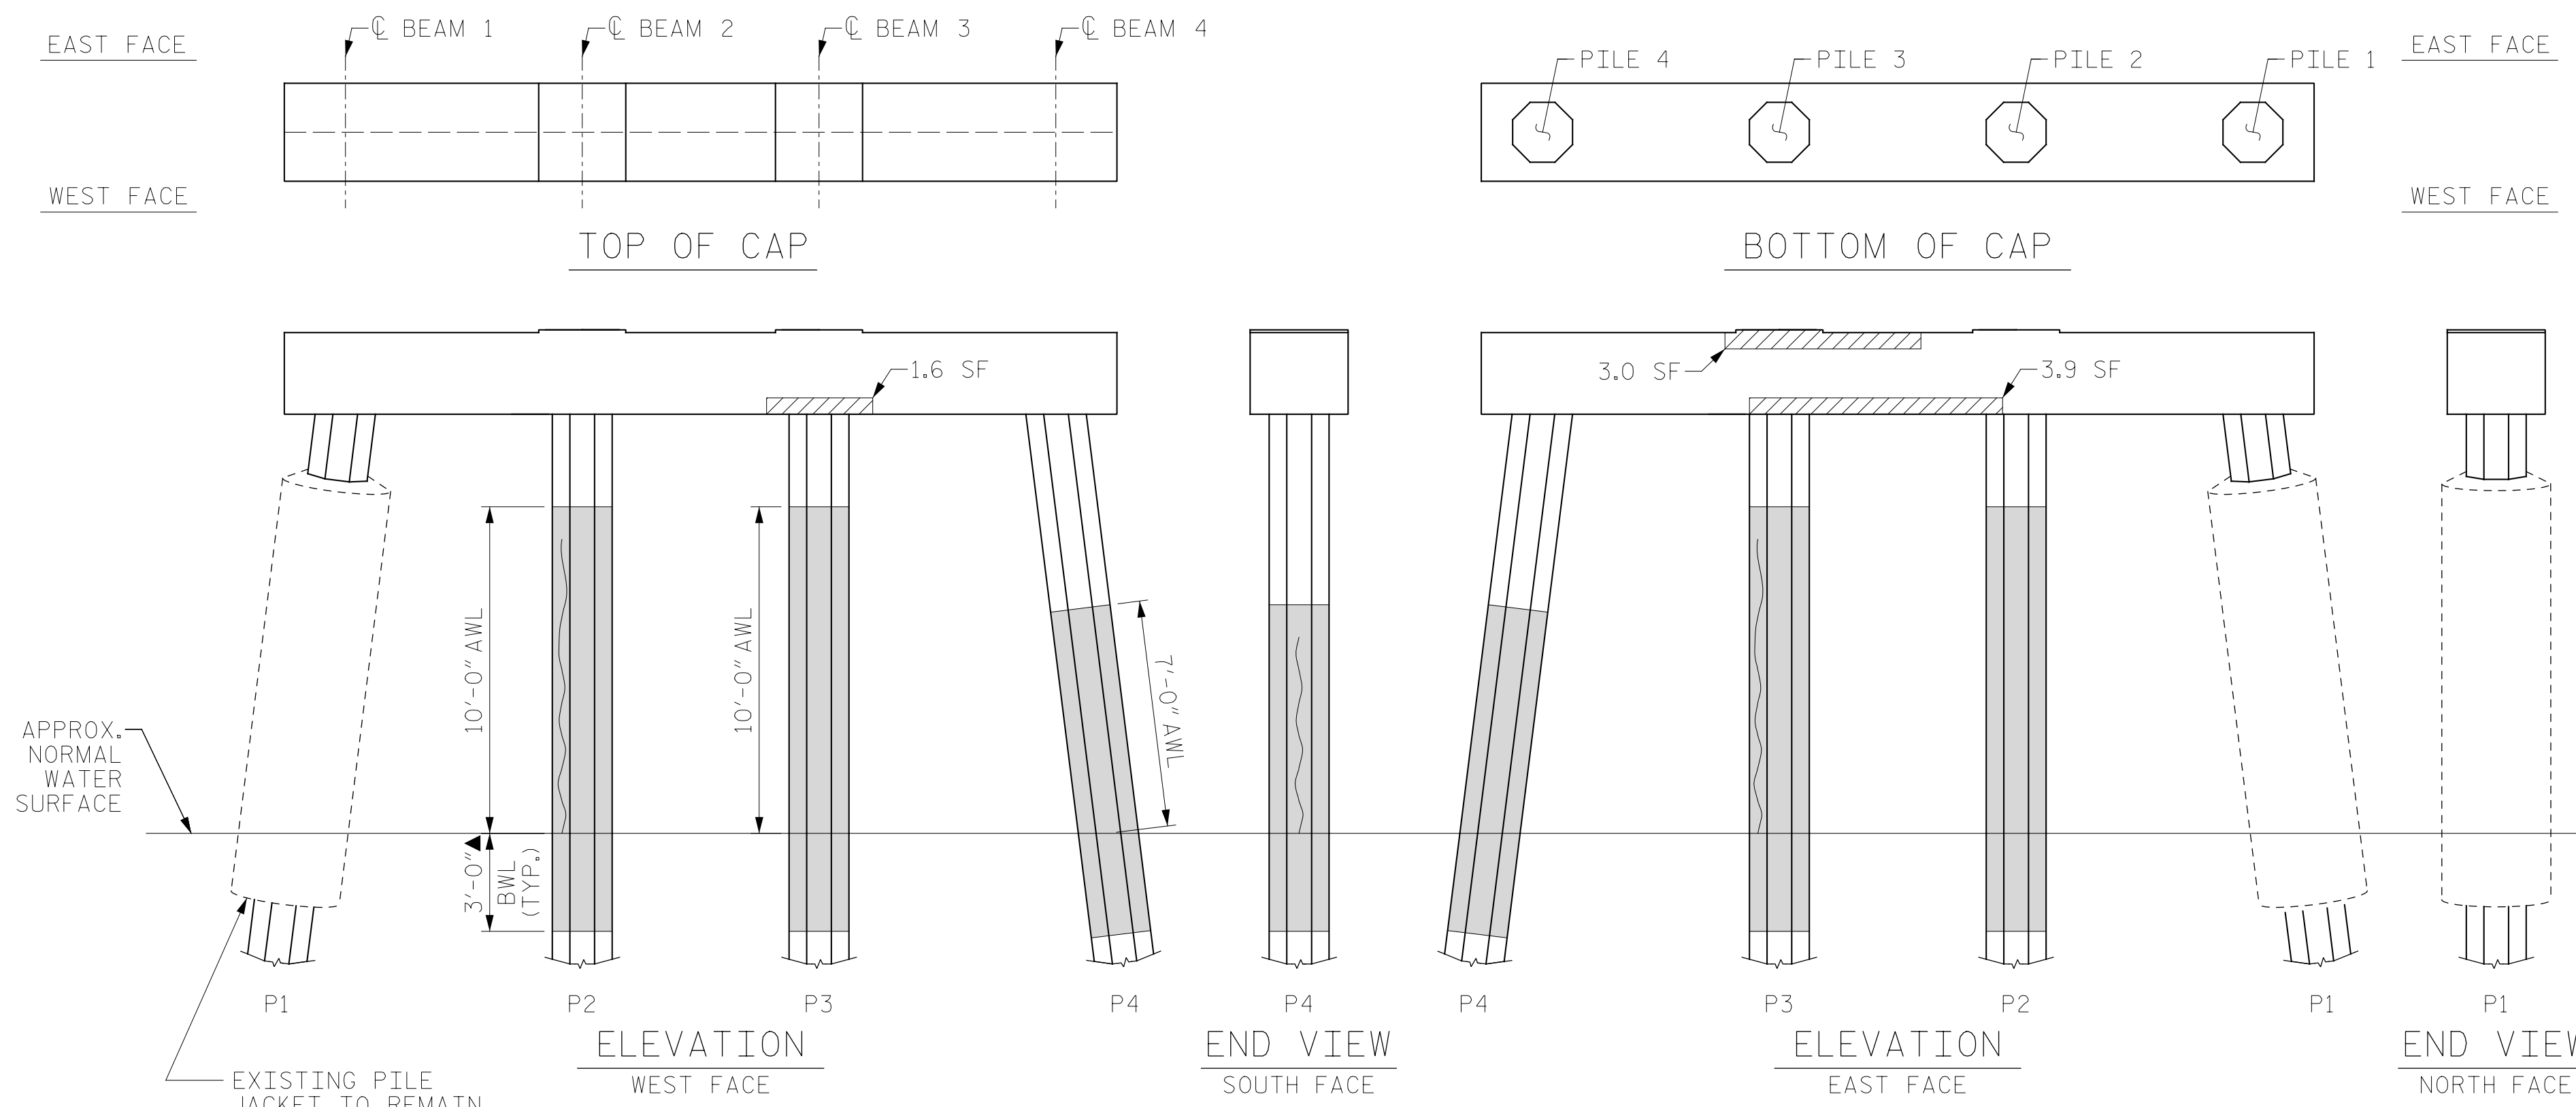
BENT 207

CAP REPAIRS			
SHOTCRETE REPAIRS	8.5 SF	4.3 CF	SF CF
EPOXY RESIN INJECTION	- LF		LF
PILE REPAIRS			
PILE CONCRETE RESTORATION	- SF	- CF	SF CF
FRP PROTECTIVE SYSTEM AWL	164.7 SF		
FRP PROTECTIVE SYSTEM BWL	54.9 SF

(AWL = ABOVE WATERLINE)
(BWL = BELOW WATERLINE)
(*QUANTITY INCLUDES ADJACENT REPAIRS)

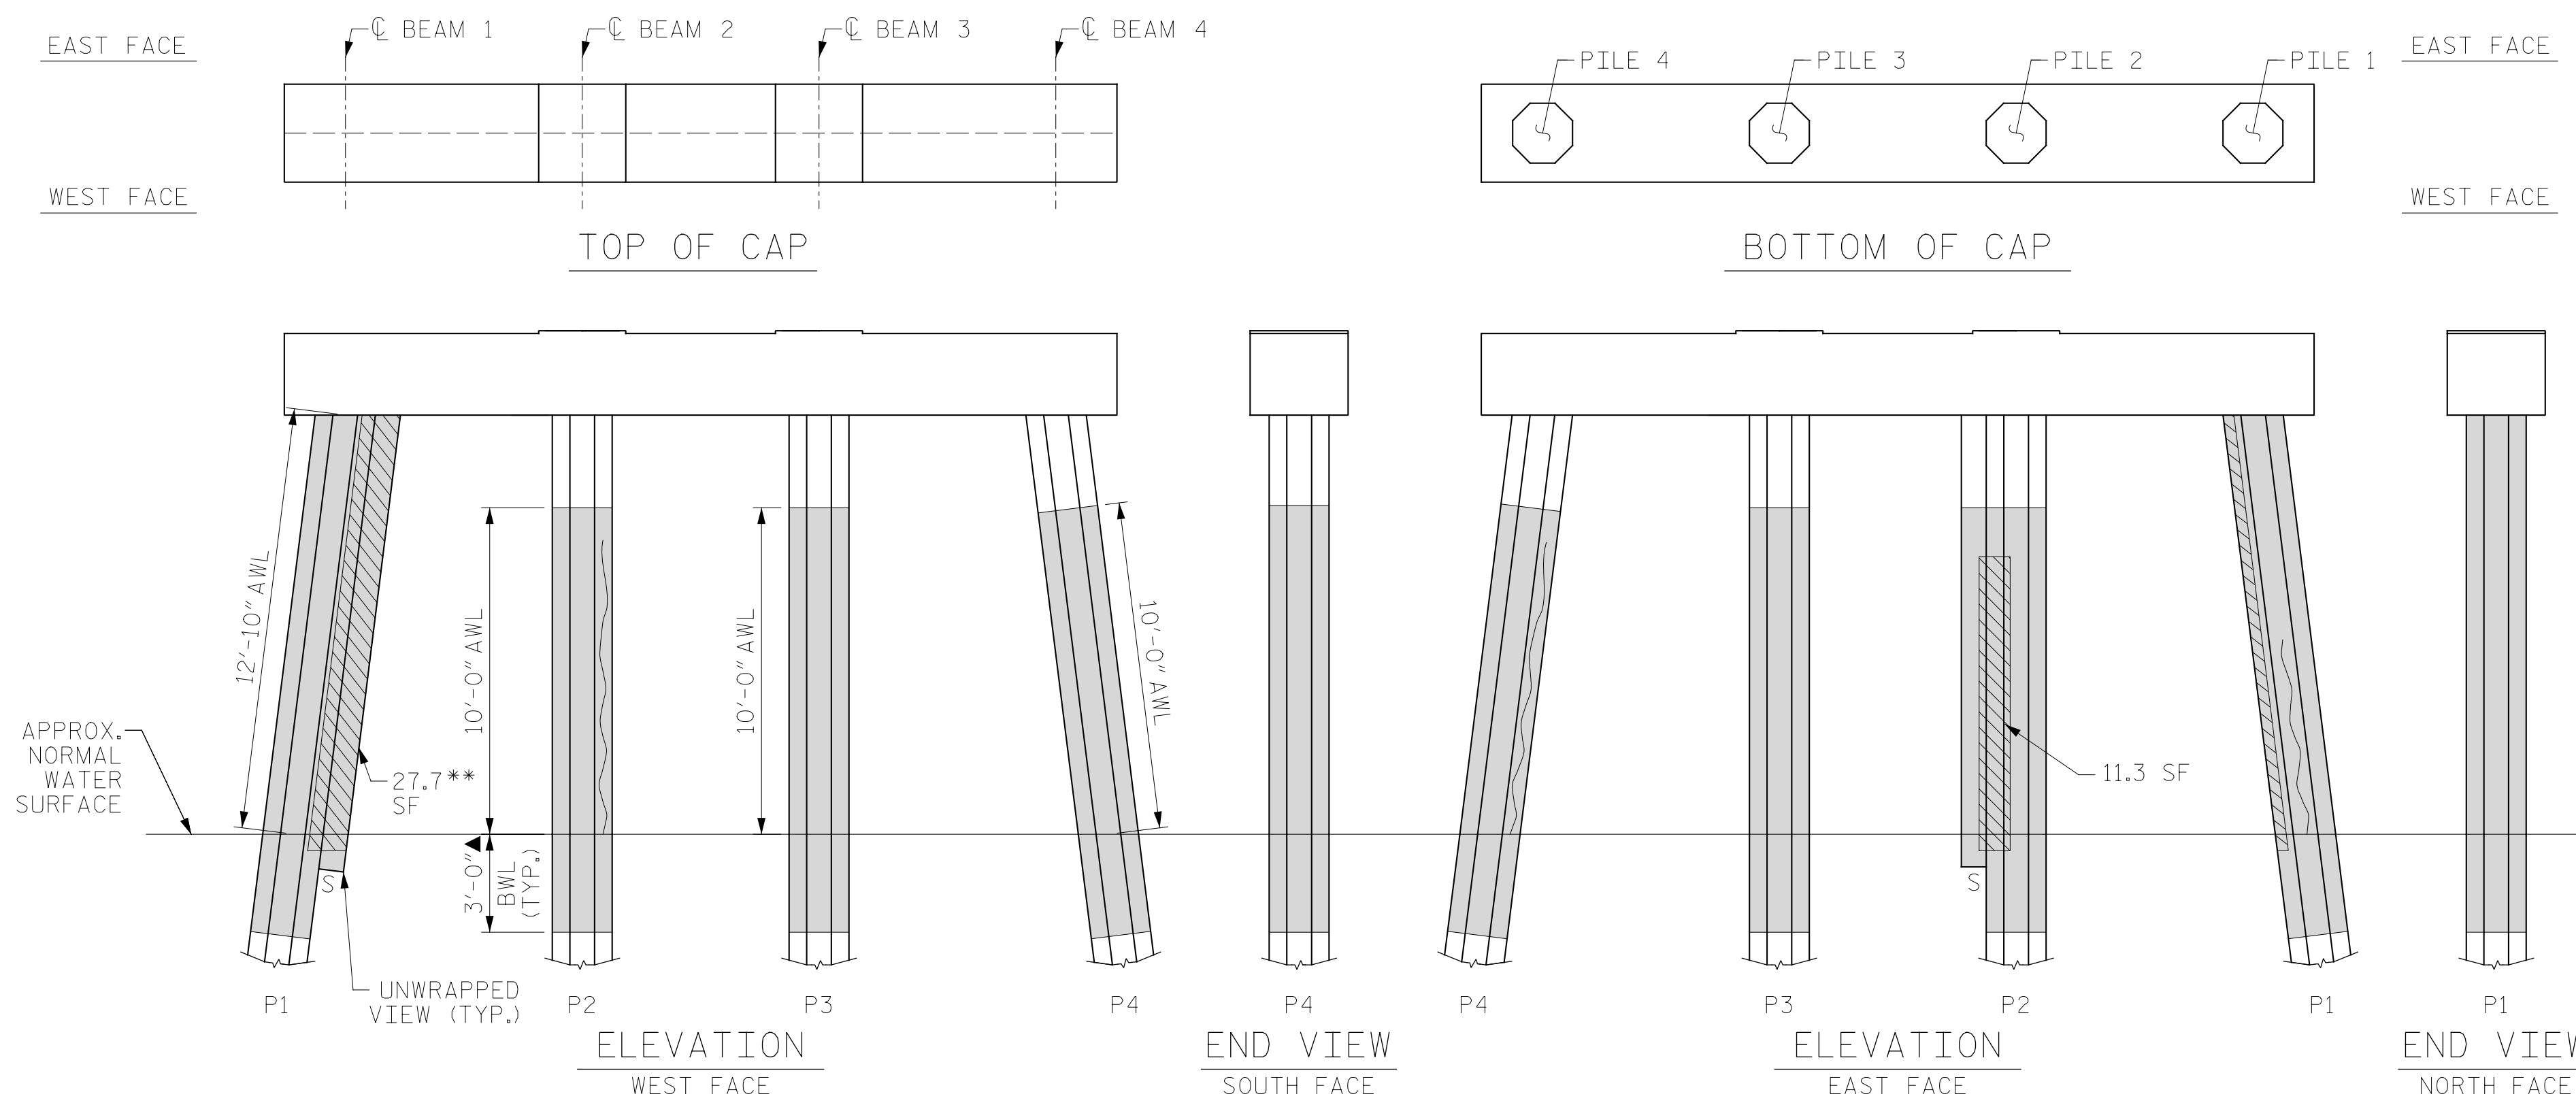
BENT 208

CAP REPAIRS			
SHOTCRETE REPAIRS	- SF	- CF	SF CF
EPOXY RESIN INJECTION	- LF		LF
PILE REPAIRS			
PILE CONCRETE RESTORATION	38.9 SF	15.7 CF	SF CF
FRP PROTECTIVE SYSTEM AWL	261.3 SF		
FRP PROTECTIVE SYSTEM BWL	73.2 SF

(AWL = ABOVE WATERLINE)
(BWL = BELOW WATERLINE)
(*QUANTITY INCLUDES ADJACENT REPAIRS)
