AS-BUILT REPAIR QUANTITY TABLE

PROJECT NO. HB-0017  
DARE COUNTY  
BRIDGE NO. 270009

STATE OF NORTH CAROLINA  
DEPARTMENT OF TRANSPORTATION  
RALEIGH

BENT 209 & BENT 210

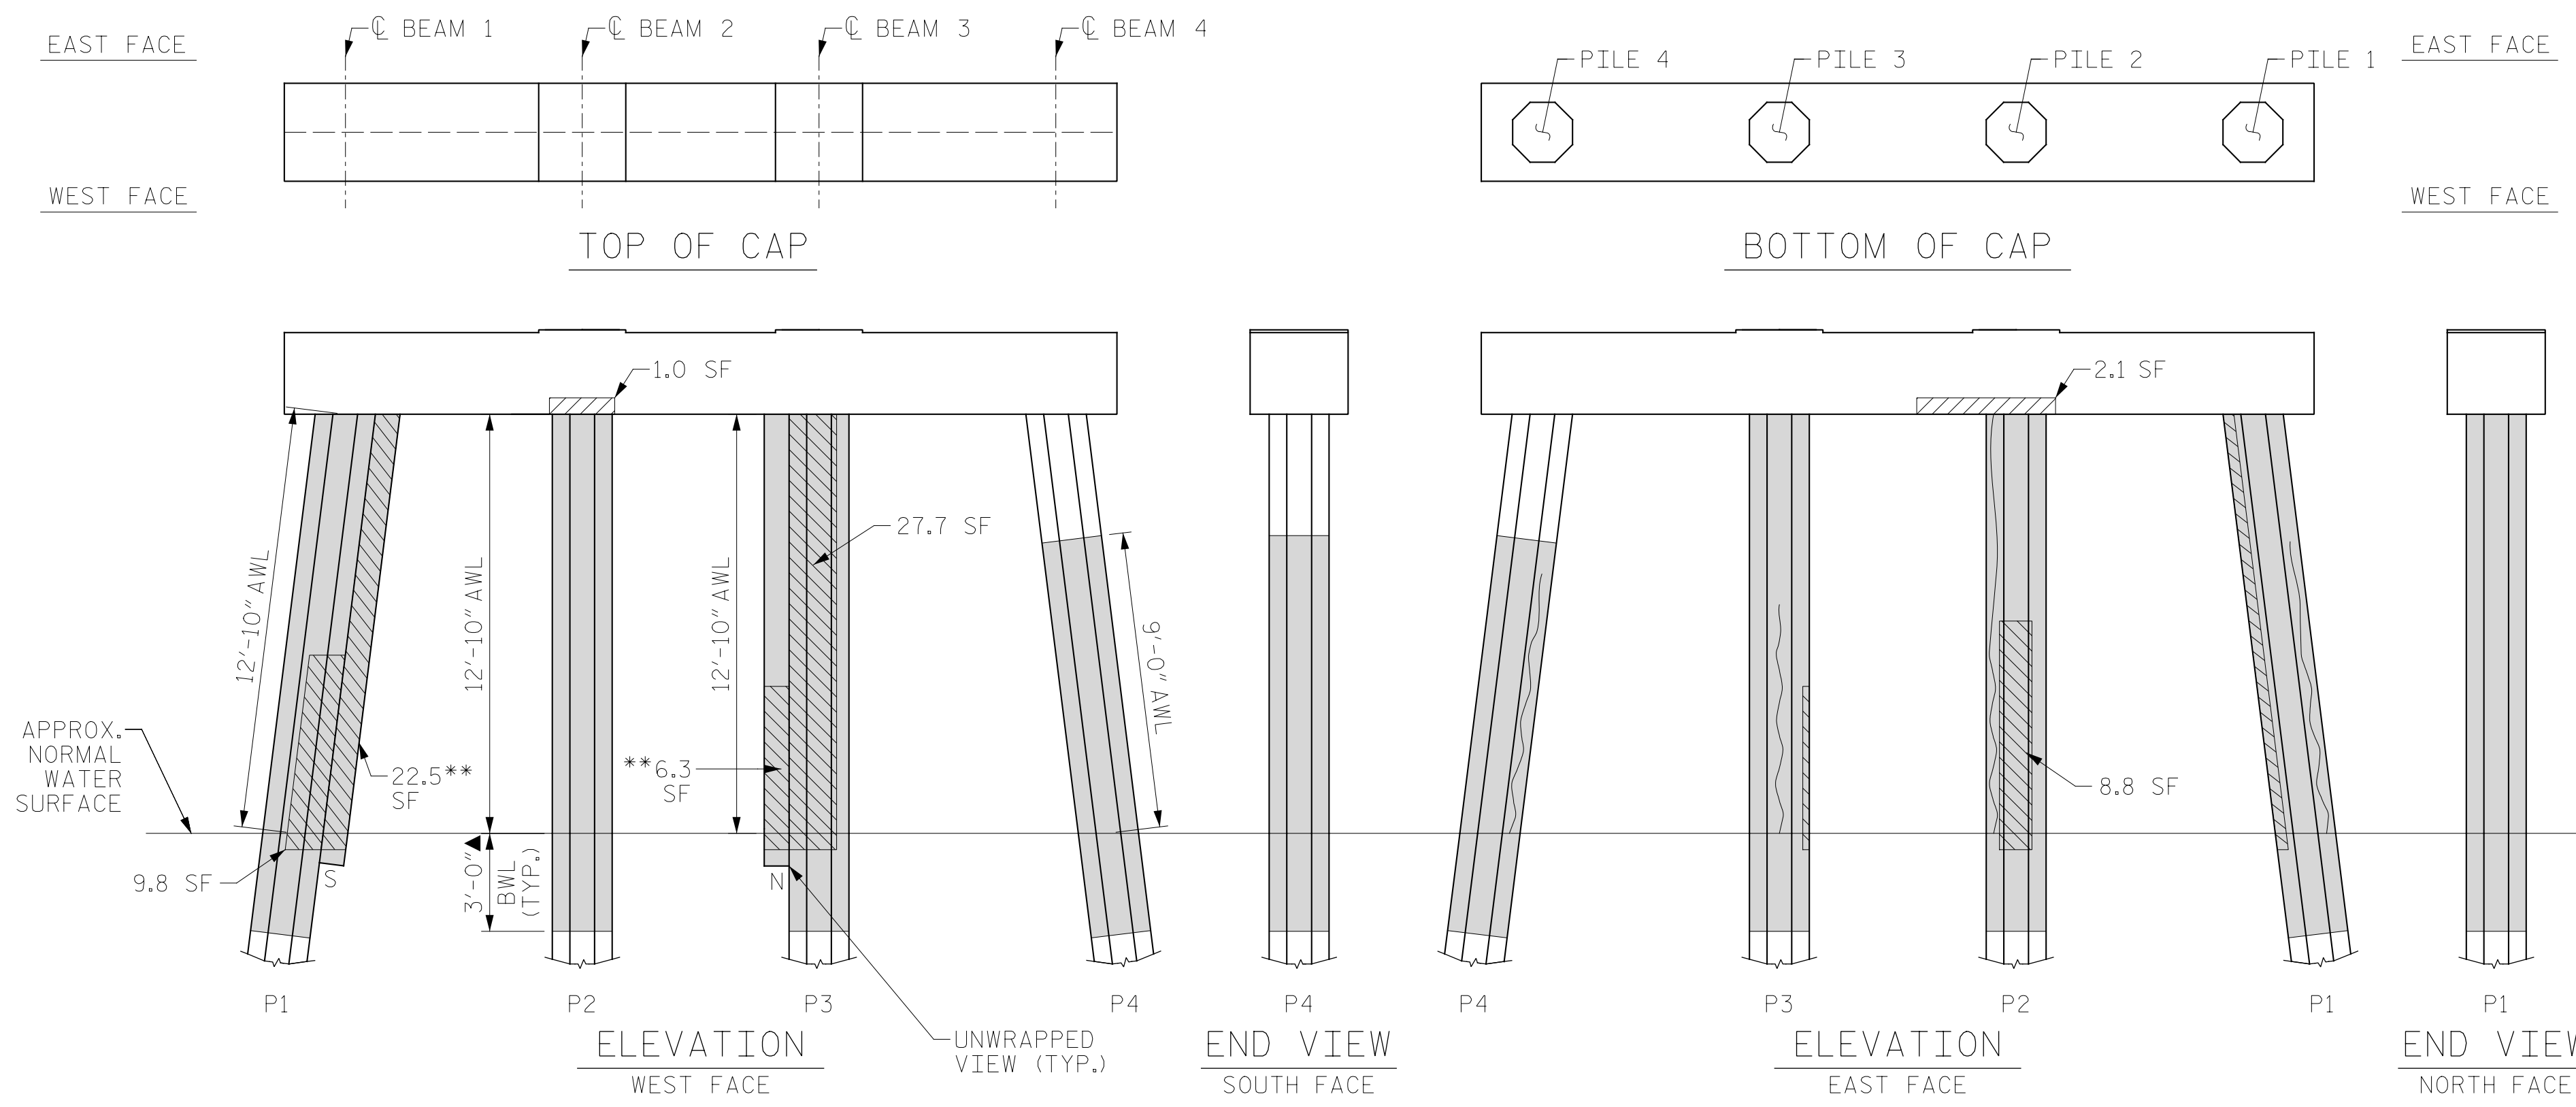
BENT 209

CAP REPAIRS			
SHOTCRETE REPAIRS	3.1 SF	1.6 CF	SF CF
EPOXY RESIN INJECTION	- LF		LF
PILE REPAIRS			
PILE CONCRETE RESTORATION	74.9 SF	31.8 CF	SF CF
FRP PROTECTIVE SYSTEM AWL	289.8 SF		
FRP PROTECTIVE SYSTEM BWL	73.2 SF

(AWL = ABOVE WATERLINE)  
(BWL = BELOW WATERLINE)  
(\*QUANTITY INCLUDES ADJACENT REPAIRS)

FOR CAP REPAIRS: VALUES IN CHART REPRESENT ESTIMATED REPAIR TOTALS AFTER REMOVAL OF UNSOUND CONCRETE, MIN. OF 1" BEHIND REBAR AND MIN. 2" CL. TO SAWCUT. SEE REPAIR DETAILS.

FOR SHOTCRETE REPAIRS, SEE SPECIAL PROVISIONS.  
FOR CONCRETE REPAIR DETAILS, SEE "TYPICAL CAP, COLUMN & UNDERDECK REPAIR DETAILS" & "PILE CONCRETE RESTORATION DETAILS" SHEETS.  
FOR PILE CONCRETE RESTORATION, SEE SPECIAL PROVISIONS.  
FOR FRP PROTECTIVE SYSTEM, SEE SPECIAL PROVISIONS.  
FOR FRP PROTECTIVE SYSTEM DETAILS AND UNDERWATER MORTAR REPAIRS, SEE "PILE FRP PROTECTIVE SYSTEM DETAILS" SHEET.

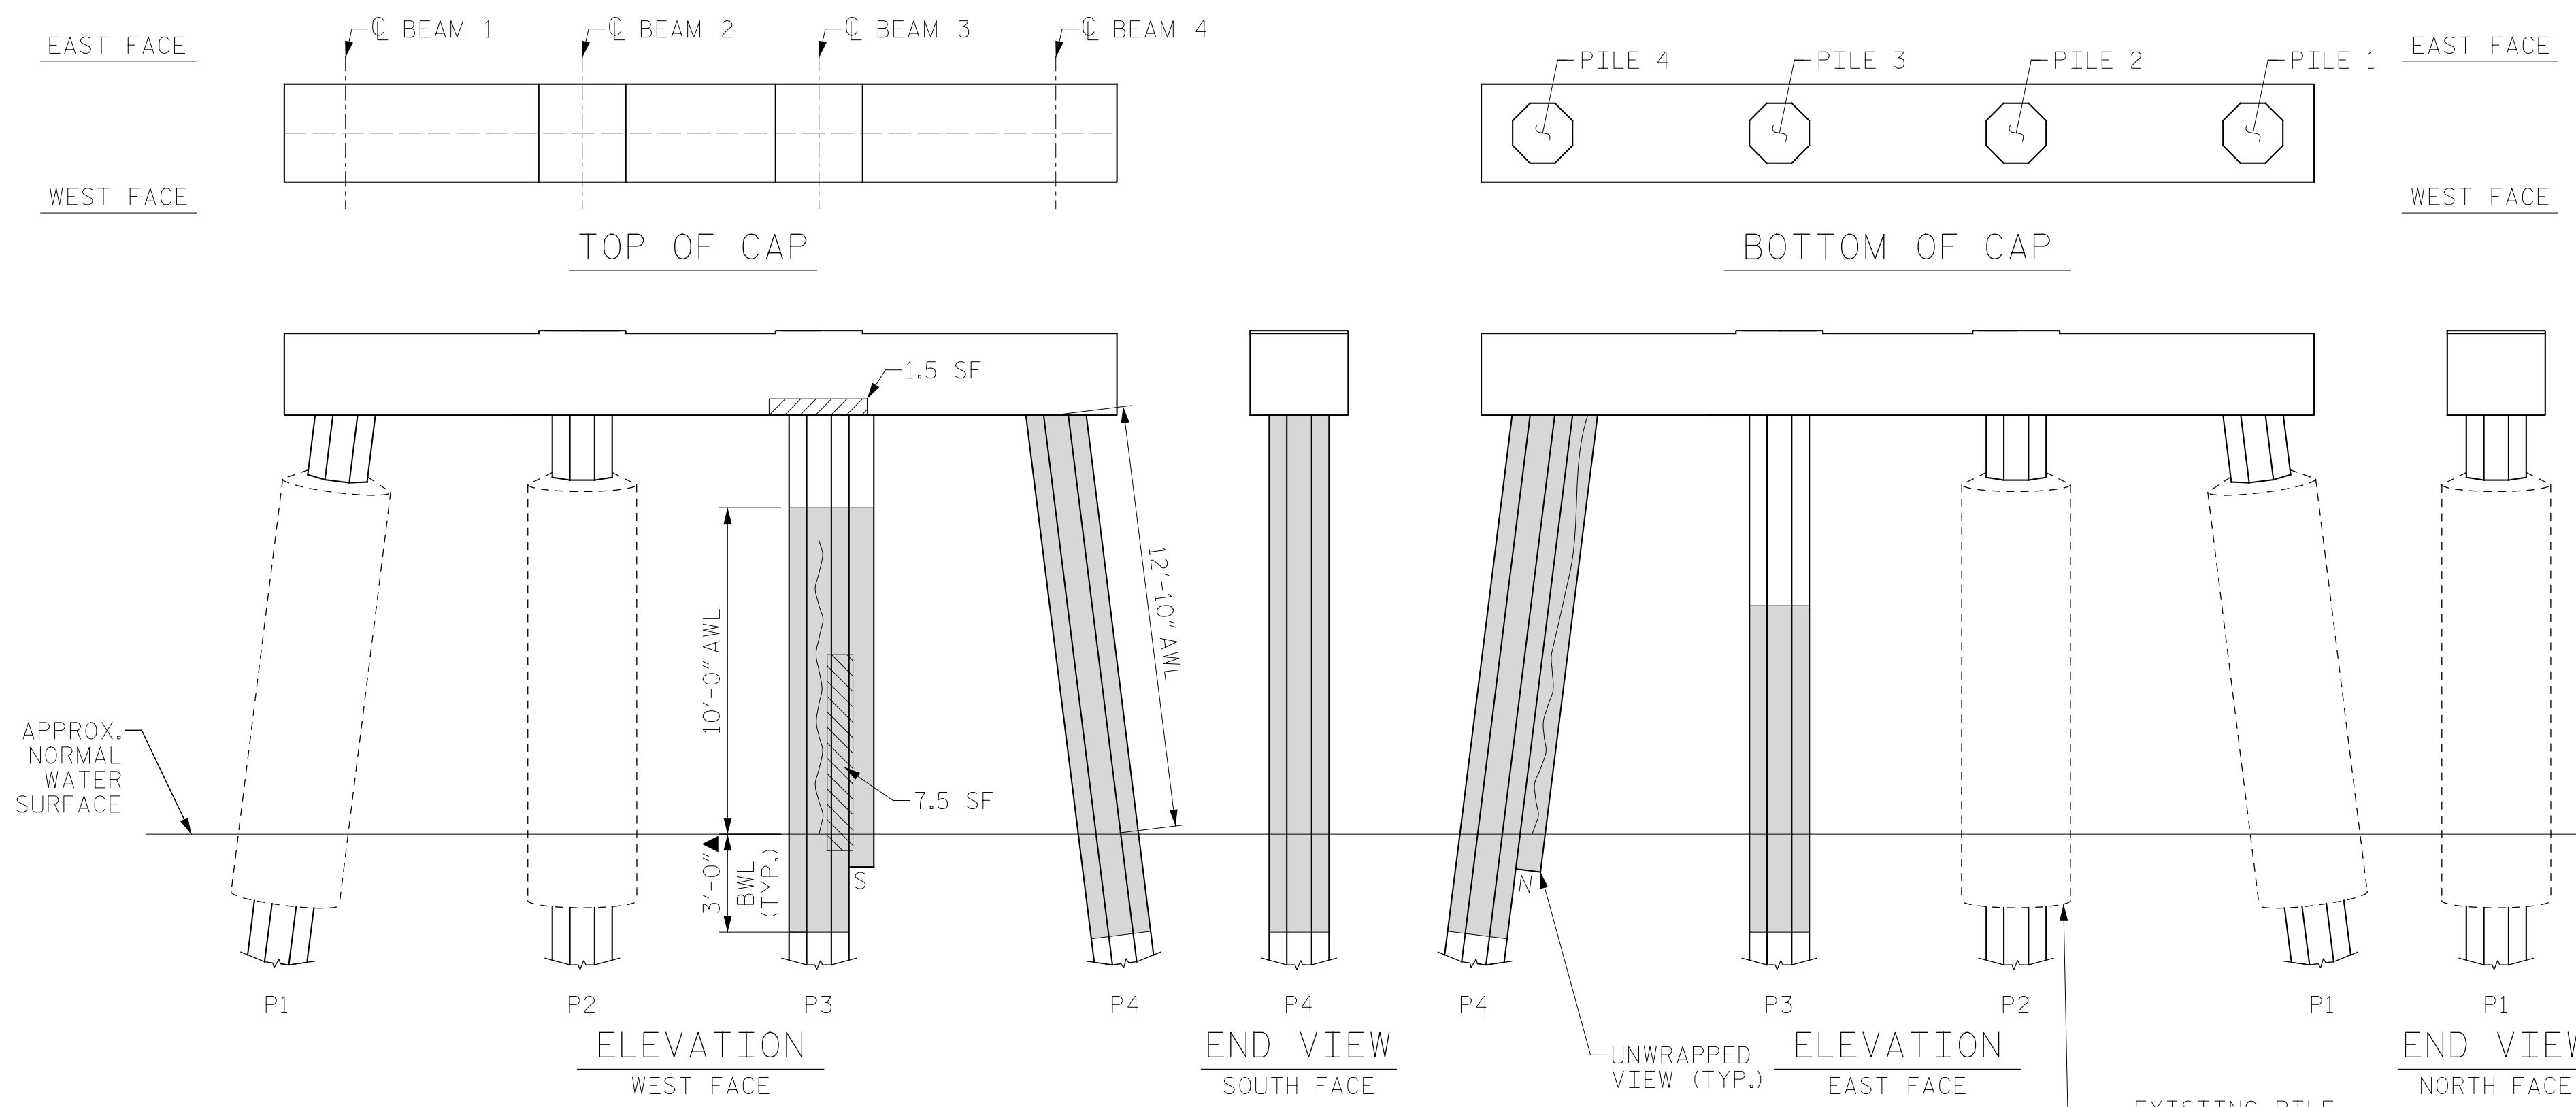
BENT 210

CAP REPAIRS			
SHOTCRETE REPAIRS	1.5 SF	0.8 CF	SF CF
EPOXY RESIN INJECTION	- LF		LF
PILE REPAIRS			
PILE CONCRETE RESTORATION	7.5 SF	3.2 CF	SF CF
FRP PROTECTIVE SYSTEM AWL	139.3 SF		
FRP PROTECTIVE SYSTEM BWL	36.6 SF

(AWL = ABOVE WATERLINE)  
(BWL = BELOW WATERLINE)  
(\*QUANTITY INCLUDES ADJACENT REPAIRS)
