AS-BUILT REPAIR QUANTITY TABLE

PROJECT NO. HB-0017
DARE COUNTY
BRIDGE NO. 270009

BENT 211 & BENT 212

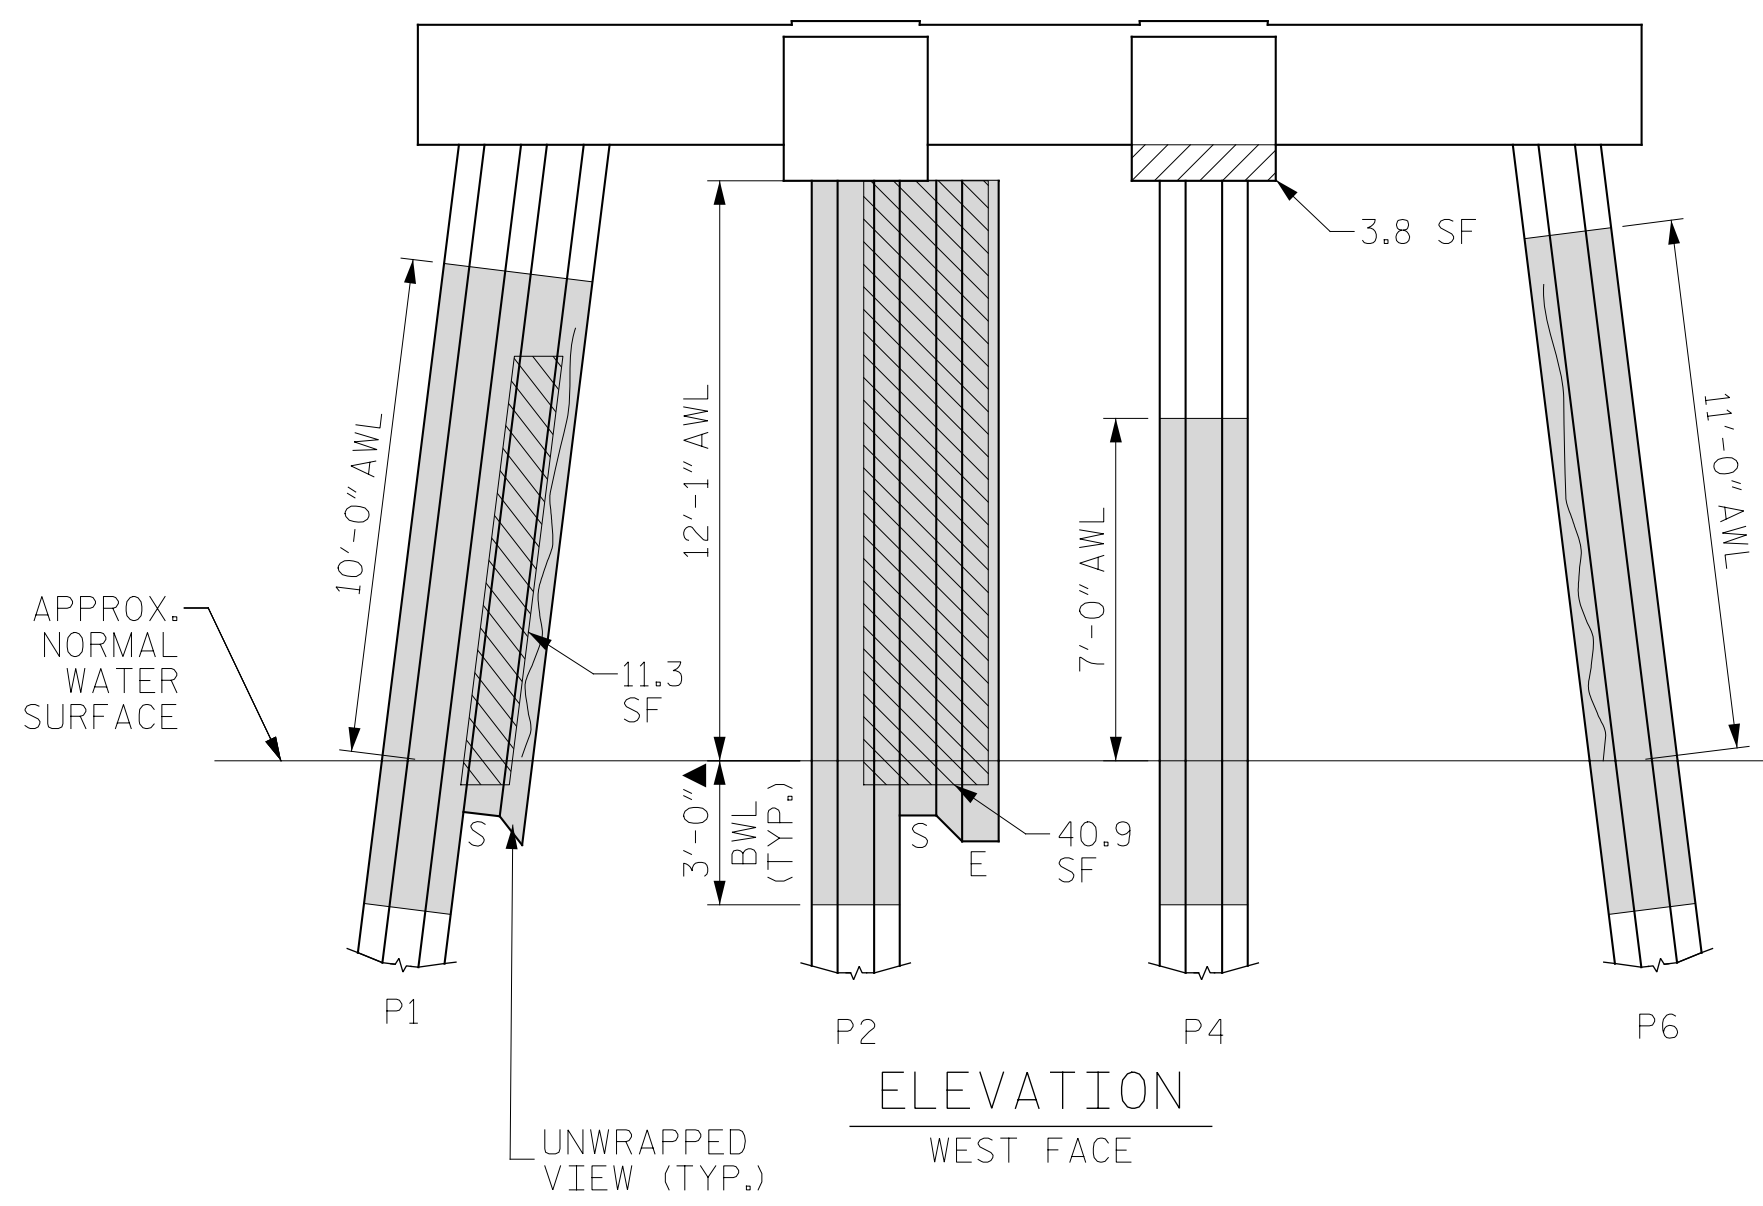
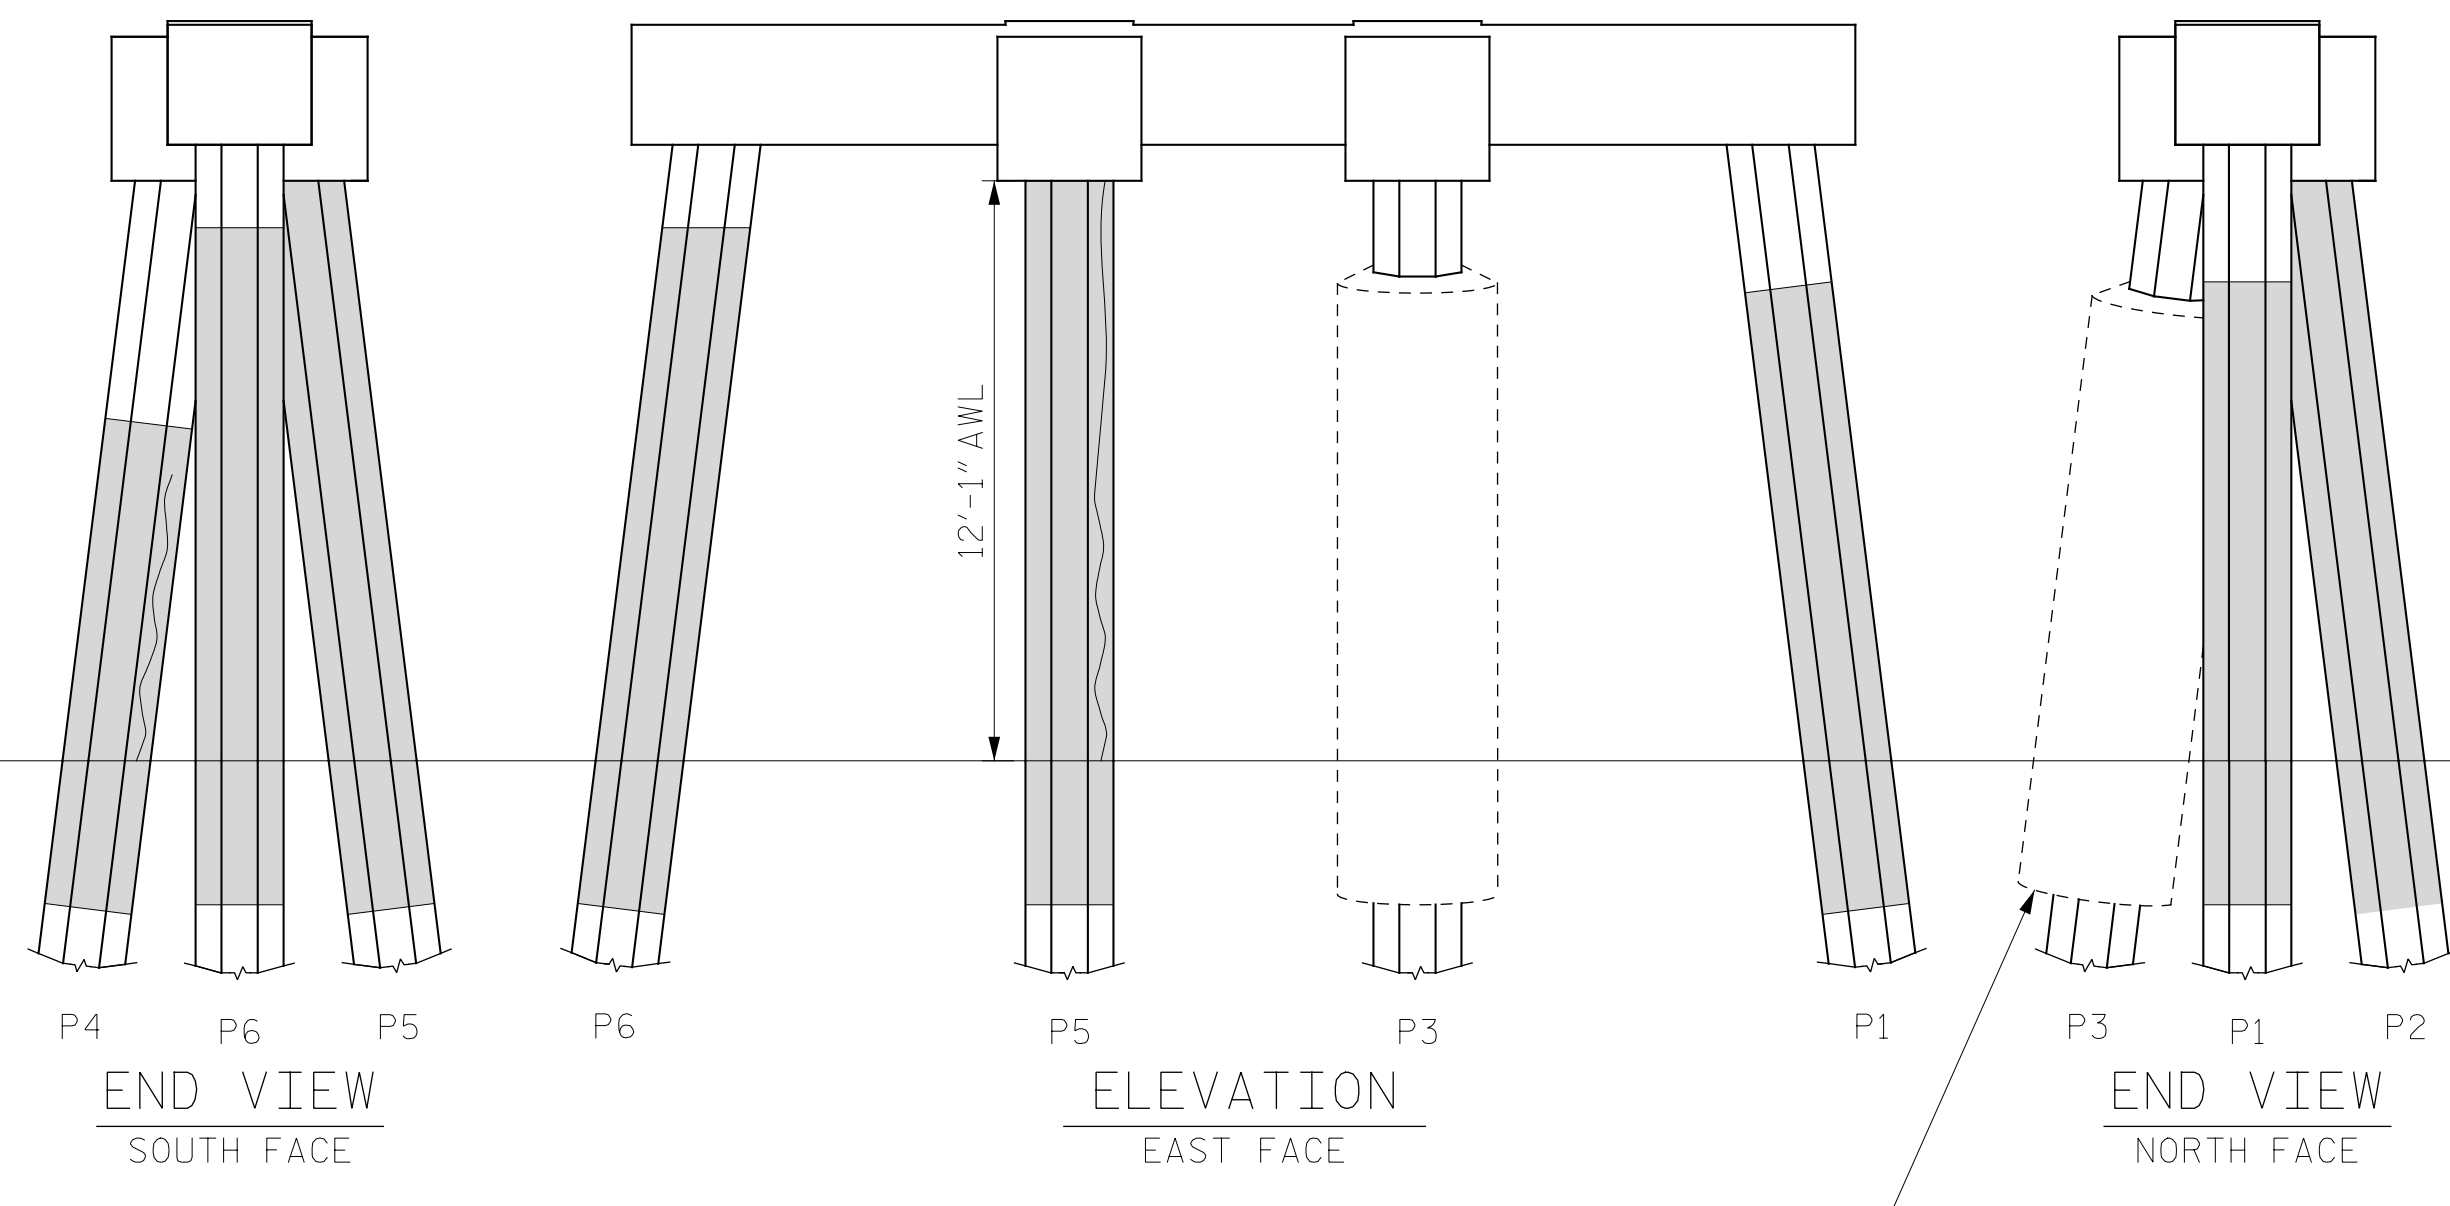
BENT 211

CAP REPAIRS			
SHOTCRETE REPAIRS	3.8 SF	1.9 CF	SF CF
EPOXY RESIN INJECTION	- LF		LF
PILE REPAIRS			
PILE CONCRETE RESTORATION	52.1 SF	21.1 CF	SF CF
FRP PROTECTIVE SYSTEM AWL	318.2 SF		
FRP PROTECTIVE SYSTEM BWL	91.5 SF

(AWL = ABOVE WATERLINE)
(BWL = BELOW WATERLINE)
(**QUANTITY INCLUDES ADJACENT REPAIRS)

FOR CAP REPAIRS: VALUES IN CHART REPRESENT ESTIMATED REPAIR TOTALS AFTER REMOVAL OF UNSOUND CONCRETE, MIN. OF 1" BEHIND REBAR AND MIN. 2" CL. TO SAWCUT. SEE REPAIR DETAILS.

FOR SHOTCRETE REPAIRS, SEE SPECIAL PROVISIONS.
FOR CONCRETE REPAIR DETAILS, SEE "TYPICAL CAP, COLUMN & UNDERDECK REPAIR DETAILS" & "PILE CONCRETE RESTORATION DETAILS" SHEETS.
FOR PILE CONCRETE RESTORATION, SEE SPECIAL PROVISIONS.
FOR FRP PROTECTIVE SYSTEM, SEE SPECIAL PROVISIONS.
FOR FRP PROTECTIVE SYSTEM DETAILS AND UNDERWATER MORTAR REPAIRS, SEE "PILE FRP PROTECTIVE SYSTEM DETAILS" SHEET.

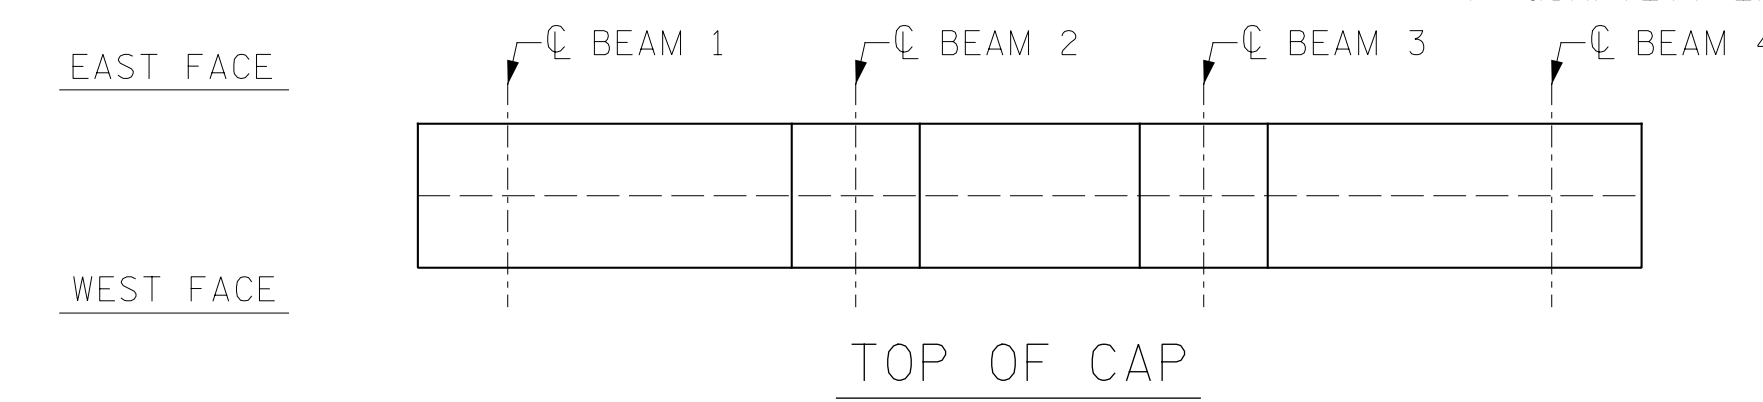
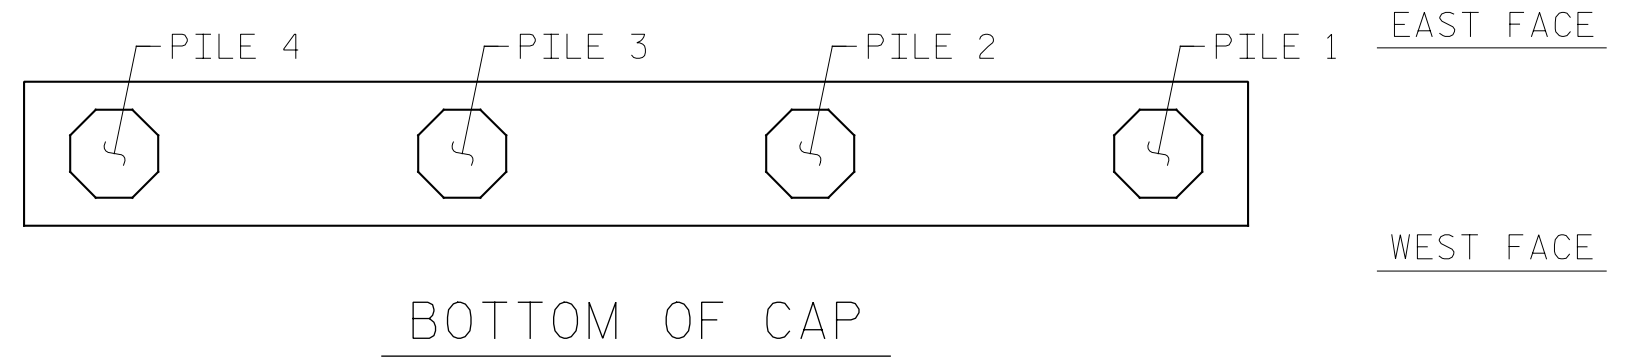
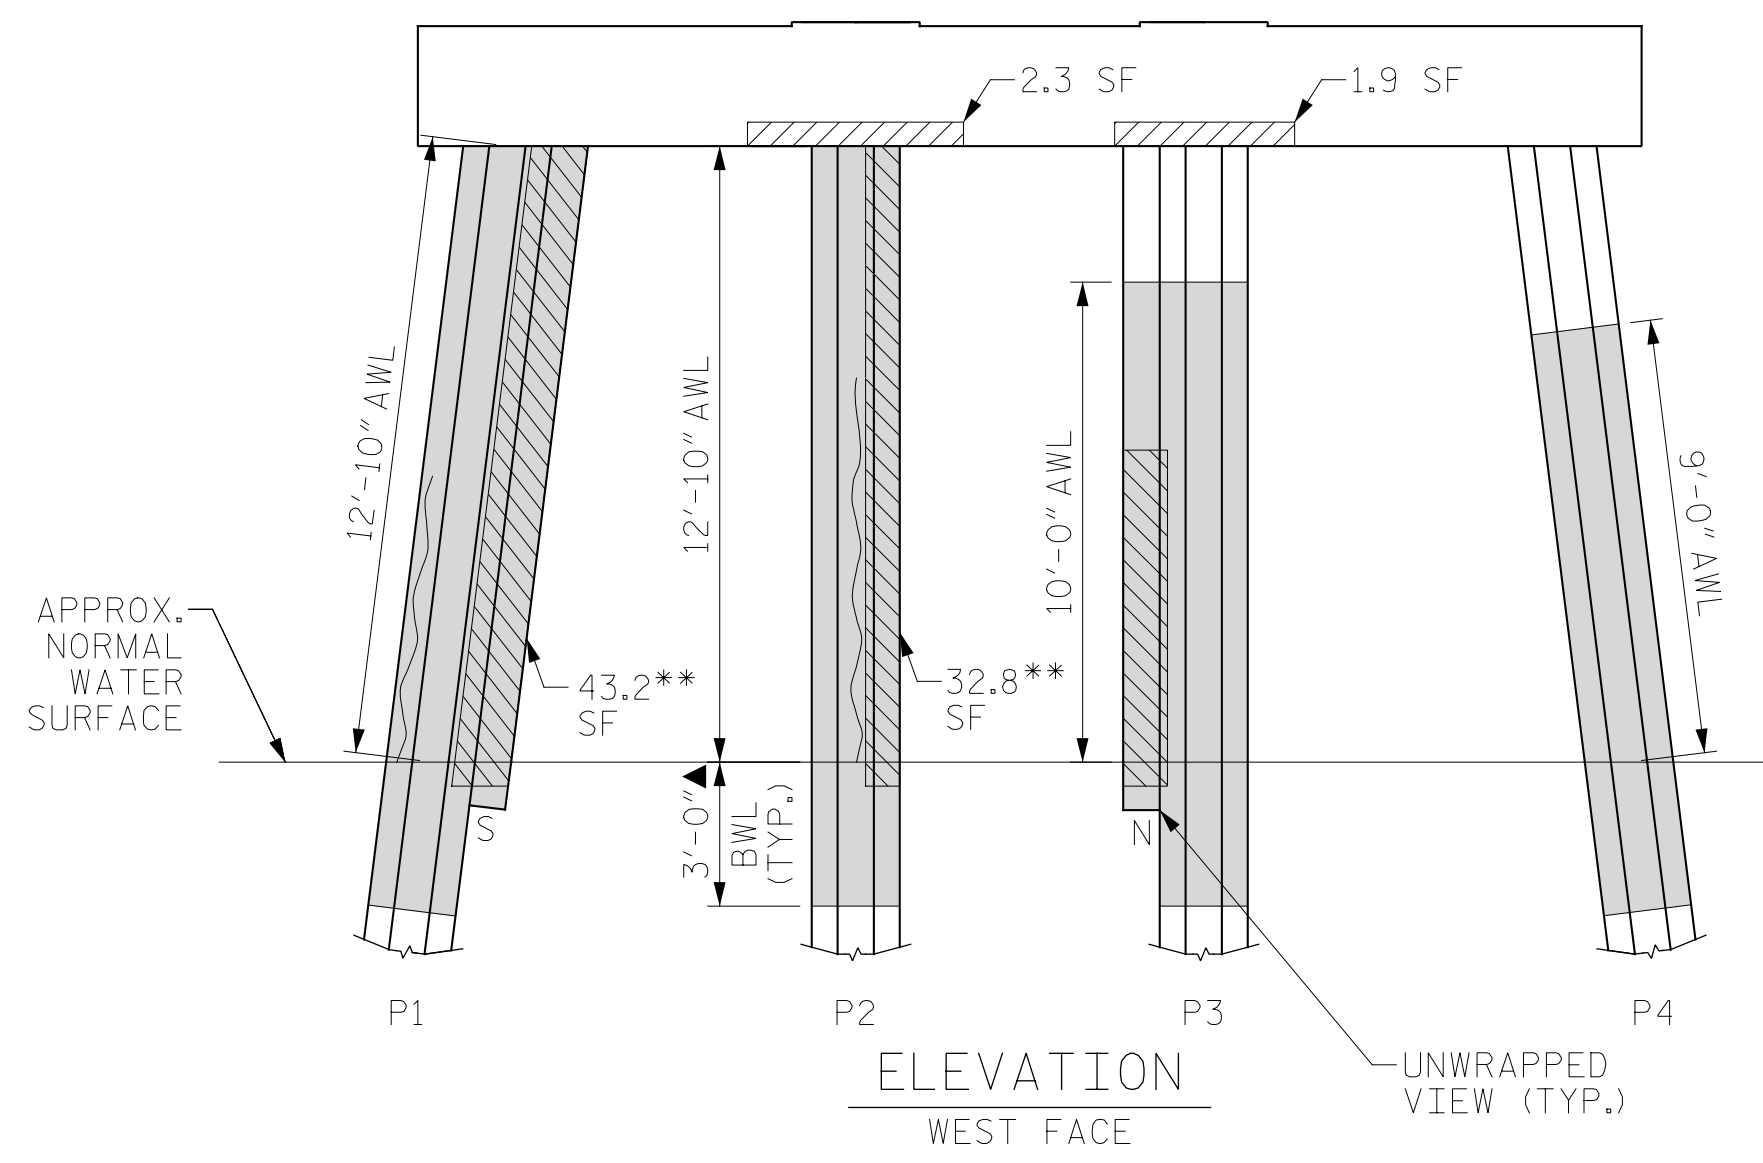
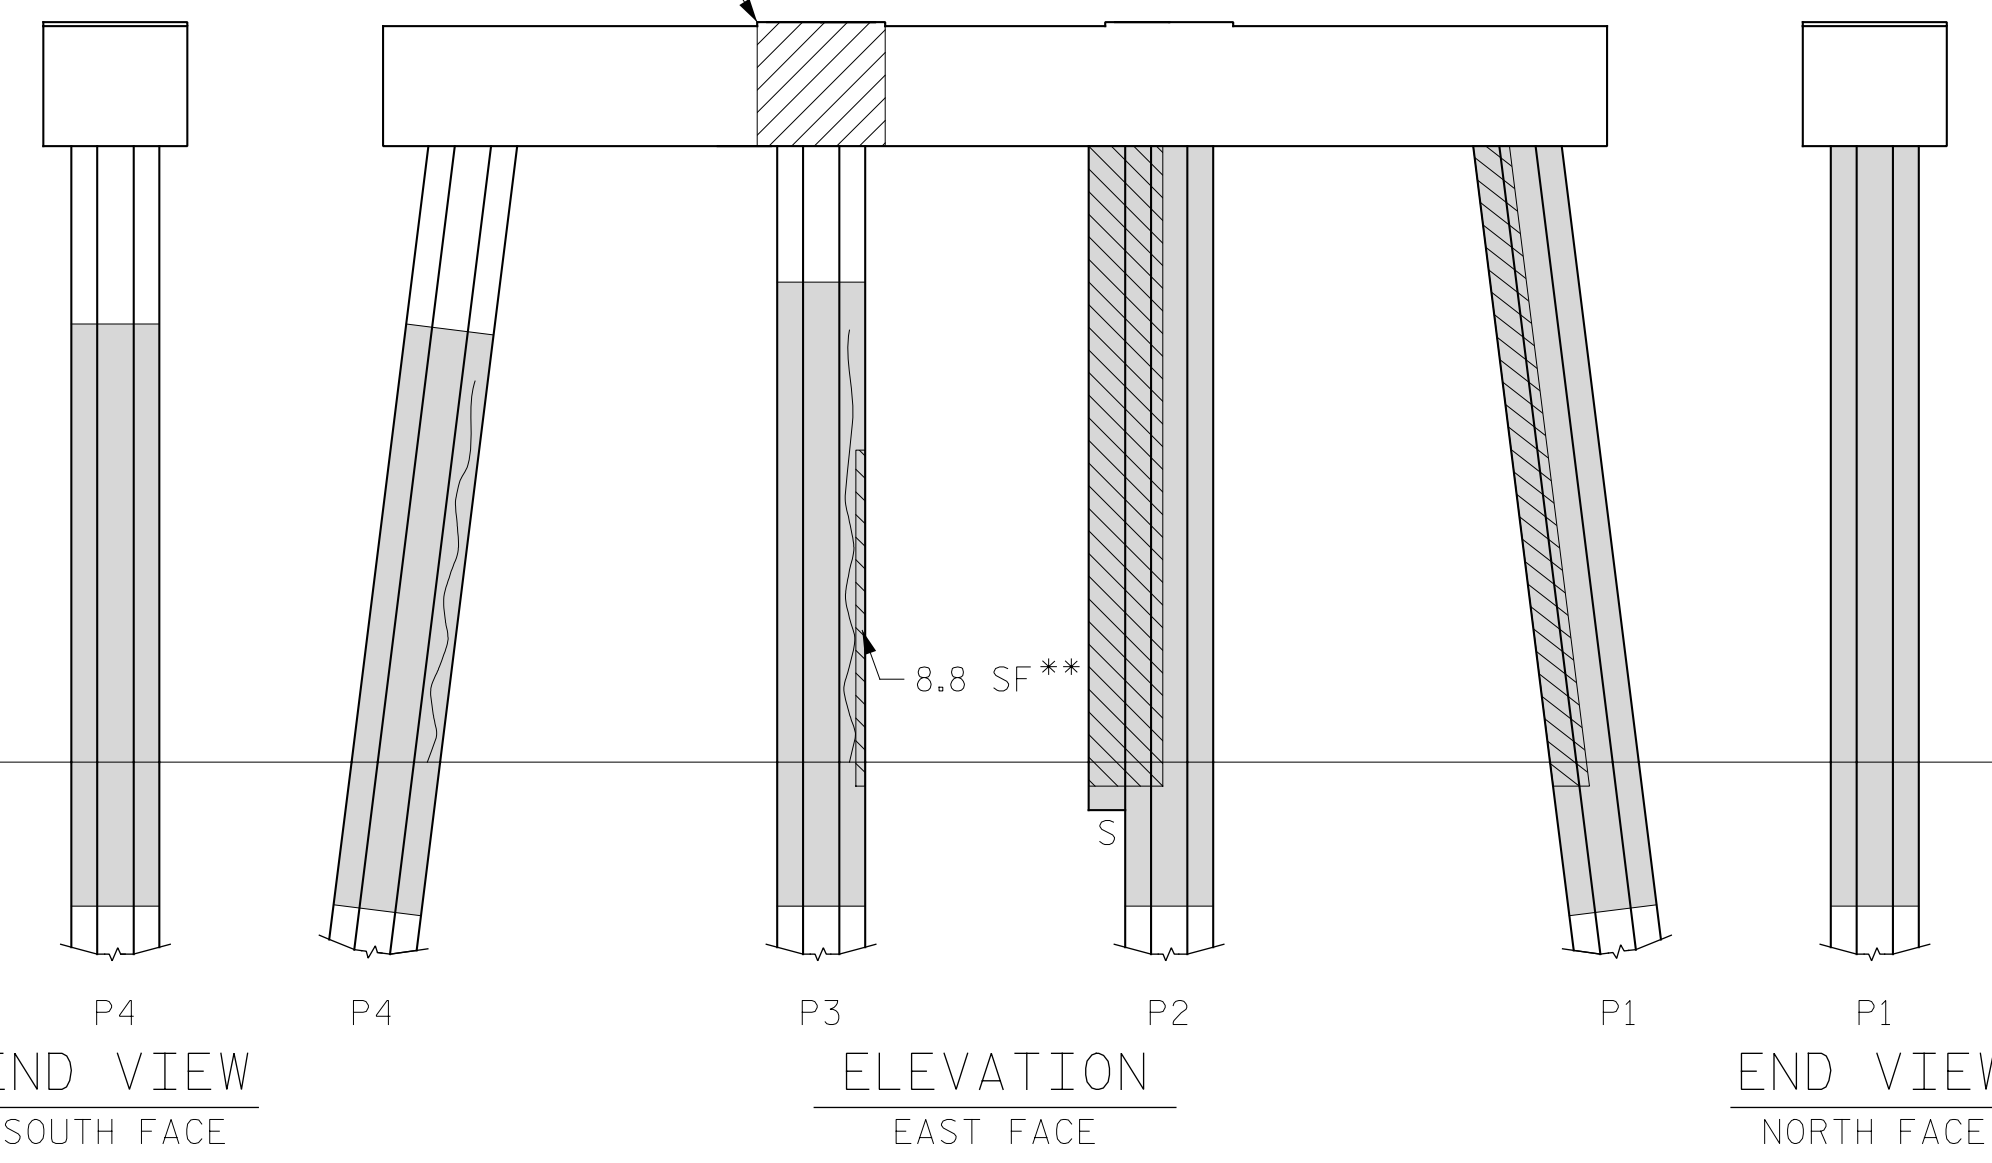
BENT 212

CAP REPAIRS			
SHOTCRETE REPAIRS	11.1 SF	5.6 CF	SF CF
EPOXY RESIN INJECTION	- LF		LF
PILE REPAIRS			
PILE CONCRETE RESTORATION	84.8 SF	34.3 CF	SF CF
FRP PROTECTIVE SYSTEM AWL	272.5 SF		
FRP PROTECTIVE SYSTEM BWL	73.2 SF

(AWL = ABOVE WATERLINE)
(BWL = BELOW WATERLINE)
(**QUANTITY INCLUDES ADJACENT REPAIRS)
