AS-BUILT REPAIR QUANTITY TABLE

PROJECT NO. HB-0017  
DARE COUNTY  
BRIDGE NO. 270009

BENT 225 & BENT 226

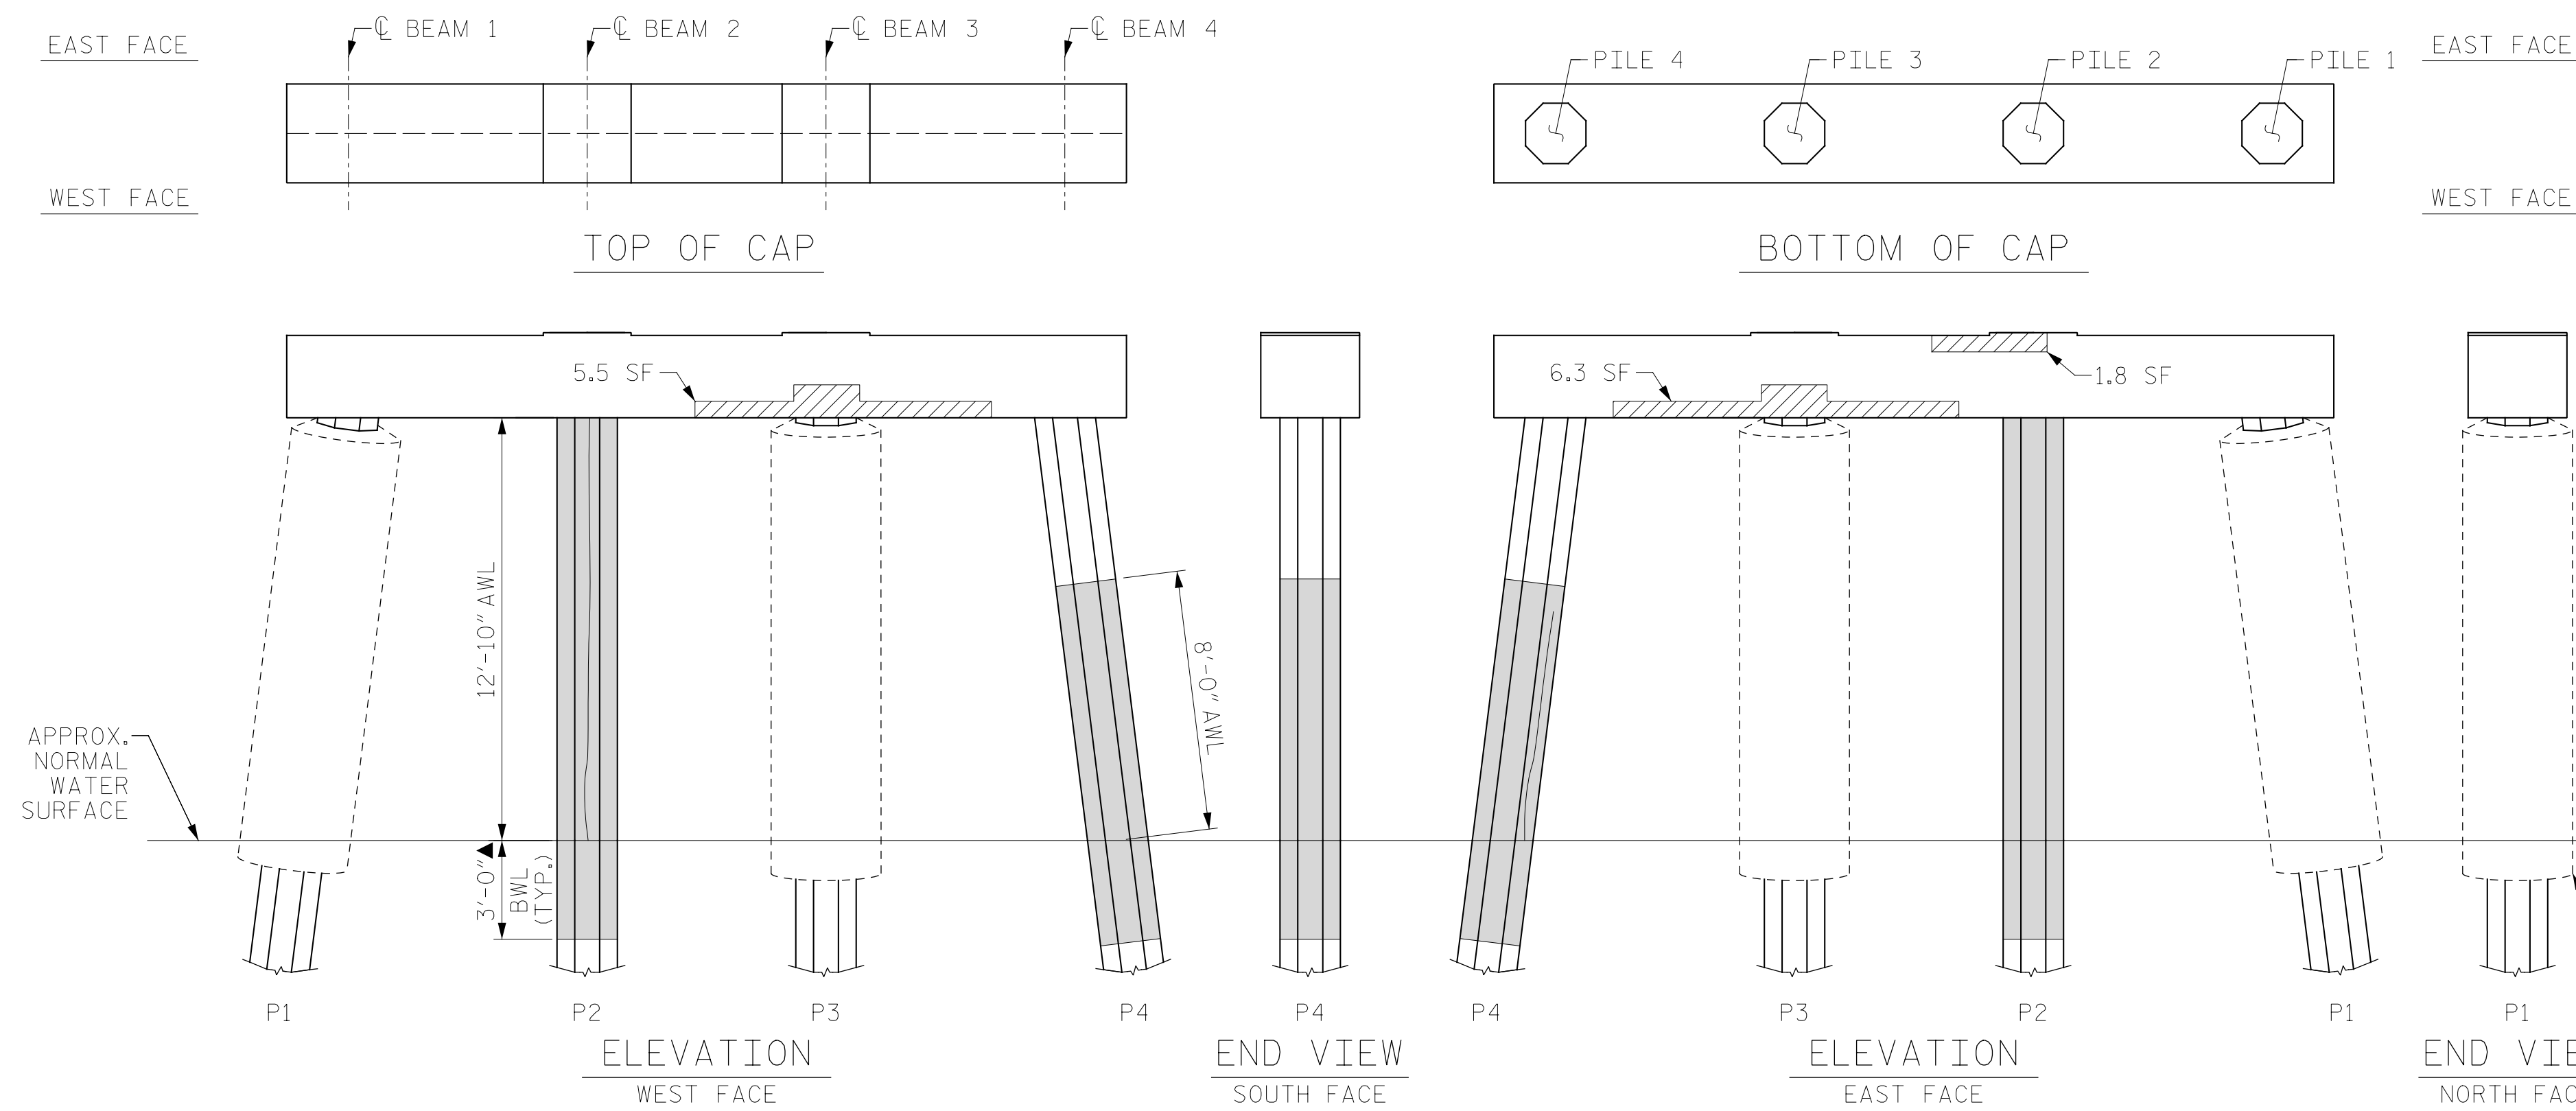
BENT 225

CAP REPAIRS				
SHOTCRETE REPAIRS	13.6 SF	6.8 CF	SF	CF
EPOXY RESIN INJECTION	- LF			LF
PILE REPAIRS				
PILE CONCRETE RESTORATION	- SF	- CF	SF	CF
FRP PROTECTIVE SYSTEM AWL	114.6 SF			
FRP PROTECTIVE SYSTEM BWL	33.0 SF

FOR CAP REPAIRS: VALUES IN CHART REPRESENT ESTIMATED REPAIR TOTALS AFTER REMOVAL OF UNSOUND CONCRETE, MIN. OF 1" BEHIND REBAR AND MIN. 2" CL. TO SAWCUT. SEE REPAIR DETAILS.

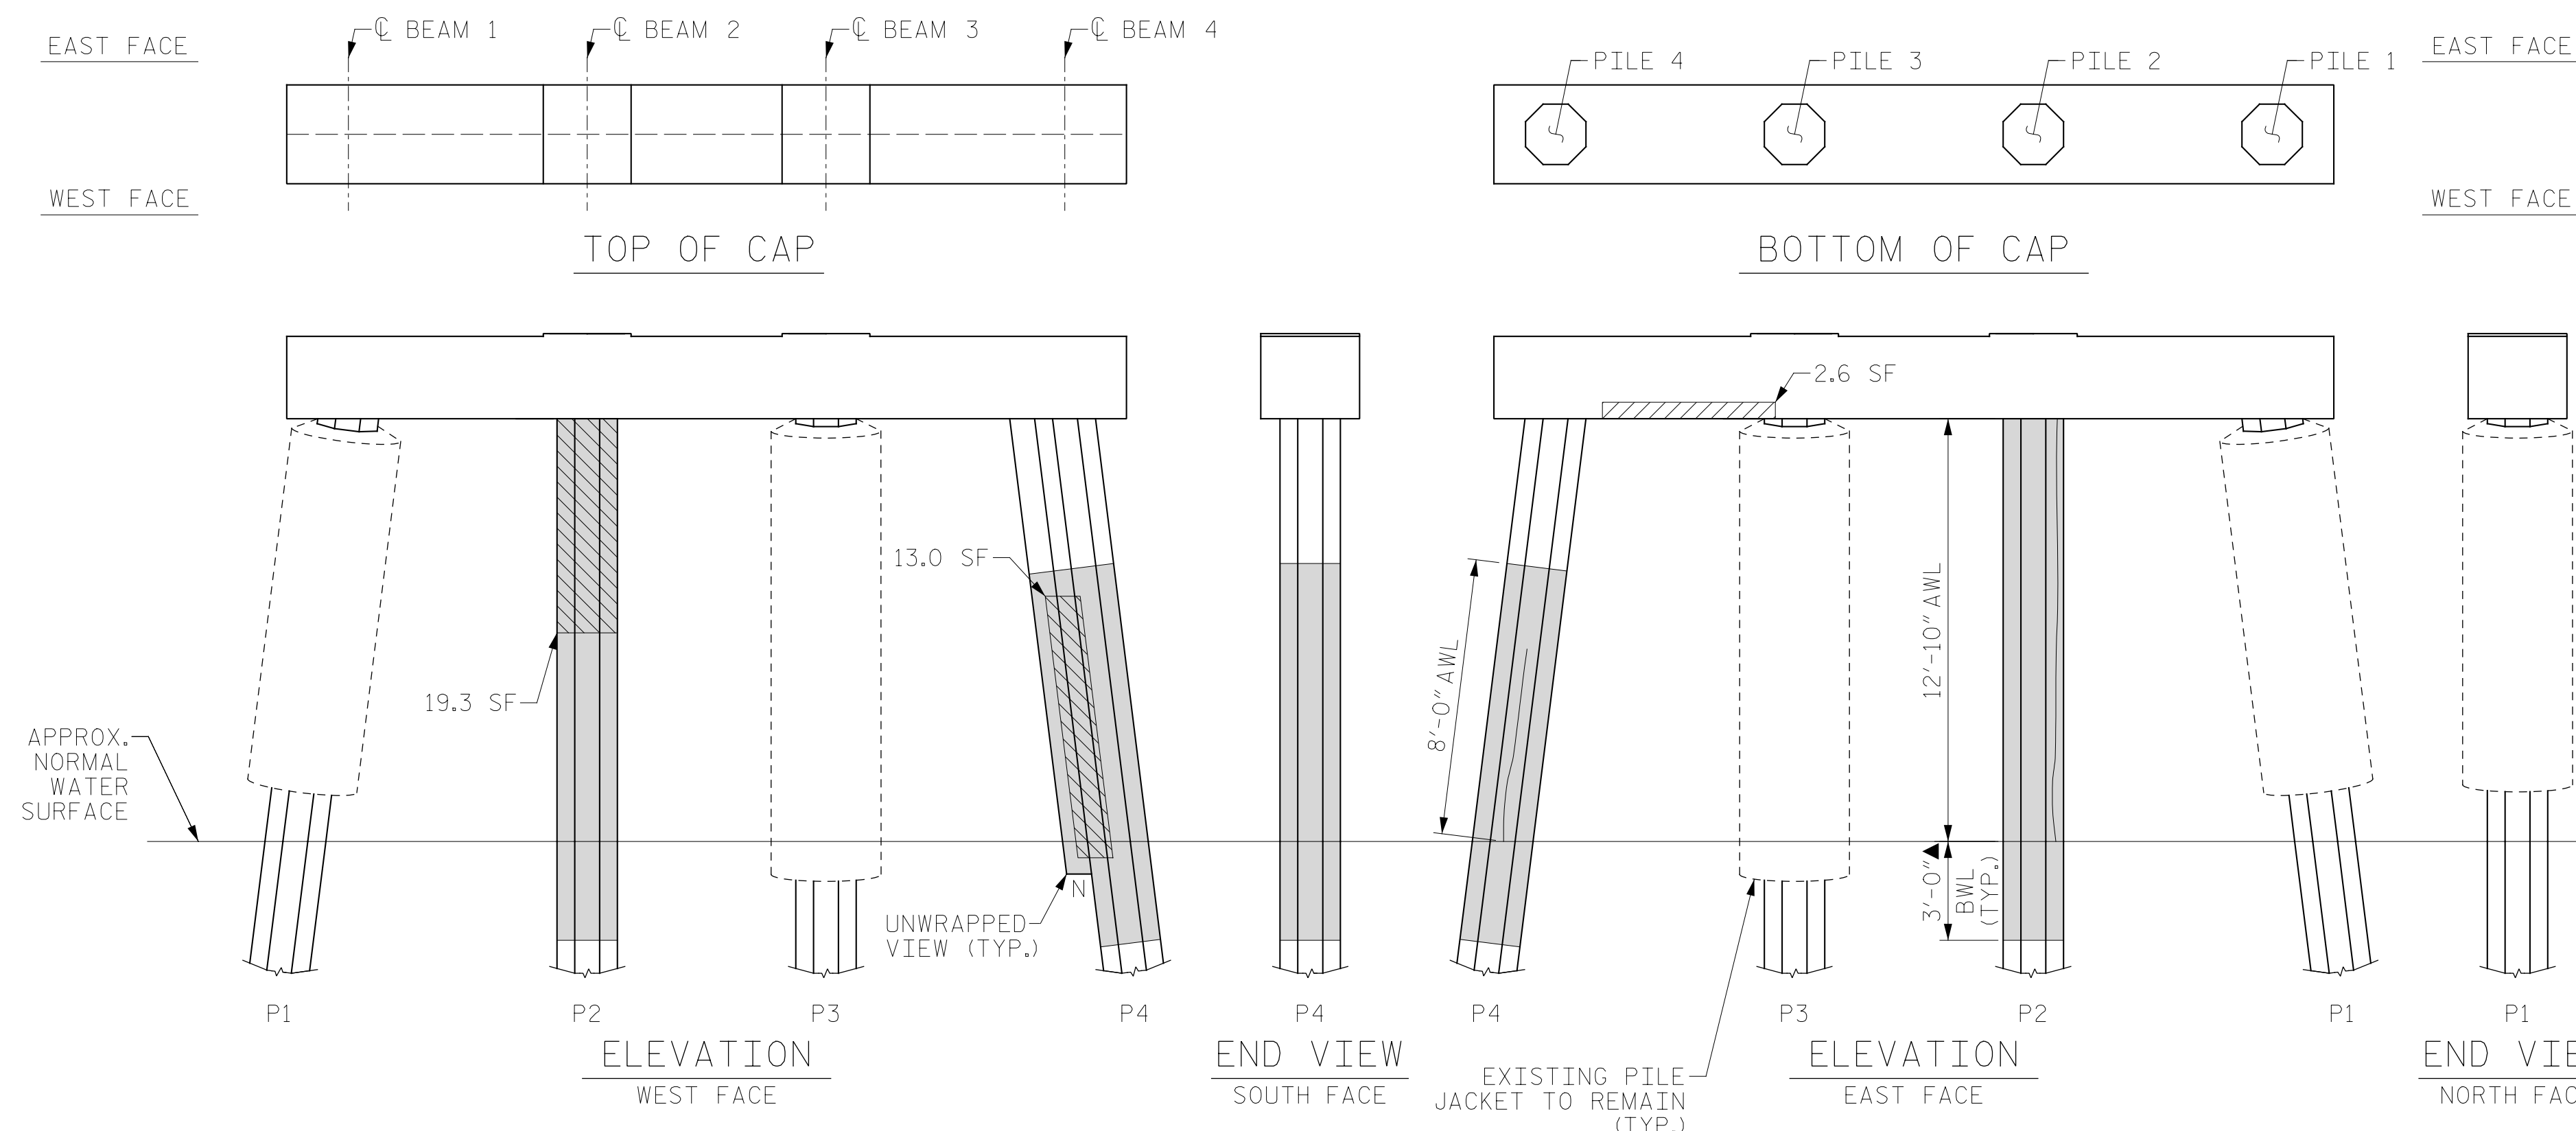
BENT 226

CAP REPAIRS				
SHOTCRETE REPAIRS	2.6 SF	1.3 CF	SF	CF
EPOXY RESIN INJECTION	- LF			LF
PILE REPAIRS				
PILE CONCRETE RESTORATION	32.3 SF	13.5 CF	SF	CF
FRP PROTECTIVE SYSTEM AWL	114.6 SF			
FRP PROTECTIVE SYSTEM BWL	33.0 SF
