AS-BUILT REPAIR QUANTITY TABLE

PROJECT NO. HB-0017  
DARE COUNTY  
BRIDGE NO. 270009

STATE OF NORTH CAROLINA  
DEPARTMENT OF TRANSPORTATION  
RALEIGH

BENT 229 & BENT 230

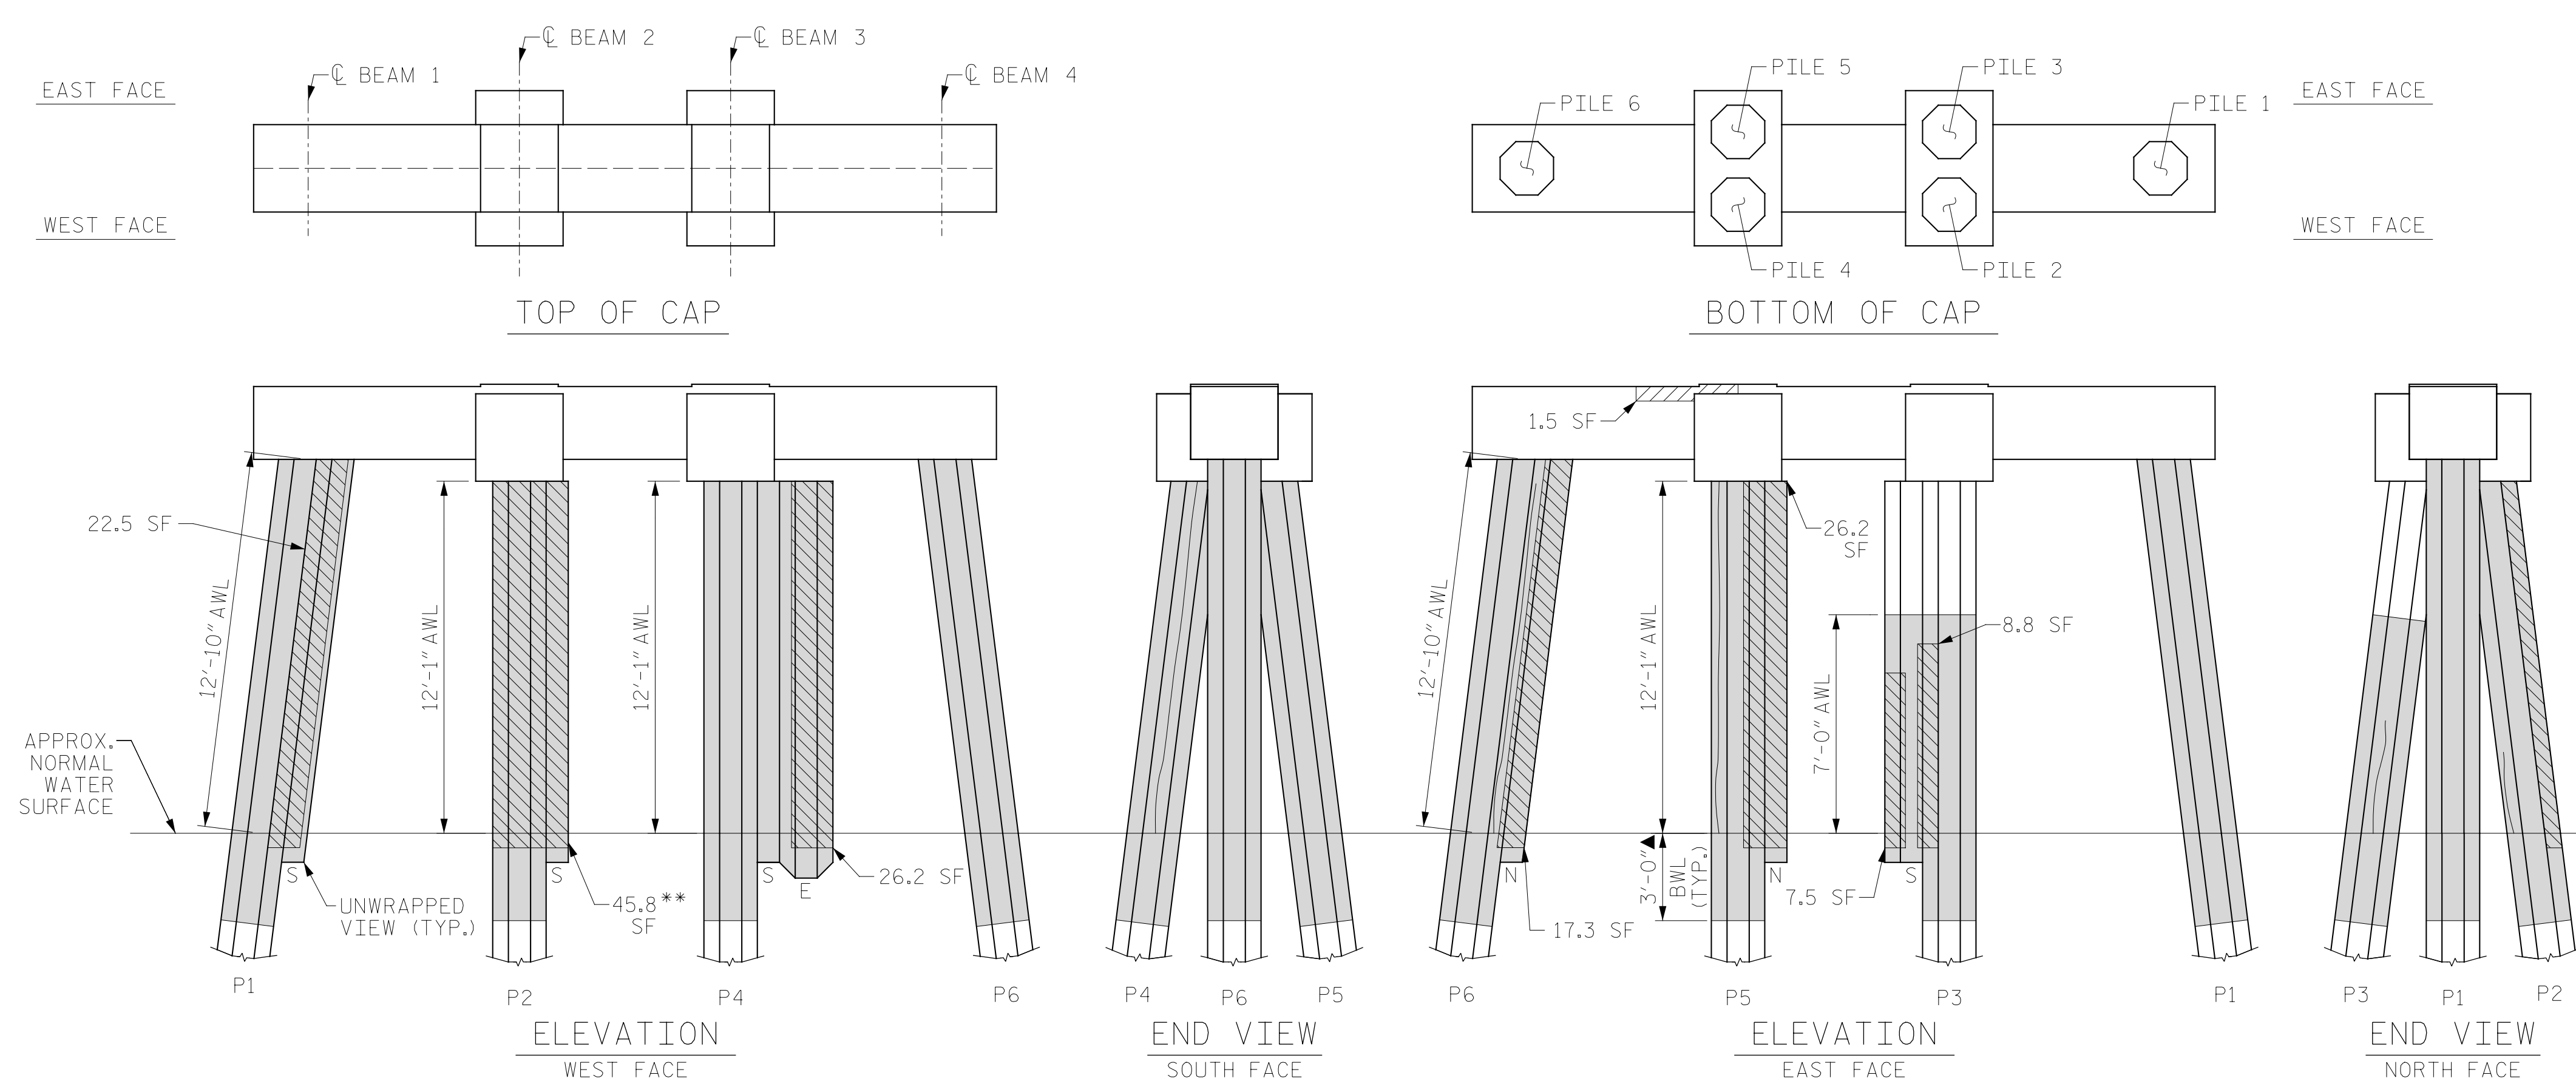
BENT 229

CAP REPAIRS			
SHOTCRETE REPAIRS	1.5 SF	0.8 CF	
EPOXY RESIN INJECTION	- LF		
PILE REPAIRS			
PILE CONCRETE RESTORATION	154.1 SF	61.9 SF	
FRP PROTECTIVE SYSTEM AWL	384.5 SF		
FRP PROTECTIVE SYSTEM BWL	99.0 SF

(AWL = ABOVE WATERLINE)  
(BWL = BELOW WATERLINE)  
(\*\*QUANTITY INCLUDES ADJACENT REPAIRS)

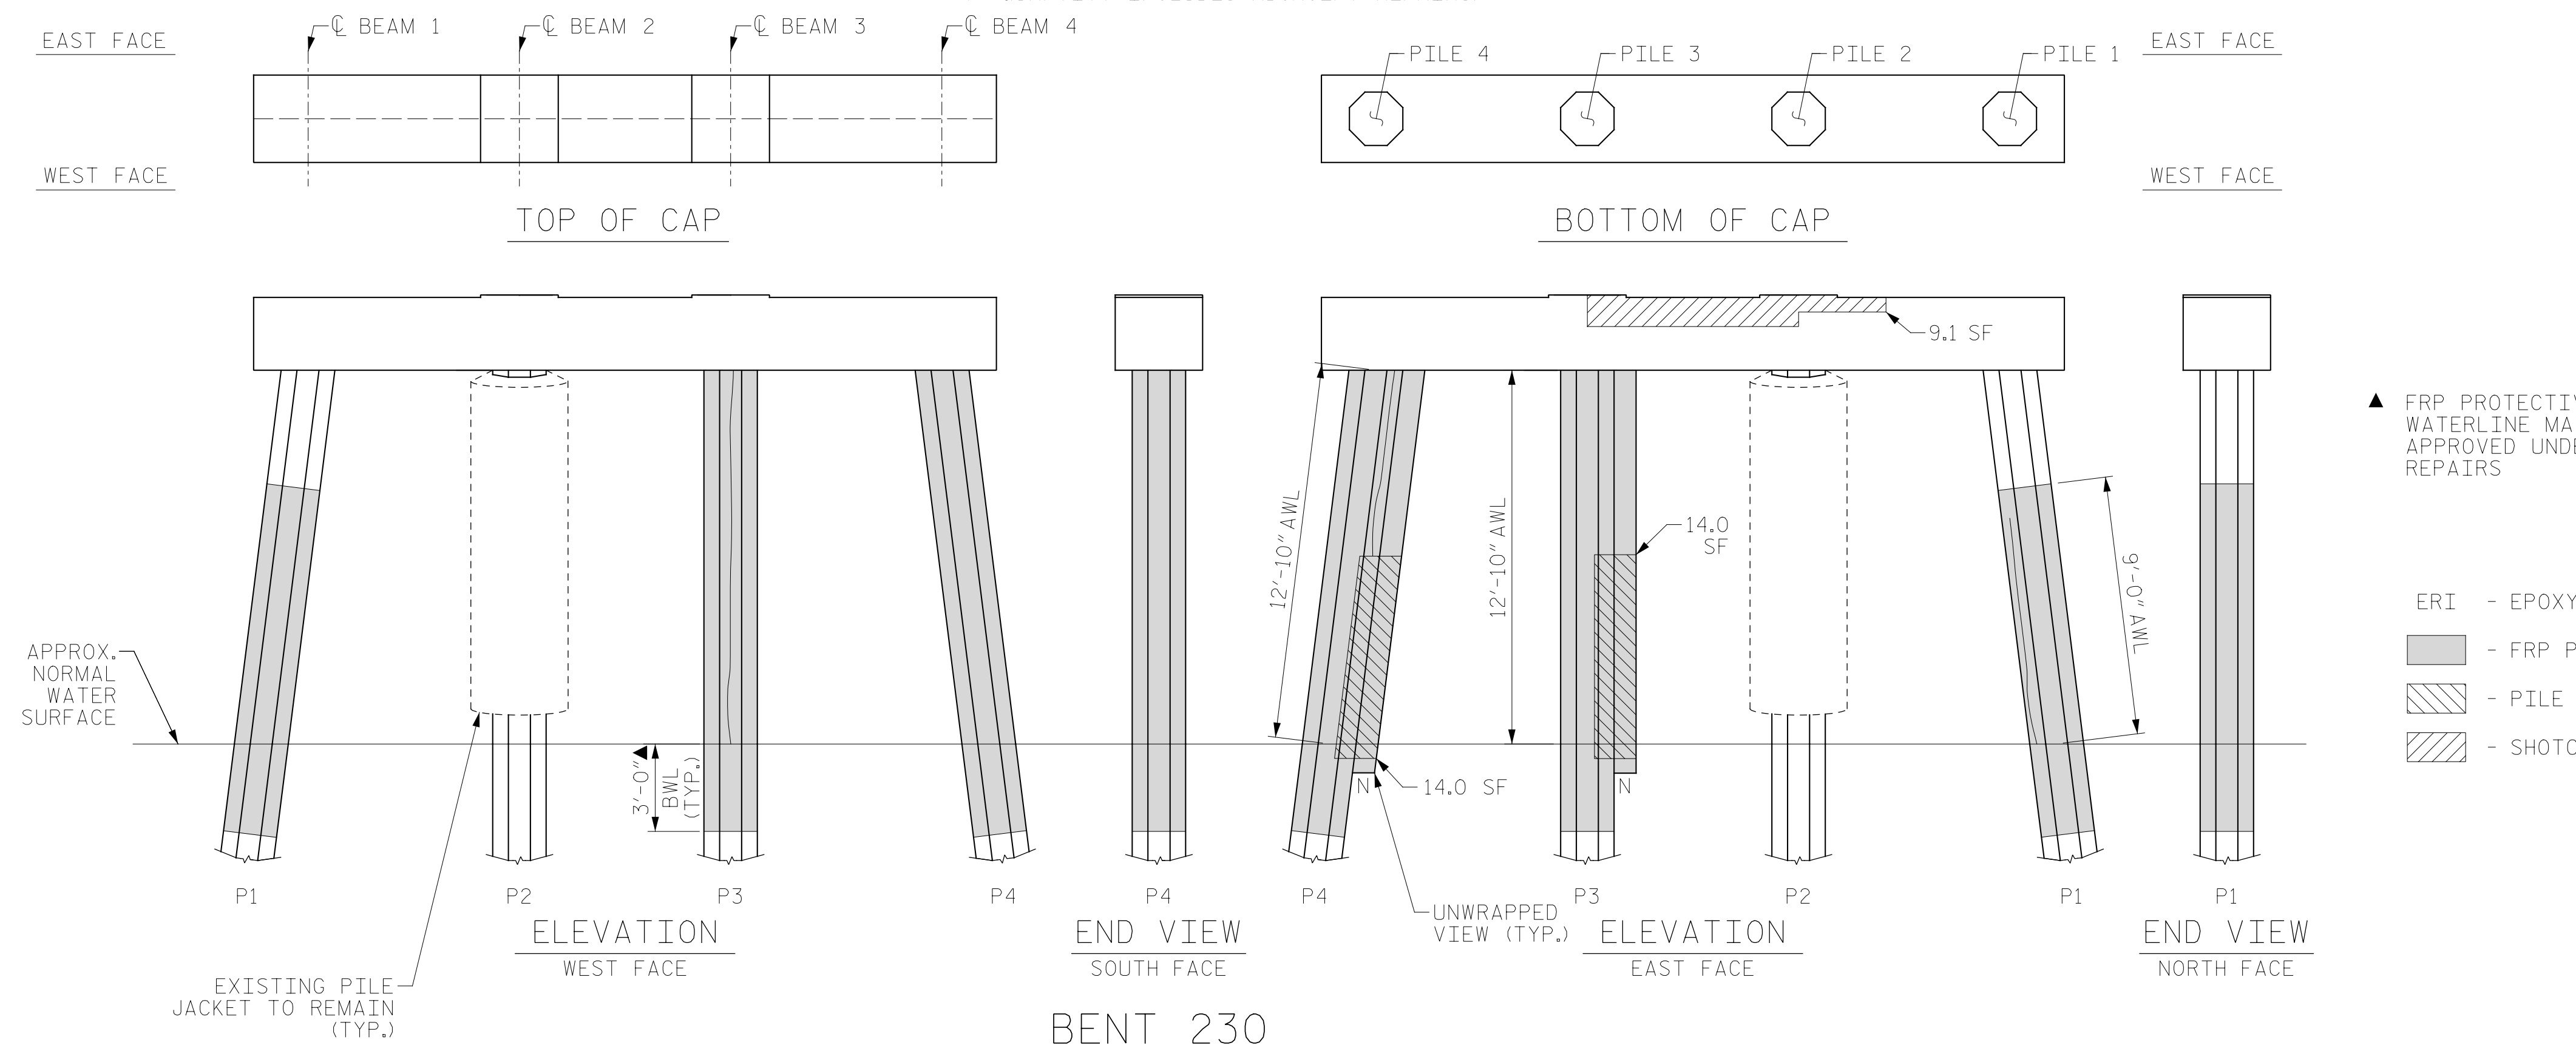
BENT 230

CAP REPAIRS			
SHOTCRETE REPAIRS	9.1 SF	4.6 CF	
EPOXY RESIN INJECTION	- LF		
PILE REPAIRS			
PILE CONCRETE RESTORATION	28.0 SF	11.1 CF	
FRP PROTECTIVE SYSTEM AWL	190.7 SF		
FRP PROTECTIVE SYSTEM BWL	49.5 SF

(AWL = ABOVE WATERLINE)  
(BWL = BELOW WATERLINE)  
(\*\*QUANTITY INCLUDES ADJACENT REPAIRS)
