AS-BUILT REPAIR QUANTITY TABLE

PROJECT NO. HB-0017
DARE COUNTY
BRIDGE NO. 270009

STATE OF NORTH CAROLINA
DEPARTMENT OF TRANSPORTATION
RALEIGH

BENT 235 & BENT 236

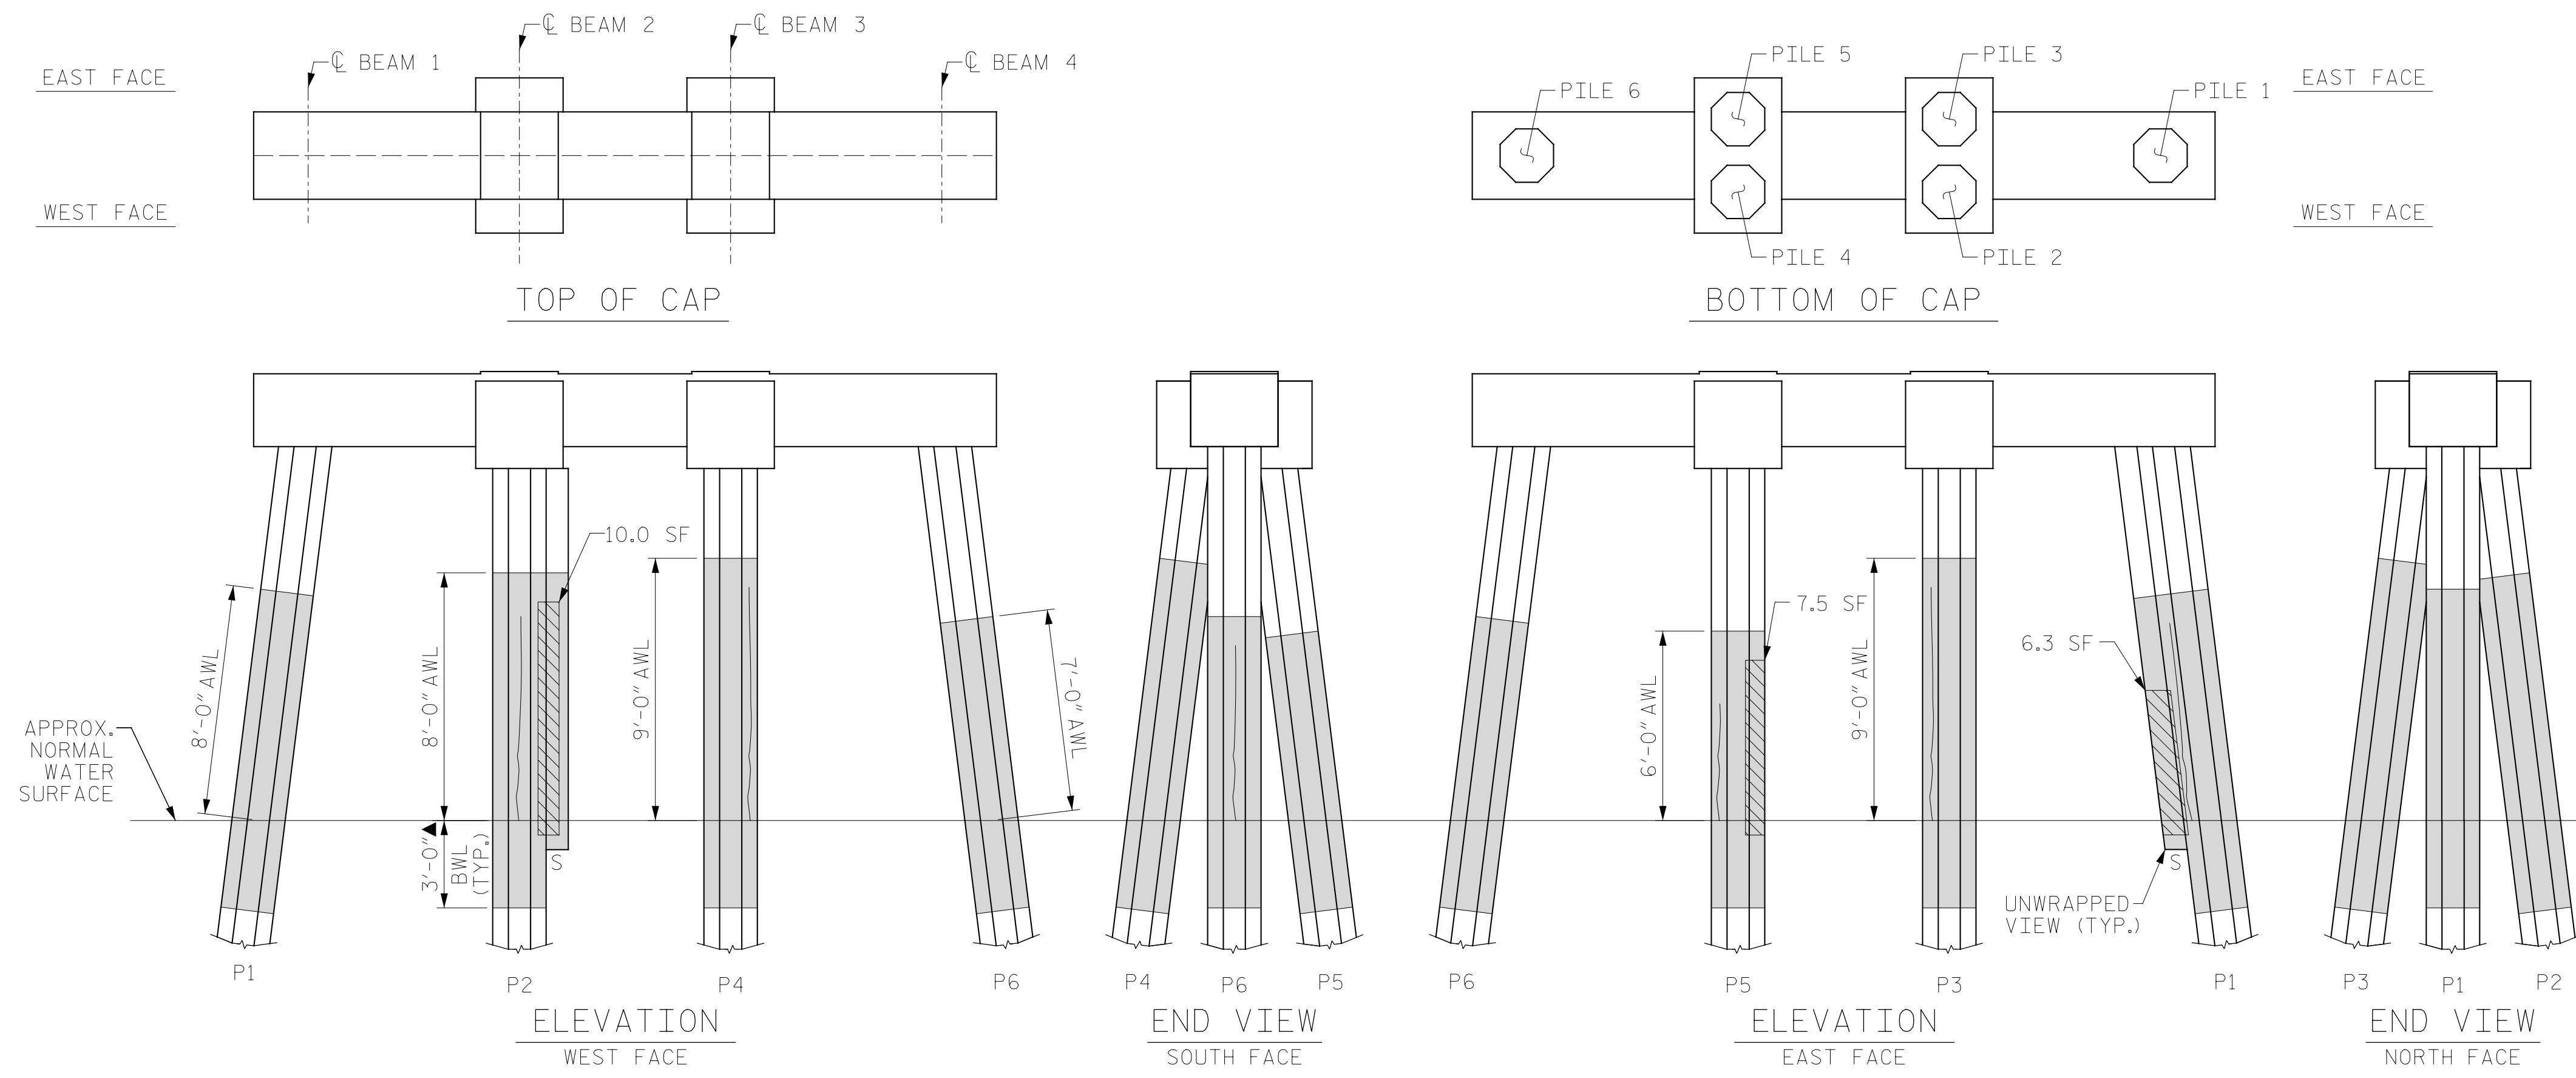
BENT 235

CAP REPAIRS			
SHOTCRETE REPAIRS	- SF	- CF	SF CF
EPOXY RESIN INJECTION	- LF		LF
PILE REPAIRS			
PILE CONCRETE RESTORATION	23.8 SF	10.1 CF	SF CF
FRP PROTECTIVE SYSTEM AWL	258.5 SF		
FRP PROTECTIVE SYSTEM BWL	99.0 SF

(AWL = ABOVE WATERLINE)
(BWL = BELOW WATERLINE)
(**QUANTITY INCLUDES ADJACENT REPAIRS)

FOR CAP REPAIRS: VALUES IN CHART REPRESENT ESTIMATED REPAIR TOTALS AFTER REMOVAL OF UNSOUND CONCRETE, MIN. OF 1" BEHIND REBAR AND MIN. 2" CL. TO SAWCUT. SEE REPAIR DETAILS.

FOR SHOTCRETE REPAIRS, SEE SPECIAL PROVISIONS.
FOR CONCRETE REPAIR DETAILS, SEE "TYPICAL CAP, COLUMN & UNDERDECK REPAIR DETAILS" & "PILE CONCRETE RESTORATION DETAILS" SHEETS.
FOR PILE CONCRETE RESTORATION, SEE SPECIAL PROVISIONS.
FOR FRP PROTECTIVE SYSTEM, SEE SPECIAL PROVISIONS.
FOR FRP PROTECTIVE SYSTEM DETAILS AND UNDERWATER MORTAR REPAIRS, SEE "PILE FRP PROTECTIVE SYSTEM DETAILS" SHEET.

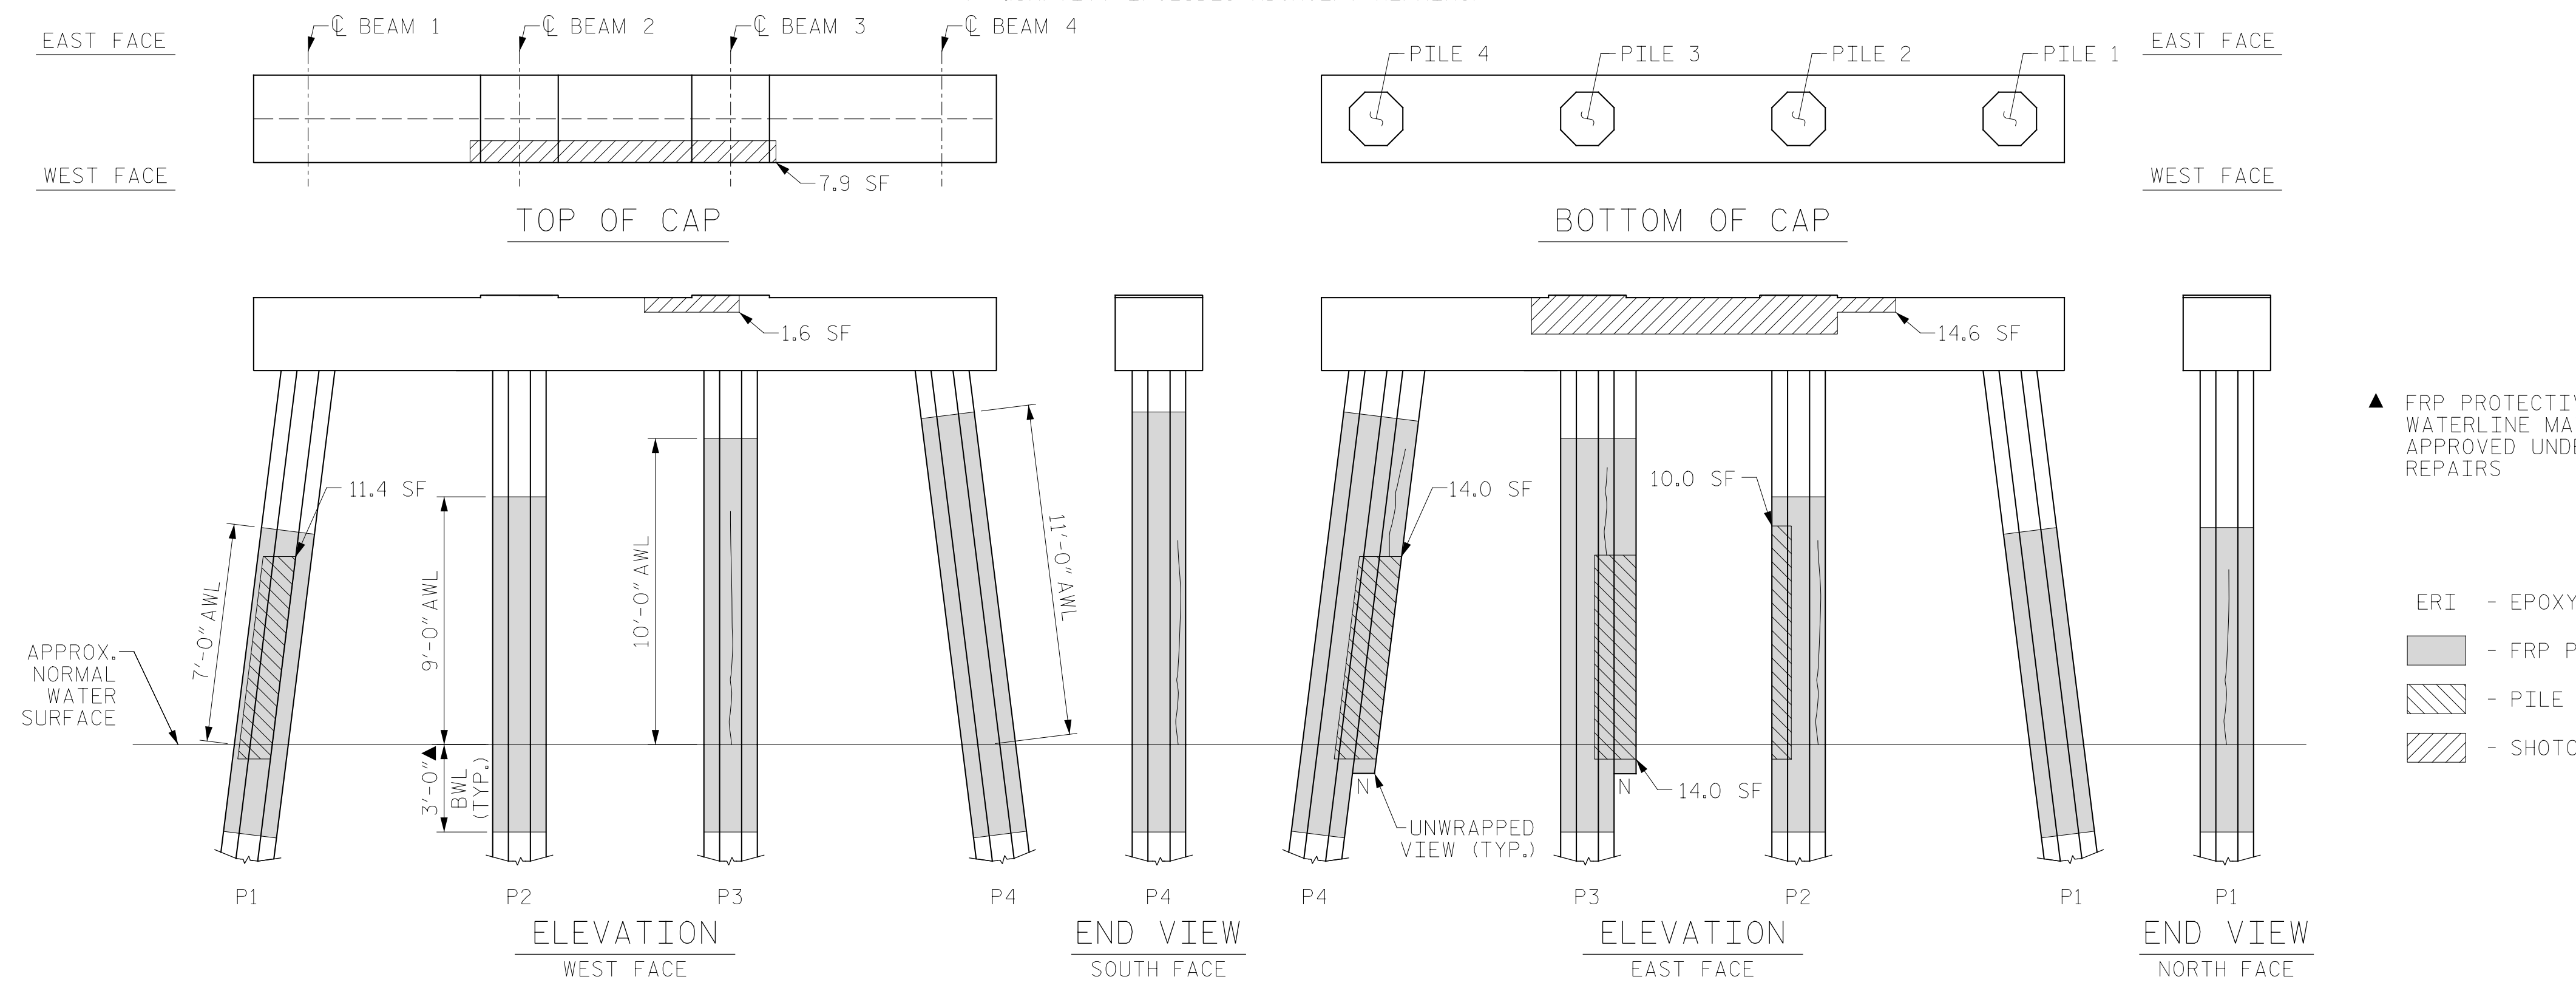
BENT 236

CAP REPAIRS			
SHOTCRETE REPAIRS	24.1 SF	12.1 CF	SF CF
EPOXY RESIN INJECTION	- LF		LF
PILE REPAIRS			
PILE CONCRETE RESTORATION	49.4 SF	20.4 CF	SF CF
FRP PROTECTIVE SYSTEM AWL	203.5 SF		
FRP PROTECTIVE SYSTEM BWL	66.0 SF

(AWL = ABOVE WATERLINE)
(BWL = BELOW WATERLINE)
(**QUANTITY INCLUDES ADJACENT REPAIRS)
