AS-BUILT REPAIR QUANTITY TABLE

PROJECT NO. HB-0017
DARE COUNTY
 BRIDGE NO. 270009

BENT 279 & BENT 280

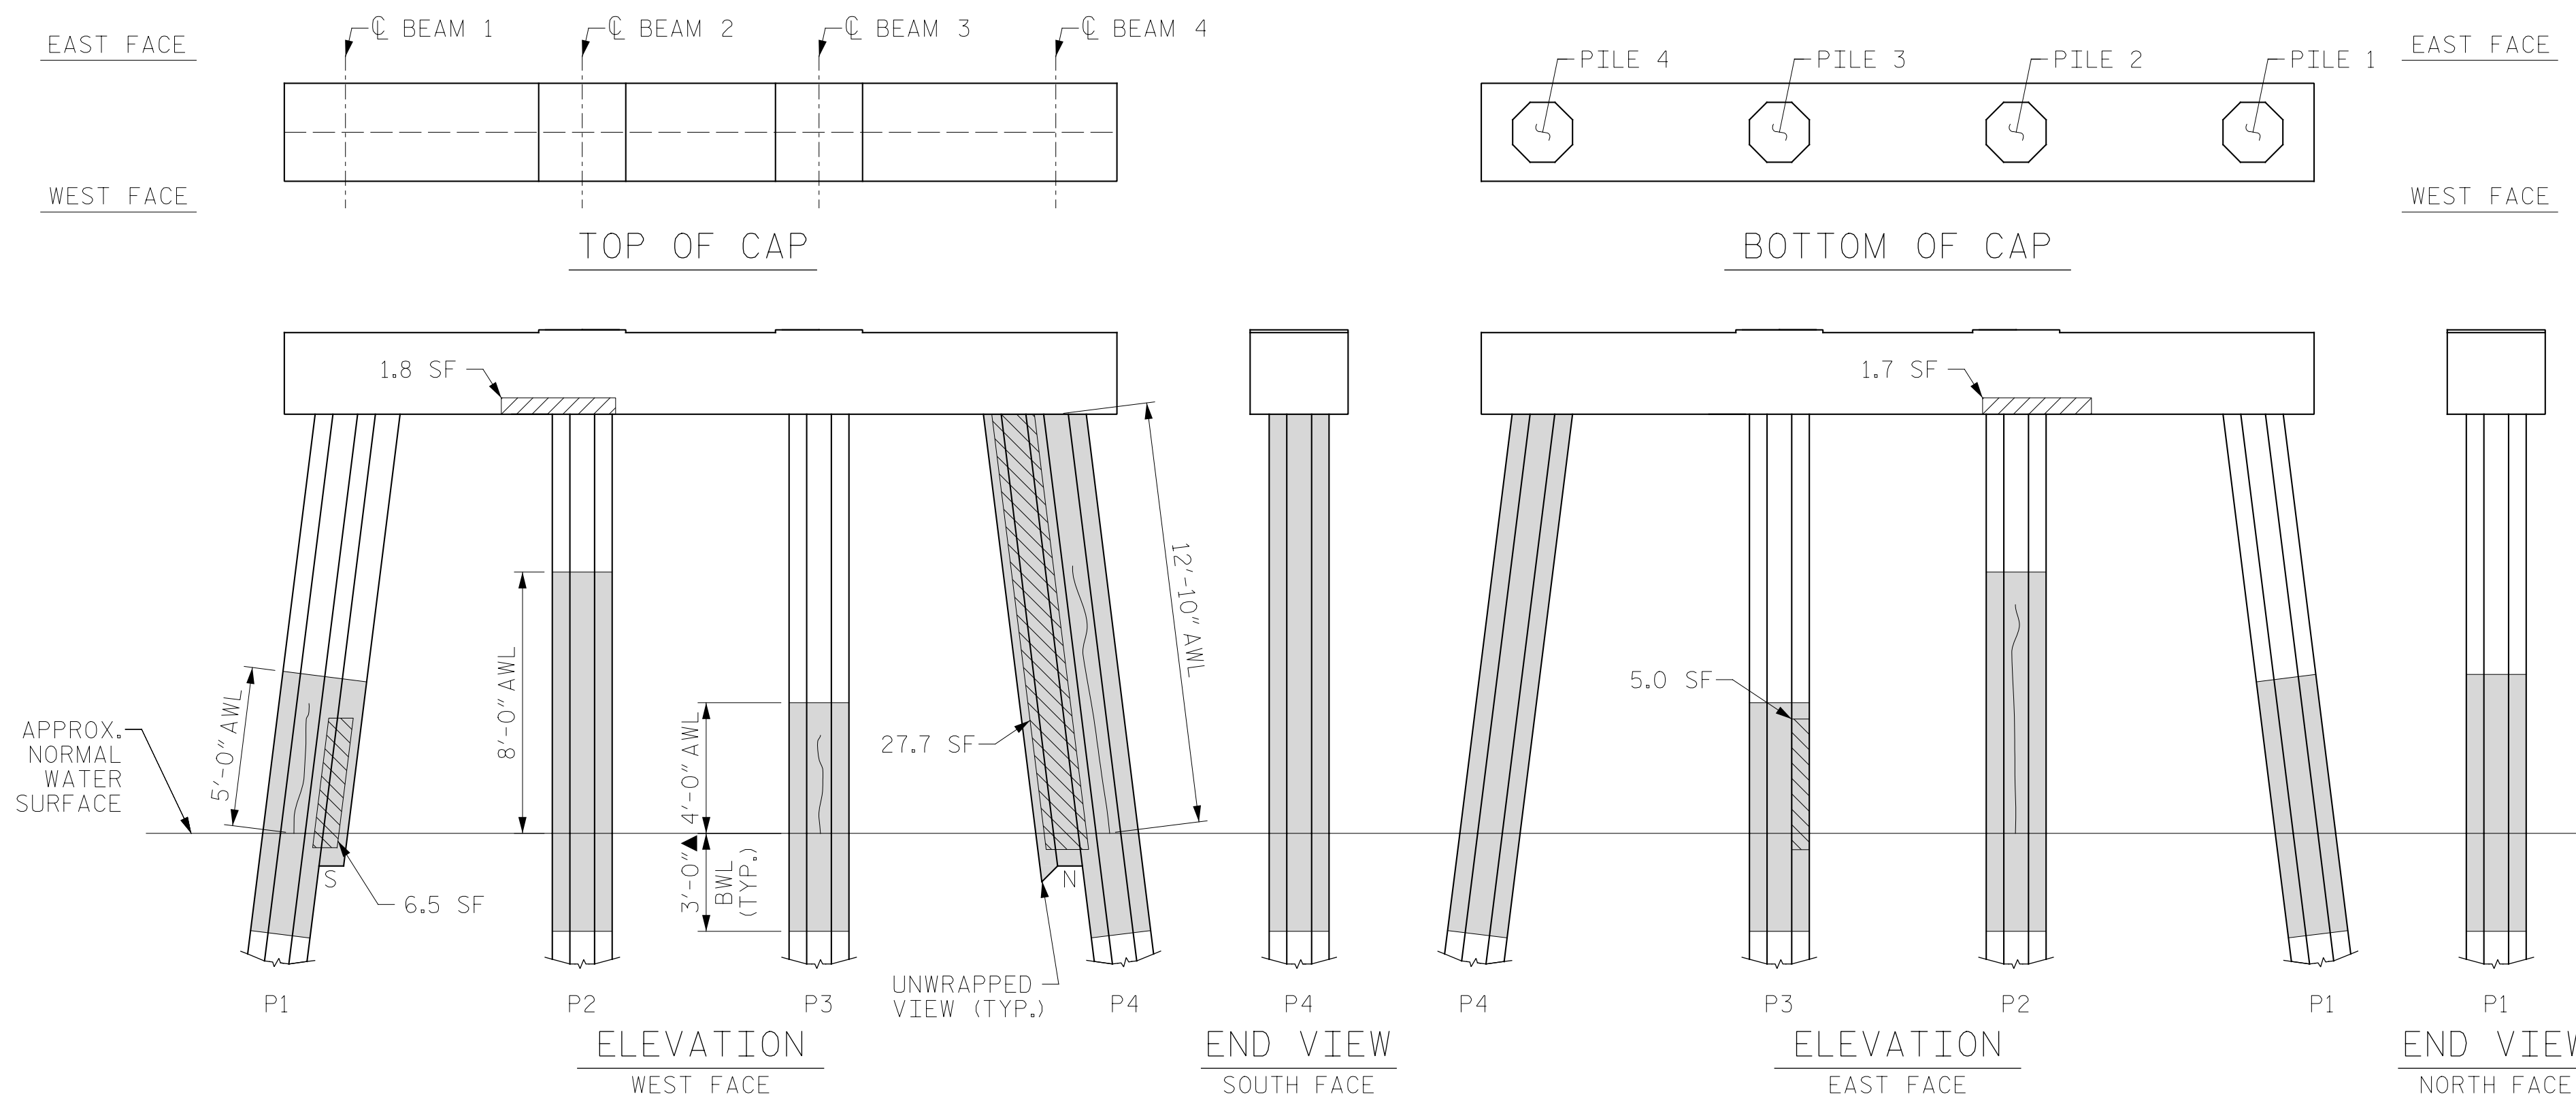
BENT 279

CAP REPAIRS			
SHOTCRETE REPAIRS	3.5 SF	1.8 CF	SF CF
EPOXY RESIN INJECTION	- LF		LF
PILE REPAIRS			
PILE CONCRETE RESTORATION	39.2 SF	16.0 CF	SF CF
FRP PROTECTIVE SYSTEM AWL	164.1 SF		
FRP PROTECTIVE SYSTEM BWL	66.0 SF

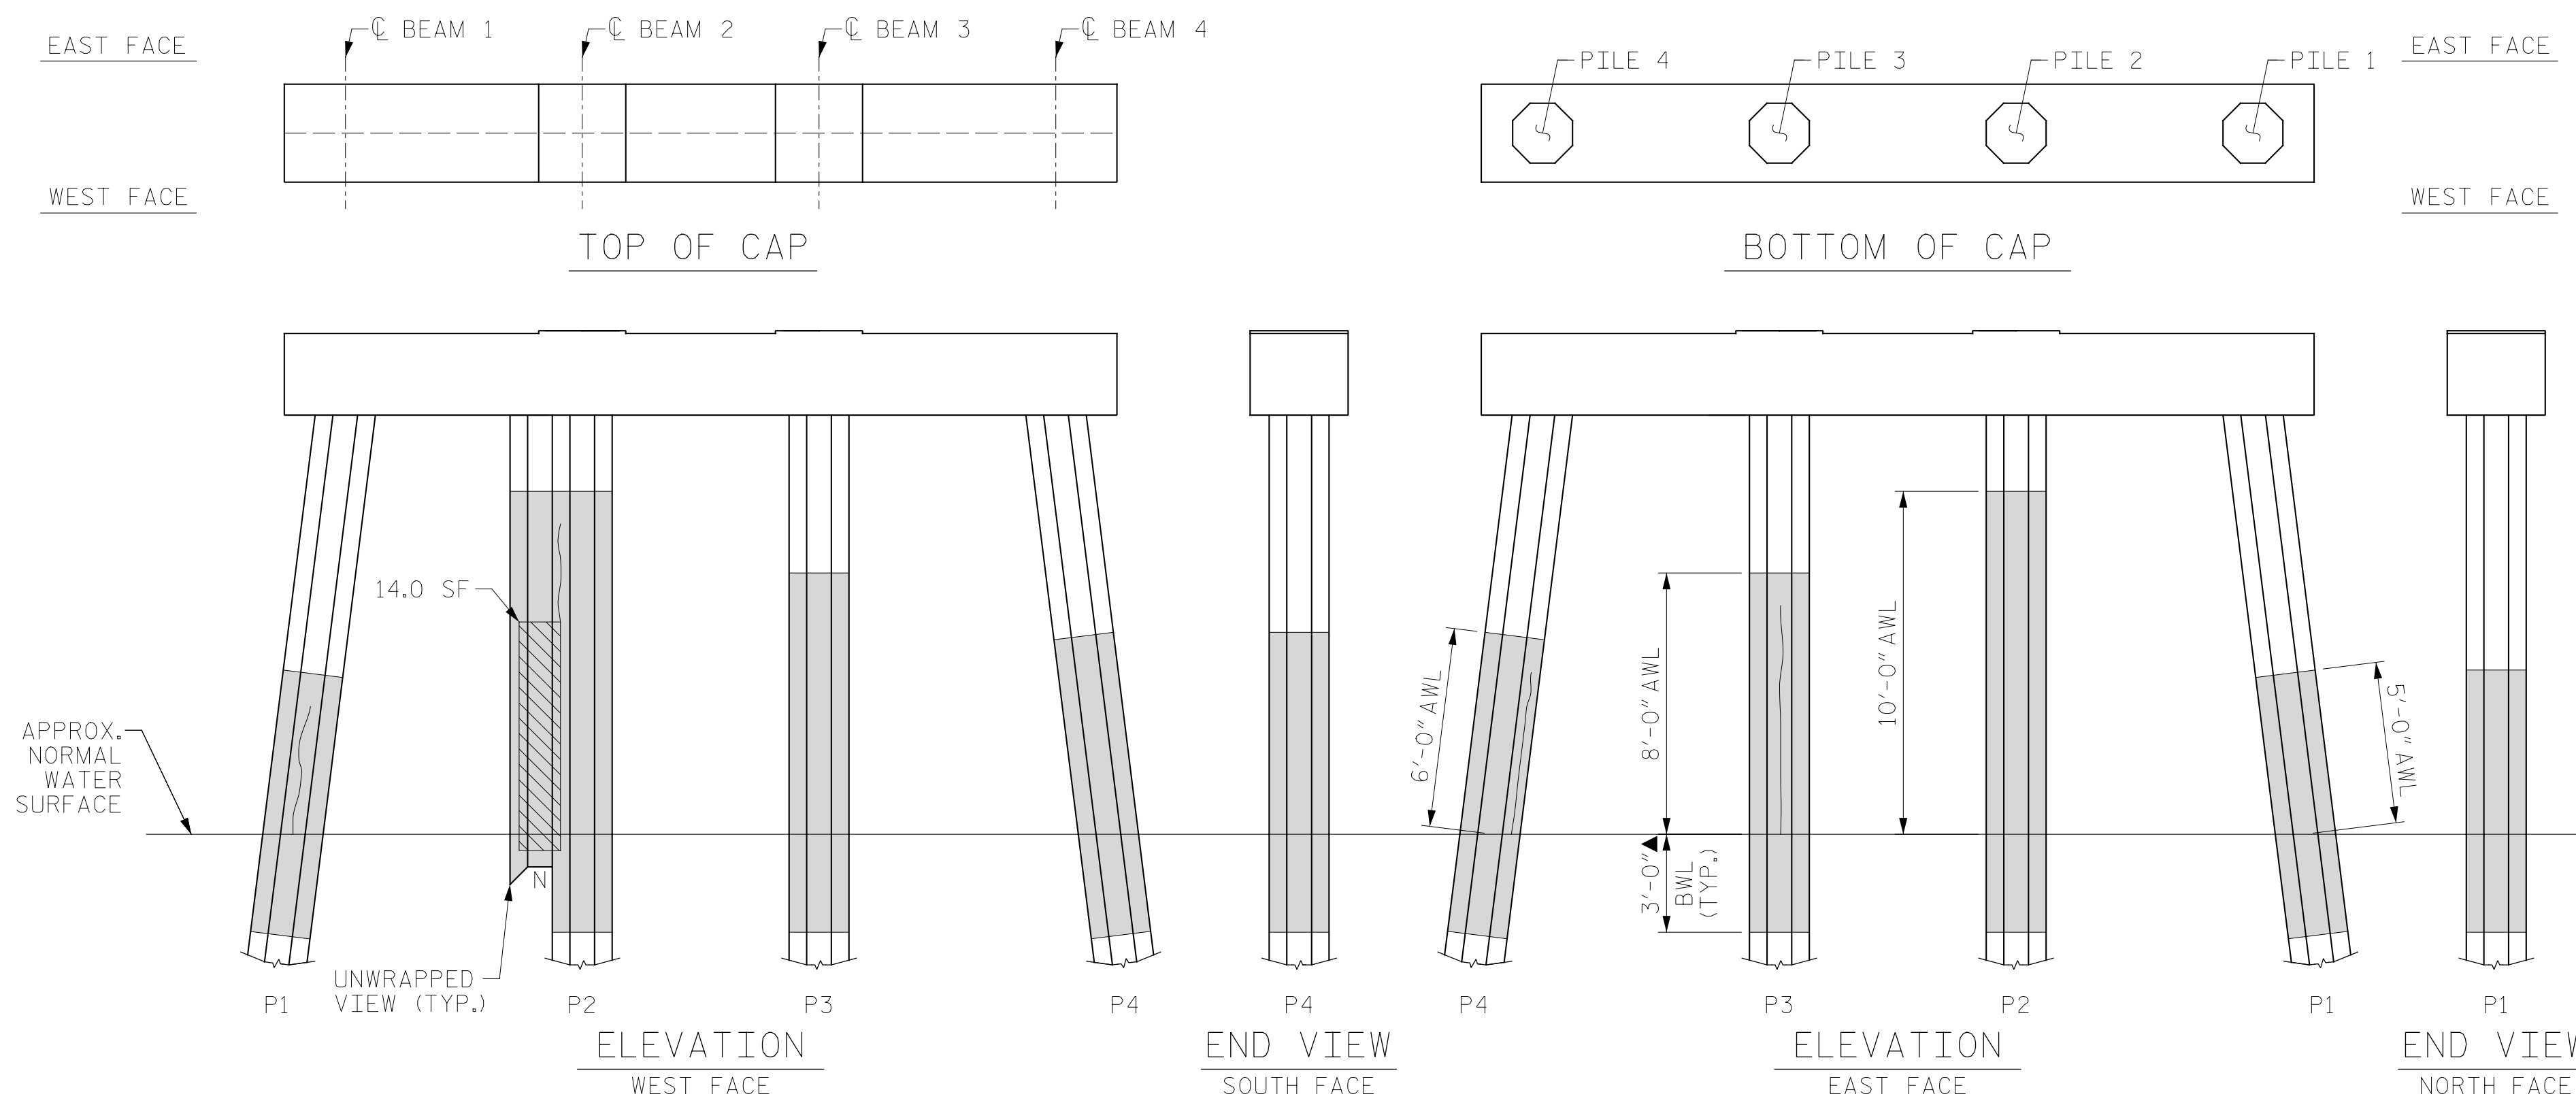
BENT 280

CAP REPAIRS			
SHOTCRETE REPAIRS	- SF	- CF	SF CF
EPOXY RESIN INJECTION	- LF		LF
PILE REPAIRS			
PILE CONCRETE RESTORATION	14.0 SF	5.5 CF	SF CF
FRP PROTECTIVE SYSTEM AWL	159.5 SF		
FRP PROTECTIVE SYSTEM BWL	66.0 SF
