AS-BUILT REPAIR QUANTITY TABLE

PROJECT NO. HB-0017  
DARE COUNTY  
BRIDGE NO. 270009

BENT 295 & BENT 296

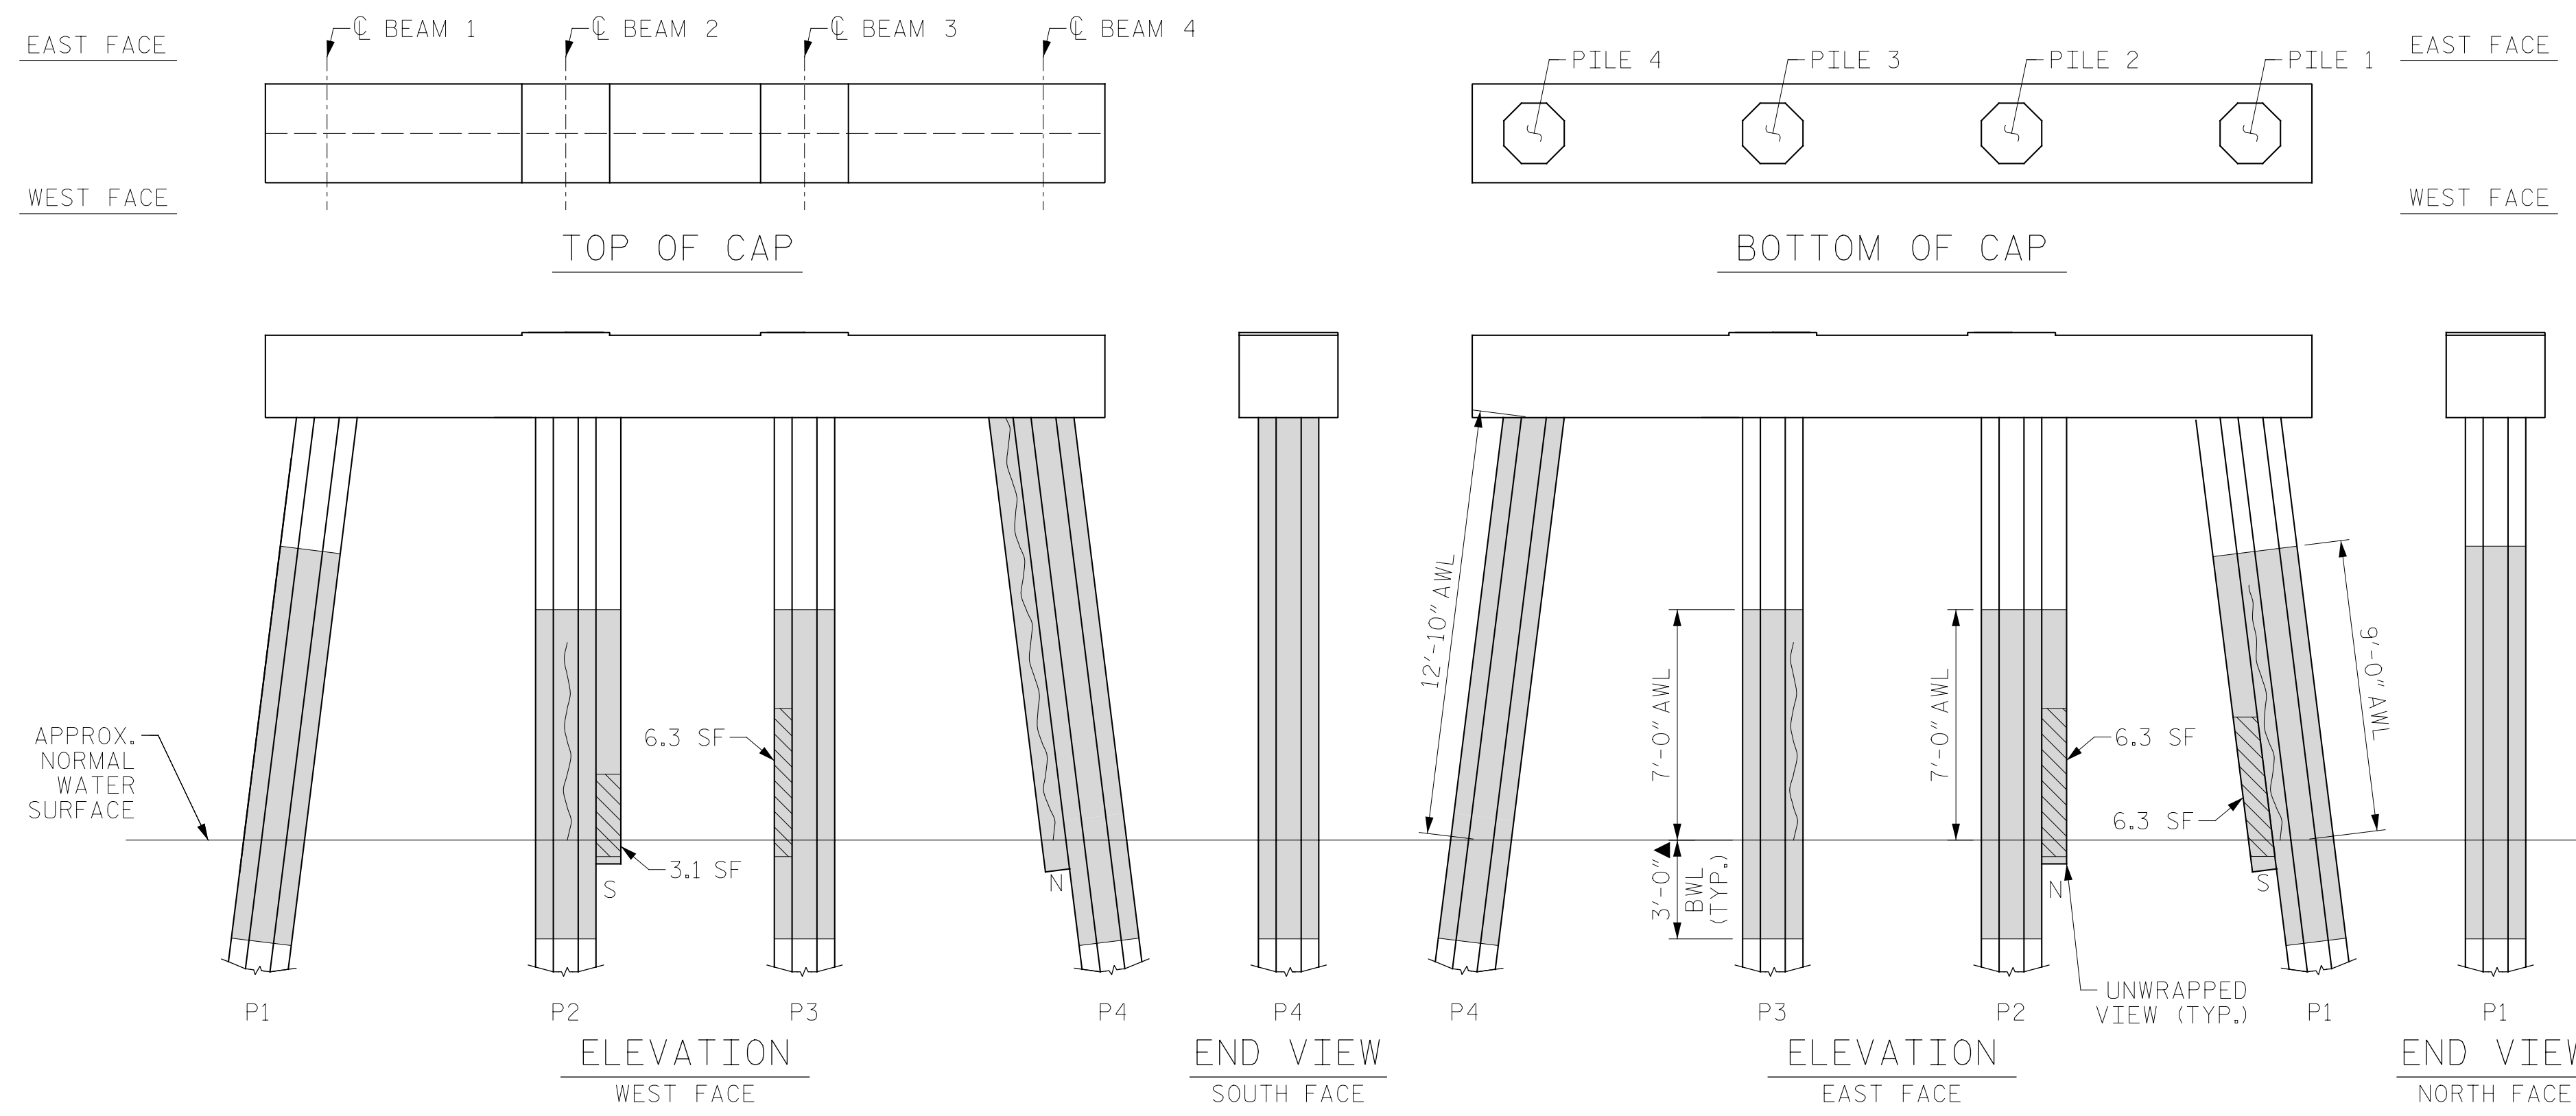
BENT 295

CAP REPAIRS		ESTIMATE			
SHOTCRETE REPAIRS	- SF	- CF	SF	CF	
EPOXY RESIN INJECTION		- LF			LF
PILE REPAIRS		ESTIMATE			
PILE CONCRETE RESTORATION	21.9 SF	9.3 CF	SF	CF	
FRP PROTECTIVE SYSTEM AWL	197.1 SF				
FRP PROTECTIVE SYSTEM BWL	66.0 SF

(AWL = ABOVE WATERLINE)  
(BWL = BELOW WATERLINE)  
(\*QUANTITY INCLUDES ADJACENT REPAIRS)

FOR CAP REPAIRS: VALUES IN CHART REPRESENT ESTIMATED REPAIR TOTALS AFTER REMOVAL OF UNSOUND CONCRETE, MIN. OF 1" BEHIND REBAR AND MIN. 2" CL. TO SAWCUT. SEE REPAIR DETAILS.

FOR SHOTCRETE REPAIRS, SEE SPECIAL PROVISIONS.  
FOR CONCRETE REPAIR DETAILS, SEE "TYPICAL CAP, COLUMN & UNDERDECK REPAIR DETAILS" & "PILE CONCRETE RESTORATION DETAILS" SHEETS.  
FOR PILE CONCRETE RESTORATION, SEE SPECIAL PROVISIONS.  
FOR FRP PROTECTIVE SYSTEM, SEE SPECIAL PROVISIONS.  
FOR FRP PROTECTIVE SYSTEM DETAILS AND UNDERWATER MORTAR REPAIRS, SEE "PILE FRP PROTECTIVE SYSTEM DETAILS" SHEET.

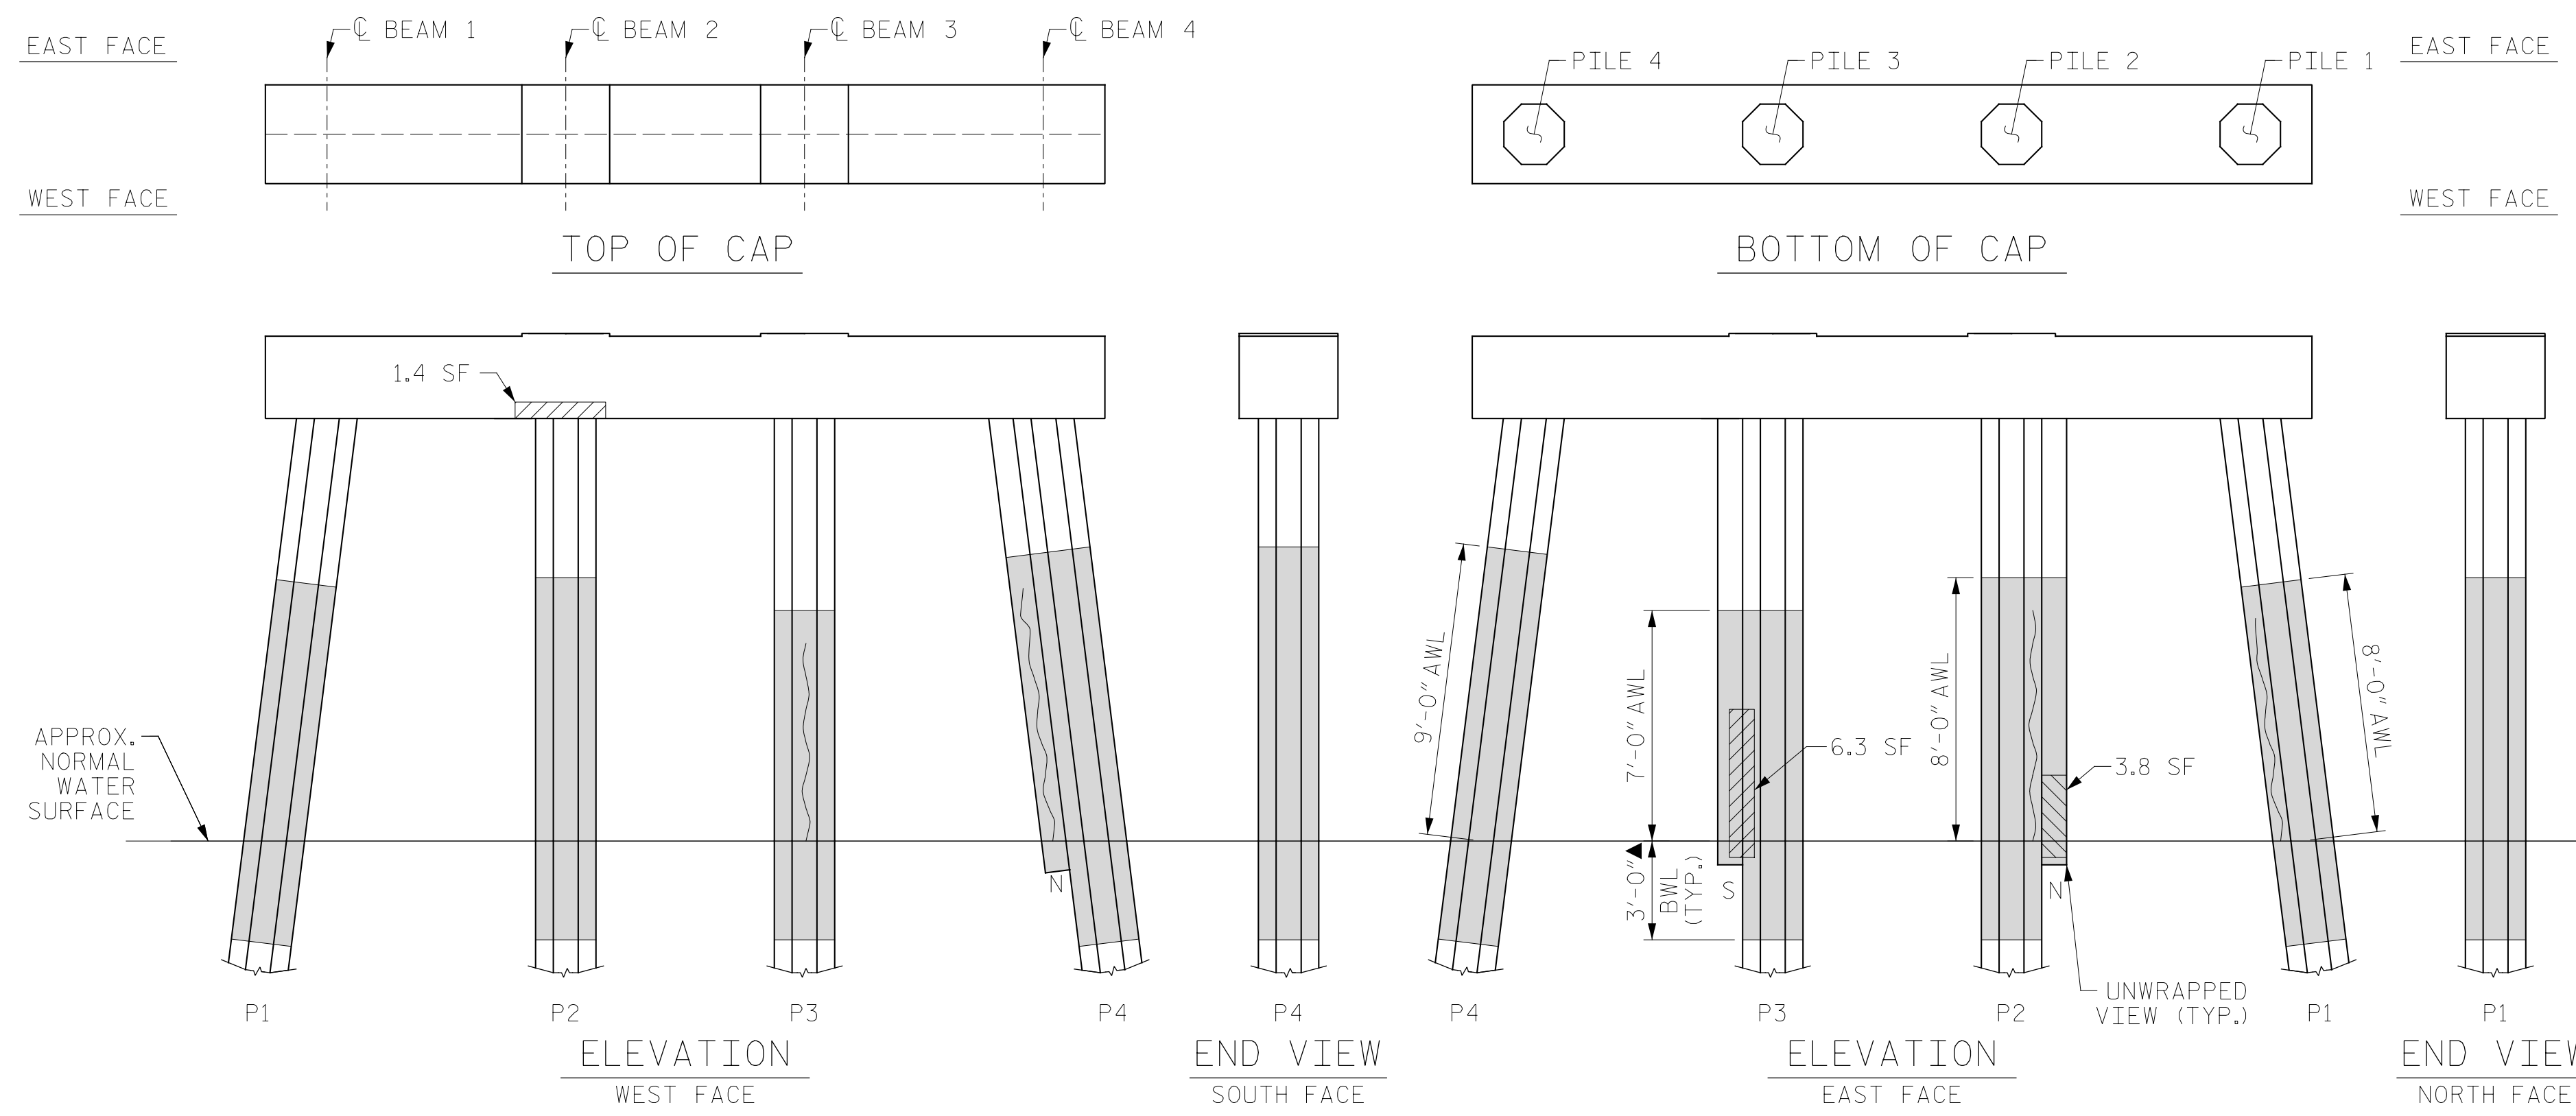
BENT 296

CAP REPAIRS		ESTIMATE			
SHOTCRETE REPAIRS	1.4 SF	0.7 CF	SF	CF	
EPOXY RESIN INJECTION		- LF			LF
PILE REPAIRS		ESTIMATE			
PILE CONCRETE RESTORATION	10.0 SF	4.2 CF	SF	CF	
FRP PROTECTIVE SYSTEM AWL	176.0 SF				
FRP PROTECTIVE SYSTEM BWL	66.0 SF

(AWL = ABOVE WATERLINE)  
(BWL = BELOW WATERLINE)  
(\*QUANTITY INCLUDES ADJACENT REPAIRS)
