AS-BUILT REPAIR QUANTITY TABLE

PROJECT NO. HB-0017  
DARE COUNTY  
BRIDGE NO. 270009

BENT 303 & BENT 304

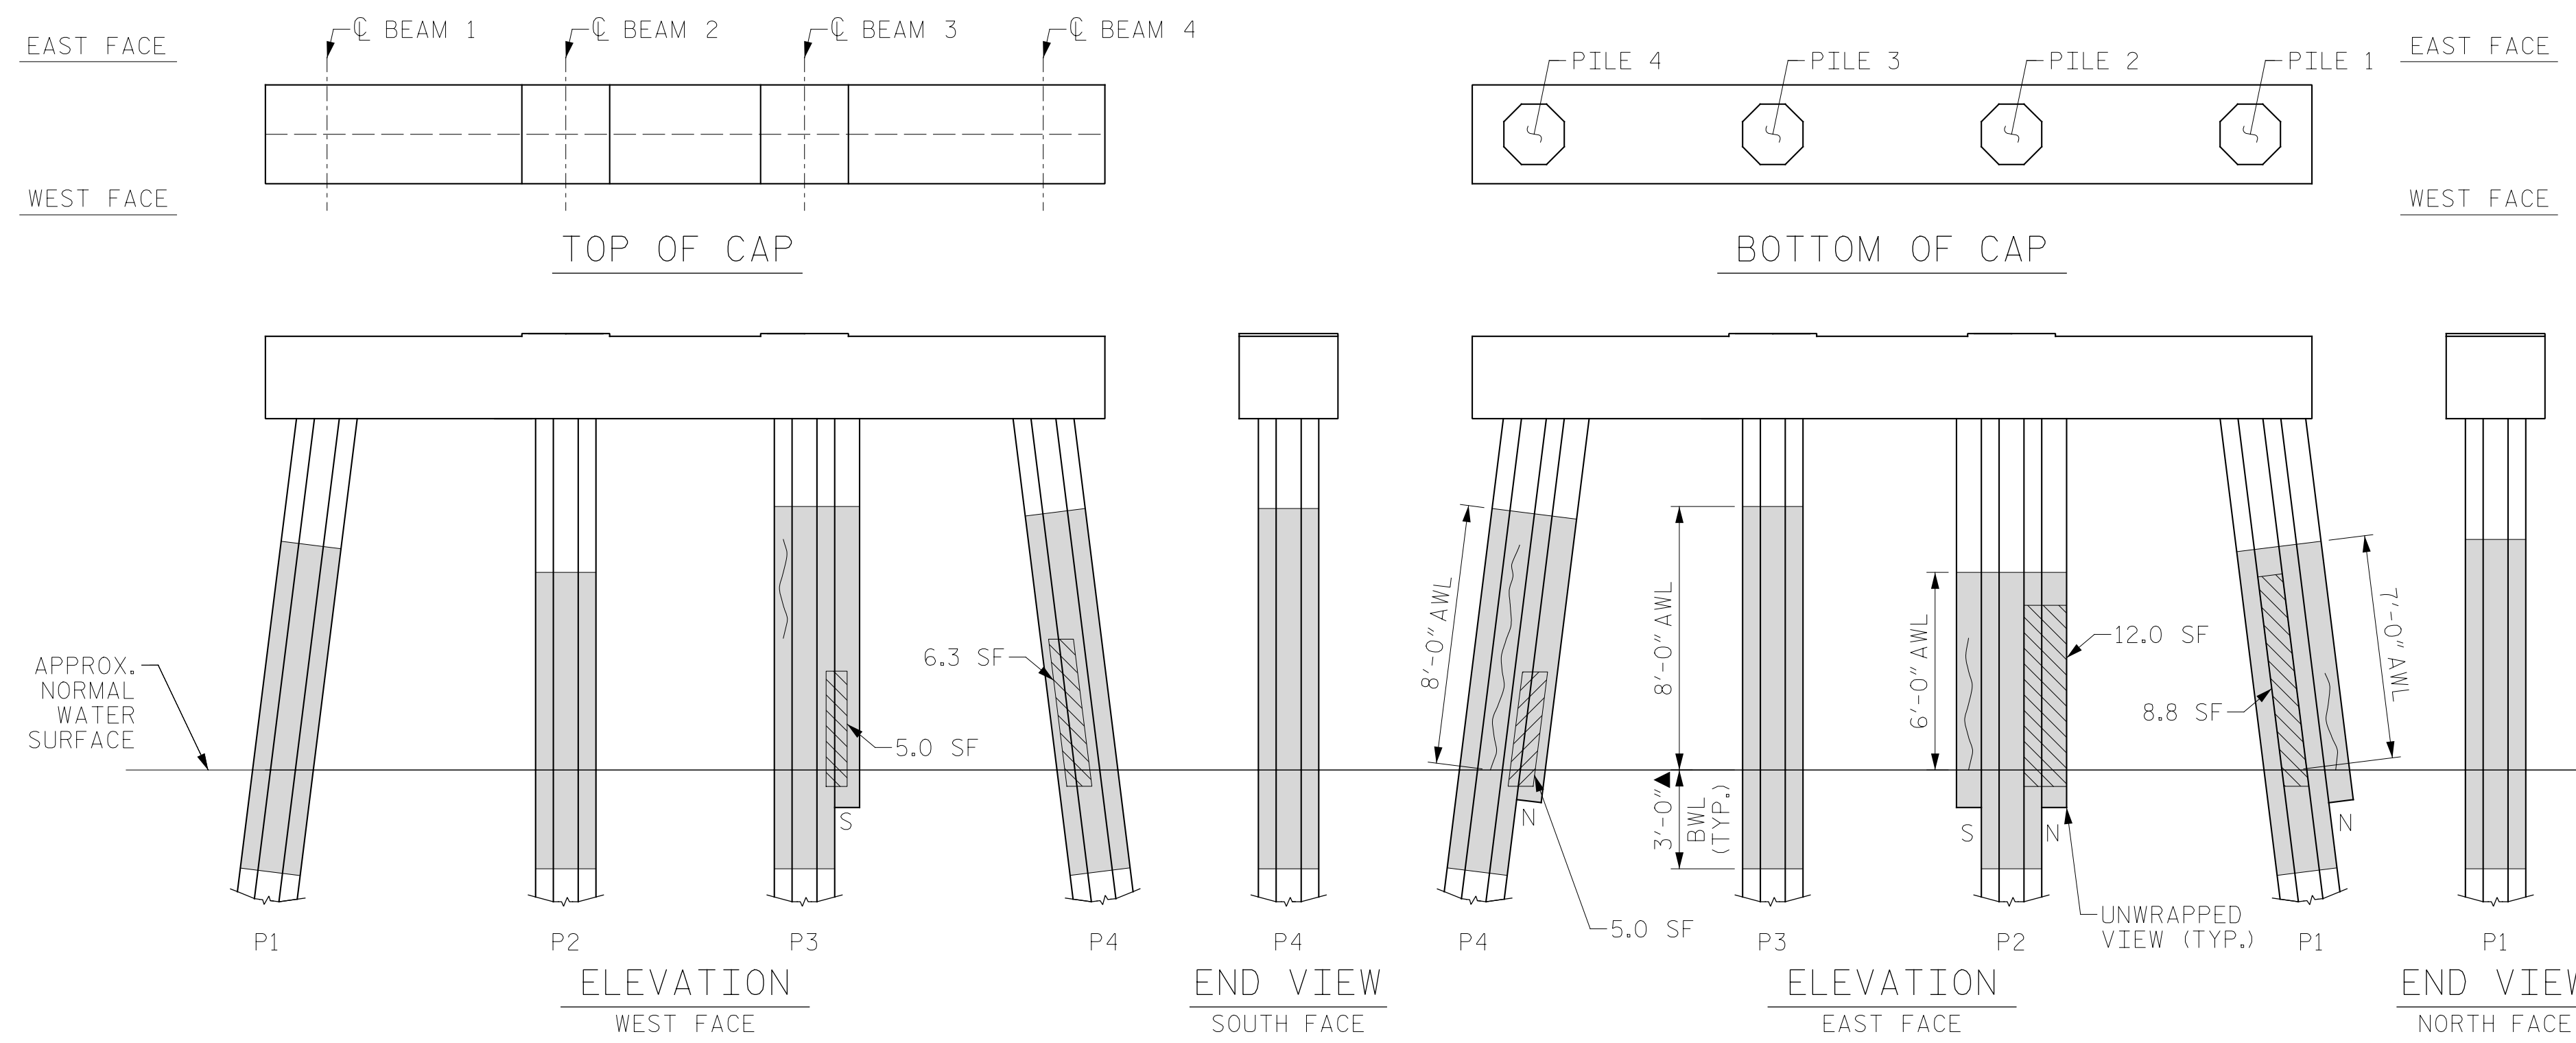
BENT 304

CAP REPAIRS		ESTIMATE			
SHOTCRETE REPAIRS	- SF	- CF	SF	CF	
EPOXY RESIN INJECTION	- LF				LF
PILE REPAIRS		ESTIMATE			
PILE CONCRETE RESTORATION	37.0 SF	15.3 CF	SF	CF	
FRP PROTECTIVE SYSTEM AWL	159.5 SF				
FRP PROTECTIVE SYSTEM BWL	66.0 SF

FOR CAP REPAIRS: VALUES IN CHART REPRESENT ESTIMATED REPAIR TOTALS AFTER REMOVAL OF UNSOUND CONCRETE, MIN. OF 1" BEHIND REBAR AND MIN. 2" CL. TO SAWCUT. SEE REPAIR DETAILS.

FOR SHOTCRETE REPAIRS, SEE SPECIAL PROVISIONS.  
FOR CONCRETE REPAIR DETAILS, SEE "TYPICAL CAP, COLUMN & UNDERDECK REPAIR DETAILS" & "PILE CONCRETE RESTORATION DETAILS" SHEETS.  
FOR PILE CONCRETE RESTORATION, SEE SPECIAL PROVISIONS.  
FOR FRP PROTECTIVE SYSTEM, SEE SPECIAL PROVISIONS.  
FOR FRP PROTECTIVE SYSTEM DETAILS AND UNDERWATER MORTAR REPAIRS, SEE "PILE FRP PROTECTIVE SYSTEM DETAILS" SHEET.
