BENT 305

BENT 306

PROJECT NO. HB-0017
DARE COUNTY
BRIDGE NO. 270009

STATE OF NORTH CAROLINA
DEPARTMENT OF TRANSPORTATION
RALEIGH
BENT 305 & BENT 306

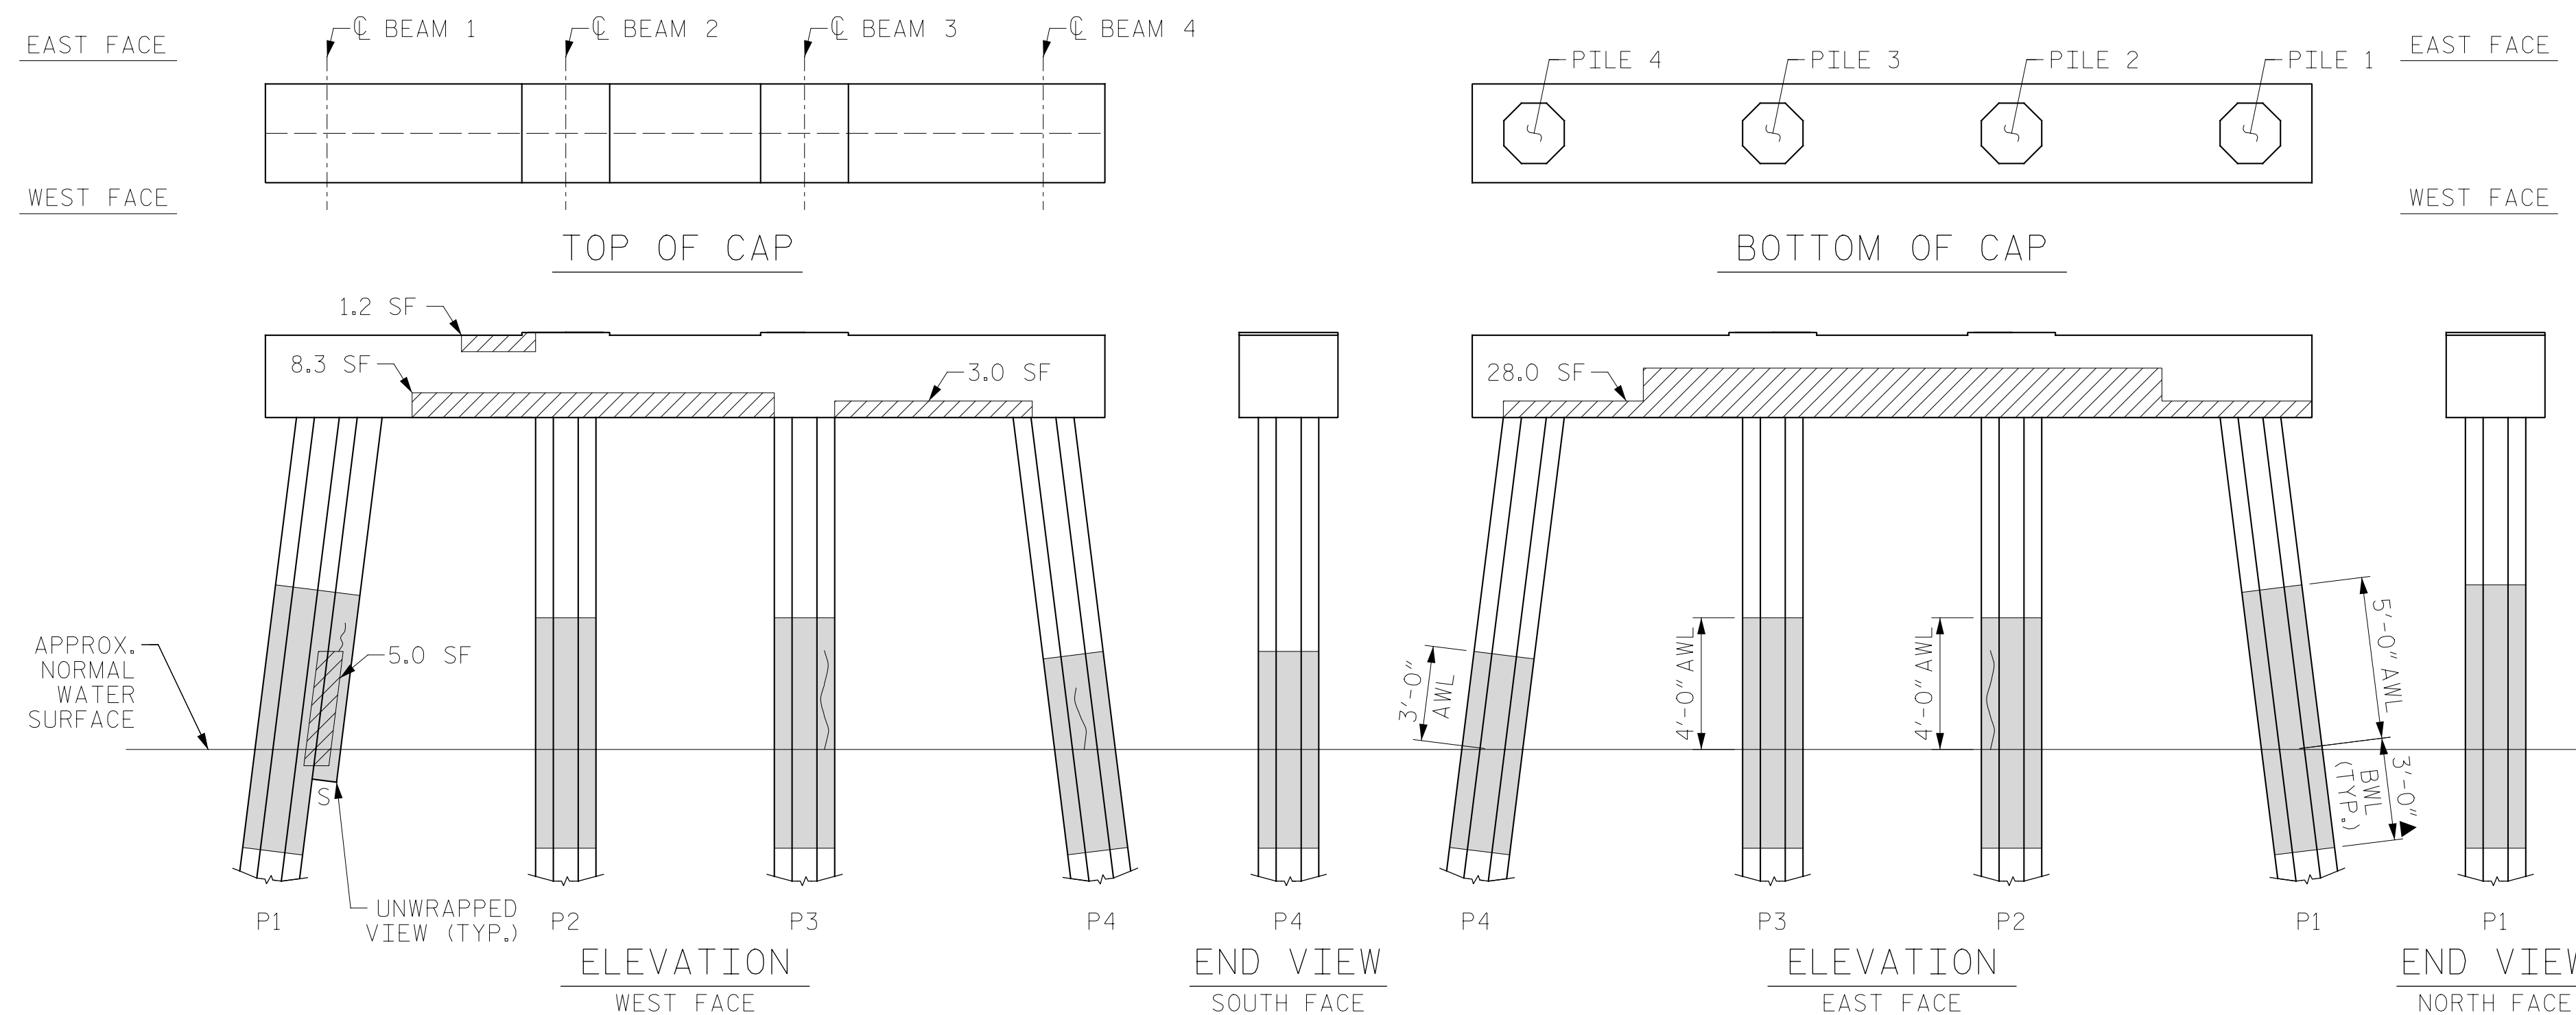
BENT 305

CAP REPAIRS		ESTIMATE			
SHOTCRETE REPAIRS	40.5 SF	20.3 CF	SF	CF	
EPOXY RESIN INJECTION	- LF				LF
PILE REPAIRS		ESTIMATE			
PILE CONCRETE RESTORATION	5.0 SF	2.1 CF	SF	CF	
FRP PROTECTIVE SYSTEM AWL	88.0 SF				
FRP PROTECTIVE SYSTEM BWL	66.0 SF

FOR CAP REPAIRS: VALUES IN CHART REPRESENT ESTIMATED REPAIR TOTALS AFTER REMOVAL OF UNSOUND CONCRETE, MIN. OF 1" BEHIND REBAR AND MIN. 2" CL. TO SAWCUT. SEE REPAIR DETAILS.

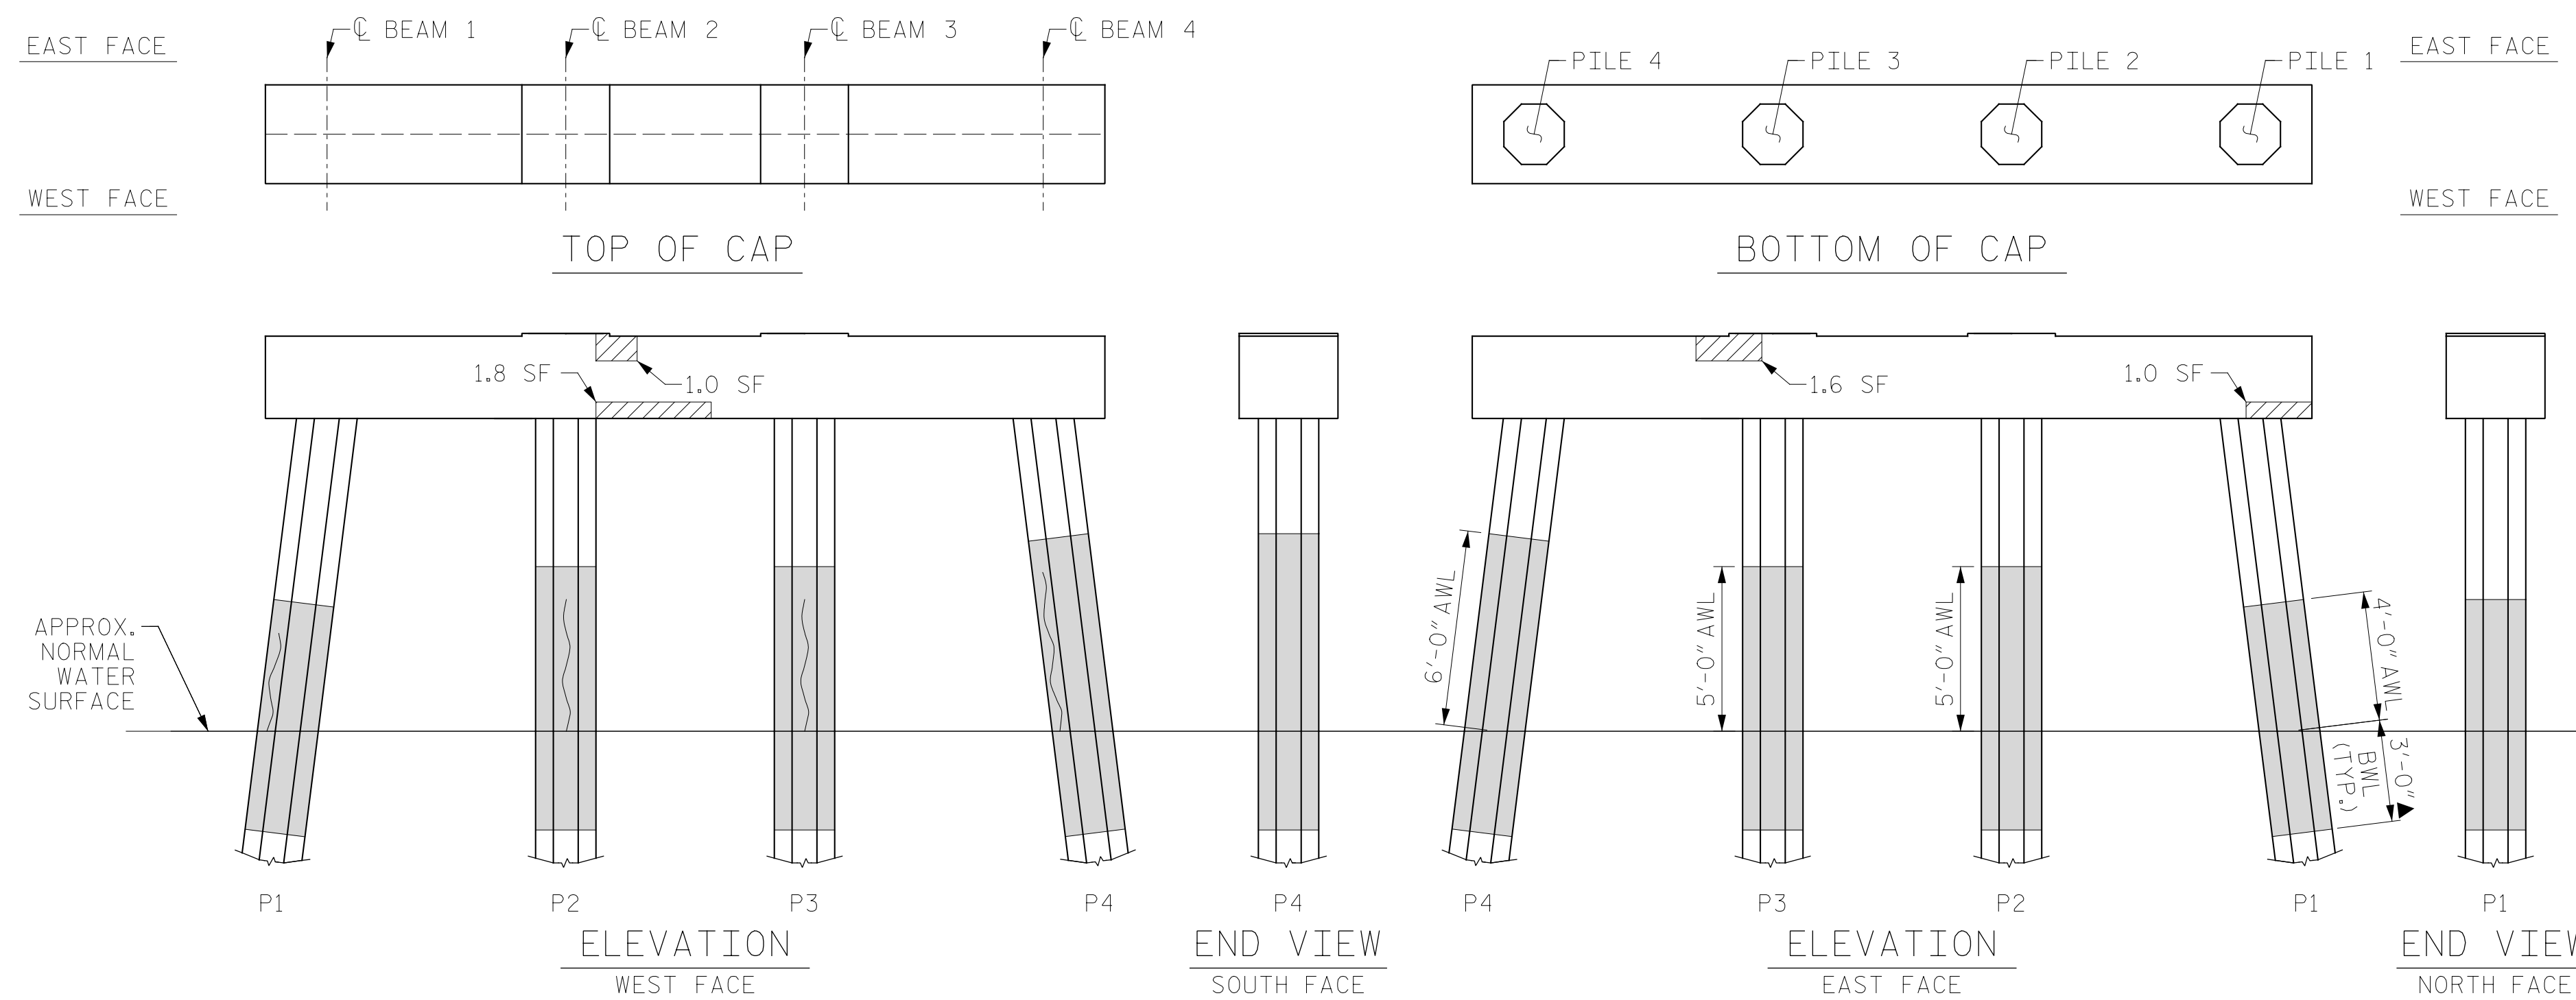
BENT 306

CAP REPAIRS		ESTIMATE			
SHOTCRETE REPAIRS	5.4 SF	2.7 CF	SF	CF	
EPOXY RESIN INJECTION	- LF				LF
PILE REPAIRS		ESTIMATE			
PILE CONCRETE RESTORATION	- SF	- CF	SF	CF	
FRP PROTECTIVE SYSTEM AWL	110.0 SF				
FRP PROTECTIVE SYSTEM BWL	66.0 SF
