AS-BUILT REPAIR QUANTITY TABLE

PROJECT NO. HB-0017  
DARE COUNTY  
BRIDGE NO. 270009

BENT 309 & BENT 310

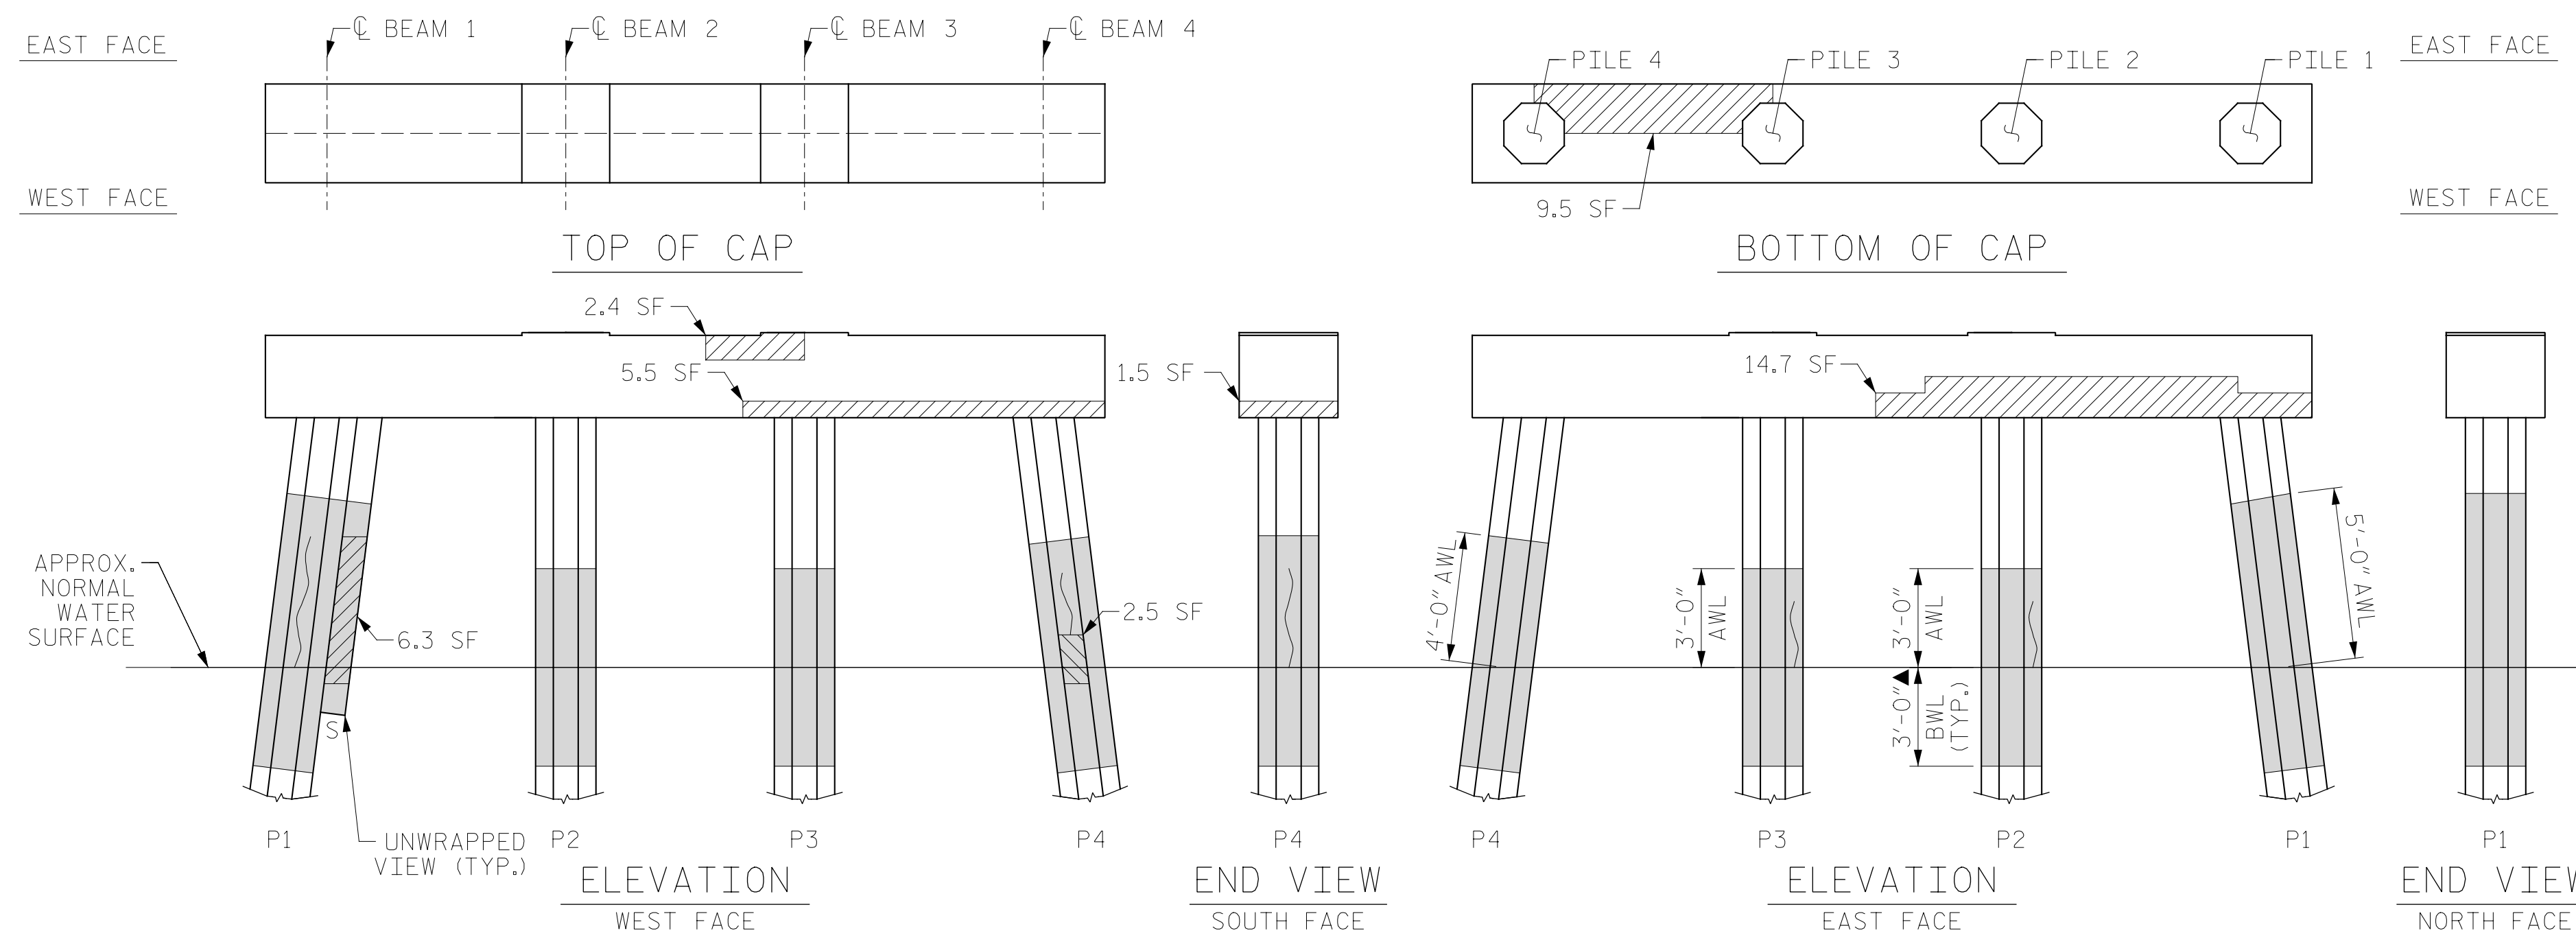
BENT 309

CAP REPAIRS		ESTIMATE			
SHOTCRETE REPAIRS	33.6 SF	16.8 CF	SF	CF	
EPOXY RESIN INJECTION	-	LF			LF
PILE REPAIRS		ESTIMATE			
PILE CONCRETE RESTORATION	8.8 SF	3.7 CF	SF	CF	
FRP PROTECTIVE SYSTEM AWL	82.5 SF				
FRP PROTECTIVE SYSTEM BWL	66.0 SF

(AWL = ABOVE WATERLINE)  
(BWL = BELOW WATERLINE)  
(\*QUANTITY INCLUDES ADJACENT REPAIRS)

FOR CAP REPAIRS: VALUES IN CHART REPRESENT ESTIMATED REPAIR TOTALS AFTER REMOVAL OF UNSOUND CONCRETE, MIN. OF 1" BEHIND REBAR AND MIN. 2" CL. TO SAWCUT. SEE REPAIR DETAILS.

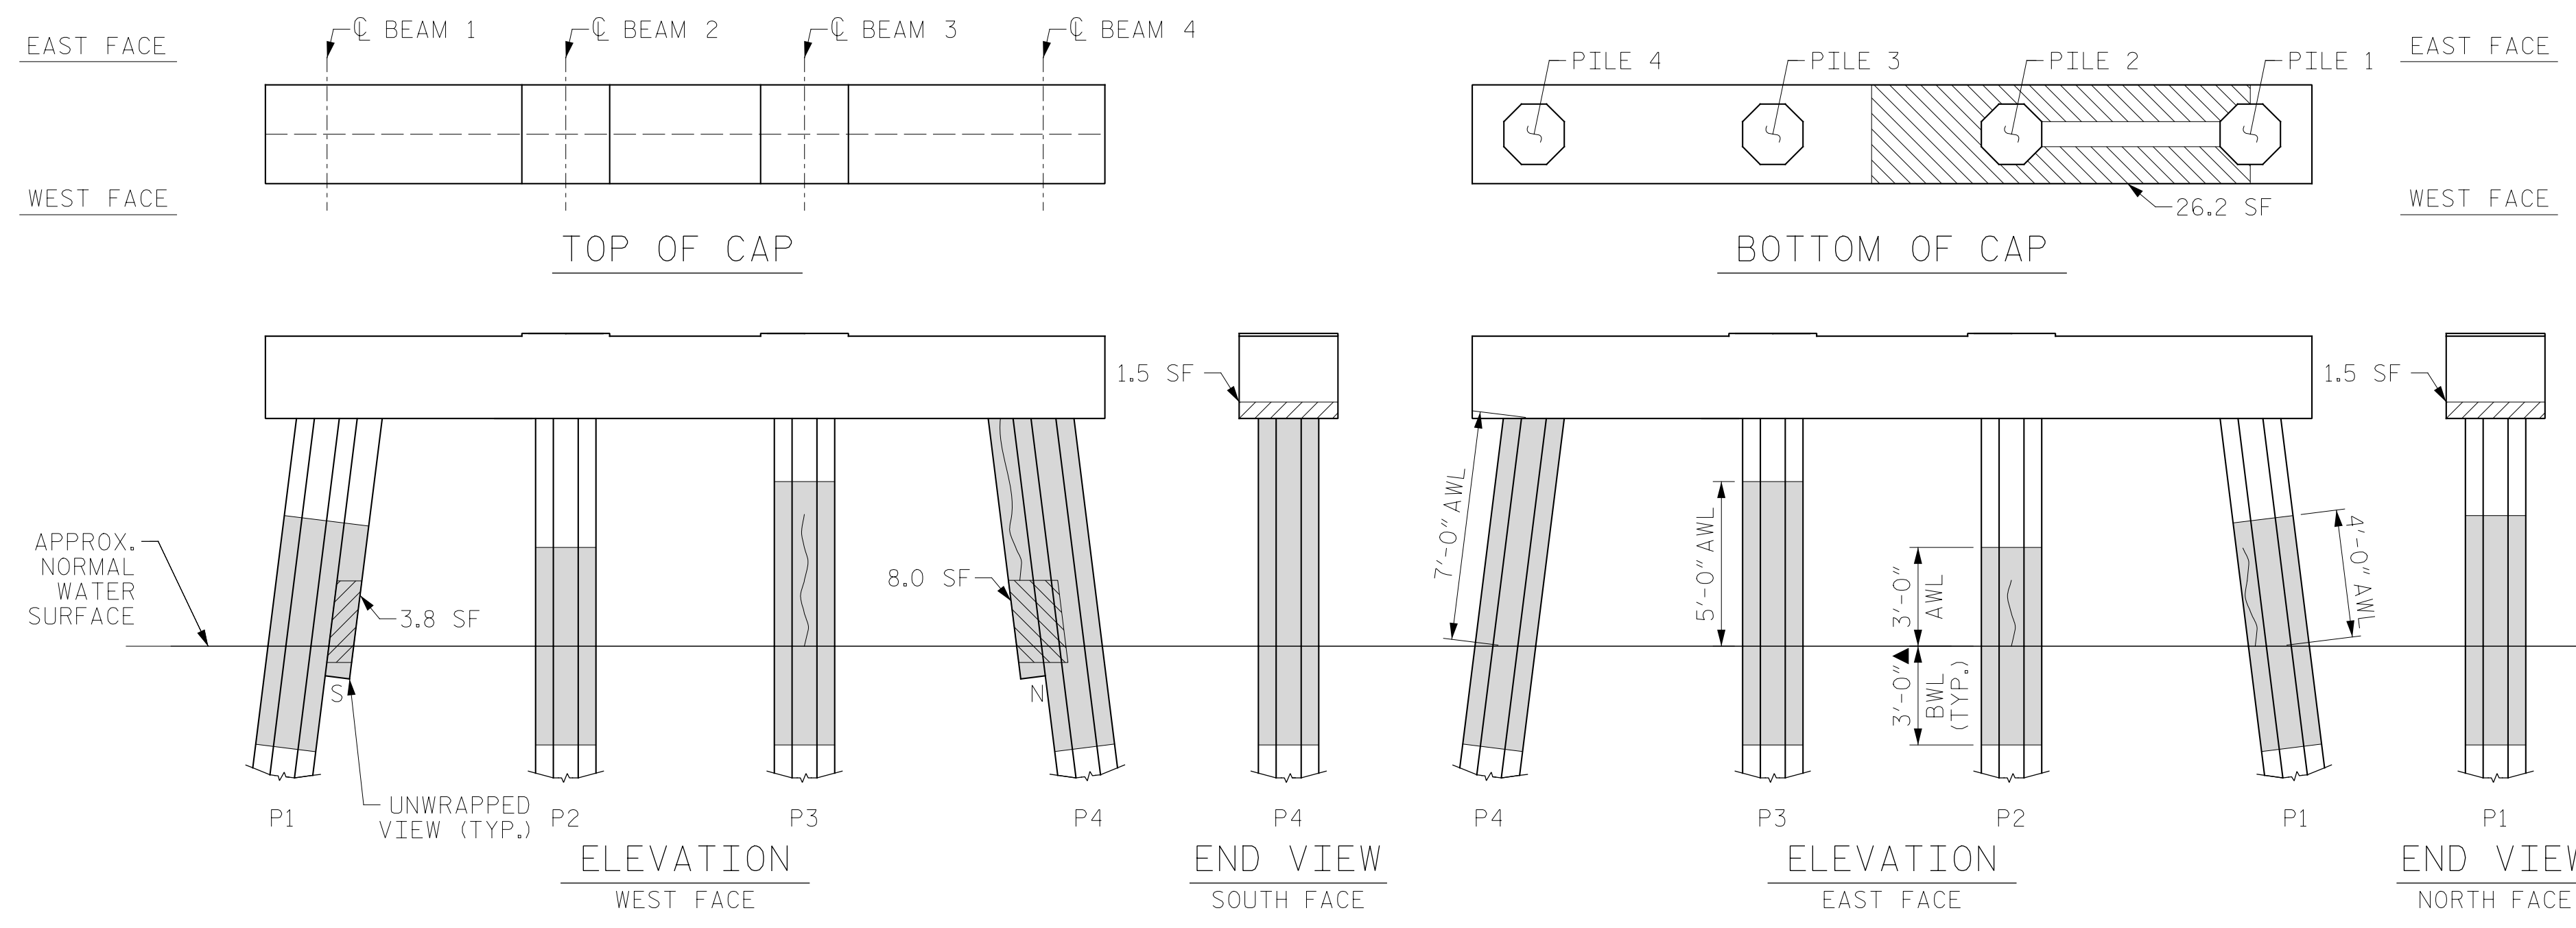
BENT 310

CAP REPAIRS		ESTIMATE			
SHOTCRETE REPAIRS	29.2 SF	14.6 CF	SF	CF	
EPOXY RESIN INJECTION	-	LF			LF
PILE REPAIRS		ESTIMATE			
PILE CONCRETE RESTORATION	11.8 SF	4.8 CF	SF	CF	
FRP PROTECTIVE SYSTEM AWL	104.5 SF				
FRP PROTECTIVE SYSTEM BWL	66.0 SF

(AWL = ABOVE WATERLINE)  
(BWL = BELOW WATERLINE)  
(\*QUANTITY INCLUDES ADJACENT REPAIRS)
