PROJECT NO. **I-5950 DAVIDSON** COUNTY 280092 BRIDGE NO. \_\_\_\_

STATE OF NORTH CAROLINA DEPARTMENT OF TRANSPORTATION

> BENT 1 SPAN A FACE

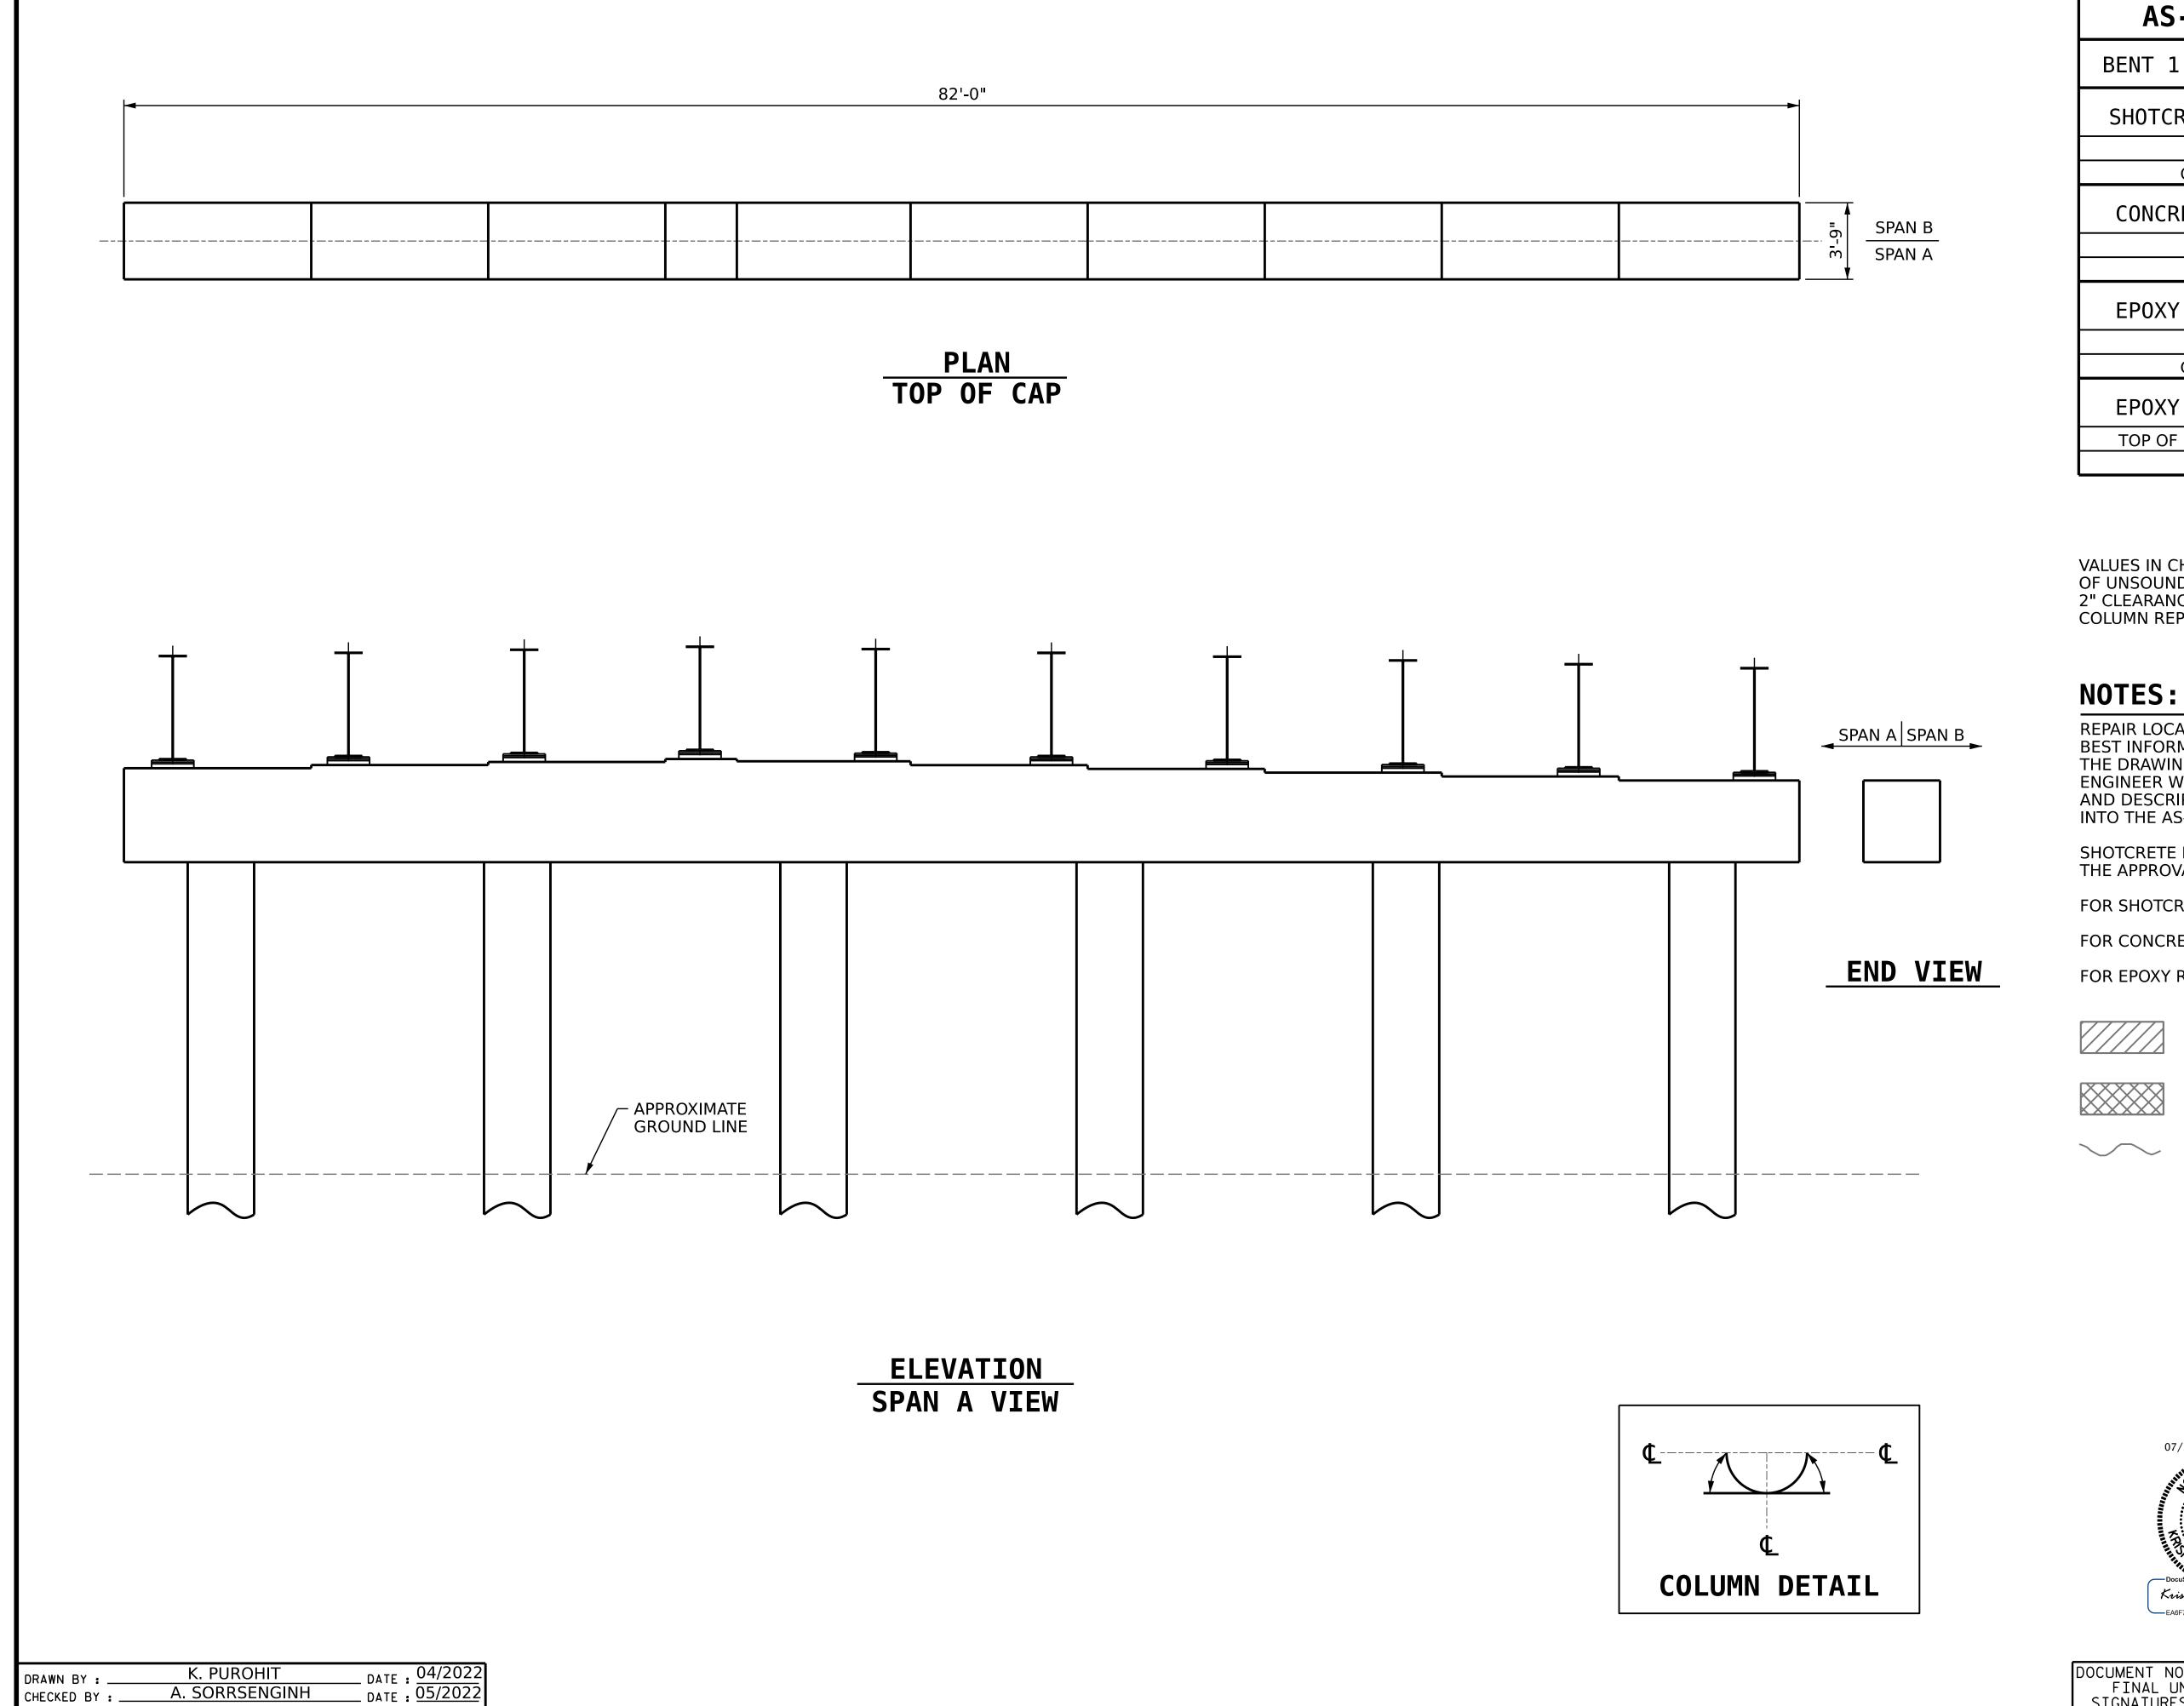
VALUES IN CHART REPRESENT ESTIMATED REPAIR TOTALS AFTER REMOVAL OF UNSOUND CONCRETE, MINIMUM OF 1" BEHIND REBAR AND MINIMUM OF 2" CLEARANCE TO SAWCUT. FOR REPAIR DETAILS, SEE ``TYPICAL CAP AND COLUMN REPAIR DETAILS" SHEET.

SHOTCRETE REPAIR AREA

CONCRETE REPAIR AREA

**EPOXY RESIN INJECTION**
