PROJECT NO. HI-0008

JOHNSTON COUNTY

BRIDGE NO. 500107

DECK UNDERSIDE & BENT DIAPHRAGM REPAIR

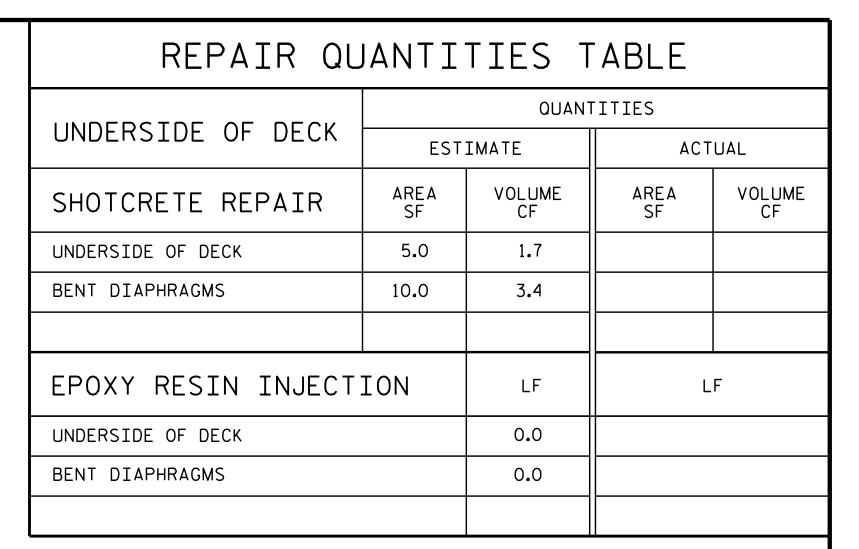
REPAIR KEY

DIAPHRAGM REPAIR

UNDERSIDE OF DECK REPAIR

EPOXY RESIN INJECTION (ERI)

VALUES IN CHART REPRESENT ESTIMATED REPAIR QUANTITIES AFTER REMOVAL OF UNSOUND CONCRETE, MIN. OF 1"BEHIND REBAR AND MIN. 1"CL TO SAWCUT. SEE REPAIR DETAILS.

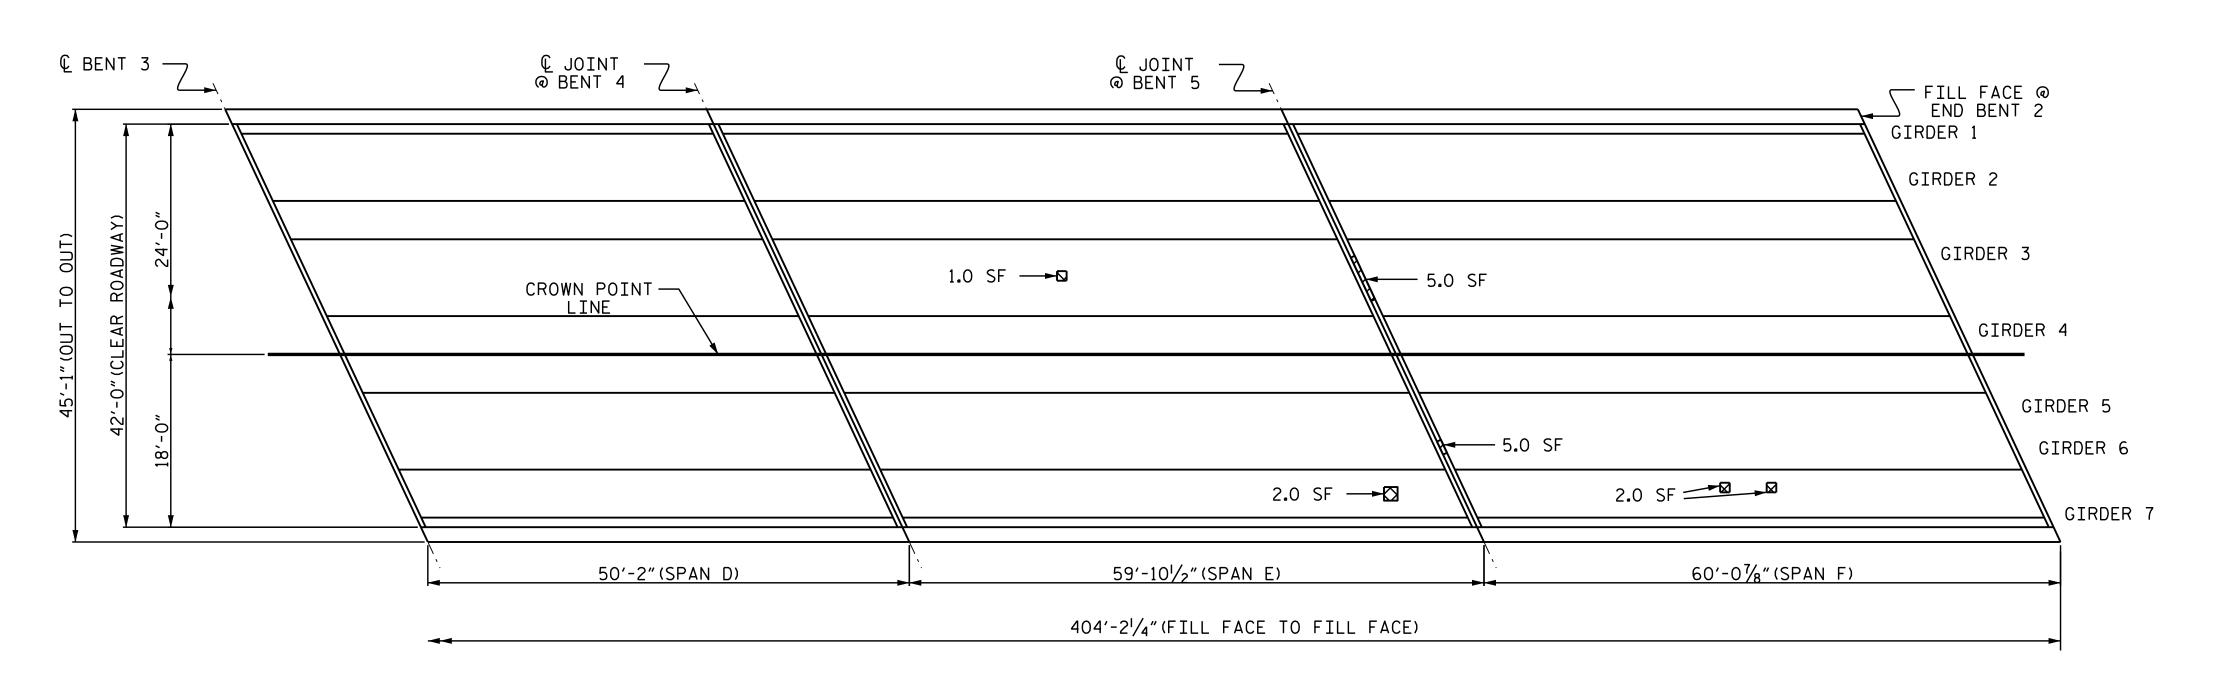
UNDERSIDE

(SPANS D-F)
