PRELIMINARY SITE ASSESSMENT REPORT
DELMUS BRIDGERS-FAMILY LIMITED PARTNERSHIP PROPERTY
PARCEL NO 24

US 13 (Berkeley Blvd) – Realignment of SR 1709
(Central Heights Road) at Berkeley Blvd.
TIP No.: U-5724
WBS Element: 54016.1.2

Report Date: October 30, 2018
MAA Job #: 000R3203.00

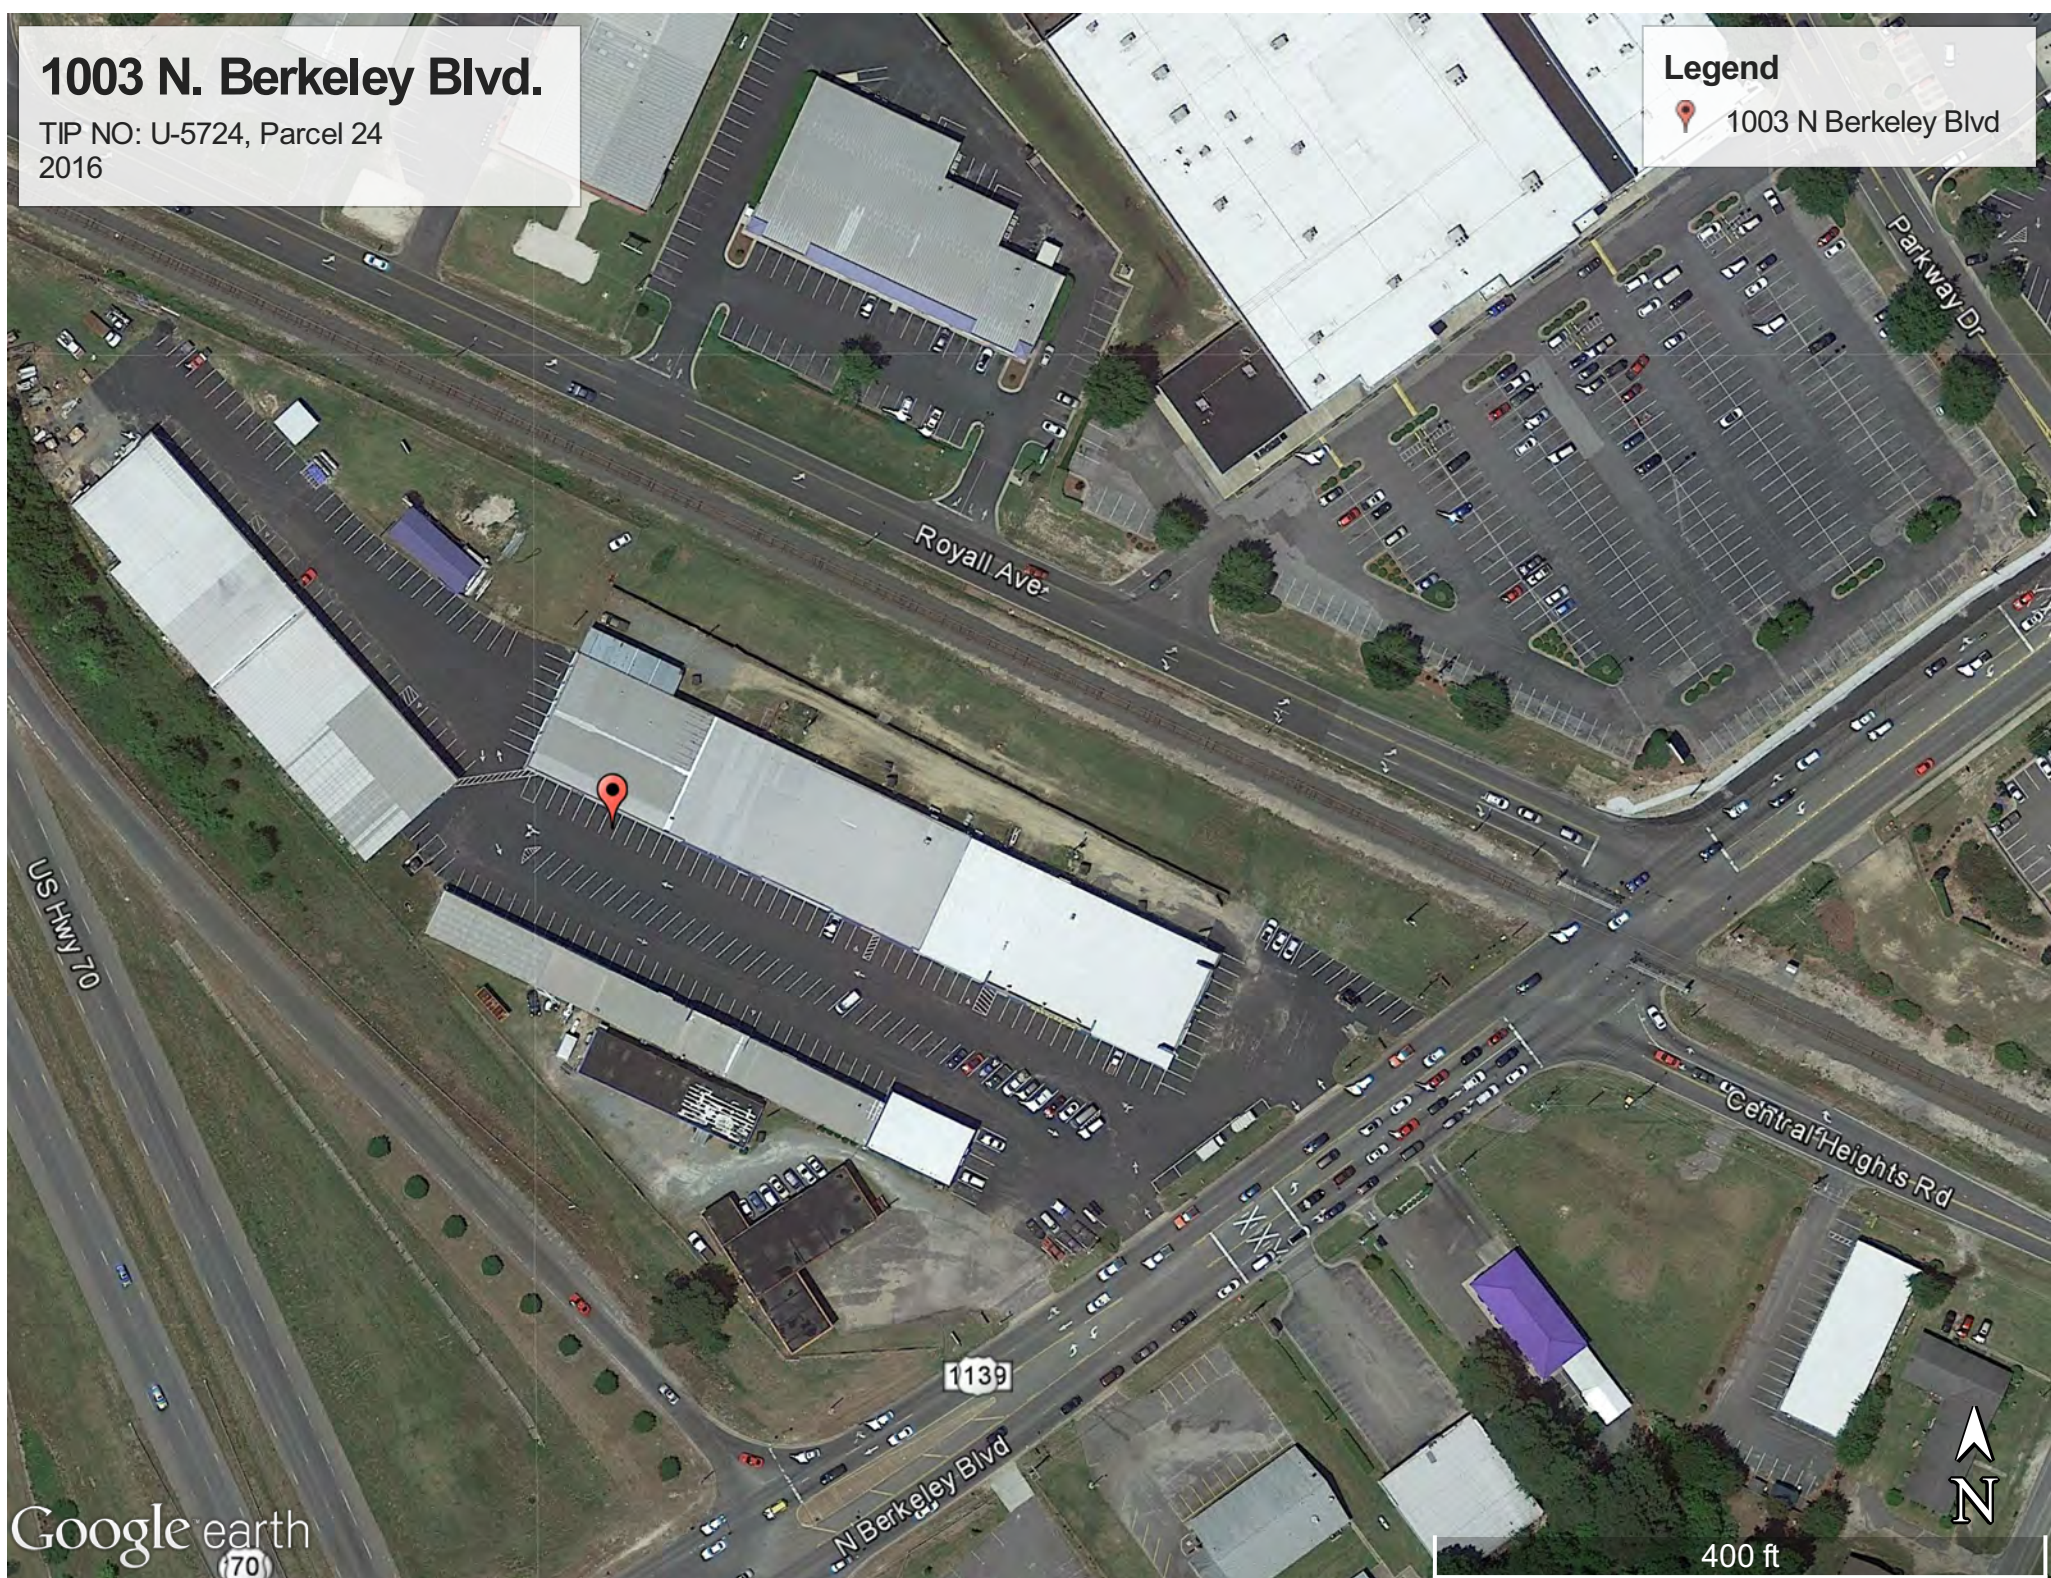
Photo 1 – A general view of site, looking west from Berkeley Boulevard.
(photo courtesy of Google Earth)

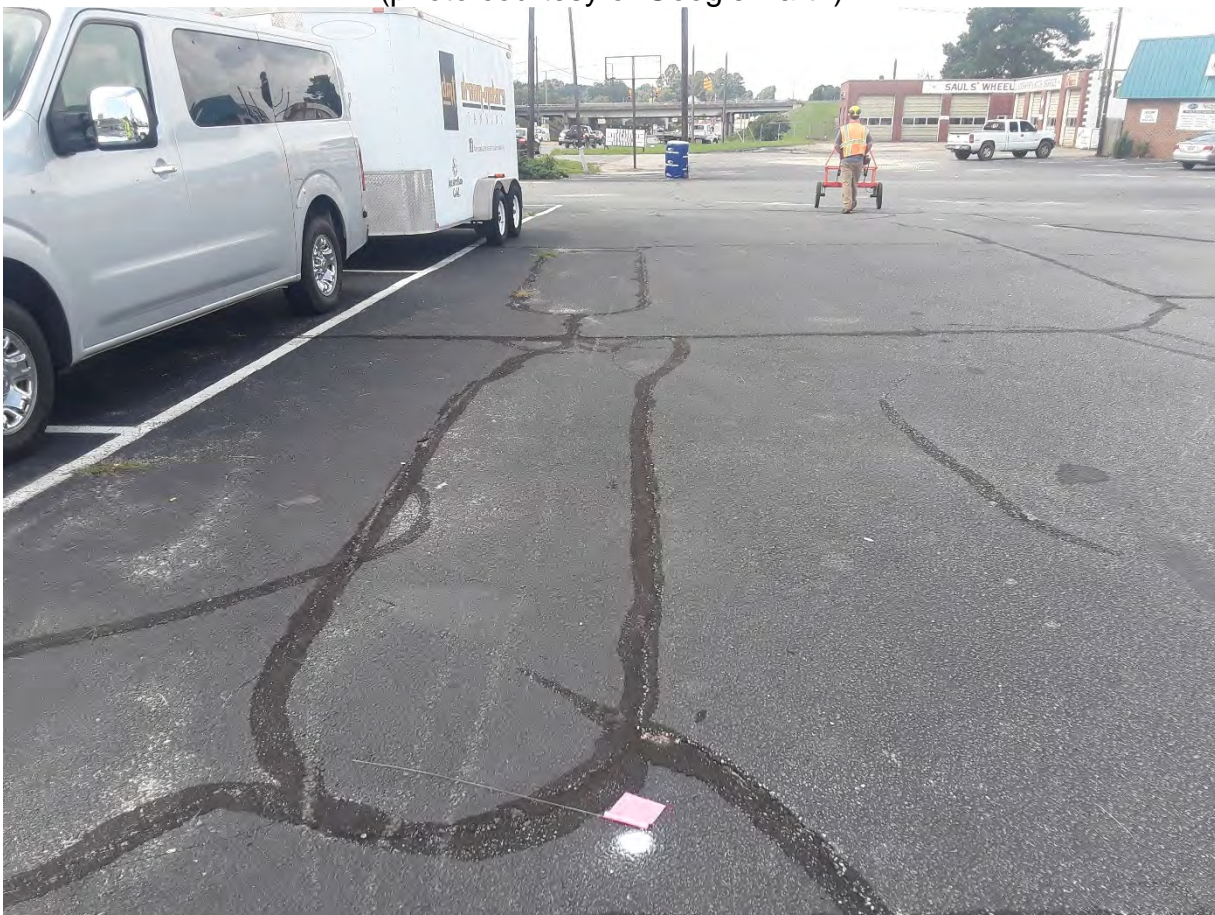
Photo 2 – Apparent former pump island area, looking southwest.

As shown in **Appendix C**, the geophysical survey found evidence characteristic of metal reinforcement (rebar or the like) beneath the apparent former pump island, but did not find evidence of USTs existing within the area of the survey. The USTs were reportedly removed in 1989.

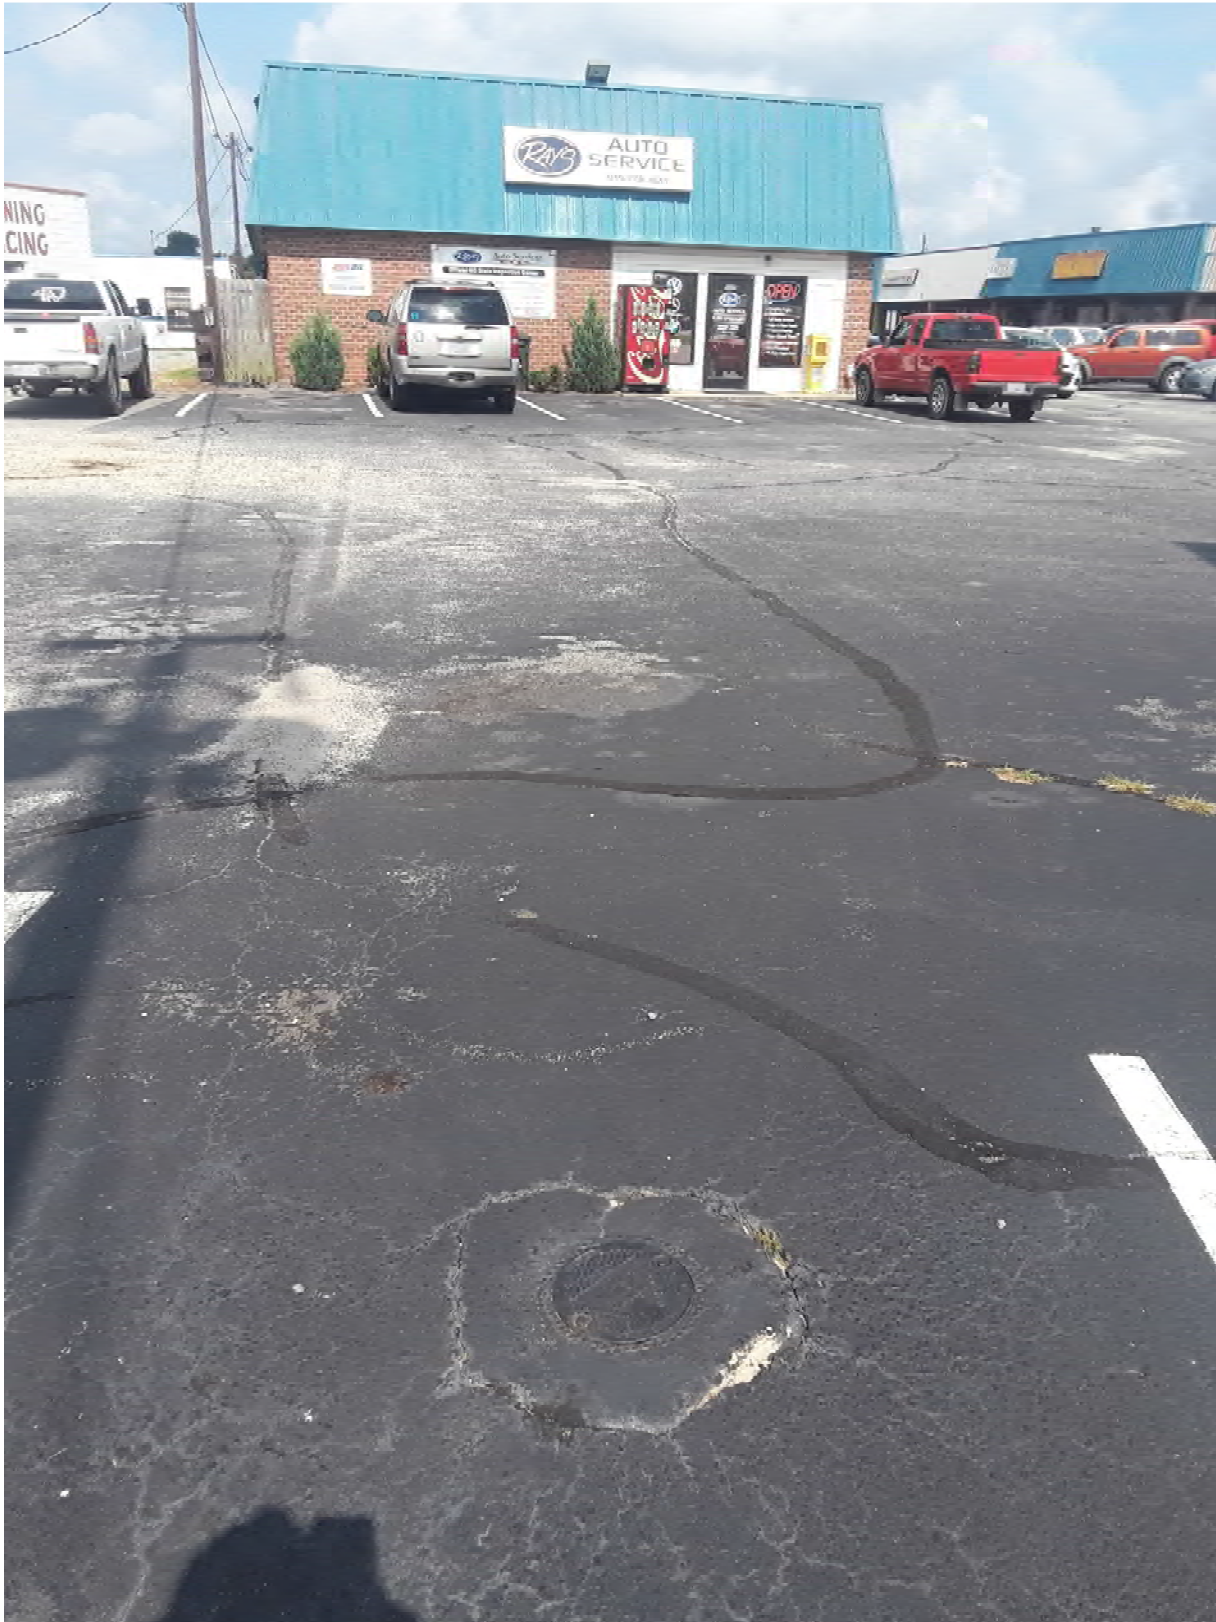
Photo 3 – A view of well MW-2 (not abandoned), looking northwest.

Mid-Atlantic observed several historical groundwater monitoring wells on the Subject Site, two of which were located in the proposed right of way acquisition area or construction easement (MW-2 and MW-3). These wells have not been abandoned. See Section 3.1 for further information.

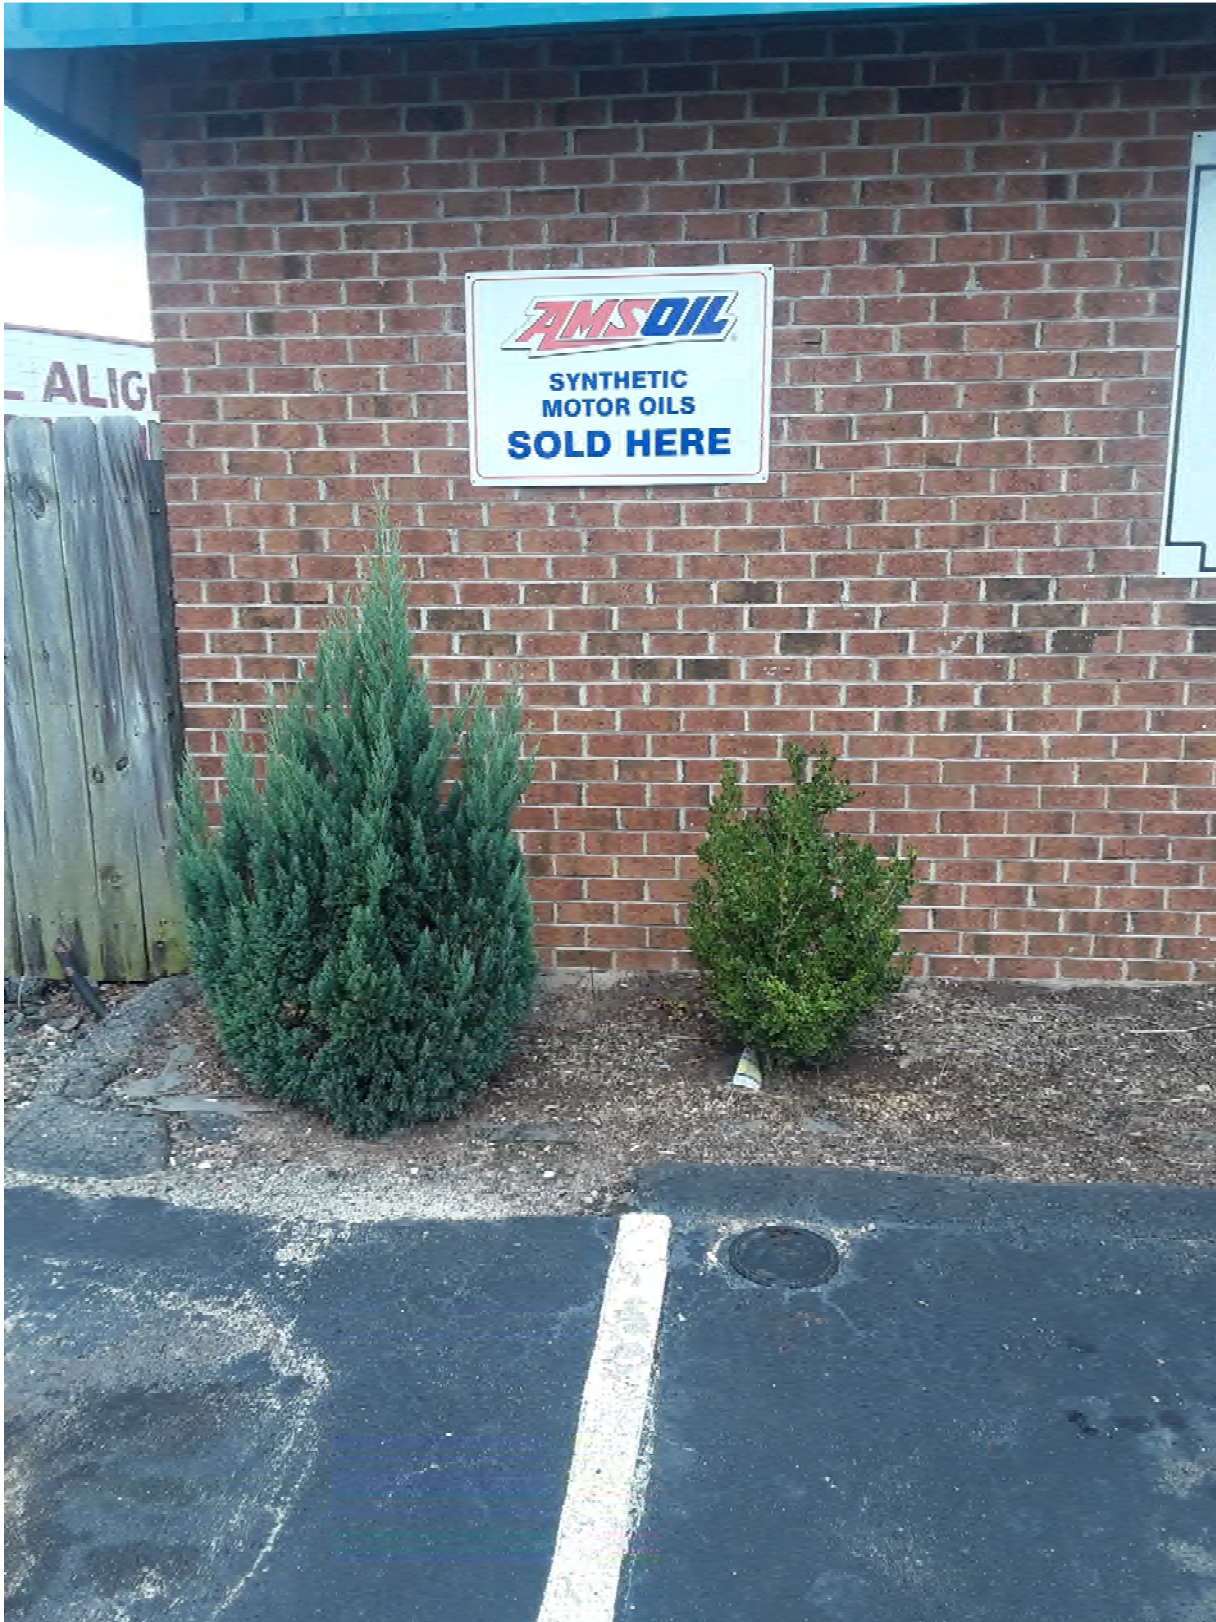
Photo 4 – A view of well MW-3 (not abandoned), adjacent to Ray's Auto, looking northwest.

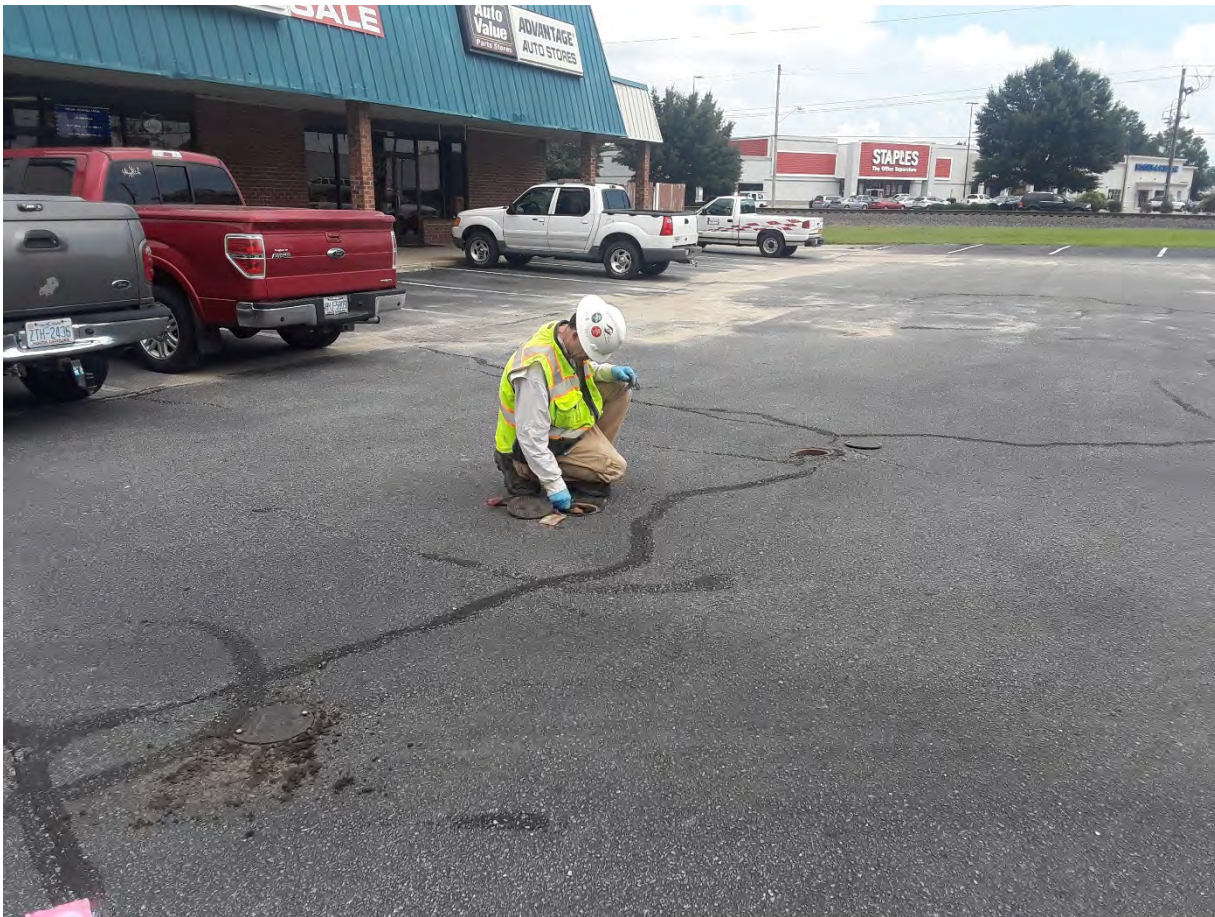
Photo 5 – A view of well MW-11A (middle, not abandoned) and two unknown wells (to the right and left of MW-11A), looking north.

Four additional monitoring wells were observed during the August 22, 2018 site reconnaissance. On the drawing provided in the 2013 Monitoring Report in **Appendix A**, two of these wells are listed as MW-5 (which is slightly outside of the parcel property line) and MW-11A. The other two wells, which are not on the drawing, are located close to MW-11A. The use of these wells is unknown. Monitoring well MW-4, which is shown on Drawing 3.1, could not be located.

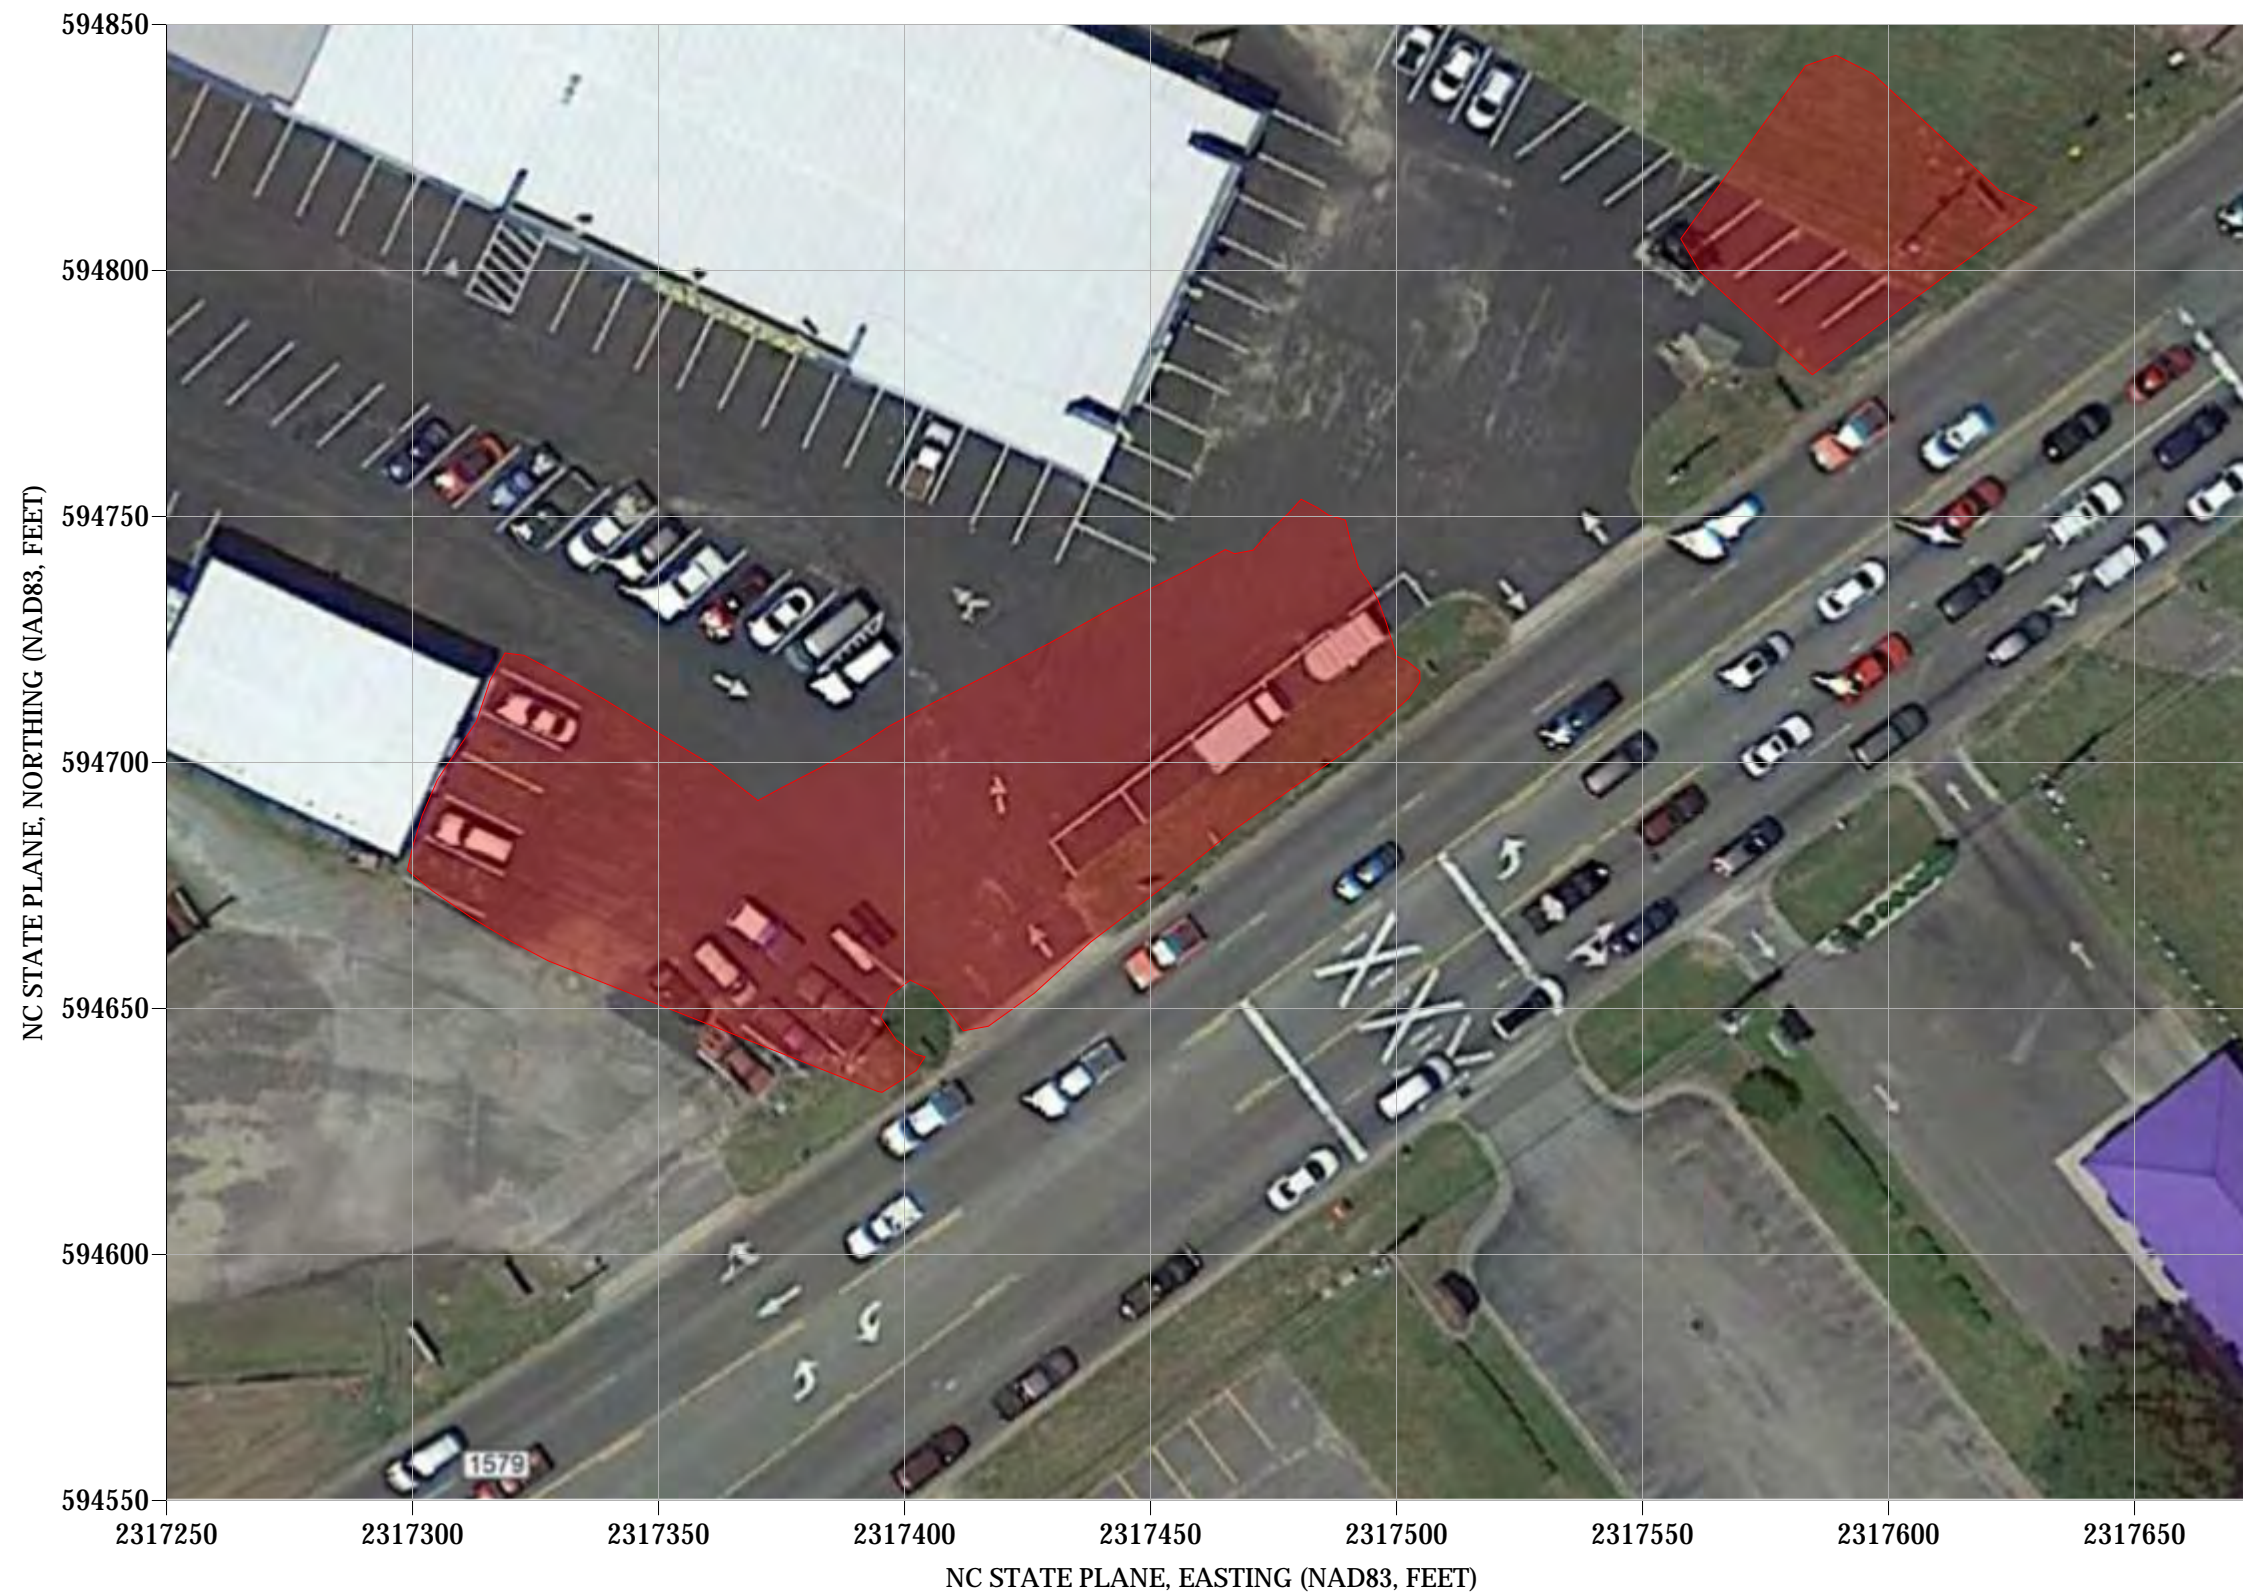
APPROXIMATE BOUNDARIES OF GEOPHYSICAL SURVEY AREA

The site included an active service garage in a shopping plaza surrounded by grass, asphalt, and gravel surfaces. An aerial photograph showing the survey area boundaries and ground-level photographs are shown in **Figure 1**.

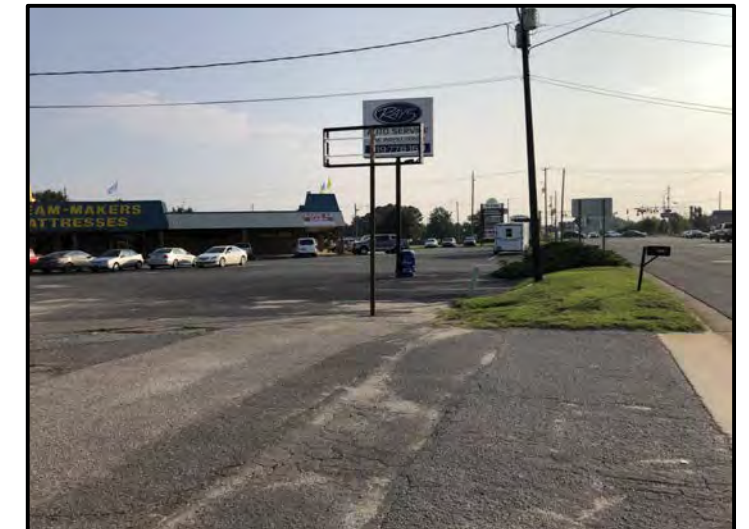
View of Survey Area
(Facing Approximately Northeast)

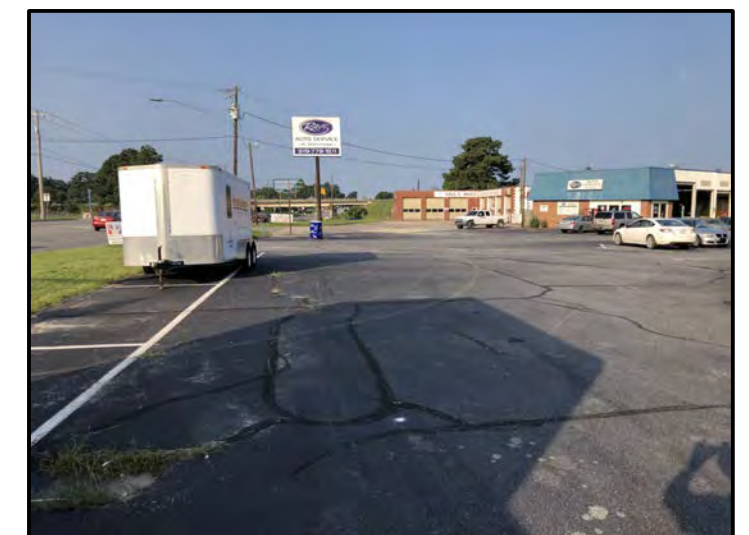
View of Survey Area
(Facing Approximately Southwest)

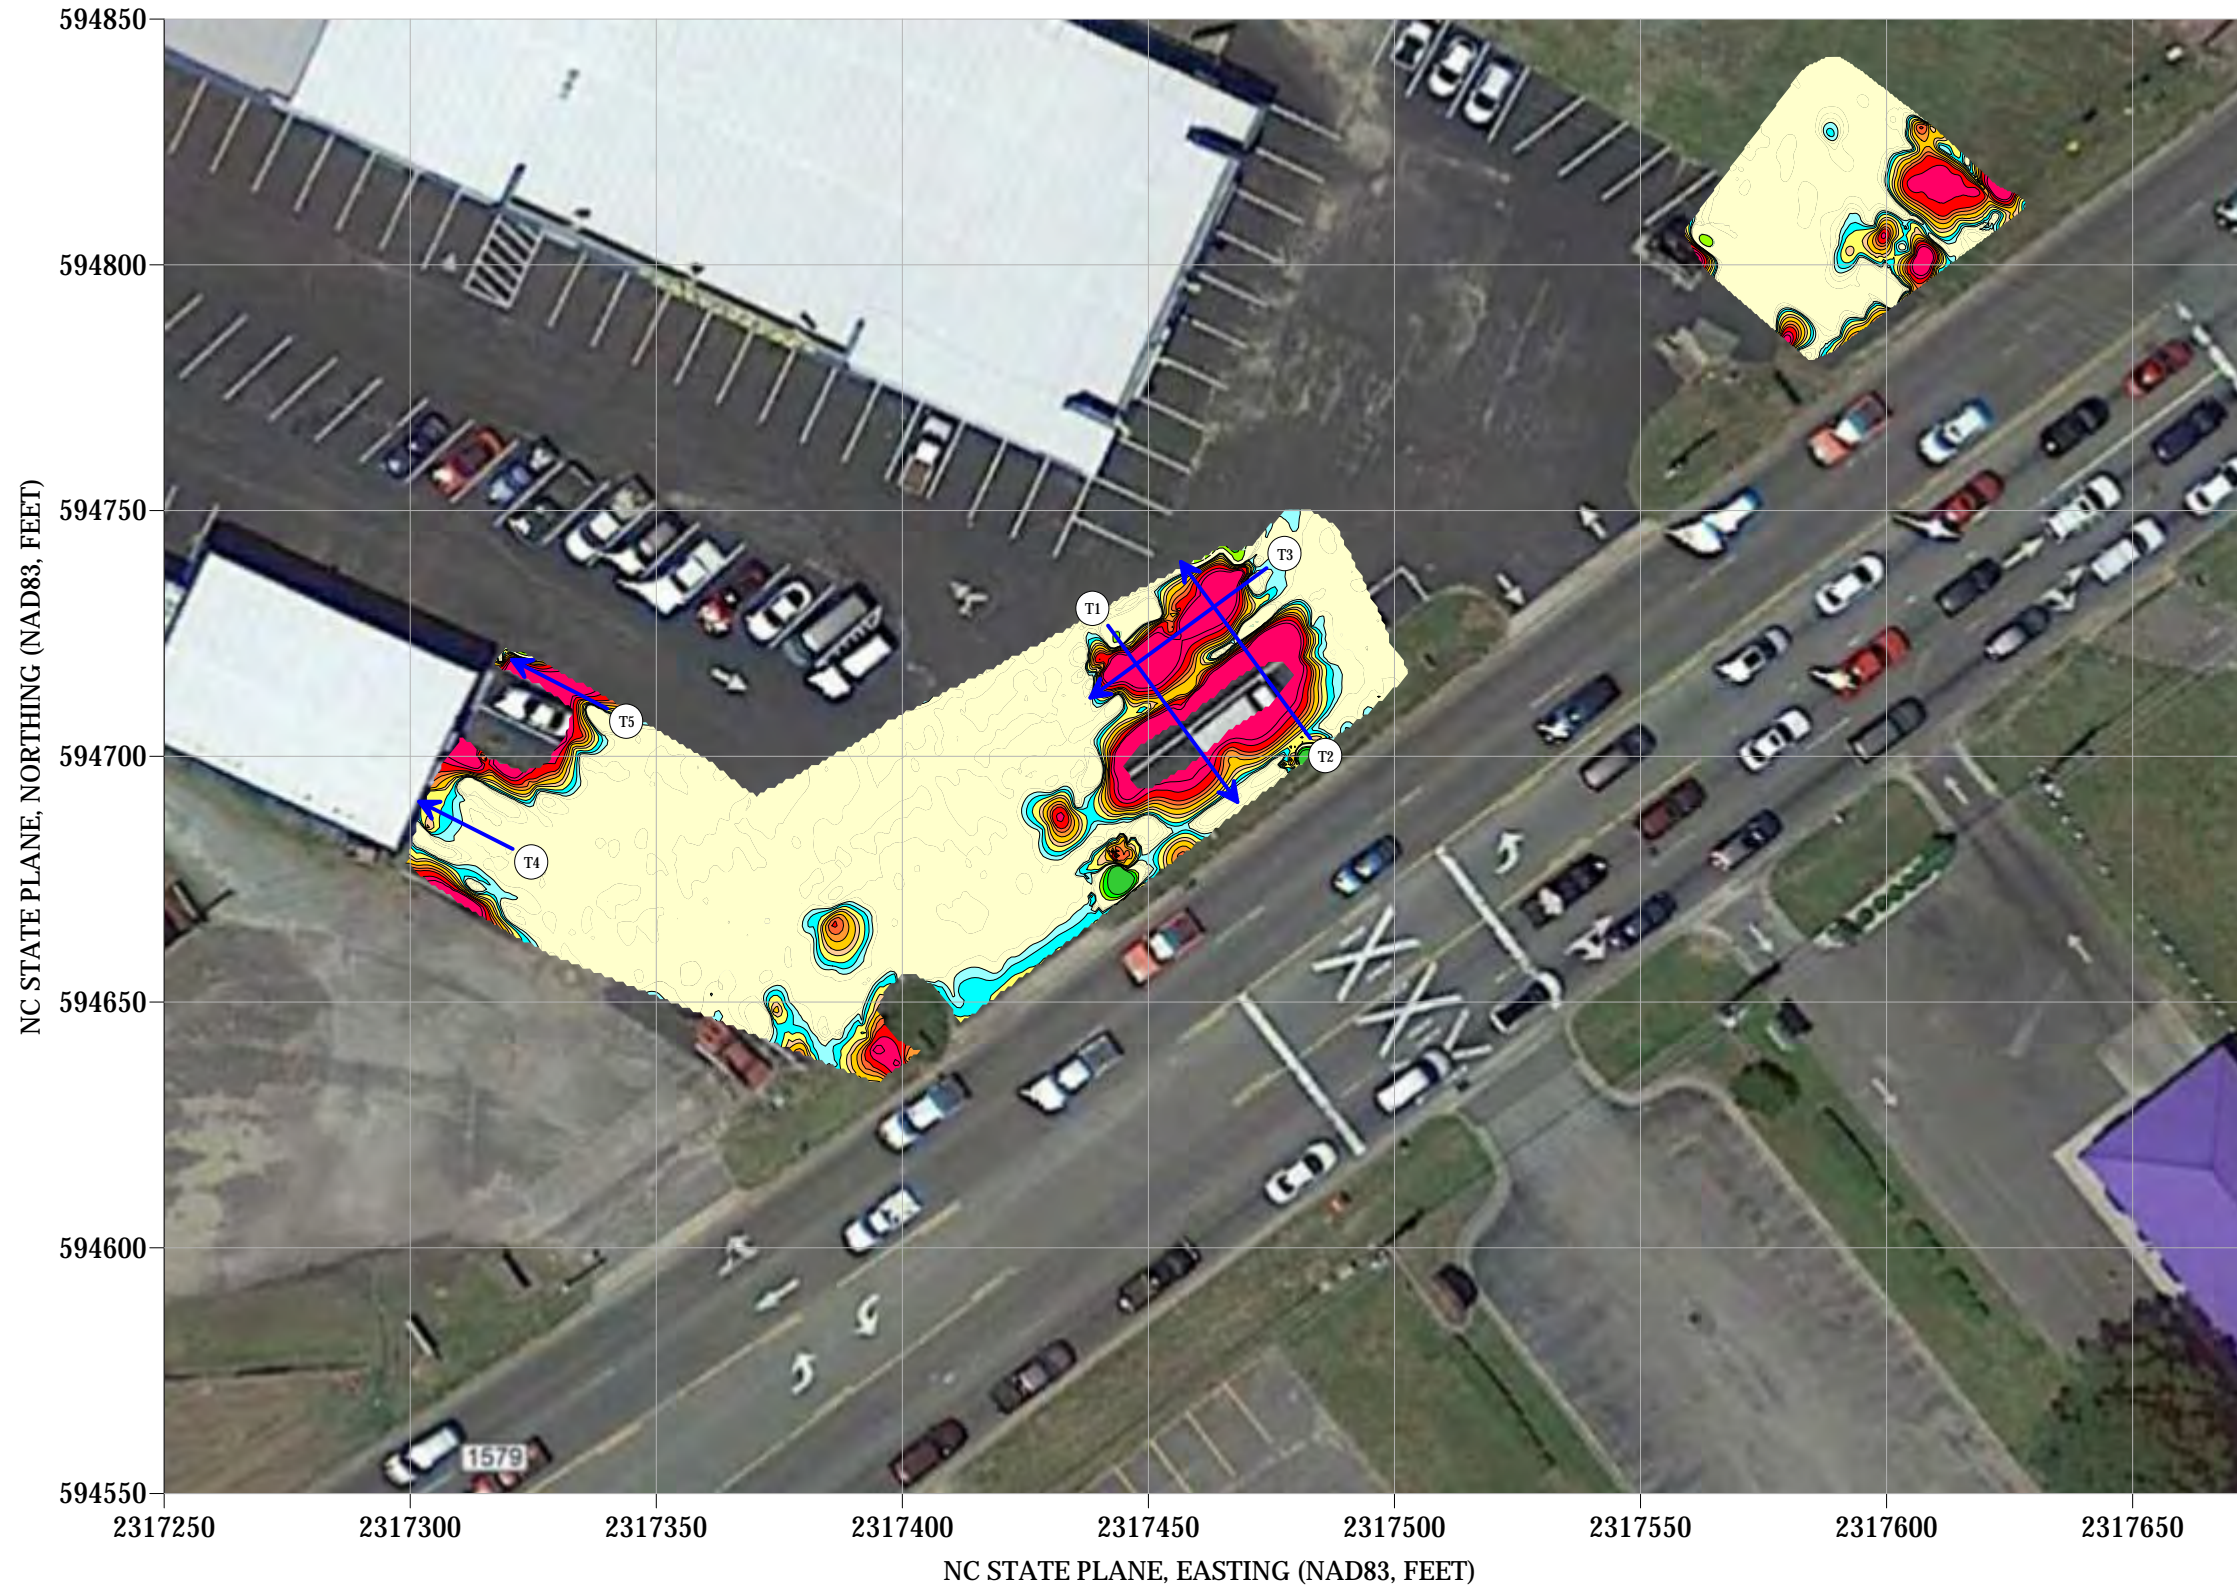
LOCATIONS OF GPR TRANSECTS

*EXTENSIVE GPR SCANS WERE CONDUCTED OVER THE ENTIRE SITE. TRANSECT LINES ON THE MAP ABOVE INDICATE LOCATIONS WHERE DATA WERE SAVED. THESE LOCATIONS WERE CHOSEN TO HIGHLIGHT STRUCTURES IDENTIFIED IN THE SUBSURFACE OR TRANSECTS THAT ARE REPRESENTATIVE OF GENERAL SUBSURFACE CONDITIONS.
