**STRUCTURE**  
**SUBSURFACE INVESTIGATION**

COUNTY CABARRUS  
 SITE DESCRIPTION BRIDGE NO. 132 ON NC 73 OVER  
DUTCH BUFFALO CREEK

STATE	STATE PROJECT REFERENCE NO.	SHEET NO.	TOTAL SHEETS
N.C.	B-5813	1	14

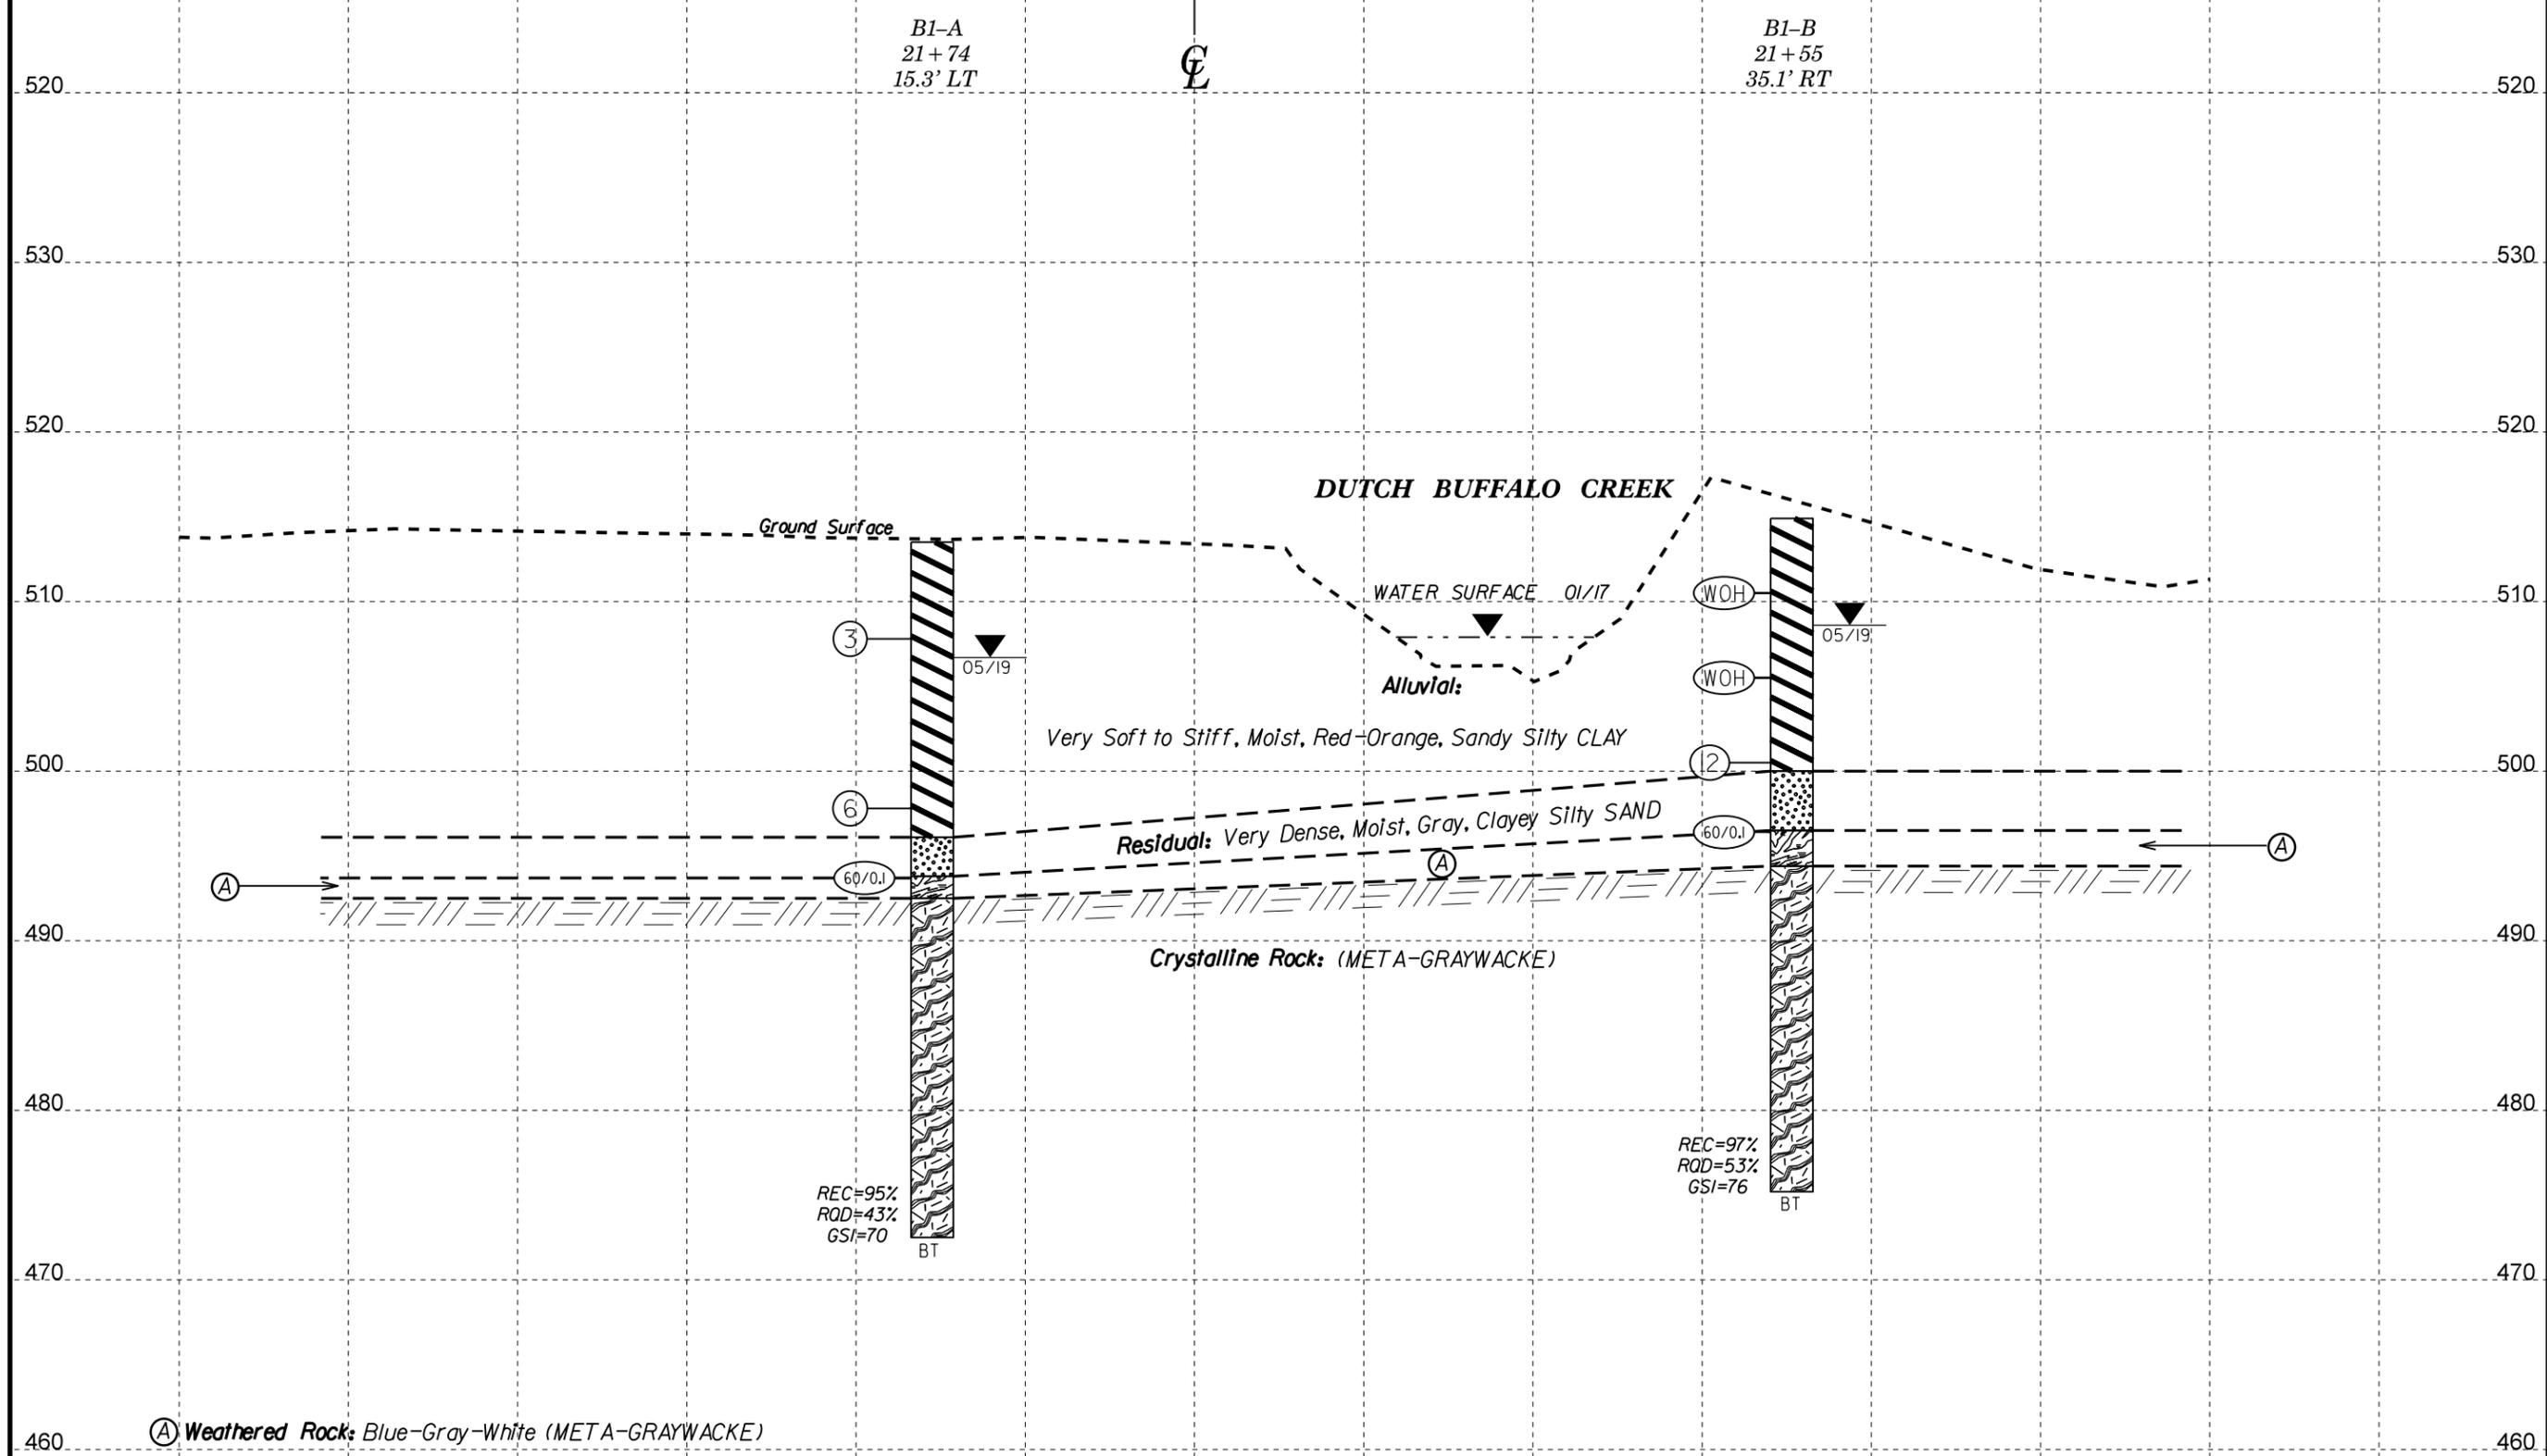
<b>PROJECT REFERENCE NO.</b>	<b>SHEET NO.</b>
B-5813	5
<b>CROSS SECTION THROUGH BENT 1</b>	
AT -L- STATION 21+66	
SKEW=110°

GROUNDLINE TAKEN FROM .TIN FILE RECEIVED BY NCDOT DATED 06/20/2019.  
INFERRED STRATIGRAPHY IS DRAWN THROUGH THE BORINGS WITH BOTH  
PROJECTED ONTO THE CROSS SECTION

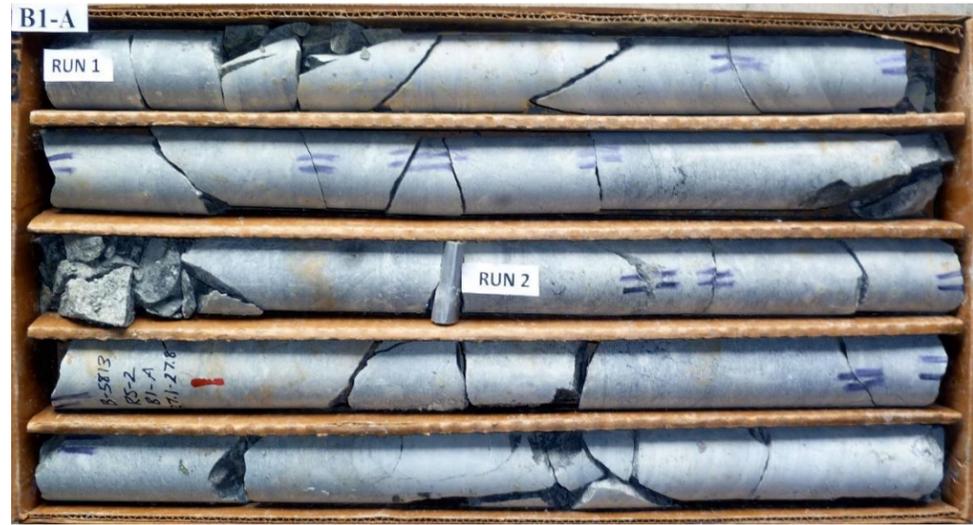
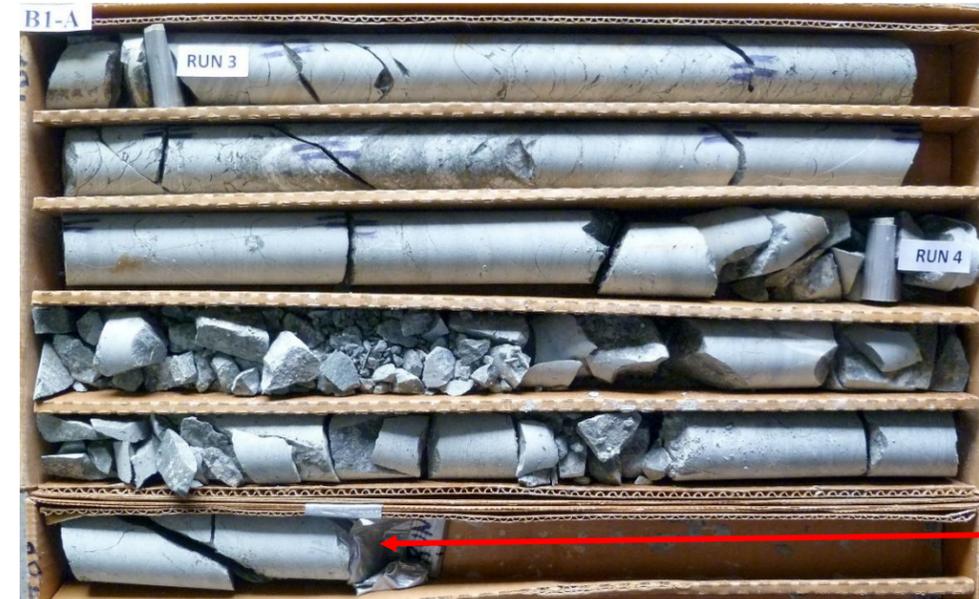
### CORE PHOTOGRAPHS: Bridge No. 132 on NC 73 over Dutch Buffalo Creek, B1-A 21+74, 15.3' LT

Begin  
21.0 feet

End  
41.0 feet

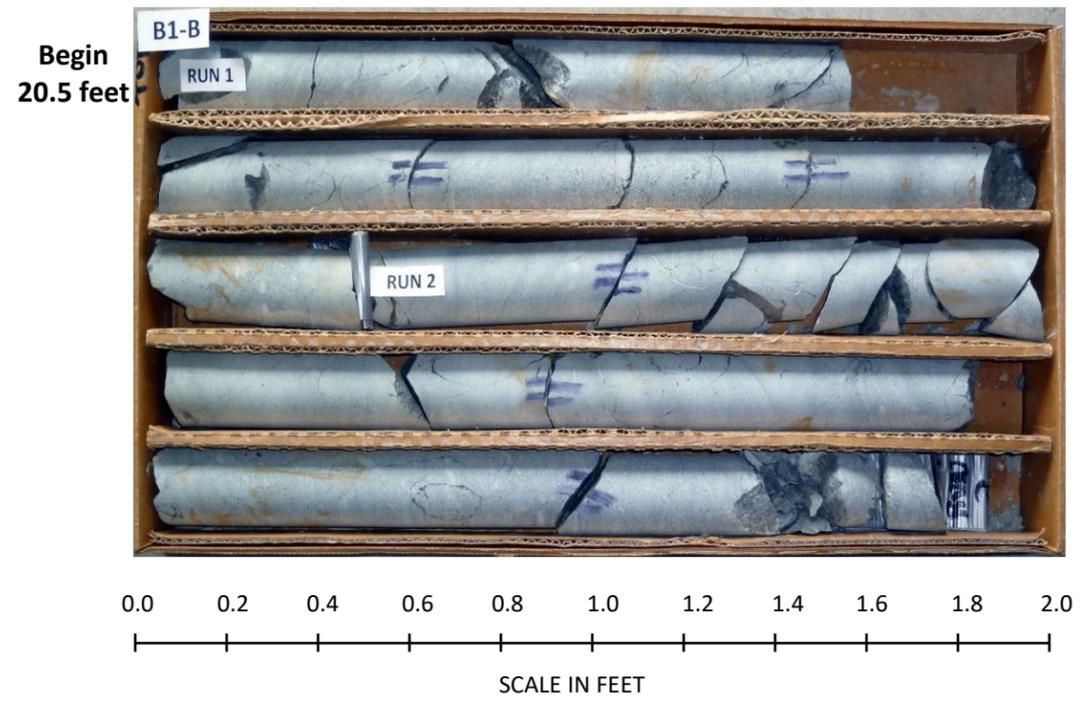
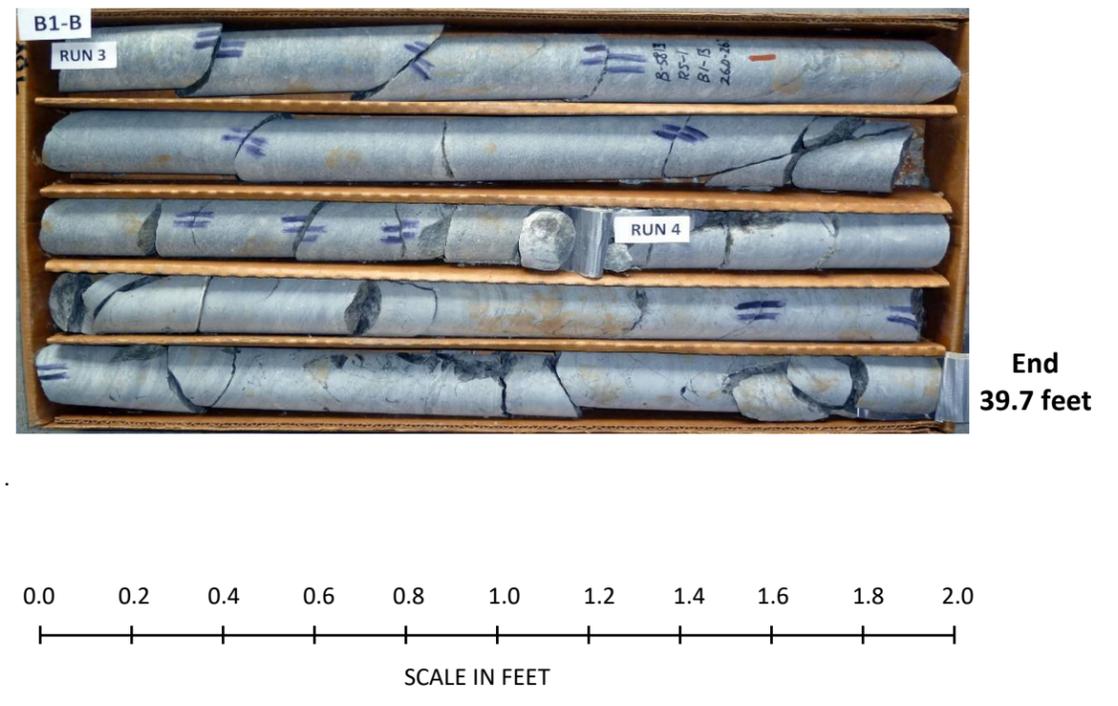
### CORE PHOTOGRAPHS: Bridge No. 132 on NC 73 over Dutch Buffalo Creek, B1-B 21+55, 35.1' RT

494.4	494.4	20.5	4.2	0:00/0.2 1:38/1.0 1:42/1.0 1:50/1.0 1:53/1.0	(3.9) 93%	(1.7) 40%		(18.6) 97%	(10.1) 53%		Begin Coring @ 20.5 ft	
490	490.2	24.7	5.0	1:54/1.0 1:42/1.0 1:44/1.0 1:49/1.0 1:41/1.0	(4.9) 98%	(3.4) 68%	RS-1				Gray, Very Slightly Weathered to Fresh, Hard to Very Hard, META-GRAYWACKE with Close to Moderately Close Fracture Spacing GSI=76	20.5
485	485.2	29.7	5.0	1:43/1.0 1:50/1.0 1:41/1.0 1:48/1.0 1:45/1.0	(4.9) 98%	(3.8) 76%						
480	480.2	34.7	5.0	1:47/1.0 1:50/1.0 1:55/1.0 1:59/1.0 1:46/1.0	(4.9) 98%	(1.2) 24%

Sample #	Boring #	Depth (ft)	Rock Type	Geologic Map Unit	Run RQD (%)	Length (in)	Diameter (in)	Unit Weight (PCF)	Unconfined Compressive Strength (PSI)	Remarks
RS-1	B1-B	26.0-26.7	Meta-Graywacke	Czy	53	0.7	1.86	178.5	5,470	Bridge No. 132
RS-2	B1-A	27.1-27.8	Meta-Graywacke	CZy	43	0.7	1.86	181.4	4,620	Bridge No. 132

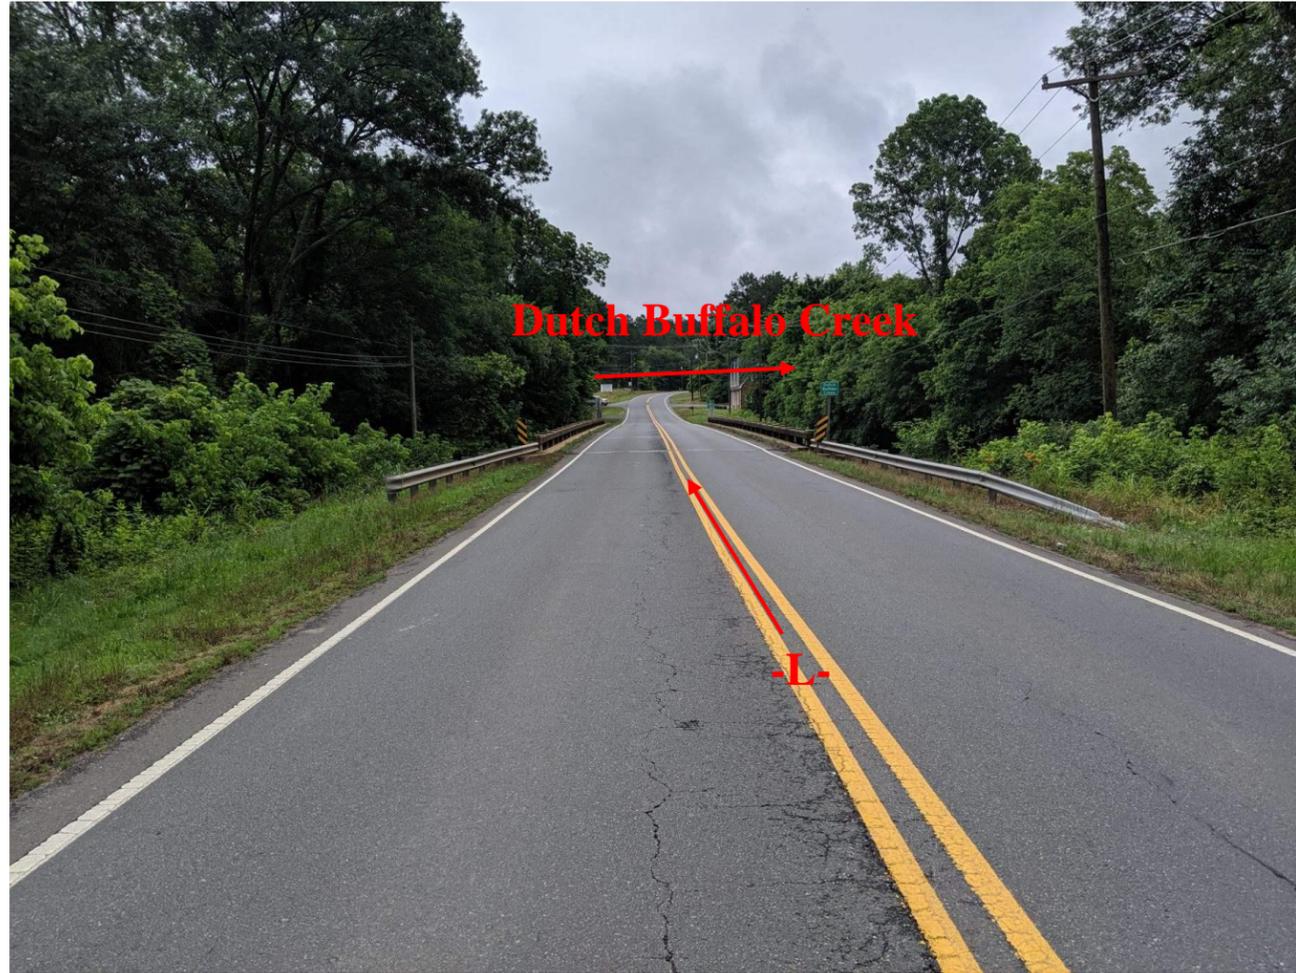
**Photograph No. 1:** Looking at End Bent 1 toward End Bent 2

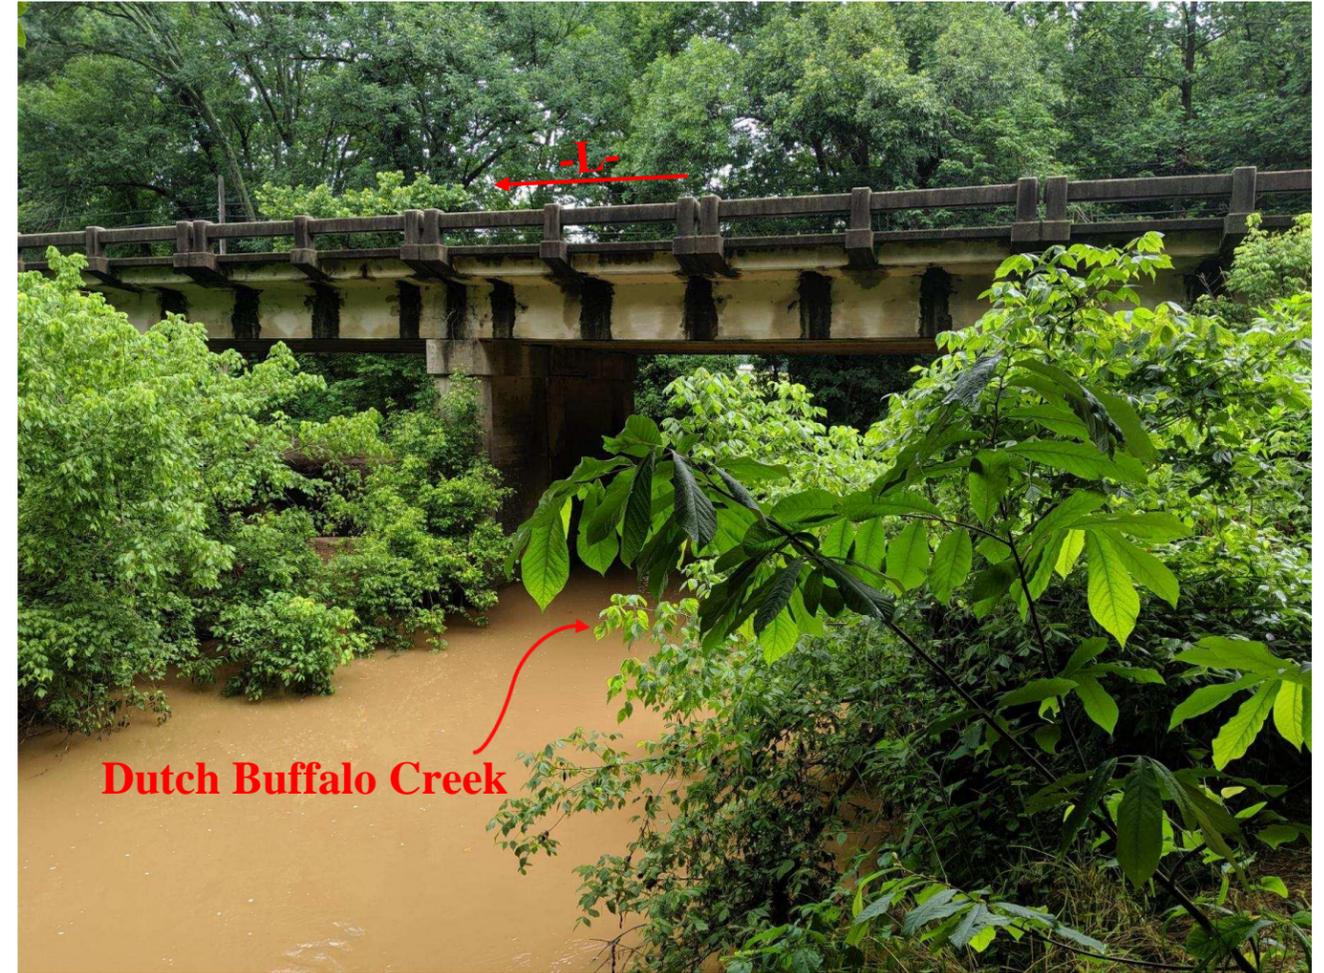
**Photograph No. 2:** Looking Downstream
