PROJECT NO. I-5955
GUILFORD COUNTY
 BRIDGE NO. 400329

STATE OF NORTH CAROLINA
 DEPARTMENT OF TRANSPORTATION
 RALEIGH

BEAM REPAIR LOCATIONS

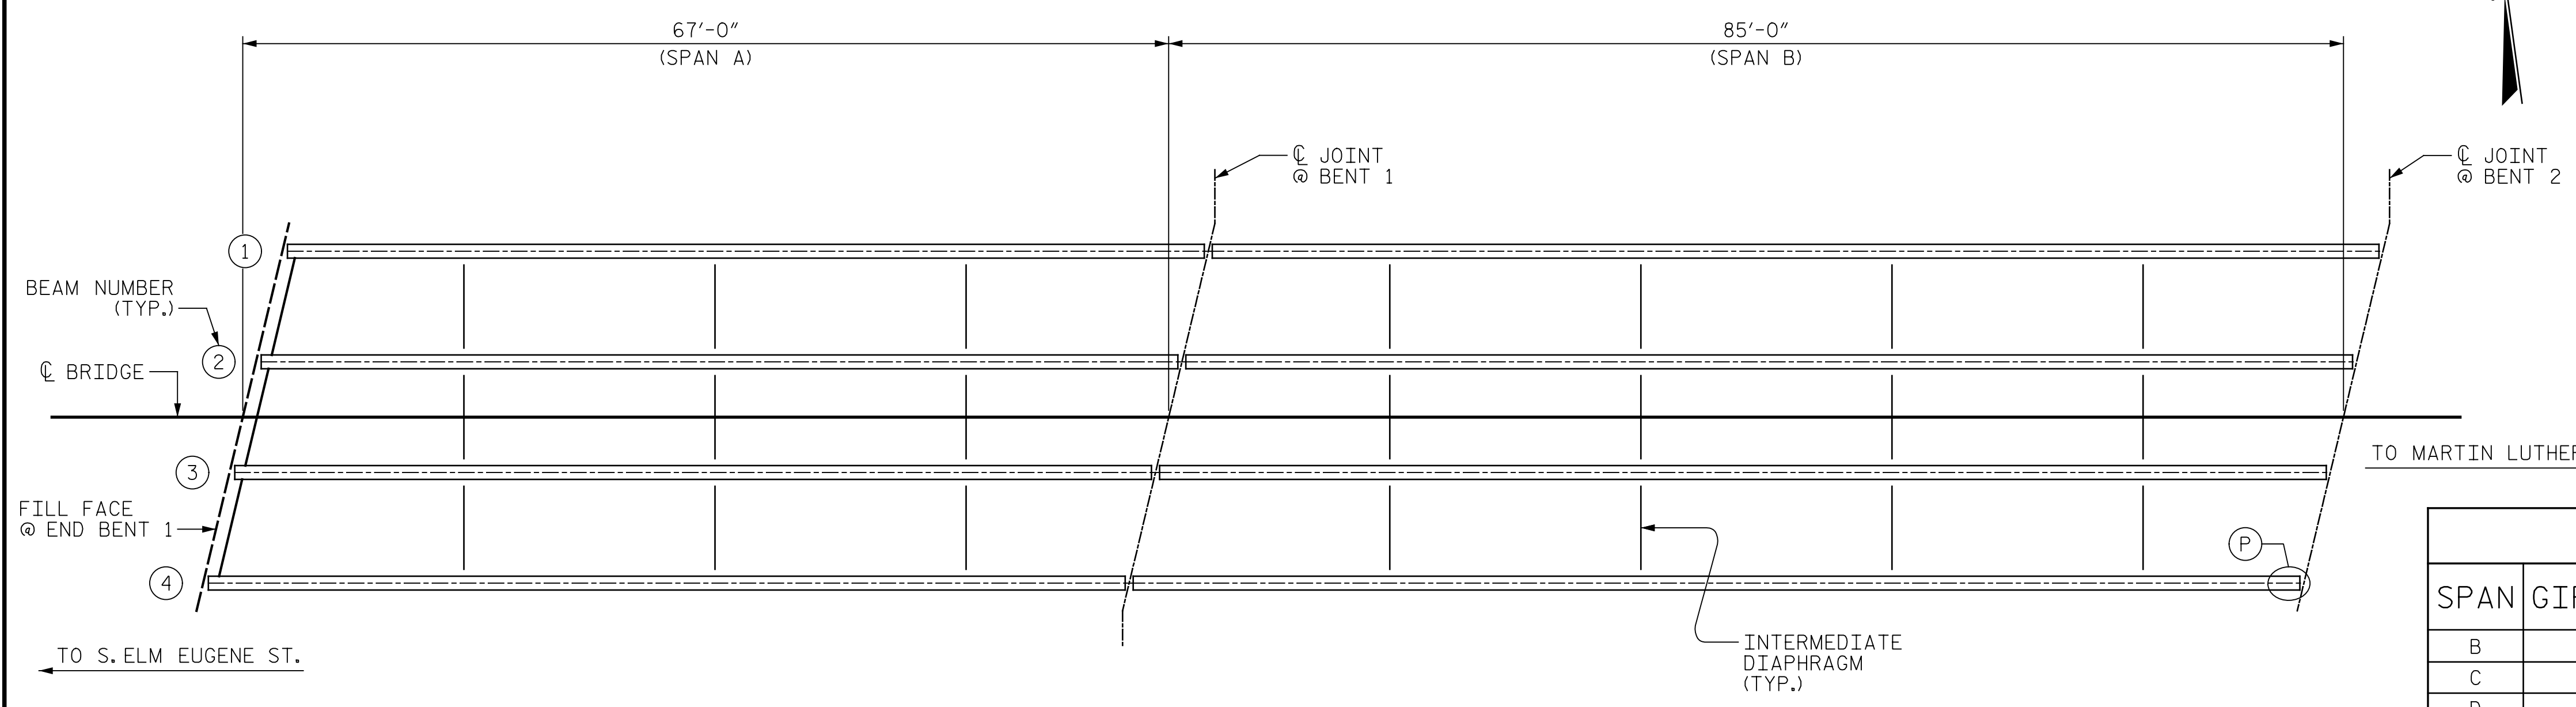
BEAM REPAIR LOCATIONS
(OTHER LOCATIONS MAY EXIST, SEE NOTES)

ANTICIPATED REPAIR LOCATIONS						
SPAN	GIRDER	LOCATION	DIM "A"	DIM "B"	DIM "C"	DIM "D"
B	4	BENT 2	1"	10"	1"	-
C	4	BENT 2	3"	11"	23"	-
D	2	BENT 3	3"	11"	1"	-
D	2	BENT 3	3"	10"	23"	-
