STATE OF NORTH CAROLINA DEPARTMENT OF TRANSPORTATION

TIP NO:
 B-5985

DESCRIPTION: Replace Bridge # 770125 over Lumber River on NC 41/NC 72 &

SUBJECT: GeoEnvironmental Planning Report

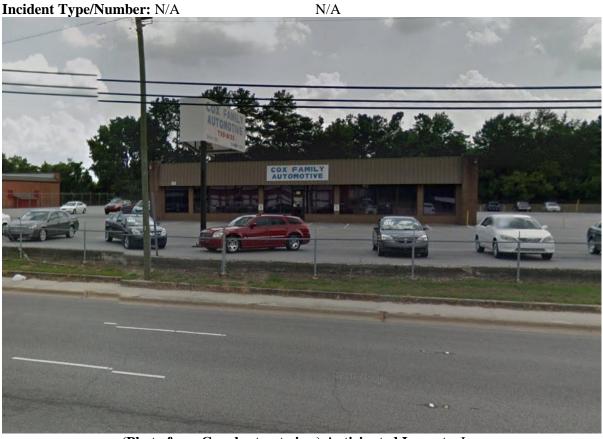
(01) Property Name: Cox Family Automotive

(Photo from Google street view) Anticipated Impacts: Low

This site is a currently a used car dealership. It is located on the south side of W 5th St at the fork of W 5th St and W 2nd St. It is the former location of Lumberton Nissan Inc. The facility is not listed in the UST section registry and there are no known incidents associated with it. There are several service bays located on back potion of the building.

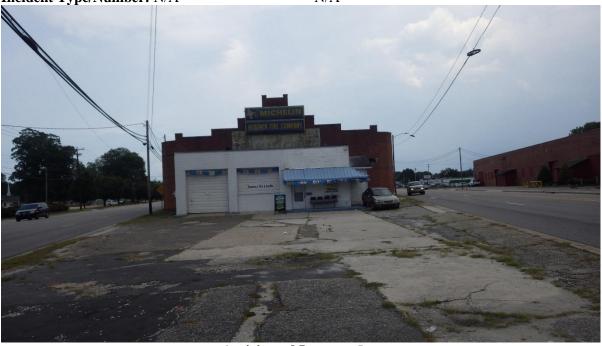
(02) Property Name: Ronnie's Tint & Auto 595 W 5th St

Anticipated Impacts: Low

This facility currently operates as an auto detail and body shop. It is located in the fork of W 2nd St & W 5th St. The current business (See Site # 3 red brick building) occupies both building on 2 separate parcels. The white brick building is the old gas station where the auto detailing is conducted. There is an outline of an old pump island on the western end of the property and 2 possible UST fill ports. The facility was not identified in the UST registry and there are no known incidents associated with it.

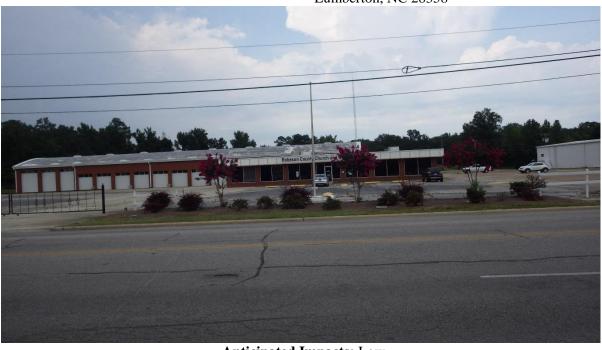
(04) Property Name:

Anticipated Impacts: Low

This facility currently operates as a church and community center. It is located on the north side of W 5th St at the intersection with W 2nd St. It is the former location of Lumberton Ford Lincoln Mercury. According to the UST section registry one 500 gallon UST was removed in 1988. There are no known incidents associated with this site.

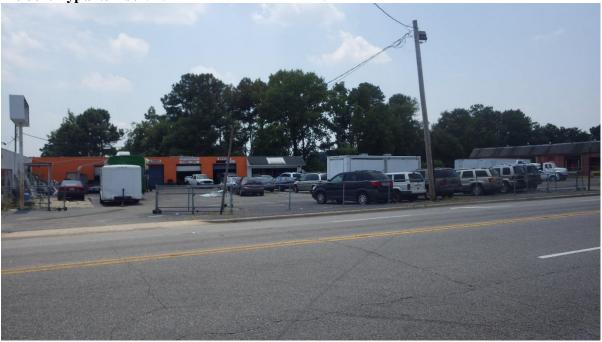
(05) Property Name:

Anticipated Impacts: Low

This site operates as an Auto repair and used car dealer. It is located on the south side of W 2nd St approximately 520 feet northwest of NC 41. This business is on two different parcels with different property owners. The western parking lot is on the property owned by the Thompson and the buildings and eastern portion of the parking lot is on the same parcel as the strip mall. The address is not listed in the UST section registry and there are no known incidents associated with it. No Evidence of USTs or monitoring wells were observed during the site investigation.

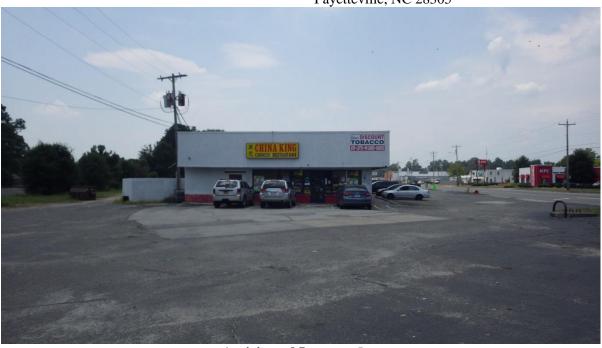
(06) Property Name:

Anticipated Impacts: Low

This facility currently operates as a Chinese Restaurant. It is the former location of Short Stop 65. It is located in the southwest quadrant of NC 41 and W 2nd St. According to the UST registry two USTs were removed from the Address 502 W 2nd St in 1999. Incident 21930 is associated with the site and is still active. The former pump island outline was visible during the site investigation and several monitor wells were observed.

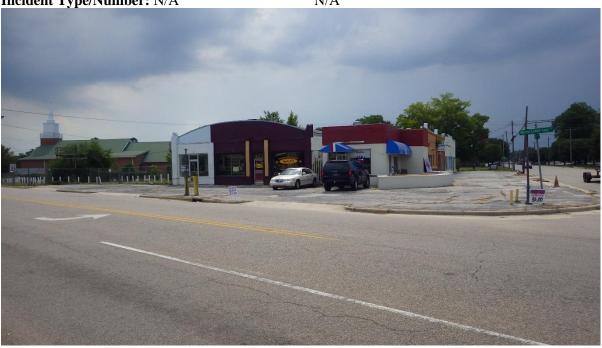
(07) Property Name:

Anticipated Impacts: Low

There are several businesses in this strip. It is located on south side of W 5th St in the triangle between W 5th St, MLK Jr. Dr. and Lincoln St. The facility is not listed in the UST section registry and there are no known incidents associated with it. No evidence of USTs or monitoring wells were observed during the site investigation. The design and location of the building suggest it may have operated as an auto repair shop or a convenience store/gas station at one time.

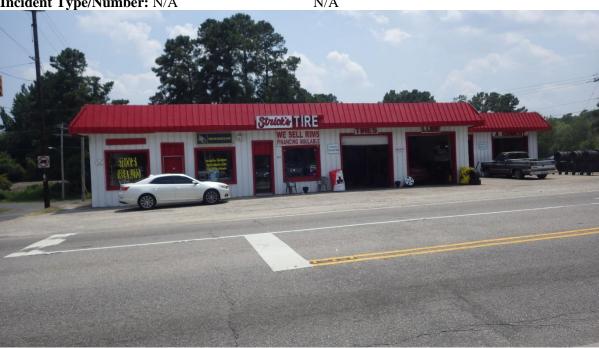
(08) Property Name:

Anticipated Impacts: Low

This facility currently operates as an auto repair shop. It is located in the southwest quadrant of W 2nd St and Water St. The facility is not listed in the UST section registry and there are no known incidents associated with it. No evidence of USTs or monitoring wells were observed during the site investigation. One used oil AST was observed in the back of the building.

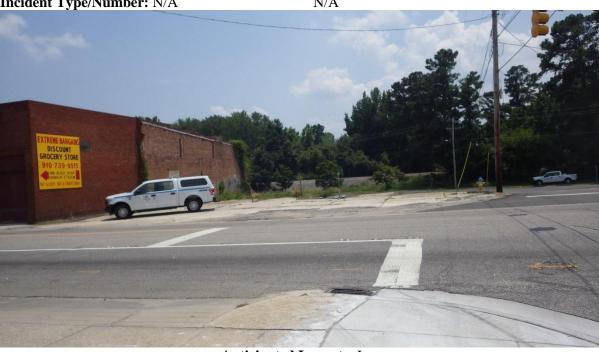
(09) Property Name:

Anticipated Impacts: Low

This site is currently a vacant lot with a concrete foundation. It is located on the southeast quadrant of W 2nd St and Water St. A possible pump island outline was observed during the site investigation. There is no other evidence of USTs and no monitoring wells were observed. The facility is not listed in the UST registry and there are no known incidents associated with it.

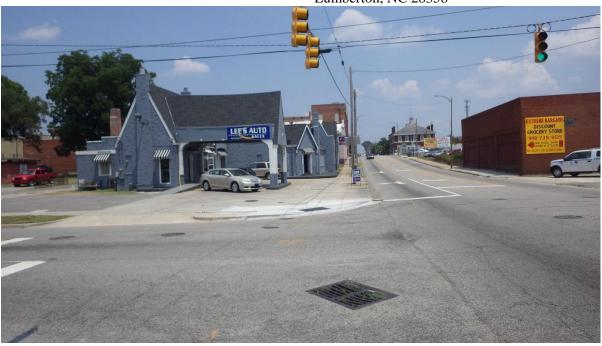
(10) Property Name:

Anticipated Impacts: Low

This former gas station currently operates as a used car dealer & auto repair shop. It is located in the northeast quadrant of W 2nd St and Water St. The facility is not listed in the UST section registry. Incident 42003 is associated with this facility and is still active. The incident database indicates that four regulated USTs were abandoned in place in 1988. Notice of regulatory requirements (NORR) sent 8/16. A possible fill port was observed near the Southwest corner of the building. Several monitoring wells were observed and appeared to be active.

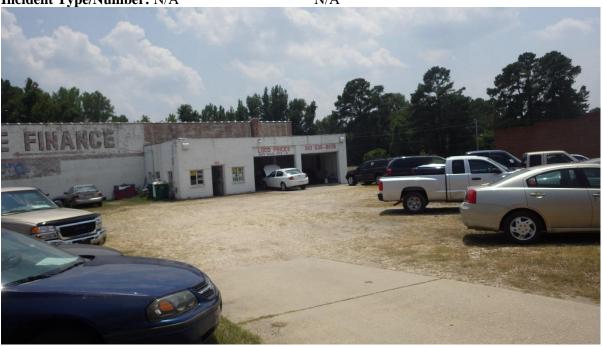
(11) Property Name:

Anticipated Impacts: Low

This facility currently operates as a used car dealer and repair shop. It is located on the south side of W 2nd St approximately 180 feet west of Elm St. The facility is not listed in the UST section registry and there are no known incidents associated with it. There is no evidence of USTs and no monitoring wells were observed during the site investigation.

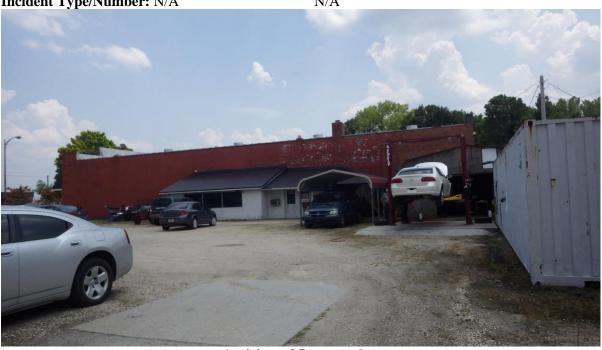
(12) Property Name:

Anticipated Impacts: Low

This facility currently operates as a used car dealer and repair shop. It is located on in the southwest quadrant of W 2nd St and Elm St. The facility is not listed in the UST section registry and there are no known incidents associated with it. There is no evidence of USTs and no monitoring wells were observed during the site investigation.

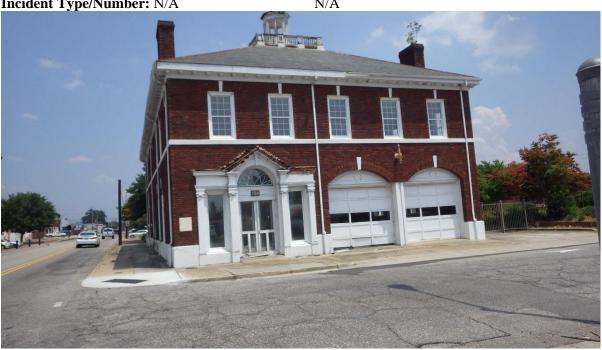
(13) Property Name:

Anticipated Impacts: Low

This facility is the old Lumberton Fire Station. It is located southwest quadrant of 2nd St and Elm St. The facility is not listed in the UST registry and there are no known incidents associated with it. Two unknown valves or possible fill ports were observed in the side walk near the intersection. No other evidence of USTs and no monitoring wells were observed.

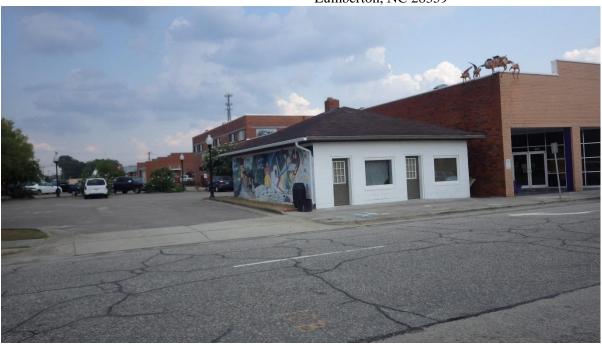
(14) Property Name:

Anticipated Impacts: Low

This parking lot is the former location of Lloyd's Texaco. According to the UST section registry three USTs were removed in 1990, one UST removed in 1998 and three USTs removed in 2004. There are two incidents associated with this facility. Incident 6455 was closed out in 1998, Incident 29131 closed out in 2004 with notice of Residual Petroleum. UST closure not properly followed by City. Over excavation limited due to natural gas line and sidewalk along 2nd St. No monitoring wells were observed during site investigation.

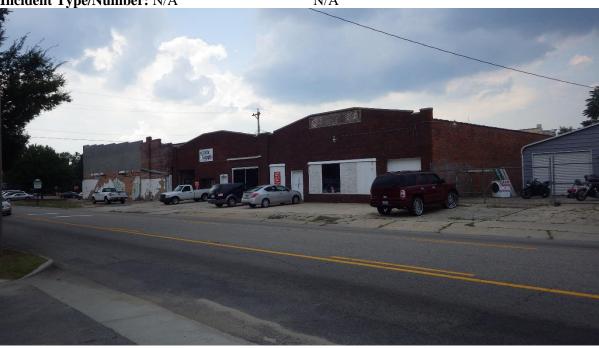
(15) Property Name:

Anticipated Impacts: Low

This facility currently operates as a Janitorial wholesale Supply Co. It is located on the north side of E 2nd St approximately 180 feet east of Chestnut St. The facility is not listed in the UST section registry and there are no known incidents associated with it. During the site investigation a possible old pump island outline was observed in front of the building. There is no other evidence of USTs and no monitoring were observed.

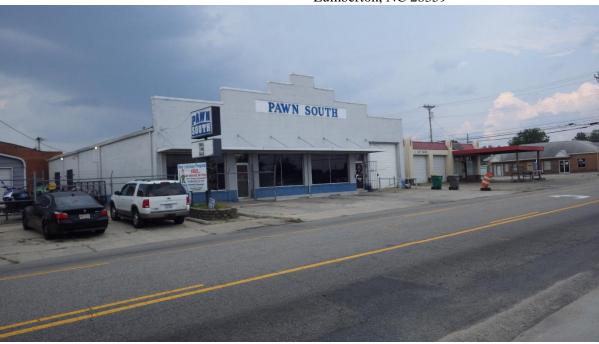
(16) Property Name:

Anticipated Impacts: Low

This facility currently operates as a pawn Shop. It is the former location of Mac's of Lumberton Auto Parts. It is located on the north side of E 2nd St approximately 150 feet west of Walnut St. According to the UST section registry three USTs were removed. The closure date in the registry is incorrect. A possible old pump island outline was observed during the site investigation. No other evidence of USTs and no monitoring wells were observed.

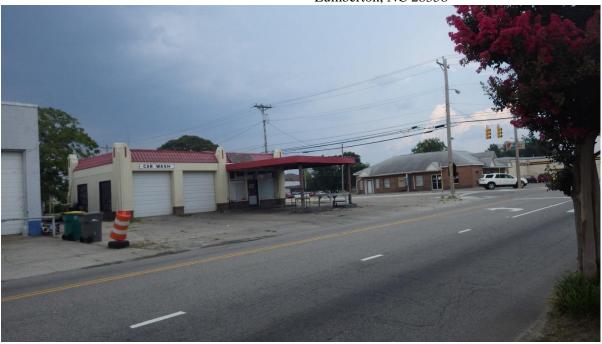
(17) Property Name: Ride Kleen Detail Shop 221 E 2nd St

Anticipated Impacts: Low

This facility currently operates as an auto detail shop. It is the former location of Davis Exxon. It is located in the northwest quadrant of E 2nd St and Walnut St. According to the UST section registry five USTs were removed in 1998. Incident 29008 is associated with this facility and is still active. NORR Sent to property owner 2002. The former pump island is still in place with the pumps removed. No Evidence of USTs and no monitoring wells were observed.

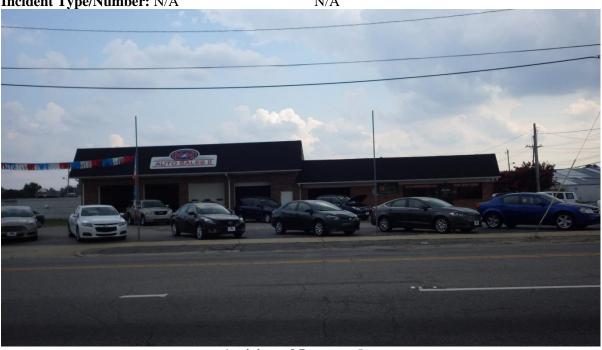
(18) Property Name:

Anticipated Impacts: Low

This facility currently operates as a used car dealer and repair shop. It is located in the southeast quadrant of E 2nd St and Walnut St. The facility is not listed on the UST section registry and there are no known incidents associated with it. No USTs or monitoring wells were observed during the site investigation.

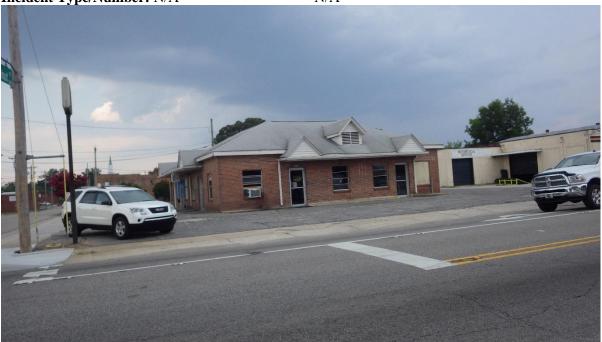
(19) Property Name:

Anticipated Impacts: Low

This facility currently operates as the Greyhound/Trailways bus station. It is located in the northeast quadrant of E 2nd St and Walnut St. The facility is not listed in the UST section registry and there are no known incidents associated with it. No USTs or monitoring wells were observed during the site investigation.

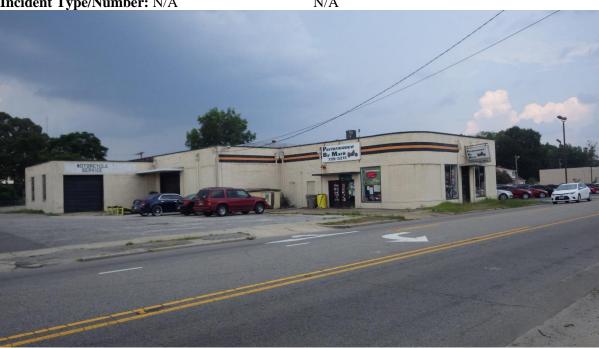
(20) Property Name:

Anticipated Impacts: Low

This facility currently operates as a motorcycle accessories and repair shop. It is located on north side of E 2nd St approximately 200 feet east of Walnut St. The facility is not listed in the UST section registry and there are no known incidents associated with it. No evidence of USTs and no monitoring wells were observed during the site investigation.

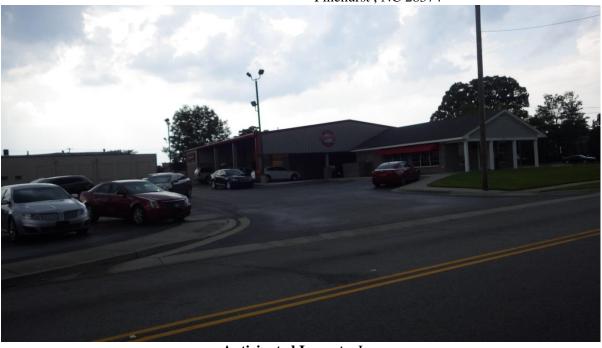
(21) Property Name:

Anticipated Impacts: Low

This facility currently operates as a used car dealer and repair shop. It is the former location of Hudson Garage. It is located in the northwest quadrant of E 2nd St and Pine St. According to the UST section registry four USTs were removed in 1988. There are no known incidents associated with it. The property was redeveloped between 2010 and 2013.

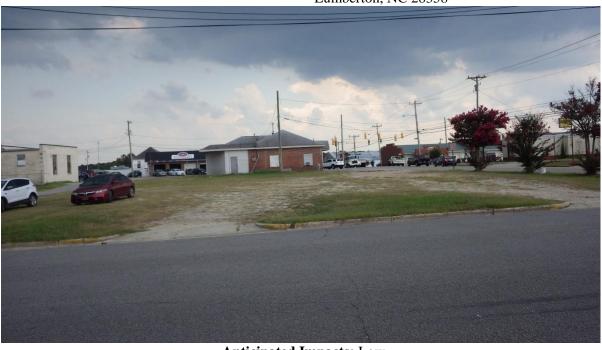
(22) Property Name:

Anticipated Impacts: Low

This site is a vacant lot. It is located in the southeast quadrant of N Walnut St and E 3rd St. According to the UST section register one UST was removed in 1974. Two Possible UST fill ports were observed on the southern end of the property approximately 118 feet east of N Walnut St and 120 feet south of E 3rd St. No monitoring wells were observed. There are no known incidents associated with this site.

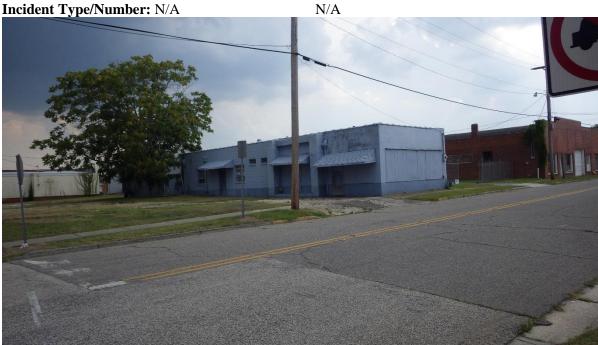
(23) Property Name:

Anticipated Impacts: Low

This facility operated as an upholstery shop. It is located in the southwest quadrant of N Walnut St and E 3rd St. The facility appeared to be vacant at the time of the site investigation. The facility is not listed in the UST section registry and there are no known incidents associated with it.

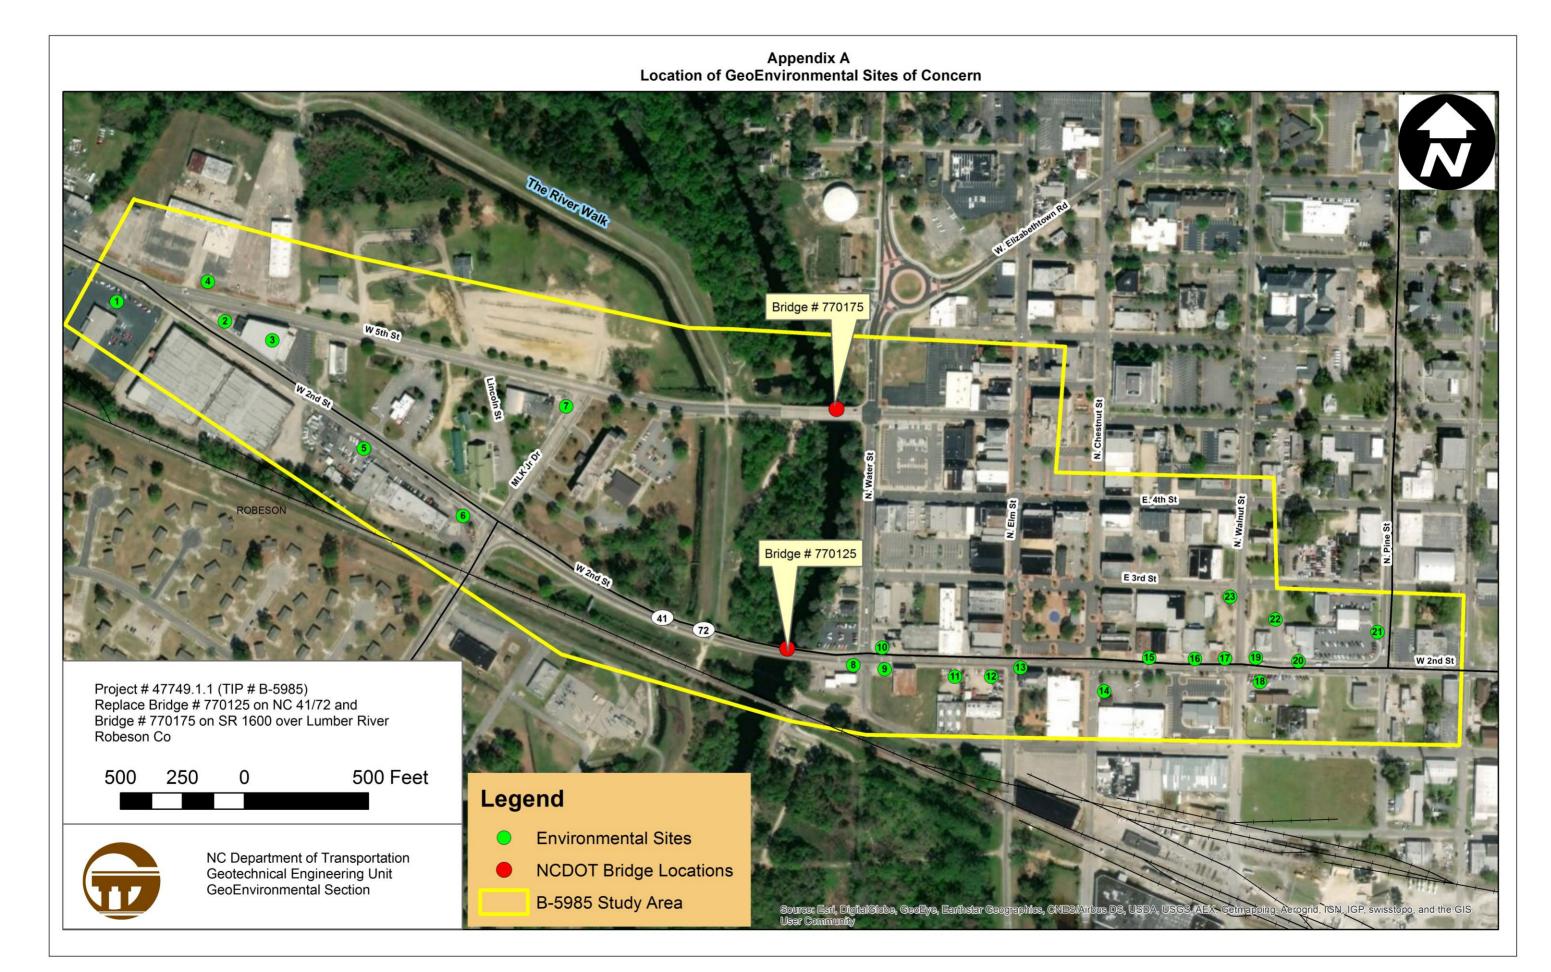
Twenty Three (23) sites of concern were identified within the proposed study area. We anticipate low monetary and scheduling impacts resulting from these sites. See the following table and figure for details.
