NOTE: CLEARING AND GRUBBING EROSION CONTROL FOR CONSTRUCTION SHEET 13

★ EXISTING SIGNAL
FOR -LI- PROFILE, SEE SHEET NO. 28
FOR -Y6- PROFILE, SEE SHEET NO. 30
FOR -Y7- PROFILE, SEE SHEET NO. 31

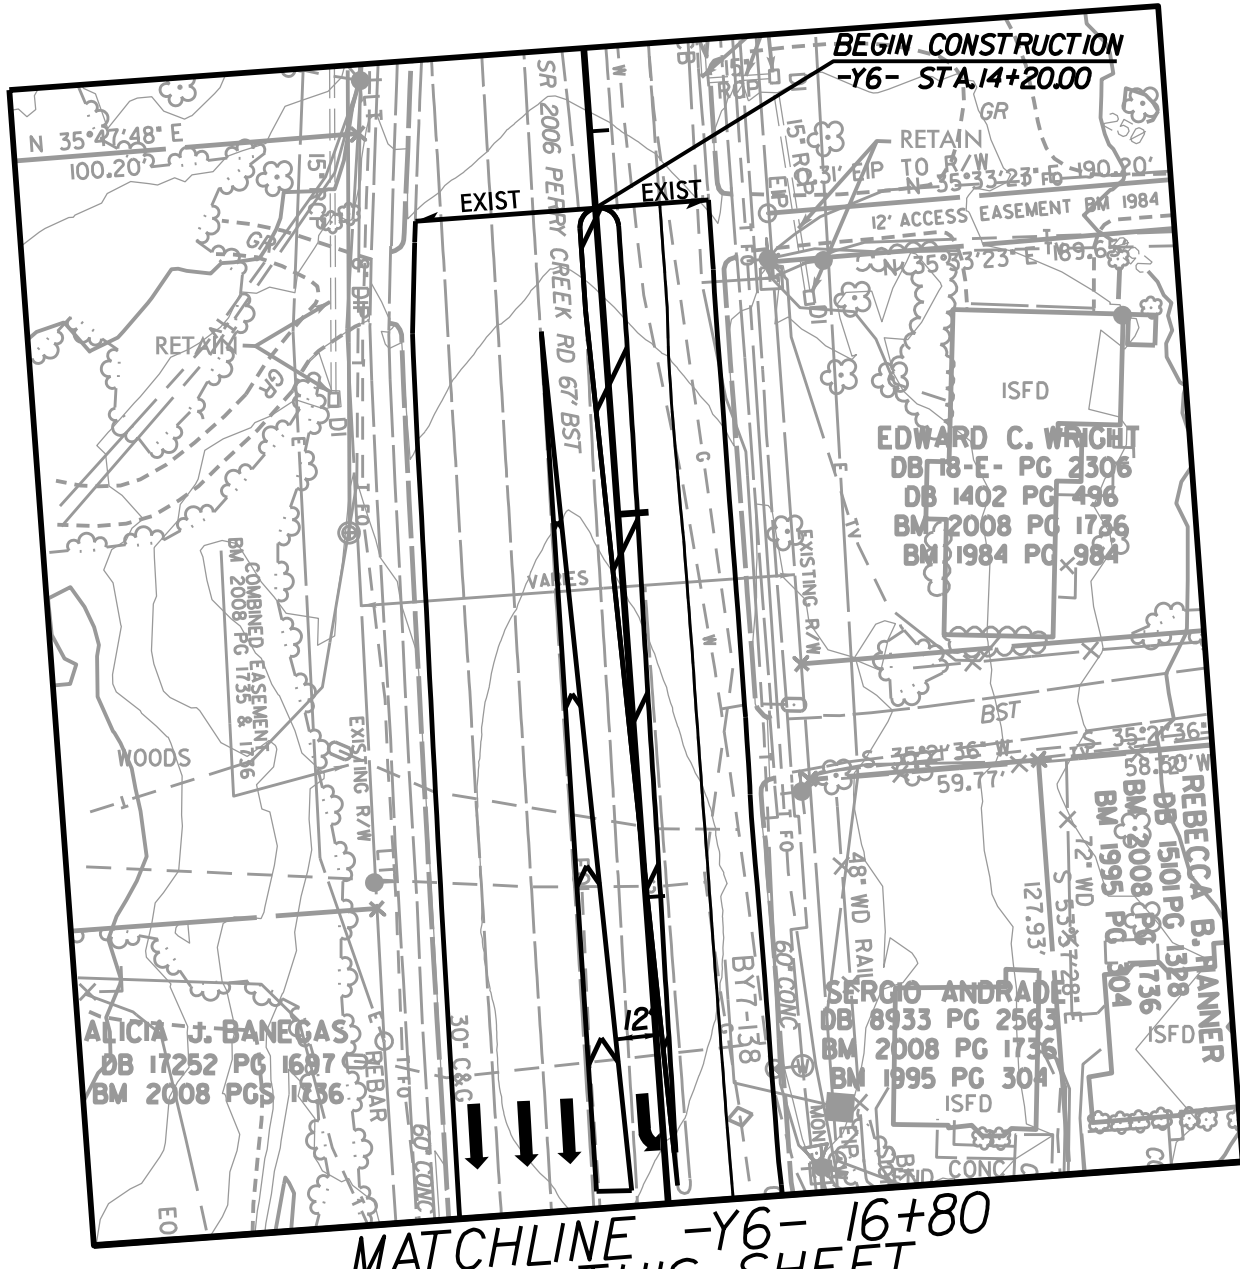
NOTE: PLACE TEMPORARY ROCK SEDIMENT DAMS TYPE - B AND TEMPORARY ROCK SILT CHECKS TYPE - A AT DRAINAGE OUTLETS.

NOTE: UTILIZE FABRIC INSERT INLET PROTECTION DEVICES IN LIEU OF ROCK INLET SEDIMENT TRAPS TYPE C IN AREAS WHERE WATER MAY POND ON ROAD OPEN TO LIVE TRAFFIC.

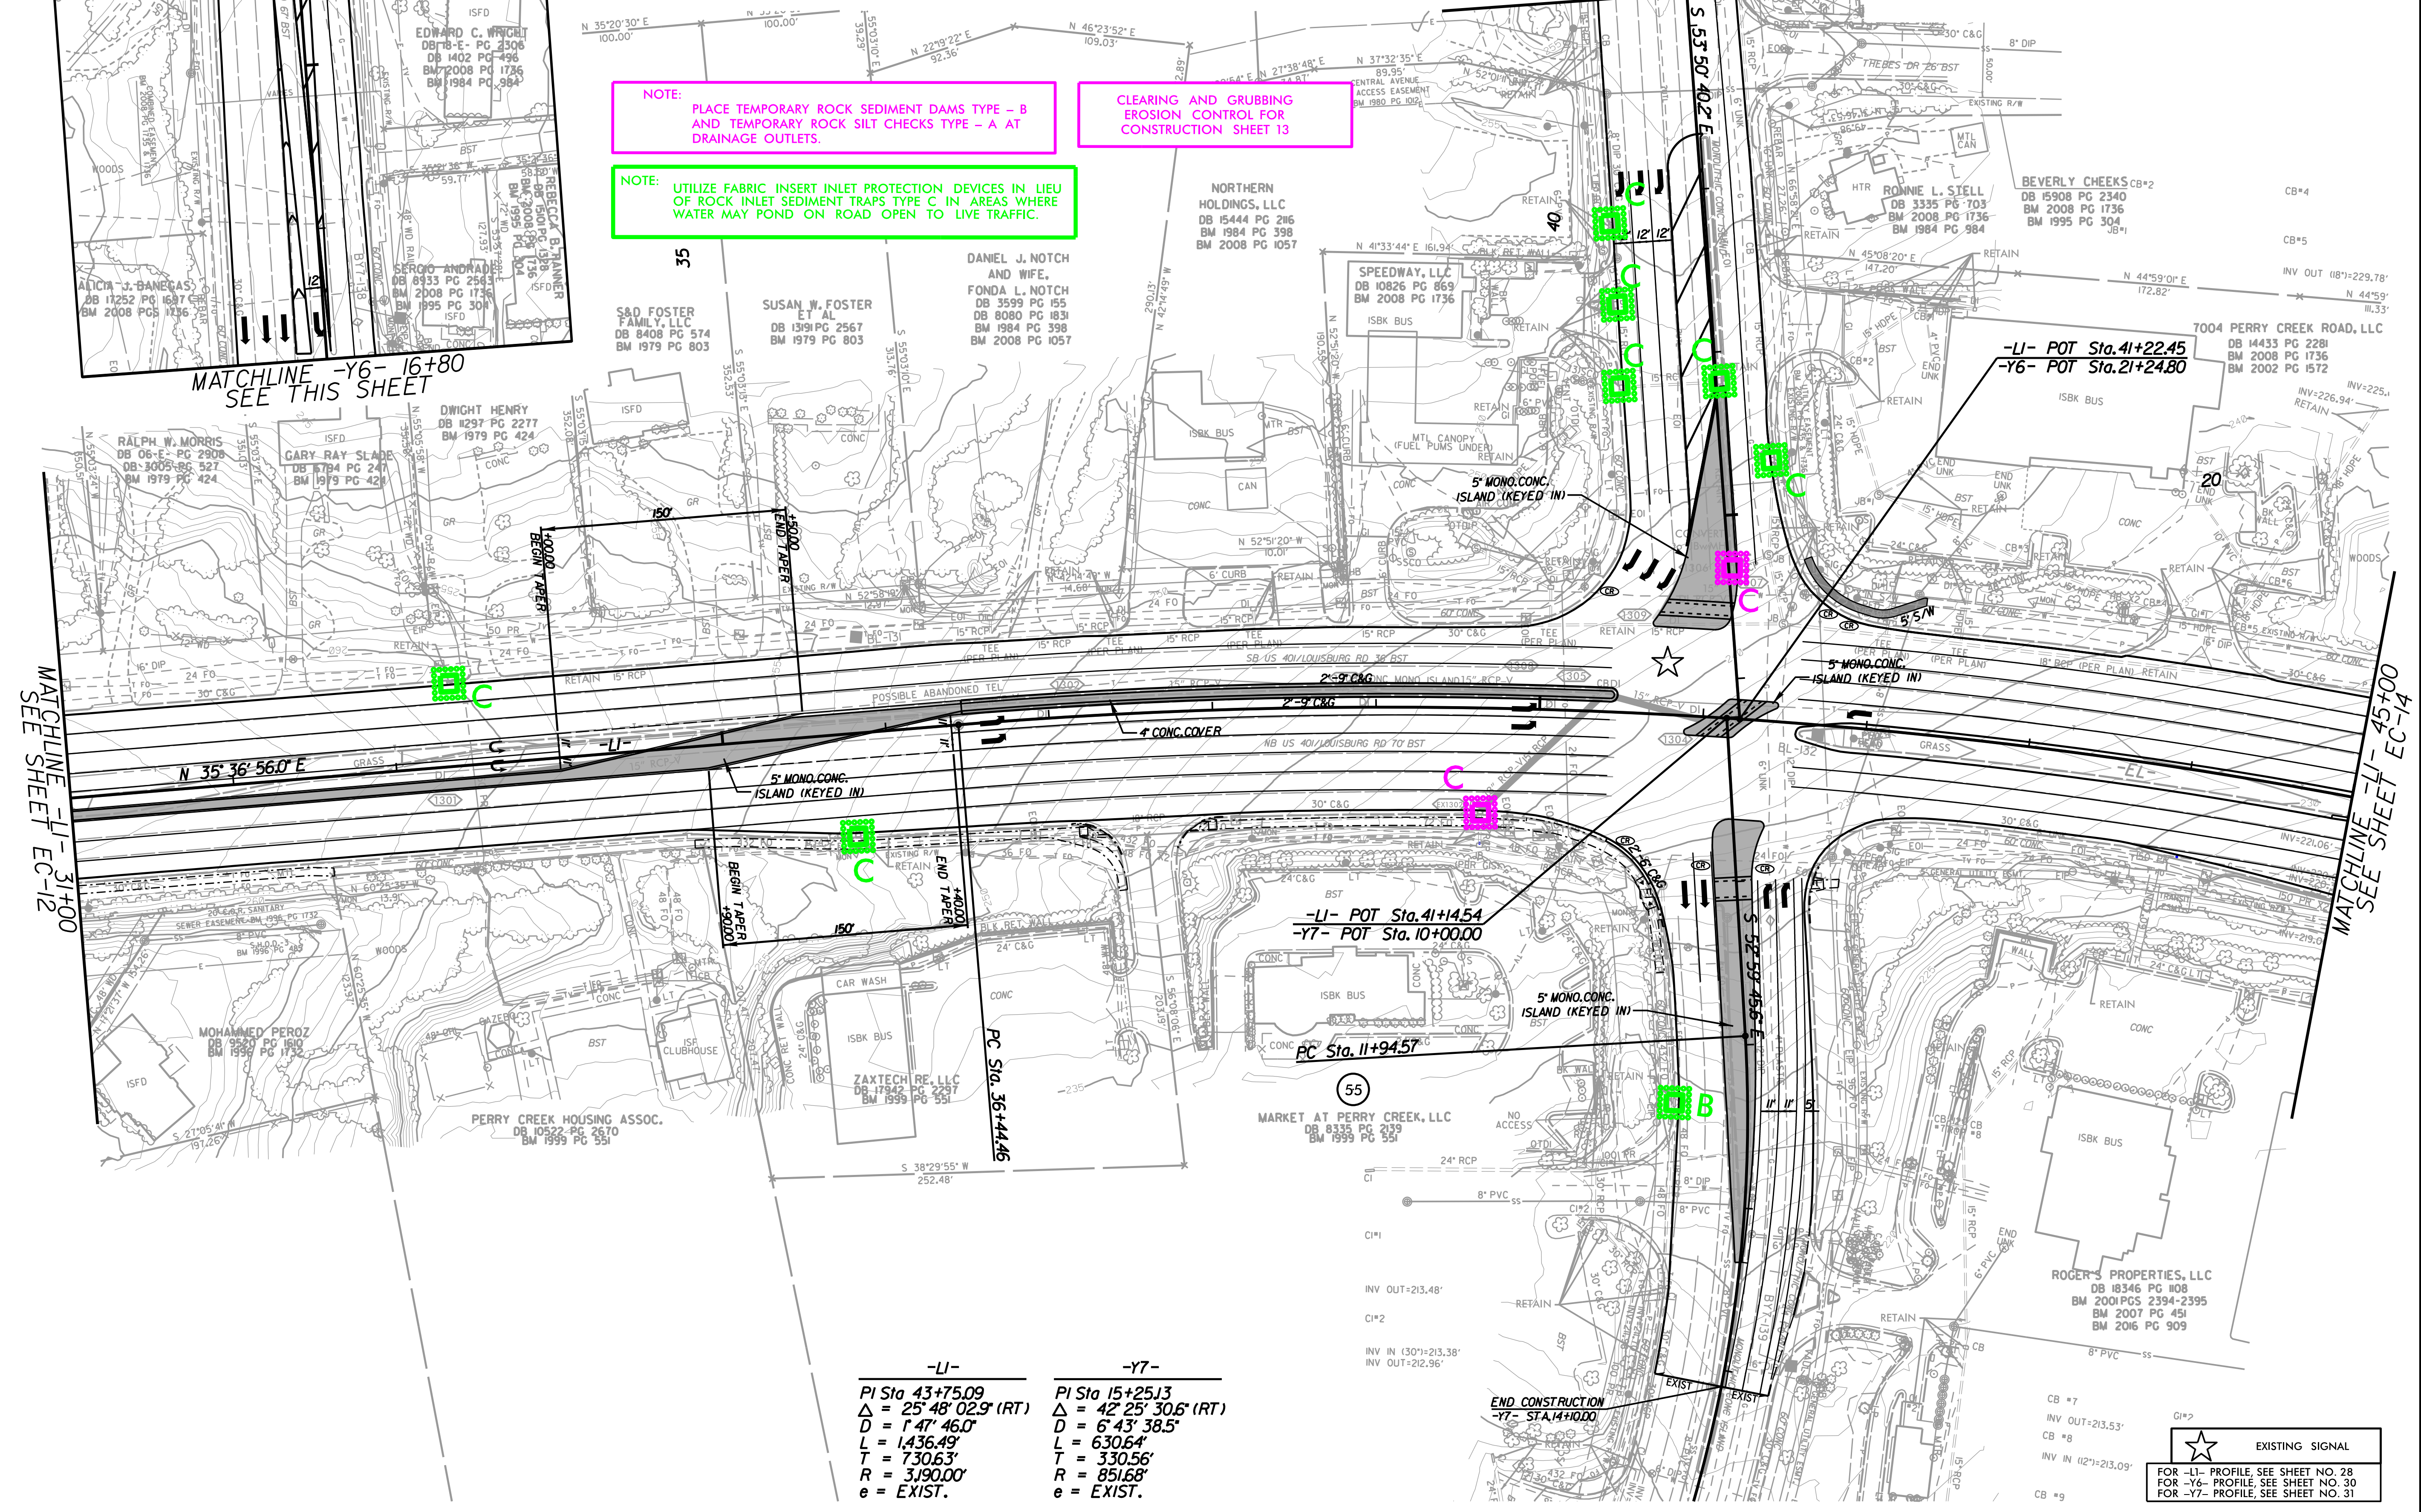
-LI-	-Y7-
PI Sta 43+75.09	PI Sta 15+25.13
Δ = 25° 48' 02.9" (RT)	Δ = 42° 25' 30.6" (RT)
D = 1' 47' 46.0"	D = 6' 43' 38.5"
L = 1,436.49'	L = 630.64'
T = 730.63'	T = 330.56'
R = 3,190.00'	R = 851.68'
e = EXIST.	e = EXIST.
