REFERENCE: BR-0152

STRUCTURE
SUBSURFACE INVESTIGATION

COUNTY DAVIE
PROJECT DESCRIPTION REPLACEMENT OF BRIDGE
NO. 76 ON SR 1436 (PINEBROOK SCHOOL ROAD)
OVER I-40
SITE DESCRIPTION STA. 19+69.97 -L-

INVESTIGATED BY KLEINFELDER, INC
DRAWN BY M. FOSTER
CHECKED BY J. FREGOSI
SUBMITTED BY KLEINFELDER, INC
DATE MAY 2024

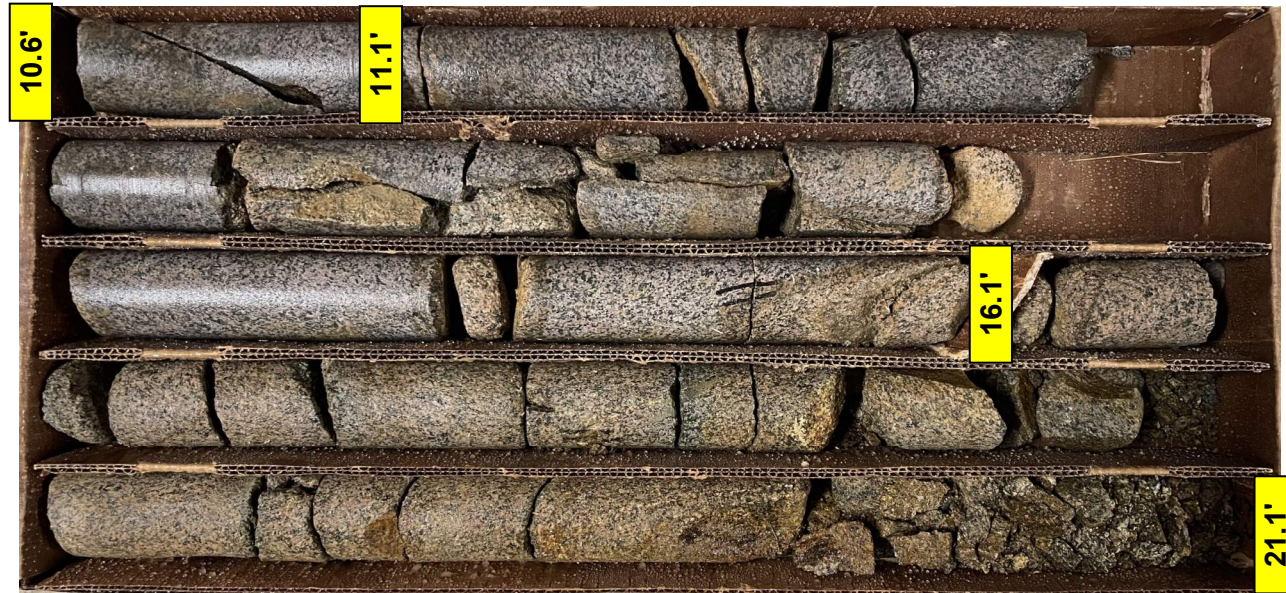
EB1-B

BOX 1: 10.6 - 21.1 FEET

718.2	718.2	0.0	0.5	0:54/0.5	(0.5)	(0.0)		(4.7)	(1.8)		718.2	Begin Coring @ 10.6 ft
	717.7	11.1	5.0	1:11	100%	0%		85%	33%		718.2	CRYSTALLINE ROCK Slight to Moderate Weathering, Hard to Moderately Hard, Gray and Pale Red, METADIORITE with Close to Very Close Fracture Spacing (GSI: 45 - 55)
715				9:27	(4.2)	(1.8)					712.7	Moderate to Moderately Severe Weathering, Medium Hard, Light Brownish Gray, METADIORITE with Close to Very Close Spacing (GSI: 30 - 40)

712.7	16.1	5.0	6:03	(4.1)	(0.0)		(3.3)	(0.0)		709.2	WEATHERED ROCK Severe Weathering, Soft to Very Soft, Light Brownish Gray, METADIORITE with Very Close Spacing
710				1:25	82%	0%		(0.8)	(0.0)		707.7	Boring Terminated at Elevation 707.7 ft in WEATHERED ROCK: METADIORITE

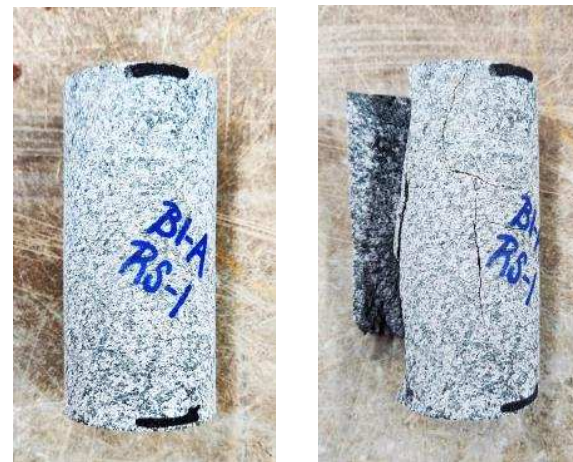
Elastic Moduli of Intact Rock Core Specimens in Uniaxial Compression

Client: Kleinfelder
 Submitted By: Dan Kubinski
 Boring No.: B1-A
 Sample ID: RS-1
 Depth, ft.: 26.1' - 26.6'

Specimen Conditions
 Diameter (in.) 1.98
 Height (in.) 4.30
 Area (in²) 3.08
 Unit Wt. (pcf) 181.4

Maximum Load = 17823 psi

Sample No.	Boring Number	Alignment	Station	Offset	Sample Depth (ft)	Core Run Interval (ft)	Core Run Recovery (%)	Core Run RQD (%)	Core Run GSI	Rock Type	Geologic Map Unit	Sample Height (in)	Sample Diameter (in)	Unit Weight (pcf)	Unconfined Compressive Strength (psi)
RS-1	B1-A	-L-	19+81	20' LT	26.1 - 26.6	25.5 - 30.5	90	44	35 - 45	METADIORITE	PzZm	4.30	1.98	181.4	17,823
RS-2	B1-B	-L-	19+96	31' RT	19.4 - 20.1	15.6 - 20.6	96	72	55 - 65	METADIORITE	PzZm	3.99	1.98	176.3	4,769

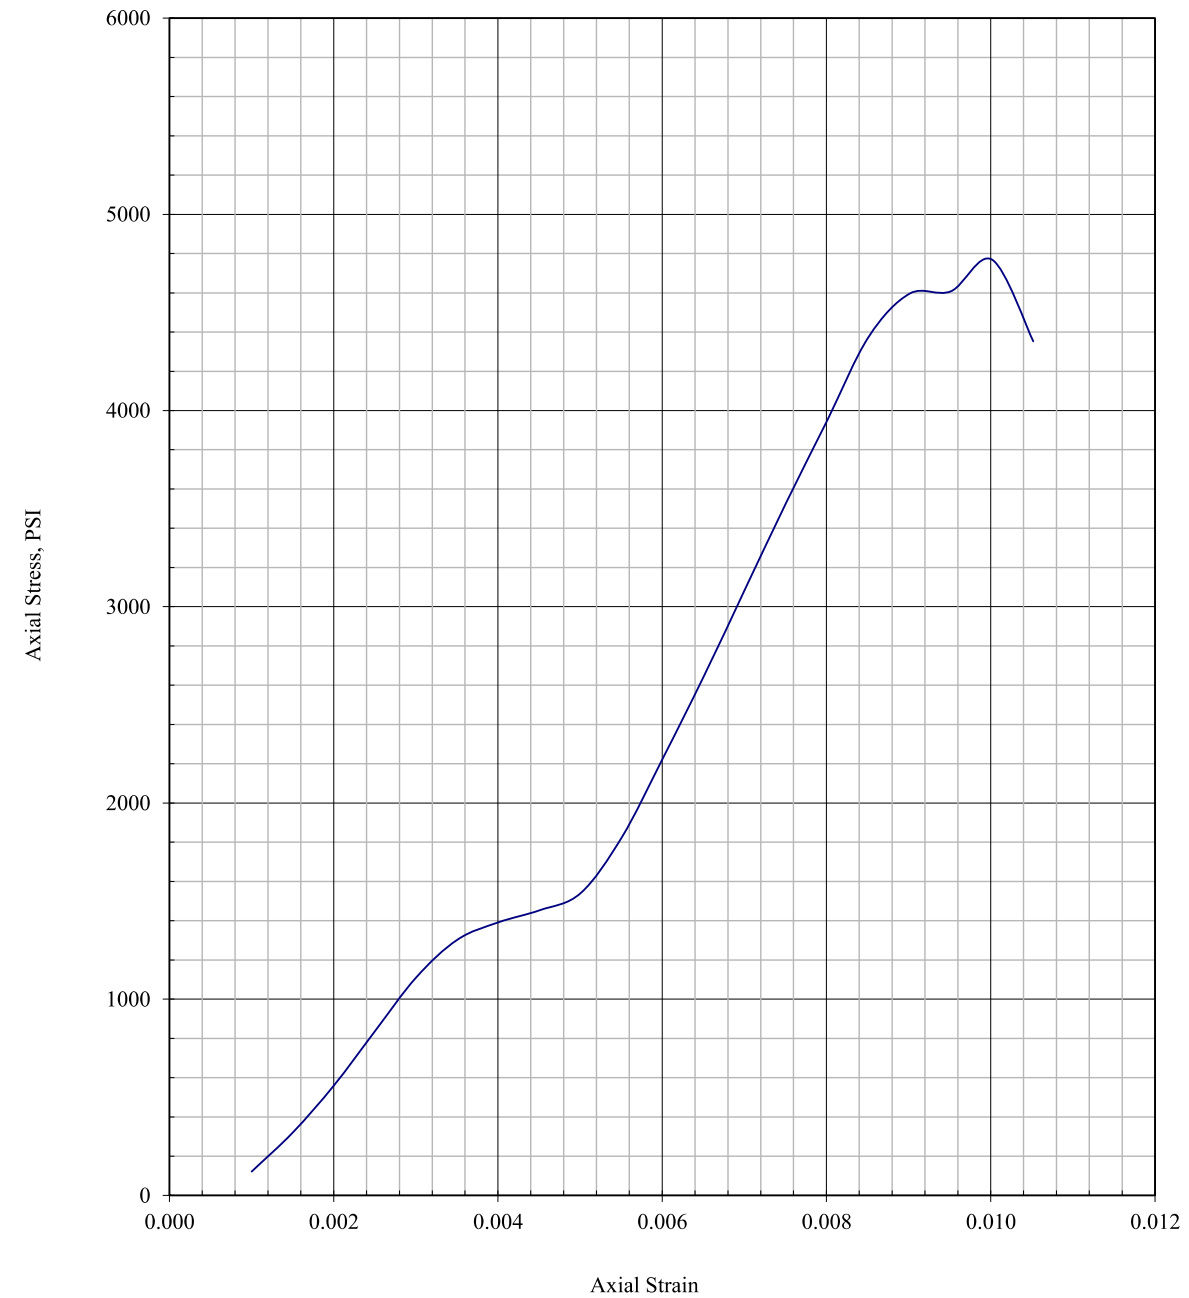
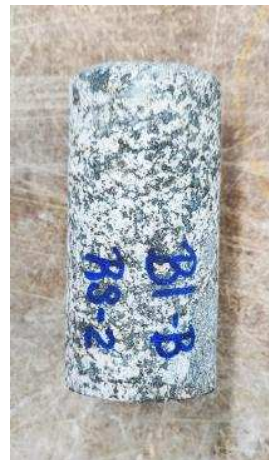
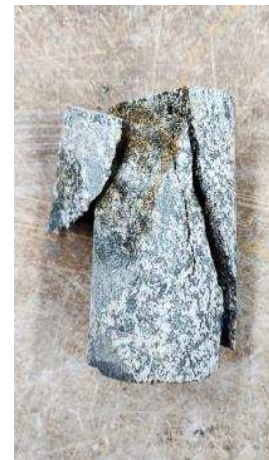
Elastic Moduli of Intact Rock Core Specimens in Uniaxial Compression

Client: Kleinfelder Project: BR-0152 Bridge Investigation
 Submitted By: Dan Kubinski (24003782.002A)
 Boring No.: B1-B F&R Project No.: 66B-0136
 Sample ID: RS-2 Testing Date: 3/29/2024
 Depth, ft.: 19.4' - 20.1' Report Date: 4/2/2024

Time to Failure	
Time (secs)	235
Specimen Conditions	
Diameter (in.)	1.98
Height (in.)	3.99
Area (in ²)	3.08
Unit Wt. (pcf)	176.3
Shear Testing Conditions	
Loading Rate (%/min):	0.012 in./min.

Maximum Load = 4769 psi

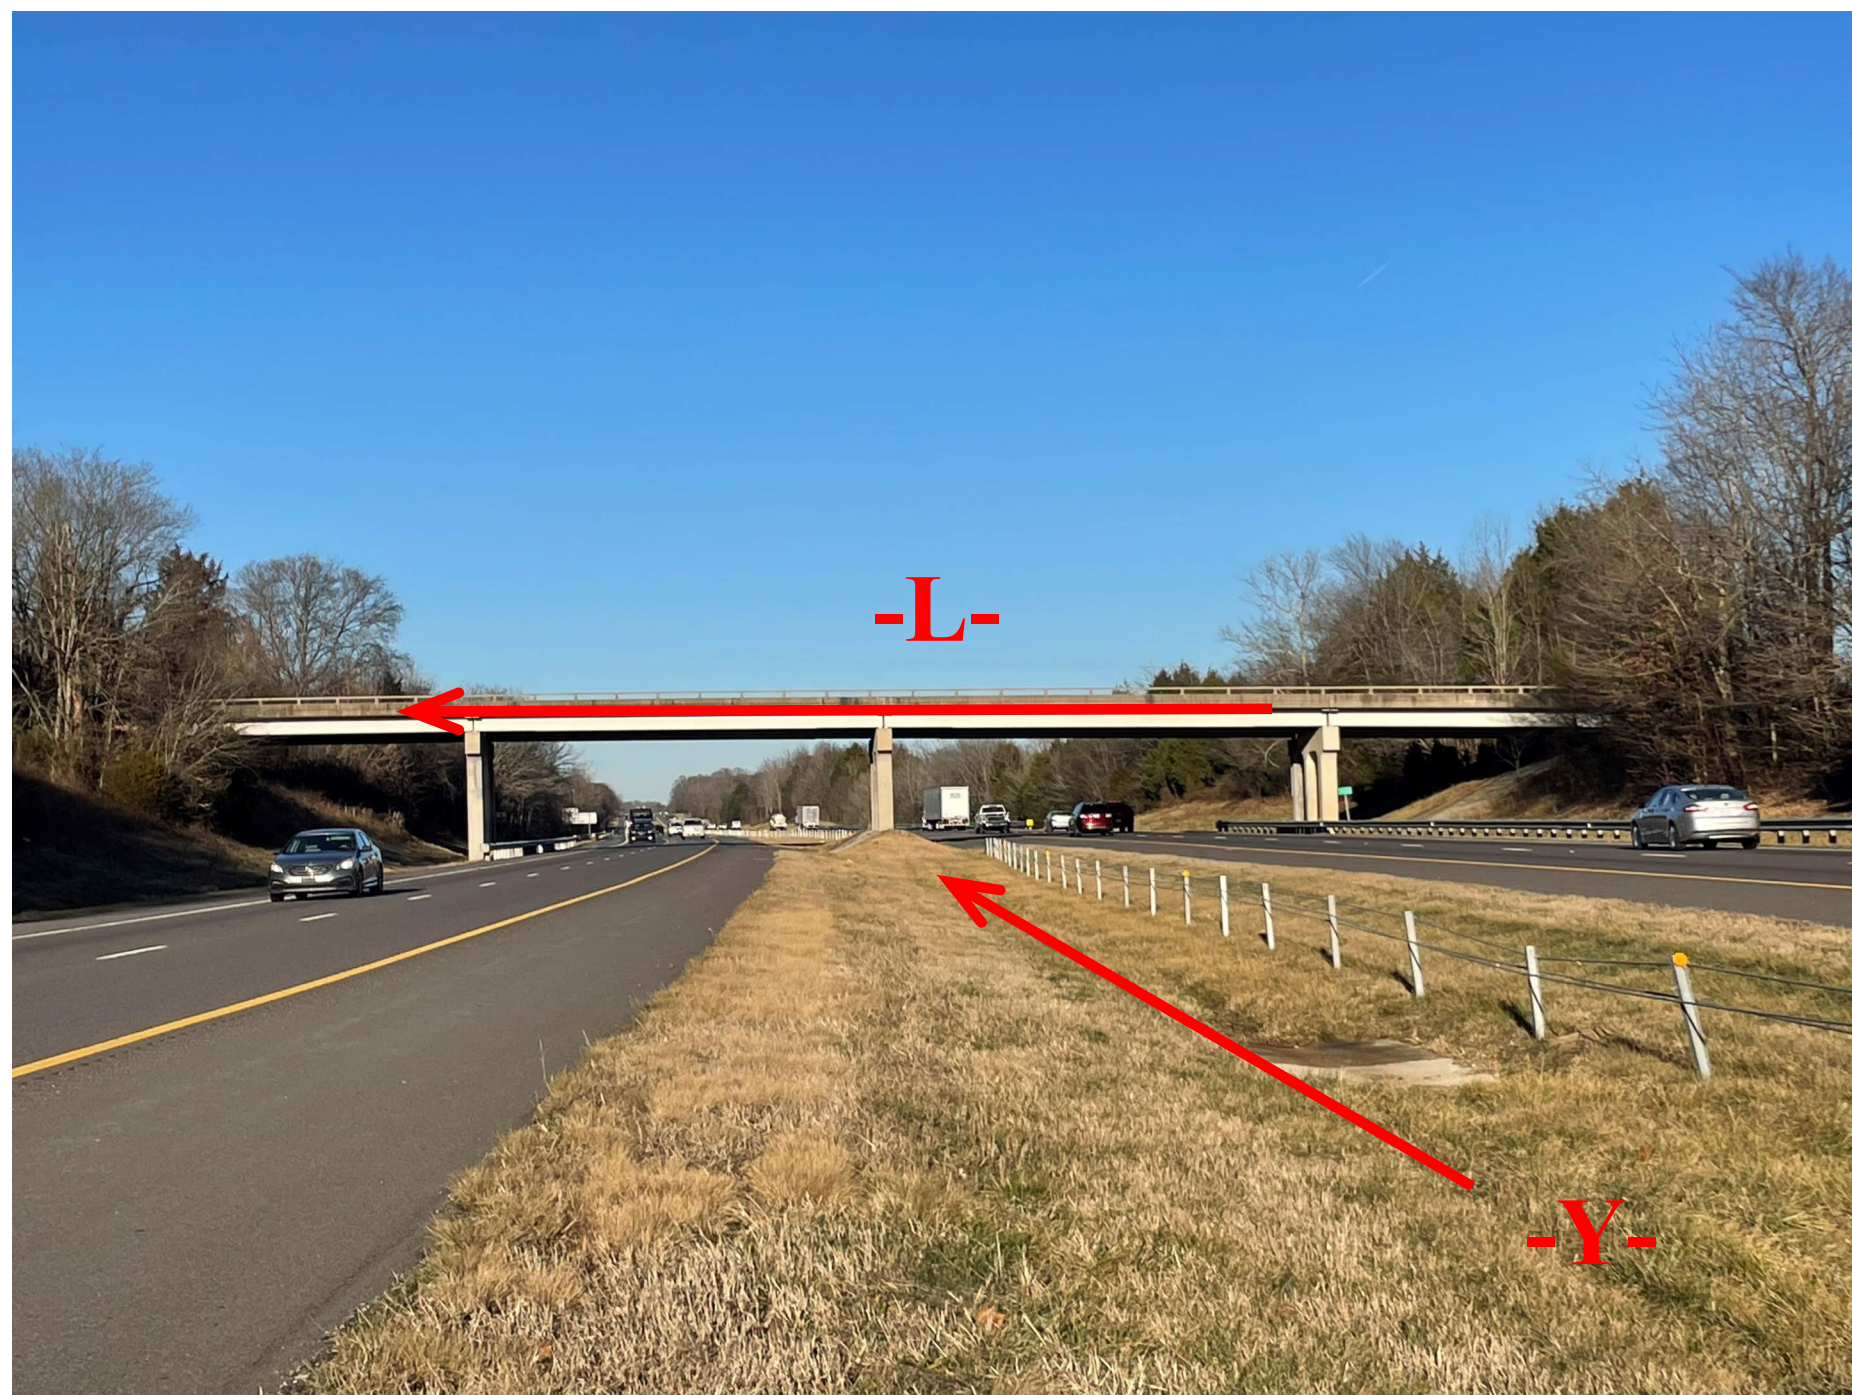
SITE PHOTOGRAPH

Looking East on I-40 (-Y-) towards Bridge No. 76 on Pinebrook School Road (-L-)
