PRELIMINARY SITE ASSESSMENT

SR 1997 (FAYETTEVILLE ROAD) WIDENING TIP NO. U-5797, WBS NO. 44367.1.1

PARCEL NO. 14

METALLIC UST INVESTIGATION: PARCEL 14 NCDOT PROJECT U-5797

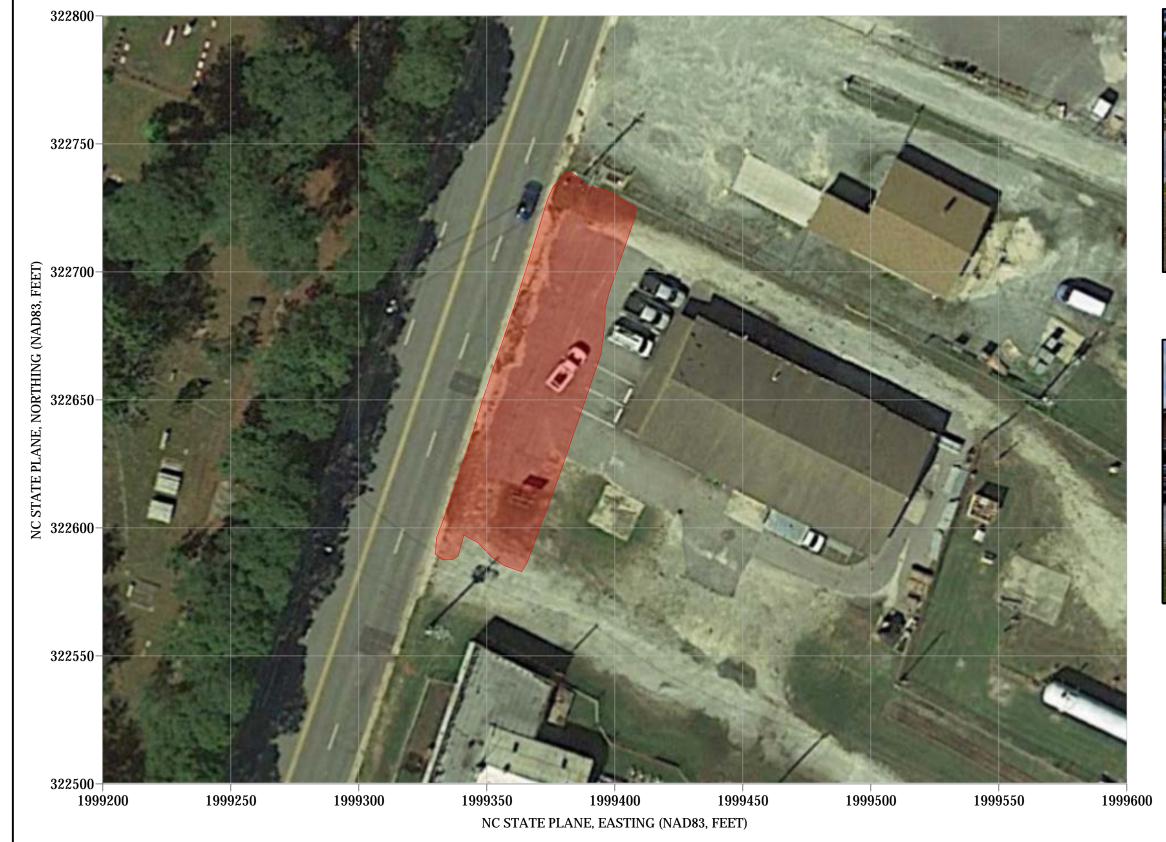
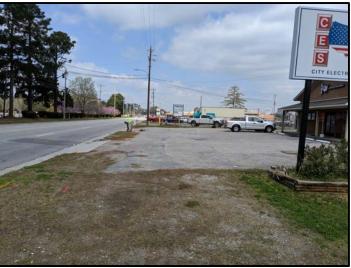
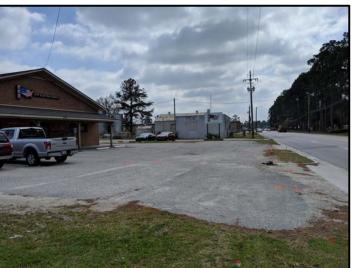
PARCEL 14 - GEOPHYSICAL SURVEY BOUNDARIES AND SITE PHOTOGRAPHS

The site included a commercial building surrounded by gravel, asphalt, and grass surfaces. An aerial photograph showing the survey area boundaries and ground-level photographs are shown in **Figure 1**.

APPROXIMATE BOUNDARIES OF GEOPHYSICAL SURVEY AREA

View of Survey Area (Facing Approximately North)

View of Survey Area (Facing Approximately South)

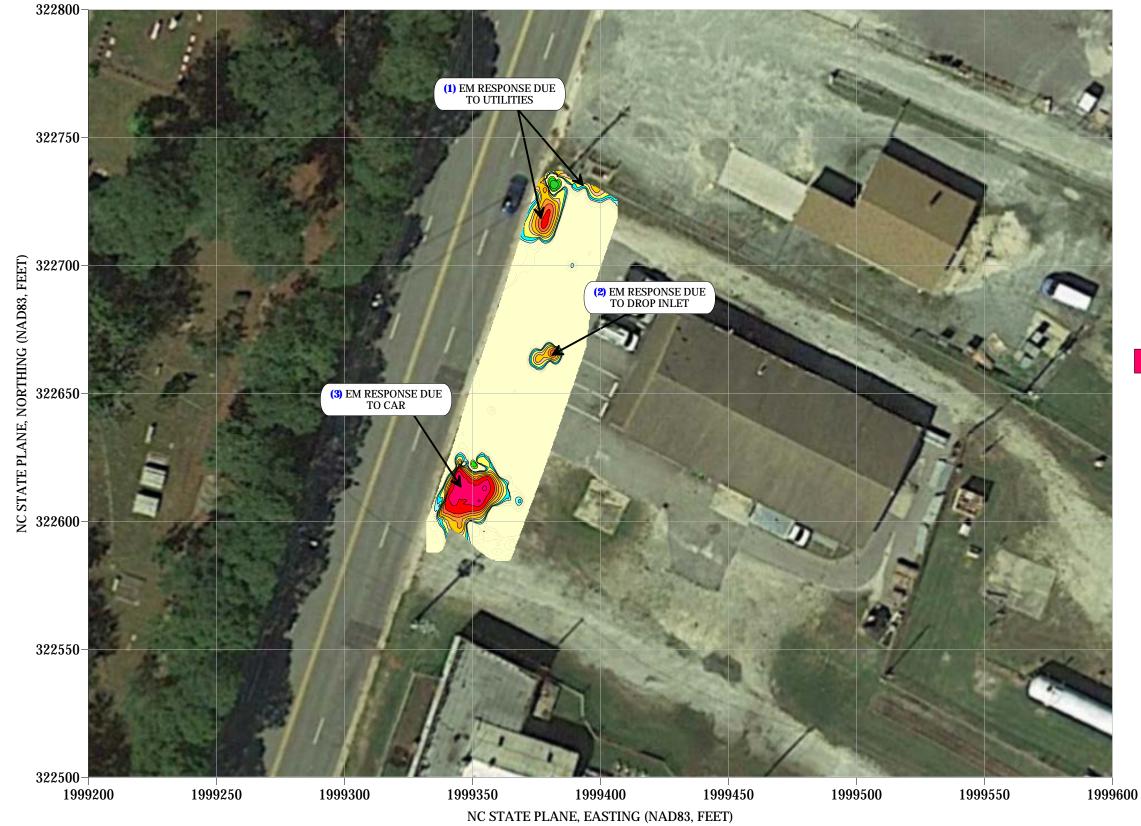
PARCEL 14 -EM61 METAL DETECTION CONTOUR MAP DATE 3/26/2019 CLIENT FALCON ENGINEERS

A contour plot of the EM61 results obtained across the survey area at the property is presented in **Figure 2**. Each EM anomaly is numbered for reference in the figure. The following table presents the list of EM anomalies and the cause of the metallic response, if known:

Metallic Anomaly #	Cause of Anomaly	Investigated with GPR
1	Utilities	
2	Drop Inlet	
3	Car	Ø

The majority of the EM anomalies were directly attributed to visible cultural features at the ground surface, including utilities, a drop inlet, and a car. EM Anomaly 3 was associated with interference from a car and was further investigated with GPR to verify that the interference did not obscure buried structures such as USTs.

EM61 METAL DETECTION RESULTS

NO EVIDENCE OF METALLIC USTs OBSERVED.

The contour plot shows the differential results of the EM61 instrument in millivolts (mV). The differential results focus on larger metallic objects such as USTs and drums. The EM data were collected on March 18, 2019, using a Geonics EM61-MK2 instrument. Verification GPR data were collected using a GSSI UtilityScan DF instrument with a dual frequency 300/800 MHz antenna on March 26, 2019.

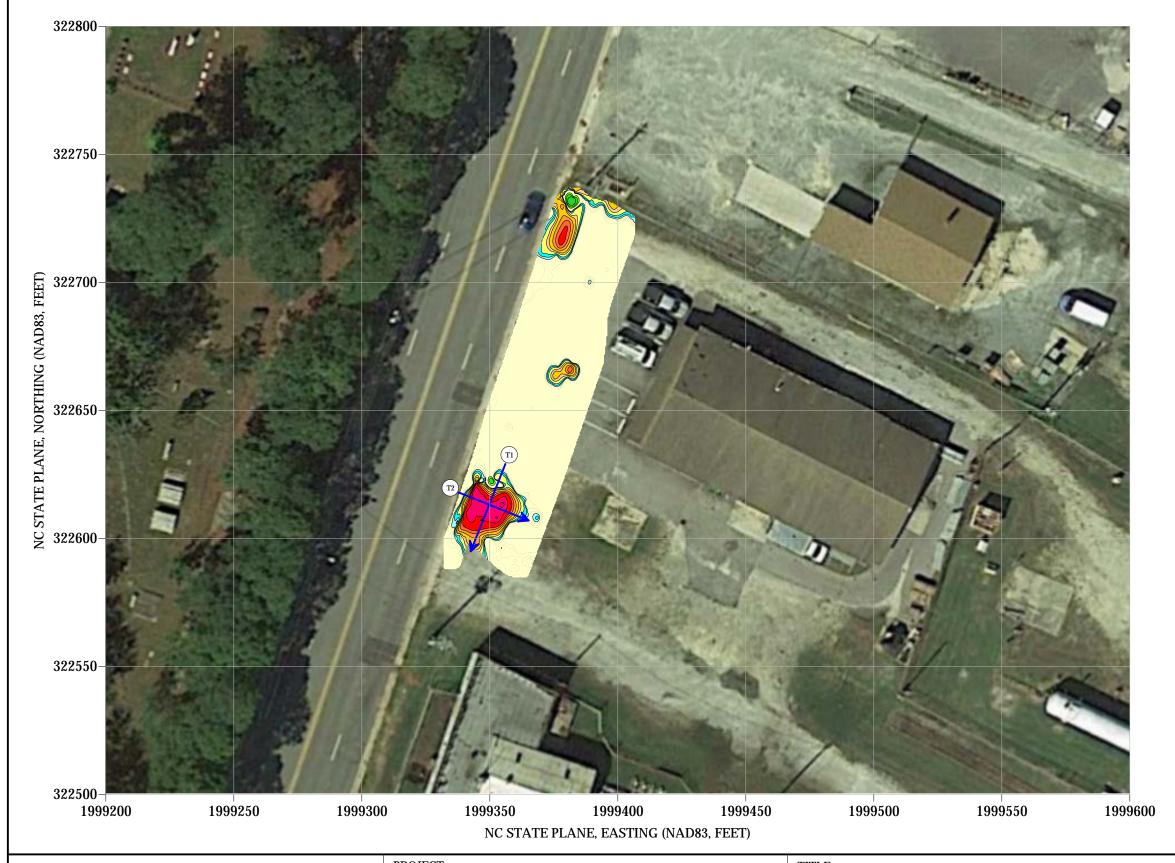
PARCEL 14 -GPR TRANSECT LOCATIONS AND IMAGES

Figure 3 presents the locations of the formal GPR transects performed at the property as well as the transect images. A total of two formal GPR transects were performed at the site. GPR Transects 1-2 were performed across EM Anomaly 3. These transects recorded no evidence of buried structures, such as USTs.

LOCATIONS OF GPR TRANSECTS

GPR TRANSECT 1 (T1)

GPR TRANSECT 2 (T2)

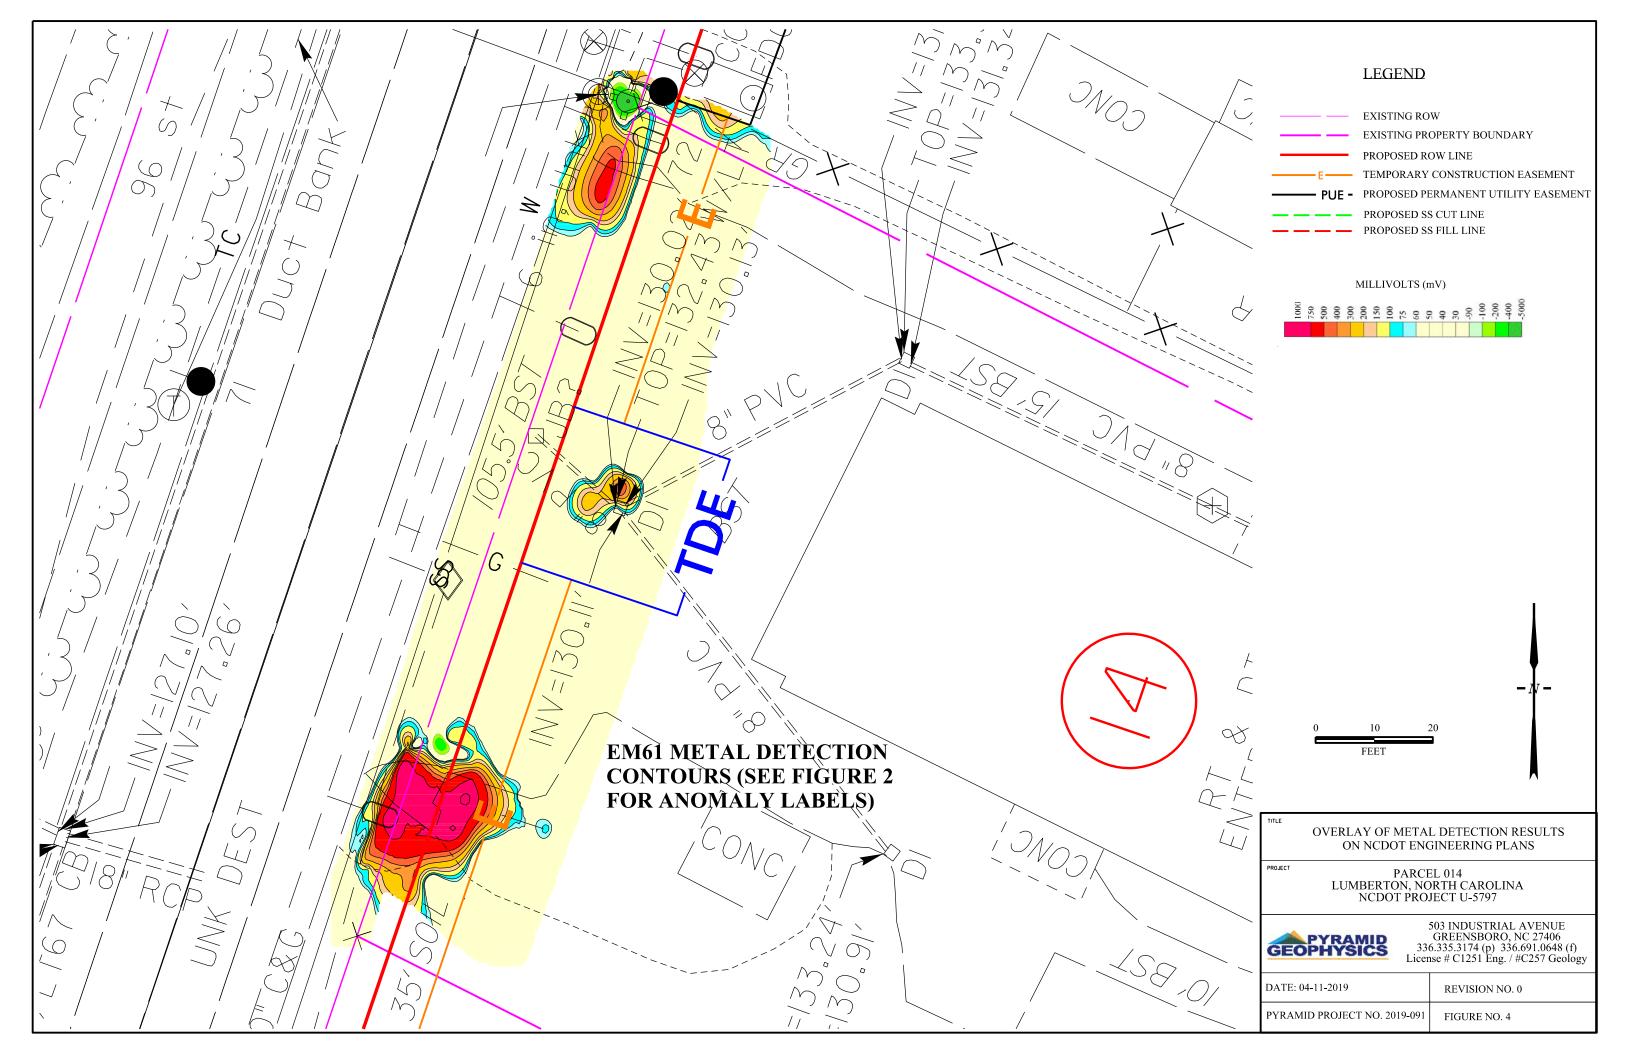
Collectively, the geophysical data <u>did not record any evidence of unknown metallic USTs</u> <u>within the geophysical survey area at Parcel 14</u>. **Figure 4** provides an overlay of the EM61 metal detection contour map onto the NCDOT MicroStation engineering plans for reference.
