STATE OF NORTH CAROLINA DEPARTMENT OF TRANSPORTATION

Subject: 1) Section 404 Nationwide Permit 3/33 & 401 Individual Water Quality Certification

for the "Upper Section" of NC 9 (from "Station 37" to the Buncombe County Line).

Henderson County, Division 14, WBS 18314.1045061.

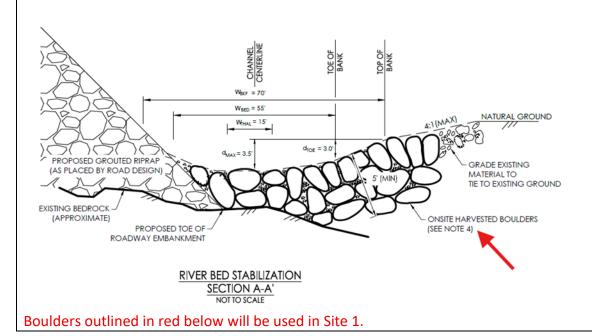
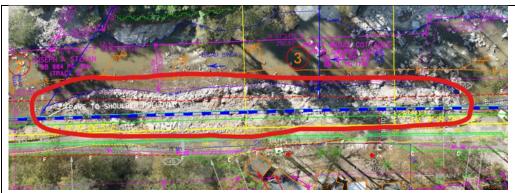
Response: Here's an excerpt of the attached in-stream construction detail. Boulders will be harvested on-site along the river including using what's remaining of the temporary berm that was built right after the storm that allowed them to build the temporary gravel "road" right after the storm. Coincidently, the stream morphologists recommended that these boulders be removed because they were causing a high energy concentration that wasn't present in the river pre-Helene so they will be beneficially used to stabilize the river.

Note 4 will allow the contractor to use non-native boulders in the lower layer topped with the harvested layer if there are not enough harvested boulders.

David McHenry (NC WRC): Per note 4, I hope they can obtain enough native alluvial material to top this channel with, much of which is under the road. That would be good if they could recoup some of that as the top-dressing.

Response: As noted above, Grant Ginn believes that there is enough.

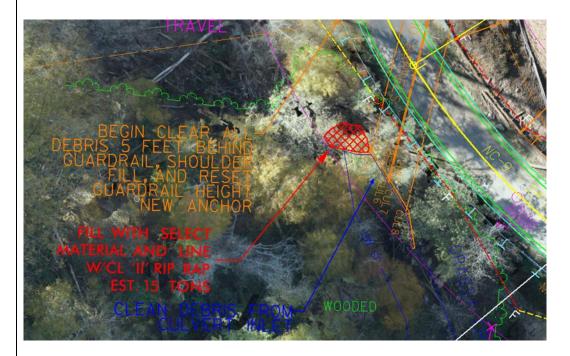
David McHenry (NC WRC): Also, at site 7, is that short class II section the fill planned to fix to the RCBC perch (and stabilize the right bank)? Attached is a picture of this area.

Response: At the Inlet, we proposed to place Class II Rip Rap behind the wingwall to repair some Helene erosion.

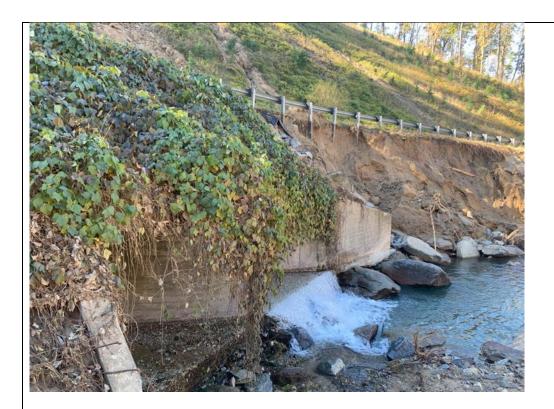
At the Outlet, we propose to place Class II Rip Rap in the creek to repair the perched culvert. As requested in the meeting, we have prepared a detail that will direct the contractor to channelize this rip rap.

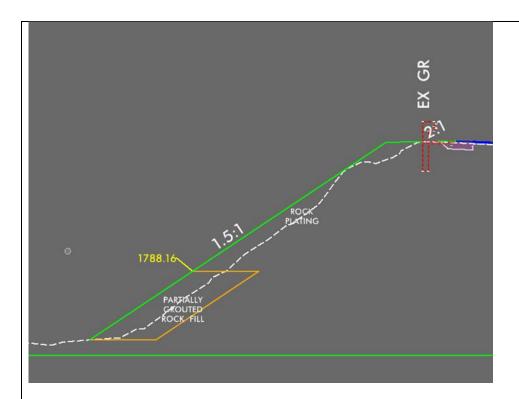
Response: Downstream from the outlet will be repaired using the same method we used along the Broad River. The stabilization material will be grouted Class VII rip rap at the toe of the slope and Class II rip rap on up the slope where it is Rock Plating as detailed in the Geotechnical portion of the plans. See below for a typical cross section at station 62+50.

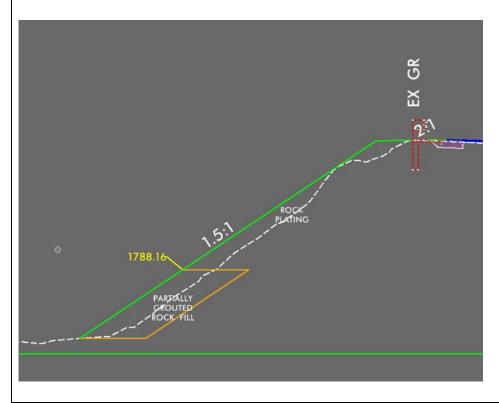
Response: As shown in the cross section at Station 62+00 below, it is not NCDOT's intention to disturb the boulders that are in the stream bed of Grassy Creek shown in your photos, only stabilize the roadside fill slope and not go beyond the pre-Helene edge of creek. From your pictures, we believe grass has grown from the hydroseeding and that grass is hiding some of the damage that needs to be repaired underneath. See photos below. The roadway and geotechnical engineers believe that these unstable areas need to be protected with rip rap.

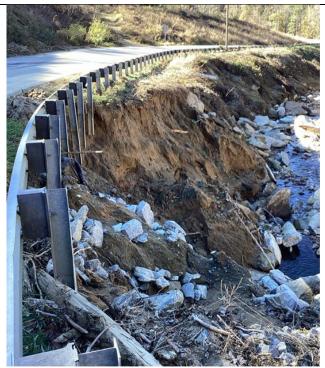
Eroded bank along Grassy Creek looking downstream (11/12/2024).

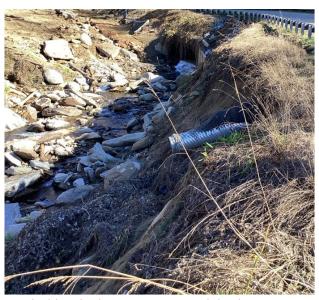
Eroded bank along Grassy Creek looking upstream (11/12/2024).
