Section 404/NEPA Merger Project Team Meeting Concurrence Points 2 and 2A October 10, 2018

NC 73 Widening
From SR 2693 (Davidson-Concord Road) to US 29 (Concord Parkway)
Mecklenburg and Cabarrus Counties, North Carolina – NCDOT Division 10

STIP Project No. R-5706 WBS No. 46378.1.1

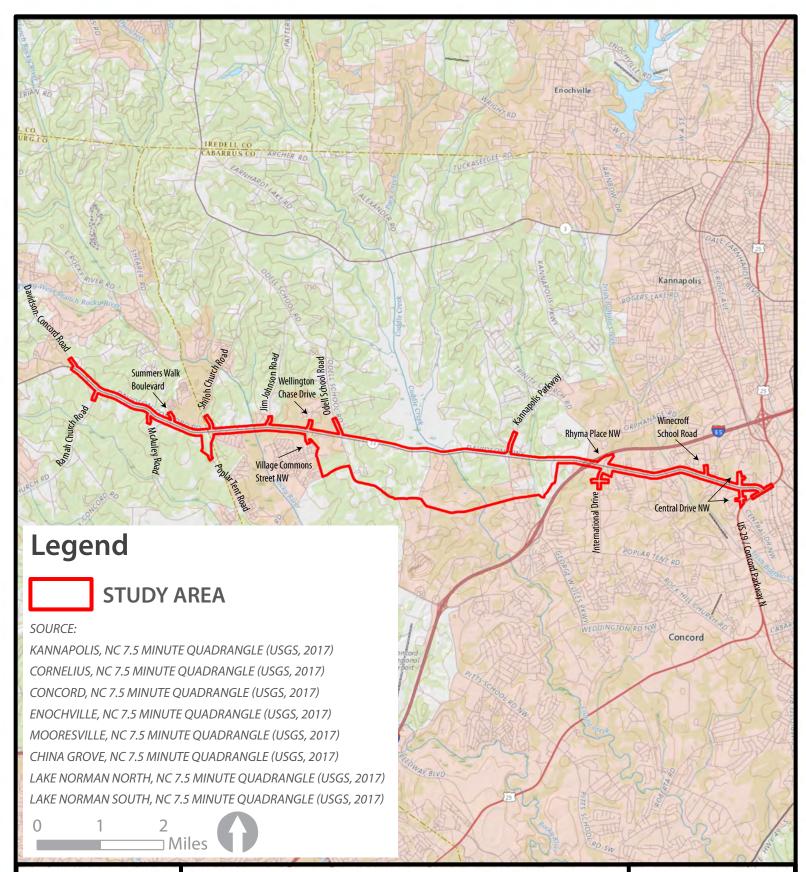
TIP No: R-5706 WBS #: 46378.1.1 Mecklenburg and Cabarrus Counties August 2018 FIGURE 2

Study Area Map

Widening of NC 73 from Davidson-Concord Road to US 29

The study area boundary is shown in Figure 2 and is described as follows:

The study area extends along NC 73 from Davidson-Concord Road to US 29, generally encompassing an area 250 feet on each side of the existing road centerline. To incorporate potential new location alignments south of Howell Reservoir, the study area expands southward (to a width of as much as one mile) between Village Commons Street Northwest and Biscayne Drive. The study area extends between approximately 1,000 and 2,800 feet along numerous y-lines and has varying widths along the y-lines.
