N.C. DEPARTMENT OF TRANSPORTATION
DIVISION OF HIGHWAYS
BRIDGE MAINTENANCE UNIT

BRIDGE INSPECTION REPORT

COUNTY PASQUOTANK BRIDGE NUMBER 690019 INSPECTION CYCLE 2 YRS

ROUTE US158 ACROSS PASQUOTANK RIVER M.P. 000+000

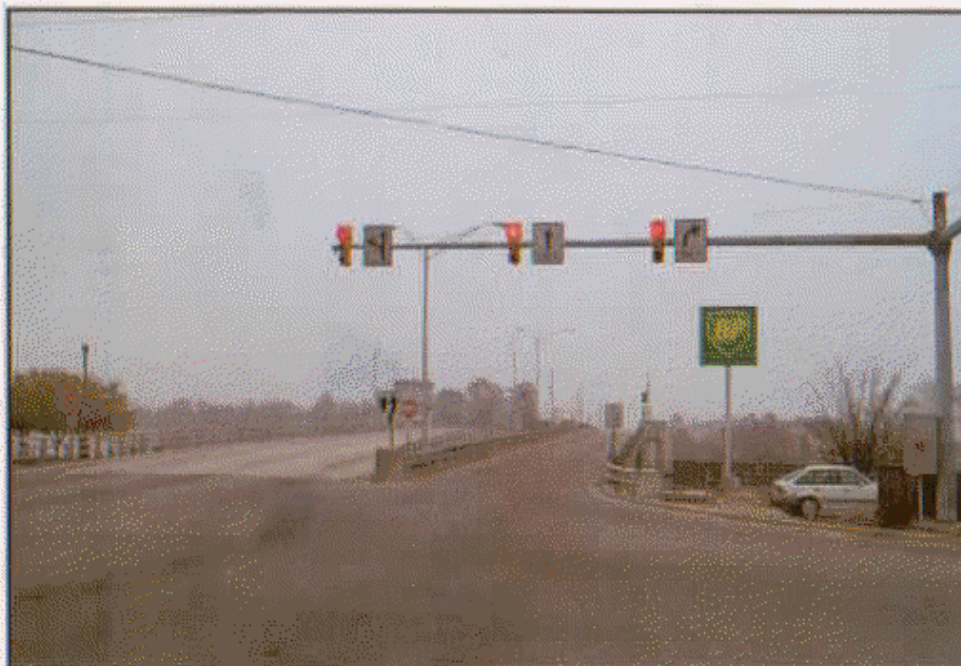
Photo Looking East

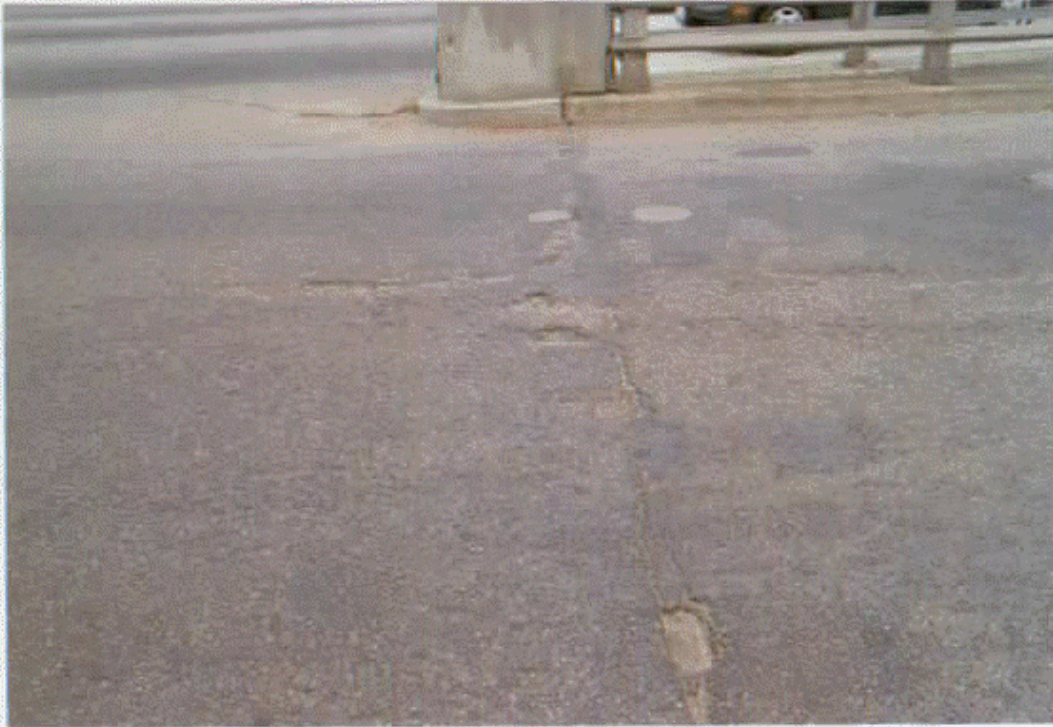
ROADWAY APPROACH

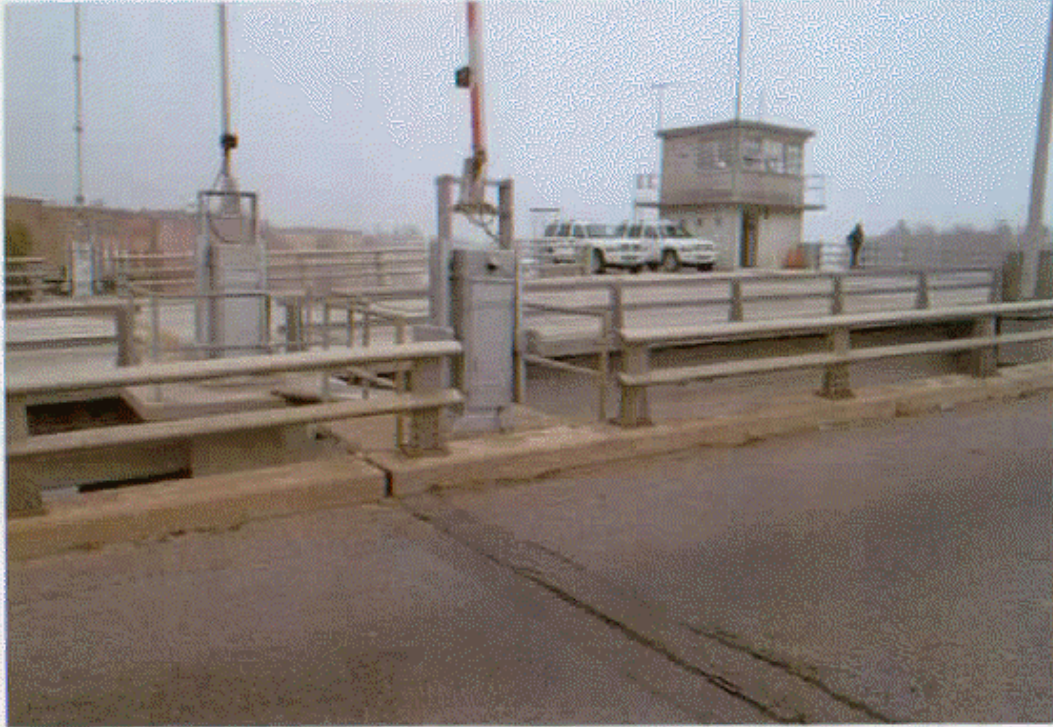
ARMS AT BT#5 SPAN #6

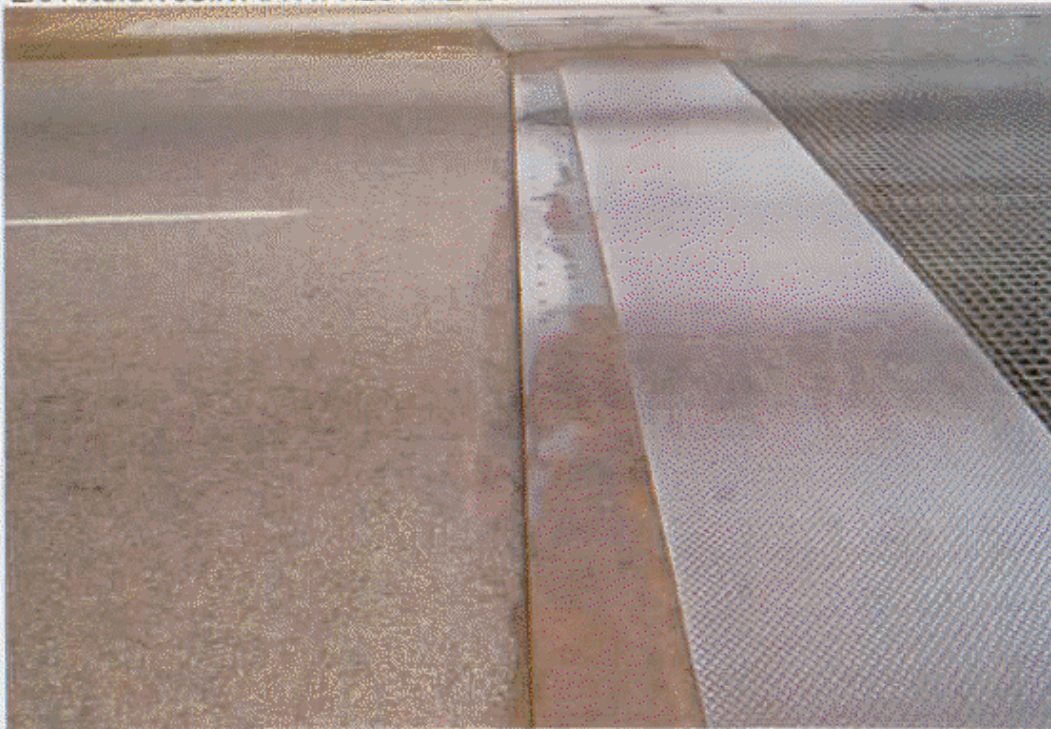
JOINT AT WEST LIFT (EAST SIMILAR)

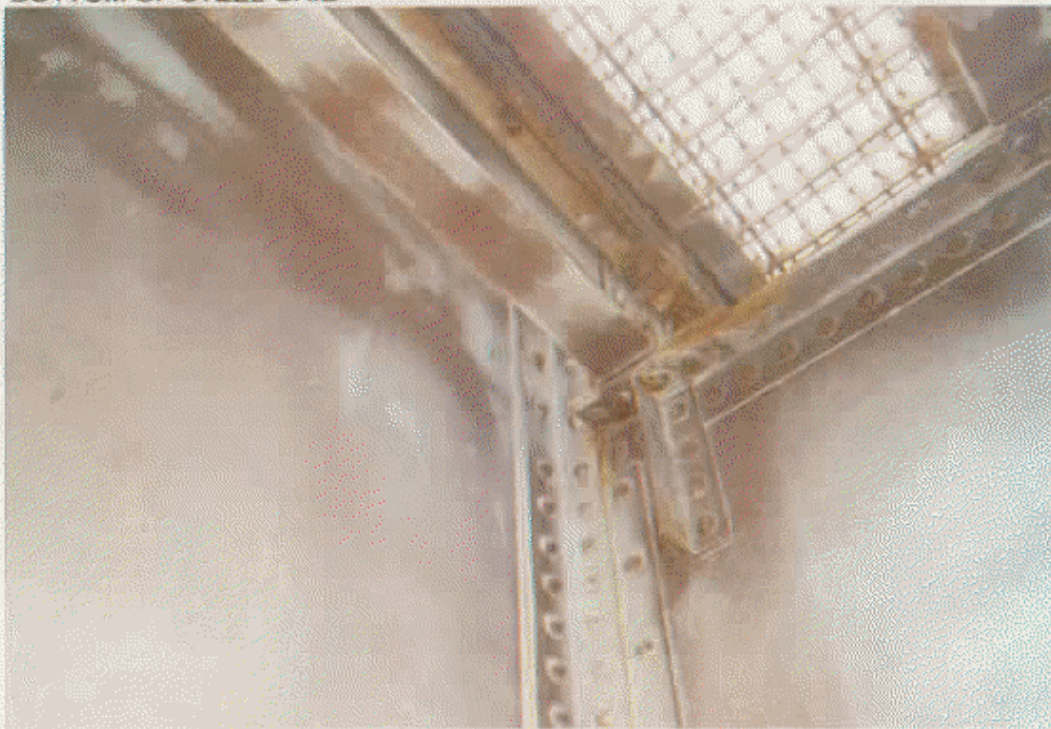
SAME AS ABOVE

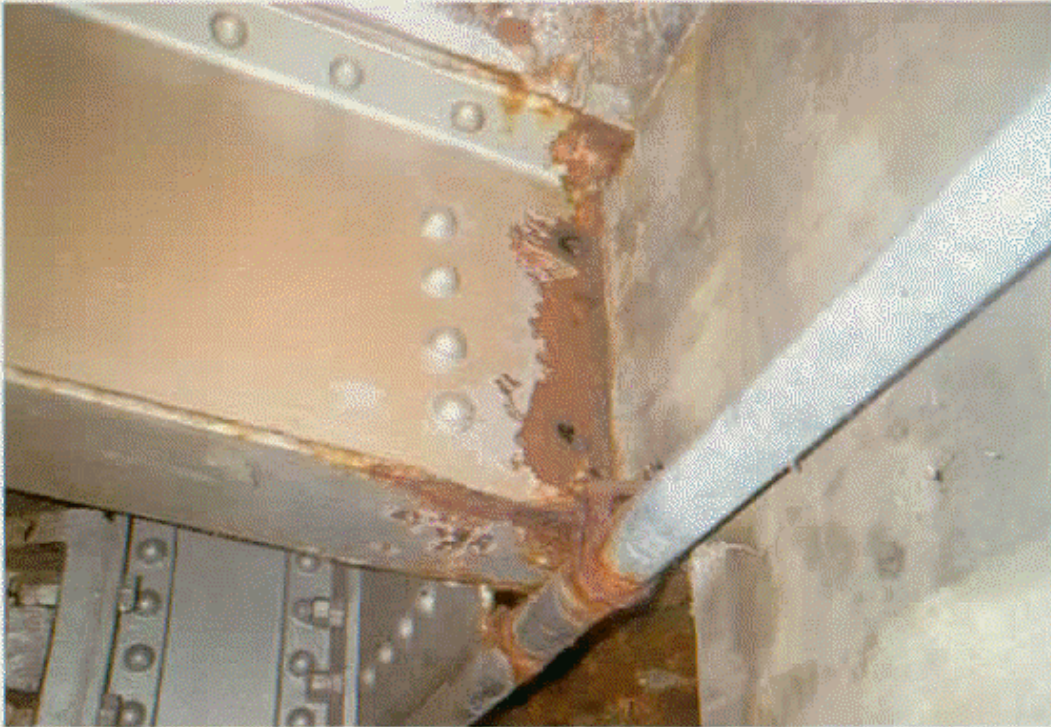
| Item No. | Description |
|---|--|
| 11 | STRINGERS - BASCULE LIFT SPAN - 5 - RUSTY WITH HEAVY SECTION LOSS AT FLOOR BEAM CONNECTIONS. SEE PHOTOS. BEAM #4 HAS HEAVY SECTION LOSS AT WEST END AND HAS TWO HOLES AT CONCRETE . HOLES ARE 2" ROUND 4" FROM TOP FLANG AND ONE HOLE IS 5" FROM BOTTOM FLANGE. PROMPT ACTION ISSUED |

BEAM #4 AT EAST END HAS HEAVY SECTION LOSS AT WEBB AND FLANGE
WEBB HAS TWO HOLES 2" ROUND ONE HOLE IS 4" FROM TOP FLANGE AND
THE OTHER HOLE 5" FROM BOTTOM FLANGE THE BOTTOM FLANGE HAS
1" SECTION LOSS ON BOTH SIDES BACK FROM CONCRETE 4" (PA)

RETURNED PROMT ACTION NOTICE SHOWING REPAIRS

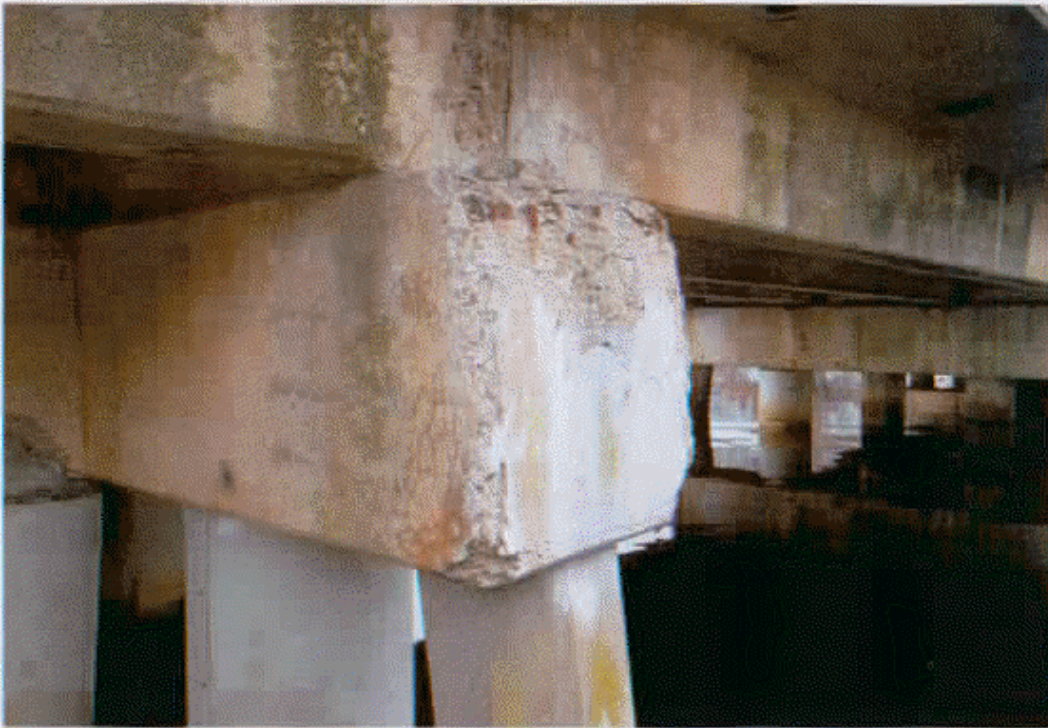
| Item No. | Description |
|---|--|
| 36 | A- END & INT. BT. CAPS. 4- CAN'T GET TO END BT. CAPS, DUE TO LOW CLEARANCE AND WATER DEPTH ON (WEST END). INT. BENT CAPS HAVE CRACKS AND DELIMINATION WITH UP TO 1/2" MAX OPENINGS. SPALL AND CONCRETE DETERIORATION ON SOME END OF CAPS, WITH RE-STEEL EXPOSED. B - INT. BENT PEDISTALS - 5 - UNDER RC THICK SLAB ONLY. CRACKS WITH DELIMINATION AT SOME CRACKS. SPALLS WITH DELIMINATION AROUND SPALLED AREAS. THERE IS CONCRETE DETERIORATION AT PLACES SEE PHOTOS. B- BREAST WALL (REST PIER 1 & 2 (BASCULE LIFT SPAN) 5- CRACKS AND DELIMINATION AT SOME CRACKS. MINOR SPALLS AT PLACES. SADDLE CAPS HAVE BEEN ADDED UNDER RD DECK GIRDERS AT REST PIER # 1 SEE PHOTO. C END & INT. BT. PILES - 5 - PILES AT END BT. NOT VISIBLE. MOST PILES AT INTERIOR BTS. HAVE BEEN ENCASED,. THIS INSPECTOR DOESN'T KNOW HOW FAR DOWN ENCASEMENT GOES. PILE NOT ENCASED HAVE MINOR CRACKS. |

LEFT END OF BENT #4 CAP (SIMILAR AT BENT #2 CAP)

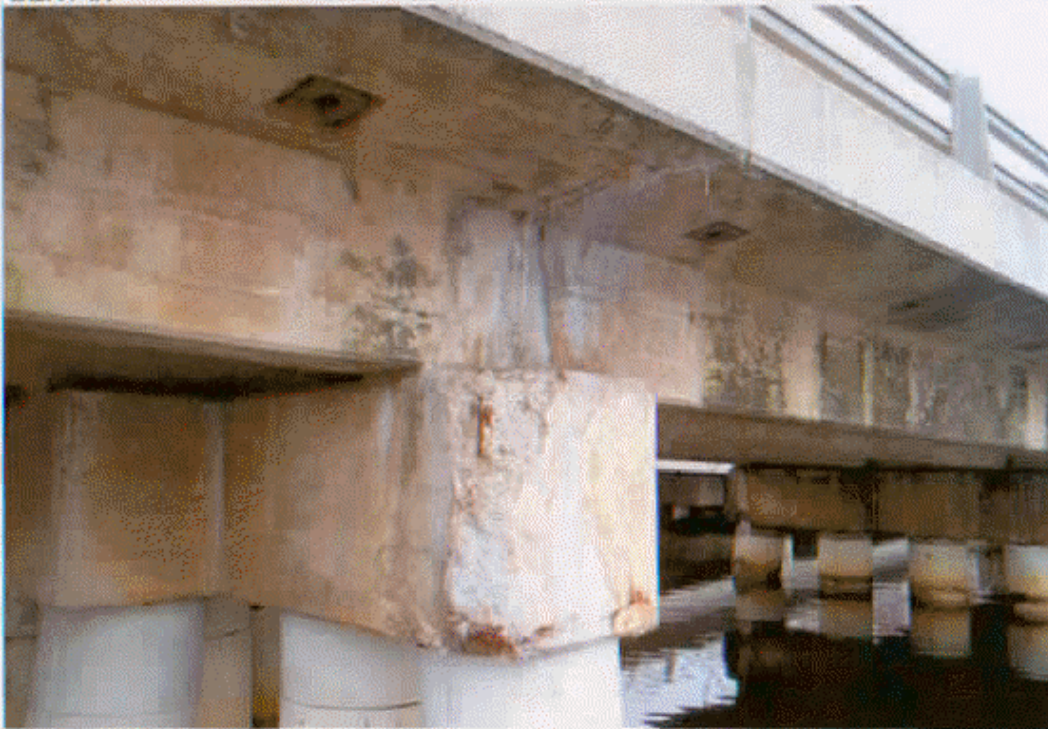
RIGHT END OF BENT #7 (LEFT END SIMILAR)

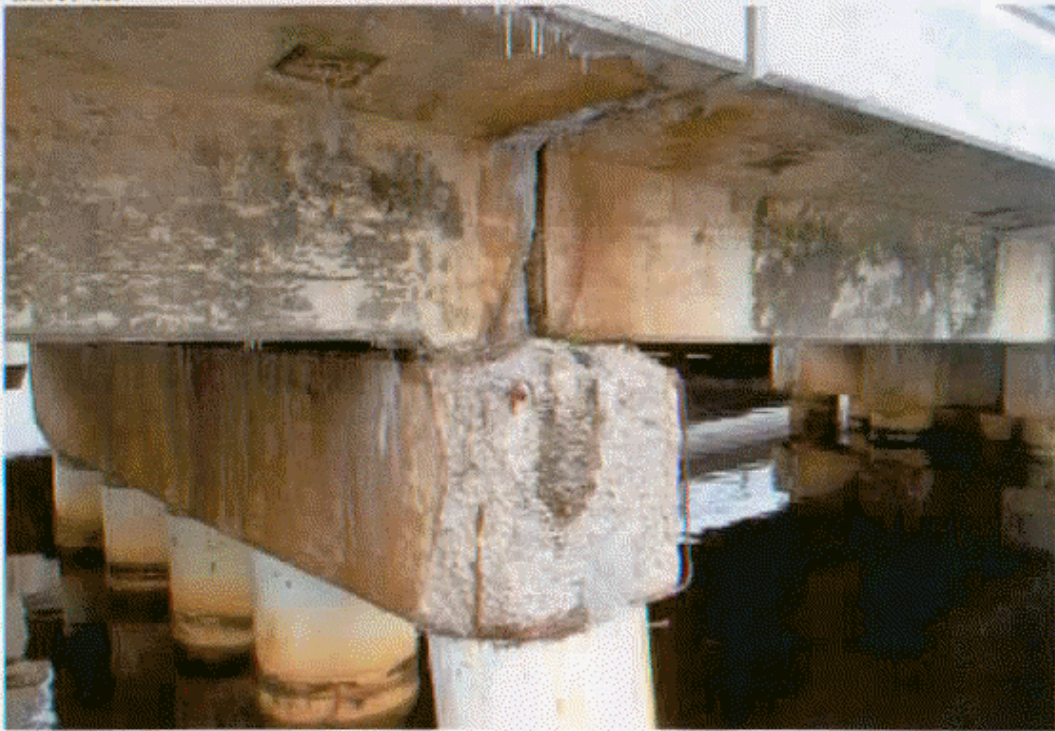
RIGHT END OF BENT #8 (LEFT END SIMILAR)

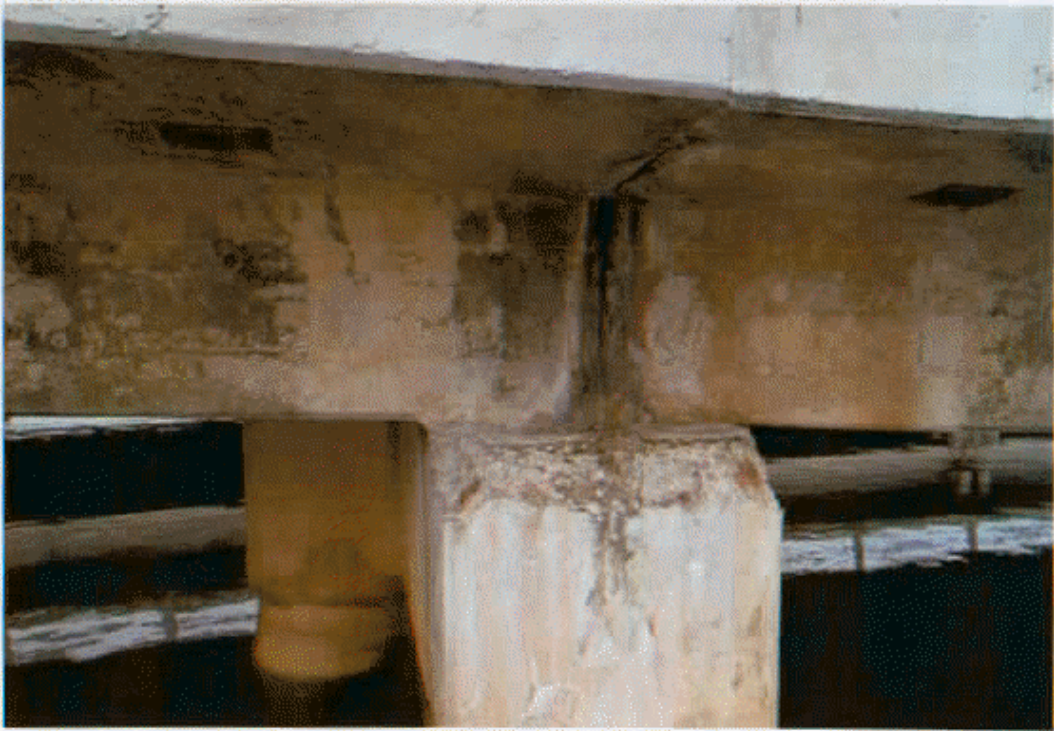
RIGHT END BENT #9 (LEFT END SIMILAR)

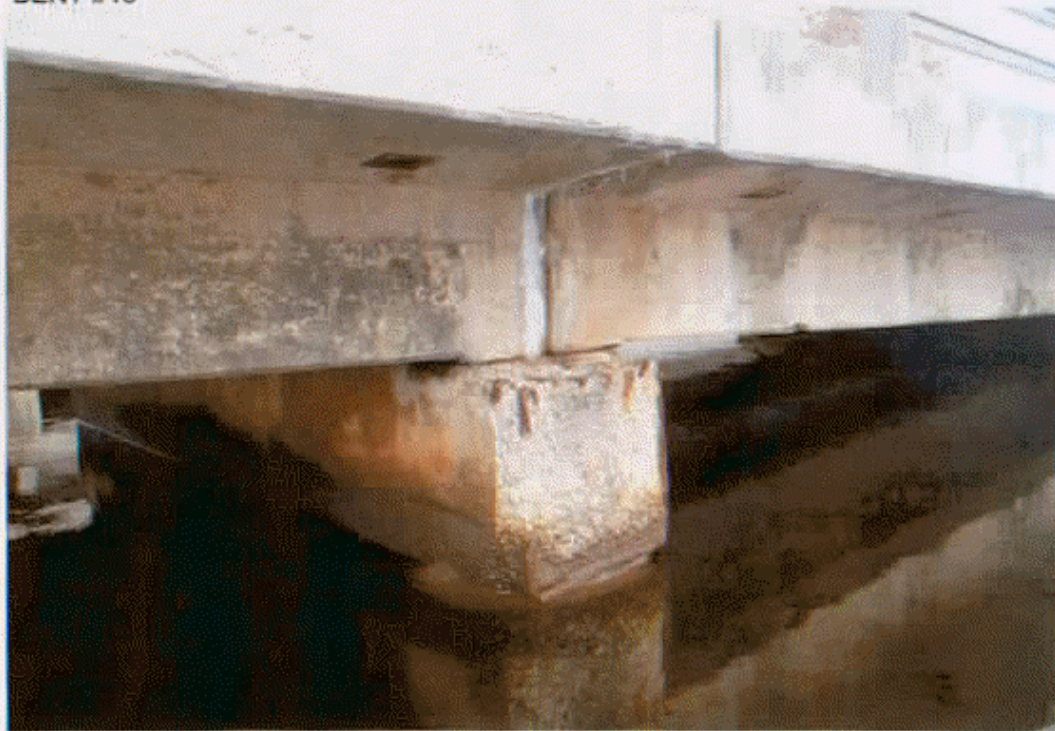
RIGHT END OF BENT #10 (LEFT END SIMILAR)

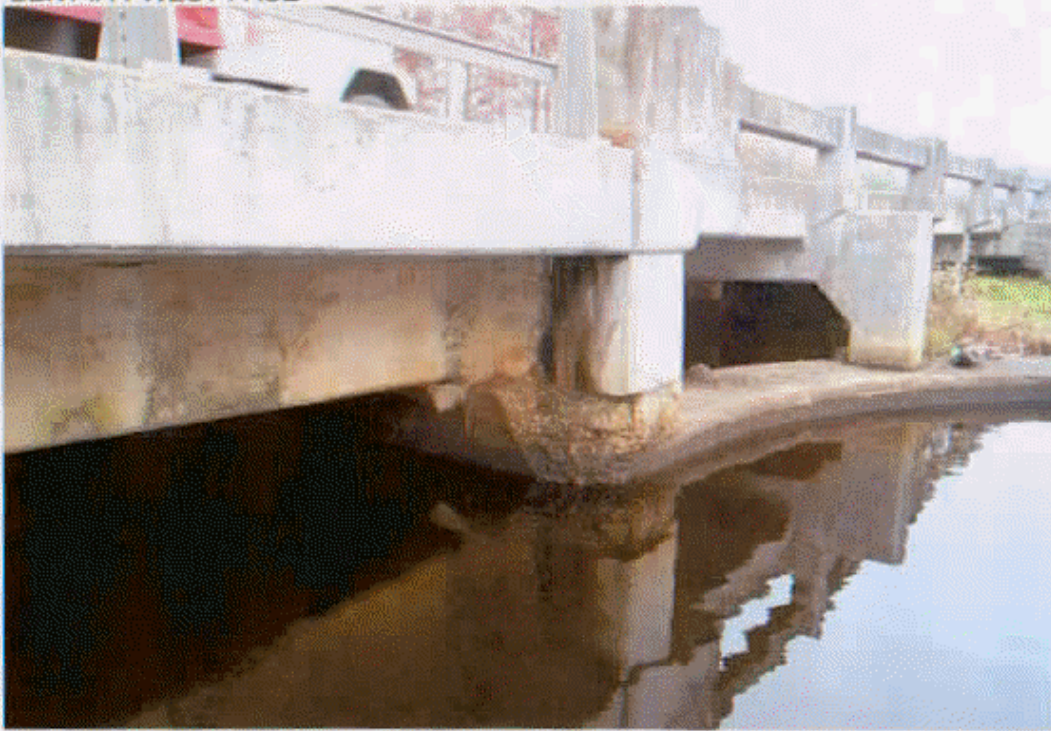
RIGHT END OF BENT #11 (LEFT END SIMILAR)

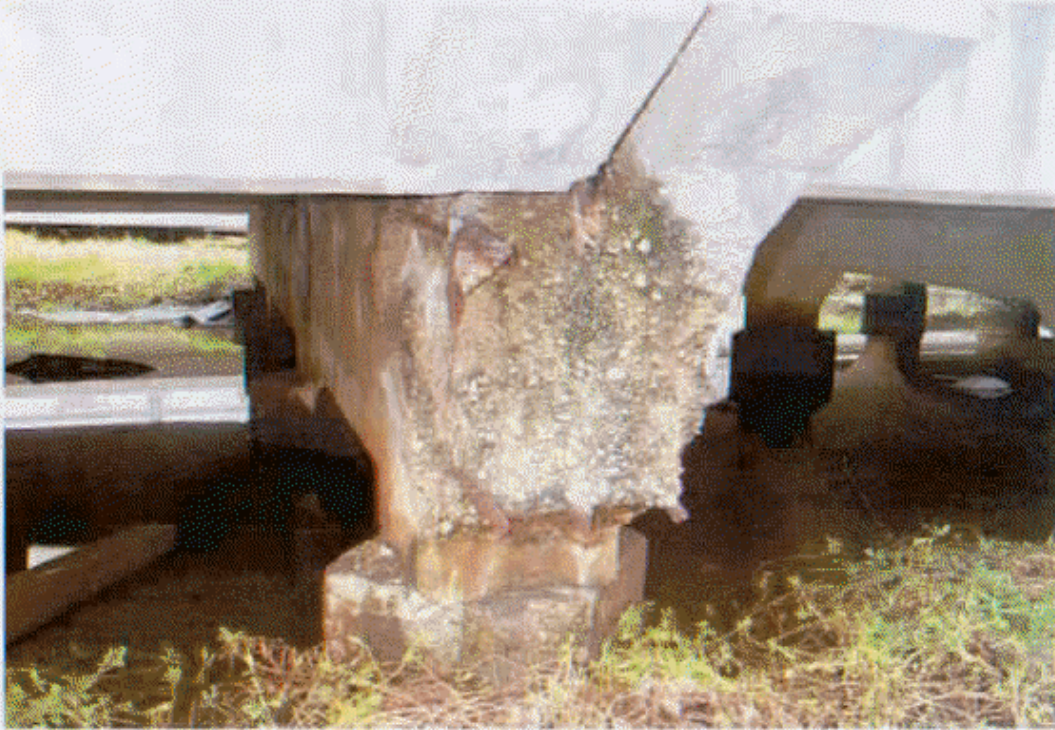
RIGHT END OF BENT #18 (LEFT END SIMILAR)

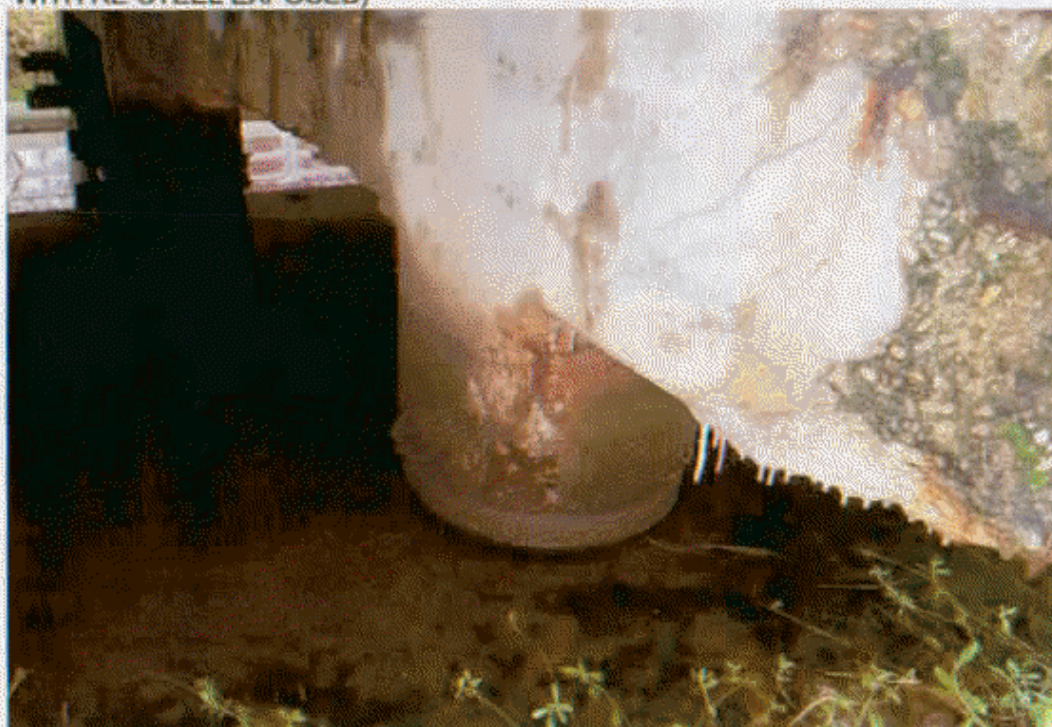
PEDESTAL #3 AT BENT #25 (PEDESTAL #2 SIMILAR)
