NC DEPARTMENT OF TRANSPORTATION
 DIVISION OF HIGHWAYS
 STRUCTURE MANAGEMENT UNIT

Structure Safety Report

Fracture Critical and Machinery Element Inspection

COUNTY: NEW HANOVER STRUCTURE NUMBER: 640013 FREQUENCY: 24 MONTHS

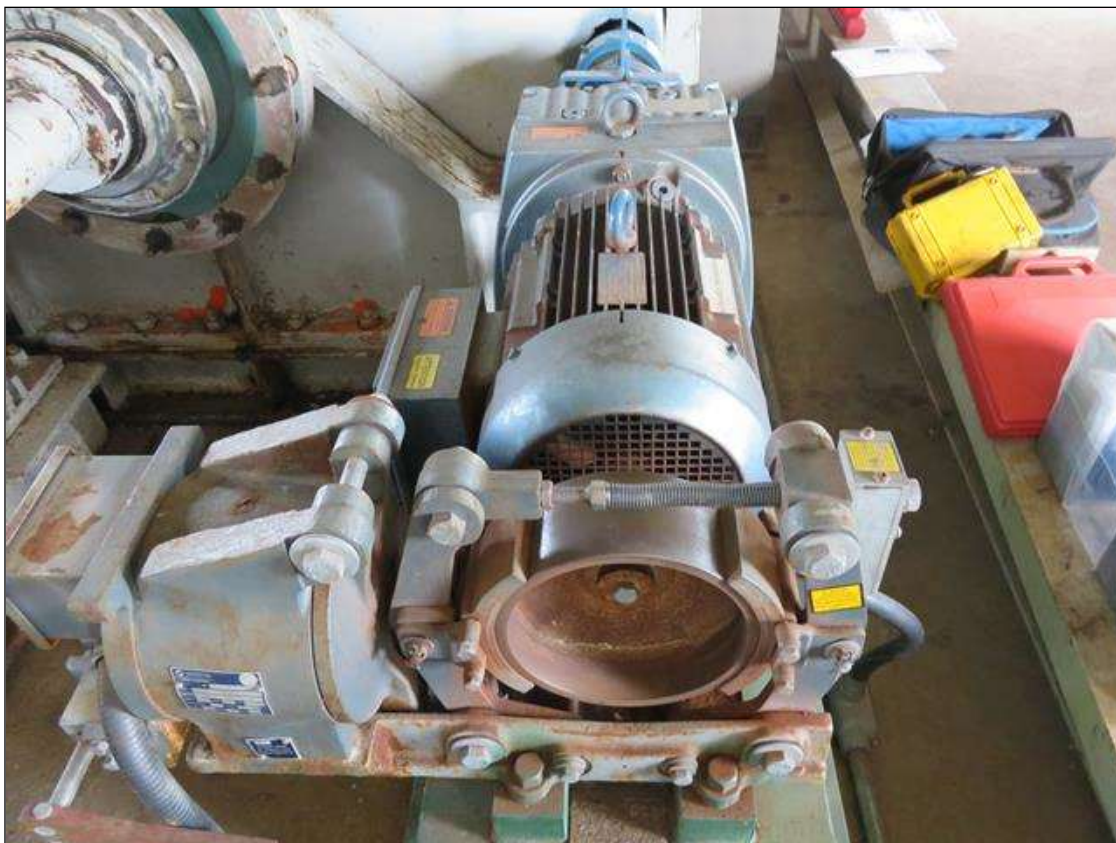
EAST AUXILARY DRIVE GEAR MOTOR BRAKE (GOOD)

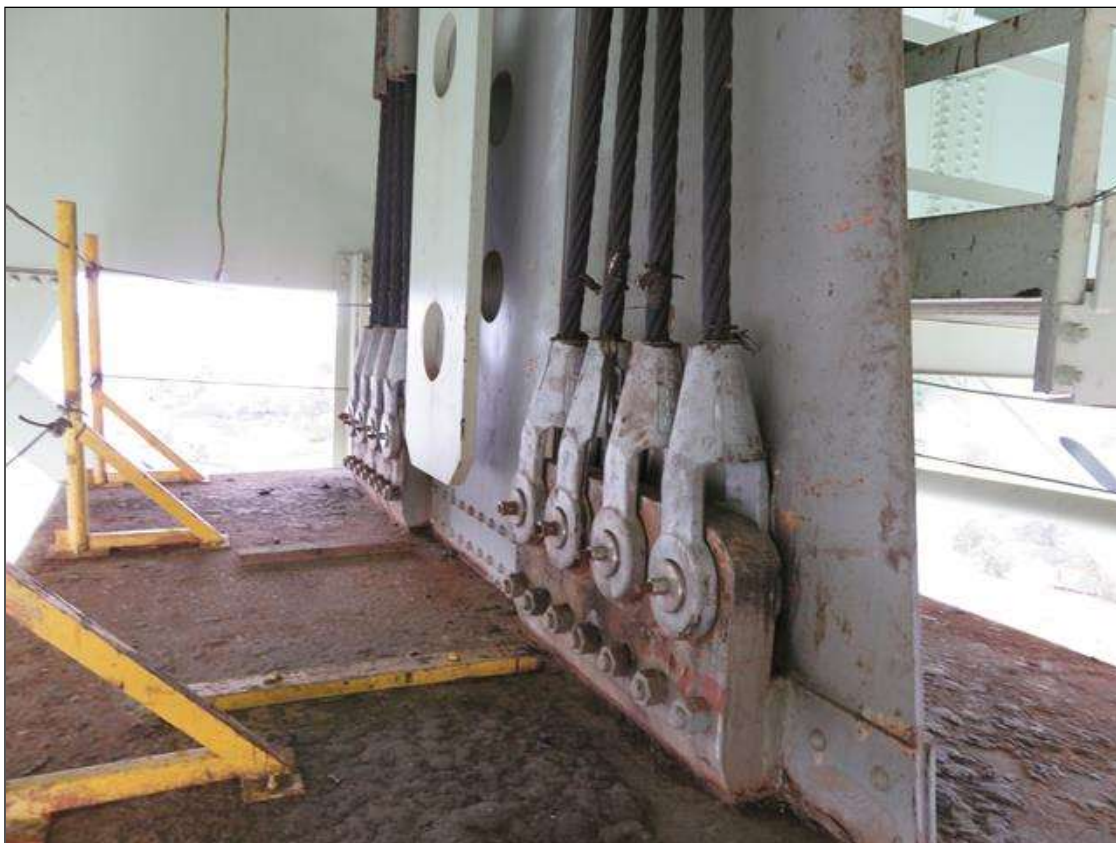
CABLE ATTACHMENT TO COUNTER WEIGHT (EAST TOWER)

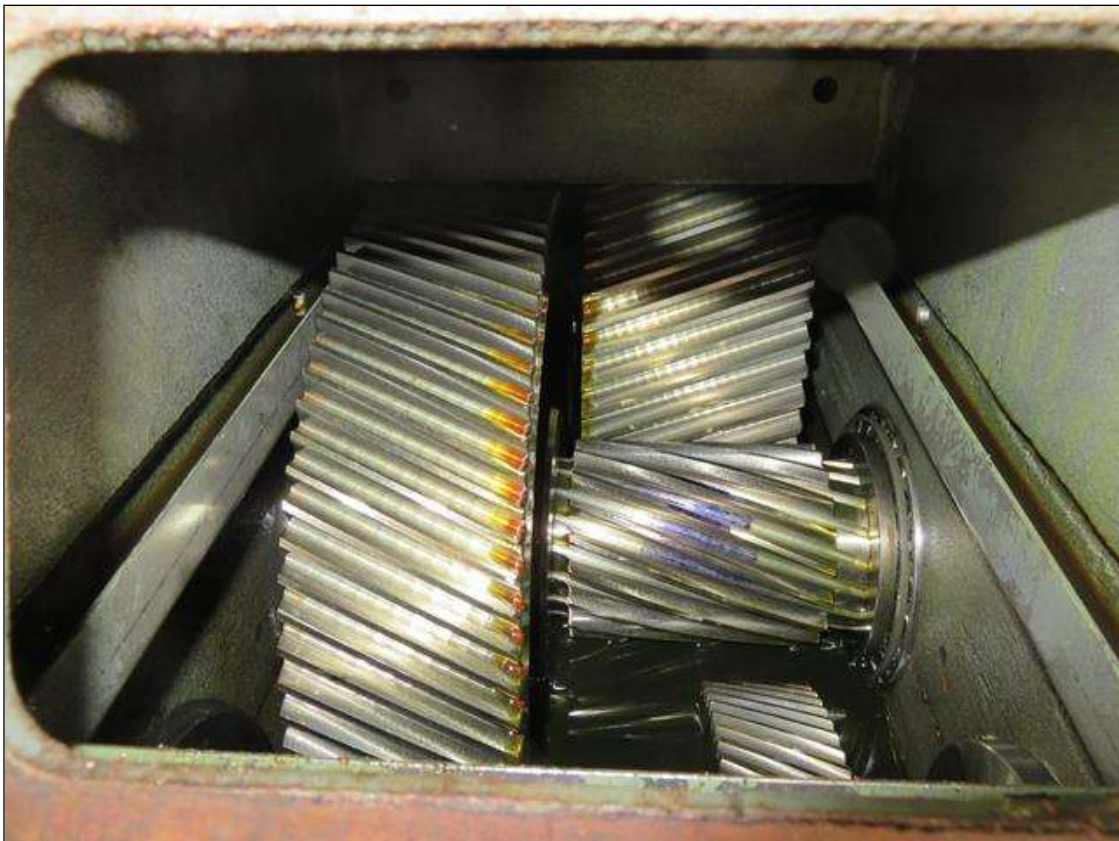
EAST END SPEED REDUCER GEARS GOOD, (FLUID SAMPLE TAKEN)

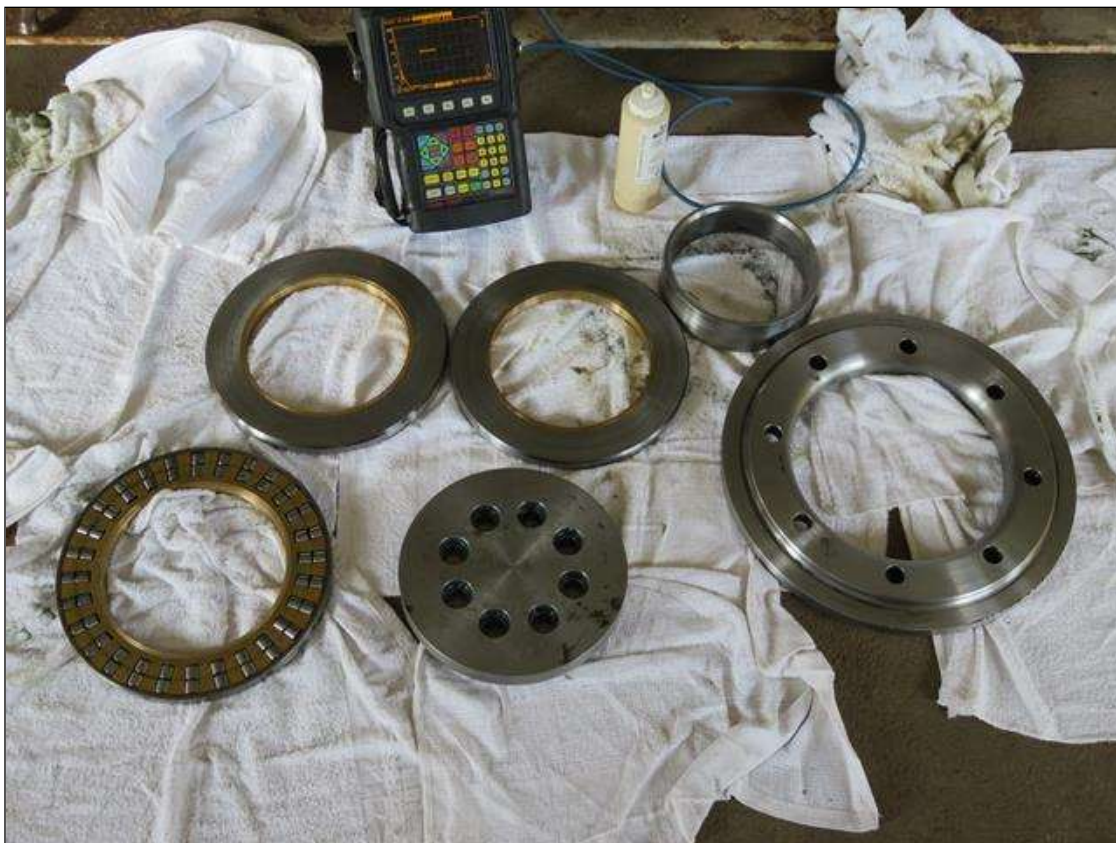
ALL PARTS FOR NORTH EAST ROOM SOUTH INNER TRINNION.

NORTH EAST ROOM INNER SOUTH SIDE RACE BUSHING HAS SEVERAL DEEP GROOVES AND IS BEING REPLACED WITH NEW DURING THE 2017 INSPECTION.

NORTH EAST ROOM INNER SOUTH SIDE TRUNNION REPLACEMENT RACE BUSHING (NEW)

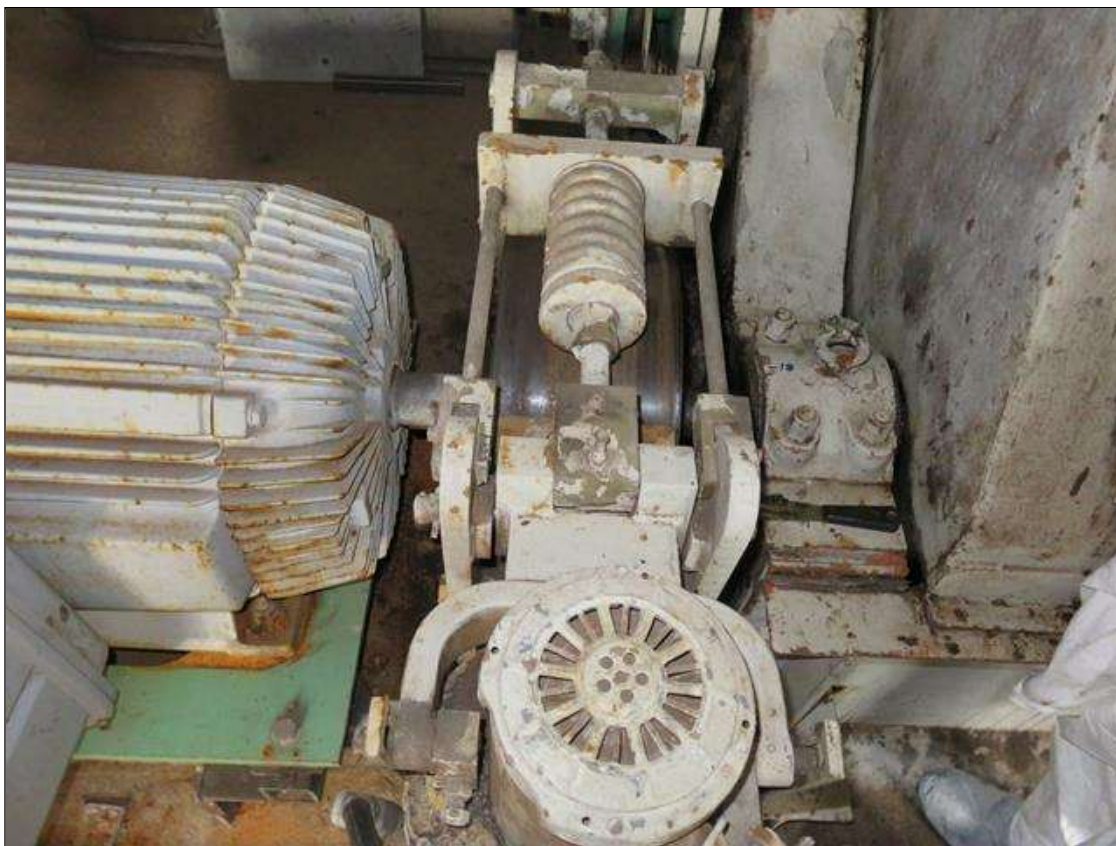
BRAKE #2 OPERATING MACHINE WEST TOWER (GOOD)
