NC DEPARTMENT OF TRANSPORTATION  
DIVISION OF HIGHWAYS  
BRIDGE MANAGEMENT UNIT

# BRIDGE INSPECTION REPORT

COUNTY IREDELL BRIDGE NUMBER 480282 INSPECTION CYCLE 2 YRS  
ROUTE SR1828 ACROSS NORTH HUNTING CREEK M.P. 0

SUPERSTRUCTURE STEEL PLANK DECK ON I-BEAMS

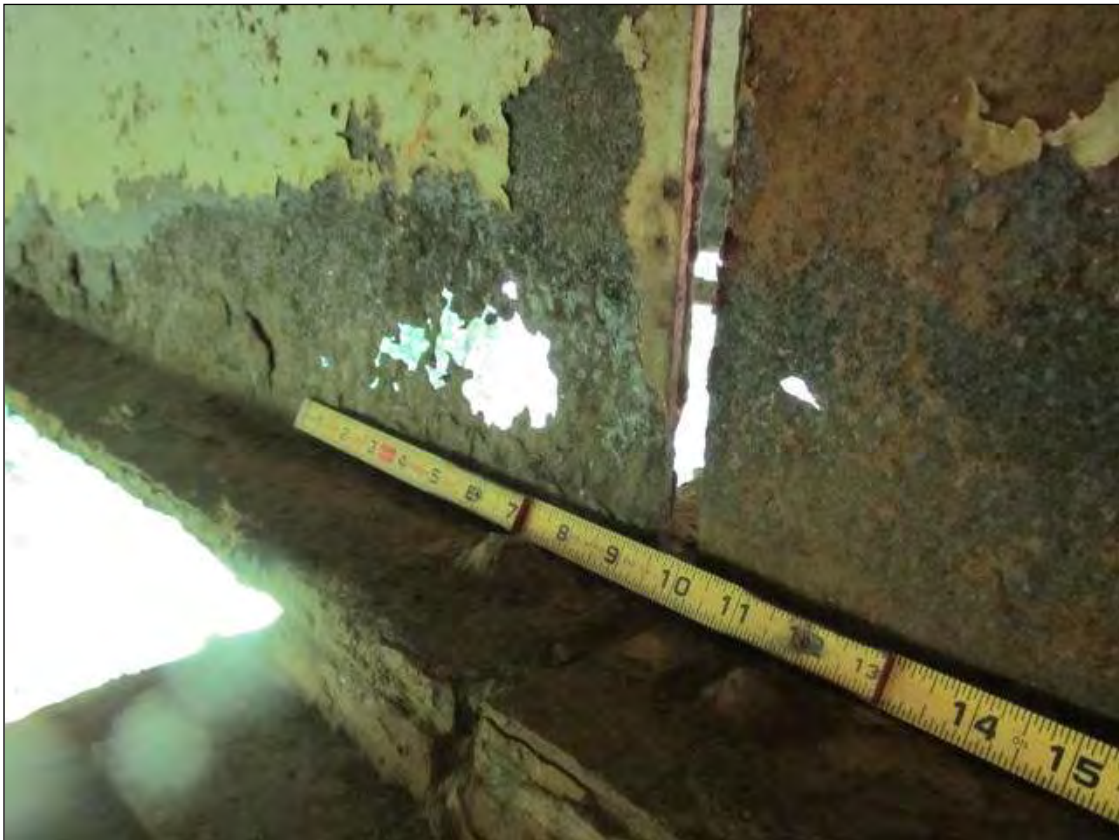
RT. SIDE BEAM (5), SPANS (A) AND (B) AT PIER ( 1)... HOLES IN WEB (+/- 9" L X 6" H) SPAN (A), AND (+/- 1" DIAM.) IN SPAN (B)... SEE SKETCH

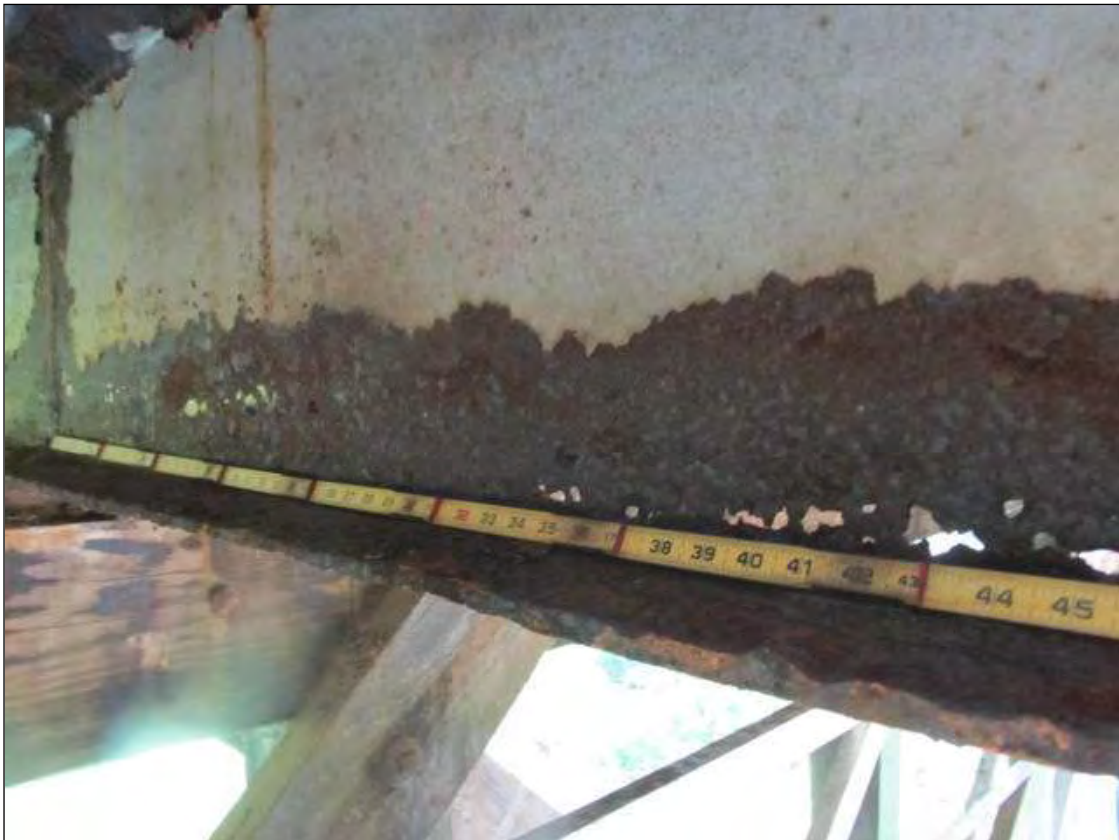
RT. SIDE BEAM (6), SPAN (B) AT PIER (1), (+/- 5' FROM EAST END OF BEAM) HOLES IN WEB (+/- 7' L X 6" H)... SEE SKETCH

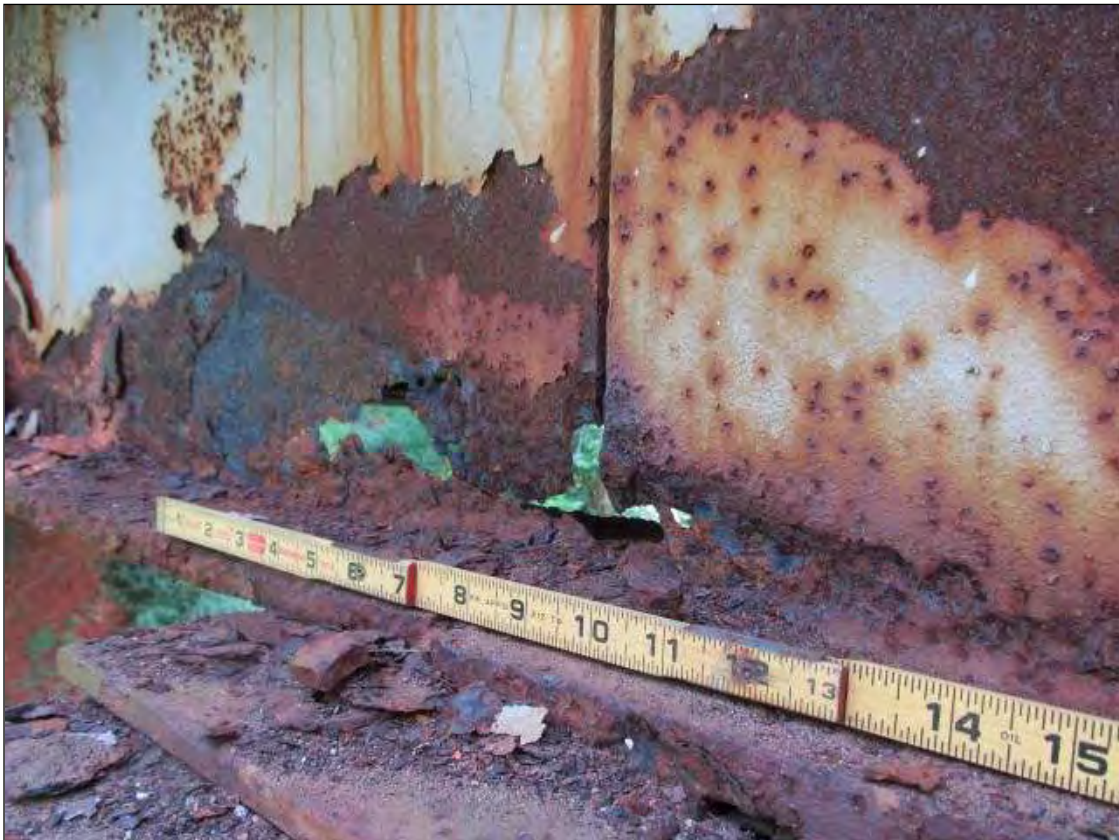
RT. SIDE OF BEAM (10), SPANS (A) AND (B) AT PIER (1)... HOLES IN WEB (+/- 12" L X 6" H), NOTE DEEP PITTING... SEE SKETCH

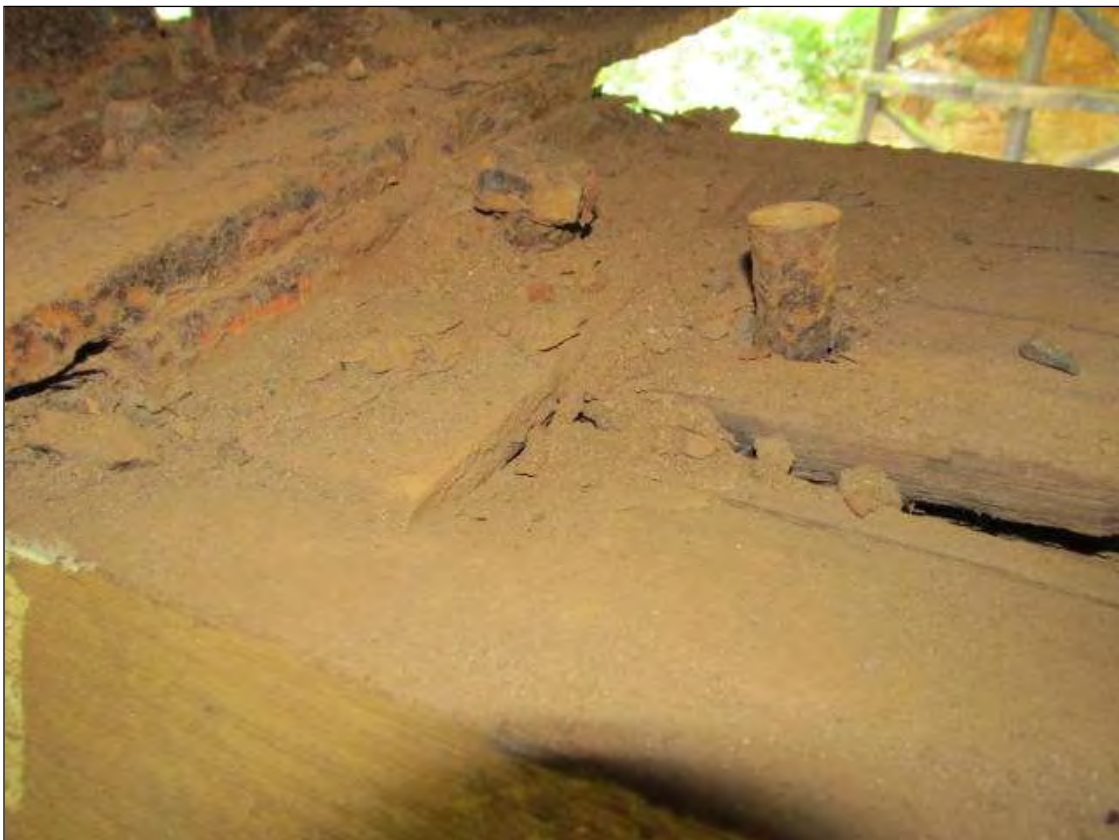
| Bridge I&A Form 1(82)H<br>State of North Carolina<br>Dept. of Transportation<br>Division of Highways | | <h1>FIELD INSPECTION REPORT</h1> <p><u>Bridge Inspection &amp; Analysis</u></p> | |
|---|---|---|--|
| 35a | C | CAPS ARE IN VERY POOR CONDITION AT THIS TIME... ALL ARE SPLIT, DECAYED AND PIER CAPS HAVE CRUSHING DEFORMATION FULL LENGTH... SEE PHOTOS<br><br>ABUT. (A) CAP IS DECAYED , AND SPLIT ALONG THE TOP, LT. END. DECAY EXTENDS BENEATH BRG. PLATE, AND PLATE IS CRUSHING INTO TOP OF CAP...<br><br>RT. END OF ABUT. (A) CAP IS DECAYED (+/- 6" DIAM.) AND EXTENDS BENEATH BEARING PLATE, WHICH IS CRUSHING INTO TOP OF CAP. CAP IS SPLIT FULL LENGTH...<br><br>LT. END OF PIER (1) CAP IS SPLIT AND DECAYED ON END, DECAY EXTENDS BENEATH BRG. PLATE, AND THROUGHOUT CAP FULL LENGTH... CAP IS HOLLOW.<br><br>SPLIT ALONG TOP CENTER OF PIER (1) CAP... SHOWN BTWN. SEATS (1) AND (2)...<br><br>WEST FACE OF PIER (2) CAP, SPLIT AND BUCKLING... CAP IS SUBJECT TO FAILURE...<br><br>LT. END OF PIER (2) CAP; (CONCRETE REPAIR ATTEMPT HAS FAILED)... CAP SPLIT, AND DETERIORATED, BRG. PLATE CRUSHING, BEAMS ARE RESTING ON CAP IN SEVERAL AREAS... (25 LF)<br><br>PIER (2) CAP SPLIT ALONG TOP CENTER, HOLLOW INSIDE, SPLIT ALONG FACES AND CRUSHING, THIS PHOTO BTWN. SEATS (1) AND (2)...<br><br>PIER (2) CAP BTWN. SEATS (3) AND (4)... SPLIT ALONG TOP CENTER IS SIMILAR FULL LENGTH...<br>BEARING PLATES ARE CRUSHING INTO TOP OF PIER (2) CAP...<br><br>PIER (3) CAP; SPLIT FULL LENGTH ALONG TOP CENTER... CAP IS DECAYED IN CENTER, SPLIT WITH DEFORMATION ALONG WEST FACE... (+/- 25 LF)<br><br>ABUTMENT (B) CAP IS BEGINNING TO DECAY ON ENDS AND SPLIT ALONG TOP CENTER... FAIR CONDITION AT THIS TIME...<br>PILES ARE WEATHERED, CHECKING AND SPLITTING... | |

BEARING PLATES ARE CRUSHING INTO TOP OF PIER (2) CAP...

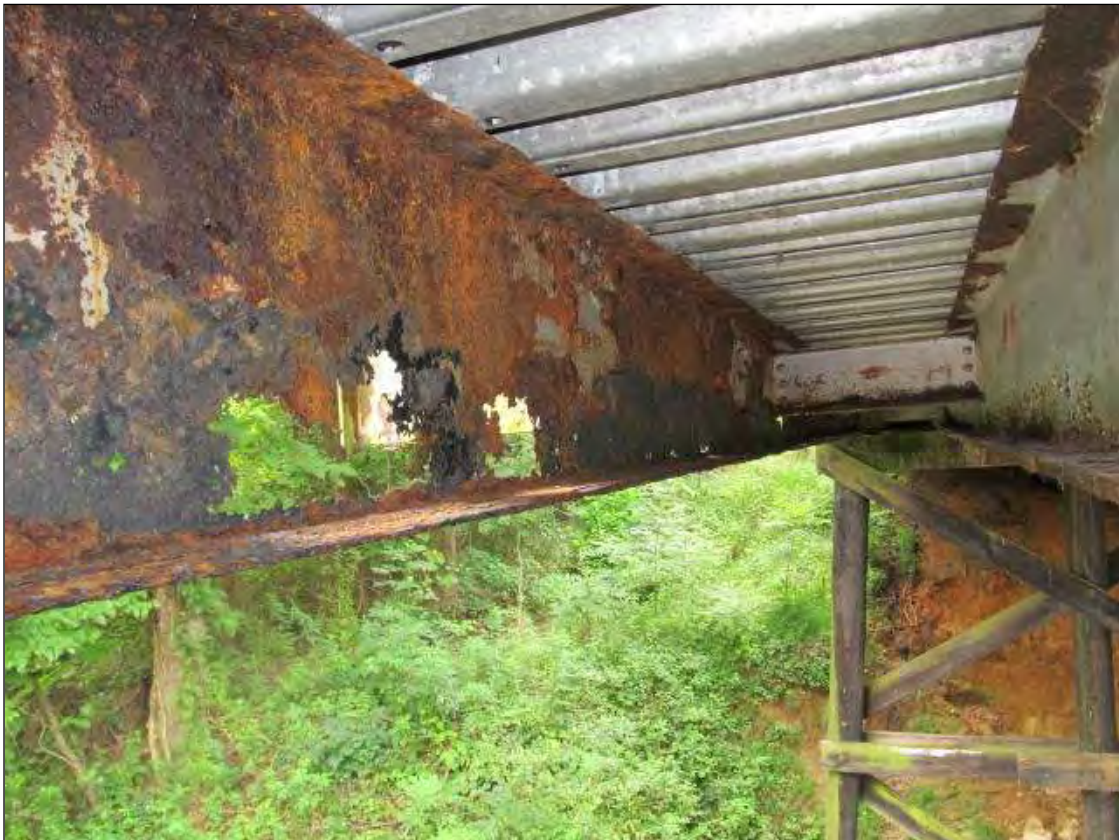
BEAM (1), SPAN (C) AT ~ MID SPAN (C)... (OUTSIDE VIEW) OF HOLES IN WEB... (+/- 12' L X 2" TO 10" H)... SEE SKETCH

| MMS Code | Description of Function | Unit | Quantity | Remarks | Est. Cost |
|---|---|---|---|---|---|
| 3314 | Maintain Steel Superstructure Components | LF | 12 | PHOTO (2), BEAM (1), SPAN (C) AT ~ MID SPAN (C)... (OUTSIDE VIEW) OF HOLES IN WEB... (+/- 12' L X 2" TO 10" H)... SEE SKETCH<br>PHOTO (1), BEAM (1), SPANS (B) AND (C) AT PIER (2)... HOLES IN WEB AT BRGS... (SPAN (B) +/- 6" DIAM., SPAN (C) +/- 12" L X 6" H)... NOTE BOTT. FLNG..<br><br>PHOTO (2), BEAM (1), SPAN (C), RT. SIDE NEAR PIER (2)... SEE REPORT SKETCH FOR DIMENSIONS AND LOCATION OF HOLES IN WEB AND DETERIORATION OF BOTT. FLANGE...<br><br>PHOTO (3), BEAM (1), SPAN (C), (LT. OUTSIDE SHOWN)... HOLES IN WEB AND DETERIORATION OF FLANGES...<br><br>(+/- 12 LF) THIS AREA... | |

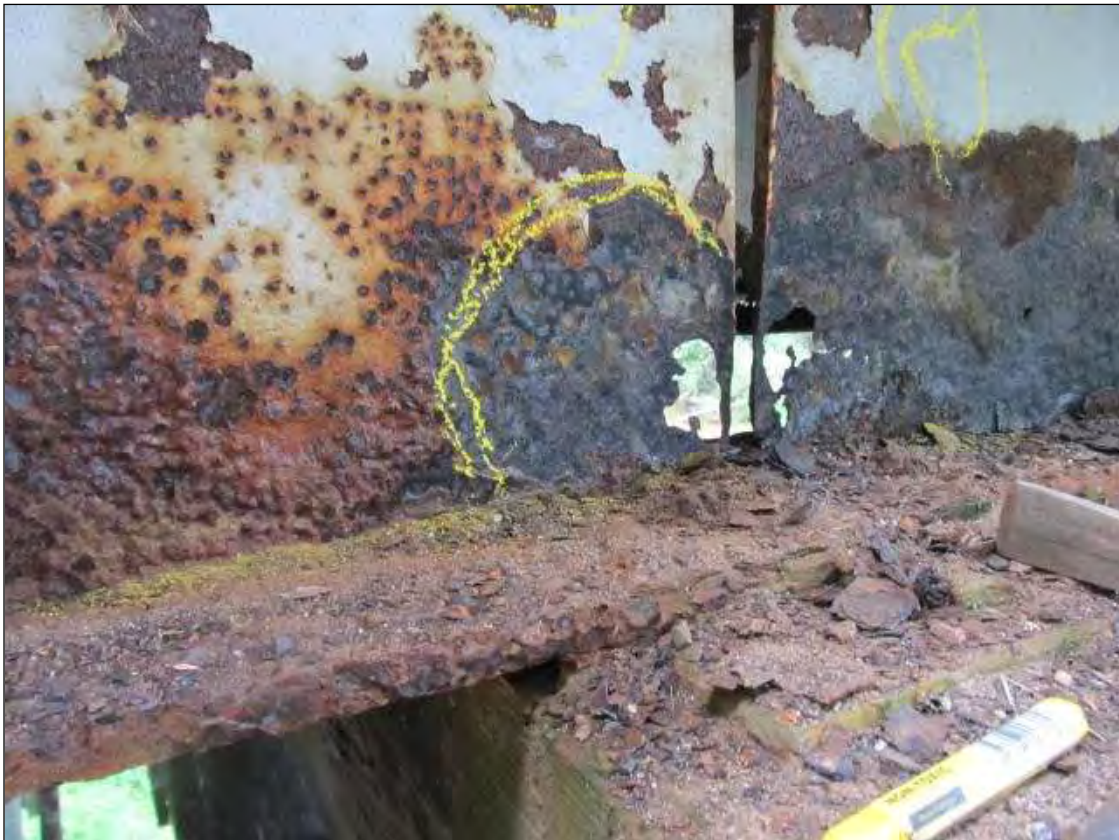
BEAM (1), SPANS (C) AND (D) AT PIER (3); HOLES IN WEB, (+/- 3" DIAM..)

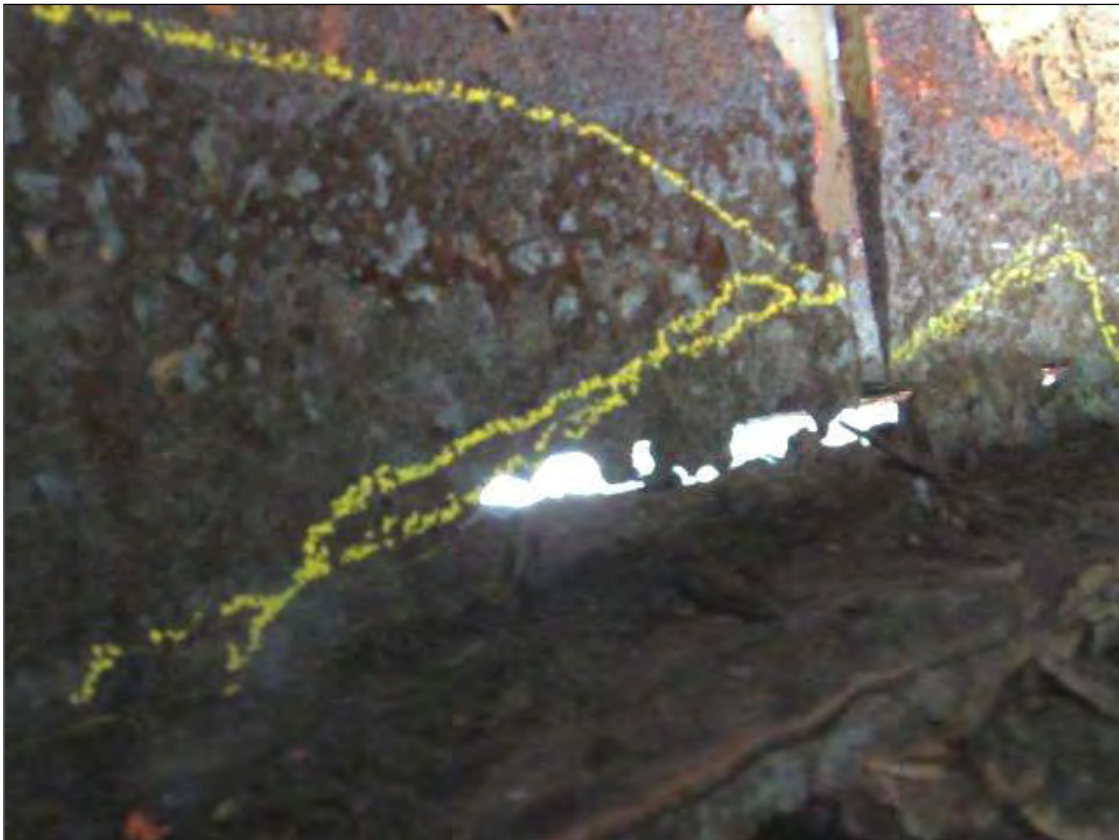
BEAM (9), SPAN (D) AT PIER (3); HOLE IN WEB, (+/- 10" L X 3" H)... SEE SKETCH

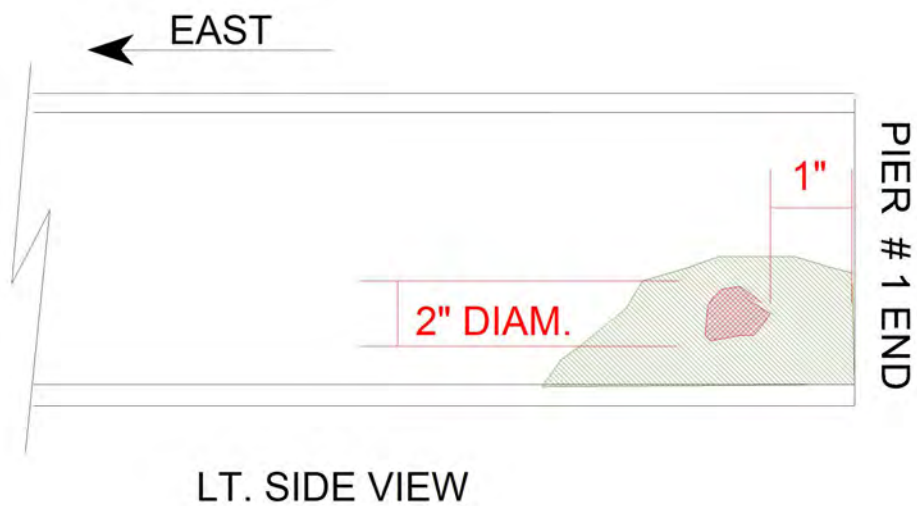
+/- 2" DIAM. HOLE IN WEB OF BM. # 3, SPAN # 1 @ PIER # 1
