NC DEPARTMENT OF TRANSPORTATION  
DIVISION OF HIGHWAYS  
STRUCTURE MANAGEMENT UNIT

## Structure Safety Report

### Routine Element Inspection

COUNTY: ROWAN STRUCTURE NUMBER: 790061 FREQUENCY: 24 MONTHS

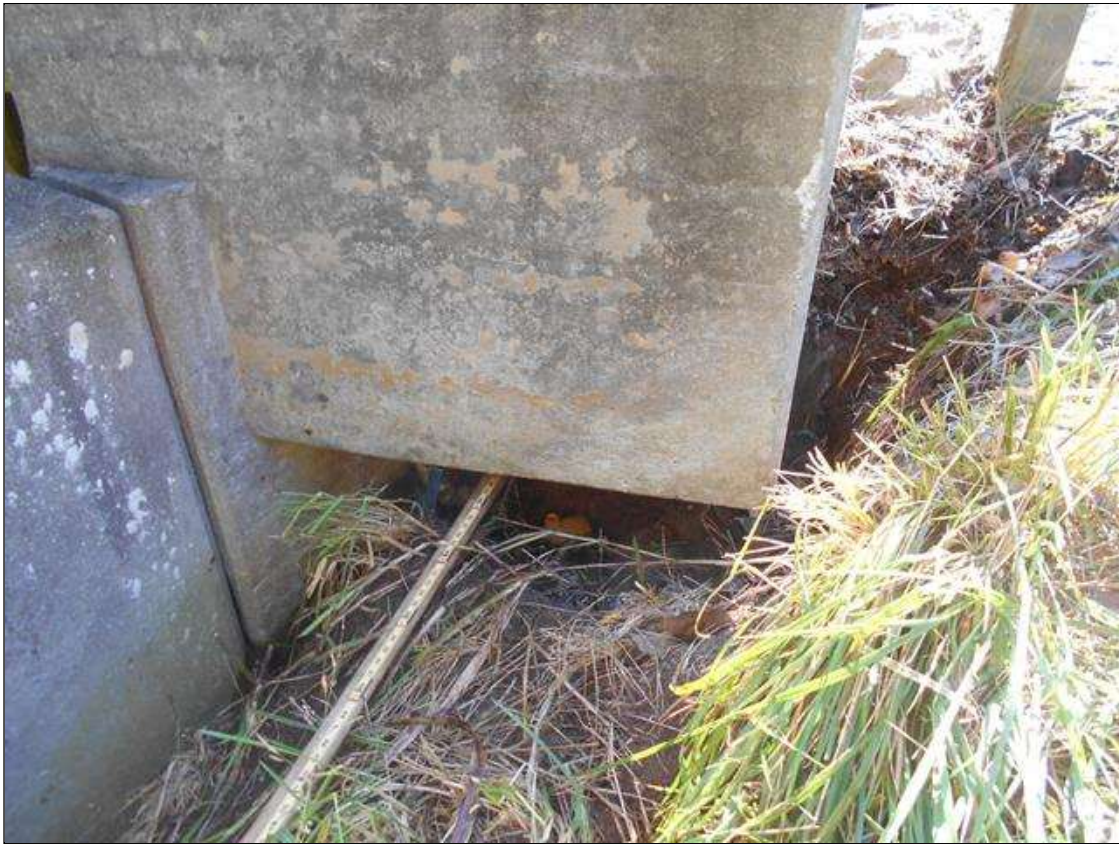
SPAN 1, LT CONCRETE RAIL END POST UNDERMINED: FILL WASHING AROUND AND UNDERNEATH 2 FT. WIDE X 3 FT. LONG X 18 IN. DEEP. PRIORITY MAINTENANCE.

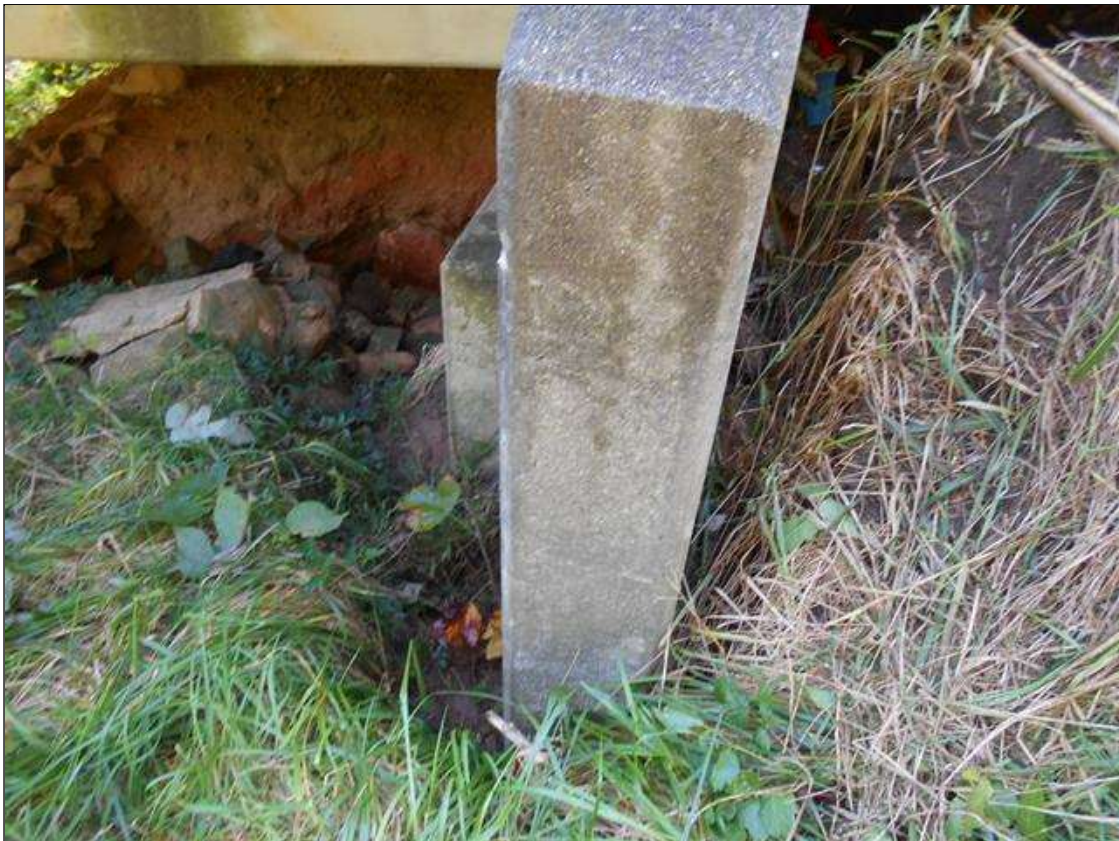
FILL SLOPE WASHING AROUND AND UNDERNEATH SW WINGWALL 18 IN. WIDE X 4 FT. LONG X 18 IN. DEEP. PRIORITY MAINTENANCE.

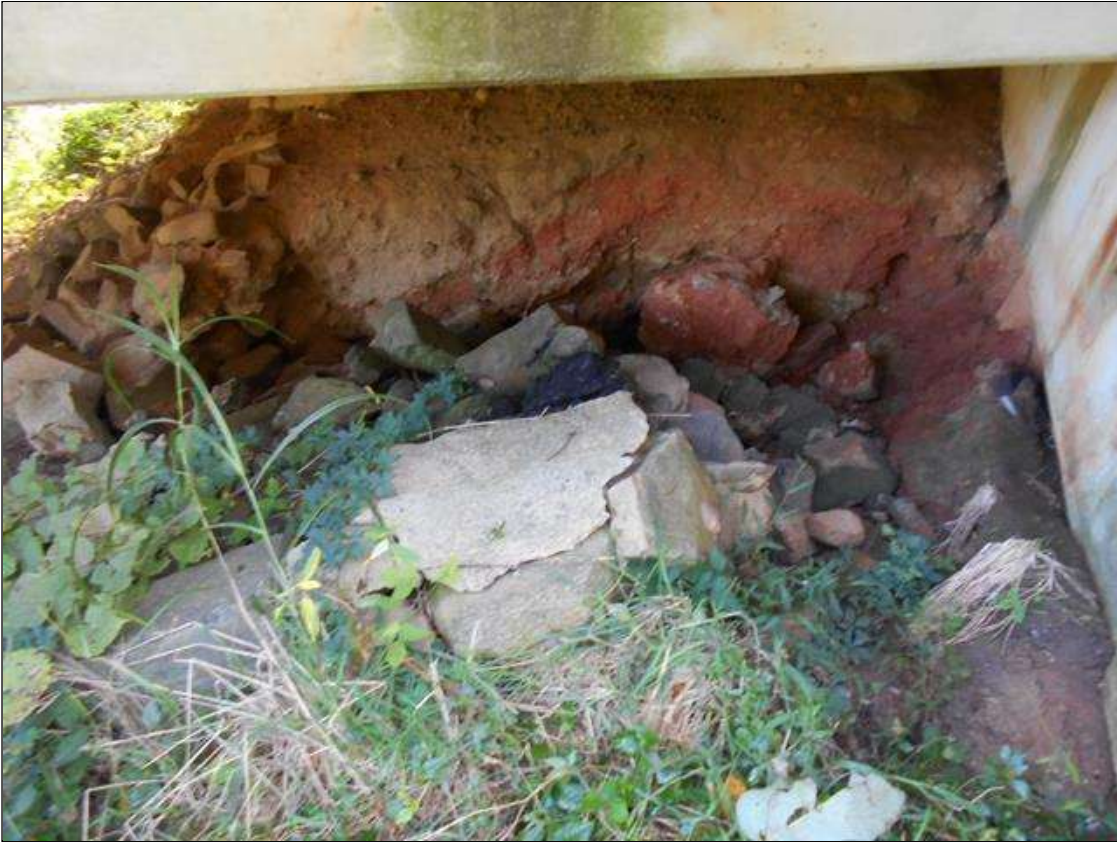
SOUTH SLOPE WASHING 3 FT. D. X 7 FT. W. X 15 FT. L. AT ABUT. 1 LT. SIDE CAP UNDERMINED 1FT. X 3 FT. LONG EXPOSING TOP OF COLUMN 1. PRIORITY MAINTENANCE.

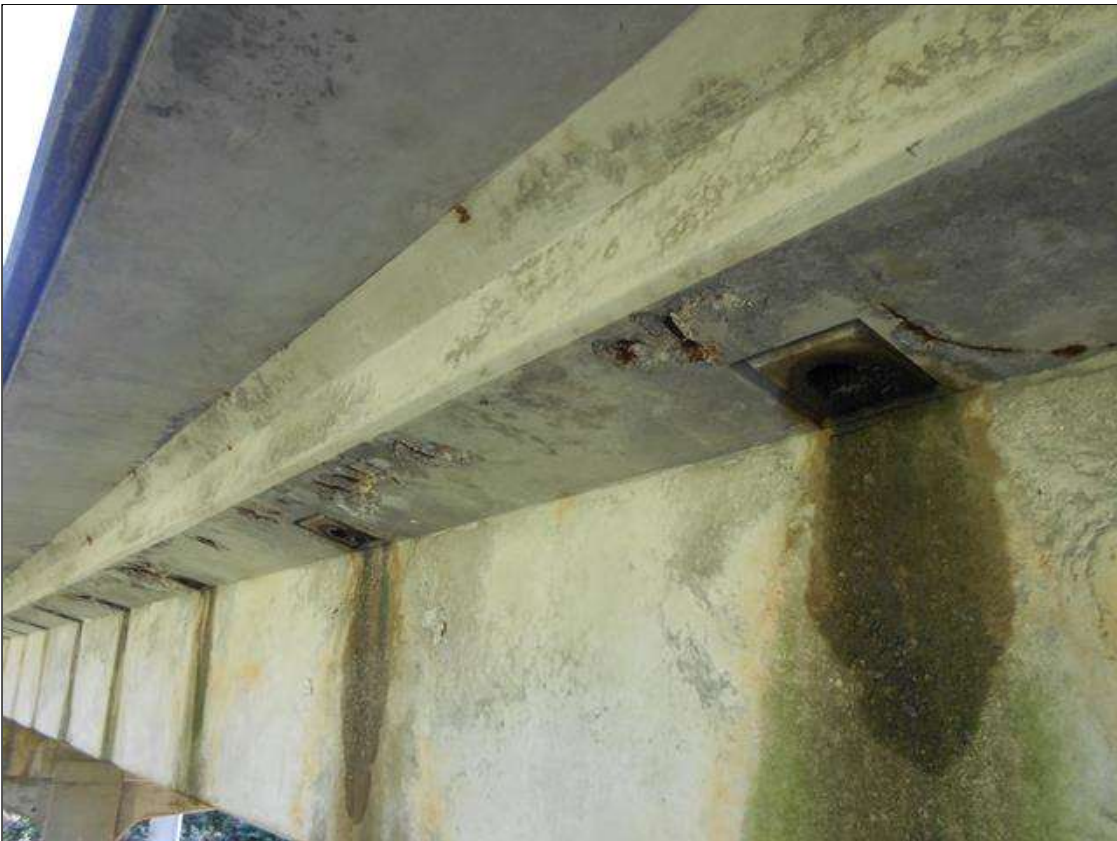
BOTH OVERHANGS HAVE FEW 1 IN. DEEP X 12 IN. SQUARE SPALLS WITH EXPOSED REBAR AROUND DRAIN HOLES.

20 Square Feet of Delamination/Spall: Delaminated. Spall 1 in. or less deep or 6 in. or less in diameter. BOTH OVERHANGS HAVE SEVERAL 1/2 IN. DEEP X 6 IN. DIA. POP-OFFS WITH EXPOSED REBAR AROUND DRAIN HOLES. BOTH CONCRETE CURBS HAVE AREAS OF POP-OFFS WITH EXPOSED REBAR: 1/2 IN. DEEP X 2 IN. WIDE X 12 IN. LONG. SPAN 1 CURTAIN WALL AT ABUT. 1 RT. END HAS TWO, 1/2 IN. DEEP POP-OFFS WITH EXPOSED REBAR, 3 IN. W X 1 FT. L, AND 6 IN. W X 14 IN. HIGH.

SPAN 1 LT. OVERHANG HAS SEVERAL 1/2 IN. DEEP POP-OFFS WITH EXPOSED REBAR AROUND DRAIN HOLES

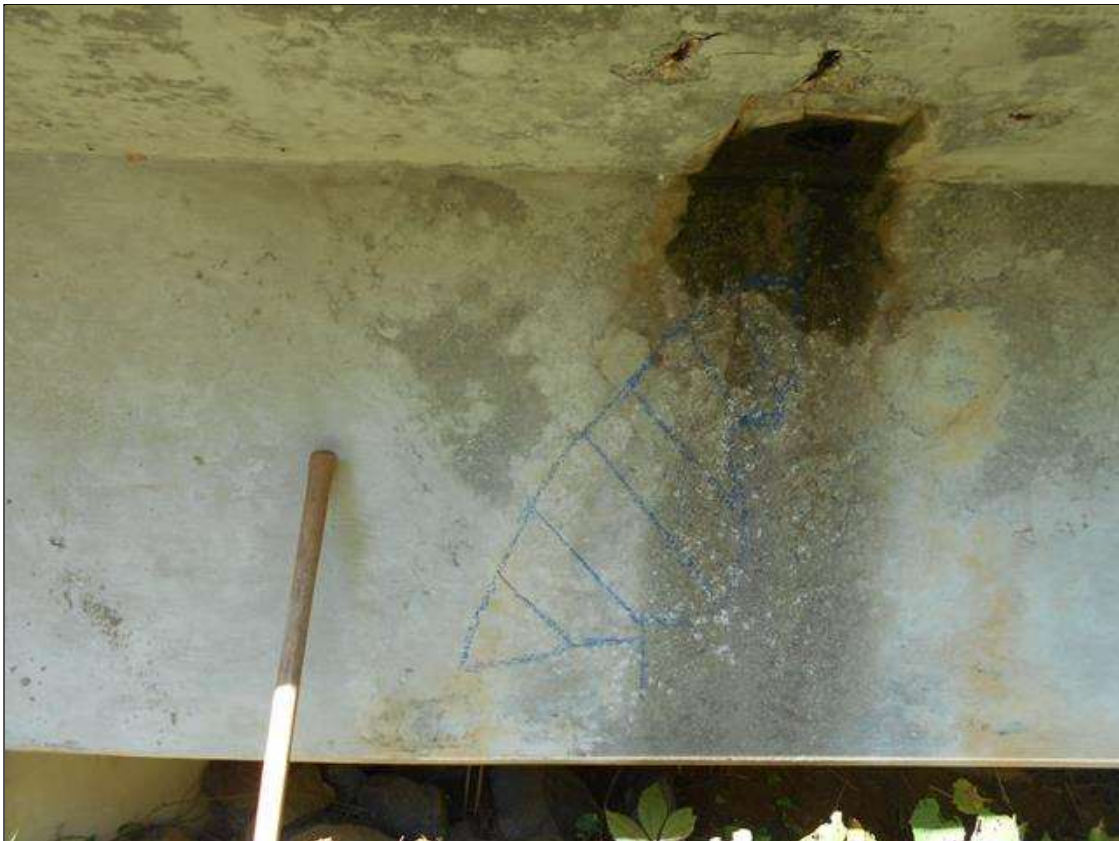
SPAN 1 GIRDER 4 EAST FACE 12 FT. FROM ABUT 1 DELAMINATION BELOW DRAIN HOLE, 30 IN. HIGH X 1 FT. WIDE.

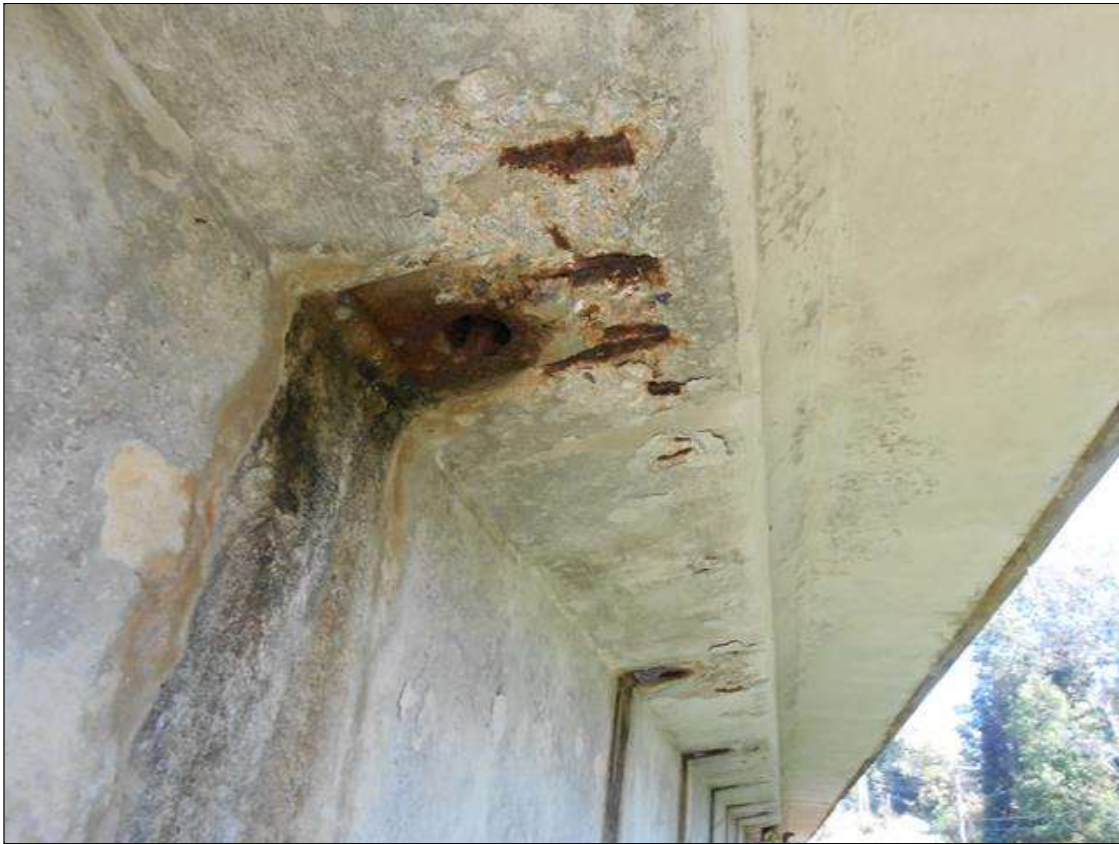
SPAN 1 RT. OVERHANG HAS SEVERAL 1/2 IN. DEEP POP-OFFS WITH EXPOSED REBAR AROUND DRAIN HOLES

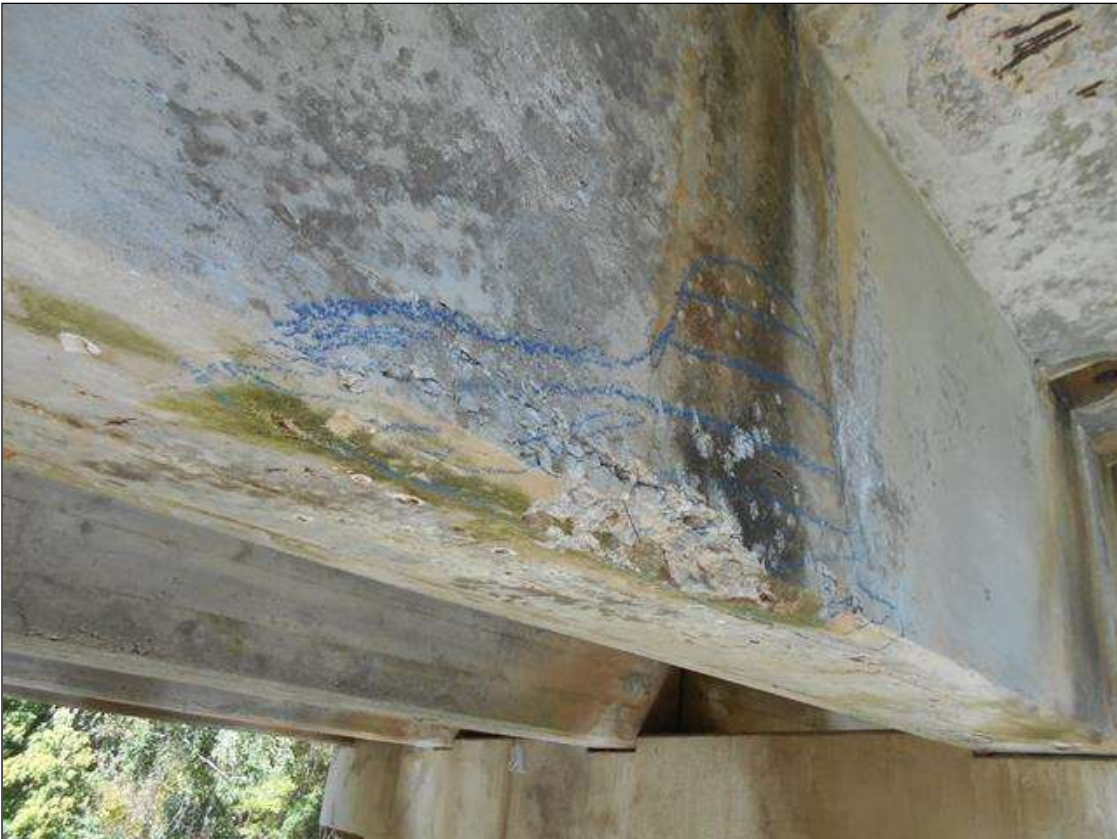
SPAN 2, GIRDER 4, 6 FT. FROM PIER 2, RT. BOTTOM CORNER 1/16 IN. CRACKS AND DELAMINATION 40 IN. LONG X 4 IN. DEEP X 4 IN. TO 16 IN. HIGH.

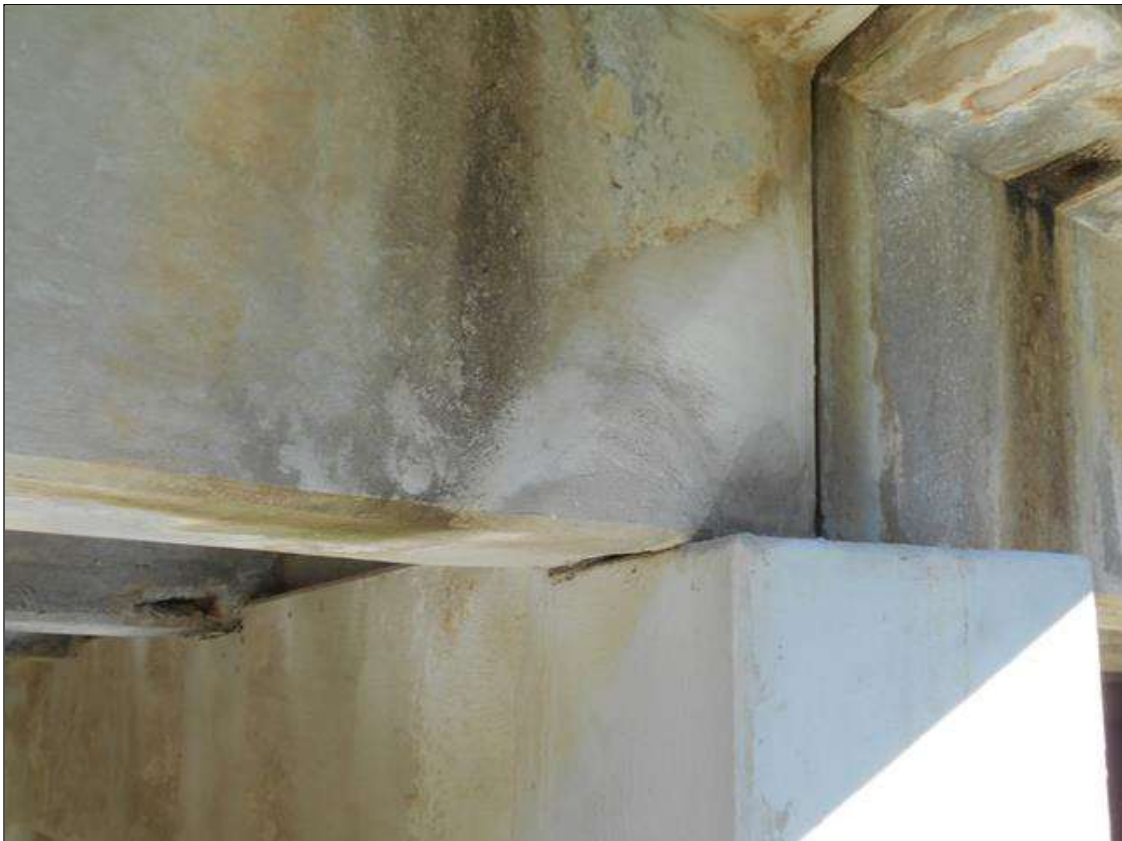
SPAN 3, GIRDER 3, AT PIER 3, HAS SOUND PATCHES ON BOTTOM 5 IN. OF GIRDER, FULL WIDTH X 30 IN. LONG, AND ON RT. FACE AT GIRDER END, 1 FT. LONG.

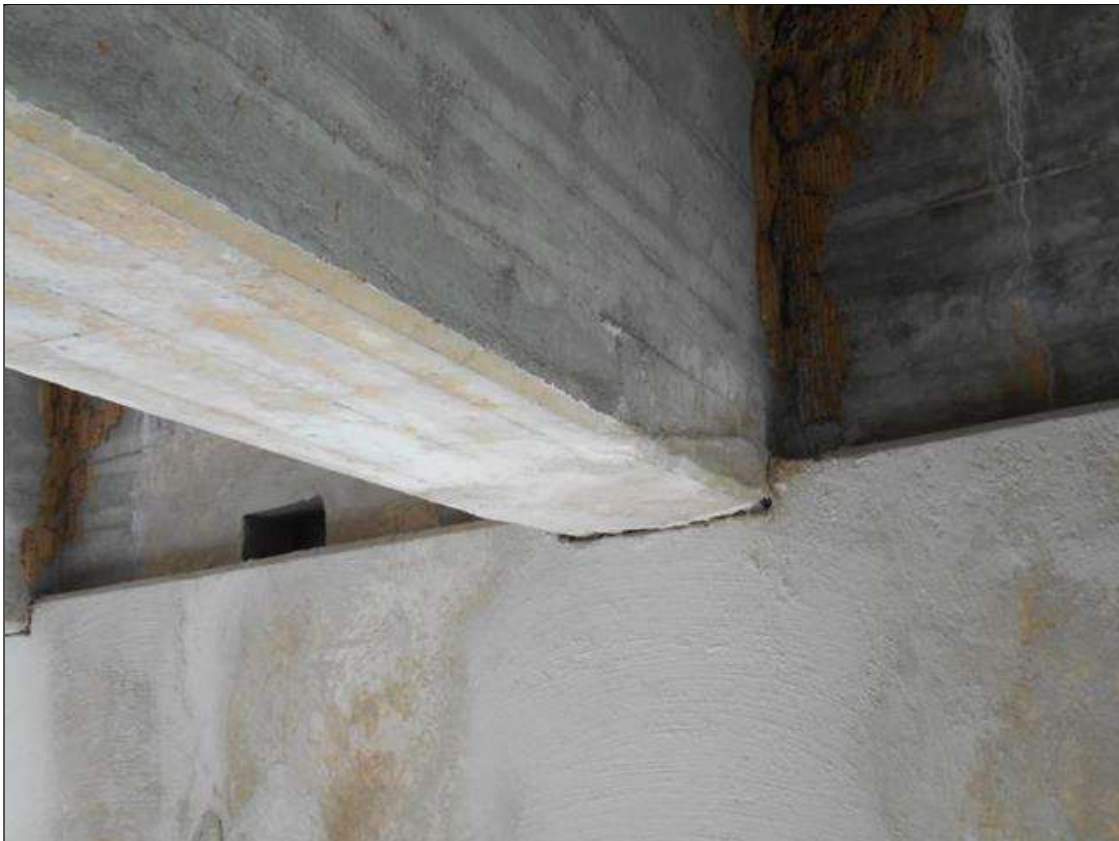
SPAN 4, GIRDER 2 AT PIER 3, HAS CONCRETE PATCH TO BOTTOM OF GIRDER, 3 IN. H X FULL WIDTH X 1 FT. LONG. LT. SIDE SHOWN.

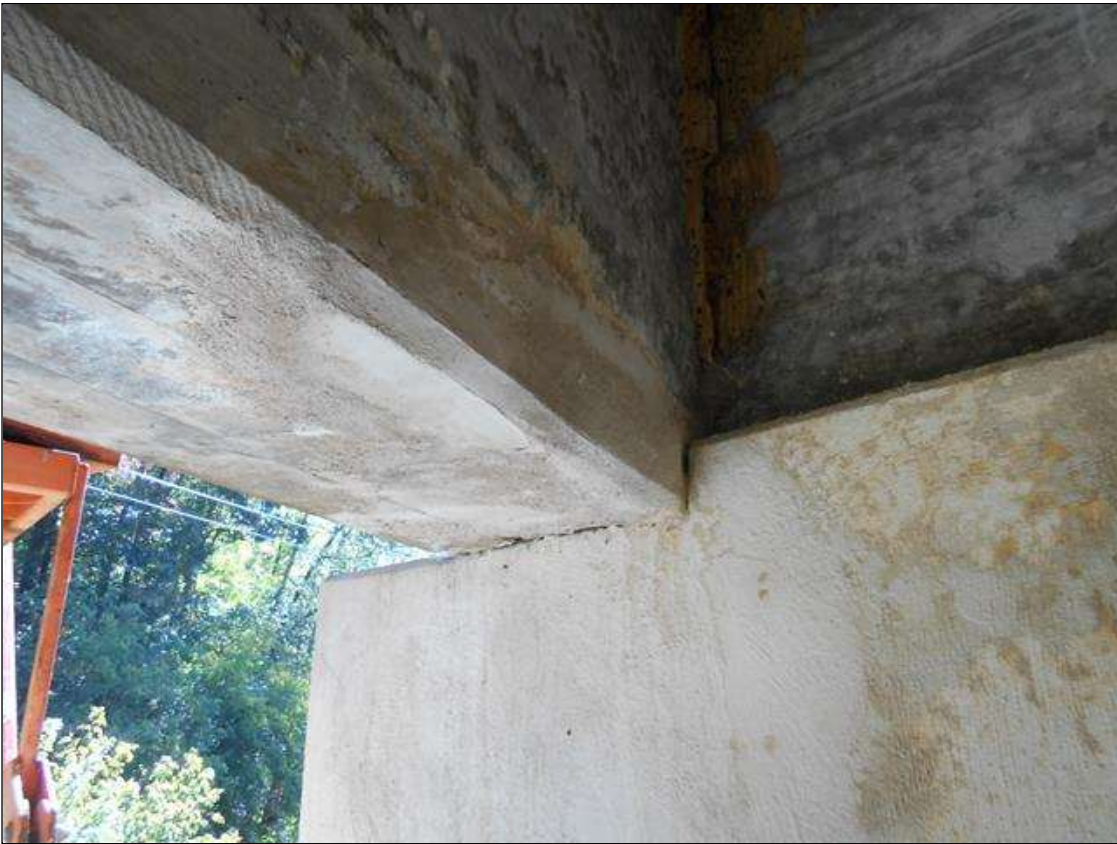
SPAN 4, GIRDER 4 AT PIER 3, SOUND CONCRETE PATCH TO BOTTOM OF GIRDER 4 IN. H X FULL WIDTH X 2 FT. LONG. LT. SIDE SHOWN.

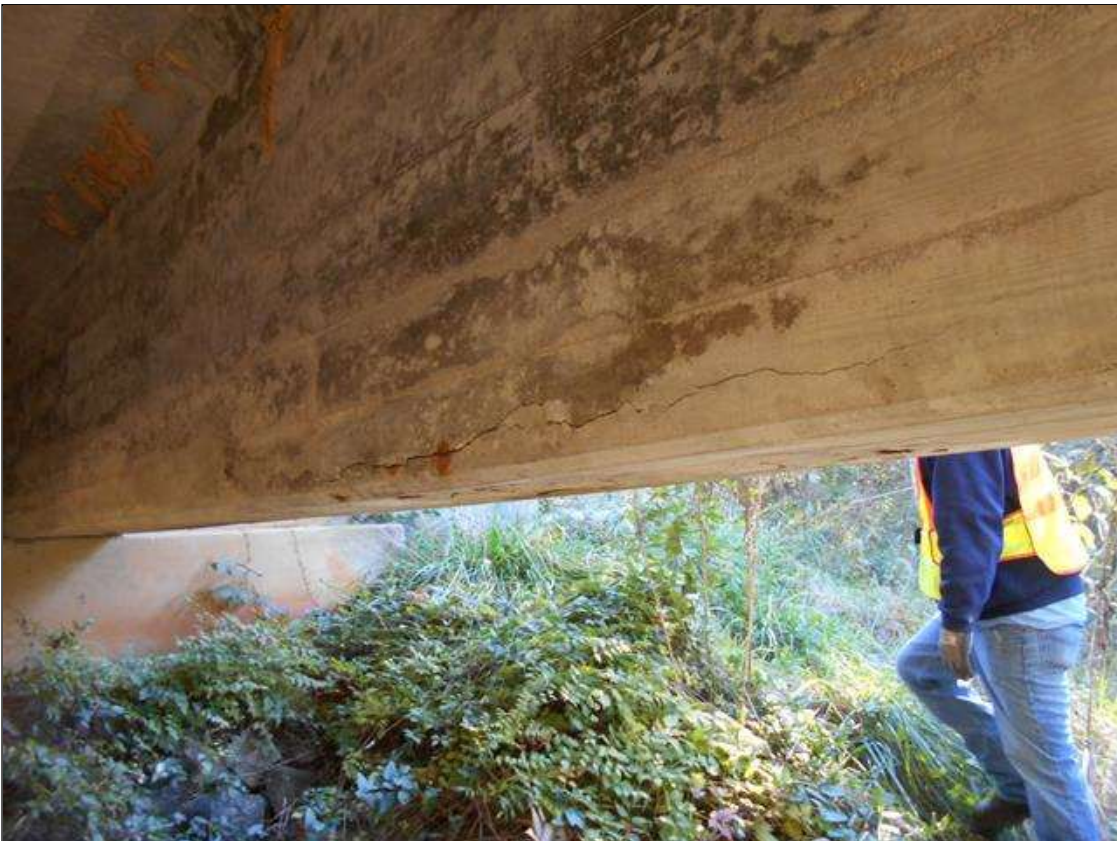
SPAN 4, GIRDER 4, 16 FT. FROM ABUT 2, BOTTOM OF GIRDER HAS 1/8 IN. CRACKS AND DELAMINATION, 3 IN. H X FULL WIDTH X 5 FT. LONG. LT. SIDE SHOWN.

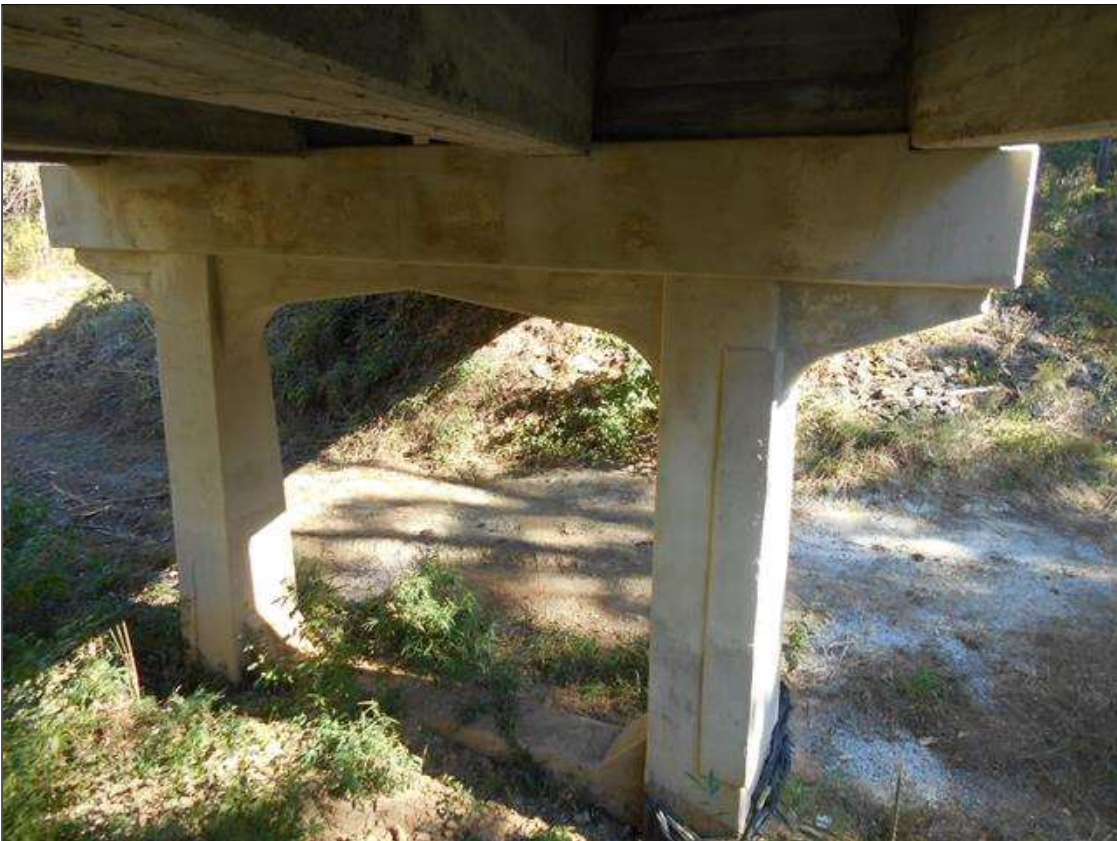
PIER 3 SOUTH SIDE, CONCRETE PATCHES TO CAP AT ALL SEATS AND ENDS, PATCH TO COLUMN 2 S W CORNER.

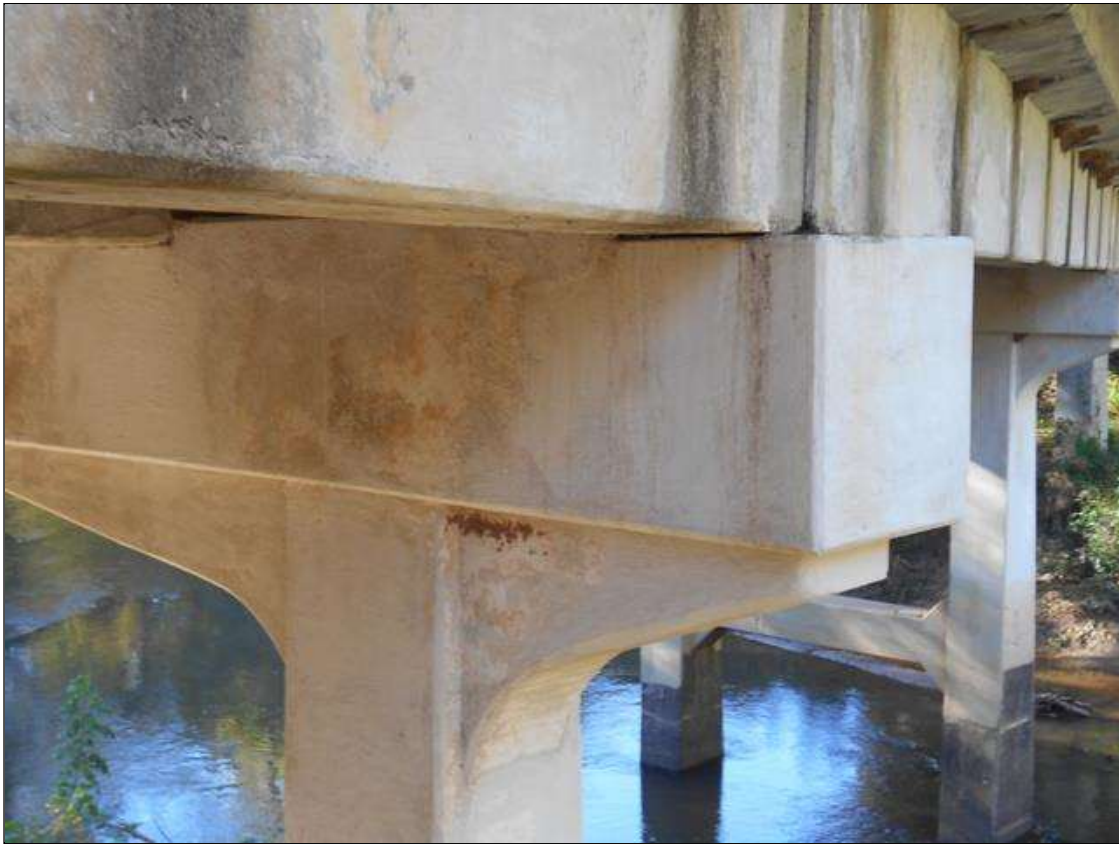
PIER 3 CAP NORTH FACE LEFT END CONCRETE PATCHING TO KNEE BRACE AND CAP.
