NC DEPARTMENT OF TRANSPORTATION  
DIVISION OF HIGHWAYS  
STRUCTURE MANAGEMENT UNIT

## Structure Safety Report

### Routine Element Inspection - Contract

COUNTY: MADISON STRUCTURE NUMBER: 560008 FREQUENCY: 24 MONTHS

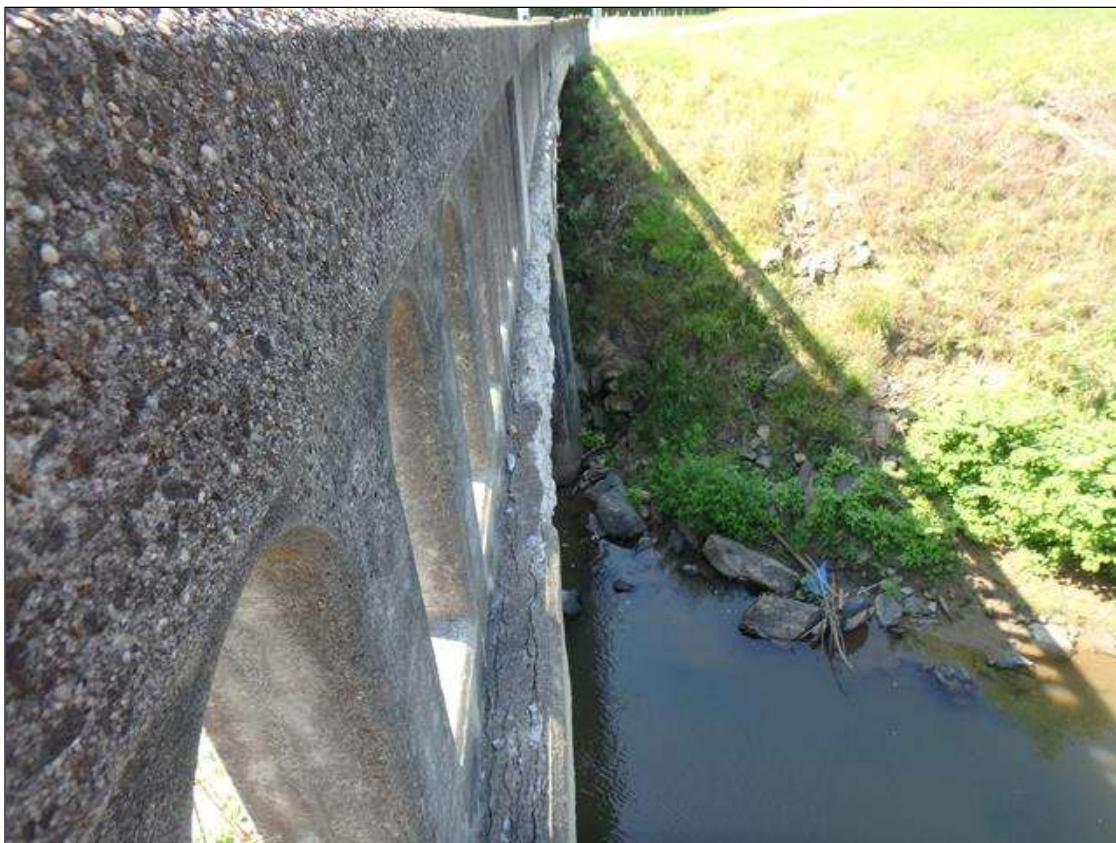
SPALL, DETERIORATING FOR 4" WIDE X FULL LENGTH BEHIND BARRIER  
 SPALL 9" X 4" X 1/2" DEEP WITH EXPOSED REBAR, NO SECTION LOSS, 5 FT FROM BENT 1  
 SCATTERED LONGITUDINAL AND VERTICAL HAIRLINE CRACKS UP TO 1 FT  
 FULL LENGTH X FULL WIDTH DELAMINATION ALONG CURB  
 CONCRETE ENDPOST AT BENT 1 MISALIGNMENT UP TO 2" TO THE EAST

Span 2 Left Bridge Rail: SPALL, DETERIORATING FOR 4" WIDE X FULL LENGTH BEHIND BARRIER

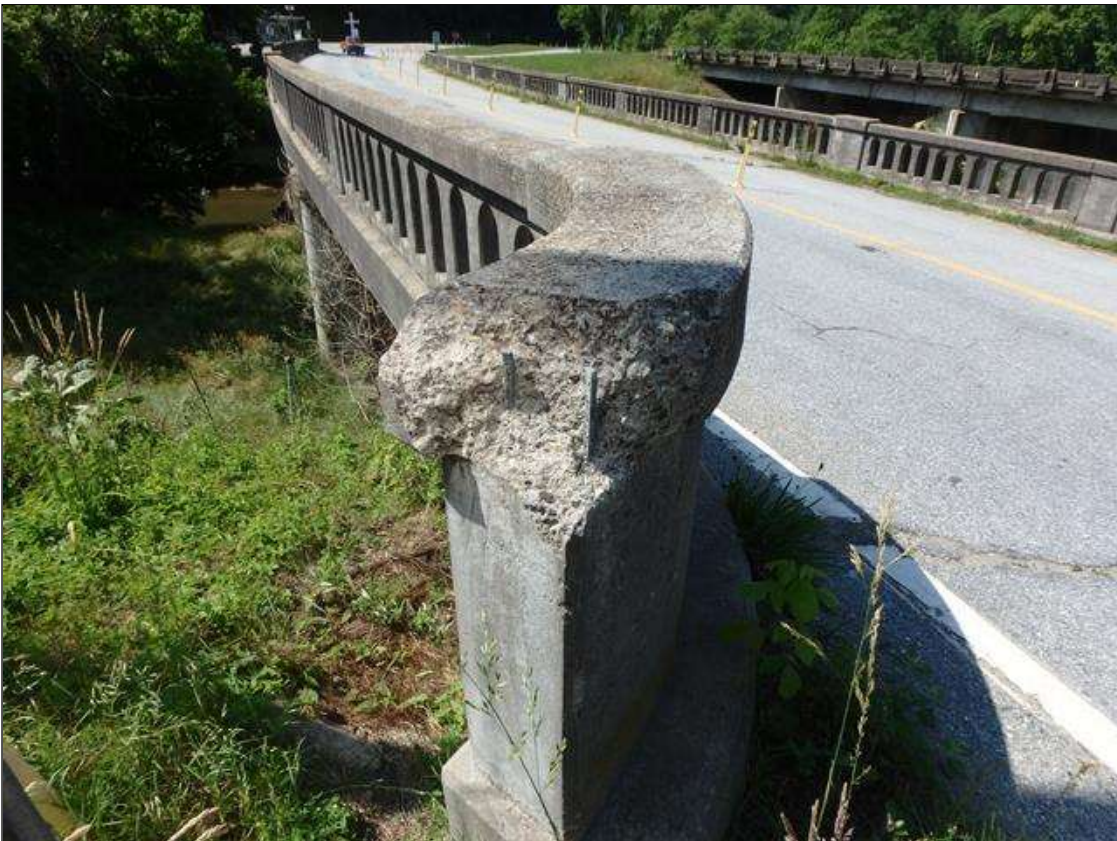
Span 5 Right Bridge Rail: SPALL 14" X 1FT X 10" WITH EXPOSED REBAR, NO SECTION LOSS, AT END BENT 2

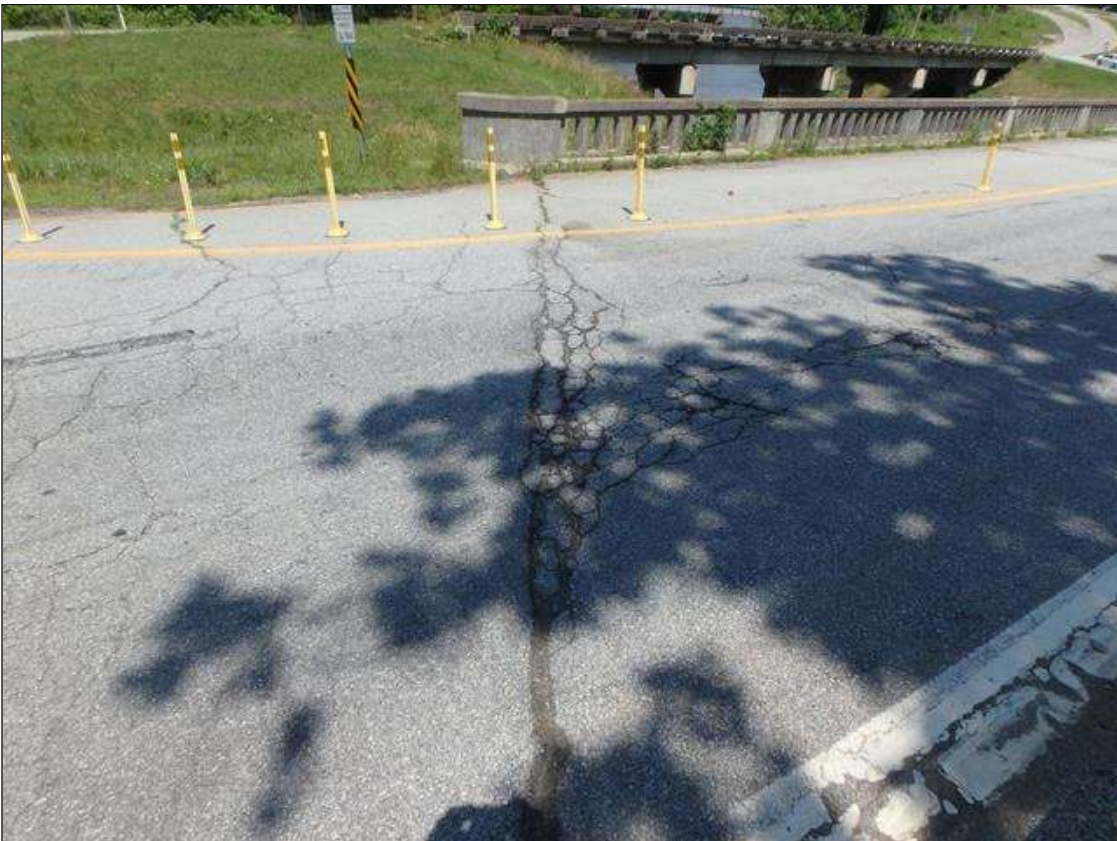
| Element Number | Defect Type | Defect Description | CS | CS Qty | Maint Qty |
|---|---|---|---|---|---|
| FULL WIDTH TRANSVERSE CRACK AND MAP CRACKING UP TO 1" WIDE AT END BENT 1<br>SCATTERED LONGITUDINAL, TRANSVERSE, MAP CRACKING UP TO 1/2" WIDE | | | | | |

Span 1 Wearing Surface: FULL WIDTH TRANSVERSE CRACK AND MAP CRACKING UP TO 1" WIDE AT END BENT 1

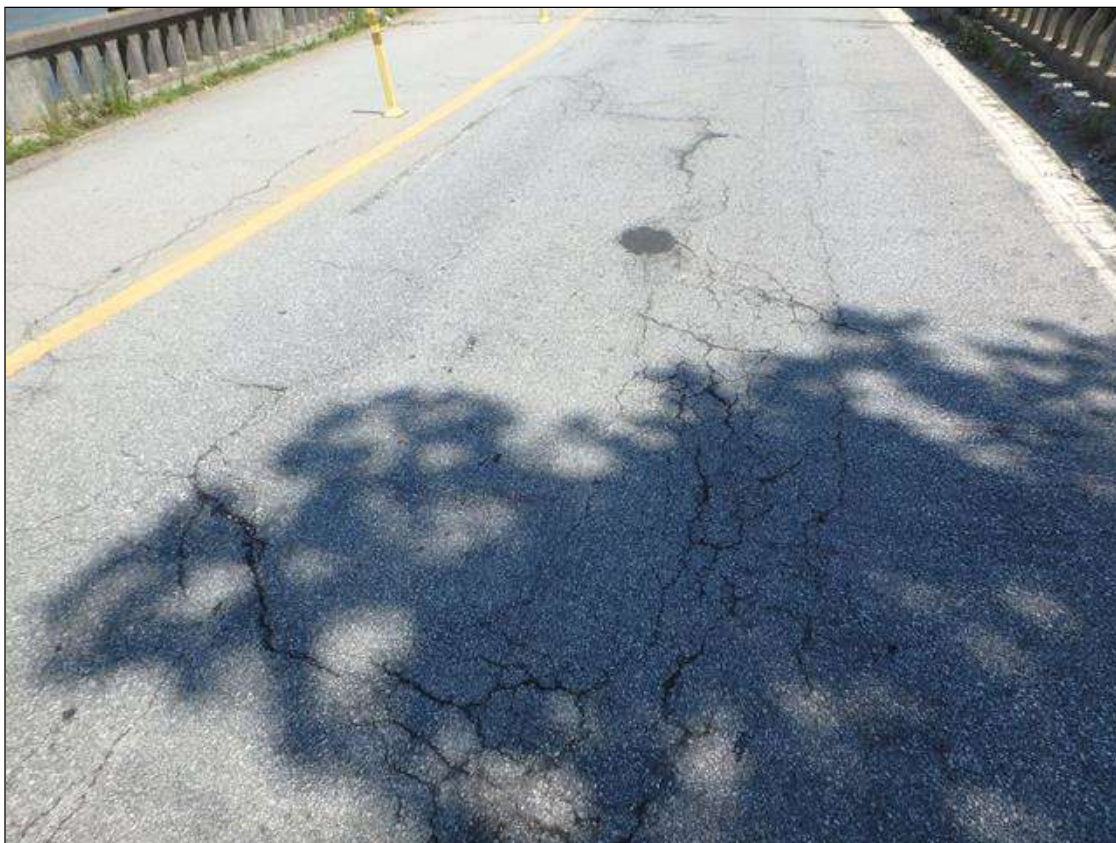
Span 1 Wearing Surface: SCATTERED LONGITUDINAL, TRANSVERSE AND MAP CRACKING UP TO 1/2" WIDE

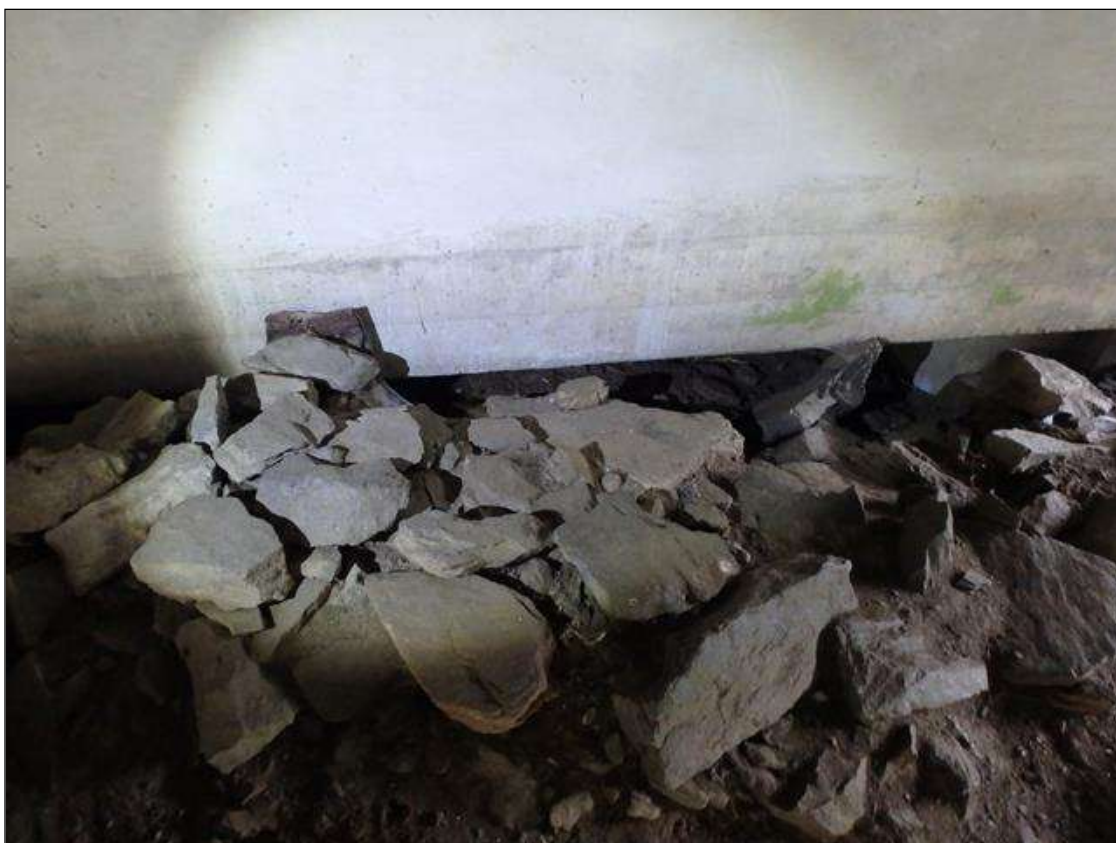
End Bent 2 Cap : UNDERMINING UP TO 3 FT DEEP X 16 FT LONG UNDER BEAMS 3-5

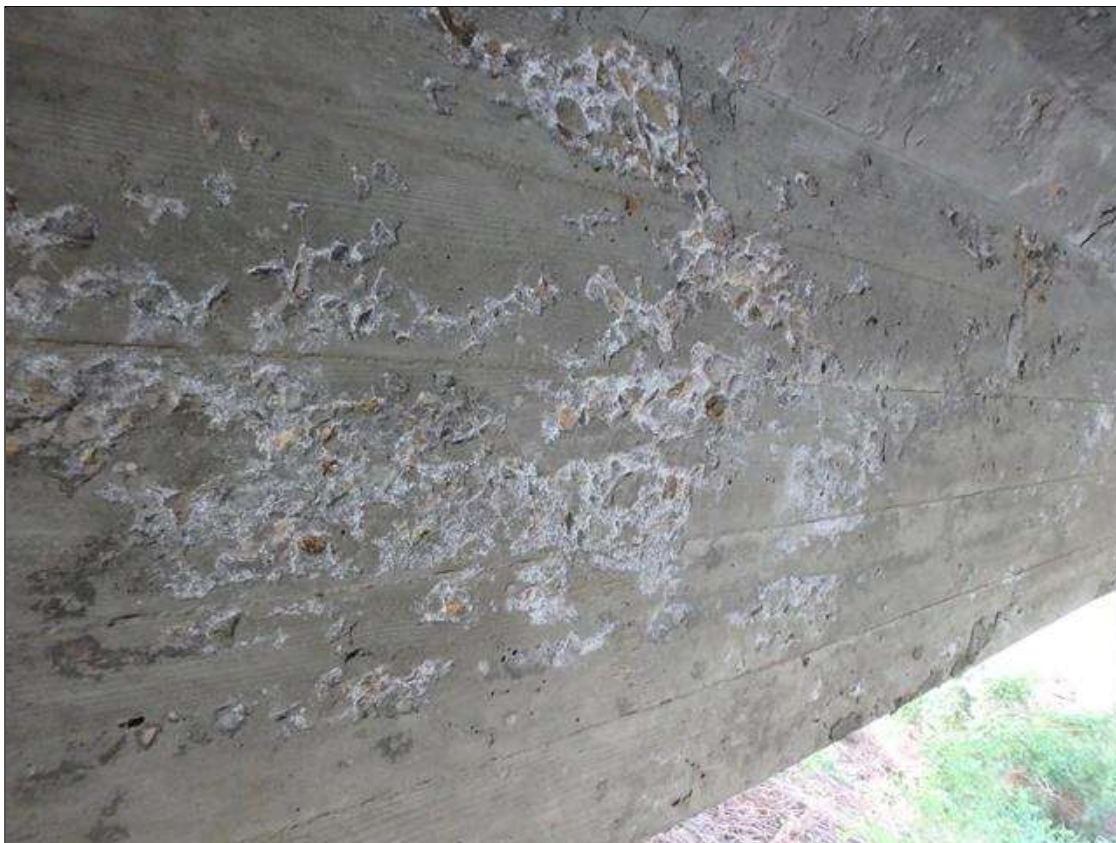
Span 5 Beam 2: SCATTERED SURFACE DETERIORATION ALONG BOTTOM AND SIDE FACES

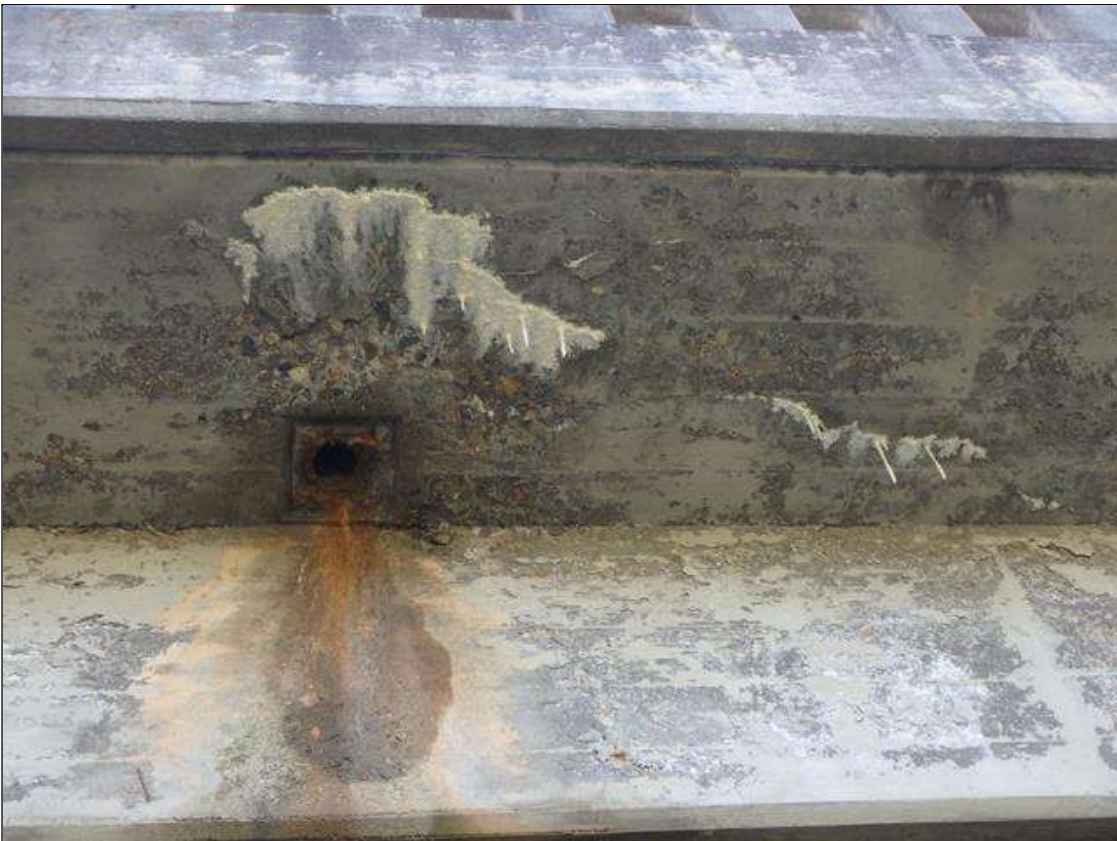
Span 5 Deck: HEAVY EFFLORESCENCE BUILDUP ALONG UNDERSIDE OF DECK IN LEFT OVERHANG 12 FT FROM BENT 4

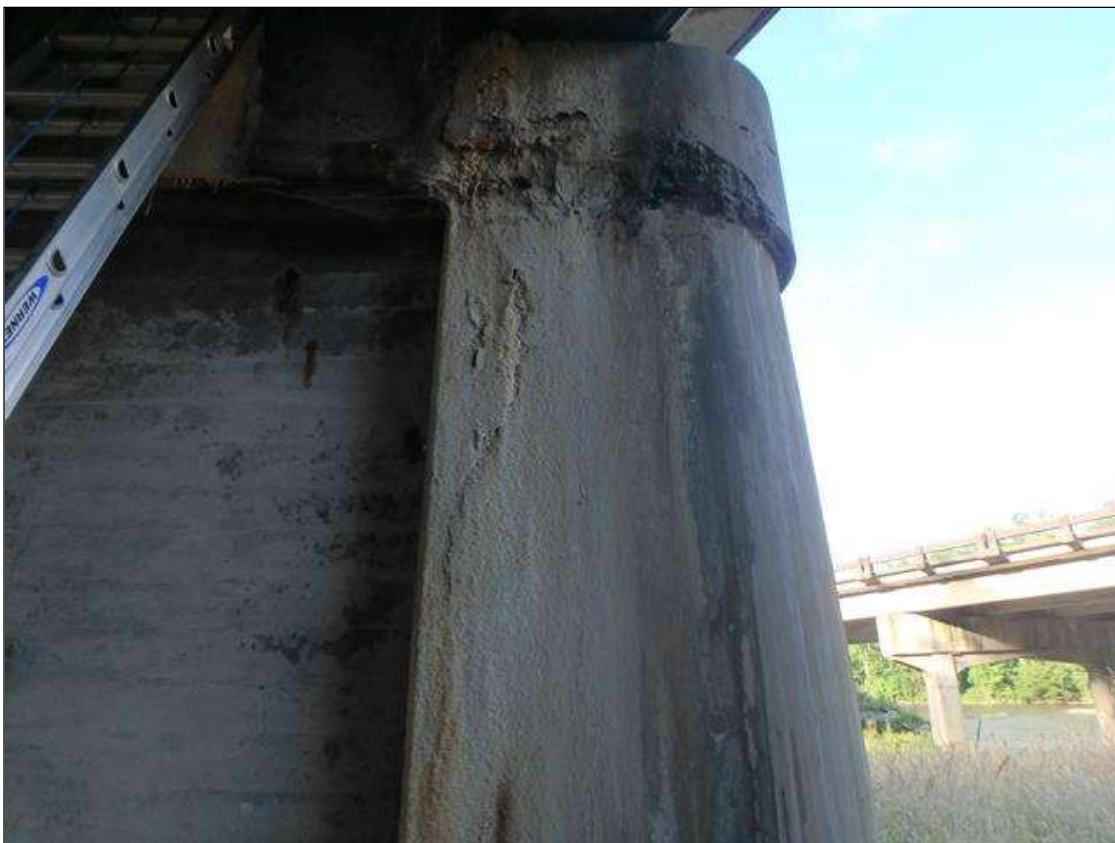
Bent 4 Pile 1: HEAVY EFFLORESCENCE BUILDUP ALONG SPAN 5 FACE

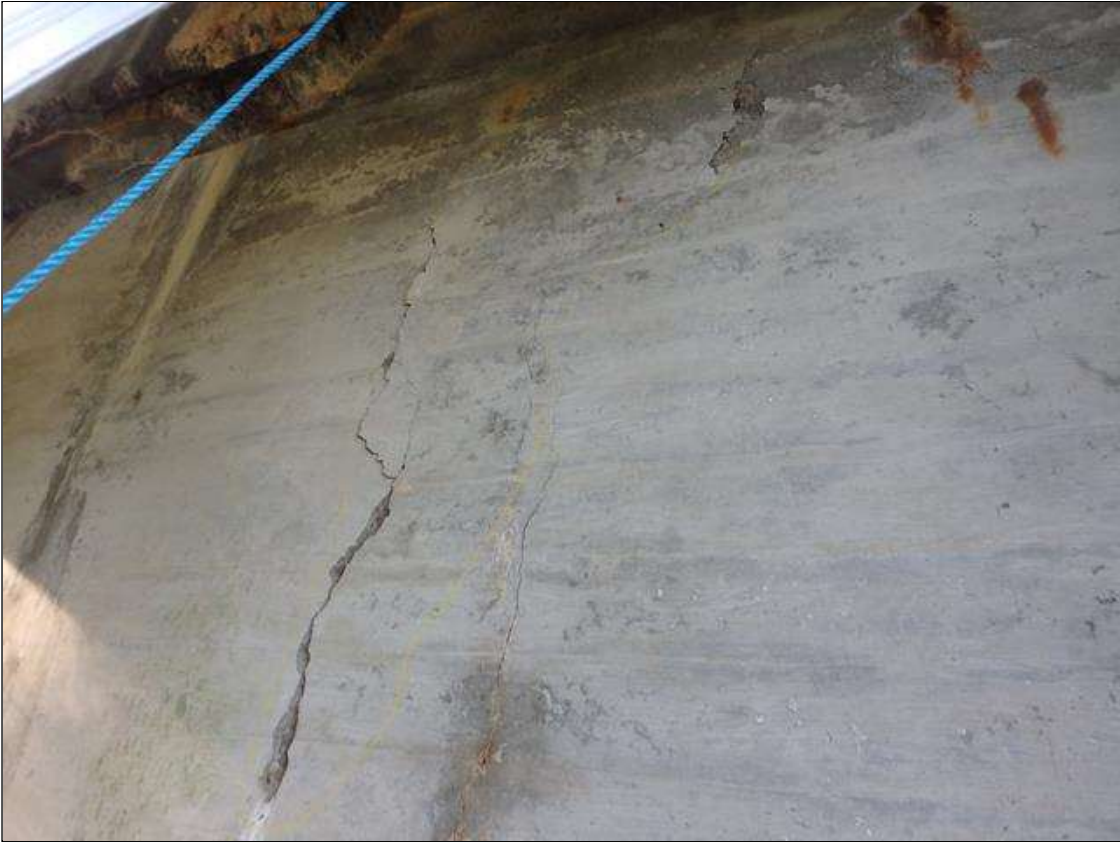
Bent 4 Cap : DELAMINATION 5 FT X 2.5 FT IN BAY 1 WALL, SPAN 5 FACE

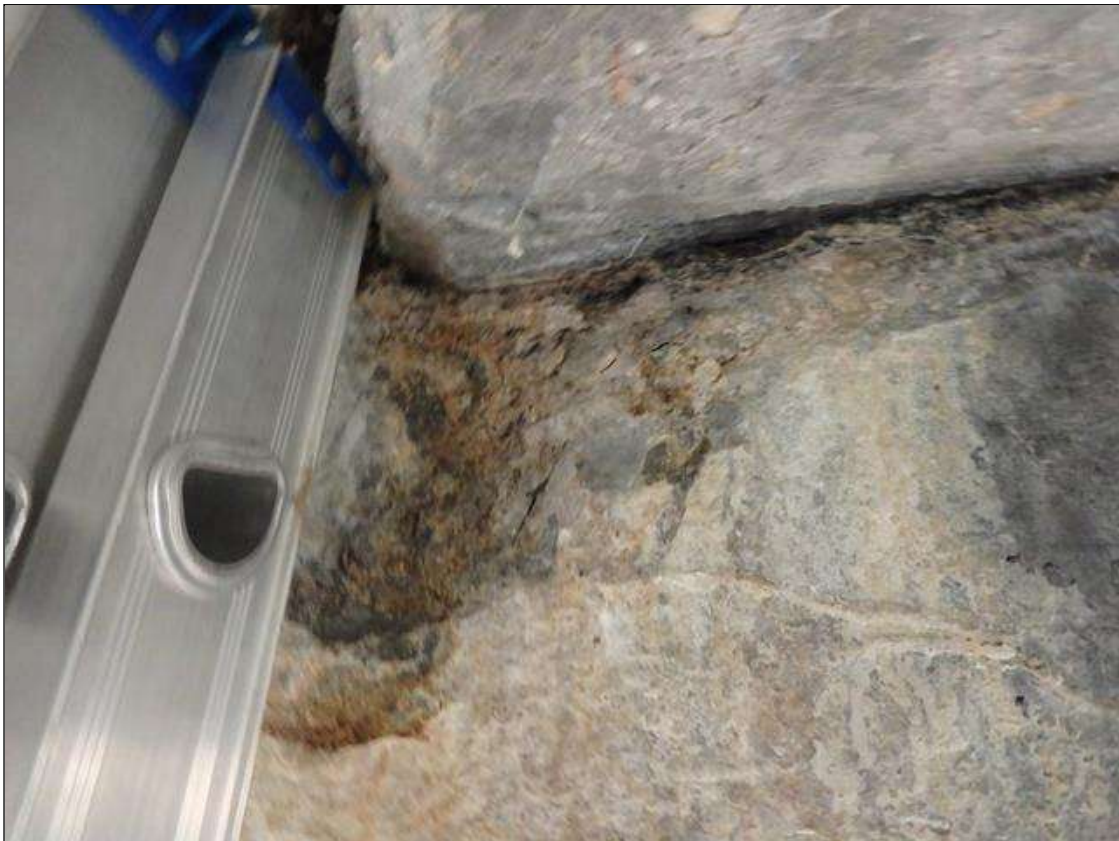
Bent 4 Cap : SPALL 8" X 6" X 2" DEEP, NO EXPOSED REBAR, UNDER BEAM 3, SPAN 5 FACE

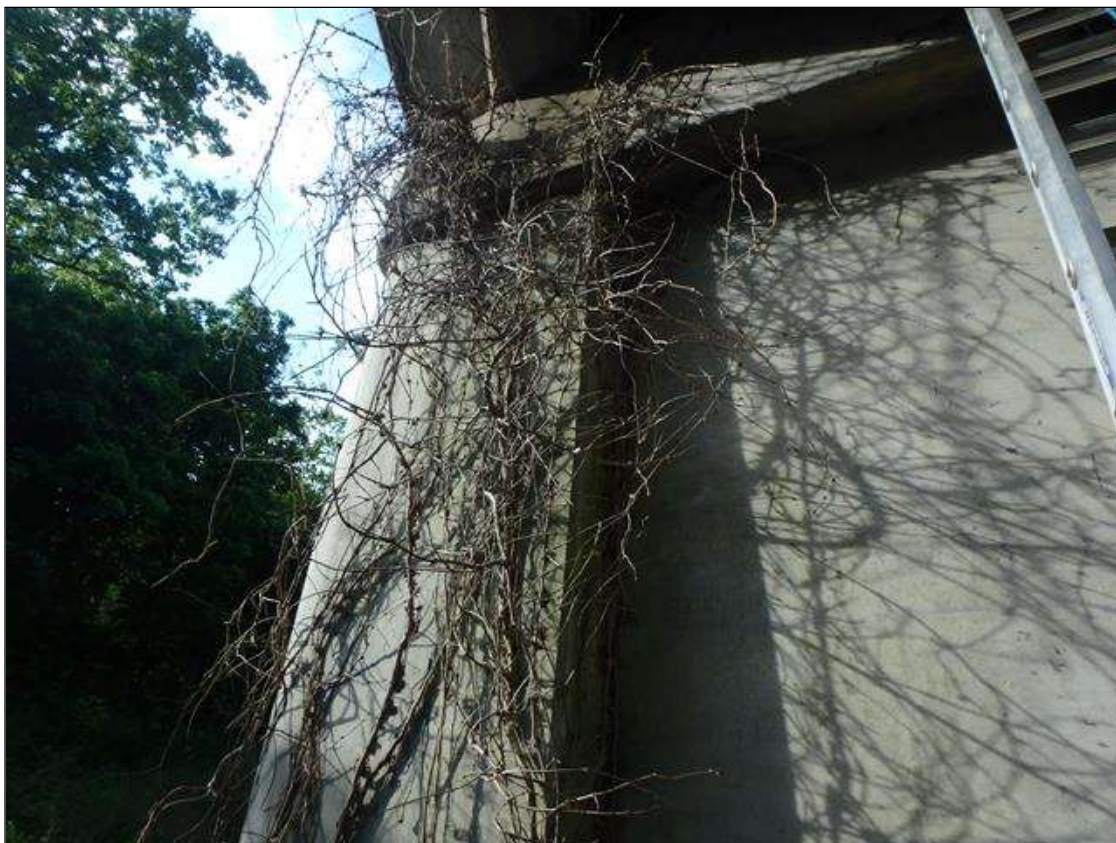
Bent 4 Pile 3: VEGETATION GROWTH ALONG SPAN 5 FACE

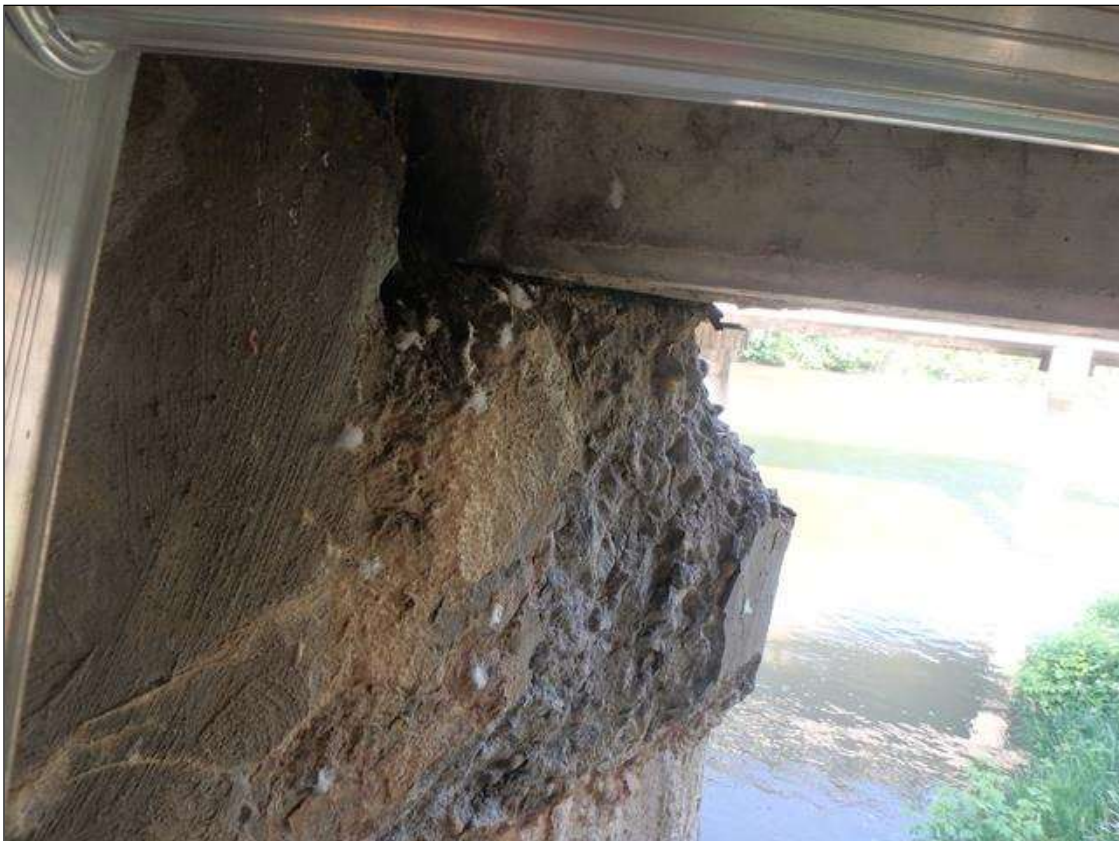
Bent 3 Cap : SPALL 2 FT X 2 FT X 3" UNDER BEAM 1, SPAN 4 FACE, RESULTING IN LOSS OF BEARING AREA, PRIORITY MAINTENANCE

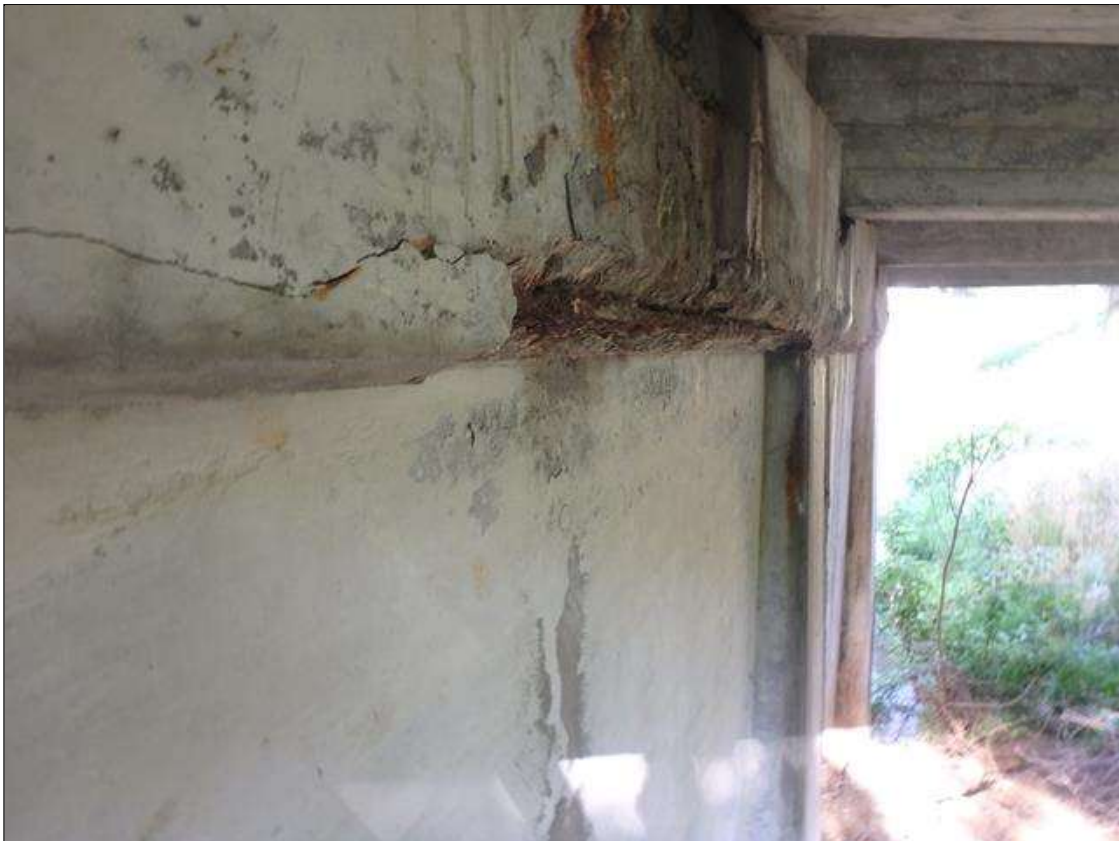
Bent 3 Cap : SPALL/DELAMINATION 10 FT X 1 FT X 1 FT WITH EXPOSED REBAR, 25% SECTION LOSS, ABOVE BAY 2 WALL, PRIORITY MAINTENANCE

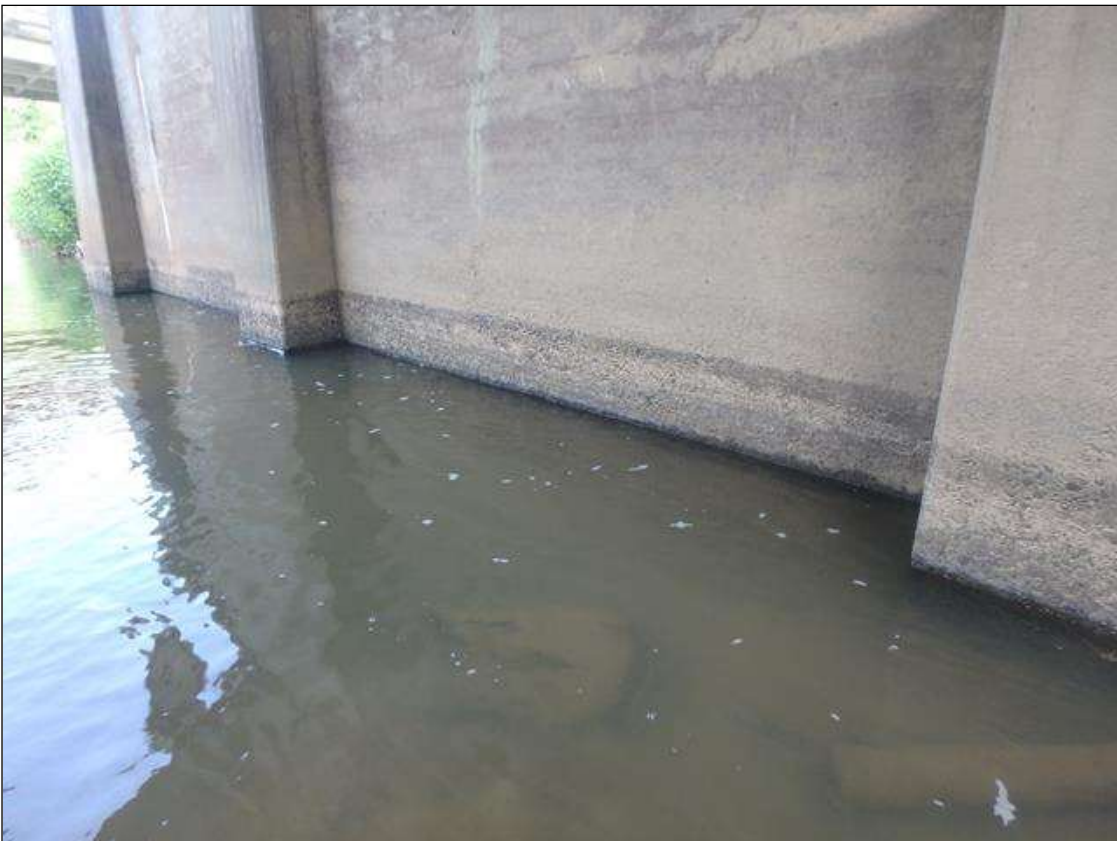
Bent 3 Cap : ABRAISION FULL LENGTH AT WATERLINE, BUT AGGREGATE REMAINS SECURE, SPAN 3 FACE

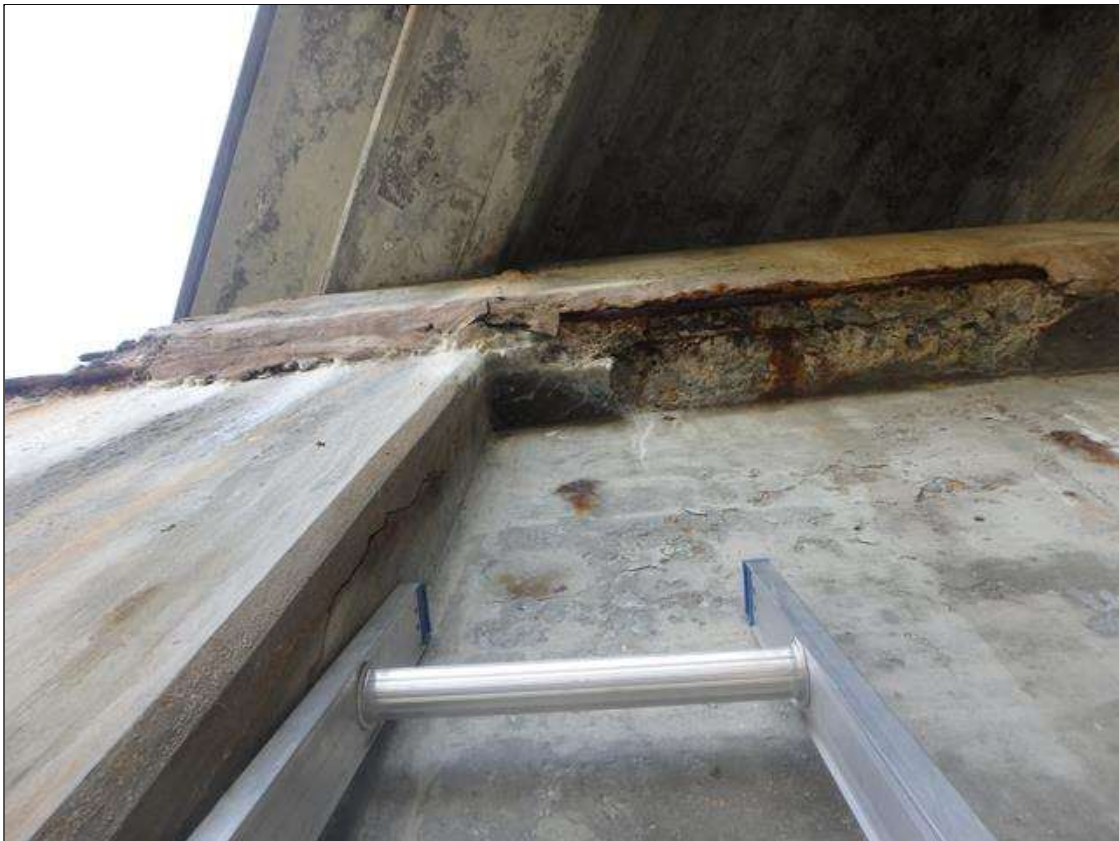
Bent 3 Cap : SPALL/DELAMINATION 6 FT X 1 FT X 6" WITH EXPOSED REBAR, 10% SECTION LOSS, NEAR COLUMN 1, SPAN 3 FACE, PRIORITY MAINTENANCE

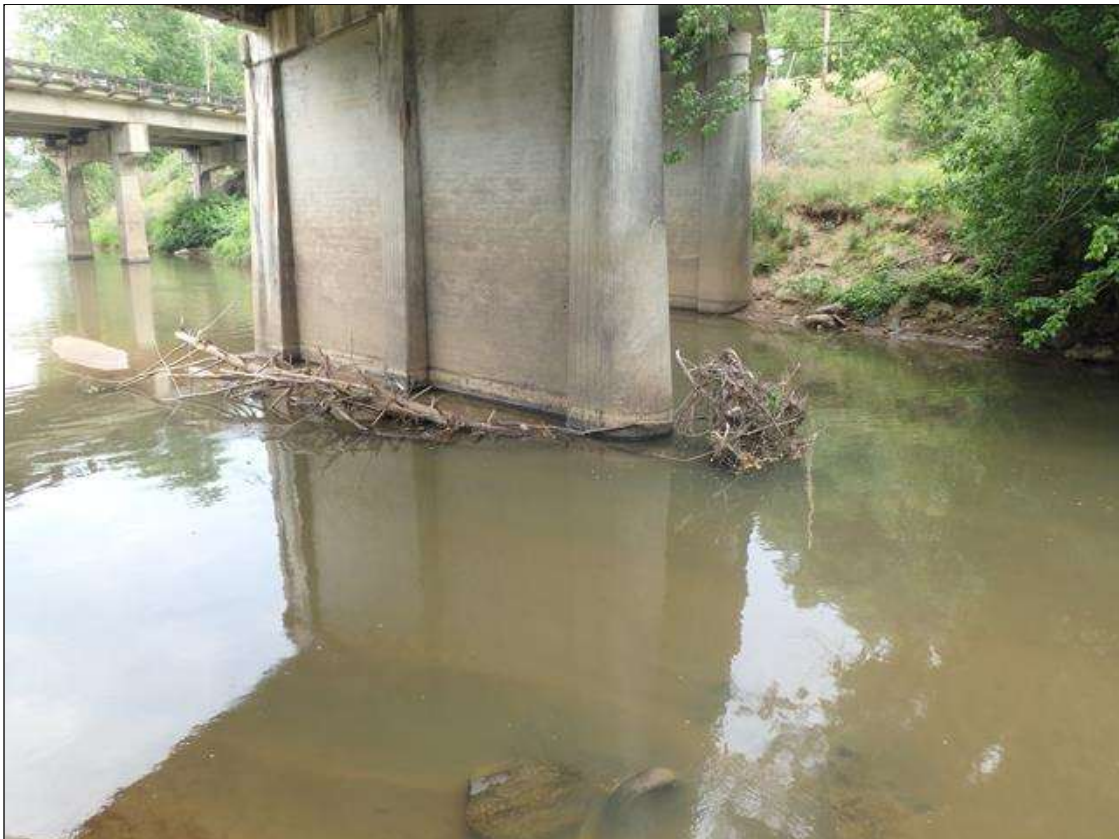
DRIFT AT UPSTREAM END OF BENT 2 AND ALONG SPAN 2 FACE

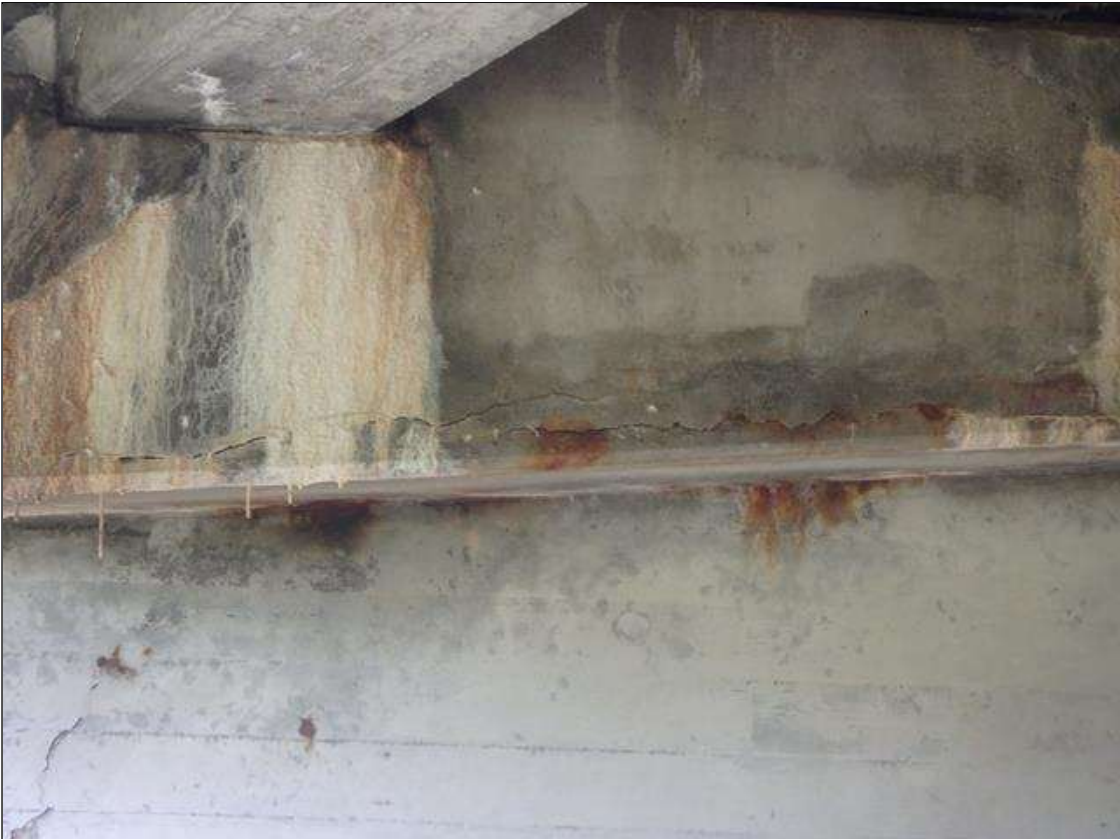
Bent 1 Cap : HORIZONTAL CRACK 18 FT X UP TO 1/8" WITH RUST STAINING ALONG BOTTOM ABOVE BAY 1 WALL, SPAN 1 FACE

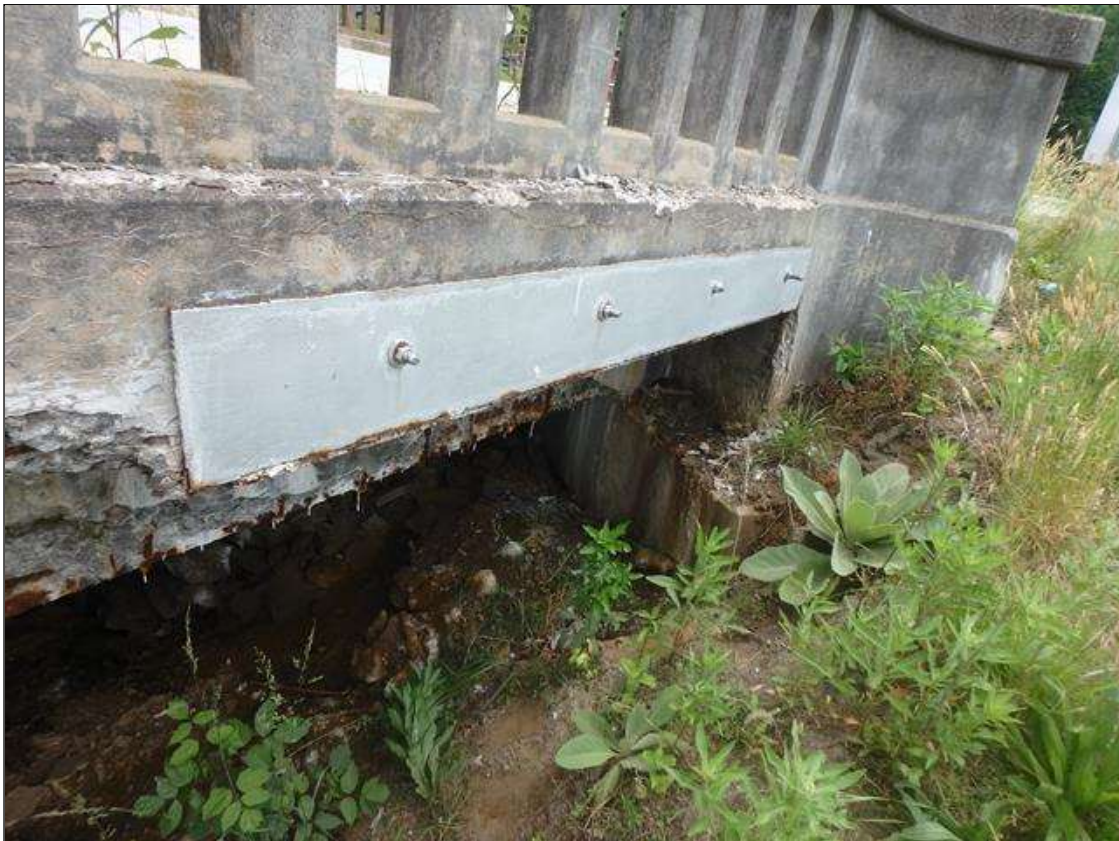
Span 1 Deck: TEMPORARY REPAIR TO LEFT EDGE OF DECK AT END BENT 1

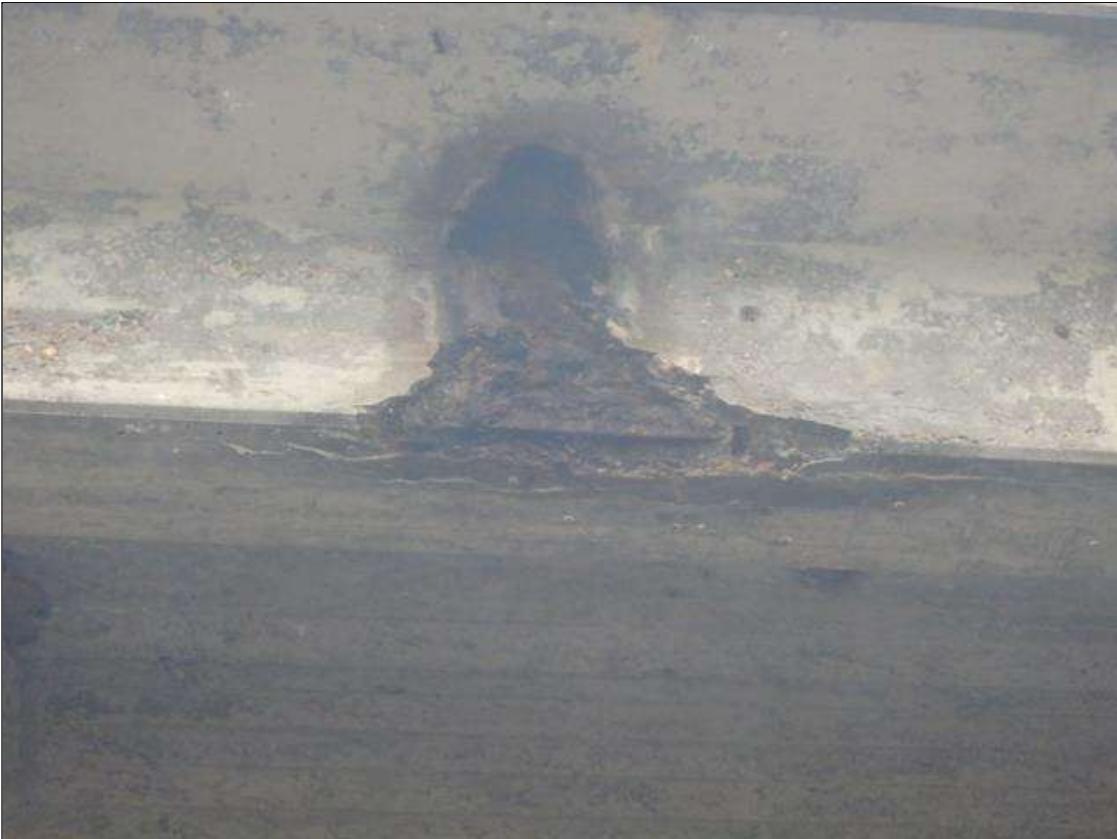
SCATTERED SURFACE DETERIORATION ALONG BOTTOM AND SIDE FACES  
 SPALL 4 FT X 16" X 5" DEEP ALONG WEST FACE WITH EXPOSED REBAR, NO SECTION LOSS, 20 FT FROM BENT 2  
 SPALL 2 FT X 8" X 4" DEEP ALONG WEST FACE, NO EXPOSED REBAR, 20 FT FROM BENT 3  
 LONGITUDINAL MAP CRACKING FOR 8 FT ALONG BOTTOM AT BOTH SPALLS  
 SPALL 2 FT X 7" X UP TO 3" DEEP WITH EXPOSED REBAR, NO SECTION LOSS, AT BENT 2

Span 3 Beam 1: SPALL 4 FT X 16" X 5" DEEP WITH EXPOSED REBAR, NO SECTION LOSS, 20 FT FROM BENT 2

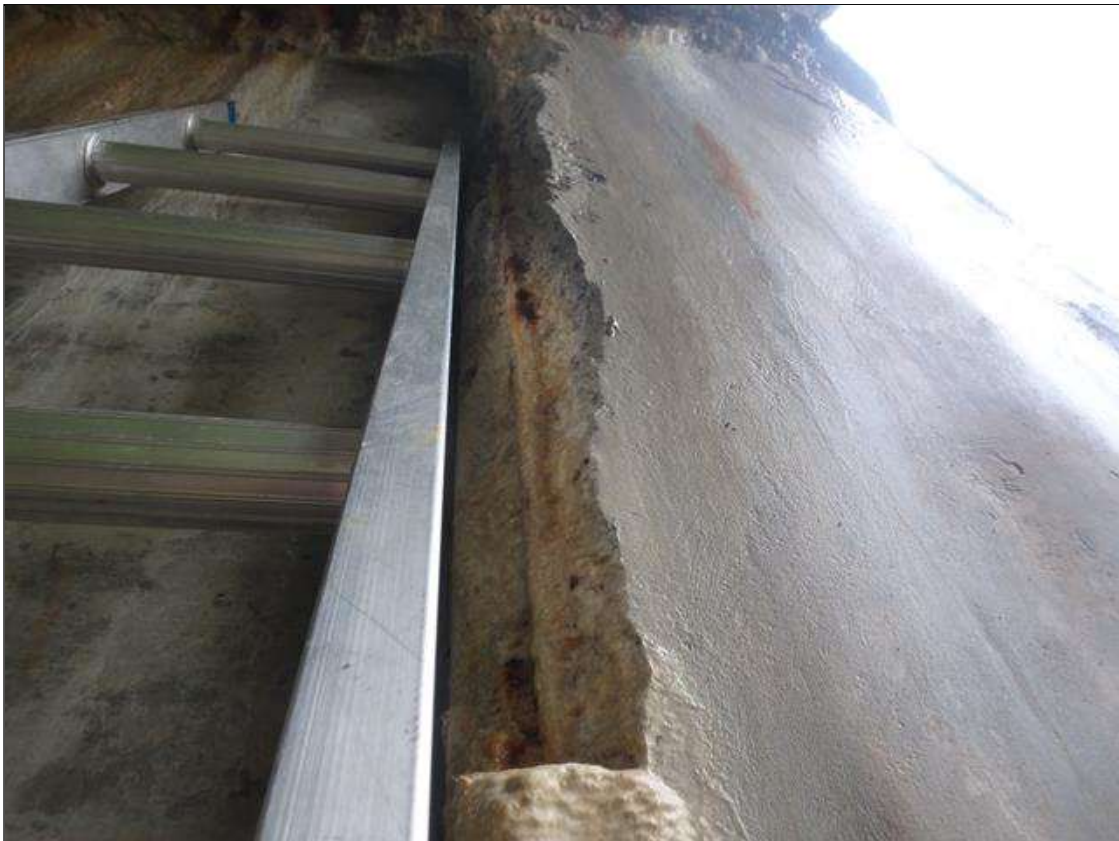
Bent 2 Pile 1: SPALL 5 FT X 6" X 4" WITH EXPOSED REBAR, NO SECTION LOSS, WITH HEAVY EFFLORESCENCE BUILDUP ALONG NORTHEAST CORNER NEAR CAP

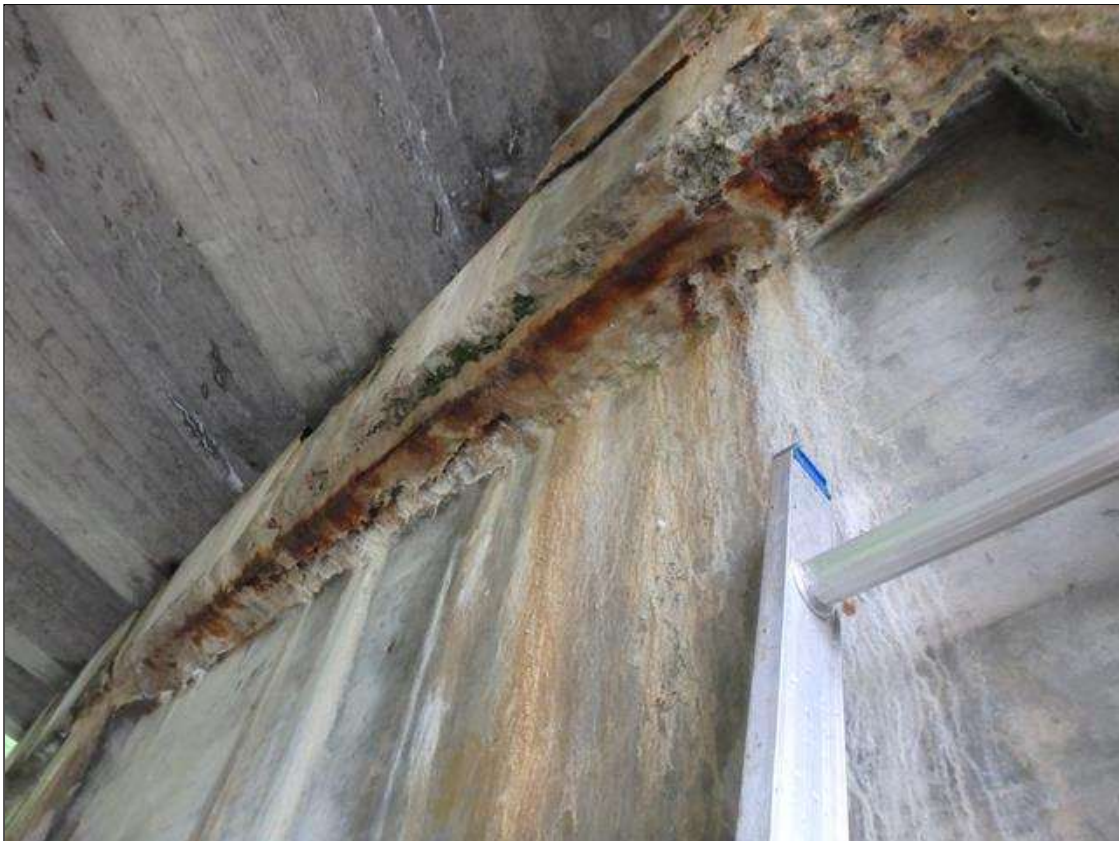
Bent 2 Cap : SPALL/DELAMINATION 15 FT X 6" WITH RUST STAINING AND EXPOSED REBAR WITH 10% SECTION LOSS, ALONG BOTTOM OF CAP, BAY 1 WALL, SPAN 3 FACE, PRIORITY MAINTENANCE

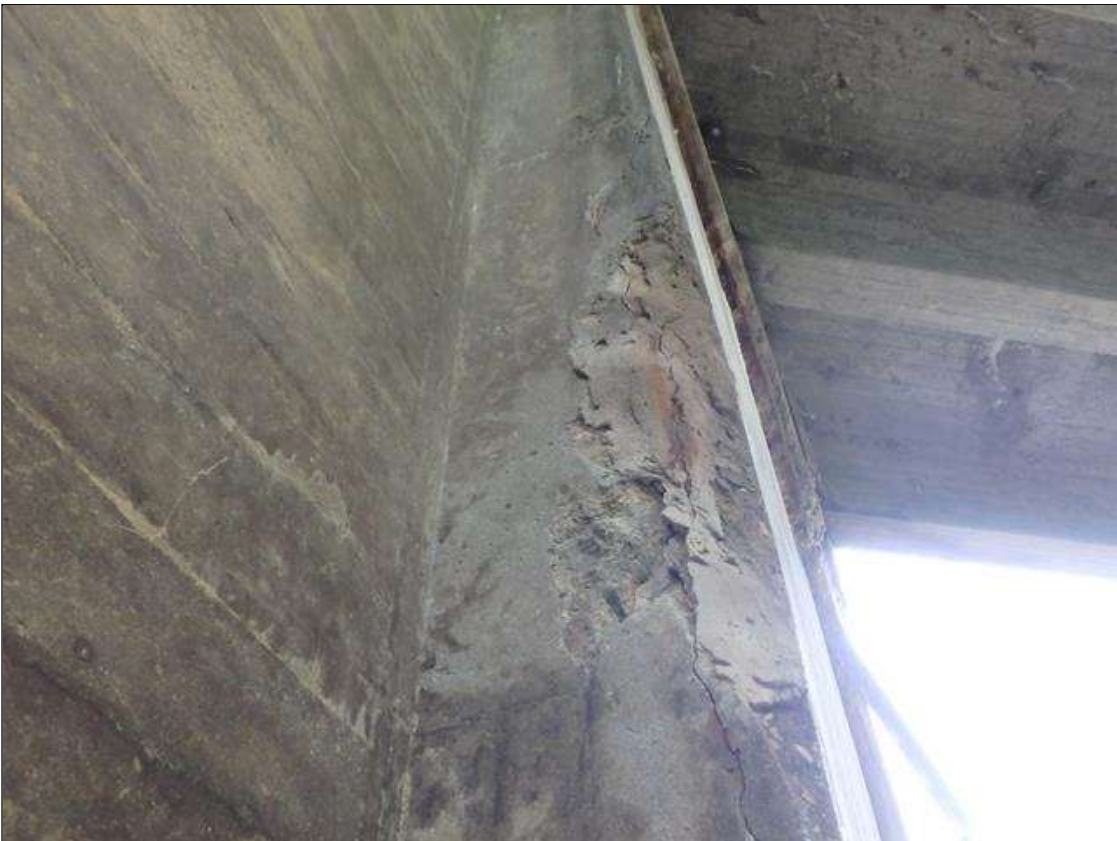
Bent 2 Pile 2: SPALL 3 FT X 6" X 6" WITH RUST STAINING ALONG NORTHEAST CORNER, SPAN 3 FACE, PREVIOUS REPAIR

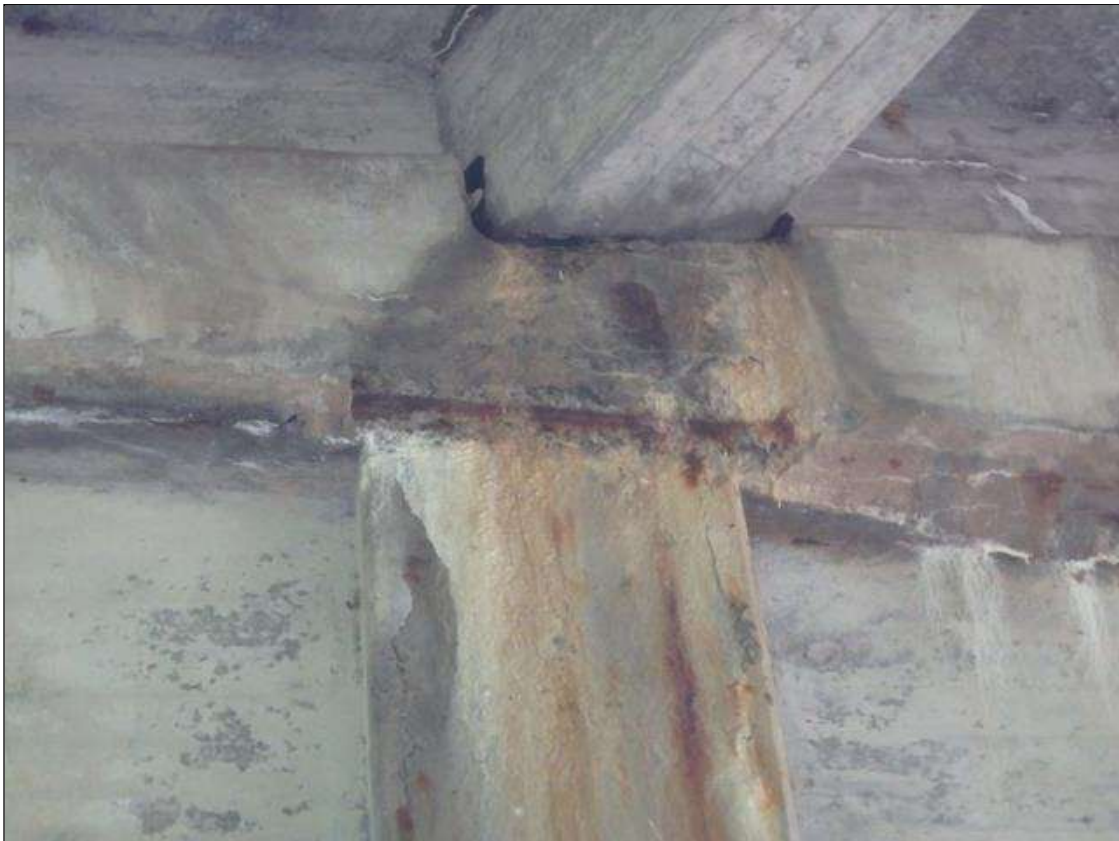
Bent 2 Cap : SPALL 3 FT X 6" X 3" DEEP WITH EXPOSED REBAR, NO SECTION LOSS UNDER BEAM 3 AT TOP OF COLUMN
