NC DEPARTMENT OF TRANSPORTATION  
DIVISION OF HIGHWAYS  
STRUCTURE MANAGEMENT UNIT

## Structure Safety Report

### Routine Element Inspection - Contract

COUNTY: MADISON STRUCTURE NUMBER: 560008 FREQUENCY: 24 MONTHS

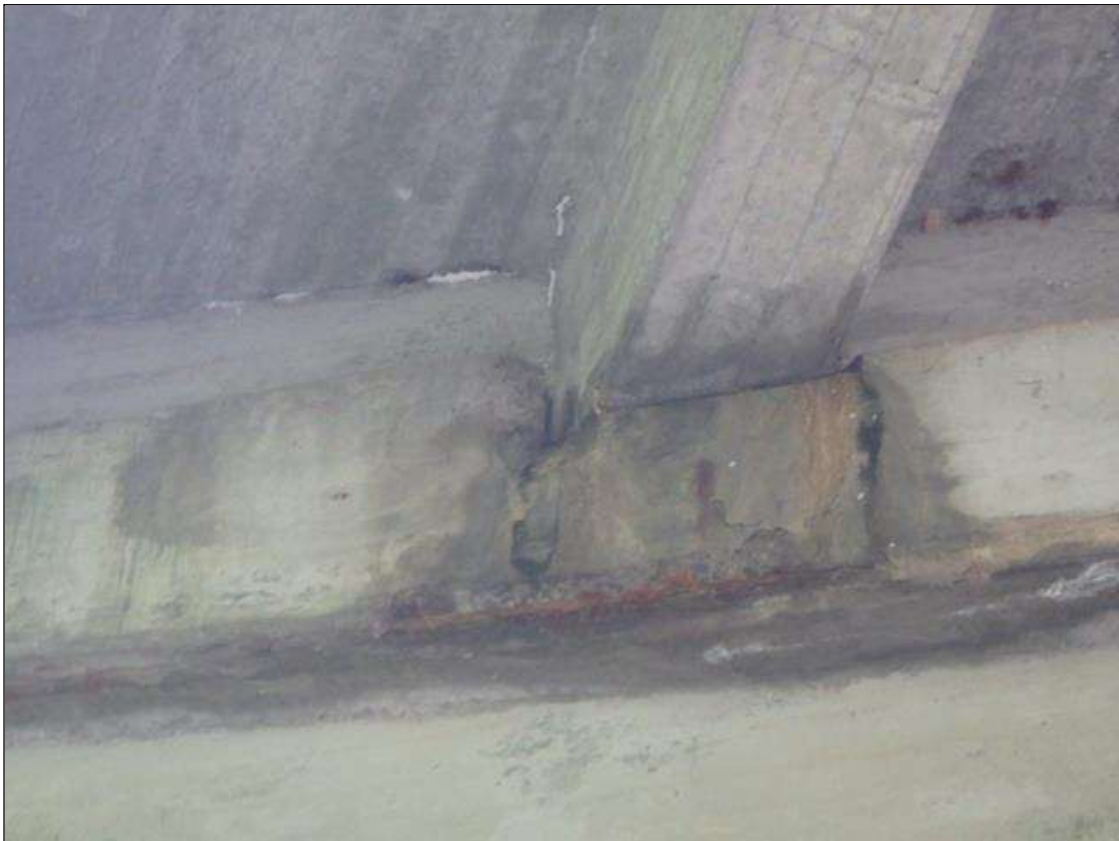
Bent 2 Cap : SPALL 6" DIAMETER X 2" DEEP AT BEAM 4, SPAN 3 FACE

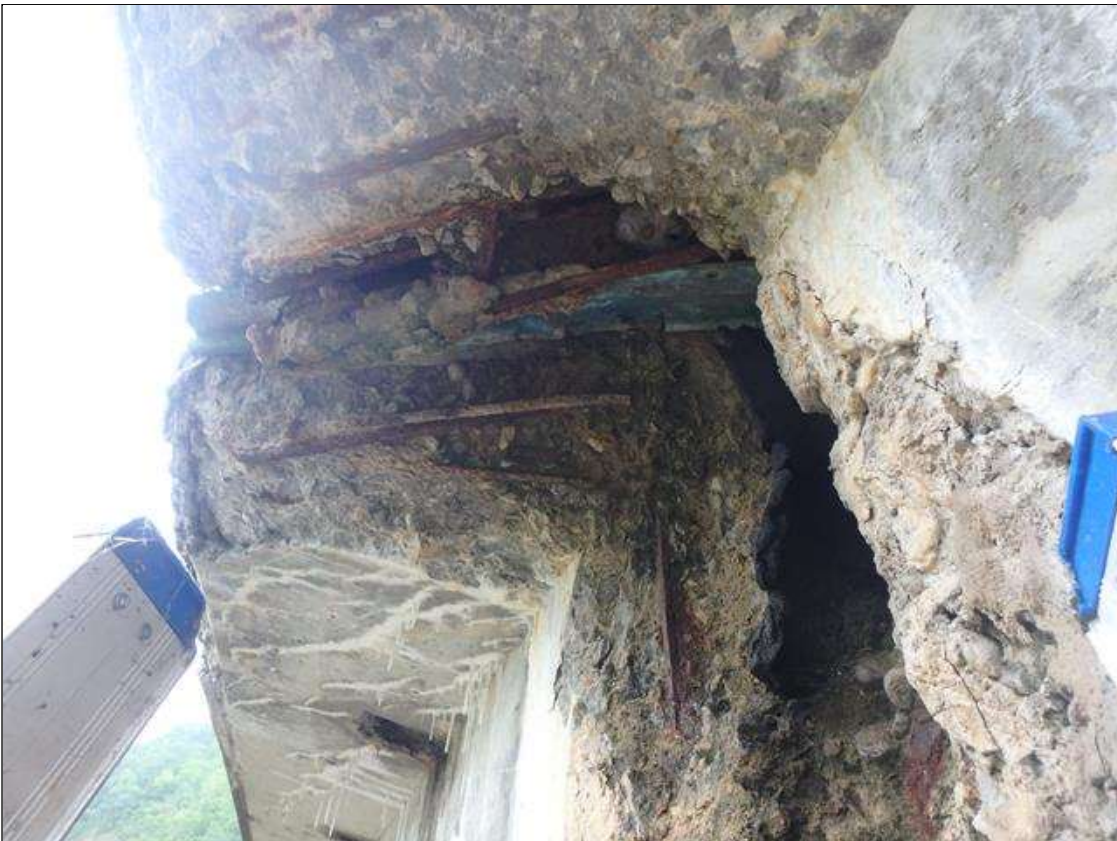
SCATTERED SURFACE DETERIORATION ALONG UNDERSIDE OF DECK  
 HEAVY EFFLORESCENCE AND RUST STAINING SCATTERED THROUGHOUT UNDERSIDE OF DECK IN ALL BAYS  
 HEAVY EFFLORESCENCE BUILDUP SCATTERED ALONG UNDERSIDE OF LEFT OVERHANG  
 SPALL 3 FT X 3 FT X UP TO 5" DEEP WITH EXPOSED REBAR, UP TO 100% SECTION LOSS, ALONG LEFT OVERHANG AT BENT 2, PRIORITY MAINTENANCE

Span 3 Deck: SPALL 3 FT X 3 FT X UP TO 5" DEEP WITH EXPOSED REBAR, UP TO 100% SECTION LOSS, ALONG LEFT OVERHANG AT BENT 2, PRIORITY MAINTENANCE

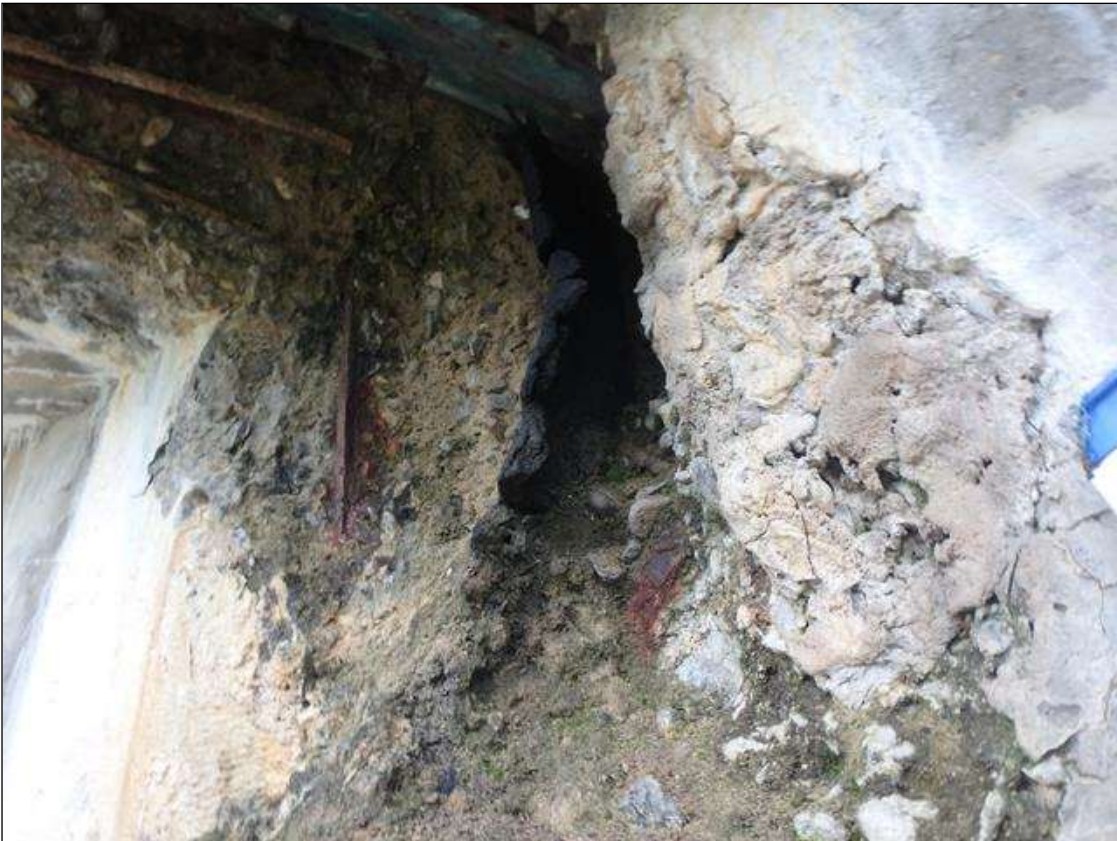
Span 2 Beam 1: SPALL 2 FT X 7" X UP TO 3" DEEP WITH EXPOSED REBAR, NO SECTION LOSS, AT BENT 2

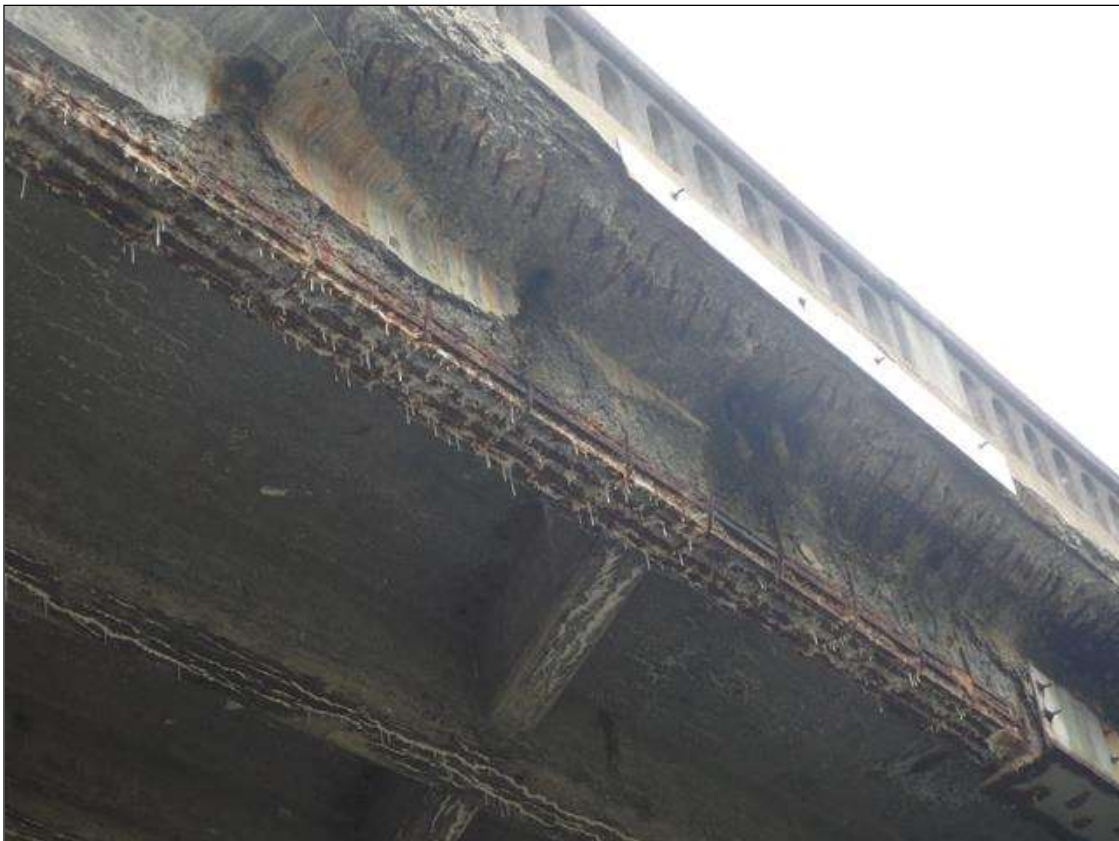
Span 2 Deck: SPALL FULL LENGTH X FULL WIDTH X UP TO 4" DEEP WITH EXPOSED REBAR WITH UP TO 100% SECTION LOSS ALONG UNDERSIDE OF LEFT OVERHANG, PRIORITY MAINTENANCE

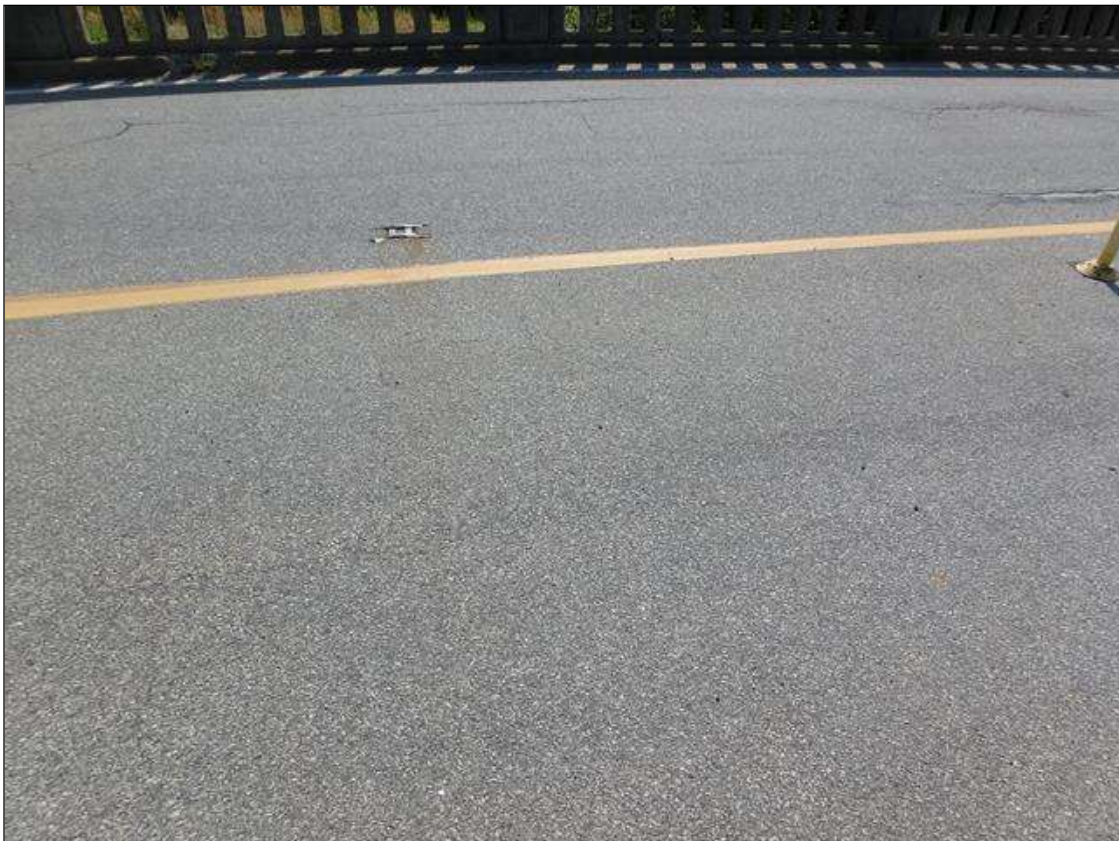
SPAN 5 ASPHALT WEARING SURFACE, OTHERS SIMILAR

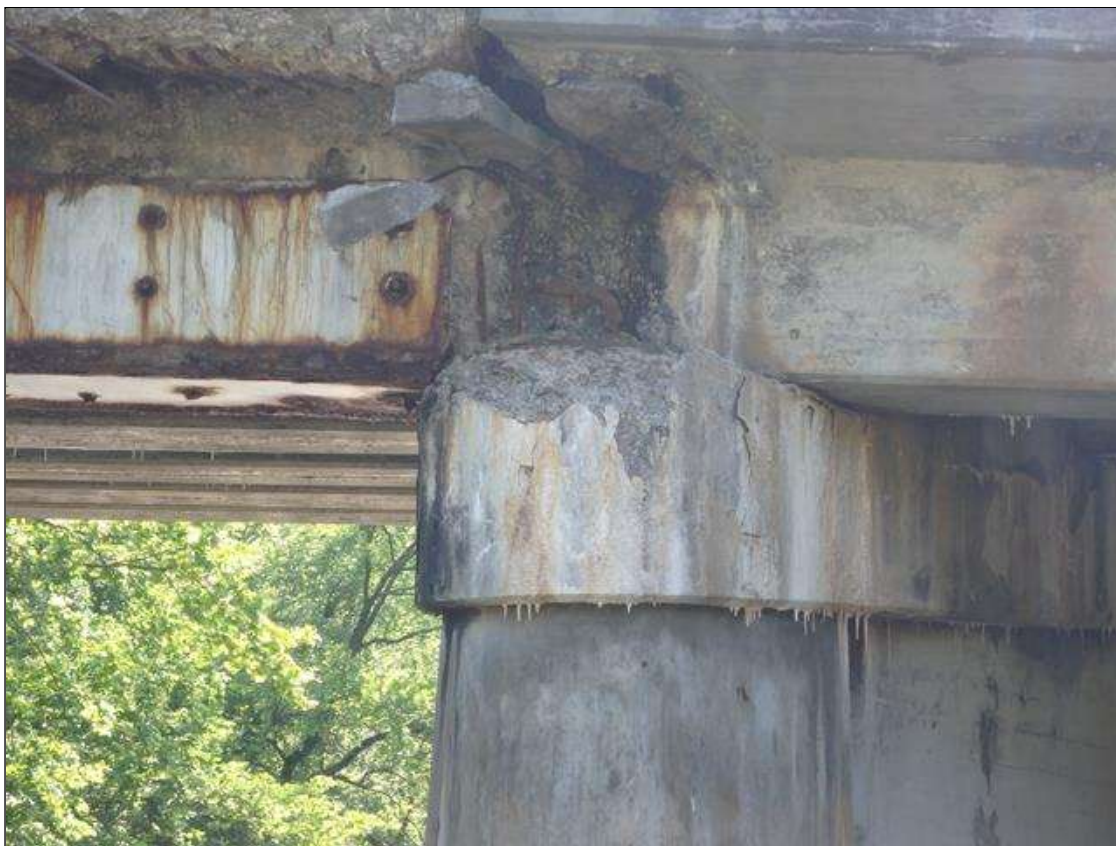
WEST END OF BENT 1 CAP, OTHERS SIMILAR

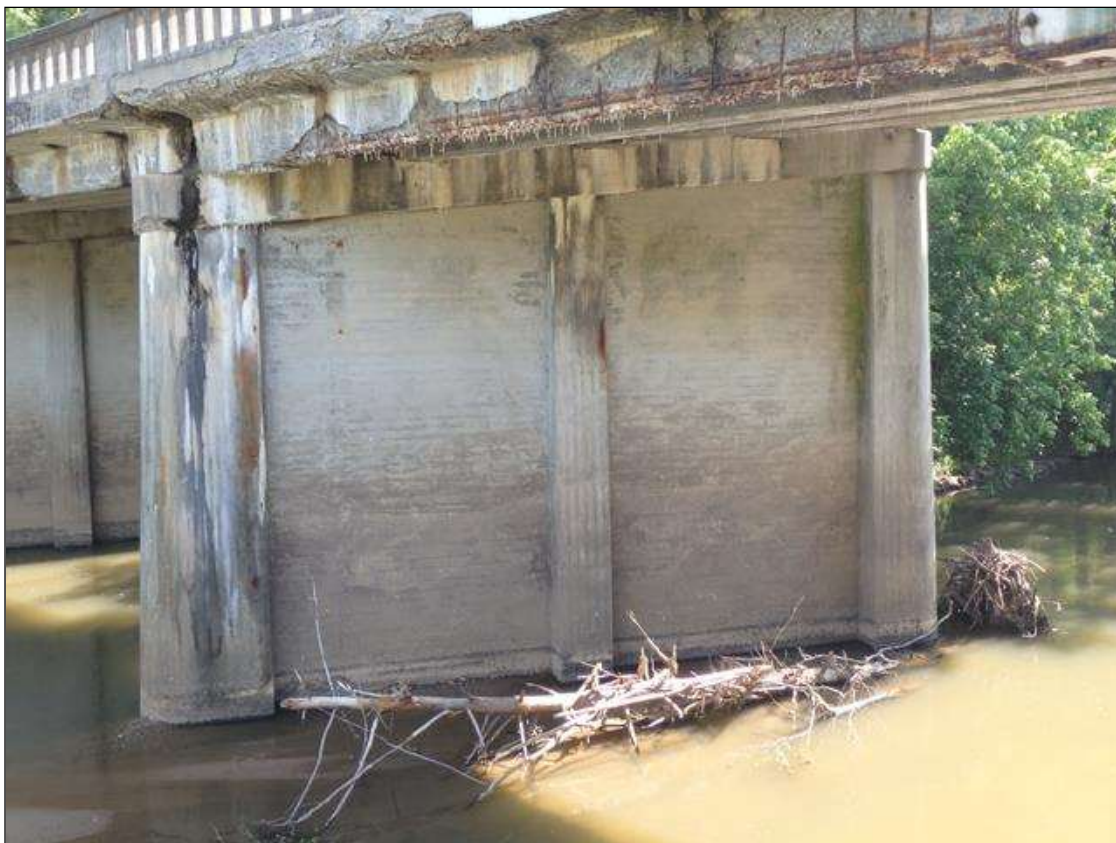
BENT 2, OTHERS SIMILAR

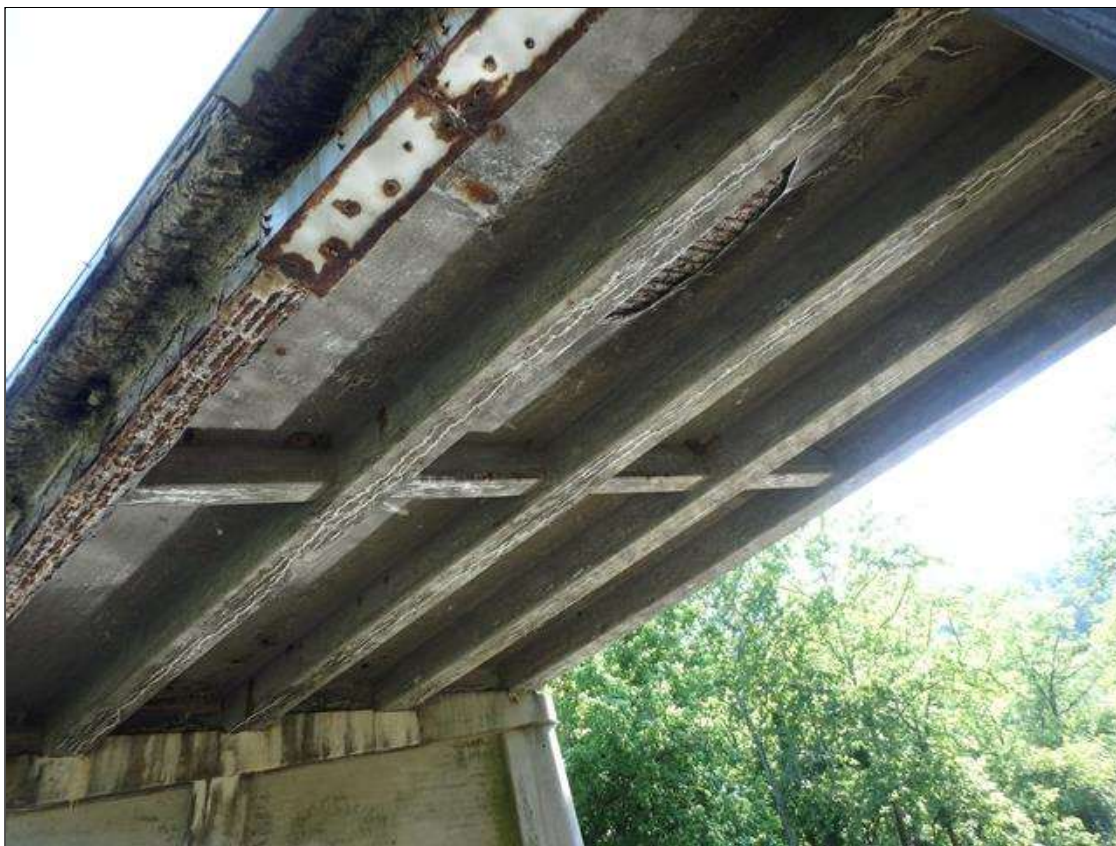
UNDERSIDE SPAN 2 , OTHER SIMILAR

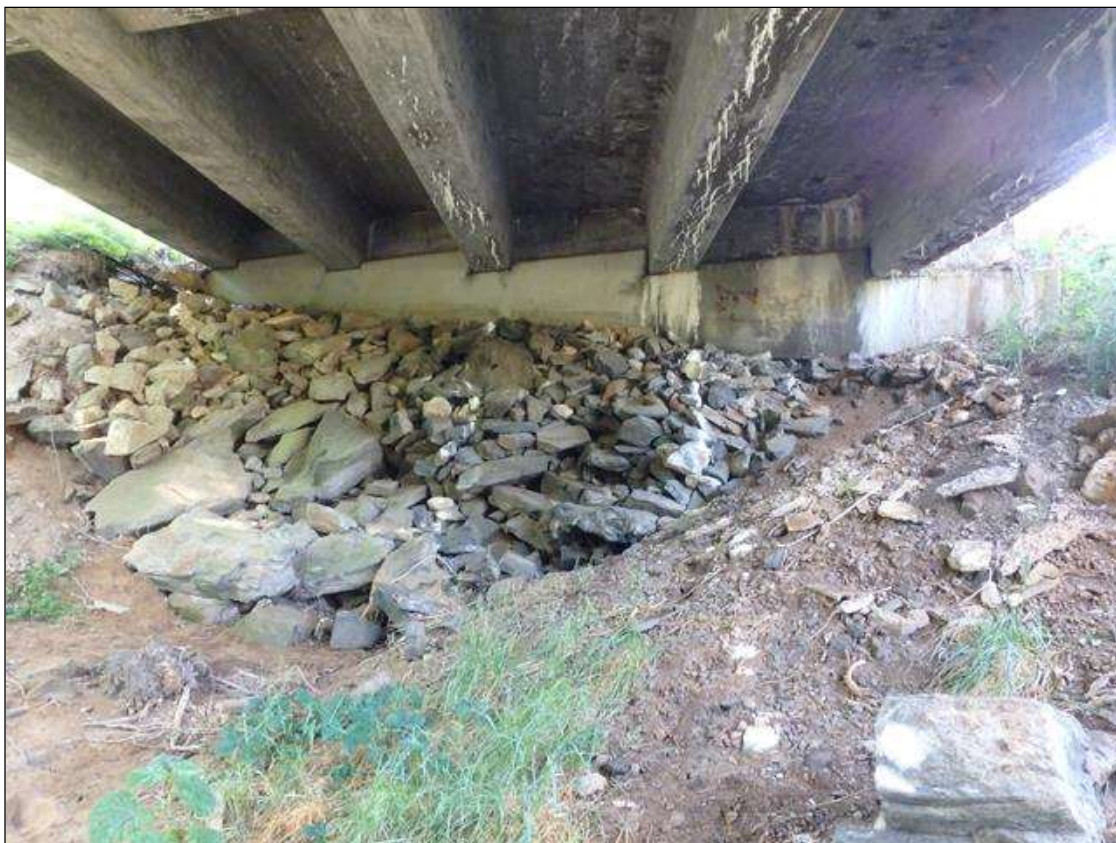
END BENT 1, OTHER SIMILAR

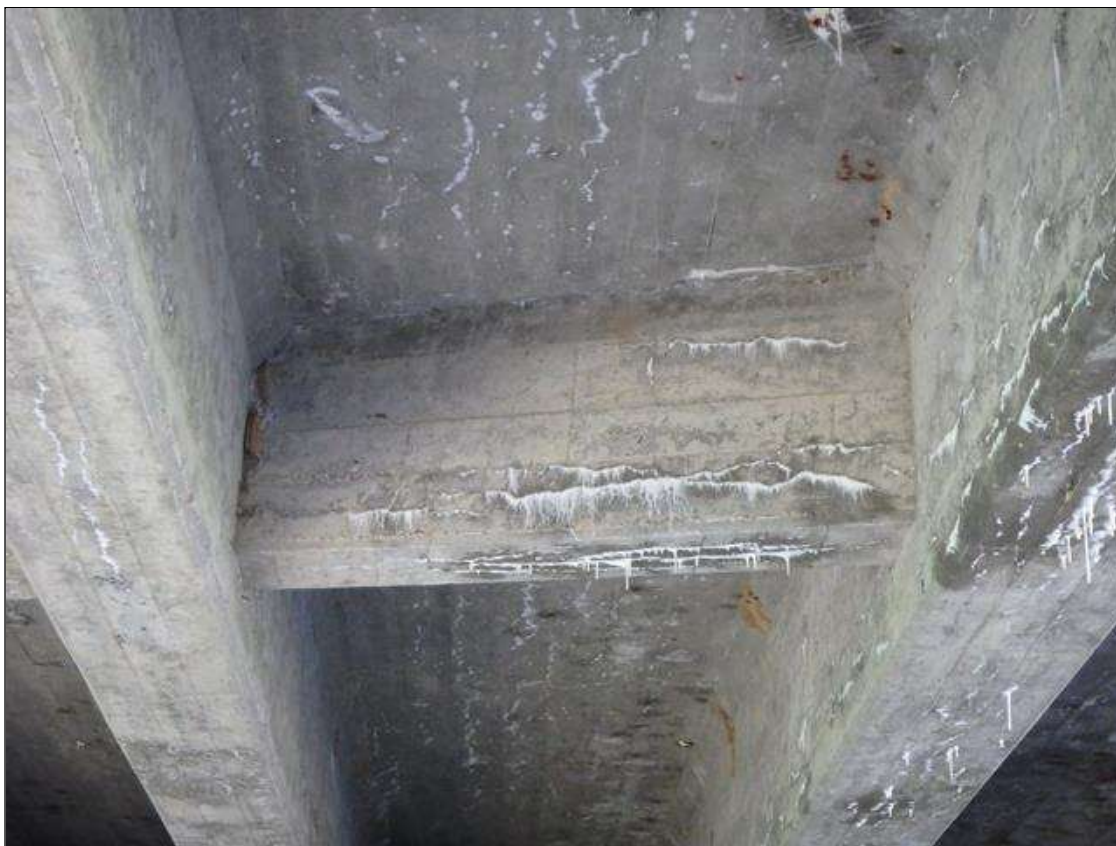
TYPICAL INTERMEDIATE DIAPHRAGM

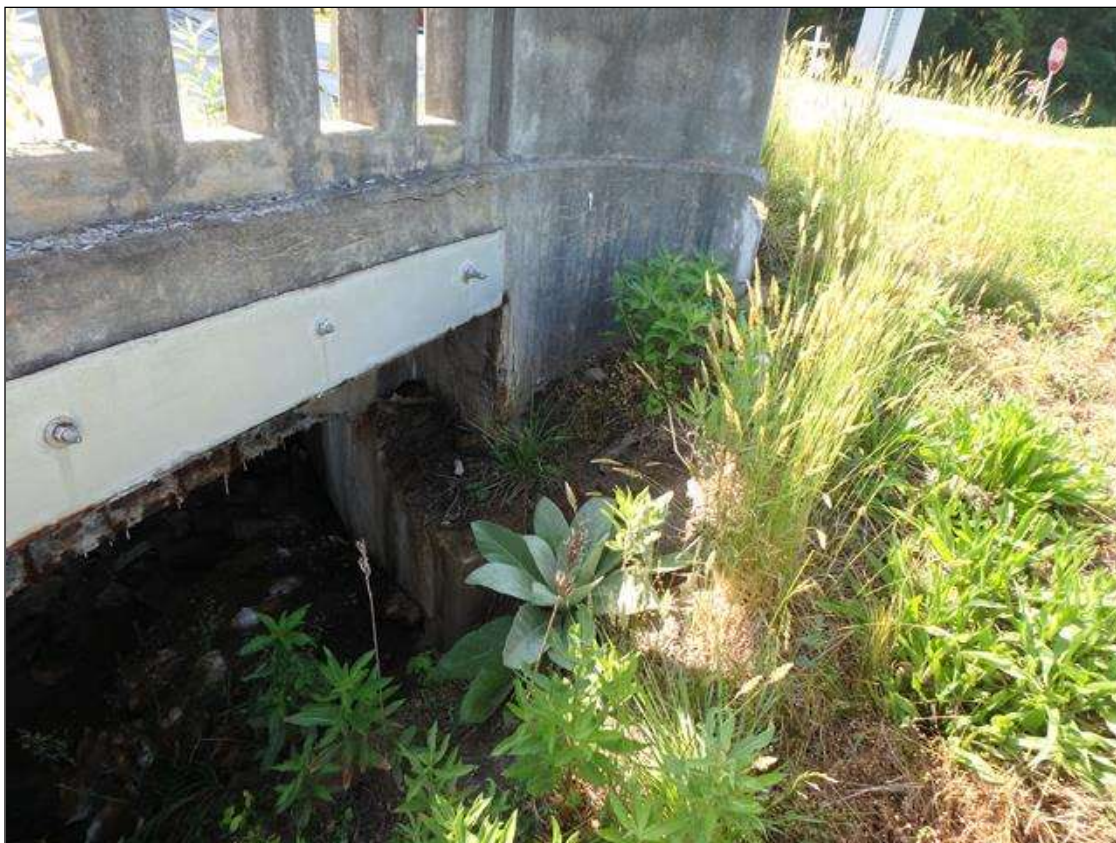
SOUTHWEST WINGWALL, OTHERS SIMILAR
