NC DEPARTMENT OF TRANSPORTATION  
DIVISION OF HIGHWAYS  
STRUCTURE MANAGEMENT UNIT

## Structure Safety Report

### Routine Element Inspection - Contract

COUNTY: MADISON STRUCTURE NUMBER: 560009 FREQUENCY: 24 MONTHS

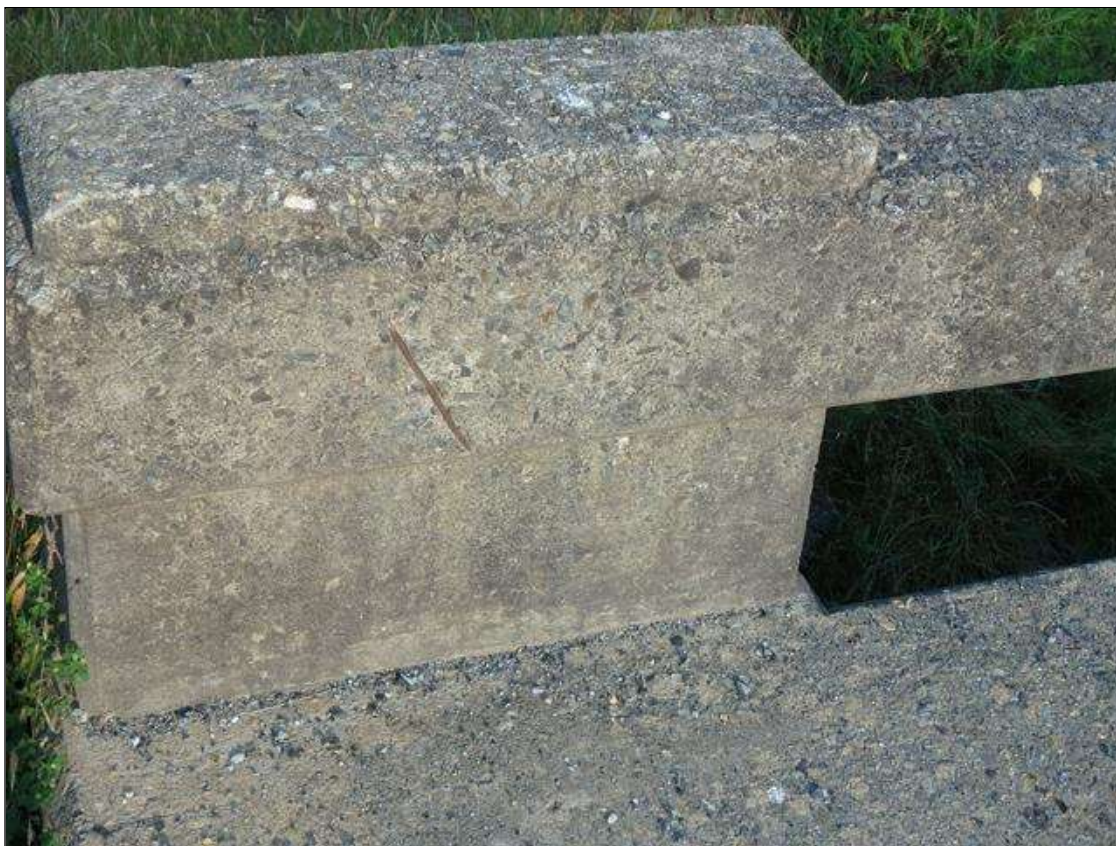
Span 1 Left Bridge Rail: EXPOSED REBAR FOR 6" AT CONCRETE END POST AT END BENT 1

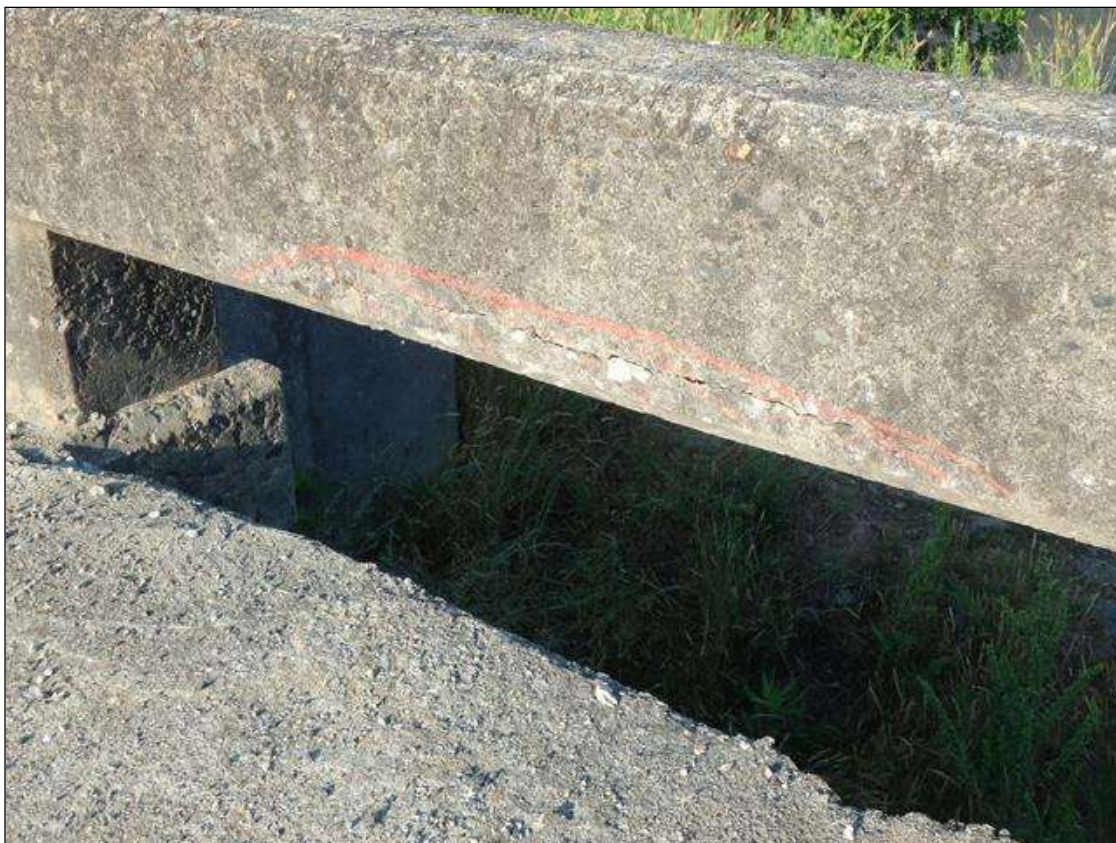
Span 1 Left Bridge Rail: DELAMINATION 2.5 FT X 3" X 3", 11FT FROM END BENT 1

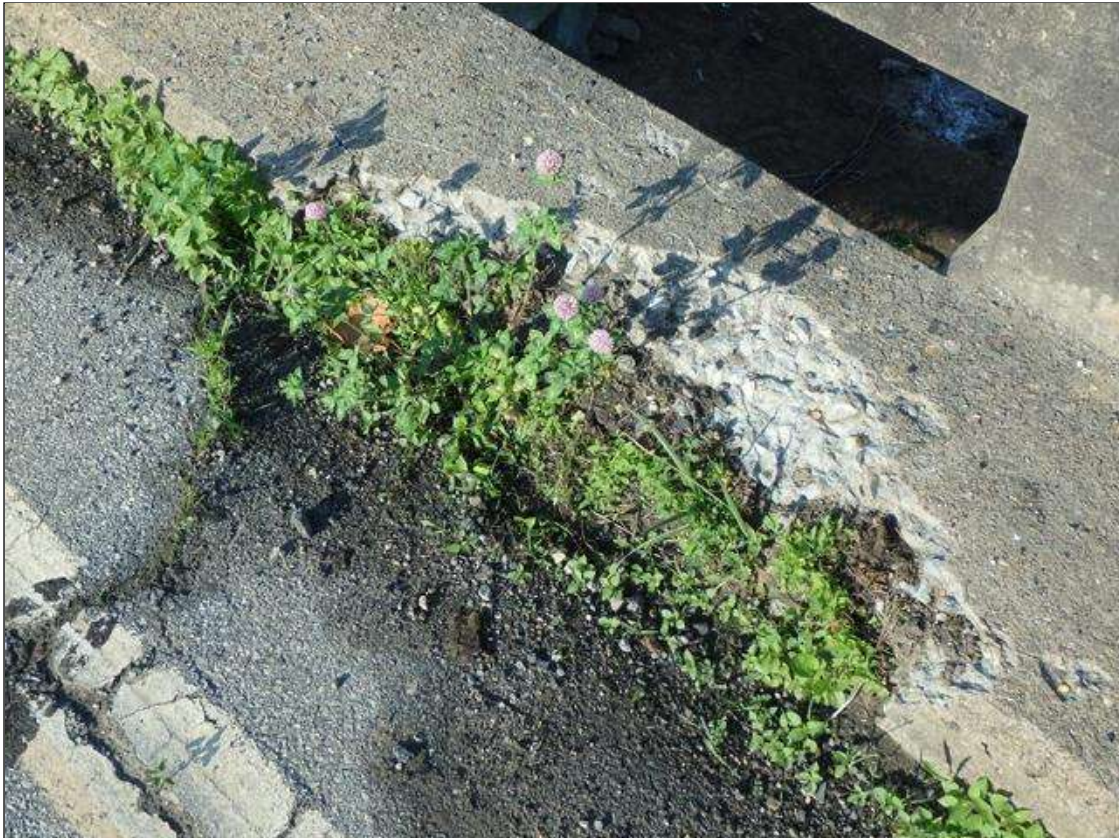
Span 2 Left Bridge Rail: SPALL 3.5 FT X 1FT X 5" WITH EXPOSED REBAR, NO SECTION LOSS, IN FACE OF CURB 22 FT FROM BENT 1

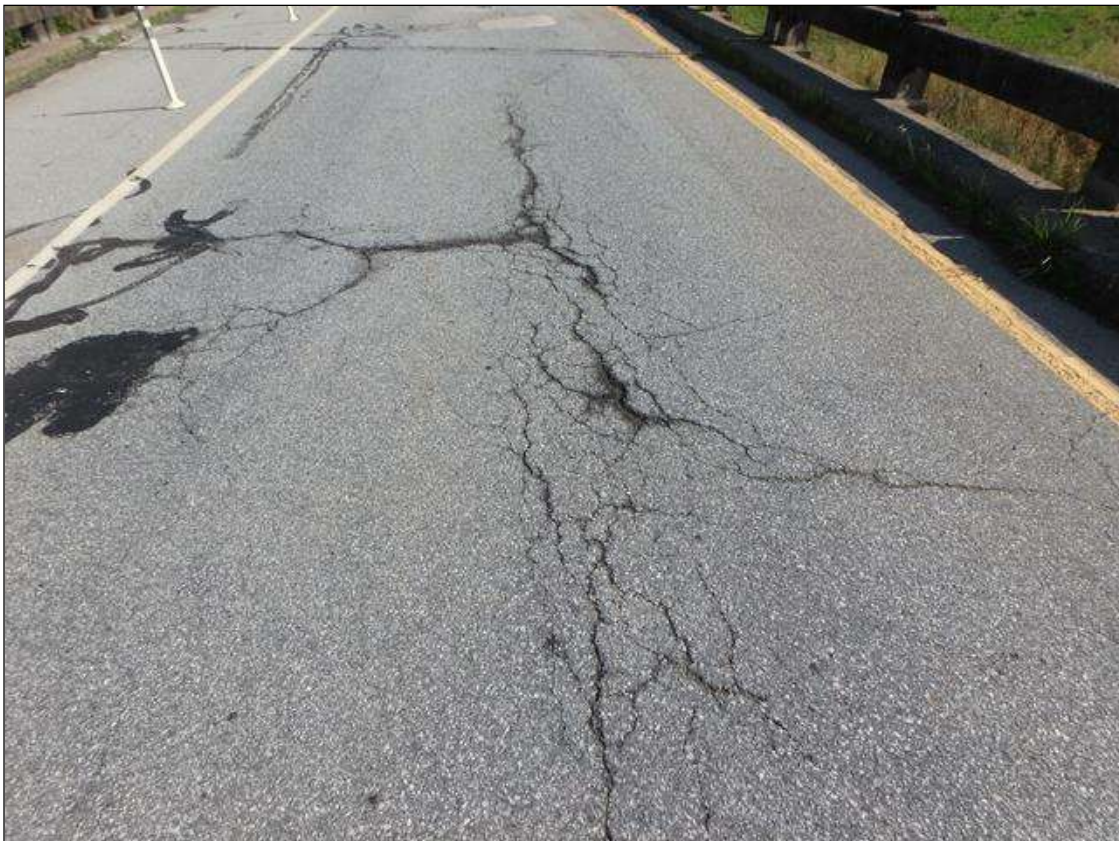
Span 3 Wearing Surface: SCATTERED LONGITUDINAL, TRANSVERSE AND MAP CRACKING UP TO 1",  
PREDOMINANTLY IN TRAVEL LANE

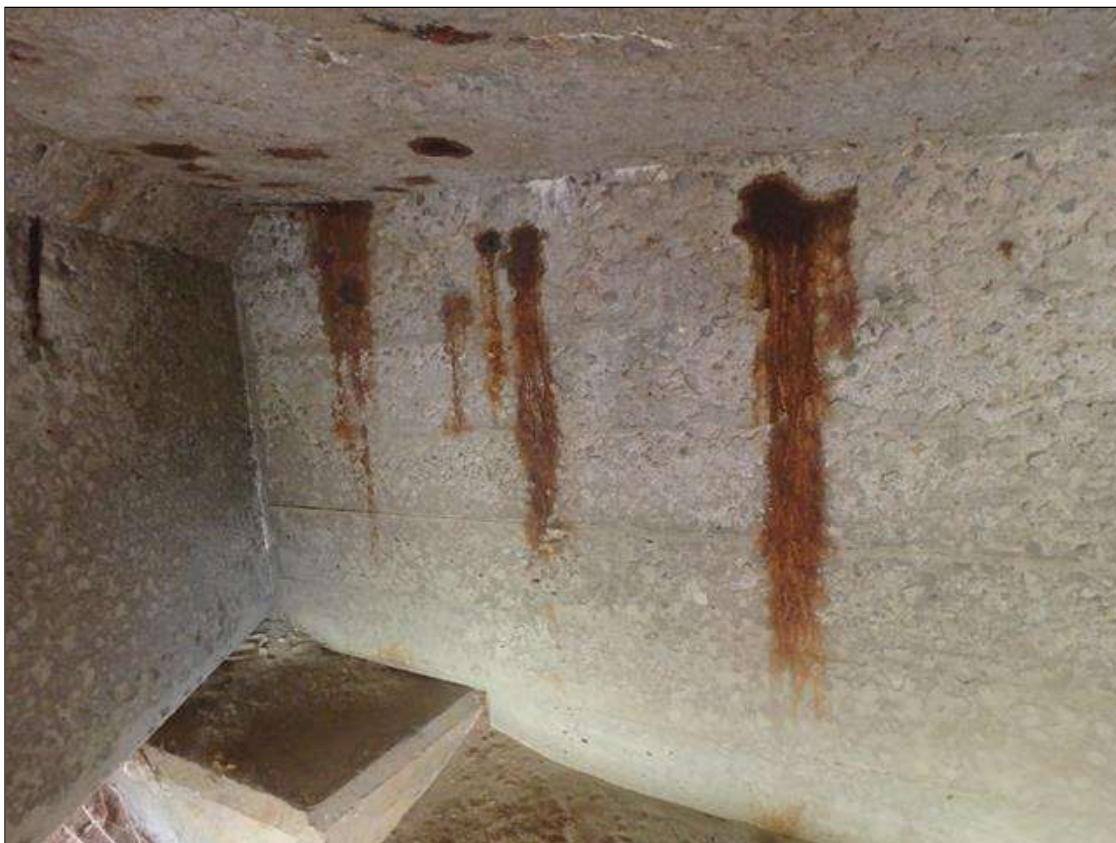
End Bent 1 Abutment/Backwall : HEAVY STAINING ALONG BACKWALL, BAY 3

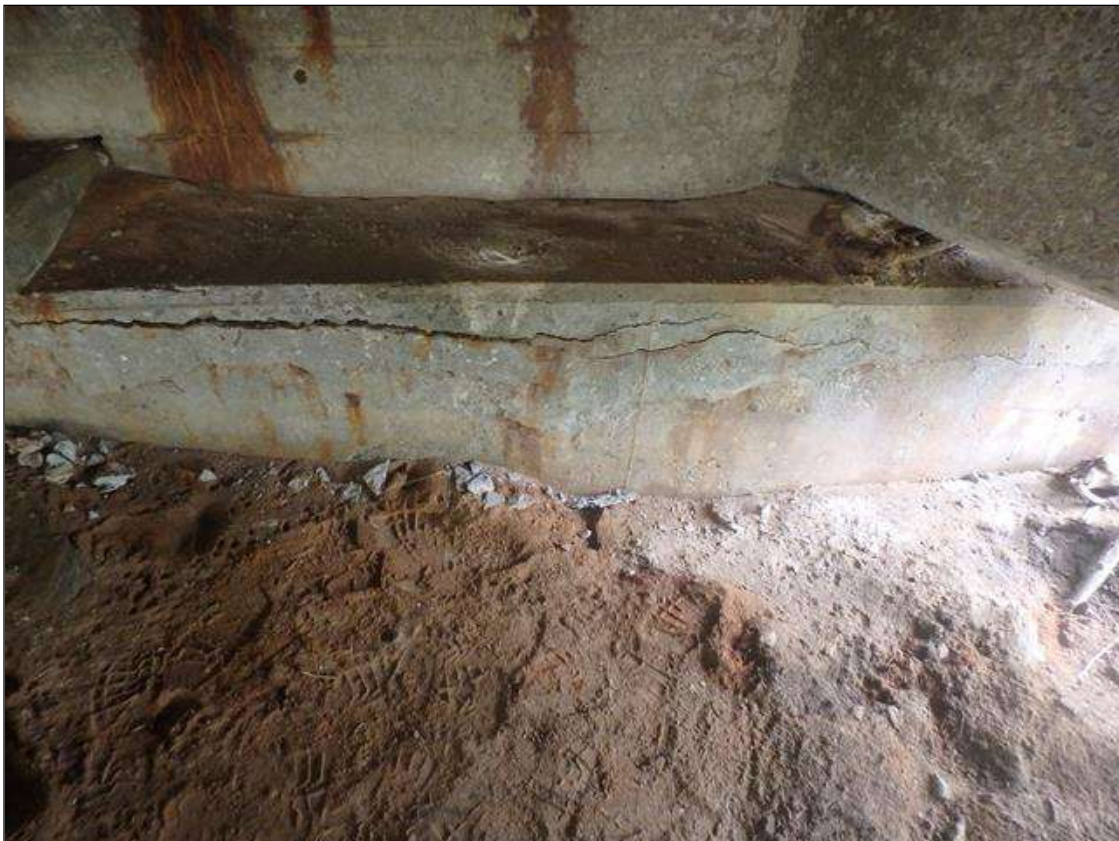
End Bent 1 Cap : HORIZONTAL CRACK 10 FT X UP TO 1/8" WITH DELAMINATION 6 FT X UP TO 9" IN BAY 1

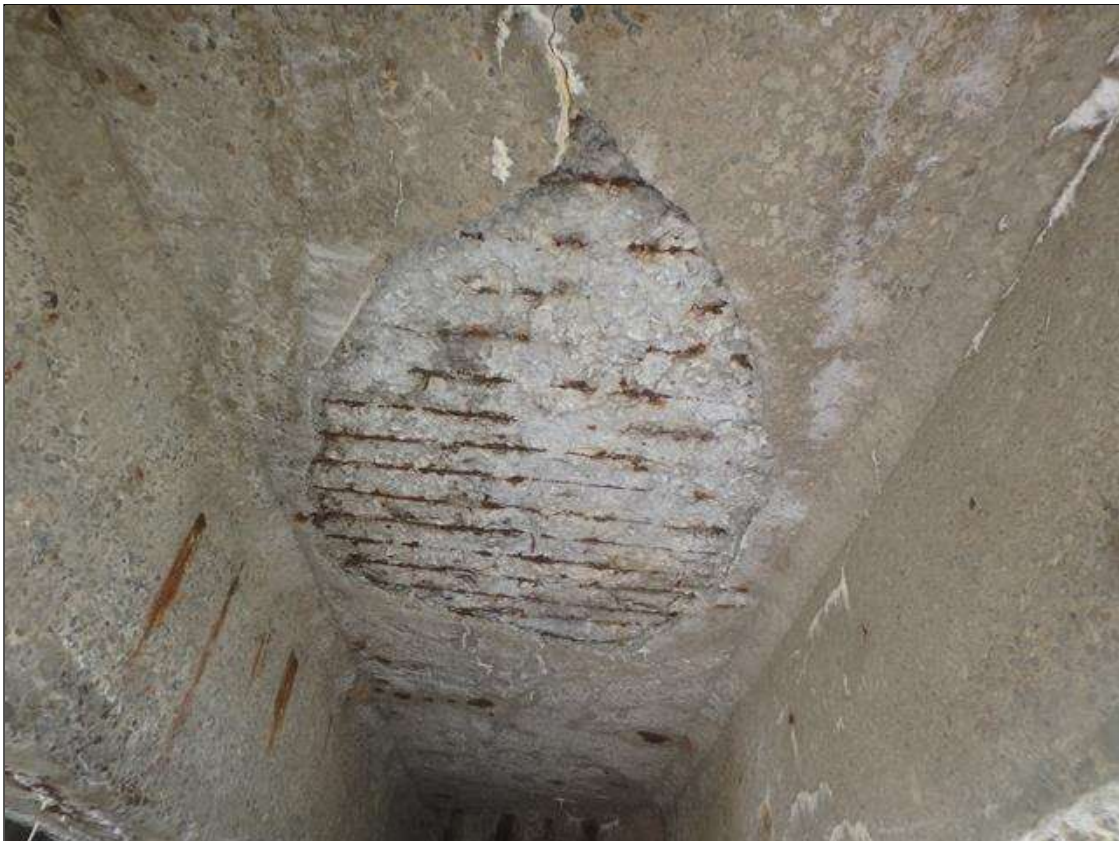
Span 1 Deck: SPALL 8 FT X 5 FT X UP TO 4" DEEP WITH EXPOSED REBAR, UP TO 100% SECTION LOSS, 15 FT FROM END BENT 1, BAY 1, PRIORITY MAINTENANCE

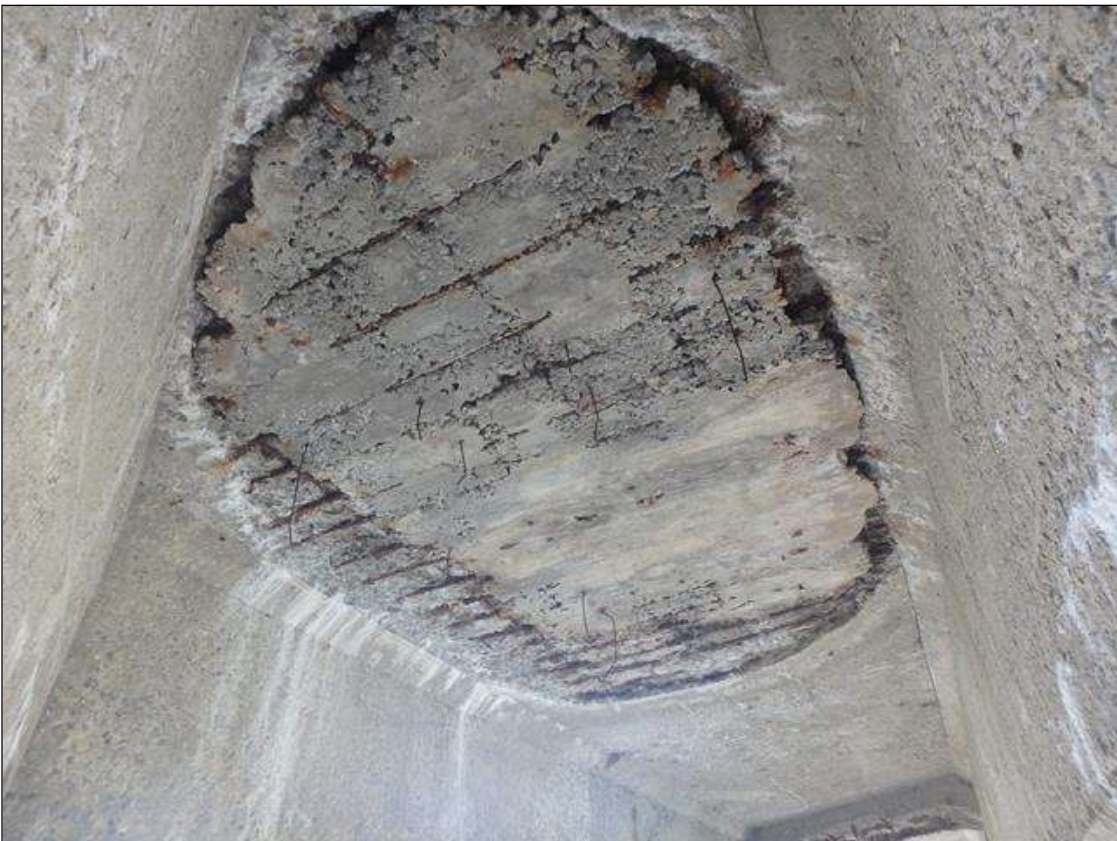
Span 1 Deck: SPALL 9 FT X 7 FT X UP TO 6" DEEP WITH EXPOSED REBAR, UP TO 50% SECTION LOSS, AND HONEYCOMBING, NEAR MIDSPAN, BAY 2, PRIORITY MAINTENANCE

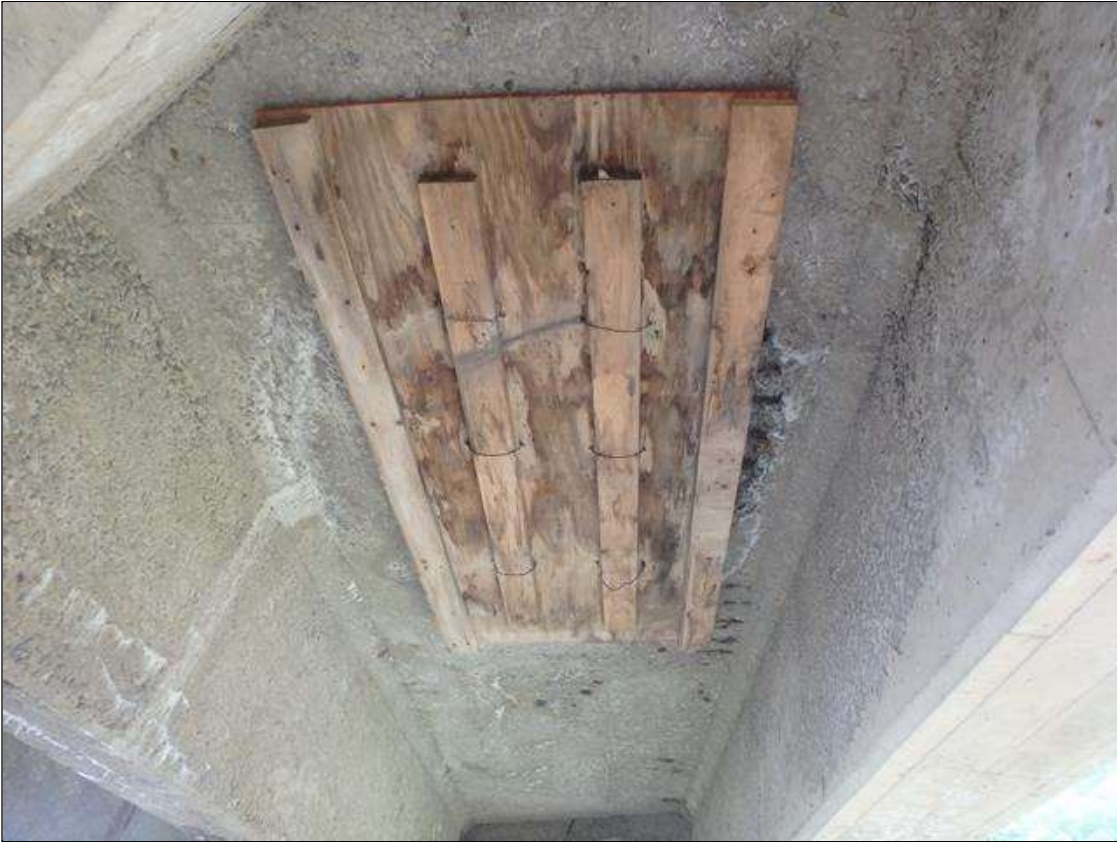
Span 1 Deck: FORMWORK FOR PATCH, 5 FT X 8 FT, 15 FT FROM BENT 1, BAY 3

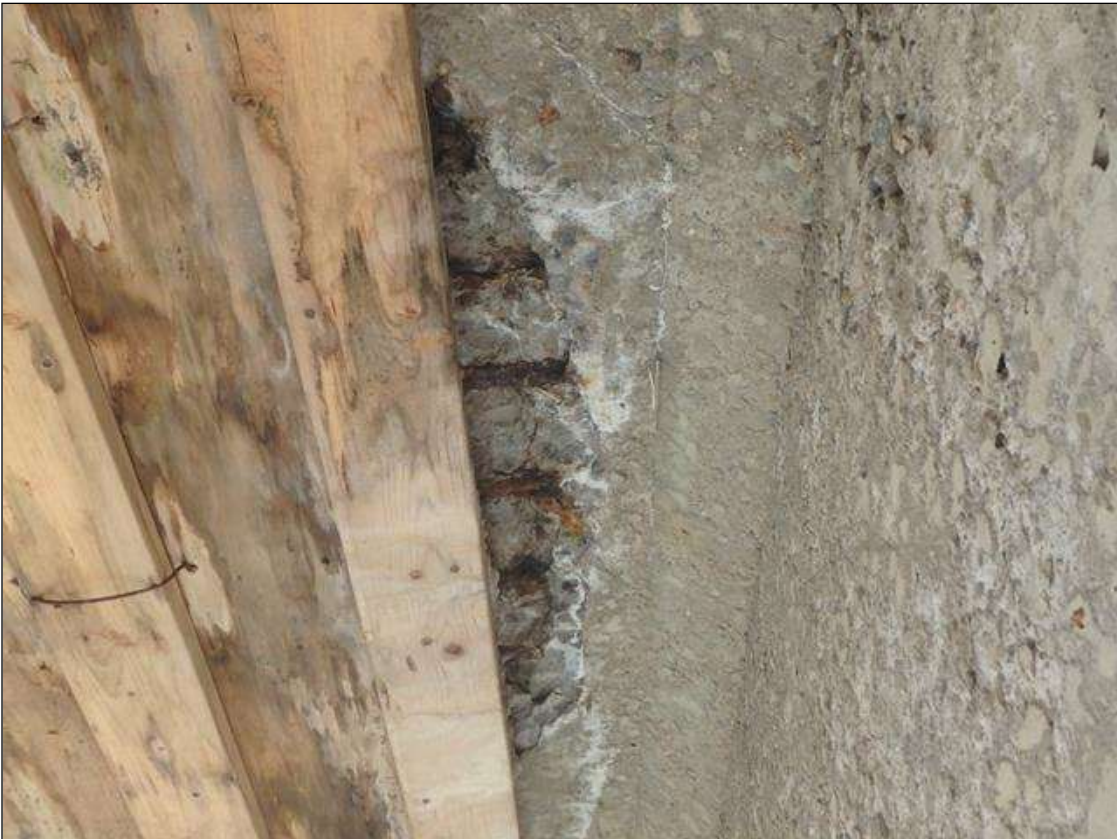
Span 1 Deck: SPALL 3 FT X 6" X UP TO 4" DEEP WITH EXPOSED REBAR, UP TO 50% SECTION LOSS, ADJACENT TO PATCH FORMWORK IN BAY, PRIORITY MAINTENANCE

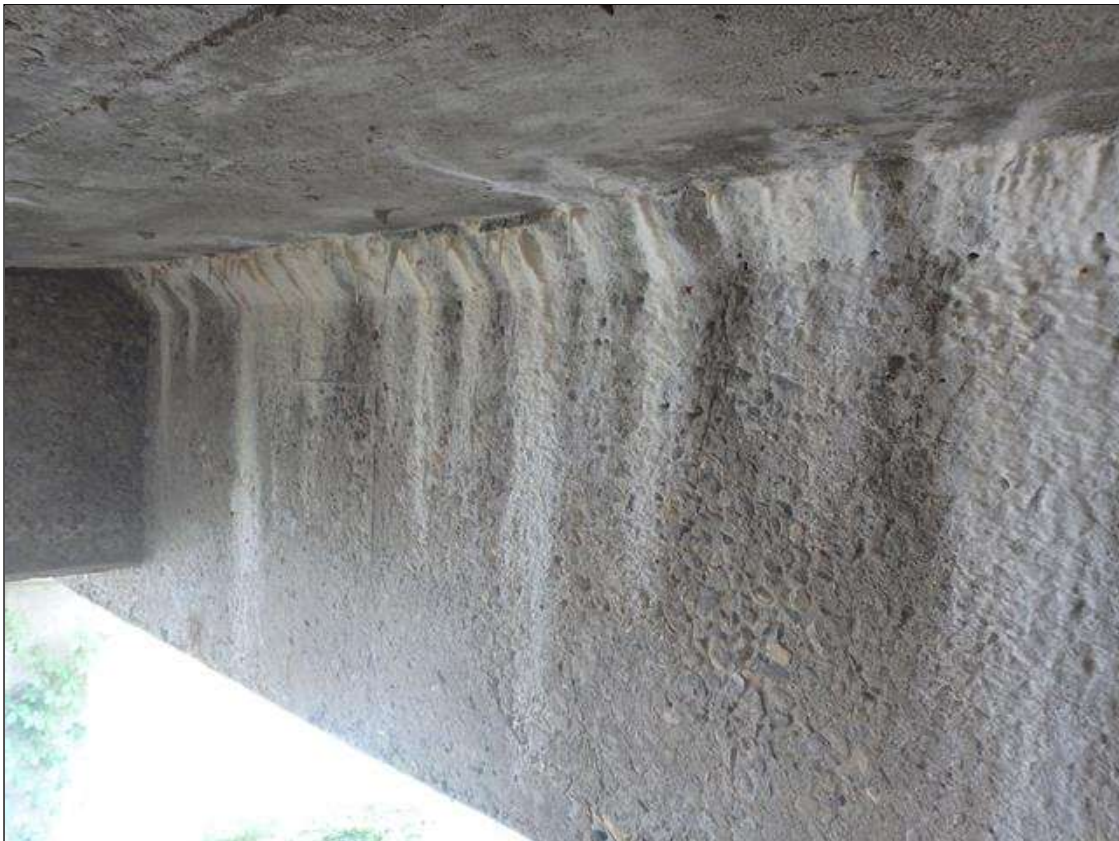
Span 1 Beam 3: HEAVY EFFLORESCENCE BUILDUP ALONG WEST FACE AT INTERMEDIATE DIAPHRAGM

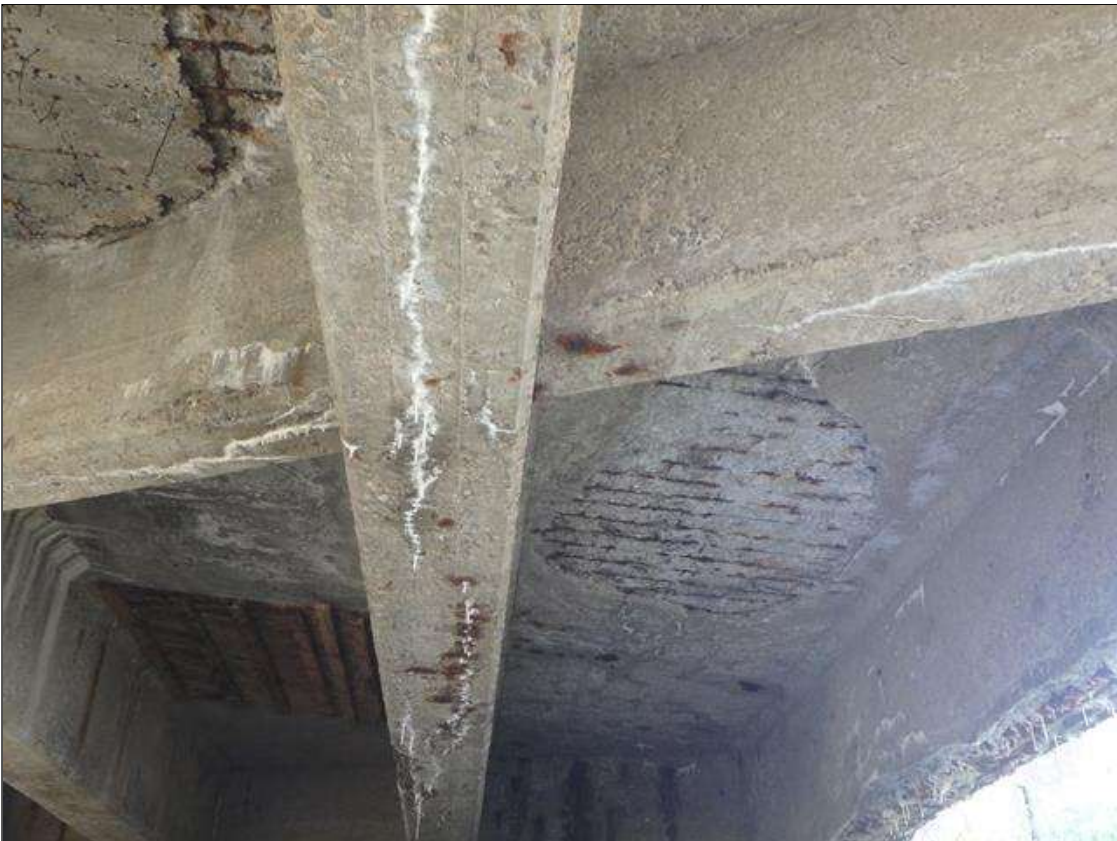
Span 1 Beam 2: HEAVY EFFLORESCENCE BUILDUP AND RUST STAINING ALONG BOTTOM FOR 20 FT NEAR MIDSPAN

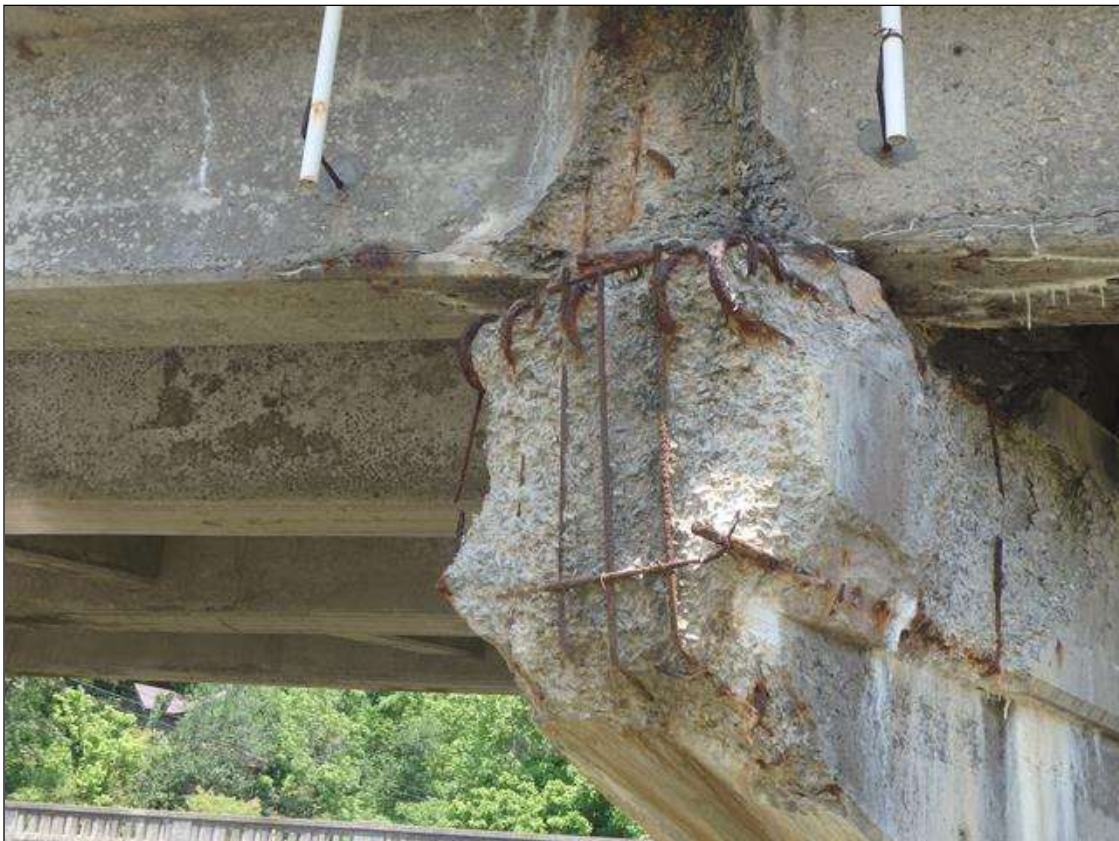
Bent 1 Cap : SPALL FULL WIDTH X FULL HEIGHT X UP TO 6" DEEP WITH EXPOSED REBAR, UP TO 100% SECTION LOSS AT LEFT END, PRIORITY MAINTENANCE

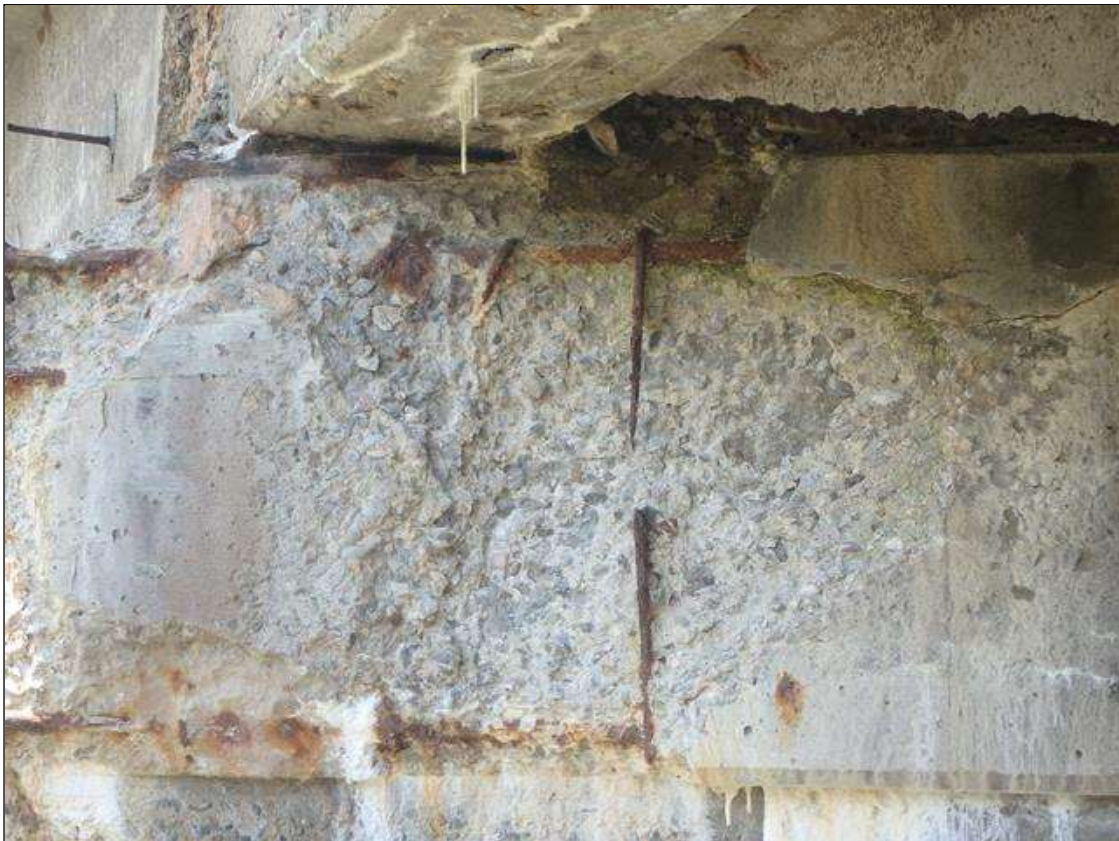
Bent 1 Cap : SPALL 4 FT X 3 FT X UP TO 5" WITH EXPOSED REBAR, UP TO 100% SECTION LOSS UNDER BEAM 1, AND LOSS OF BEARING AREA, SPAN 1 FACE, PRIORITY MAINTENANCE

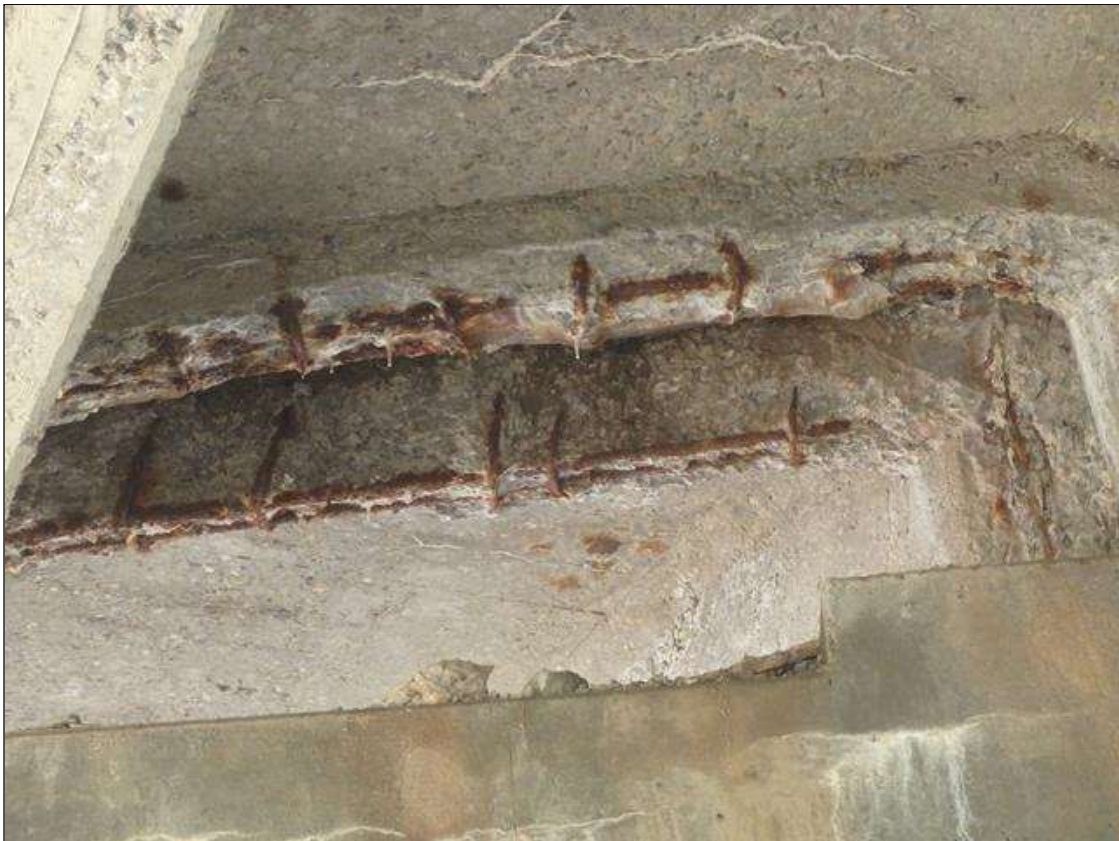
END DIAPHRAGMS, BAY 2, BENT 1, SPALLED FULL WIDTH UP TO 3" DEEP WITH EXPOSED REBAR, OTHER BAYS SIMILAR THROUGHOUT

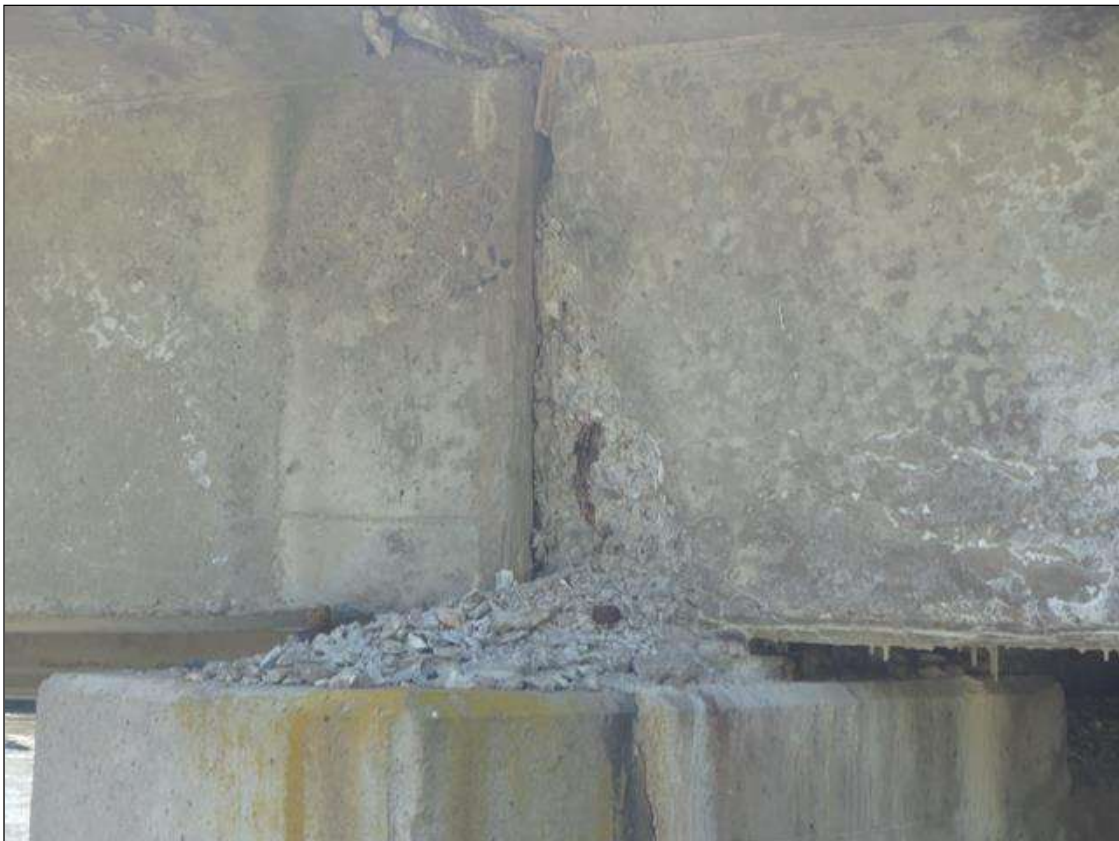
Span 5 Beam 4: SPALL 2 FT X 1 FT X UP TO 3" DEEP WITH EXPOSED REBAR, NO SECTION LOSS, AND DETERIORATING CONCRETE ALONG EAST FACE AT BENT 4

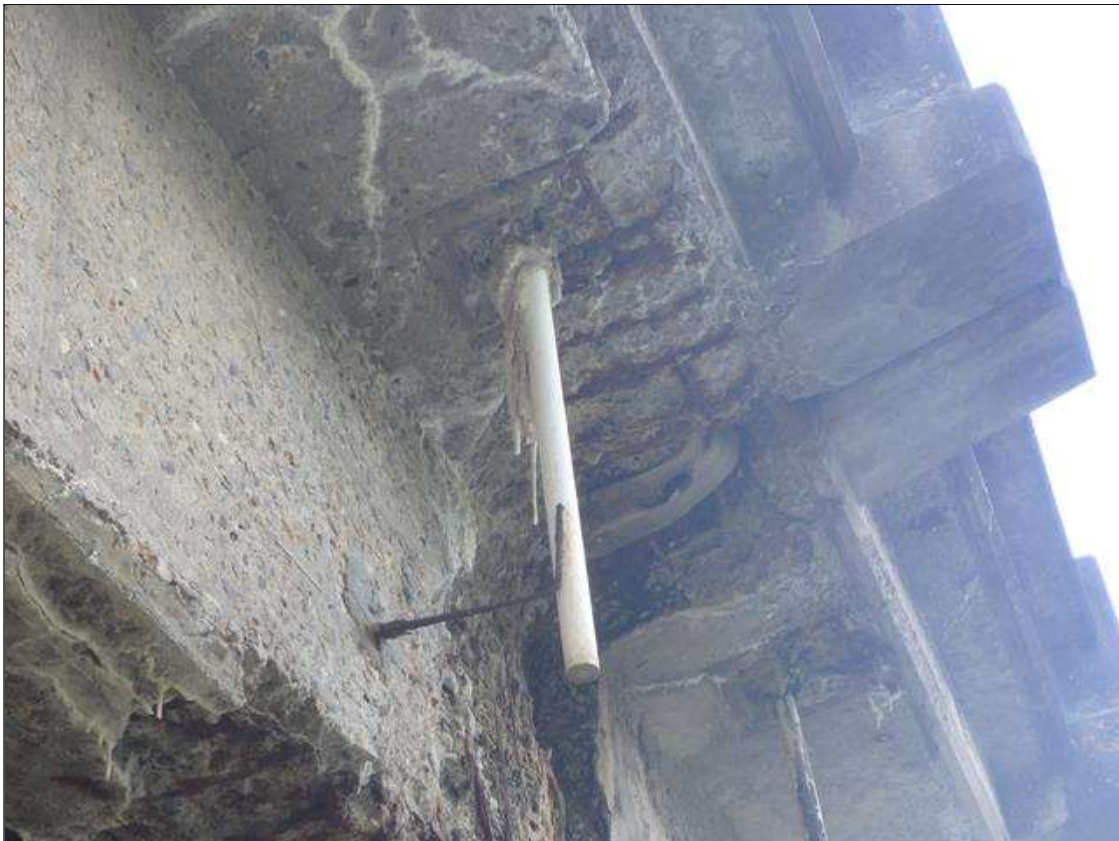
Span 5 Deck: SPALL 4 FT X 2 FT X UP TO 4" DEEP WITH EXPOSED REBAR, UP TO 25% SECTION LOSS ALONG UNDERSIDE OF LEFT OVERHANG AT BENT 4, PRIORITY MAINTENANCE

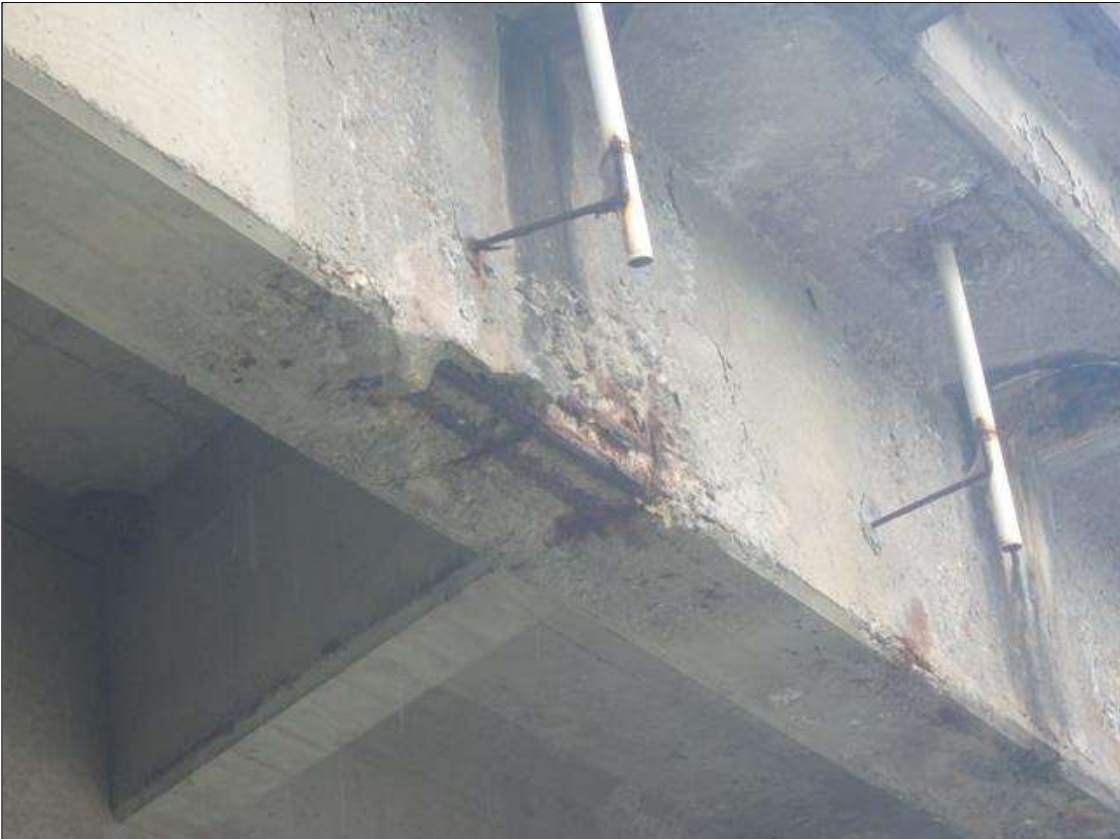
Span 4 Beam 1: SPALL 4 FT X 1 FT X 1 FT WITH EXPOSED REBAR, UP TO 10% SECTION LOSS AT MIDSPAN, PRIORITY MAINTENANCE

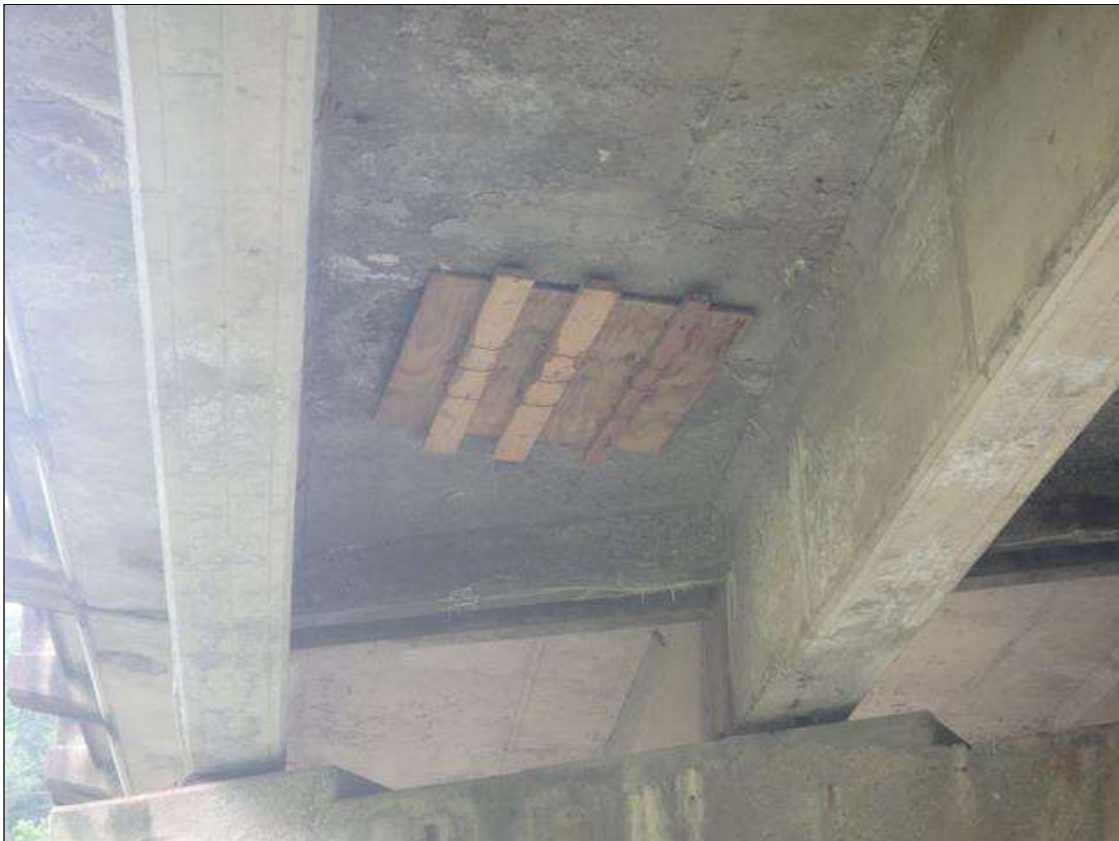
Span 4 Deck: PATCHED AREA 5 FT X 5 FT IN BAY 3, 8 FT FROM BENT 3

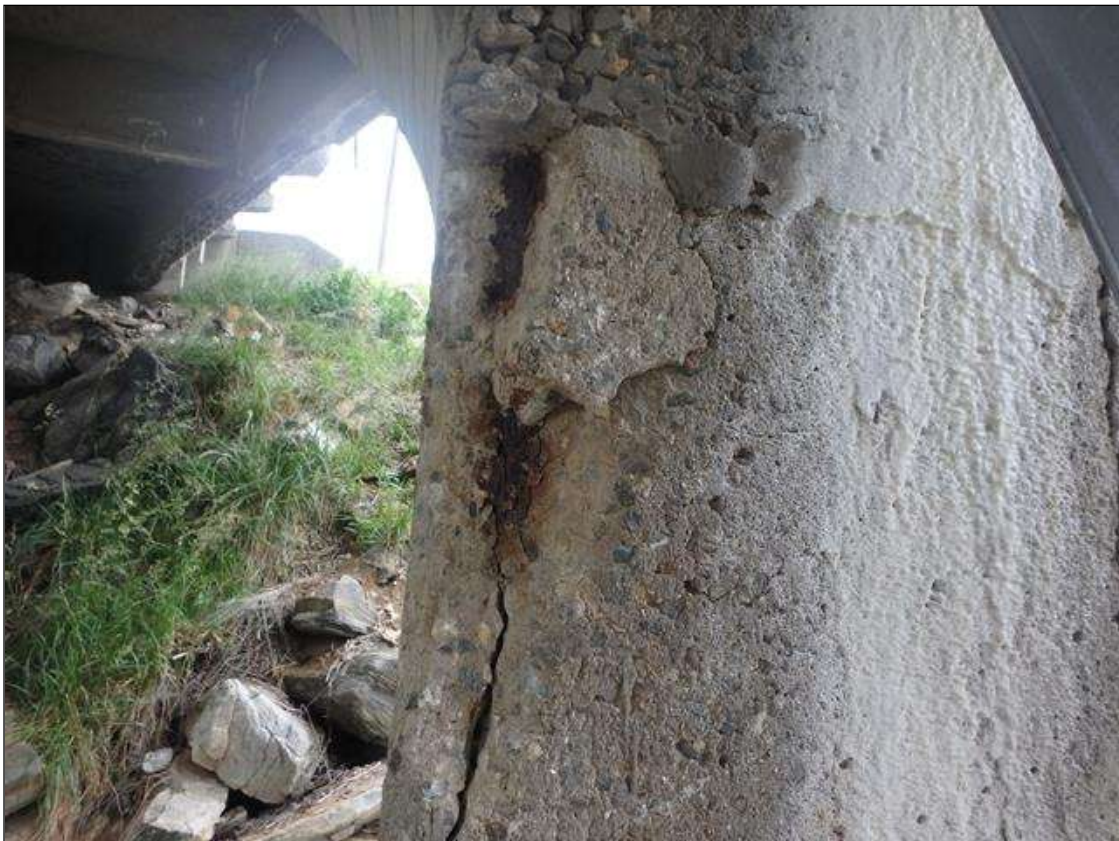
Bent 1 Pile 1: SPALL 2 FT X 6" X 6" WITH EXPOSED REBAR, NO SECTION LOSS, ALONG NORTHEAST CORNER

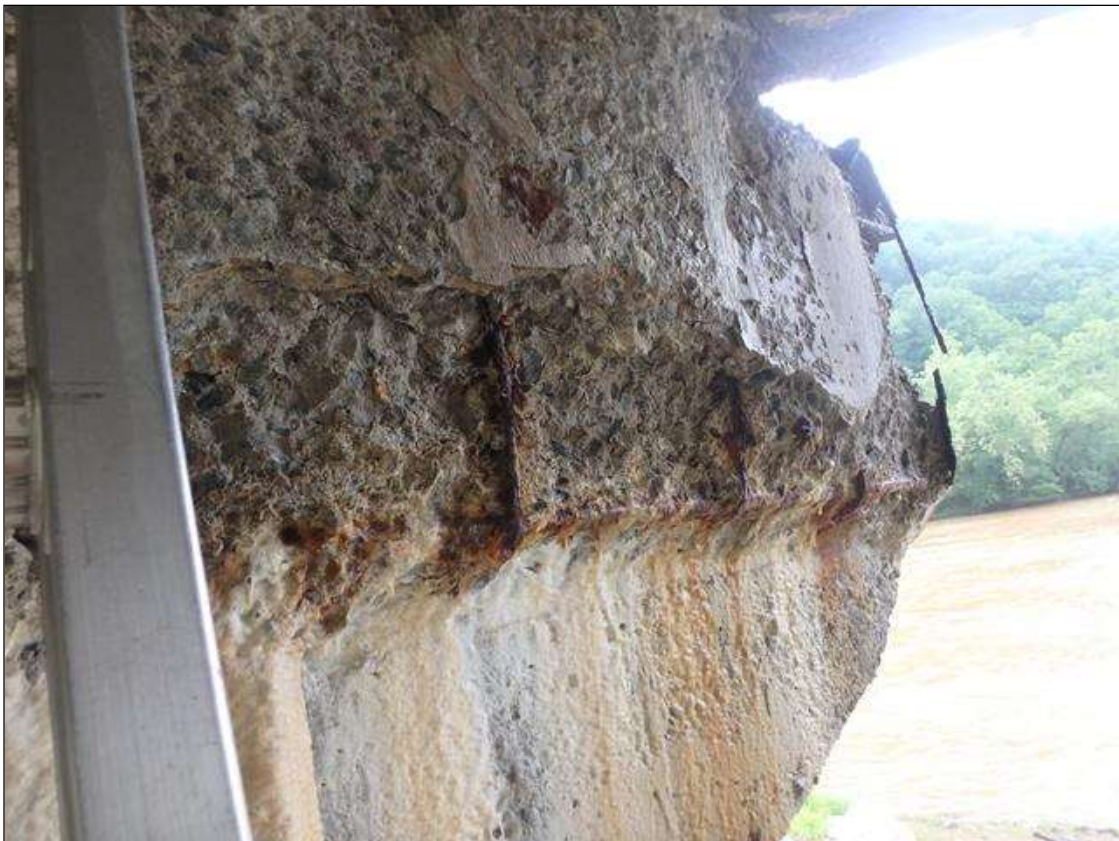
Bent 1 Cap : SPALL 6 FT X 1 FT X 6" WITH EXPOSED REBAR, UP TO 25% SECTION LOSS, AND DETERIORATING CONCRETE UNDER BEAM 1, SPAN 2 FACE, PRIORITY MAINTENANCE

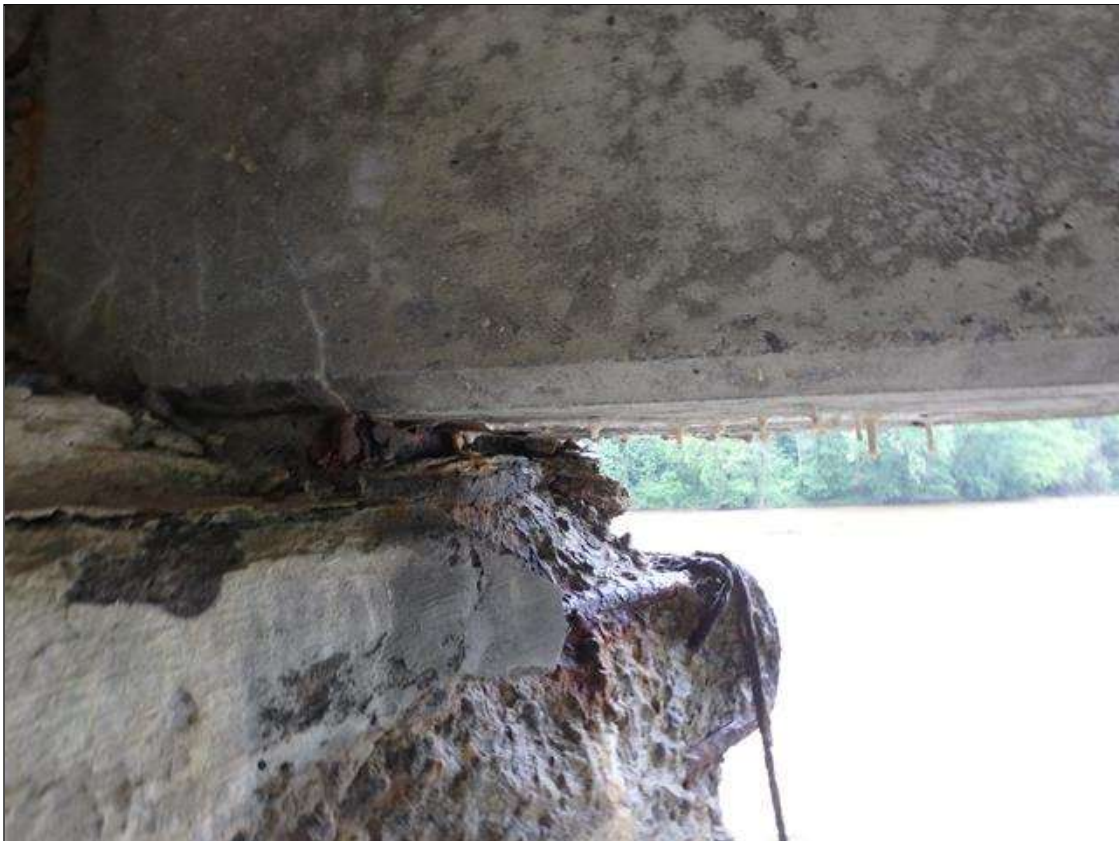
Bent 1 Cap : SPALL 2 FT X 1 FT X 6" DEEP WITH EXPOSED REBAR, SECTION LOSS UP TO 25%, AND LOSS OF BEARING AREA FOR BEAM 1, SPAN 2 FACE, PRIORITY MAINTENANCE

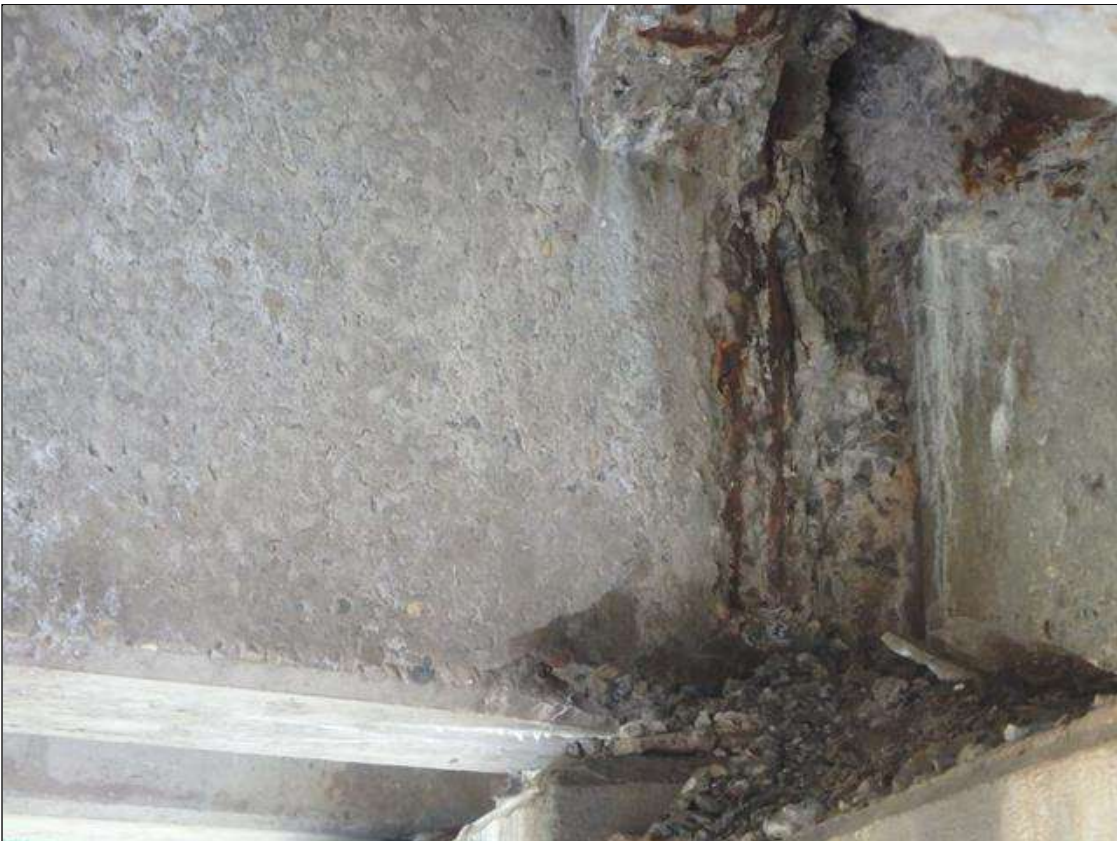
Span 2 Beam 3: SPALL 1 FT X 3 FT X UP TO 3" DEEP WITH EXPOSED REBAR, NO SECTION LOSS ALONG WEST FACE AT BENT 1
