NC DEPARTMENT OF TRANSPORTATION  
DIVISION OF HIGHWAYS  
STRUCTURE MANAGEMENT UNIT

## Structure Safety Report

### Routine Element Inspection - Contract

COUNTY: MADISON STRUCTURE NUMBER: 560009 FREQUENCY: 24 MONTHS

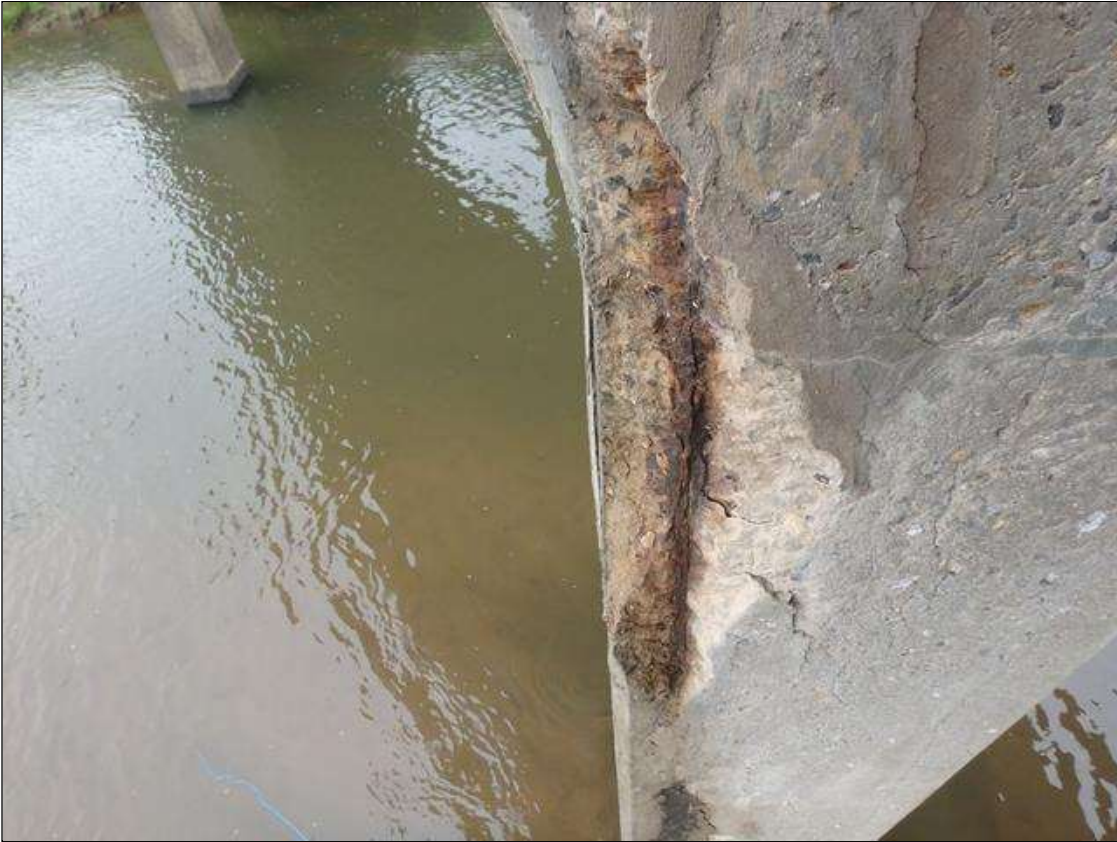
Bent 2 Pile 1: SPALL 4 FT X 10" X 6" WITH EXPOSED REBAR, 25% SECTION LOSS, ALONG SOUTHWEST CORNER, 5 FT BELOW CAP, PRIORITY MAINTENANCE

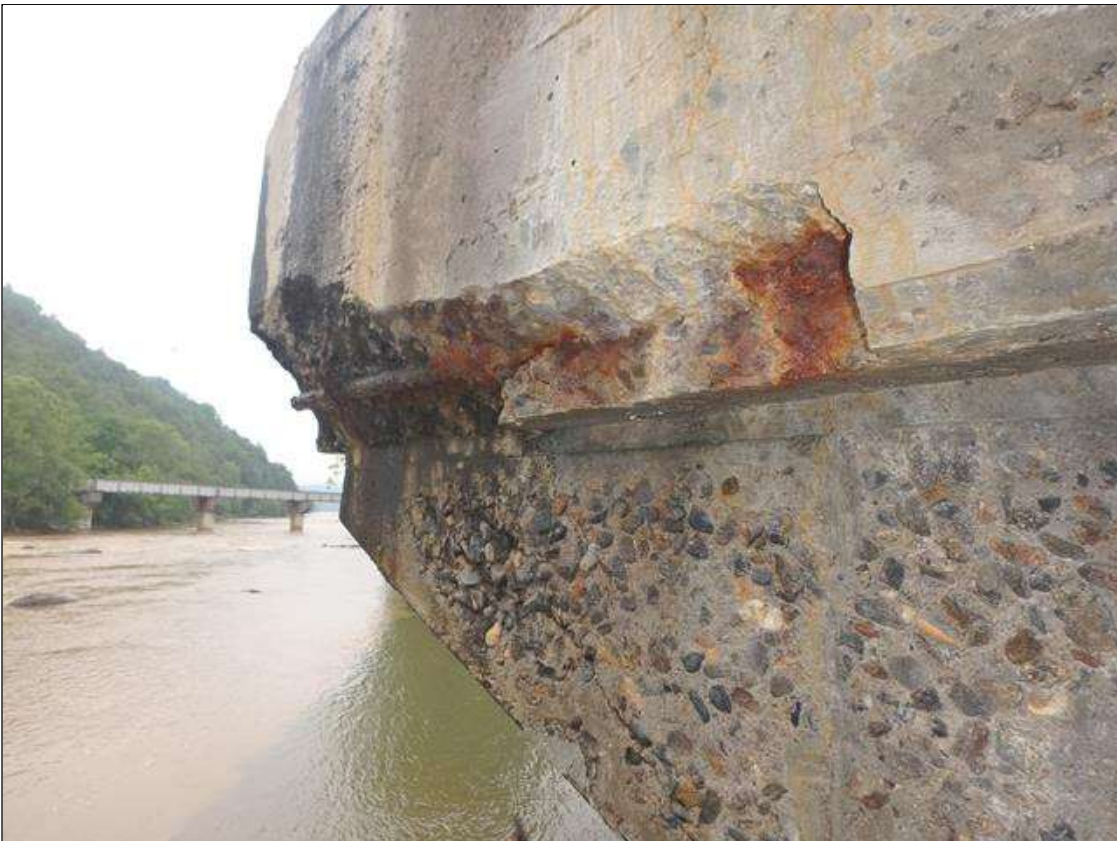
Bent 2 Cap : SPALL 8 FT X 1 FT X 6" WITH EXPOSED REBAR, NO SECTION LOSS, OVER COLUMN 1, SPAN 2 FACE, PRIORITY MAINTENANCE

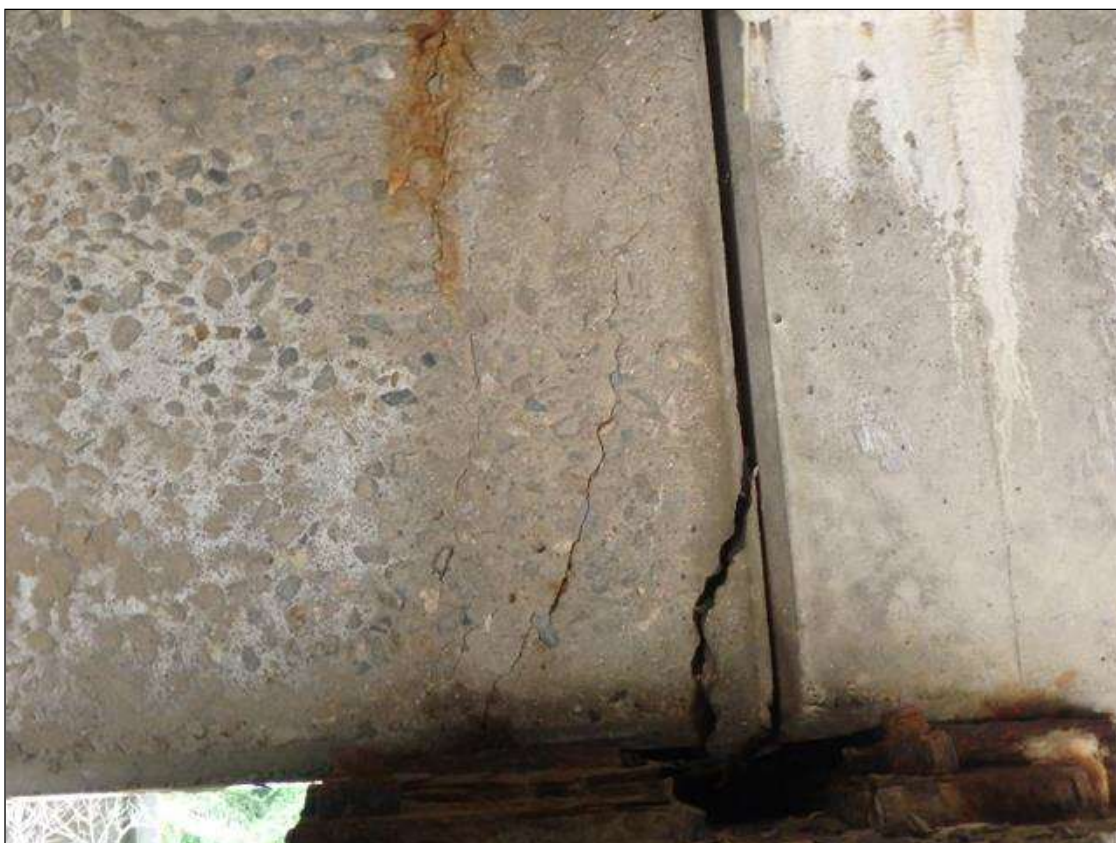
Span 3 Beam 2: SPALL 6" X 4" ALONG WEST FACE AT BENT 2

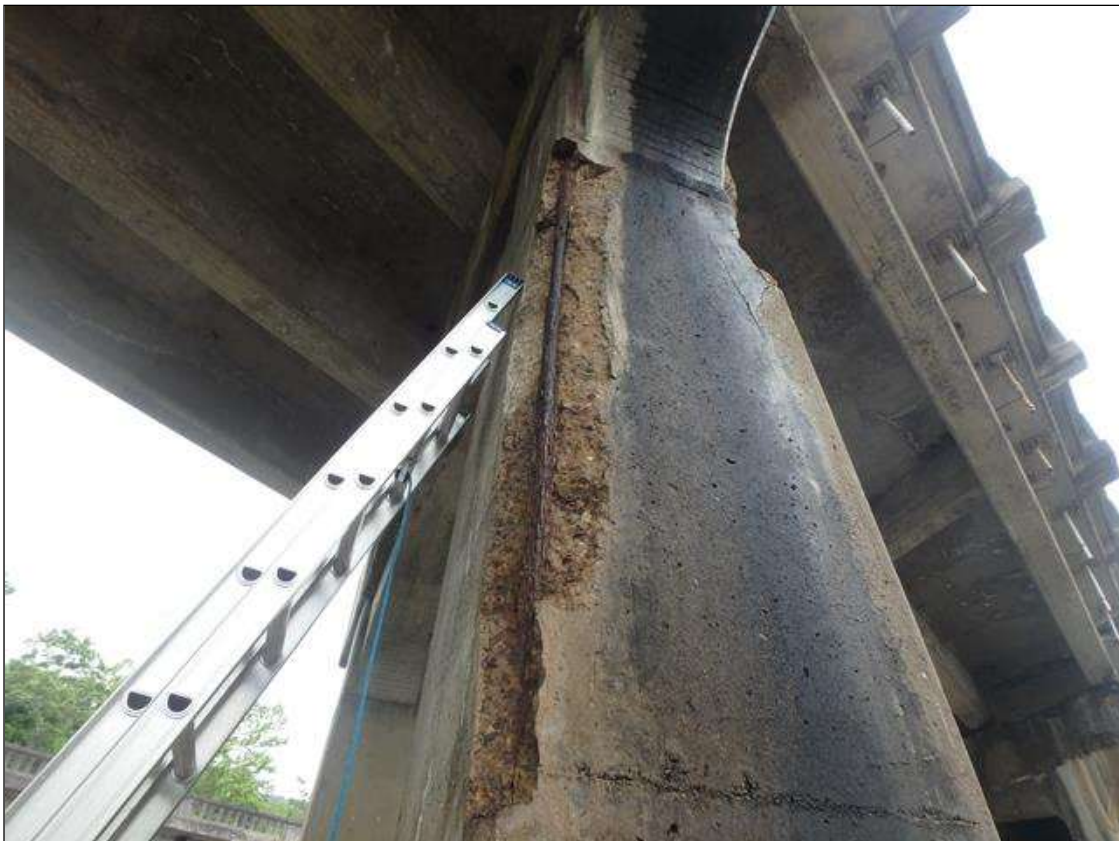
Bent 2 Pile 1: SPALL 8 FT X 1 FT X 8" WITH EXPOSED REBAR, 25% SECTION LOSS, ALONG NORTHWEST CORNER, PRIORITY MAINTENANCE

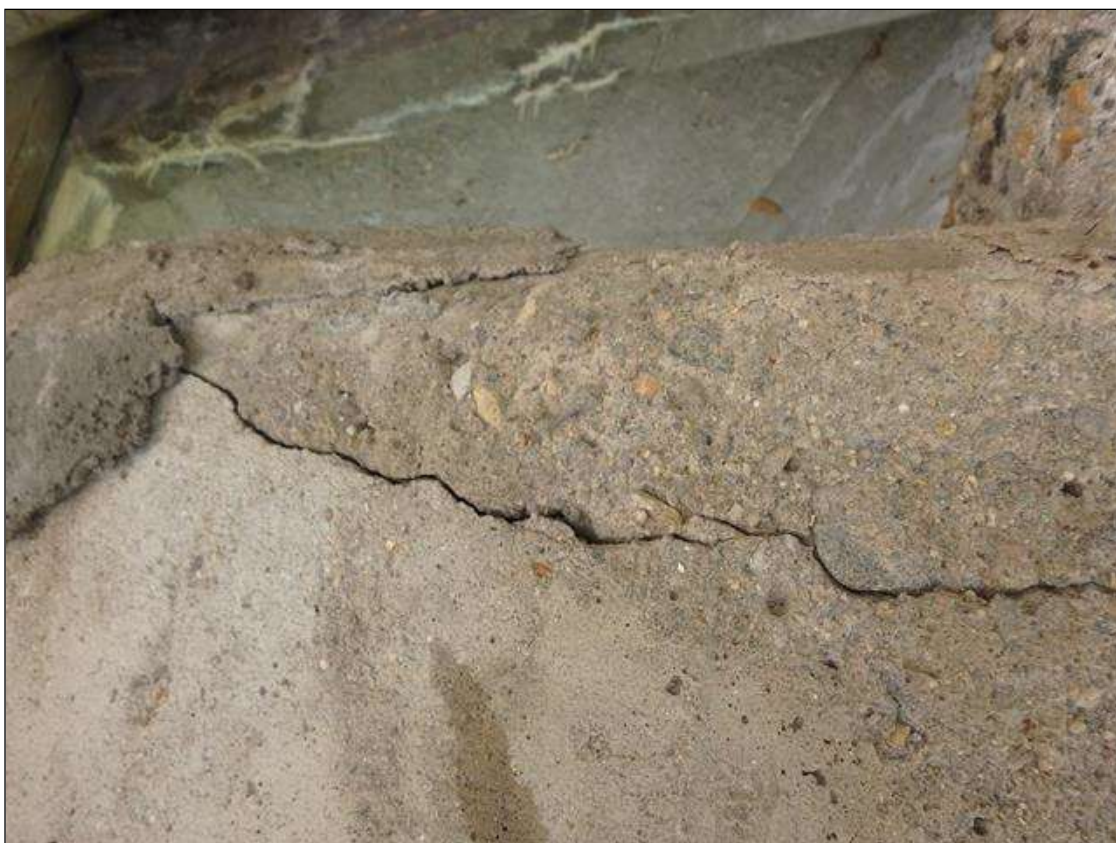
Bent 3 Cap : PREVIOUS REPAIR WITH 1 FT HORIZONTAL CRACK UP TO 1/8" IN BAY 3, SPAN 3 FACE

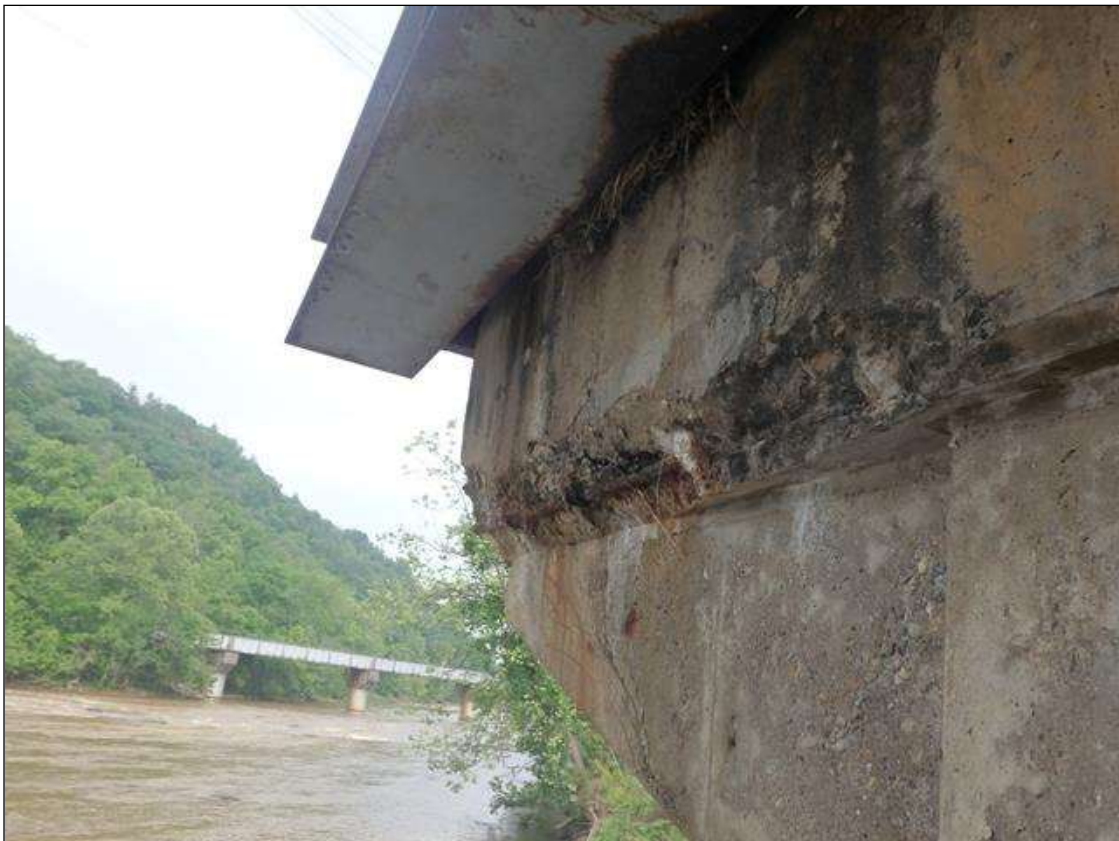
Bent 3 Cap : SPALL 4 FT X 6" X 6" WITH EXPOSED REBAR, NO SECTION LOSS, ALONG LEFT END, SPAN 3 FACE

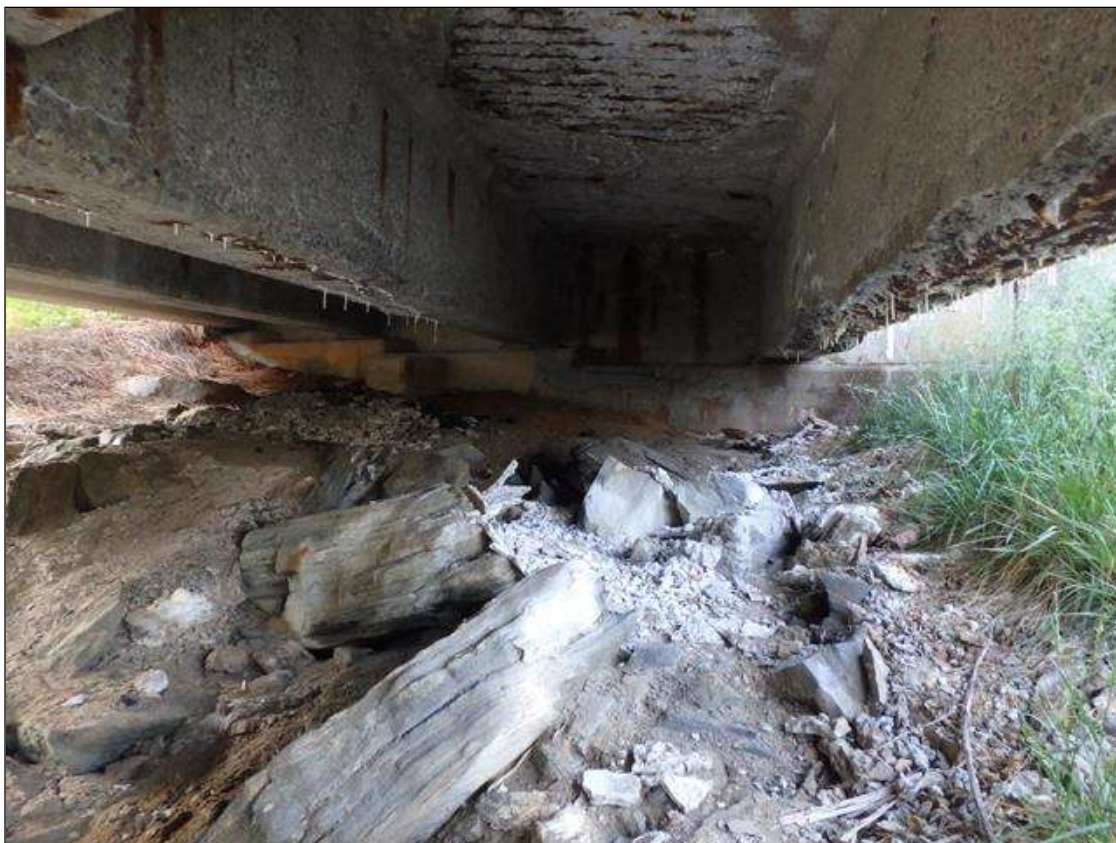
END BENT 1, END BENT 2 SIMILAR

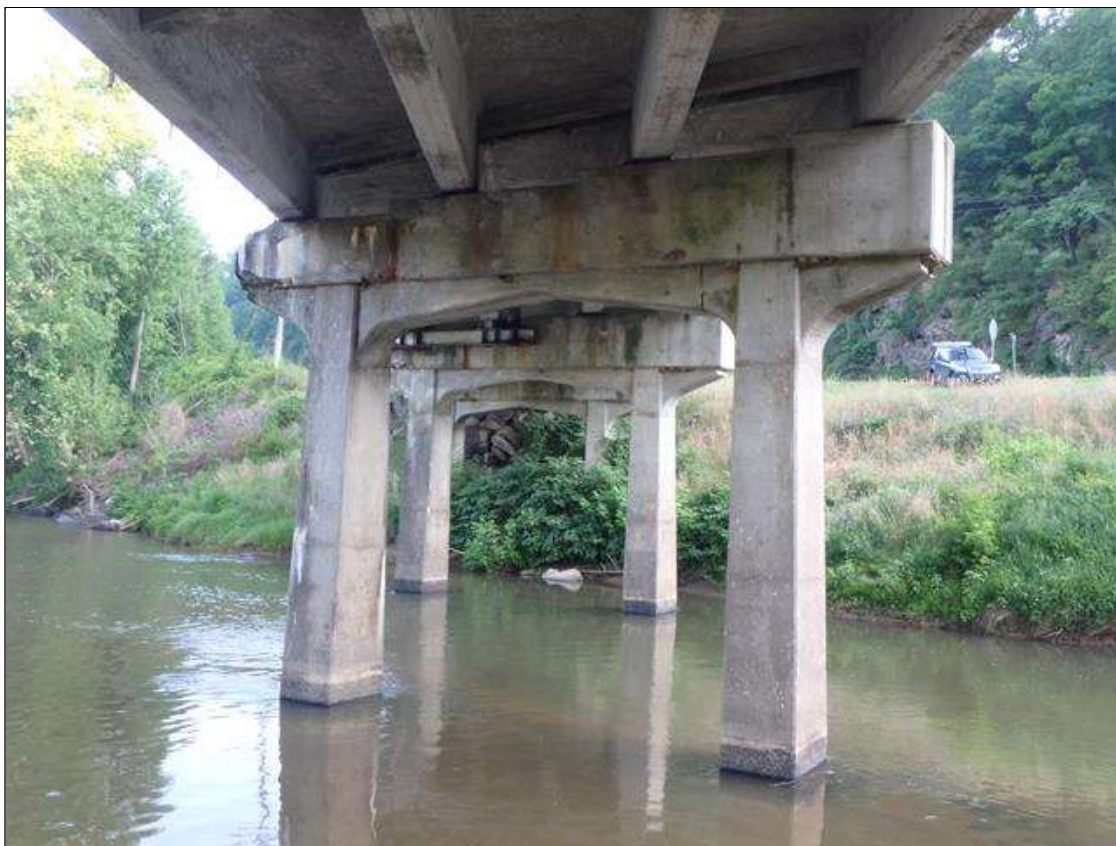
BENT 2, OTHERS SIMILAR

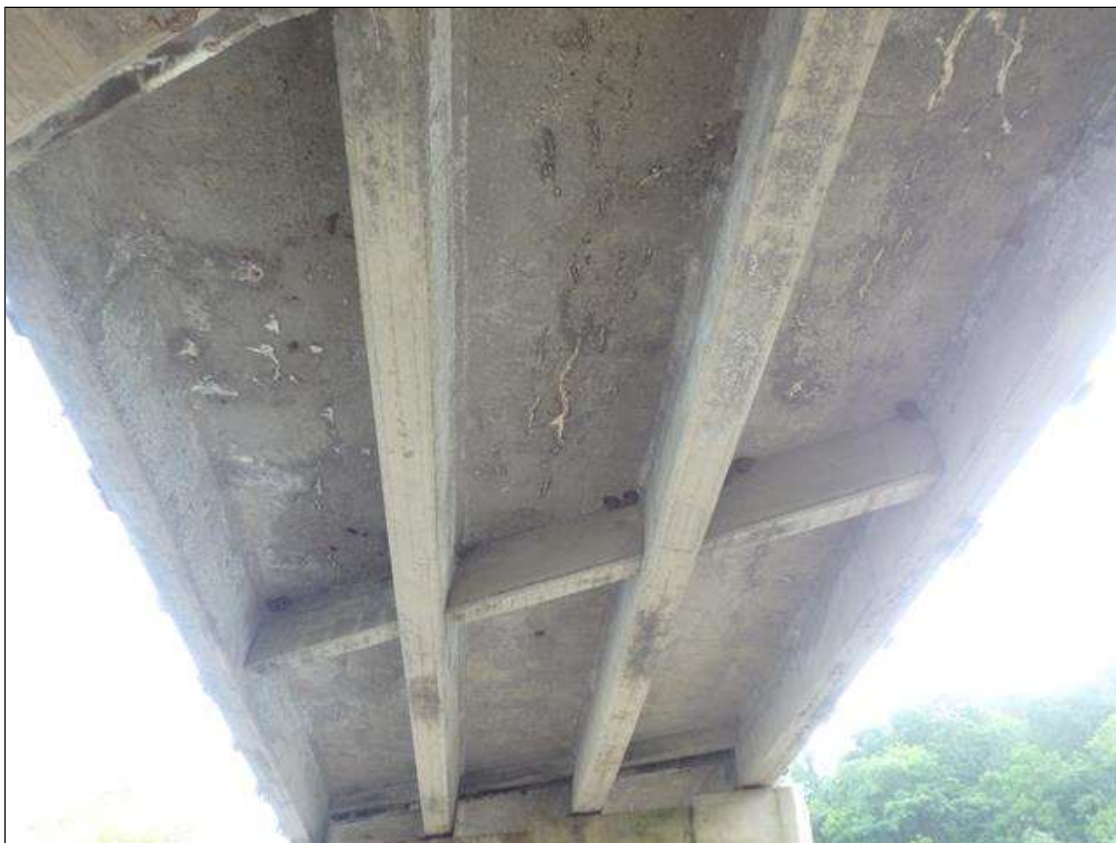
UNDERSIDE SPAN 2, OTHERS SIMILAR

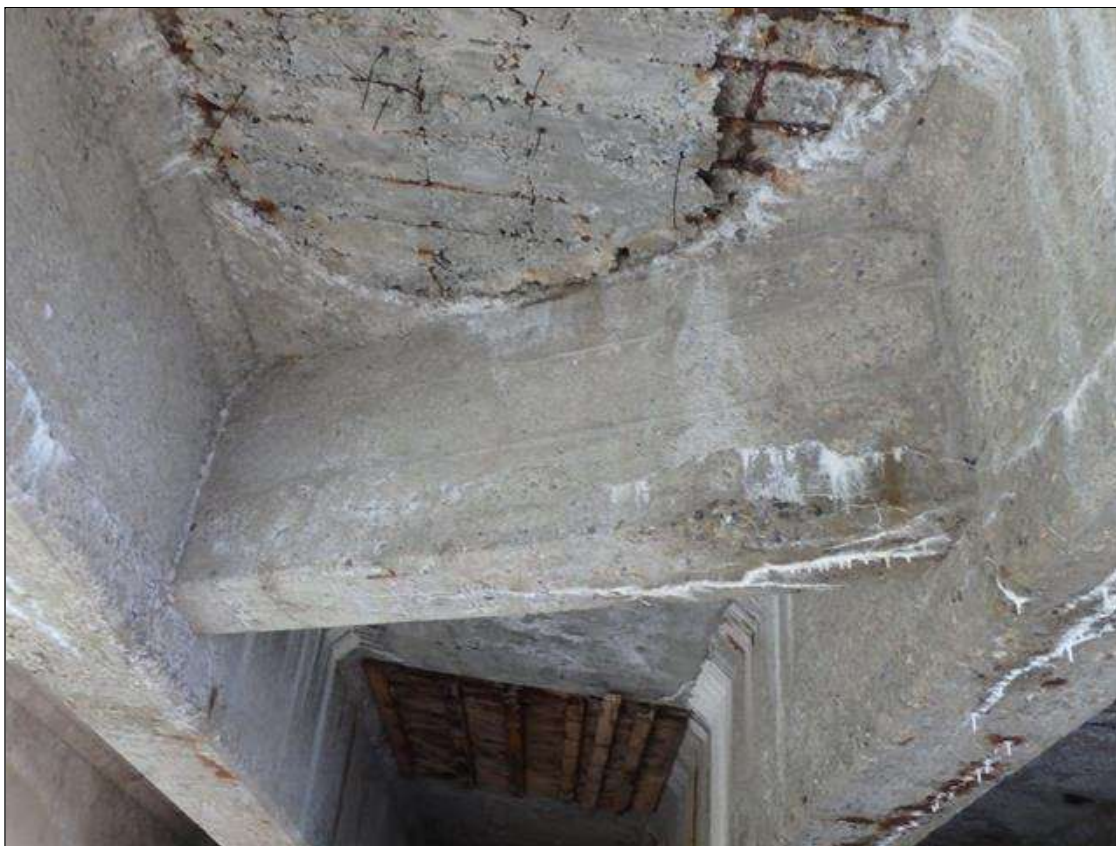
TYPICAL INTERMEDIATE DIAPHRAGM

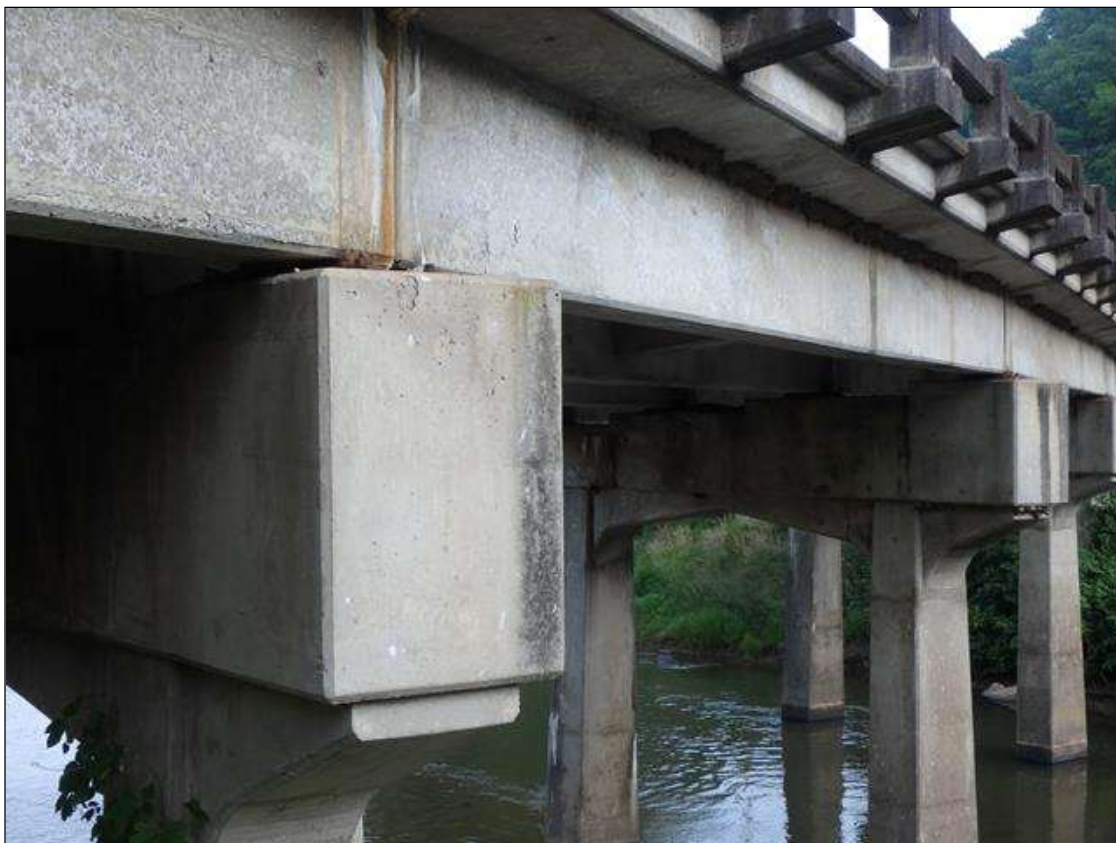
EAST END OF BENT 1 CAP, OTHERS SIMILAR

| MMS Code | Description of Function | Unit | Quantity | Remarks | Est. Cost |
|---|---|---|---|---|---|
| 3348 | Maintain Concrete Substructure Components | LF | 1 | BENT 1 CAP : SPALL FULL WIDTH X FULL HEIGHT X UP TO 6" DEEP WITH EXPOSED REBAR, UP TO 100% SECTION LOSS AT LEFT END, PRIORITY MAINTENANCE | |

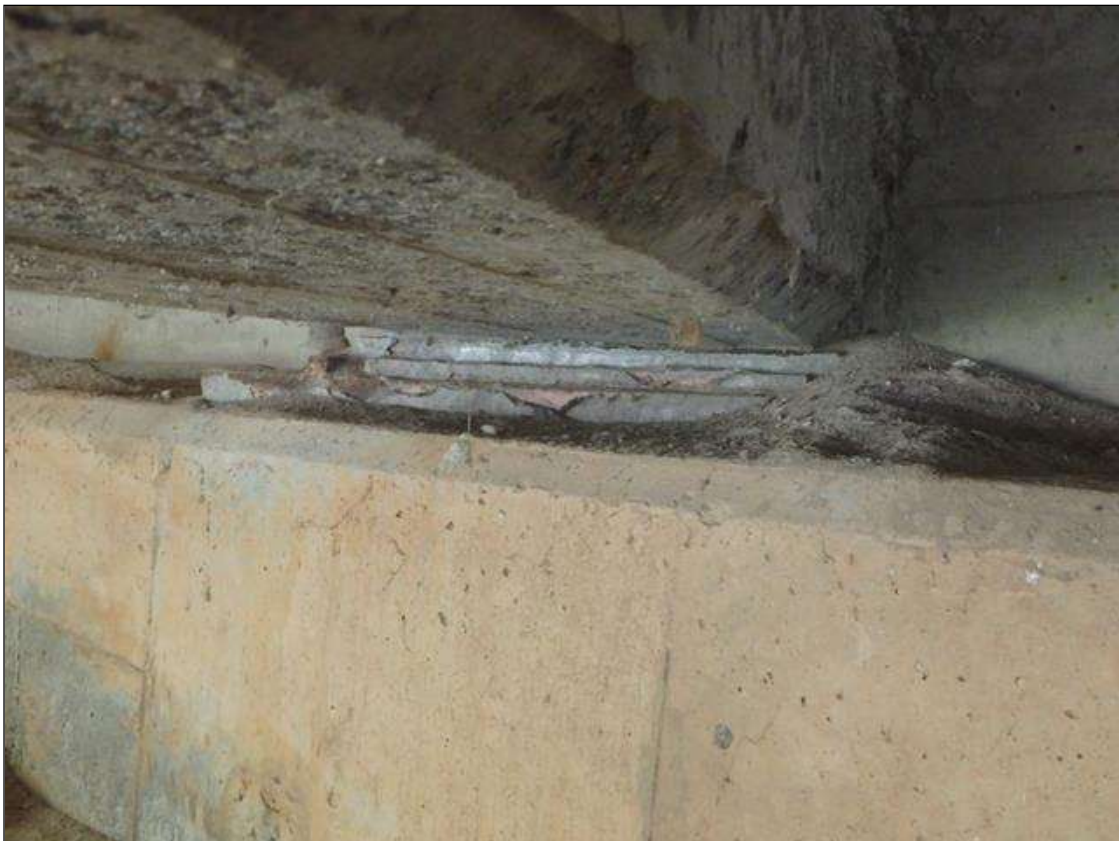
BEAM 3 BEARING AT END BENT 1, OTHERS SIMILAR

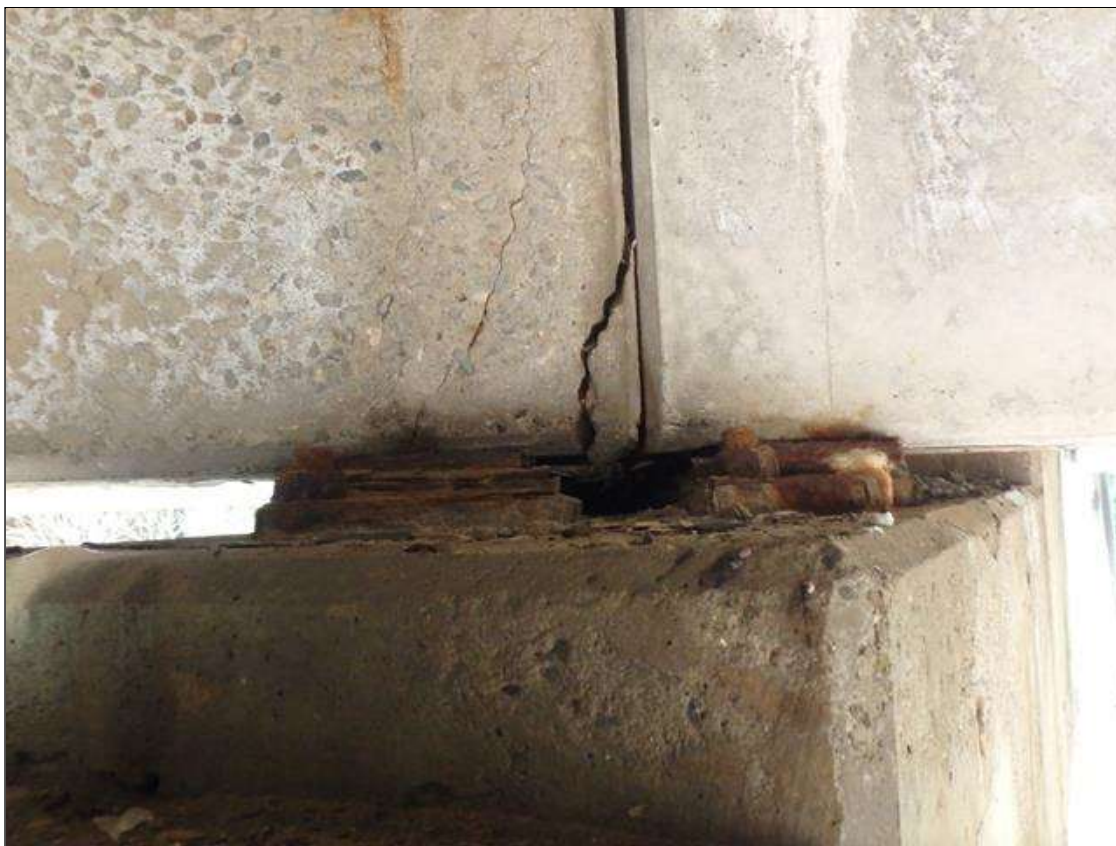
BEARING AT BEAM 2, BENT 2
