NC DEPARTMENT OF TRANSPORTATION  
DIVISION OF HIGHWAYS  
STRUCTURE MANAGEMENT UNIT

## Structure Safety Report

### Routine Element Inspection

COUNTY: ROBESON STRUCTURE NUMBER: 770028 FREQUENCY: 24 MONTHS

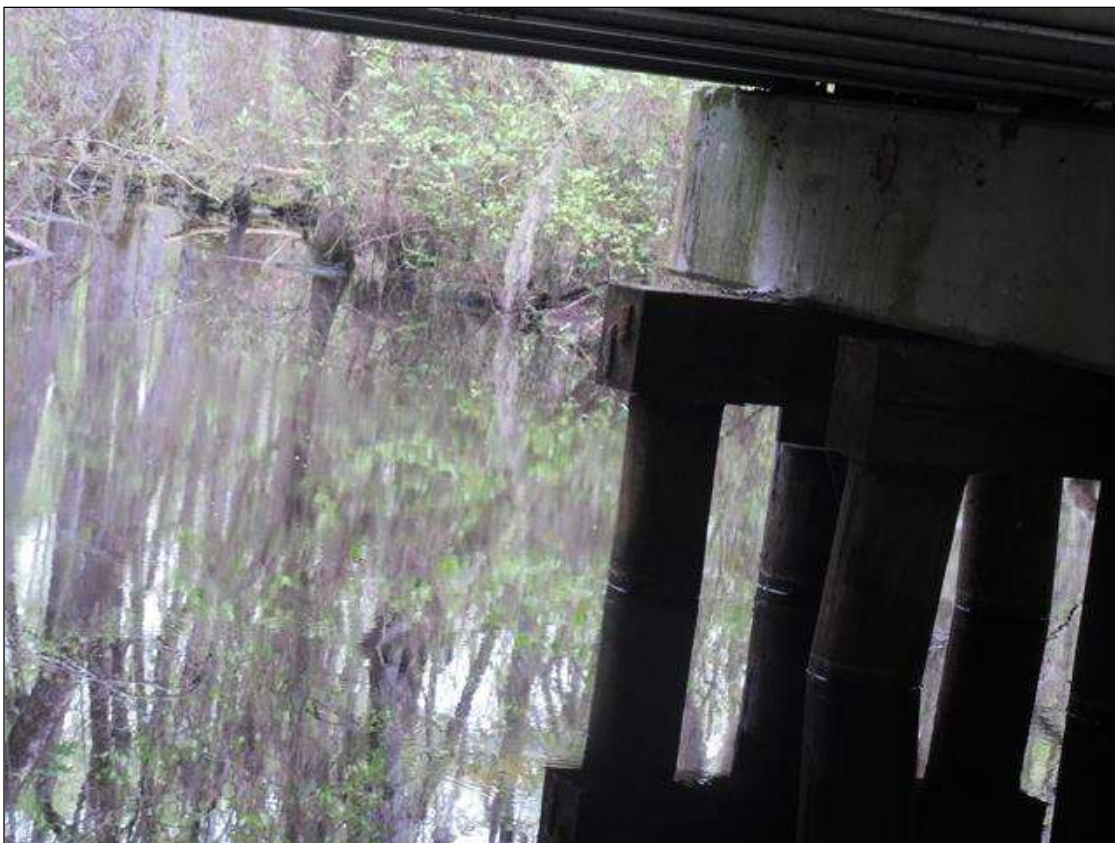
TIMBER CRUTCH WEST OF PILE 3 AT BENT 1 SHORED STRUCTURE ( PHOTO # 6524 )

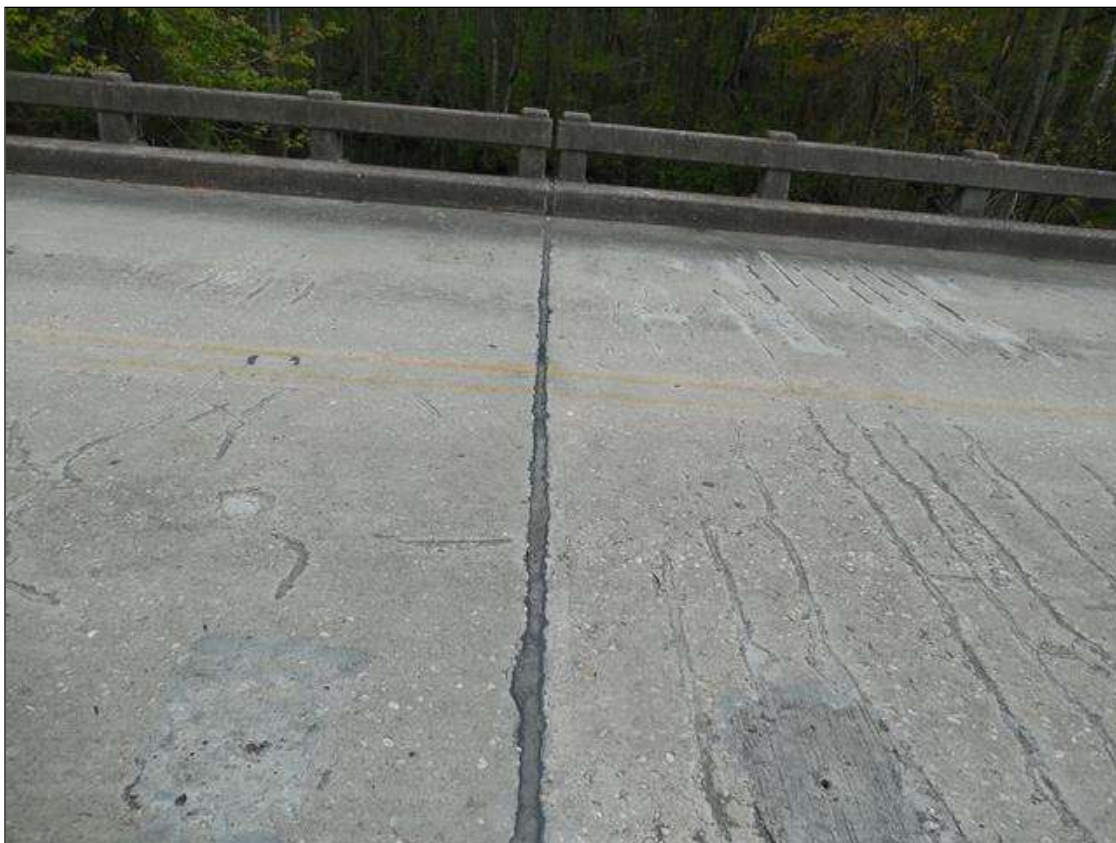
BENT 2 STANDARD JOINT, BENT 4 JOINT SIMILAR

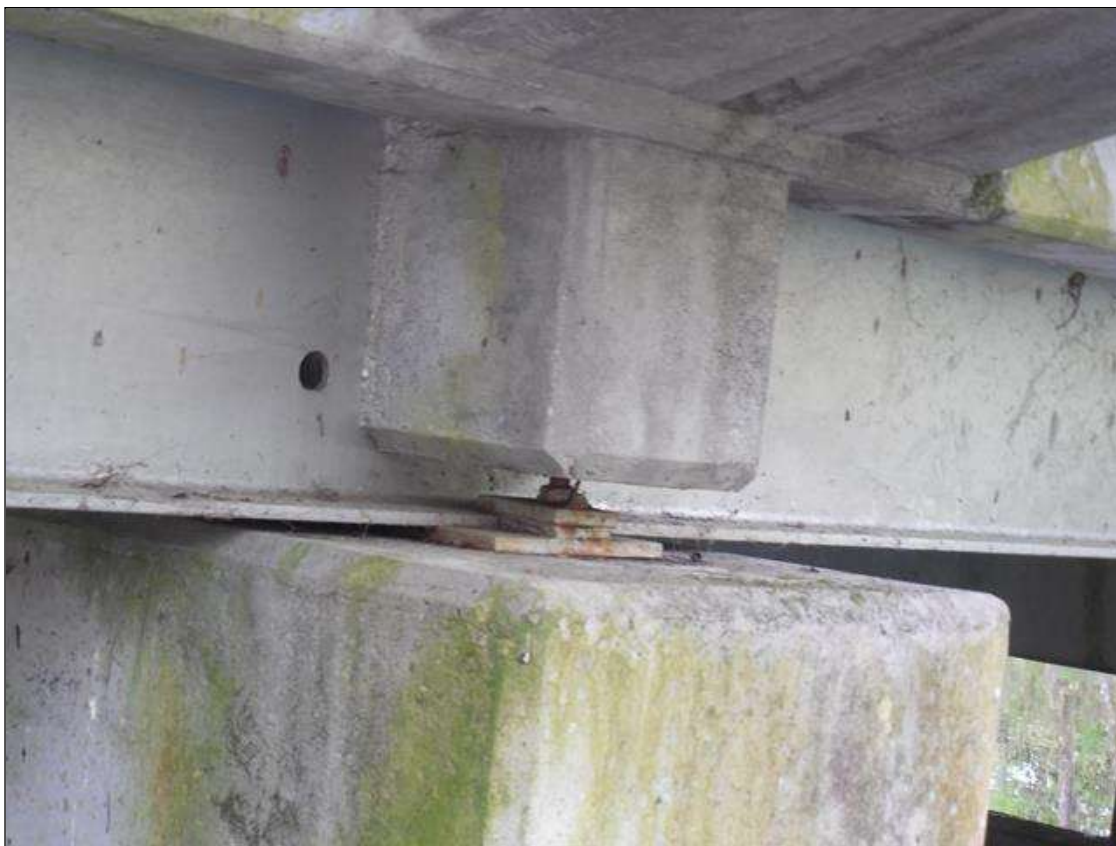
BEAM 1 BEARING AT BENT 5, ALL INTERIOR BEARINGS ARE SIMILAR

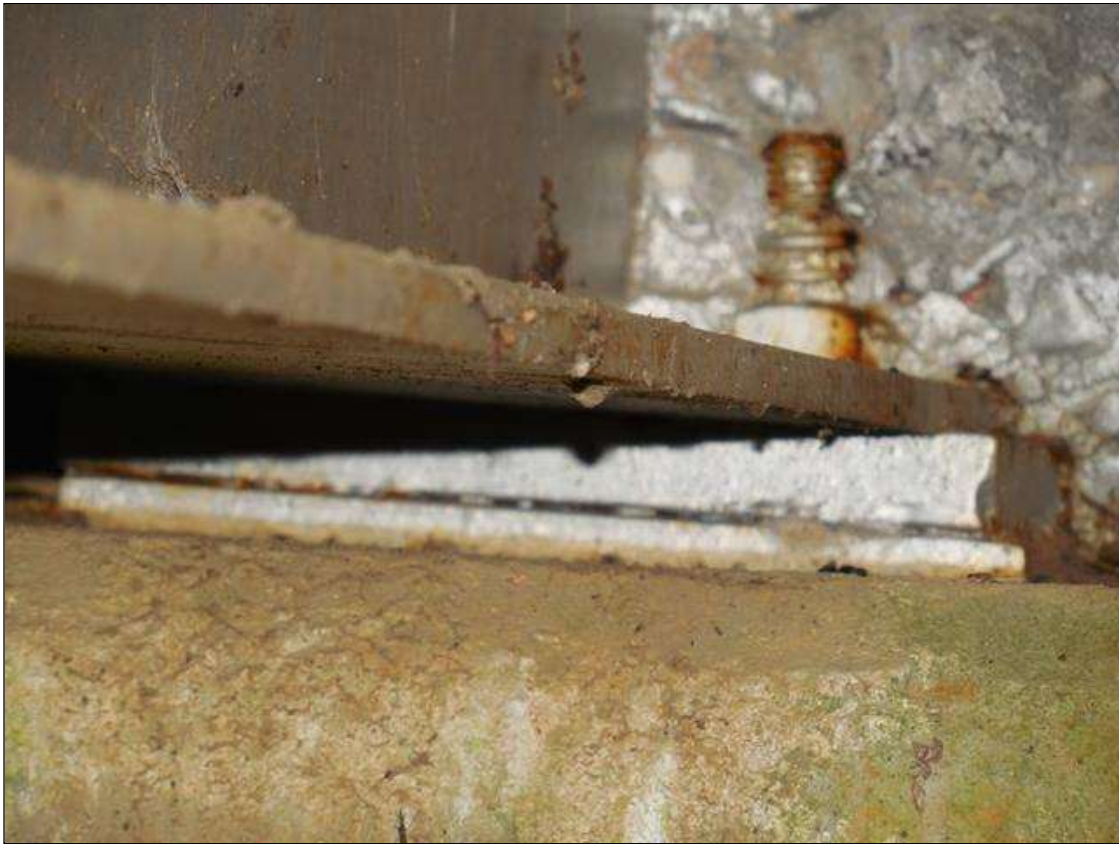
BEAM 6 BEARING AT END BENT 2, ALL END BENT BEARINGS ARE SIMILAR
