NC DEPARTMENT OF TRANSPORTATION  
DIVISION OF HIGHWAYS  
STRUCTURE MANAGEMENT UNIT

## Structure Safety Report

### Routine Element Inspection

COUNTY: BLADEN STRUCTURE NUMBER: 080013 FREQUENCY: 24 MONTHS  
FACILITY CARRIED: SR1100 MILE POST: \_\_\_\_\_  
LOCATION: 0.4MI.E. OF JCT. SR1122  
FEATURE INTERSECTED: CRAWLEY SWAMP  
LATITUDE: 34° 37' 6.02" LONGITUDE: 78° 48' 2.78"  
SUPERSTRUCTURE: RC FLOOR ON TIMBER JOISTS  
SUBSTRUCTURE: EBTS&IBTS:TIMBER CAPS ON TIMBER PILES @ VAR.CTS.  
SPANS: 1@18"; 3@16.83"; 1@18"  
☐ FRACTURE CRITICAL ☐ TEMPORARY SHORING ☐ SCOUR CRITICAL ☒ SCOUR PLAN OF ACTION  
PRESENT CONDITION: Poor INSPECTION DATE: 06/09/2015  
POSTED SV: 19 POSTED TTST: 28  
OTHER SIGNS PRESENT: 4 DELINEATORS

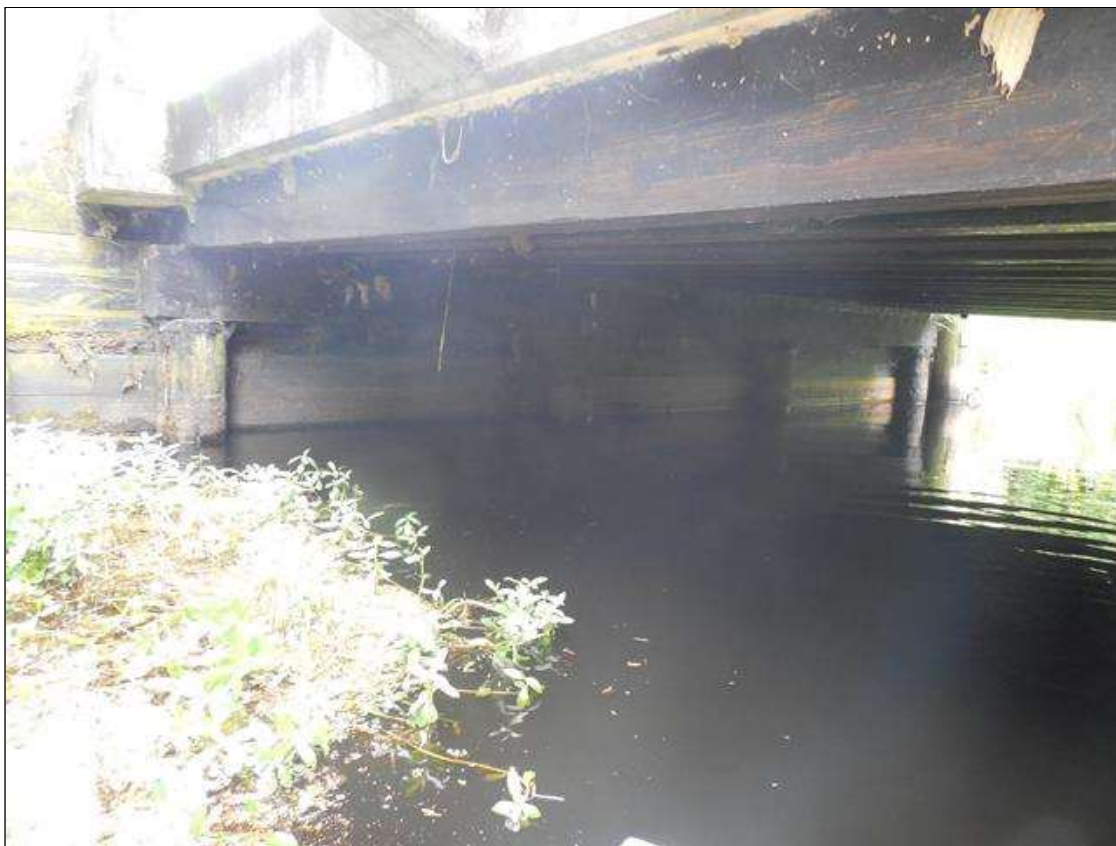
SURFACE SOFT TO 1/8".  
 APROX. MAX. W/D AT ABUTMENT 1- 2.0"  
 1 Feet of Decay/Section Loss: Affects 10% or more of the member but does not warrant structural review. TURNPILE AT  
 SOUTHWEST CORNER DECAYED 4' HIGH X 6" WIDE X 3" DEEP

END BENT 1 TIMBER ABUTMENT DECAYED 4' AT SOUTHWEST CORNER

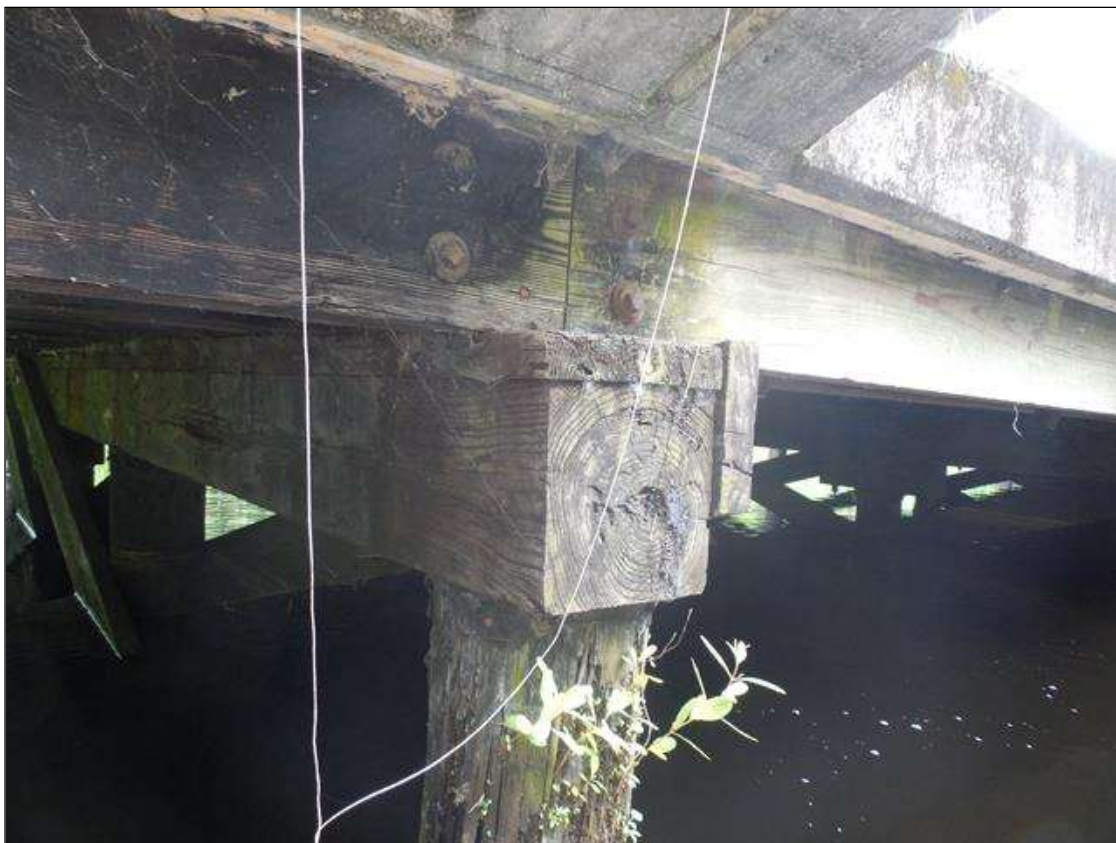
SOUTH END OF BENT 1 CAP

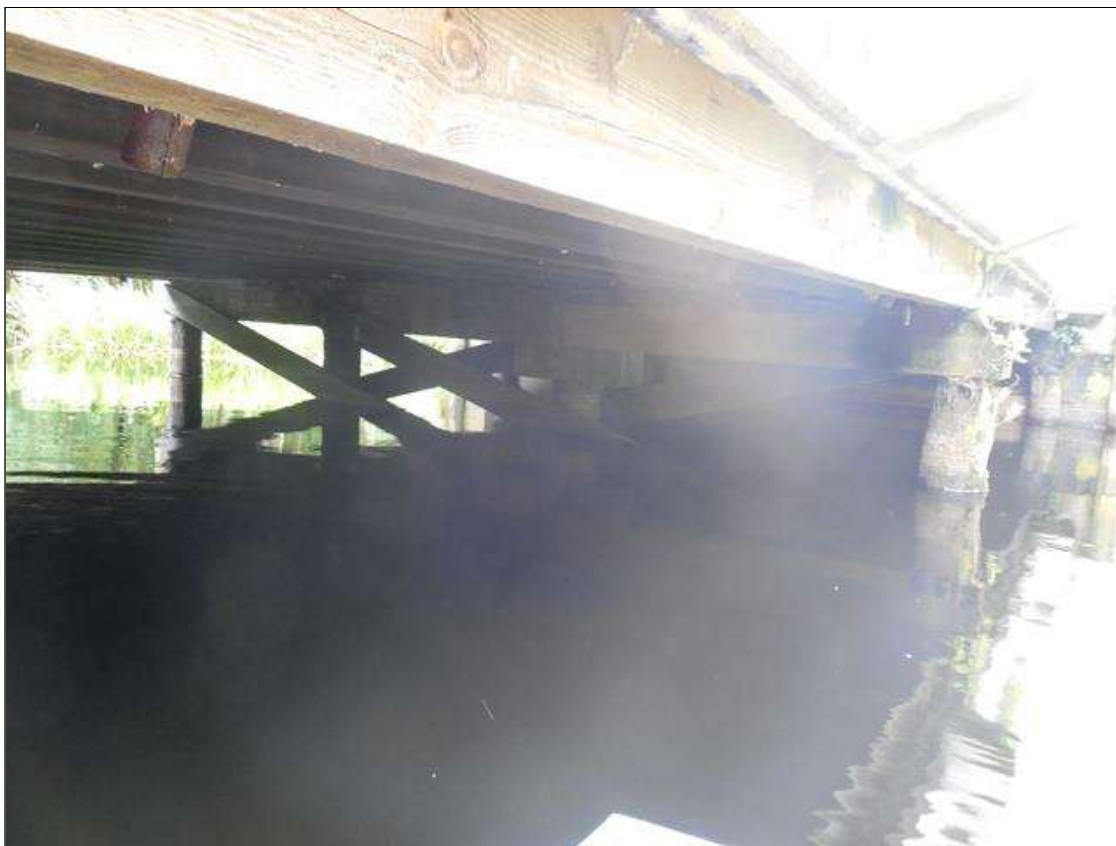
PILE 1 AT BENT 1 DECAYED 2' HIGH X 10" WIDE X 2" DEEP

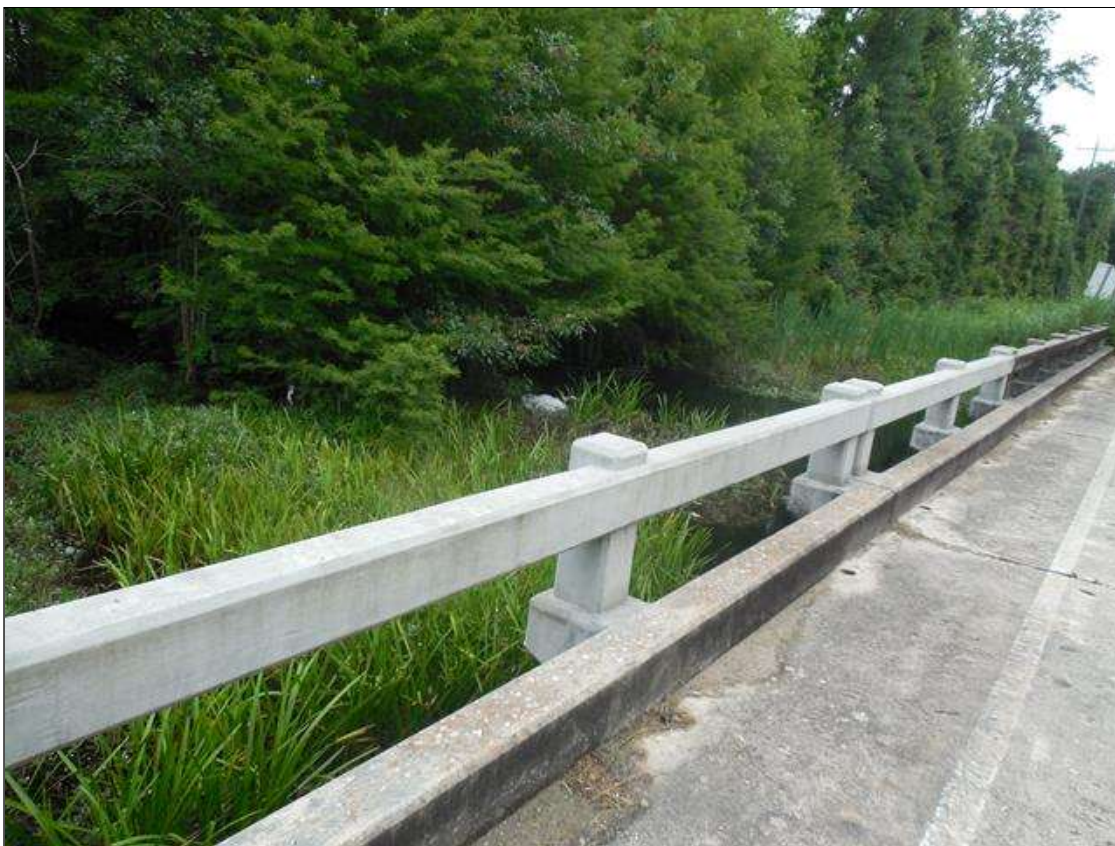
NEW LEFT RAIL IN SPANS 1 AND 2
