NC DEPARTMENT OF TRANSPORTATION  
DIVISION OF HIGHWAYS  
STRUCTURE MANAGEMENT UNIT

## Structure Safety Report

### Routine Element Inspection - Contract

COUNTY: ROBESON STRUCTURE NUMBER: 770434 FREQUENCY: 24 MONTHS

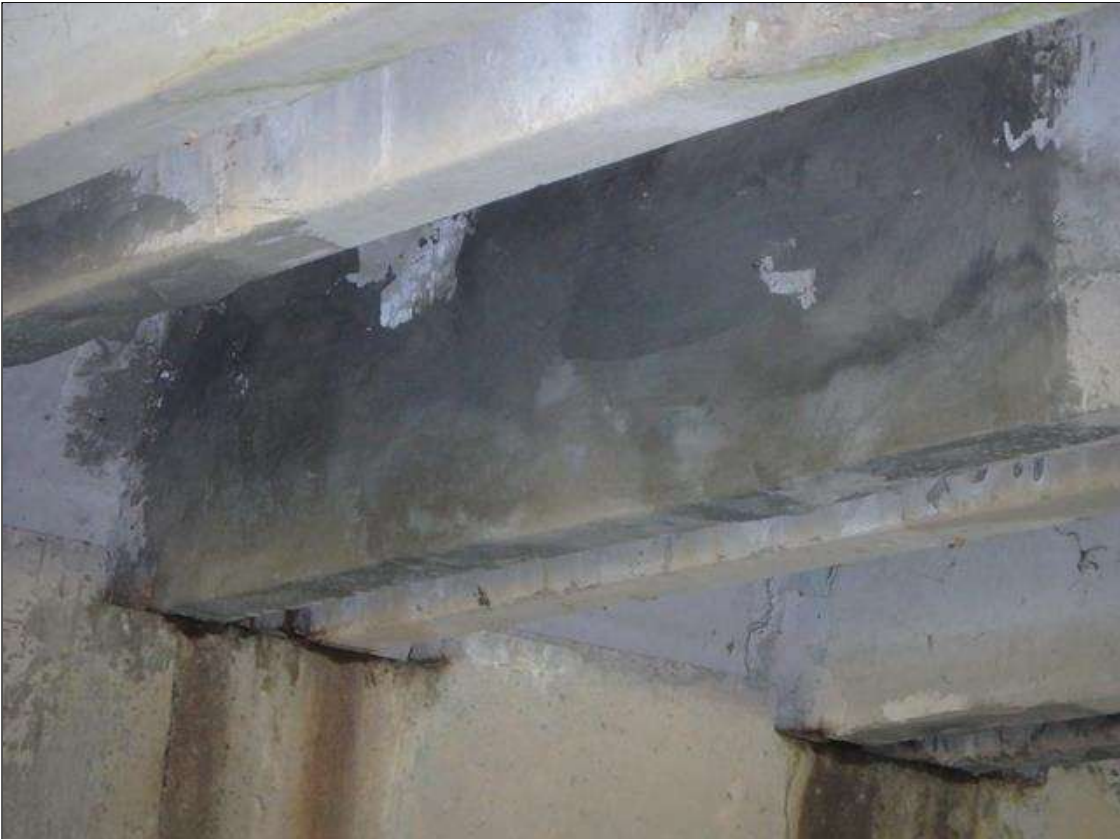
SPAN 1 CHANNEL 4 AT BENT, BOTTOM OF RT LEG HAS TEMPORARY REPAIR SOUND CONC. PATCH 3FT. LONG

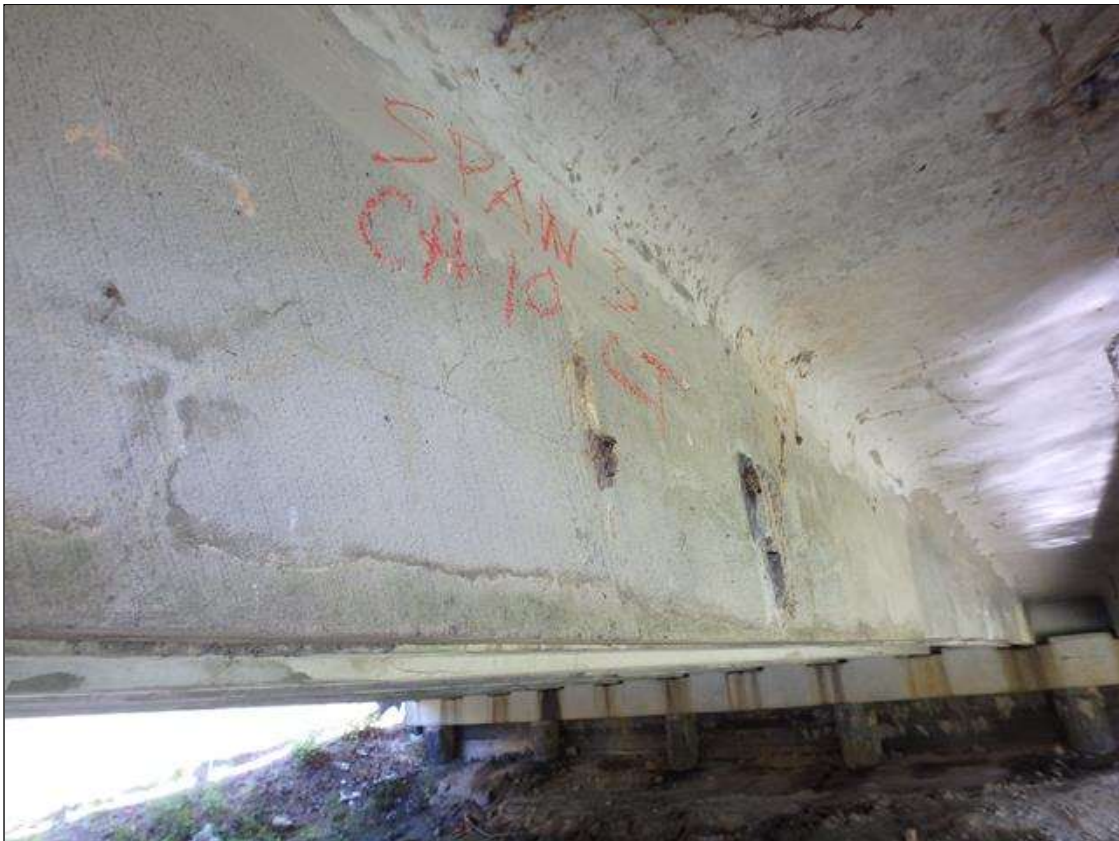
SPAN 3 CHANNEL 10 BEGIN 2FT. FROM BENT BOTTOM LT. LEG HAS TEMPORARY REPAIR, SOUND CONC. PATCHING 20FT. LONG.

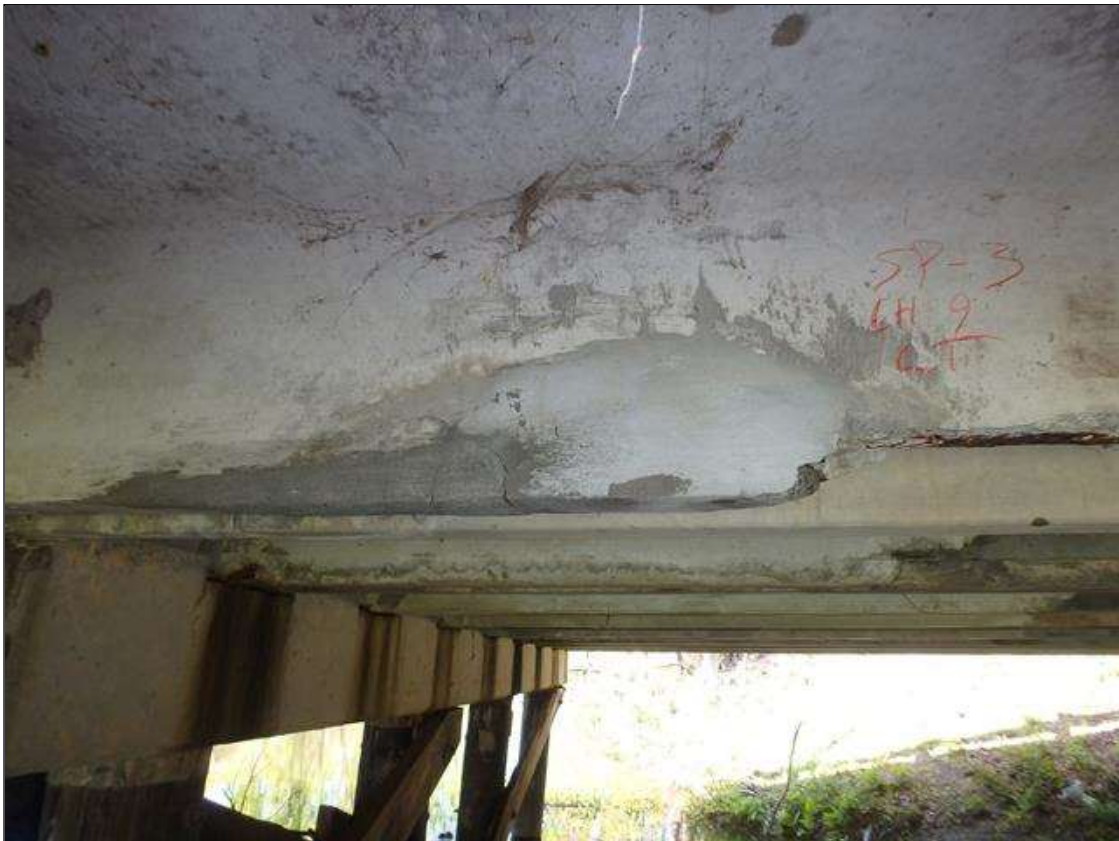
SPAN 3 CHANNEL 9 BOTTOM LT. LEG NEAR BENT PATCH W/ DELAMINATION 3IN. H X 30IN. L & SPALL WITH EXPOSED STEEL 3IN. H X 20IN. LONG. PRIORITY MAINTENANCE

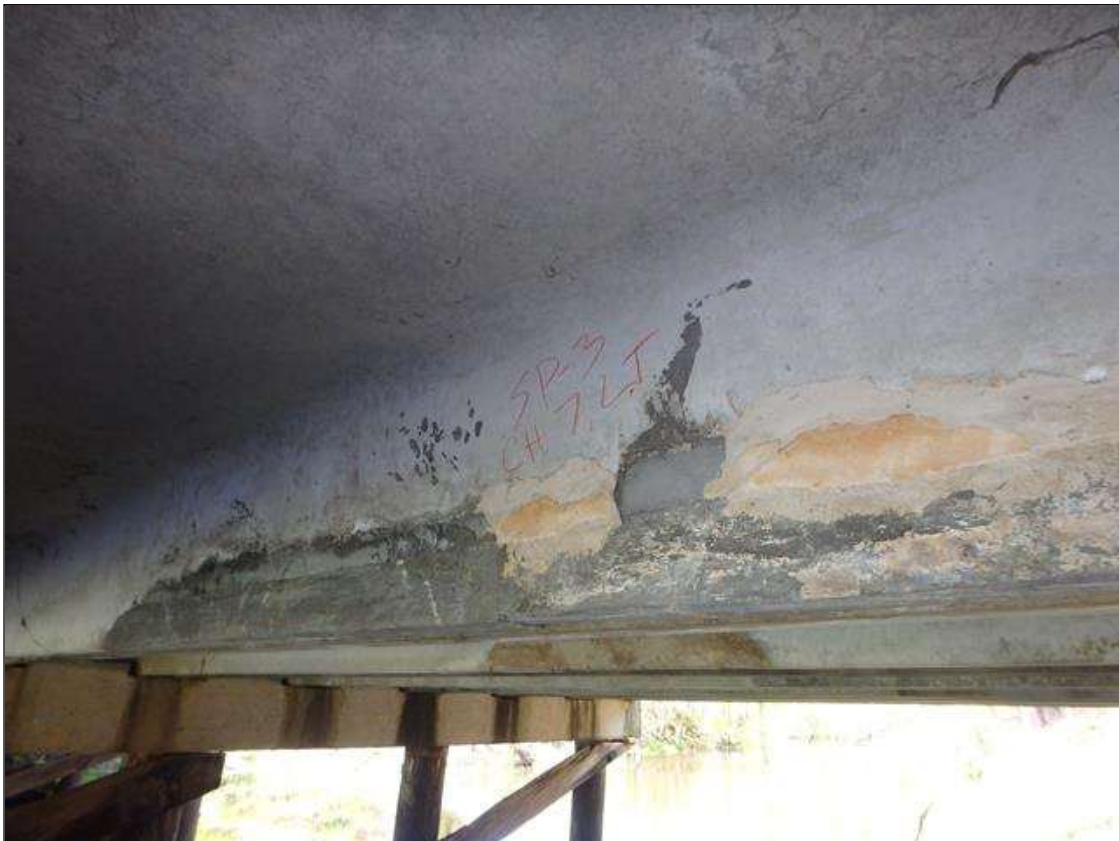
MID-SPAN 3 CHANNEL 7 BOTTOM OF LT. LEG HAS TEMPORARY REPAIR, SOUND CONC. PATCH 4IN. H X 7FT. LONG.

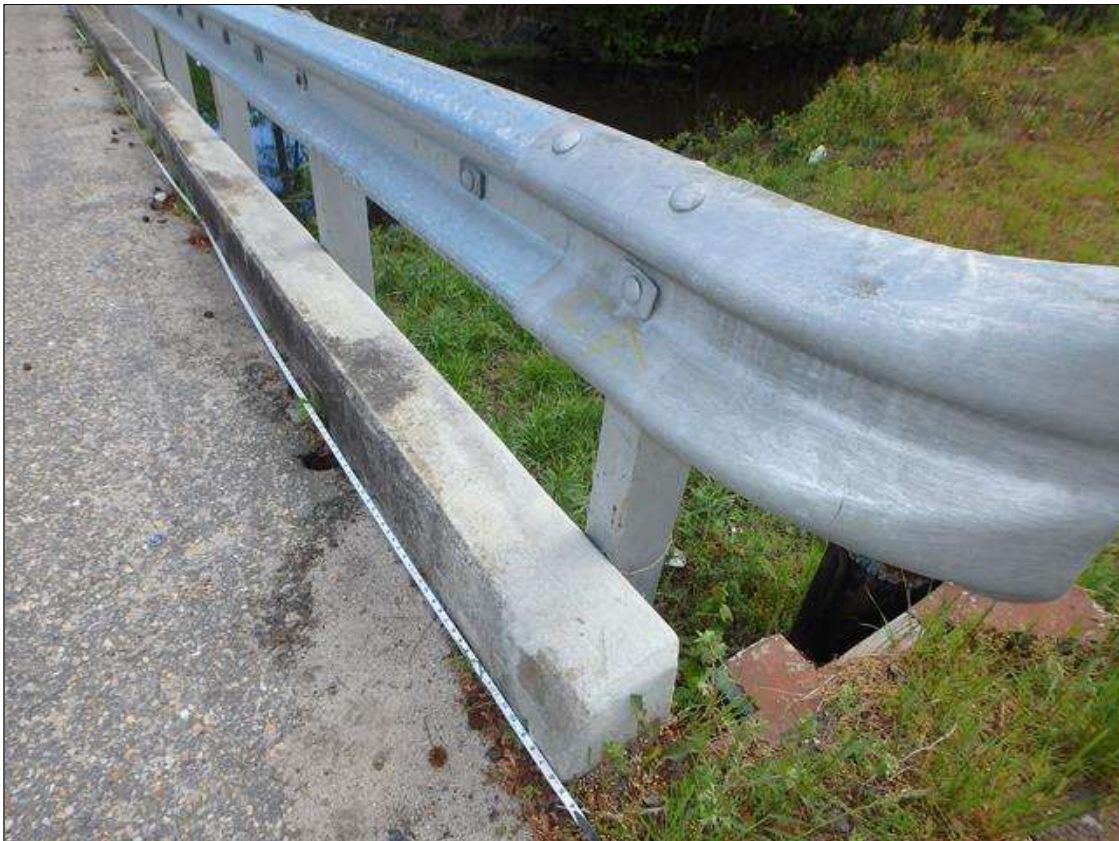
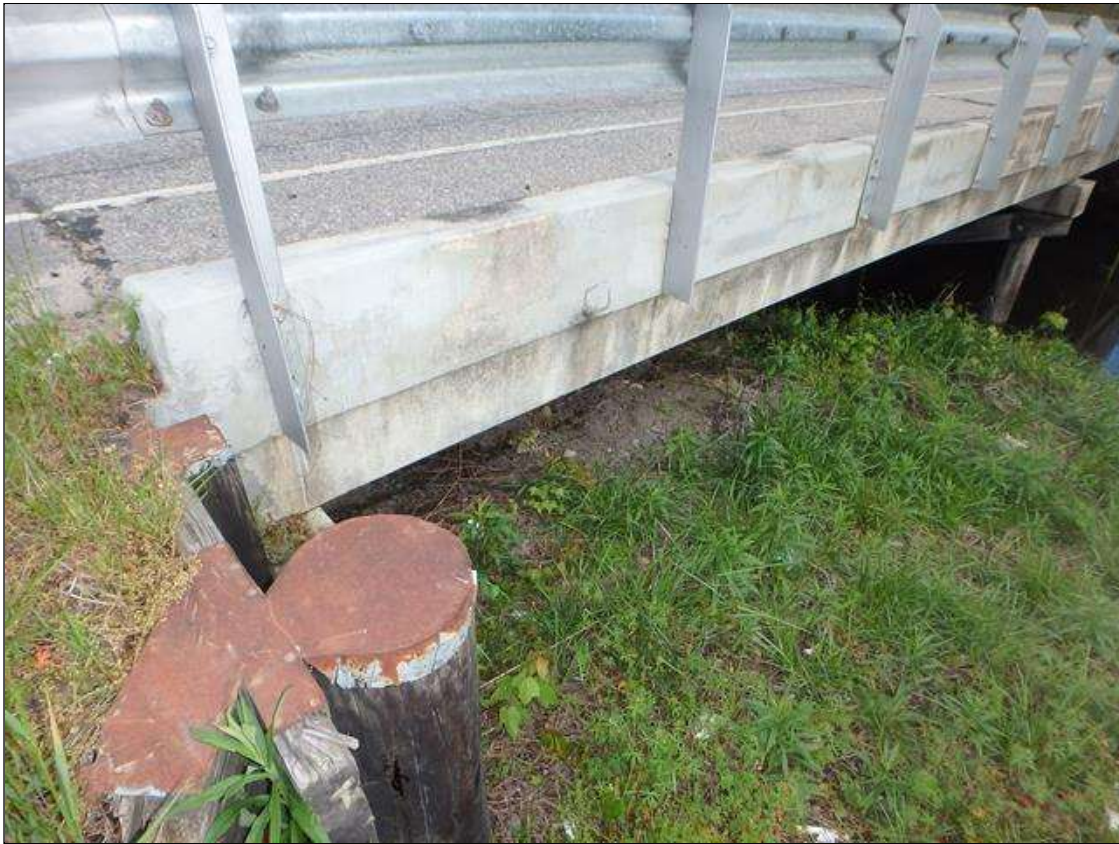
RIGHT CURB SPAN 1 HAS CONCRETE PATCHING 14 FT. LONG STARTING AT SOUTH END.

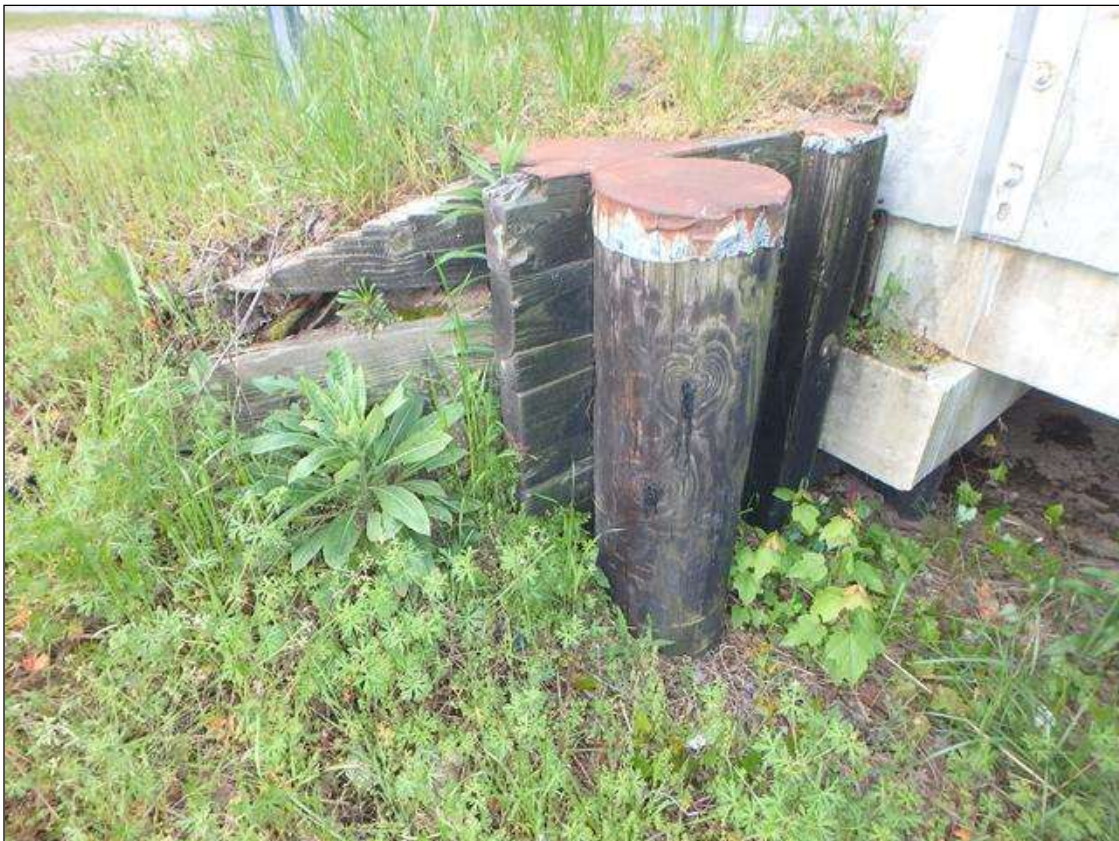
SOUTHEAST CORNER WINGWALL TOP BOARD DECAYED AND LOOSE EXPOSING FILL.

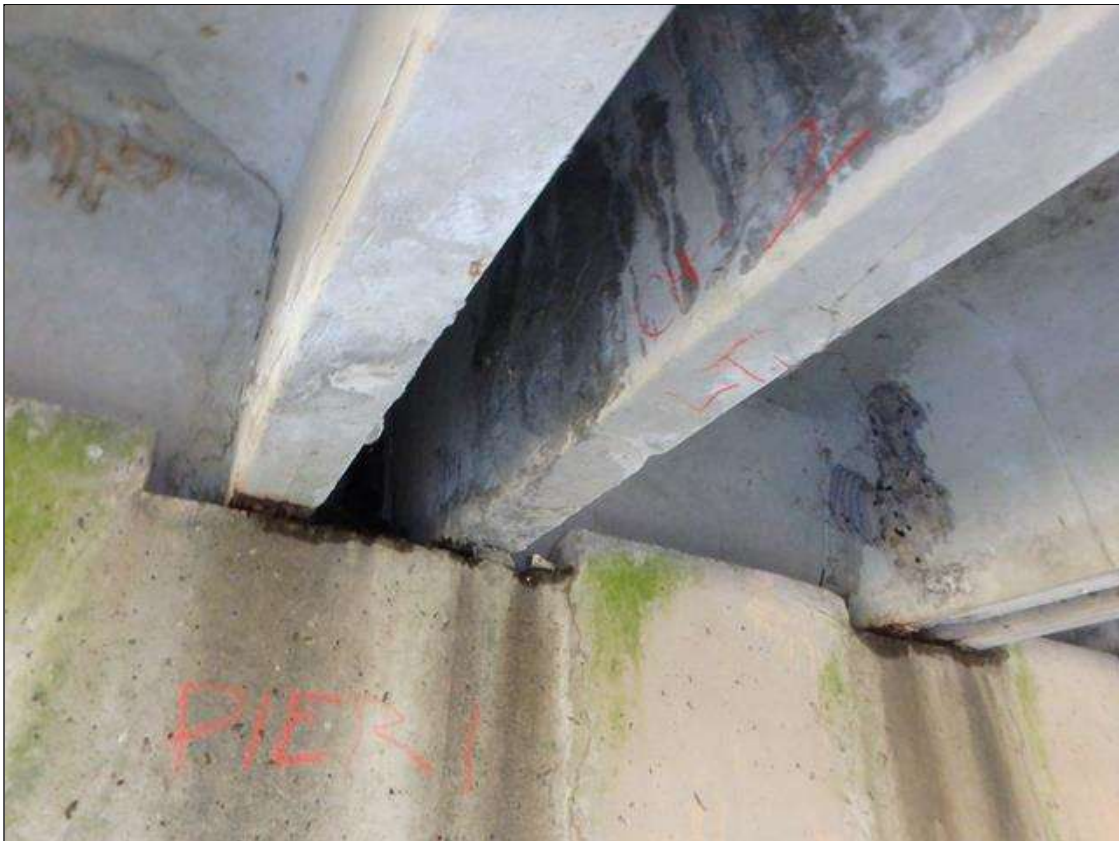
SPAN 1 CHANNEL 2 AT BENT 1 BOTTOM OF LEFT LEG HAS TEMPORARY REPAIR CONC. PATCHING 18IN. LONG X 4IN. HIGH TO LEFT SIDE.

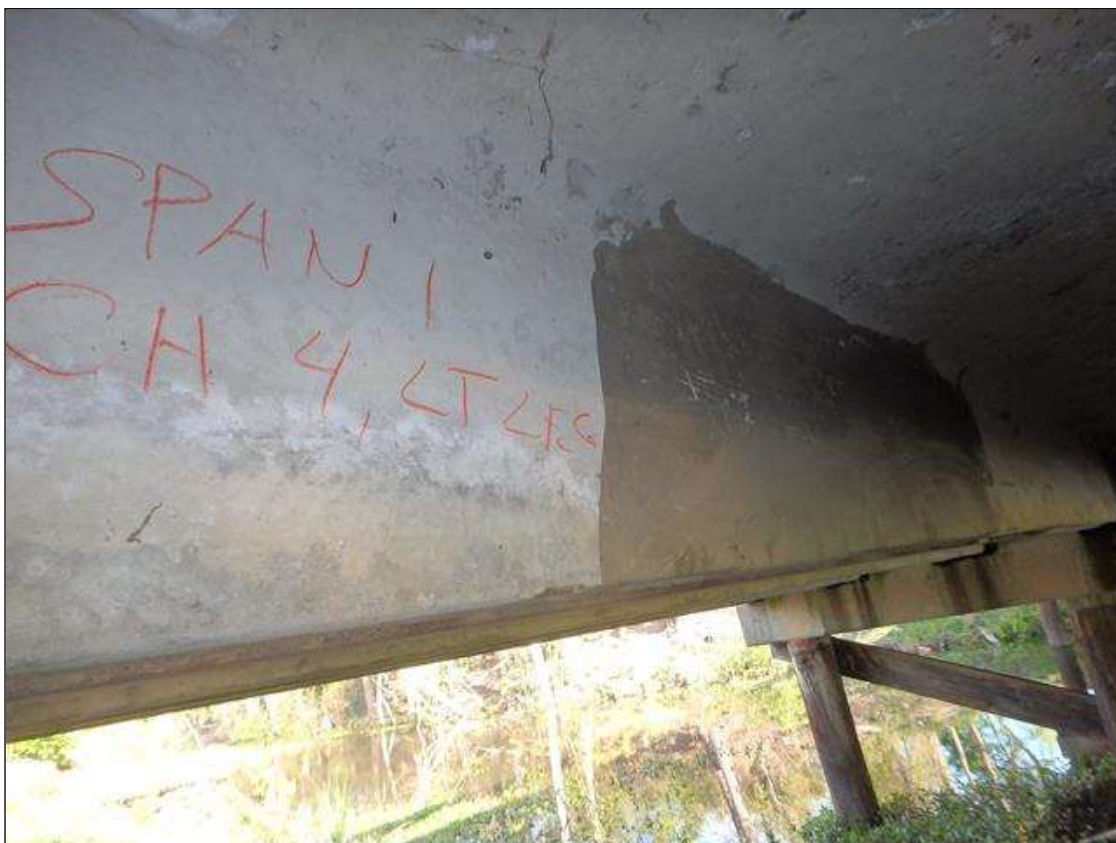
CHANNEL 4 AT BENT 1 AND AT MID-SPAN BOTTOM OF BOTH LEGS HAVE TEMPORARY REPAIRS SOUND CONC. PATCHES 4FT. LONG AT EACH LOCATION.

SPAN 1 CHANNEL 4 AT MID-SPAN LT. LEG HAS TEMPORARY REPAIR SOUND CONC. PATCH 4FT. LONG

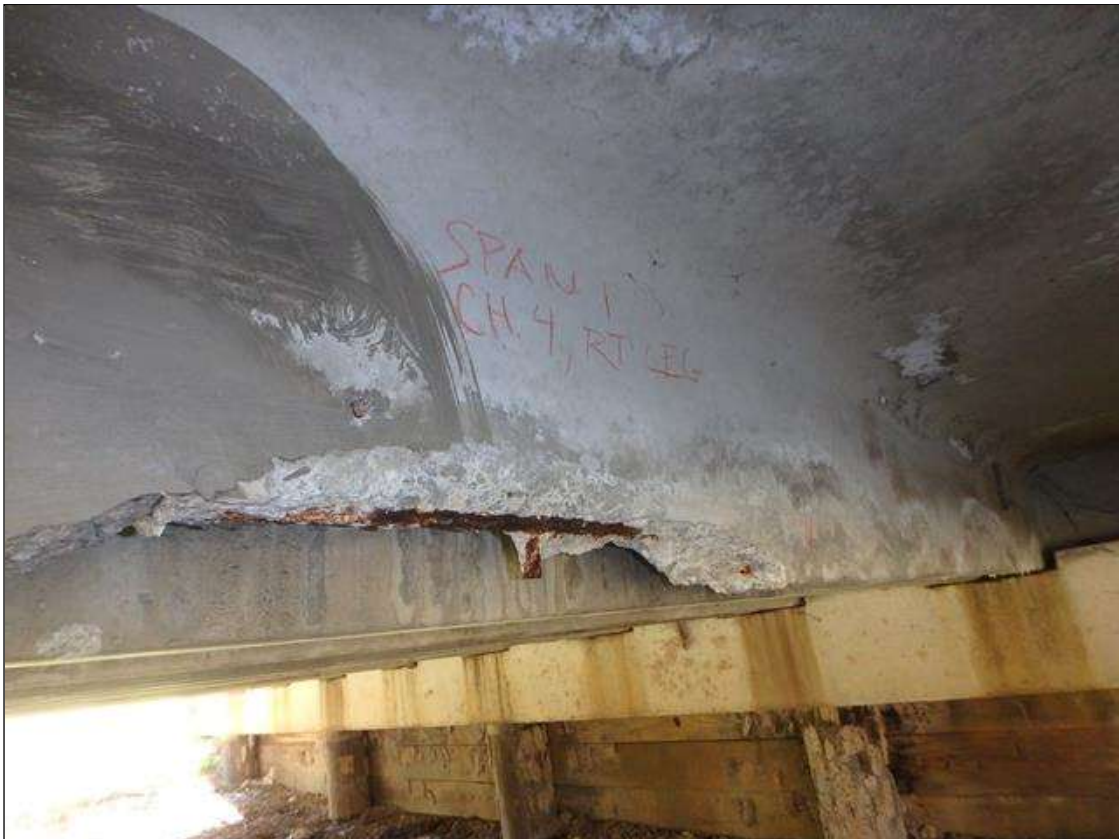
8 Feet of Delamination/Spall: Spall greater than 1 in. deep or greater than 6 in. diameter. Does not warrant structural review. BEGIN AT ABUT 1, BOTTOM RT. LEG HAS 1/16" CRACKS/ DELAMINATION 3IN. H X 5FT. LONG THEN SPALL W/ EXPOSED STEEL 3IN. H X 2FT. L. PRIORITY MAINTENANCE

SPAN 1 CHANNEL 4 BEGIN AT ABUT 1, BOTTOM RT. LEG HAS 1/16" CRACKS/ DELAMINATION 3IN. H X 5FT. LONG THEN SPALL W/ EXPOSED STEEL 3IN. H X 2FT. L. PRIORITY MAINTENANCE

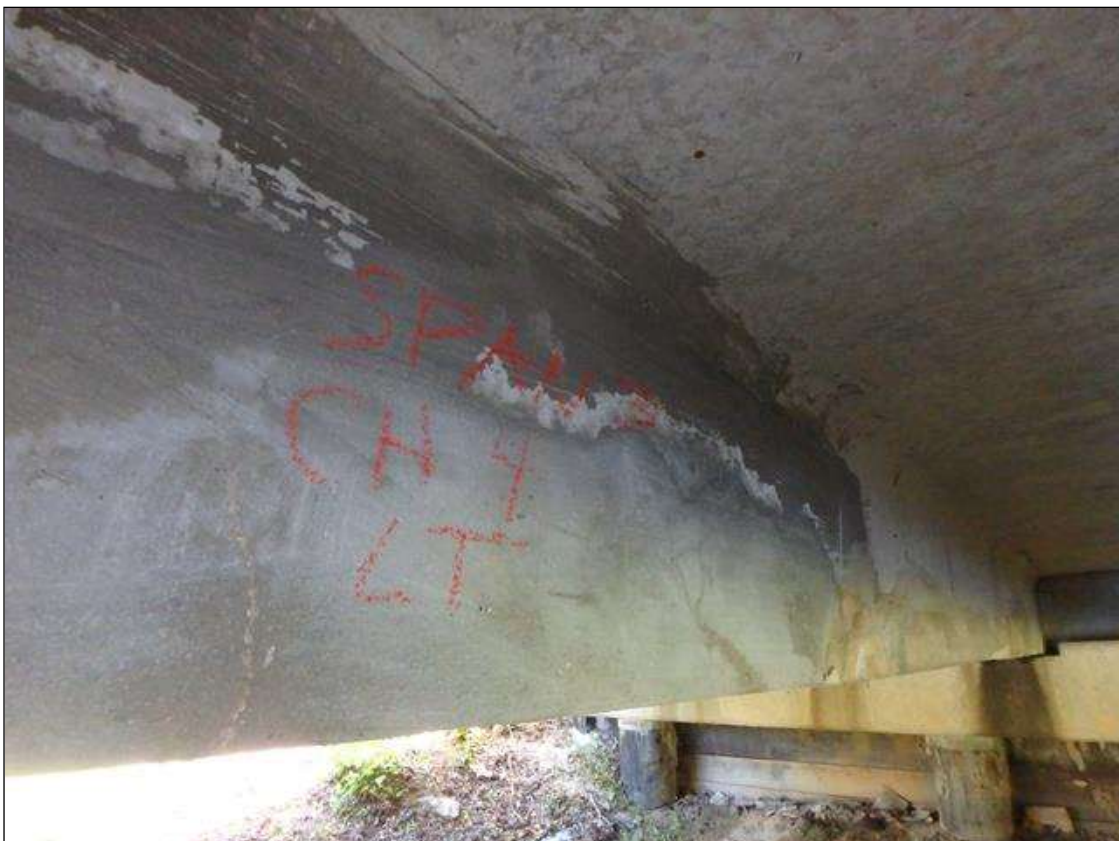
SPAN 3 CHANNEL 4 BEGIN NEAR ABUTMENT 2, LT. LEG HAS TEMPORARY REPAIR, SOUND CONC. PATCHING 6IN. H X 12FT. LONG.

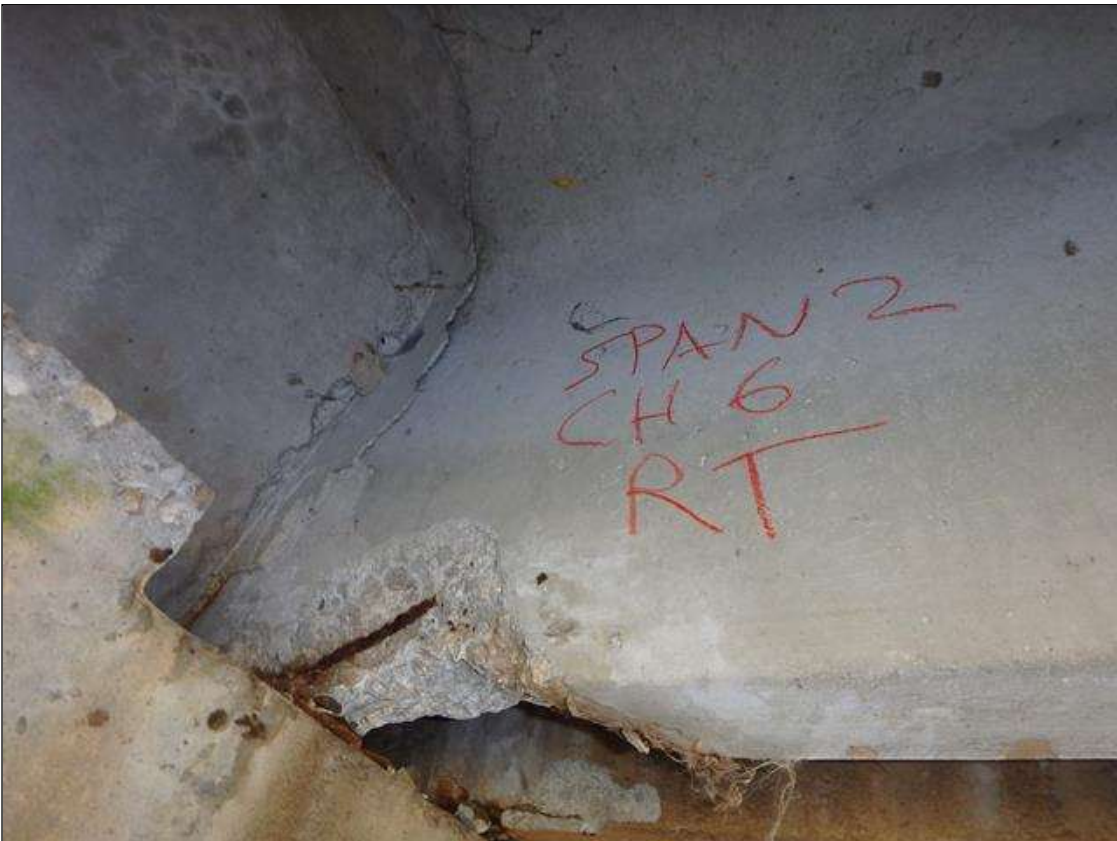
SPAN 2 CHANNEL 6 AT BENT 2 BOTTOM RT. LEG HAS SPALL WITH EXPOSED STEEL 6IN. L X 3IN. HIGH. PRIORITY MAINTENANCE

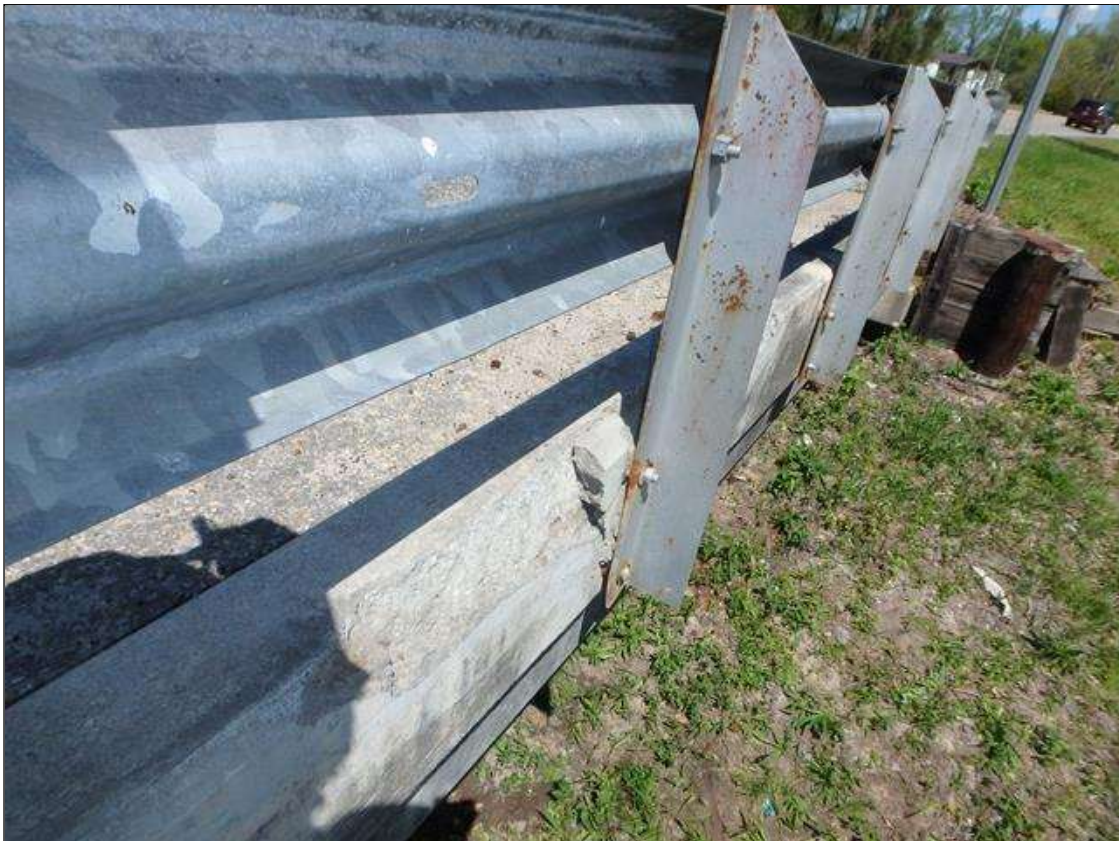
SPAN 3 RT. STEEL RAIL 4TH POST FROM ABUT 2 CONNECTION LOOSE DUE TO SPALL IN CURB 5FT. LONG X  
3IN. D X 4IN. HIGH. PRIORITY MAINTENANCE

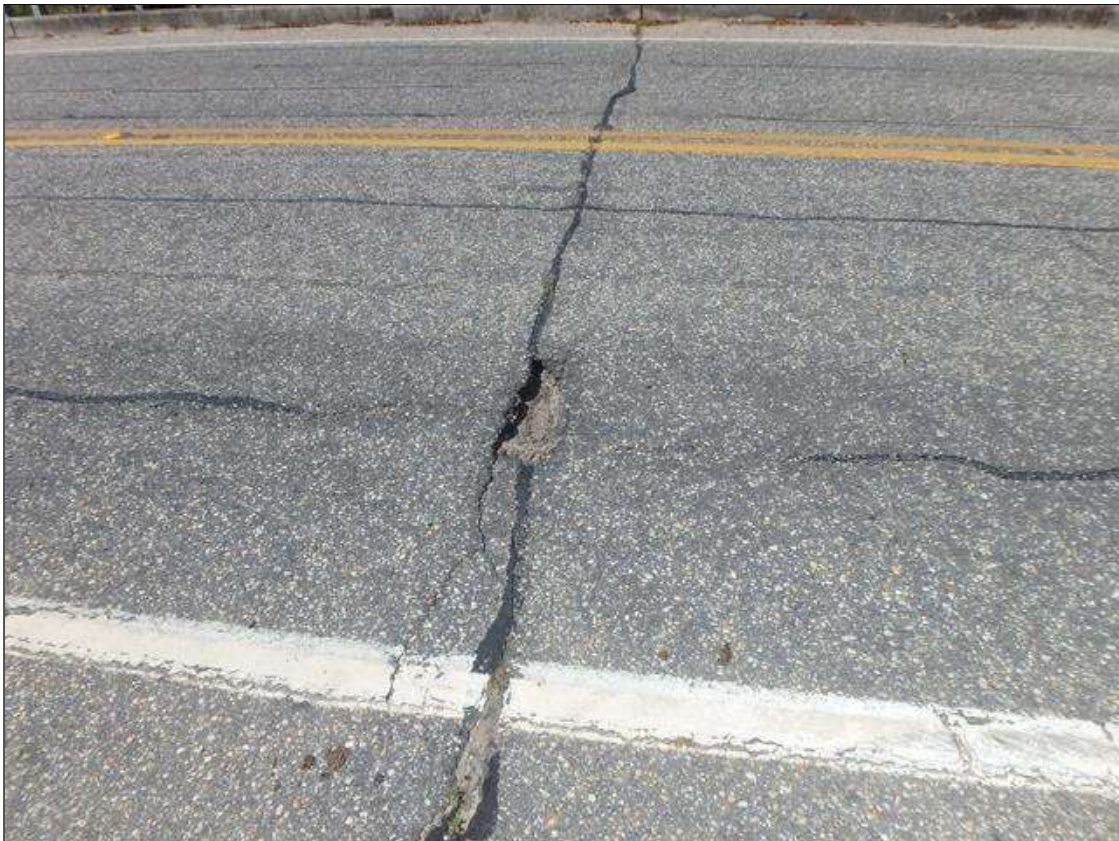
AWS ABOVE BENT 2 JOINT 1/16IN. CRACKS AND RAVELING WITH MATERIAL MISSING IN NBL 16IN. W X 6IN. L X 2-1/2IN. DEEP.

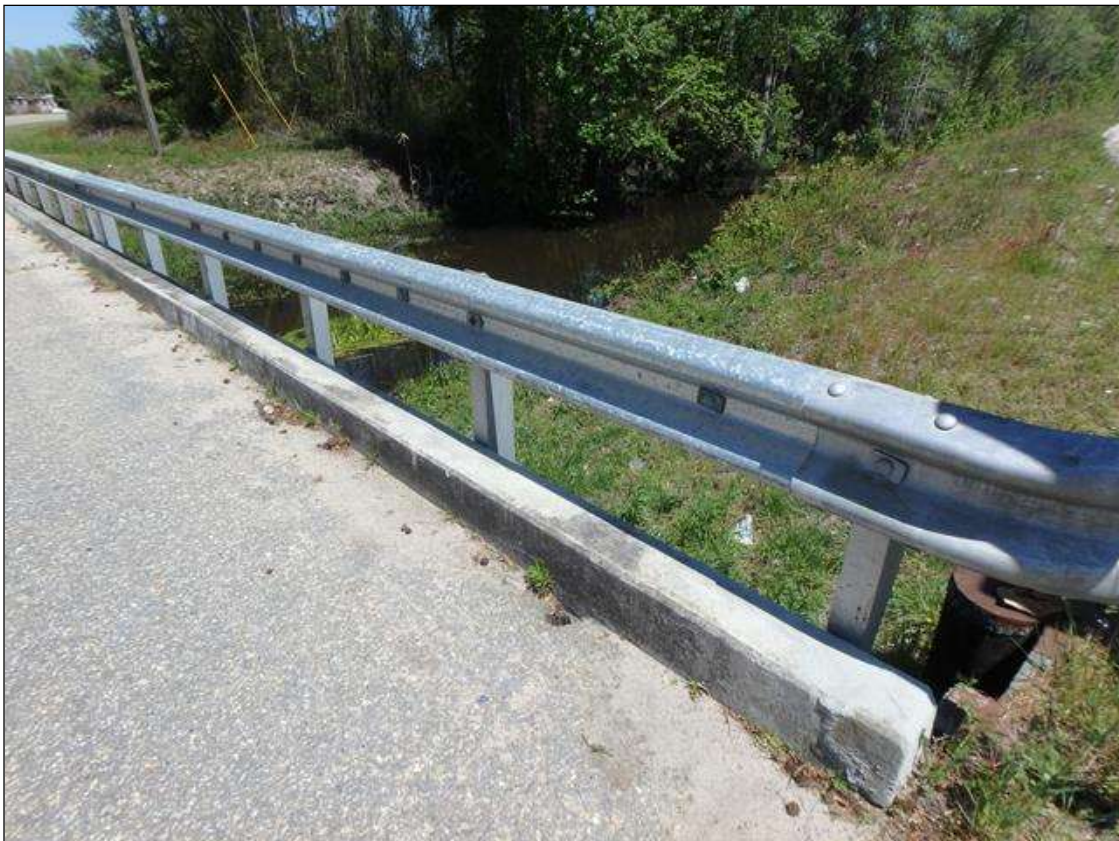
RT. STEEL GUARDRAIL SPAN 1 HAS NEW 20FT. LONG SECTION BEGINNING AT ABUTMENT 1 WITH 6 NEW STEEL POSTS. CONCRETE CURB PATCHED HERE.

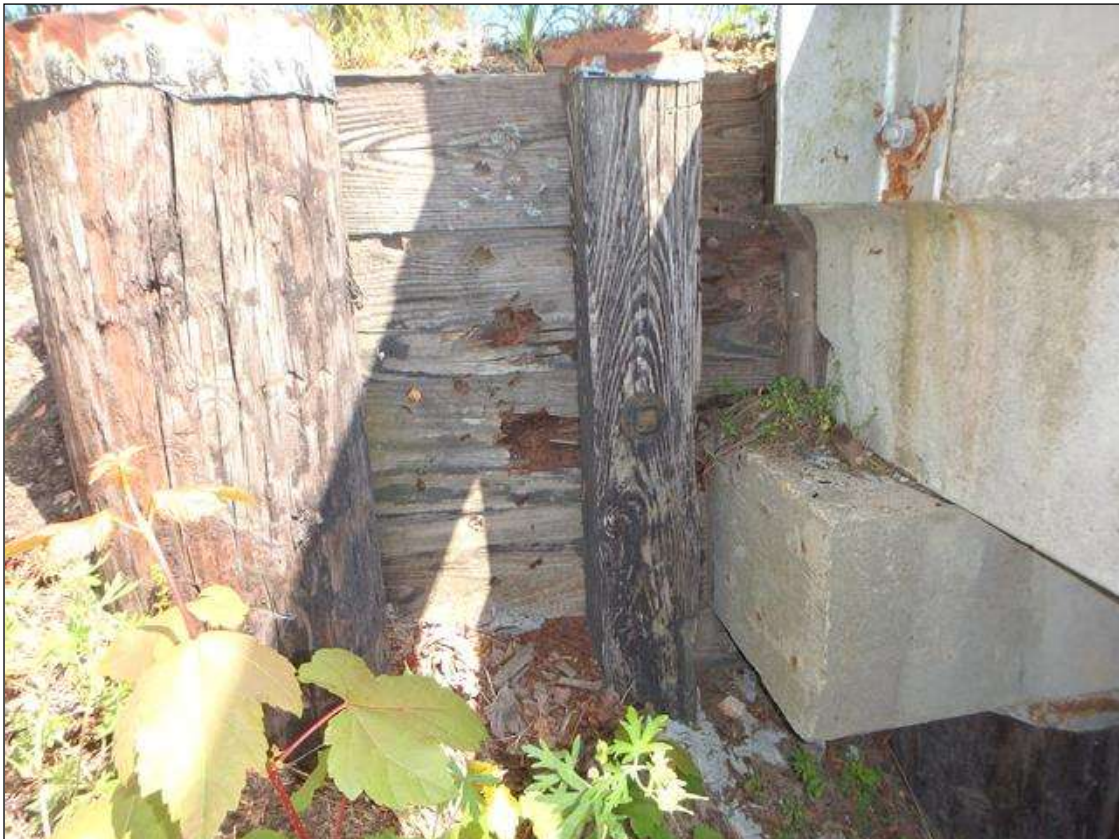
ABUT 2 LT. END BULKHEAD BOARDS HAVE 3SF OF DECAY EXPOSING FILL. PRIORITY MAINTENANCE
