NC DEPARTMENT OF TRANSPORTATION  
DIVISION OF HIGHWAYS  
STRUCTURE MANAGEMENT UNIT

## Structure Safety Report

### Routine Element Inspection - Contract

DIVISION: 6 COUNTY: HARNETT STRUCTURE NUMBER: 420234 FREQUENCY: 24 MONTHS

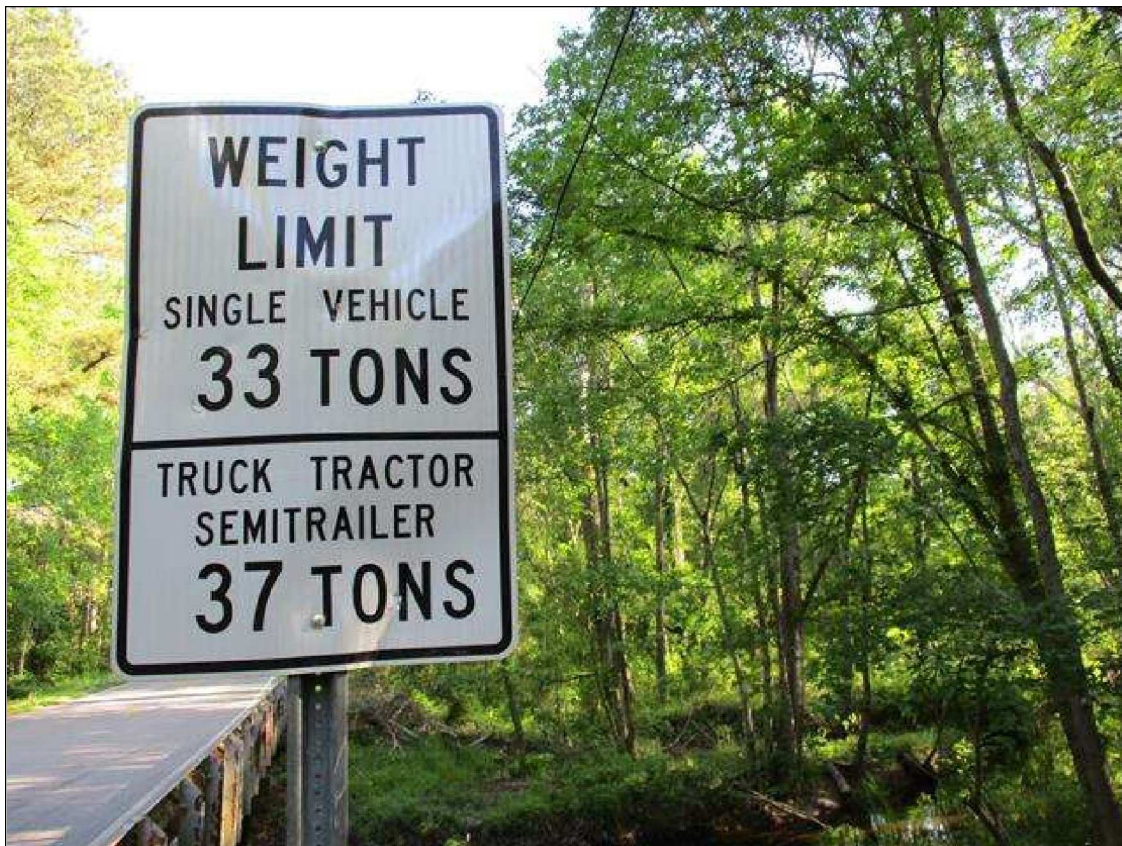
POSTING SV 33 TONS TTST 37 TONS

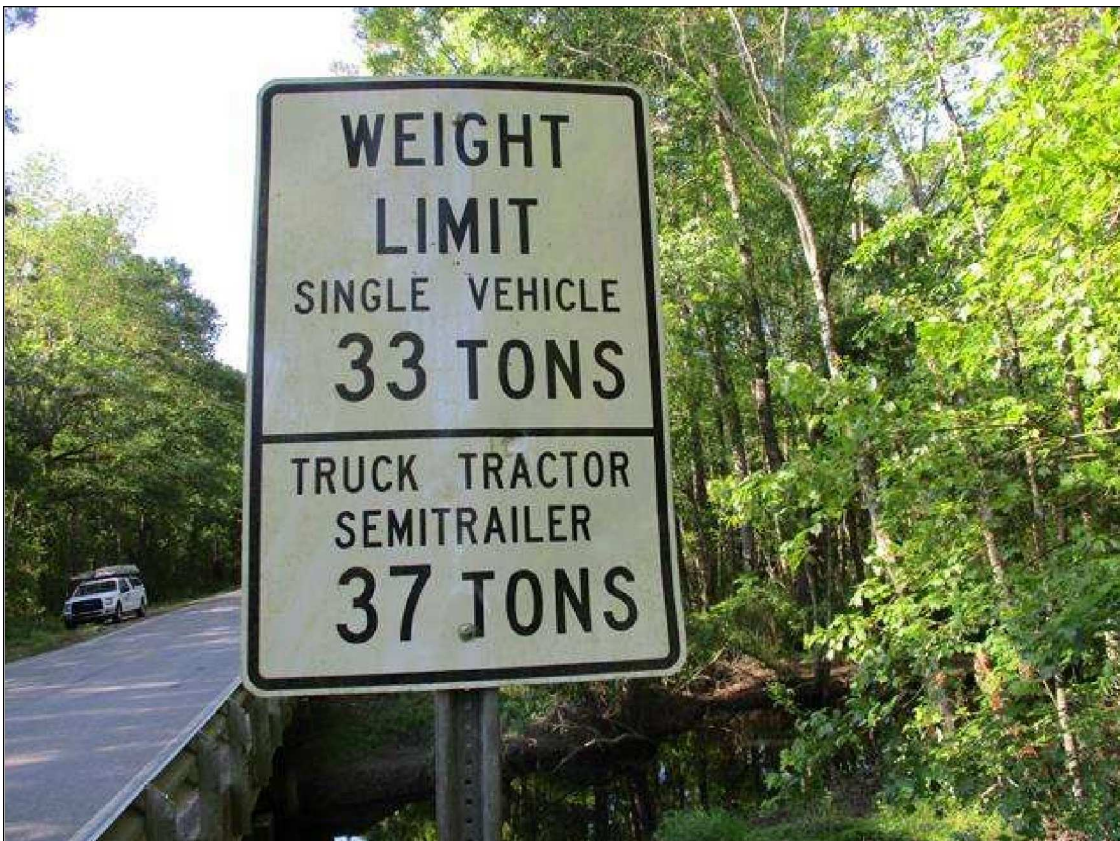
POSTING SV 33 TONS TTST 37 TONS
