NC DEPARTMENT OF TRANSPORTATION  
DIVISION OF HIGHWAYS  
STRUCTURE MANAGEMENT UNIT

## Structure Safety Report

### Routine Element Inspection - Contract

DIVISION: 14 COUNTY: HAYWOOD STRUCTURE NUMBER: 430057 FREQUENCY: 24 MONTHS

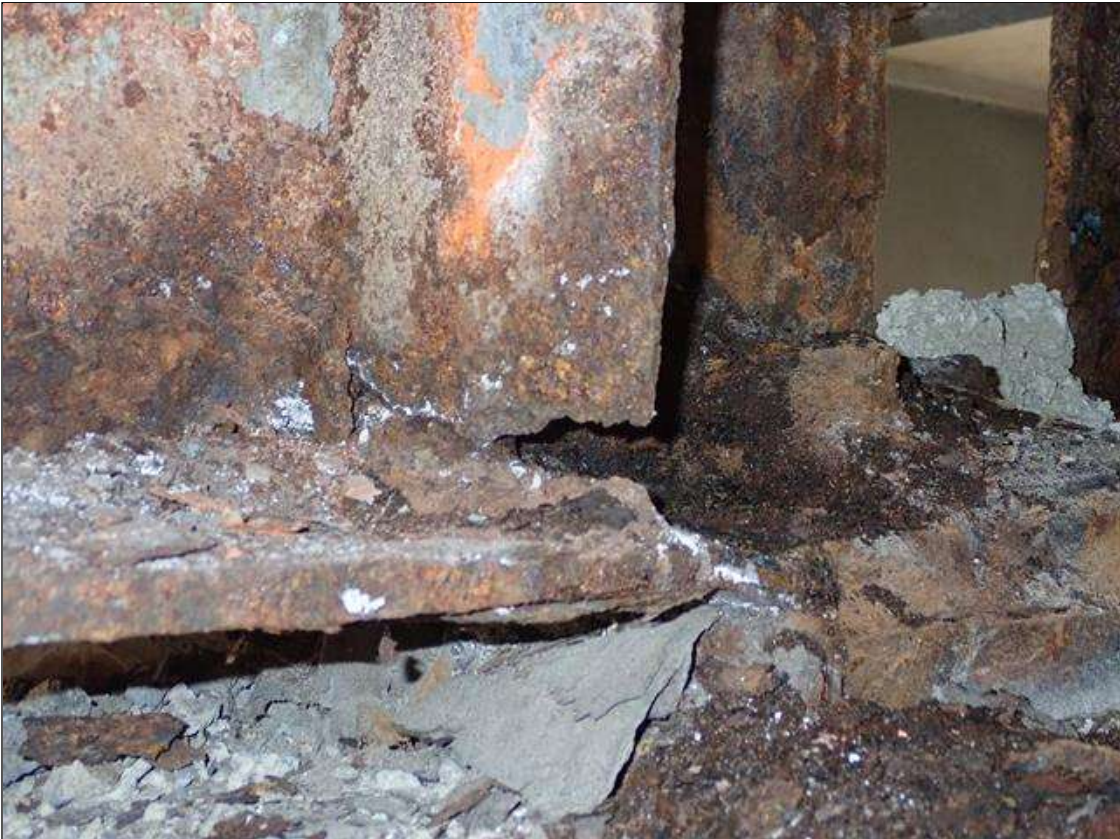
Span 3 Beam 6: 3 FT. OF CORROSION WITH 1/2" REMAINING SECTION IN BOTTOM FLANGE AND 2.5" X 1" HOLE IN BEARING STIFFENER AT BENT 2 (PRIORITY MAINTENANCE ISSUED)

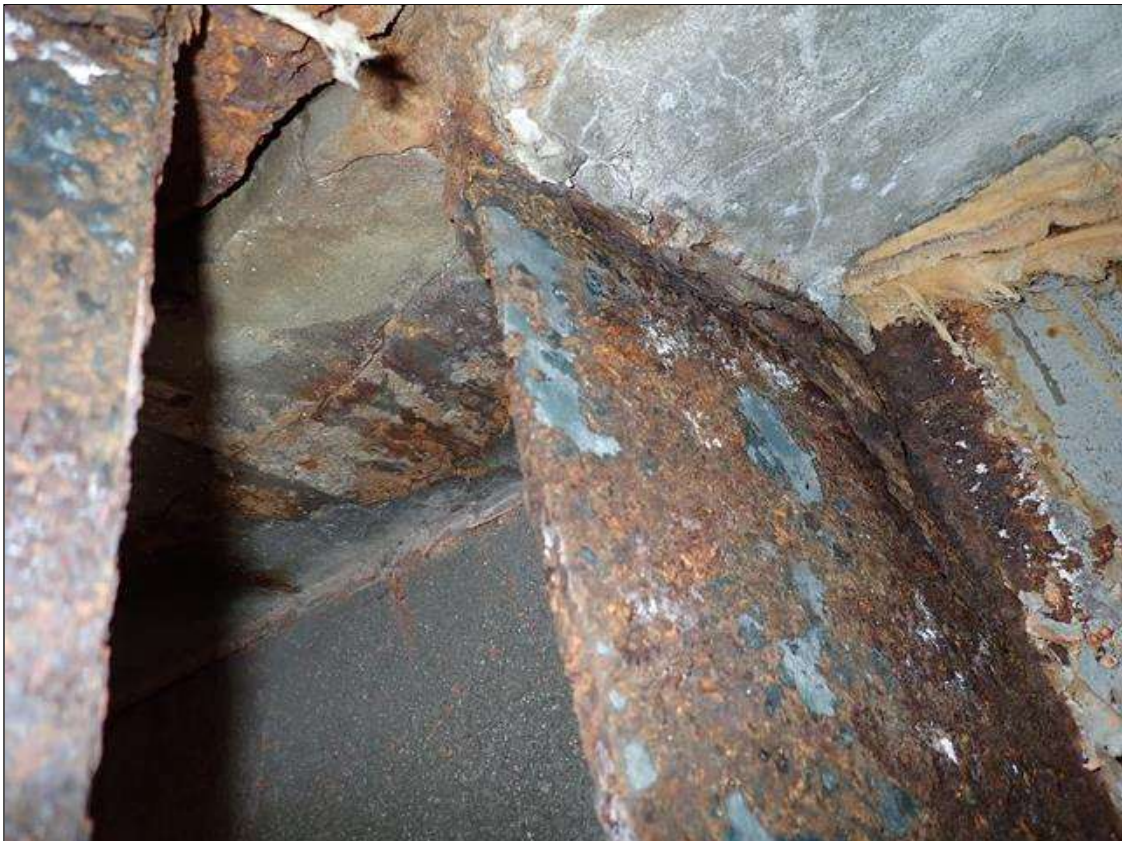
Span 3 Beam 5: 6 FT. OF CORROSION WITH 0.4" REMAINING THICKNESS IN STIFFNER AND 3/4" REMAINING SECTION IN BOTTOM FLANGE AT BENT 2 (PRIORITY MAINTENANCE ISSUED)

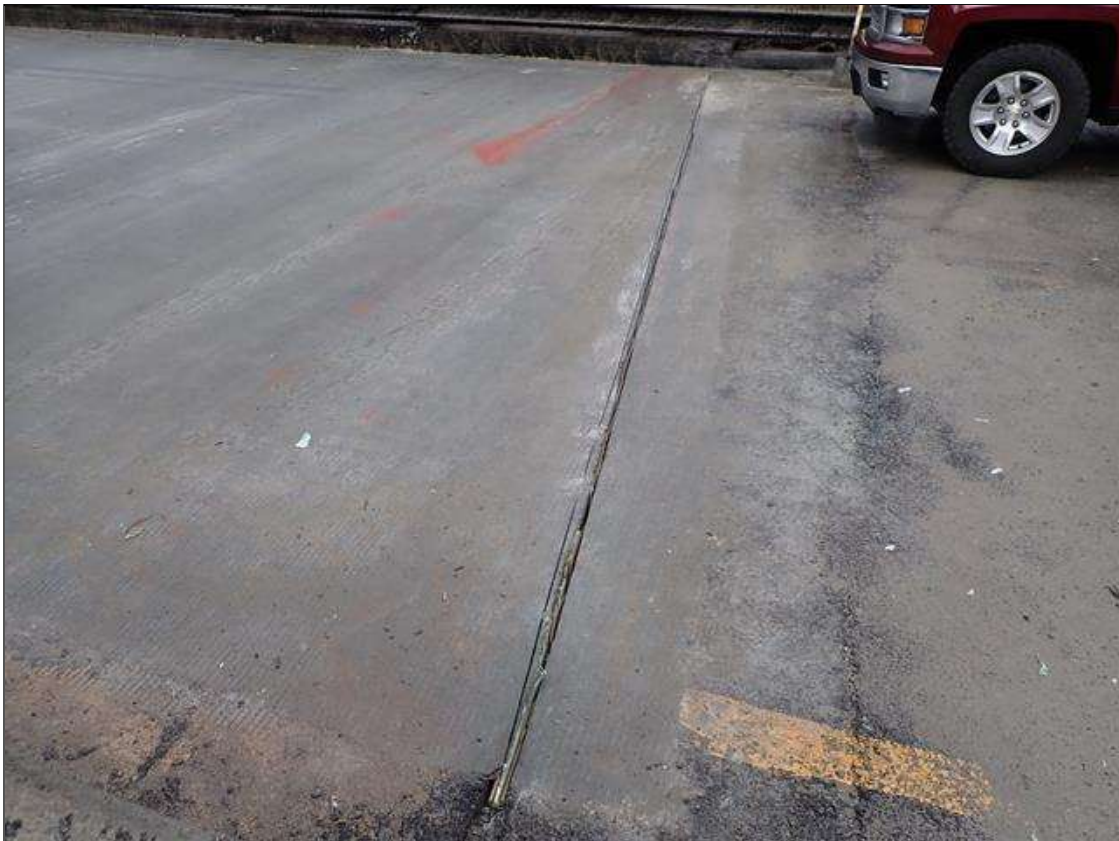
Expansion Joint : JOINT REPAIR AT END BENT 1 ALONG FULL LENGTH OF EAST BOUND LANE

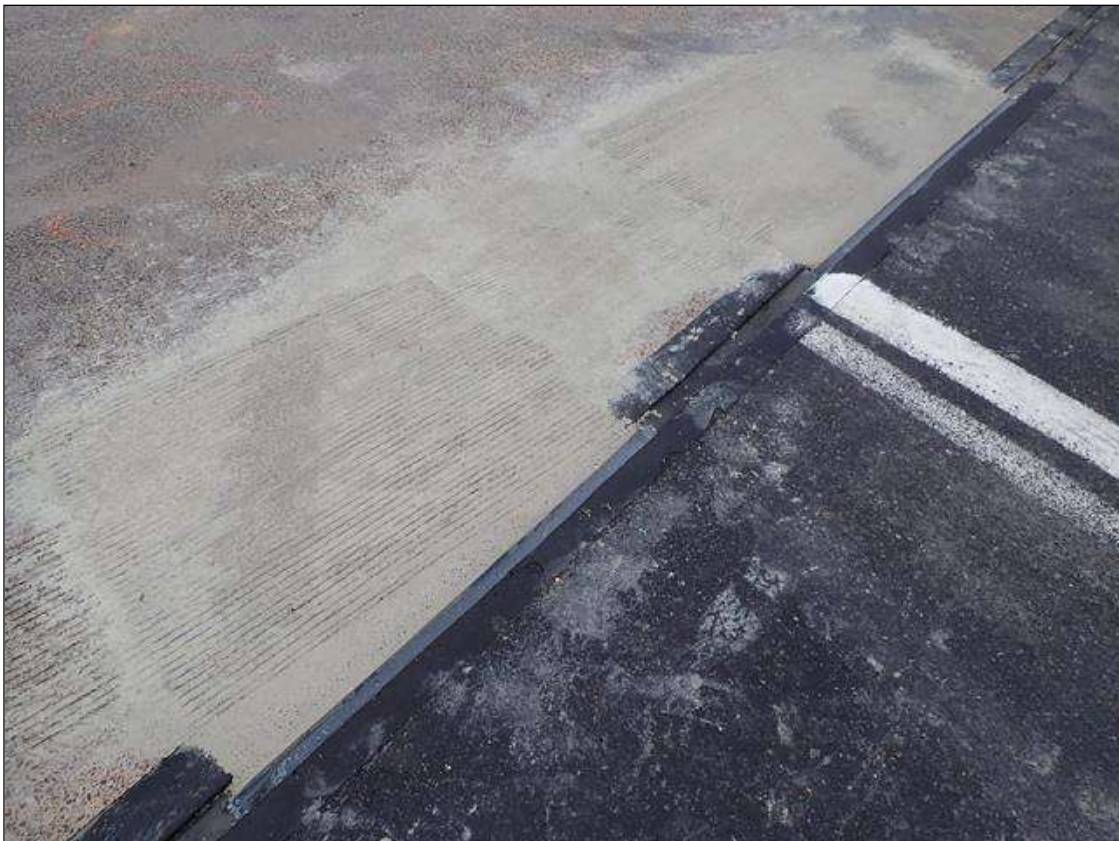
| Element Number | Defect Type | Defect Description | CS | CS Qty | Maint Qty | |
|---|---|---|---|---|---|---|
| 302 | Seal Damage | 15 FT OF JOINT REPAIR IN WEST BOUND LANES | 2 | 15 | | Feet |

Expansion Joint : 15 FT OF JOINT REPAIR IN WEST BOUND LANES

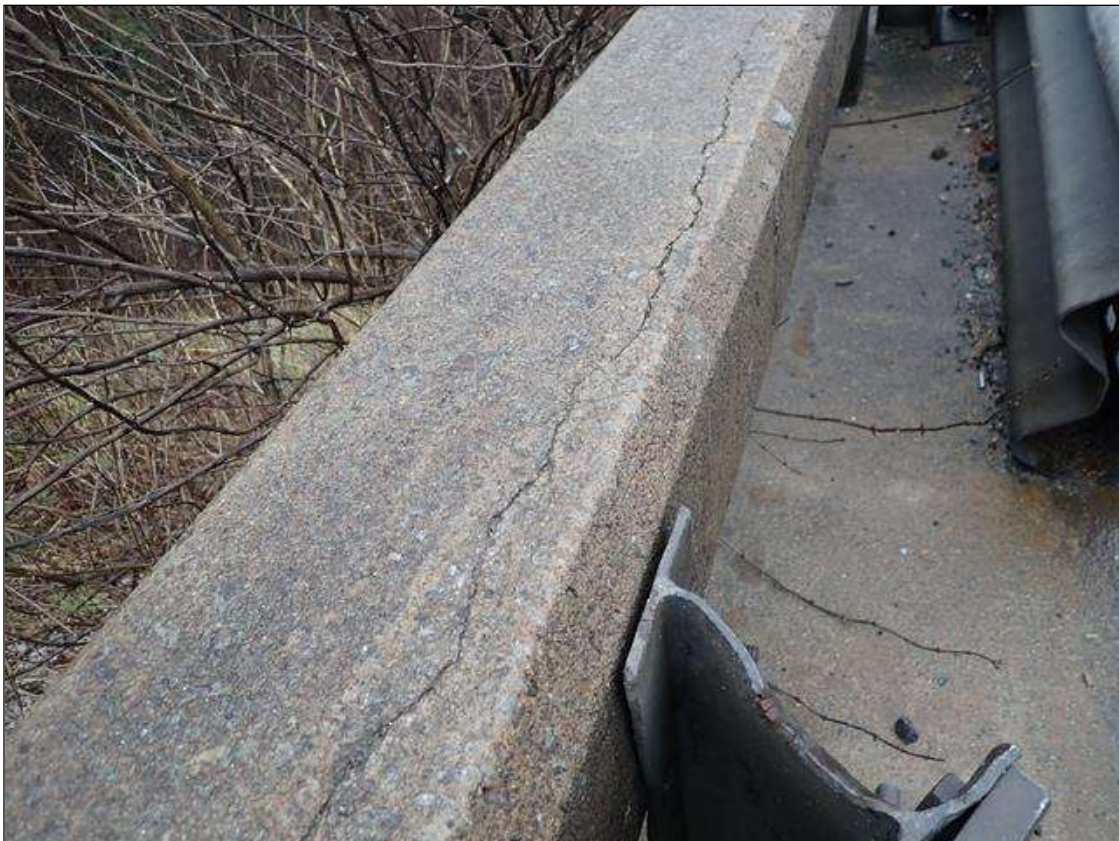
| Element Number | Defect Type | Defect Description | CS | CS Qty | Maint Qty | |
|---|---|---|---|---|---|---|
| 333 | Cracking (RC and Other) | 17 FT. OF HORIZONTAL CRACKS IN TOP OF RAIL, UP TO 1/8" WIDE AT END BENT 1 | 3 | 17 | 17 | Feet |

Span 1 Left Bridge Rail: 17 FT. OF HORIZONTAL CRACKS IN TOP OF RAIL, UP TO 1/8" WIDE AT END BENT 1

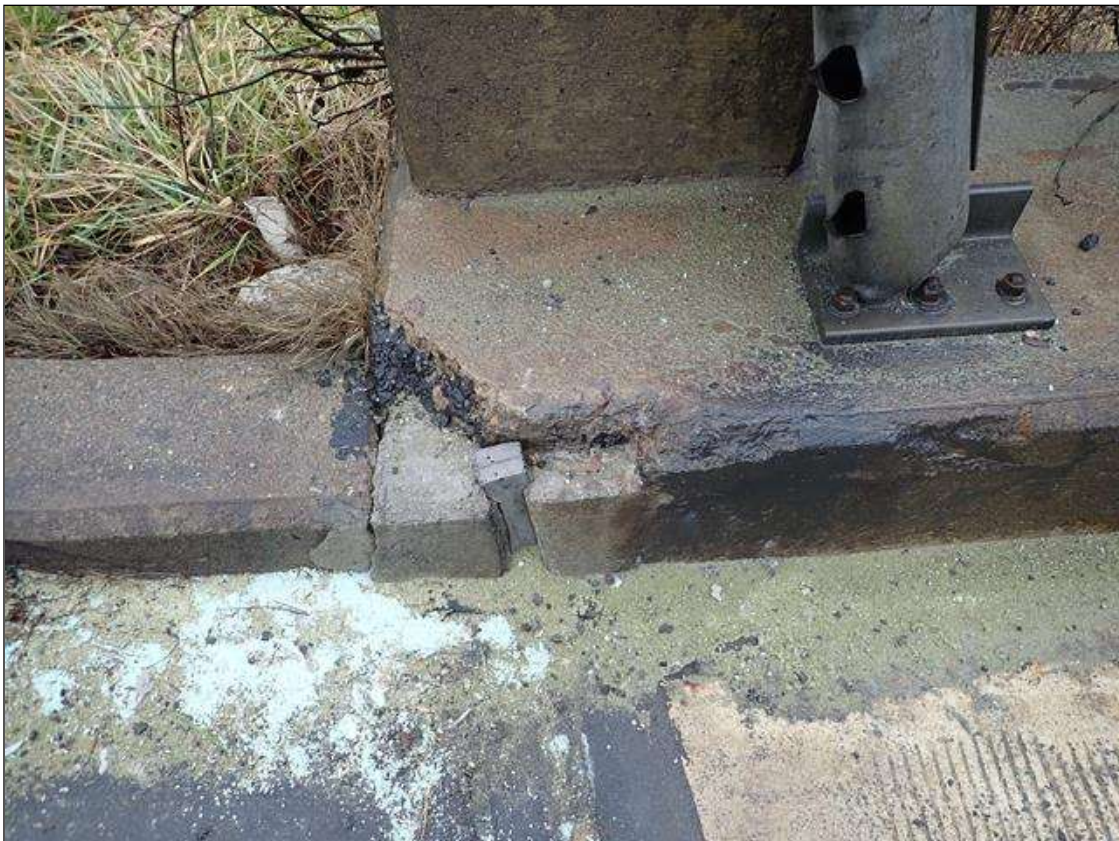
| Element Number | Defect Type | Defect Description | CS | CS Qty | Maint Qty | |
|---|---|---|---|---|---|---|
| 333 | Delamination/Spall | 15" X 12" X 4" SPALL IN TOP OF CURB AT END BENT 1 | 3 | 2 | 2 | Feet |

Span 1 Left Bridge Rail: 15" X 12" X 4" SPALL IN TOP OF CURB AT END BENT 1

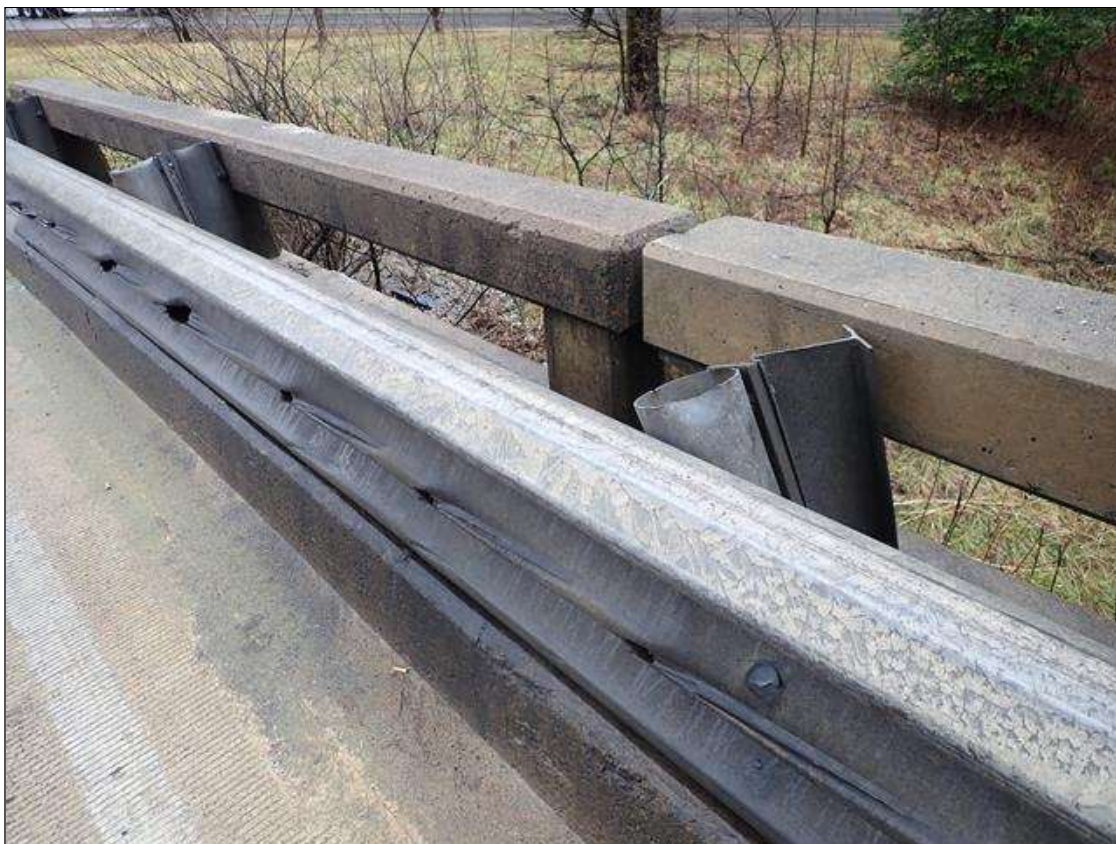
| Element Number | Defect Type | Defect Description | CS | CS Qty | Maint Qty | |
|---|---|---|---|---|---|---|
| 333 | Damage | 25 FT OF IMPACT DAMAGE ON GUARDRAIL AT END BENT 1 | 3 | | | Feet |

Span 1 Left Bridge Rail: 25 FT OF IMPACT DAMAGE ON GUARDRAIL AT END BENT 1

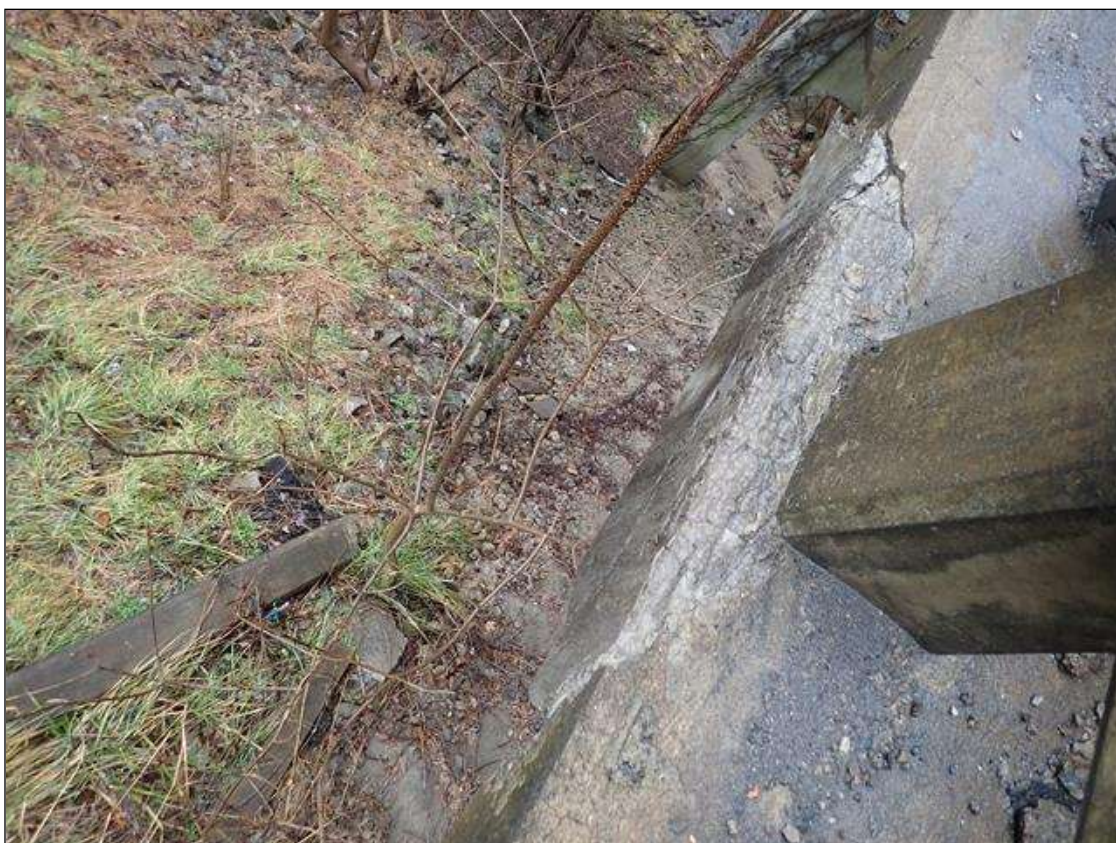
Span 1 Left Bridge Rail: 4 FT DELAMINATION IN UNSOUND PATCH IN OVERHANG AT MIDSPAN OF LEFT BARRIER RAIL

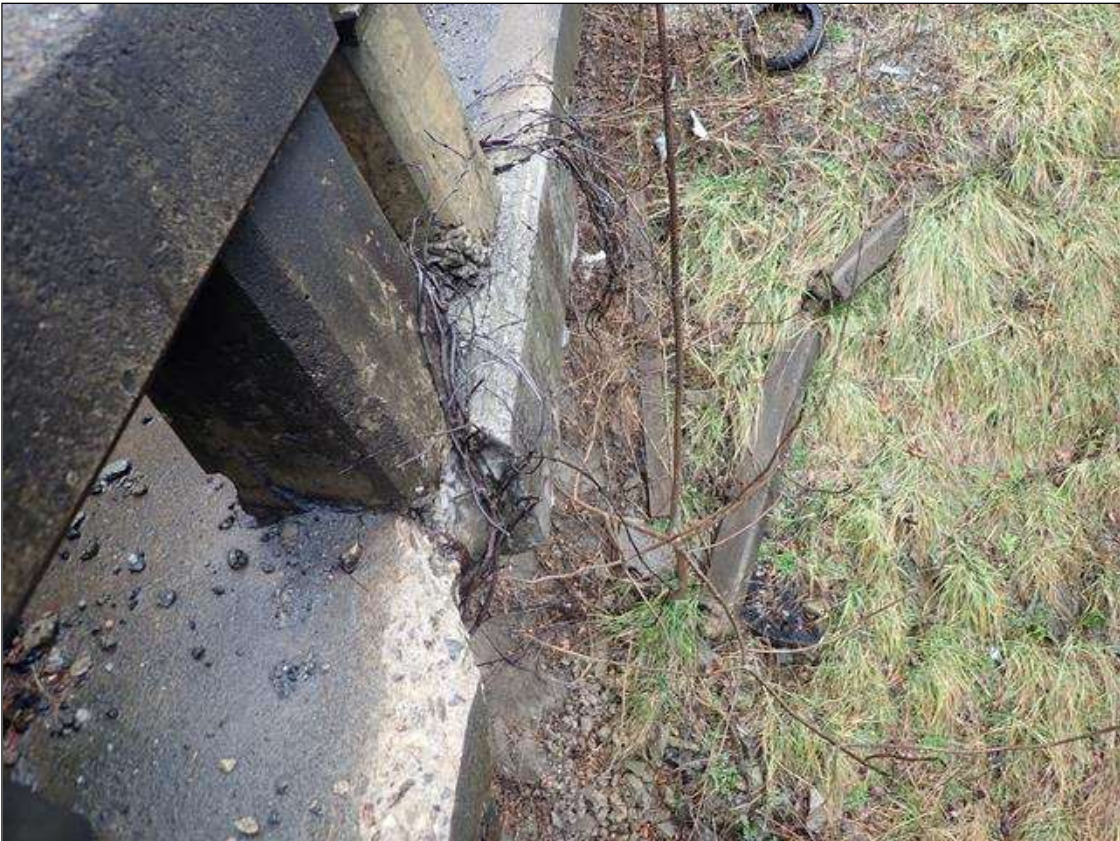
Span 1 Left Bridge Rail: 4 FT OF DELAMINATION AND SPALL WITH EXPOSED REBAR IN THE OUTSIDE FACE OF POST #6

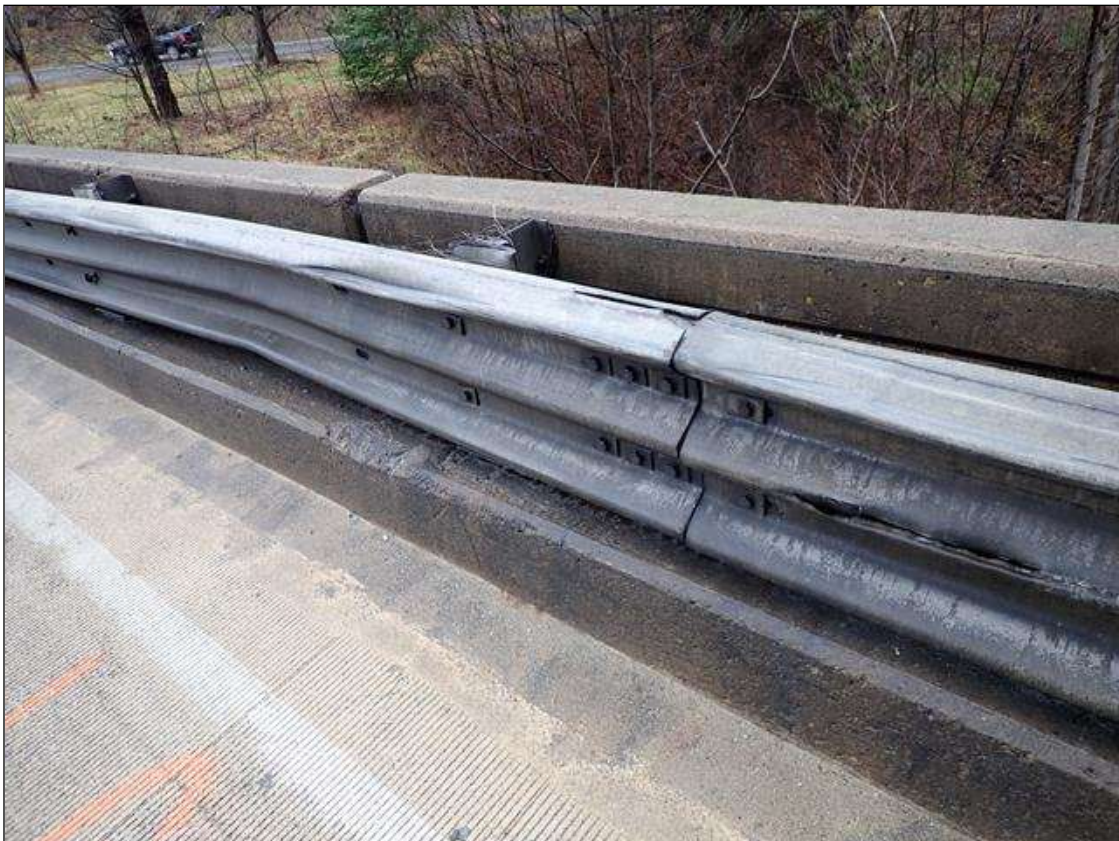
Span 1 Left Bridge Rail: 10 FT OF IMPACT DAMAGE AT 8 FT FROM BENT 1, UP TO 5" OF DEFLECTION

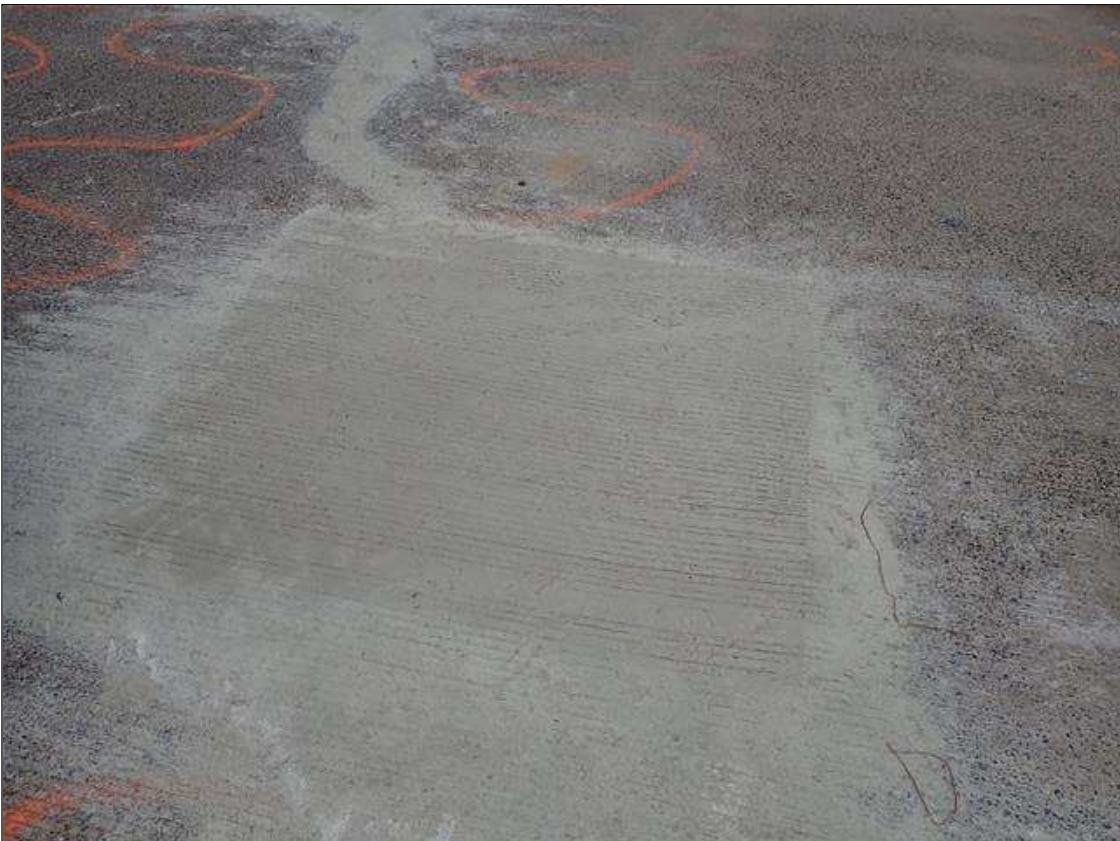
| Element Number | Defect Type | Defect Description | CS | CS Qty | Maint Qty | |
|---|---|---|---|---|---|---|
| 12 | Patched Areas | 4 FT BY 5 FT REPAIR IN TOP OF DECK IN WEST BOUND LANES AT 40 FT FROM END BENT 1 IN NORTH LANE. | 2 | 20 | | Square Feet |

Span 1 Deck: 4 FT BY 5 FT REPAIR IN TOP OF DECK IN WEST BOUND LANES AT 40 FT FROM END BENT 1 IN NORTH LANE.

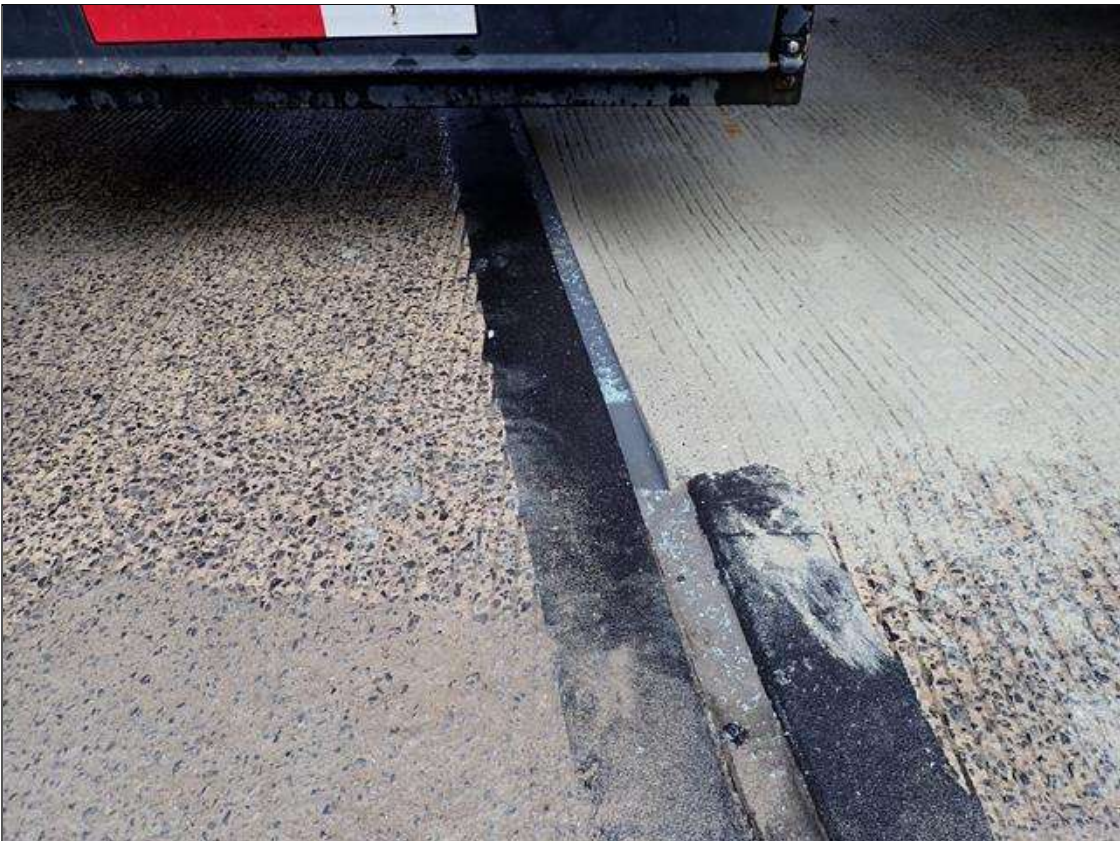
Expansion Joint : 5.5 FT SOUND REPAIR AT JOINT OVER BENT 1

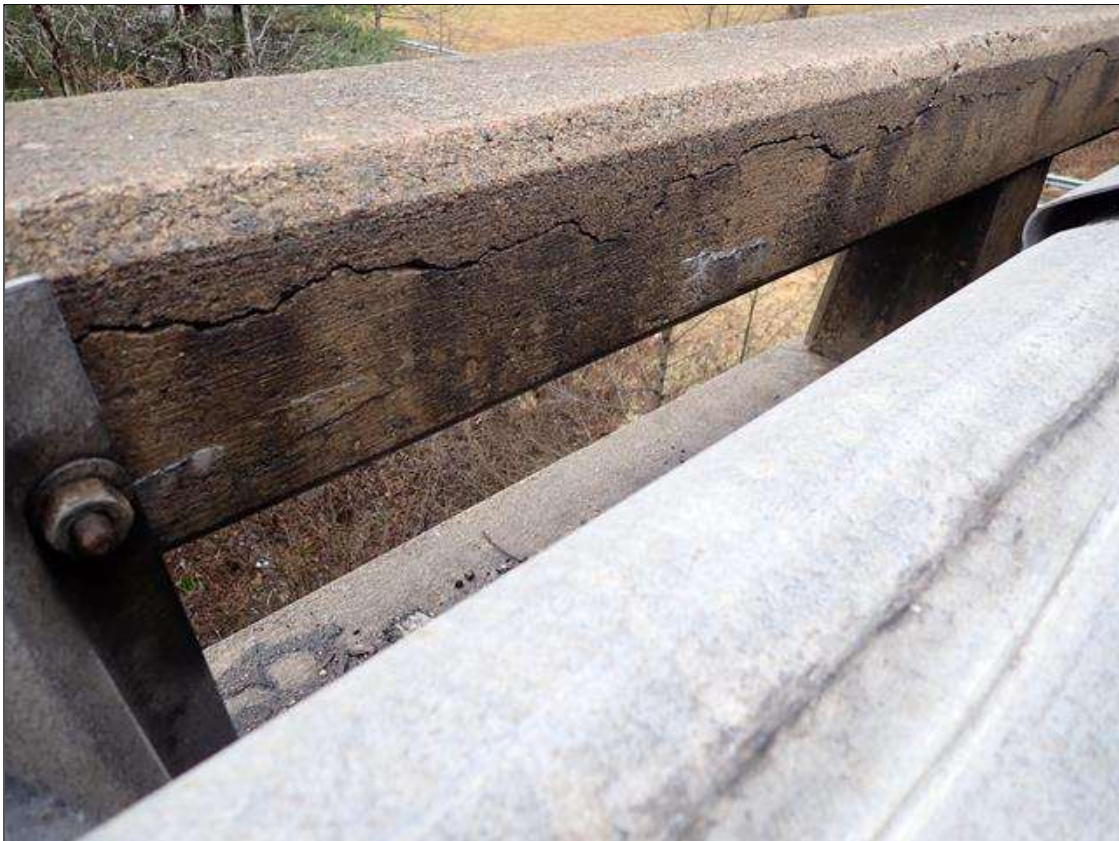
Span 2 Left Bridge Rail: 33 FT LONGITUDINAL CRACK IN TOP FACE OF RAIL UP TO 1/8" WIDE AT BENT 1 AND 8 FT FROM BENT 2

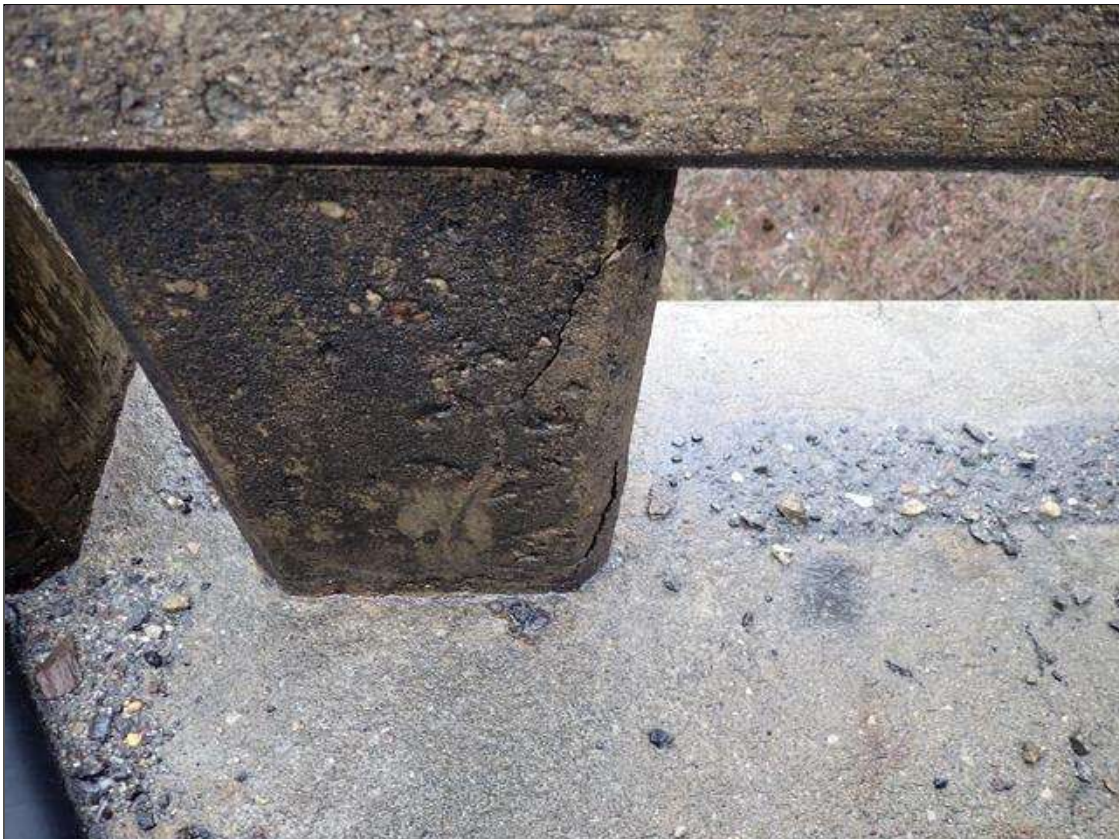
Span 2 Left Bridge Rail: RAIL POSTS CRACKED ALONG FULL HEIGHT UP TO 1/16"

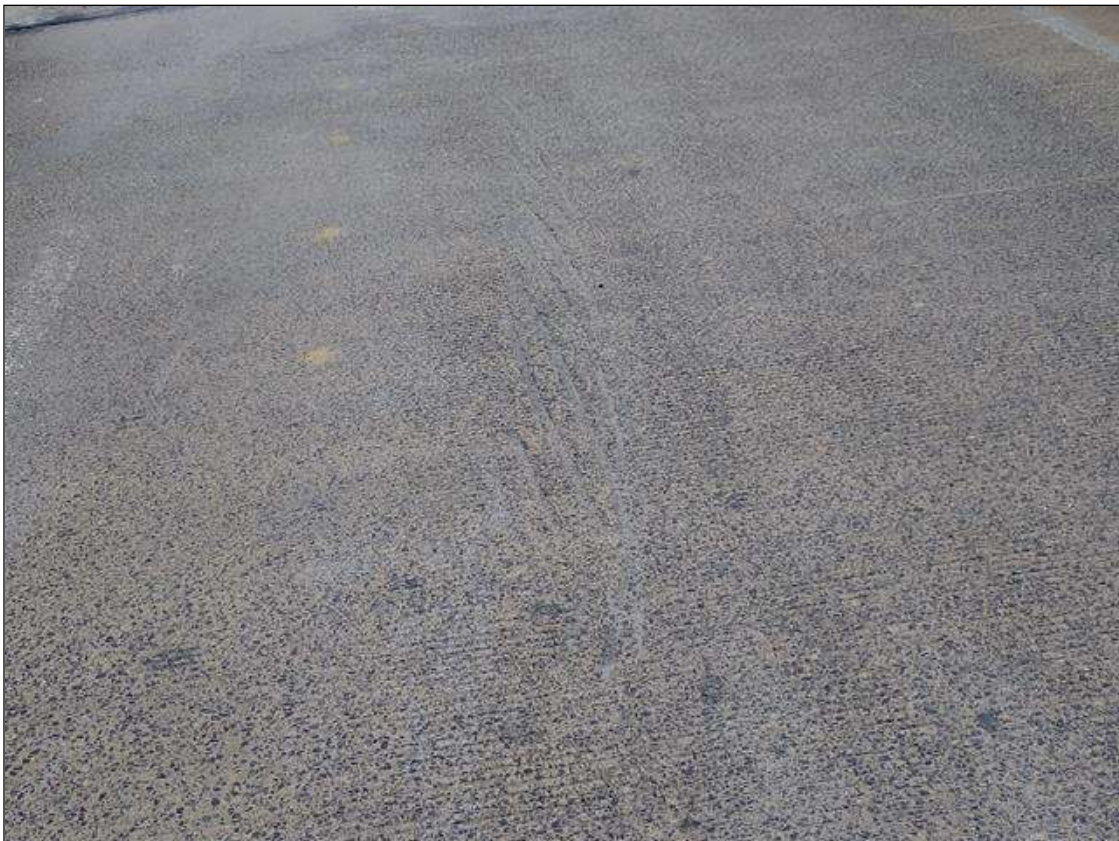
Span 2 Wearing Surface: 9 FT BY 1 FT AREA OF GOUGES IN DECK NEAR BENT 1 IN TOP OF DECK IN WEST BOUND LANES

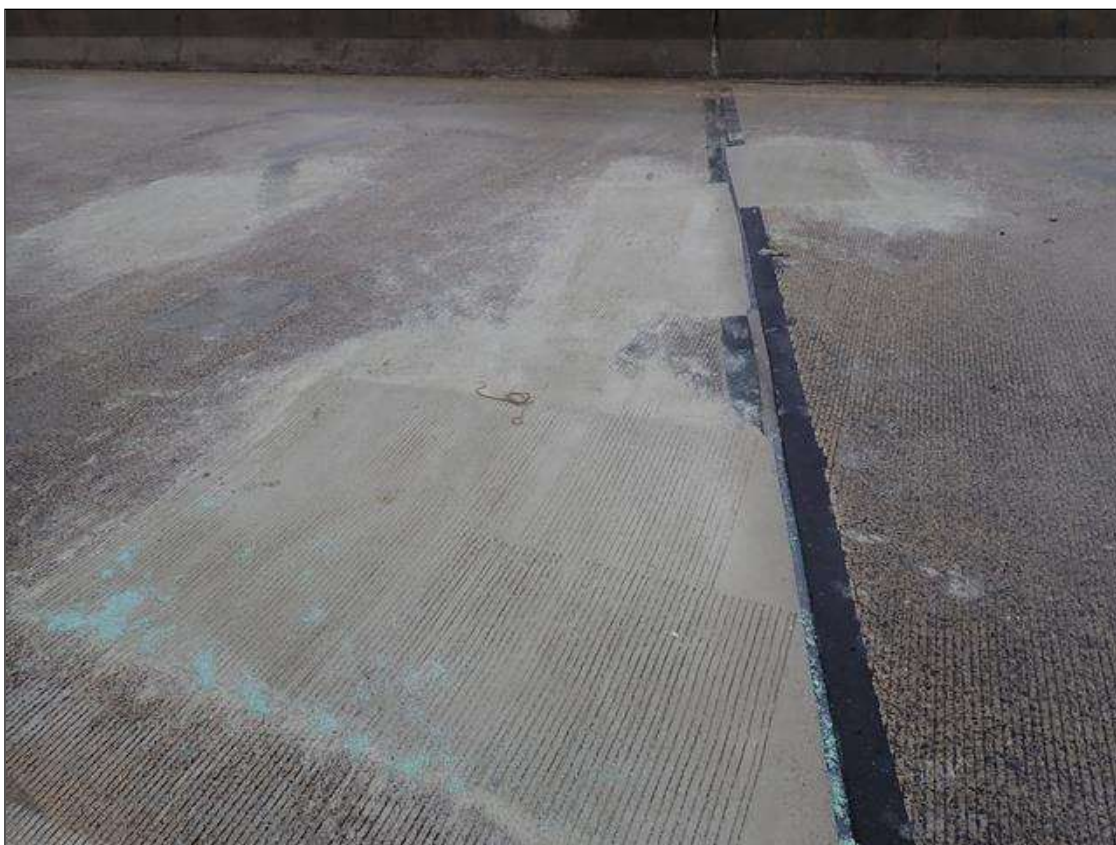
Span 3 Wearing Surface: 6 FT BY 5 FT REPAIR AND, 2 FT BY 6 FT REPAIR AT BENT 2

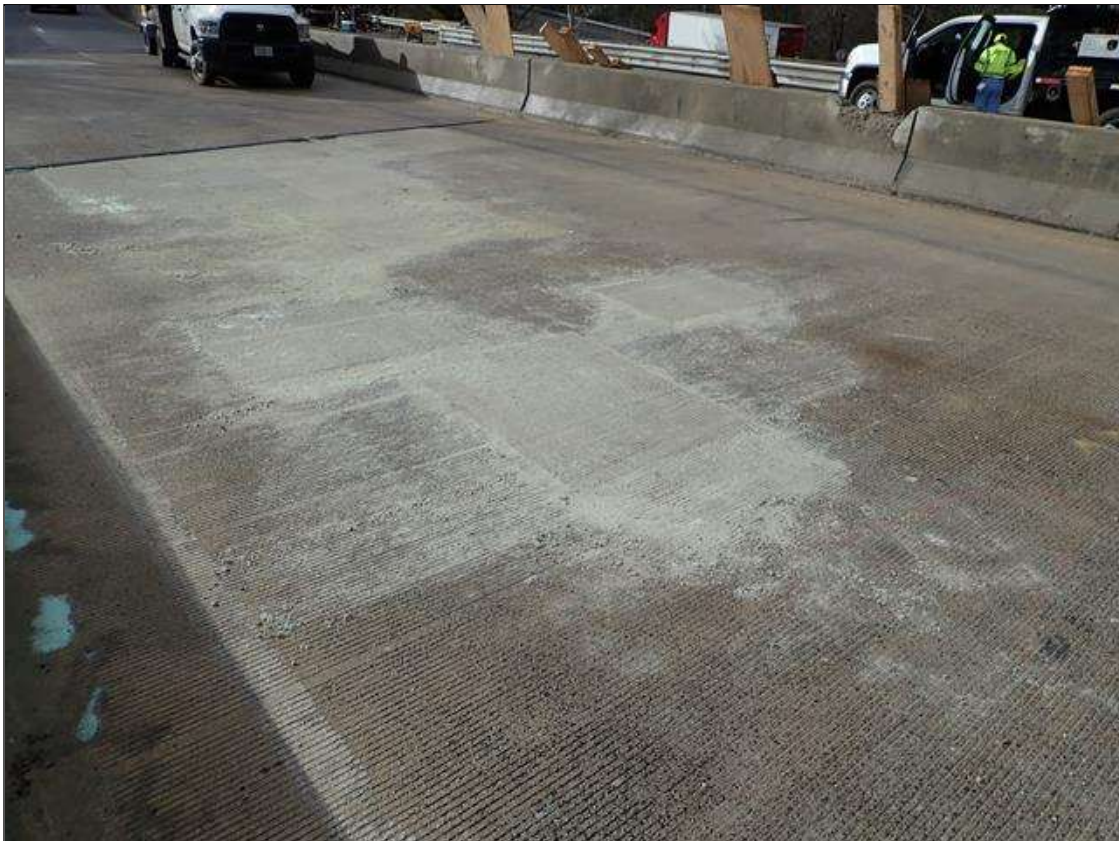
Span 3 Wearing Surface: 3 FT BY 4 FT SOUND REPAIR AND 3 FT BY 3 FT SOUND REPAIR AT 49 FT FROM BENT 2 IN TOP OF DECK IN WEST BOUND LANES IN NORTH LANE

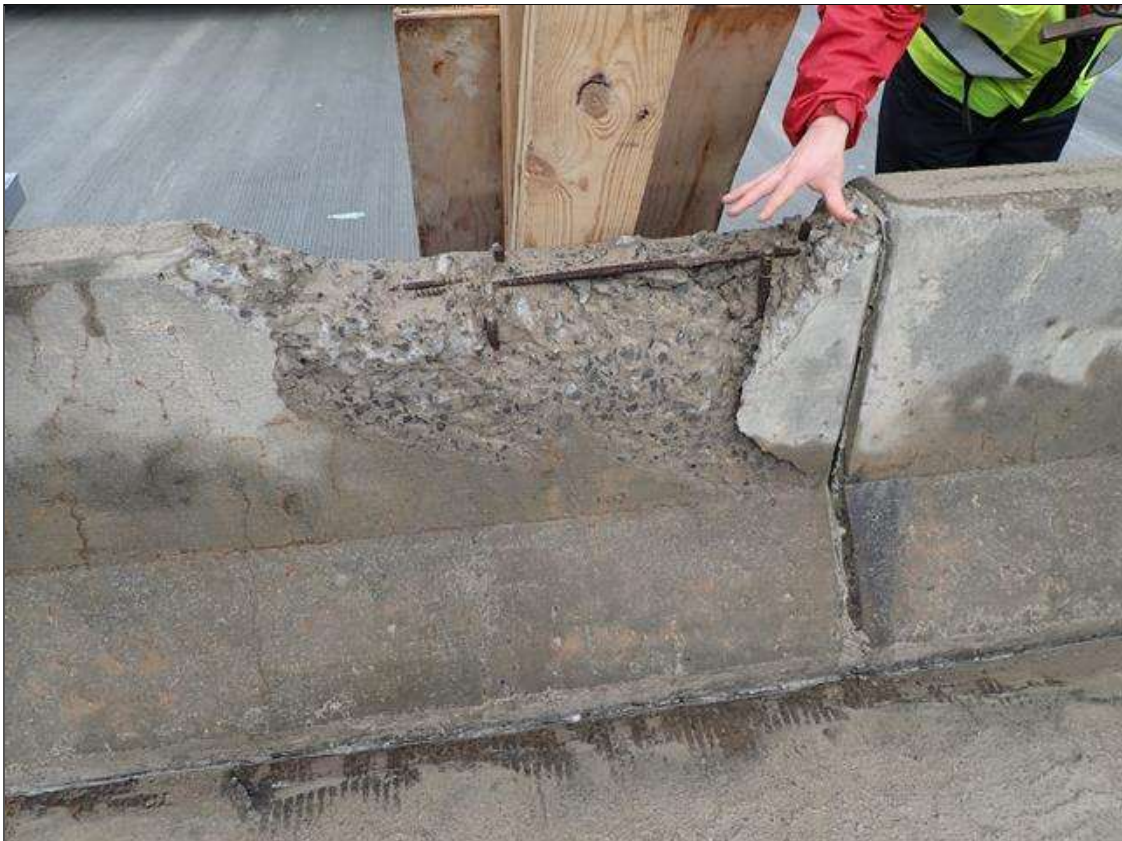
Span 3 Median Rail: 3 FT X 1.5 FT TALL X 6" DEEP SPALL IN TOP OF BARRIER RAIL WITH EXPOSED REBAR IN MIDSPAN 3

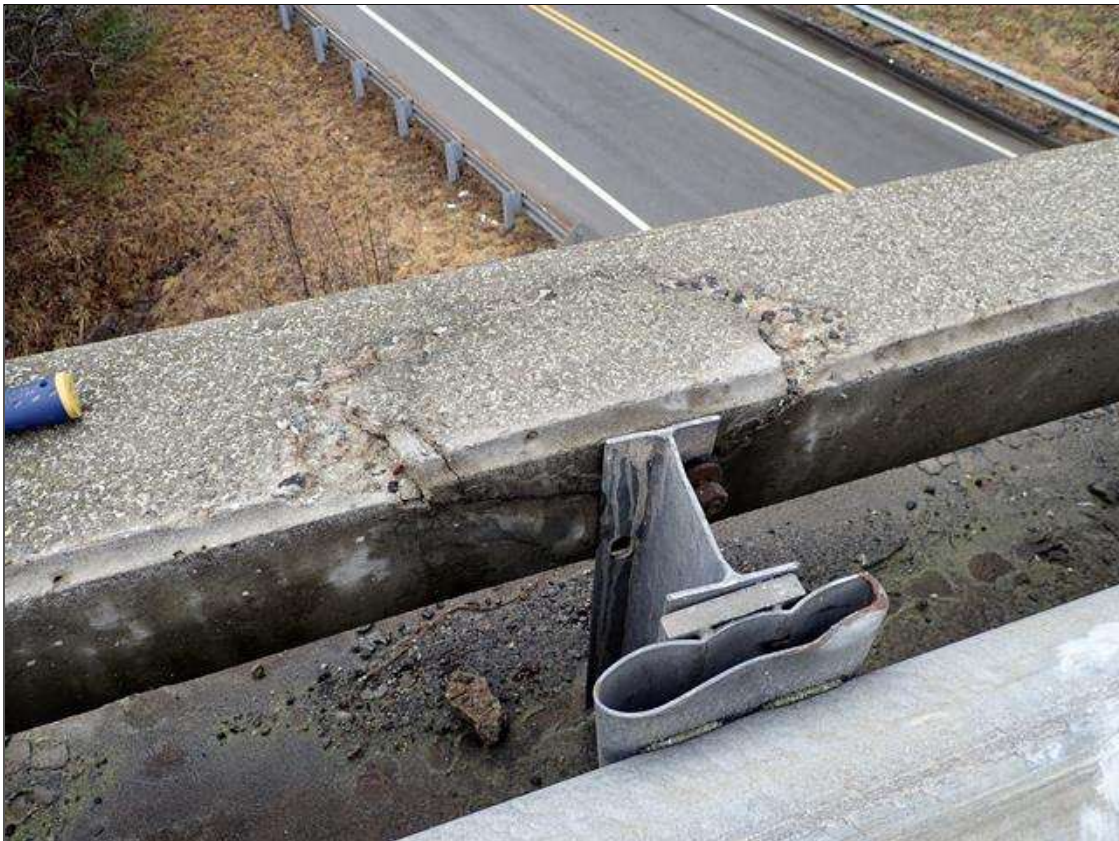
Span 3 Left Bridge Rail: 18" X 6" SPALL IN TOP OF RAIL AT 7 FT FROM BENT 2 WHERE POST MEETS

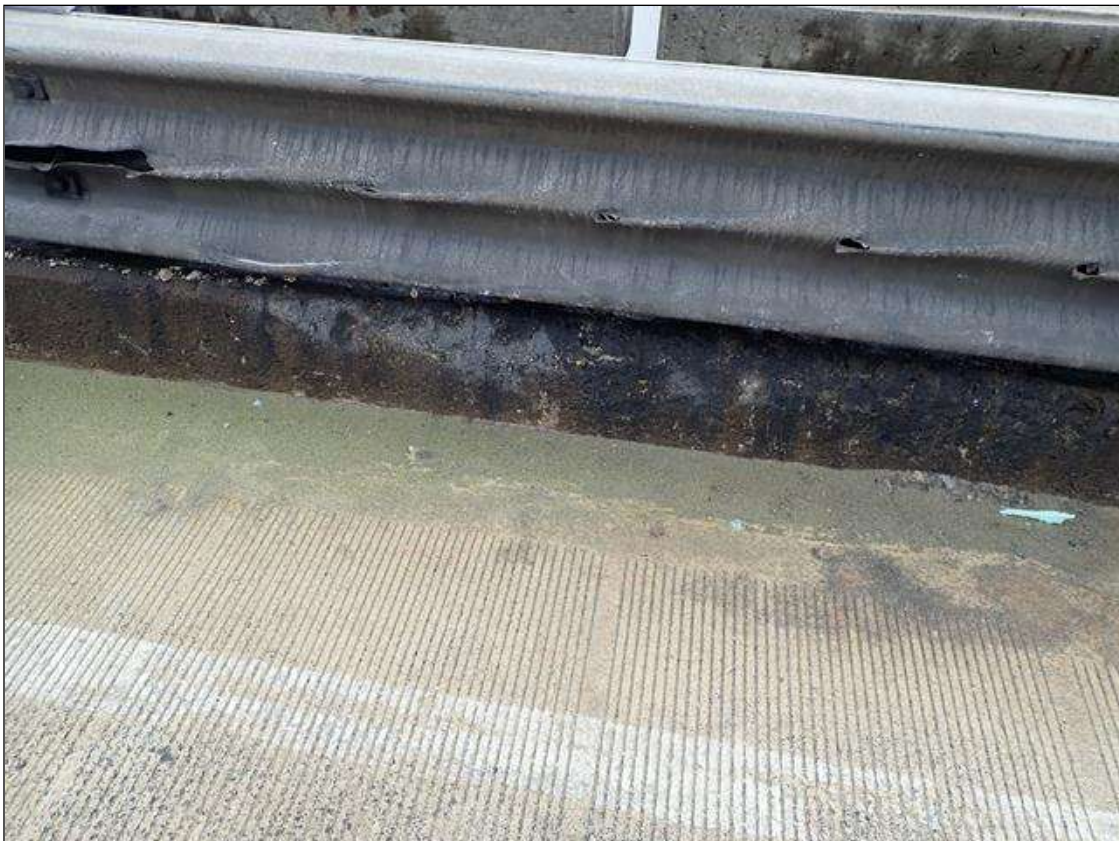
Span 3 Left Bridge Rail: 5 FT X 5" WIDE X 1" DEEP SPALL IN CURB AT 15 FT FROM BENT 2

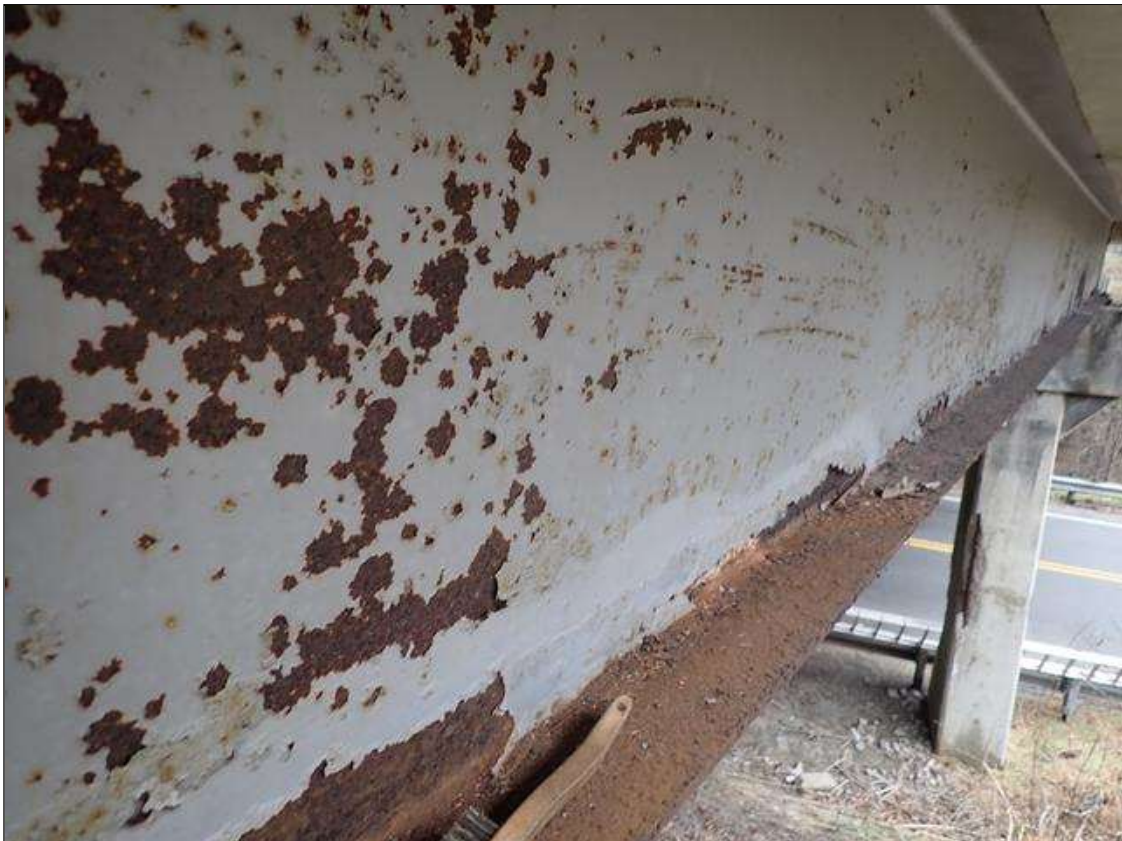
Span 4 Beam 1: 46 FT. OF SURFACE CORROSION ON TOP AND BOTTOM FACES OF BOTTOM FLANGE, ON FULL HEIGHT OF OUTSIDE FACE OF WEB.

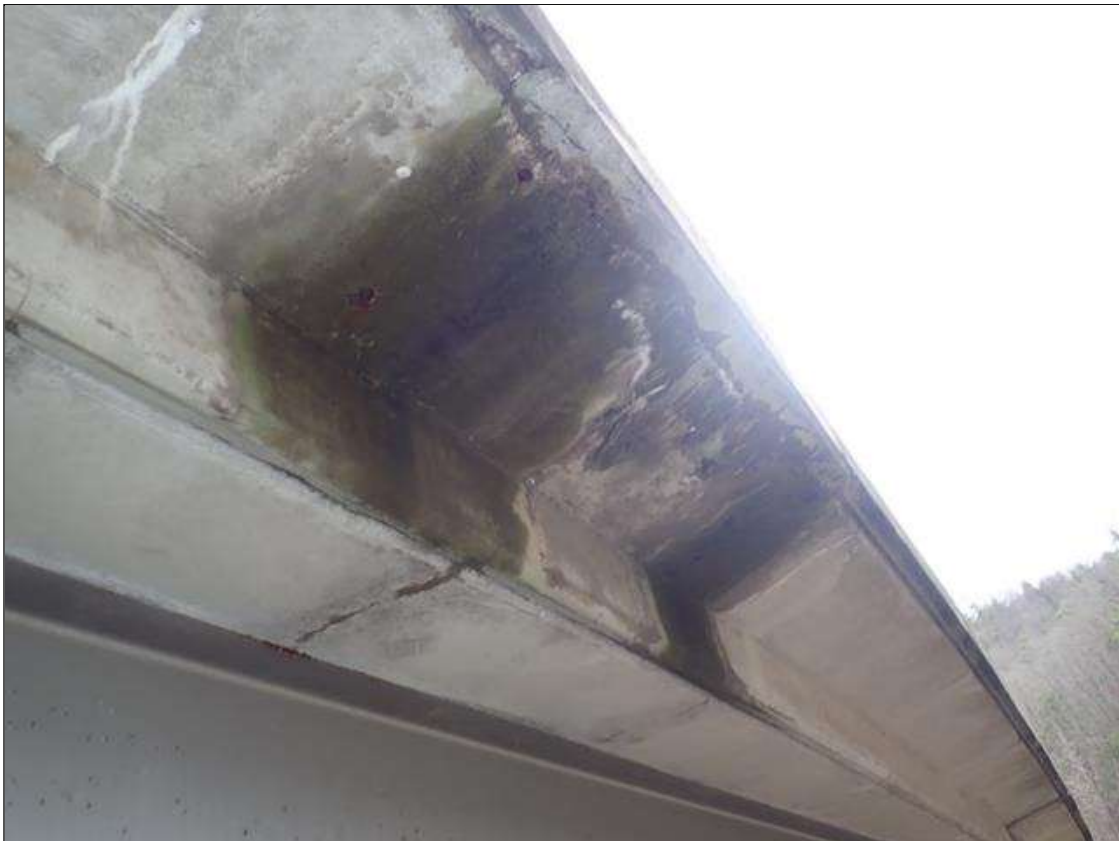
Span 4 Deck: PACTH REPAIR UNDERSIDE OF OVERHANG AT MIDSPAN

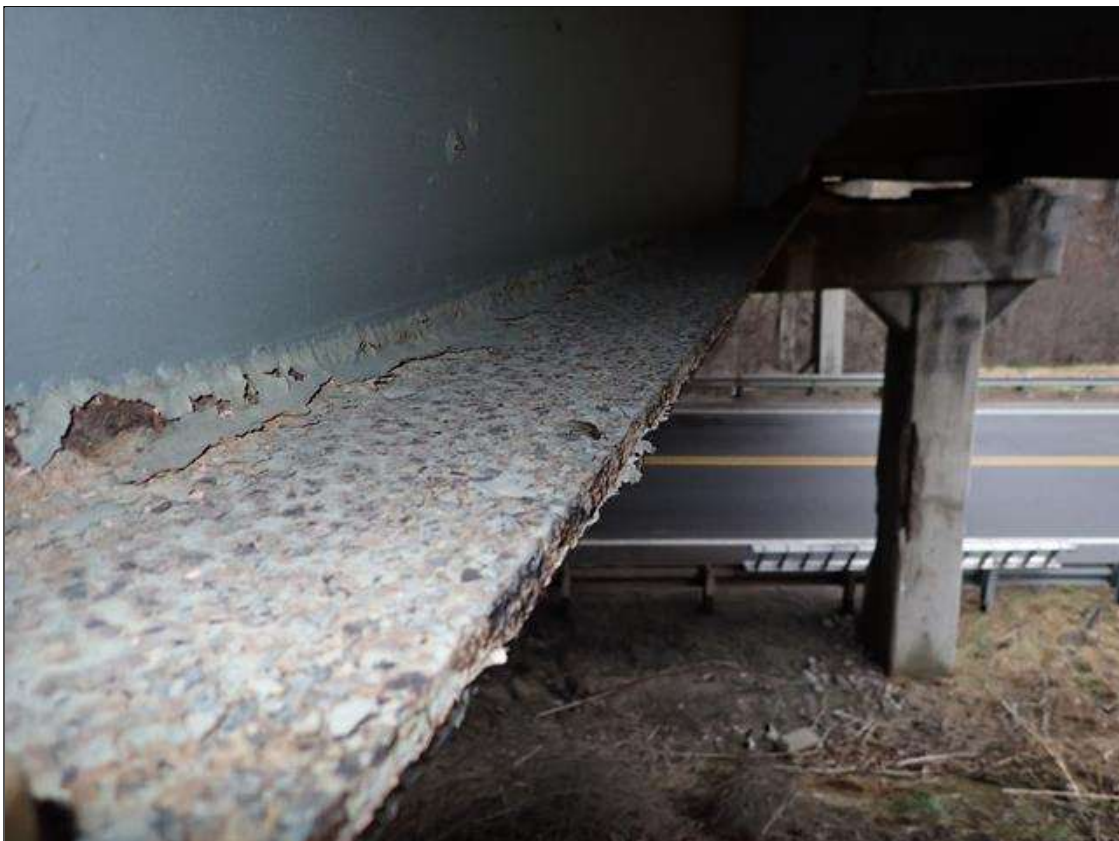
Span 4 Beam 2: SURFACE CORROSION ON BOTTOM FLANGE FOR FULL LENGTH ON BOTH SIDES
