NC DEPARTMENT OF TRANSPORTATION  
DIVISION OF HIGHWAYS  
STRUCTURE MANAGEMENT UNIT

## Structure Safety Report

### Routine Element Inspection - Contract

DIVISION: 14 COUNTY: HAYWOOD STRUCTURE NUMBER: 430057 FREQUENCY: 24 MONTHS

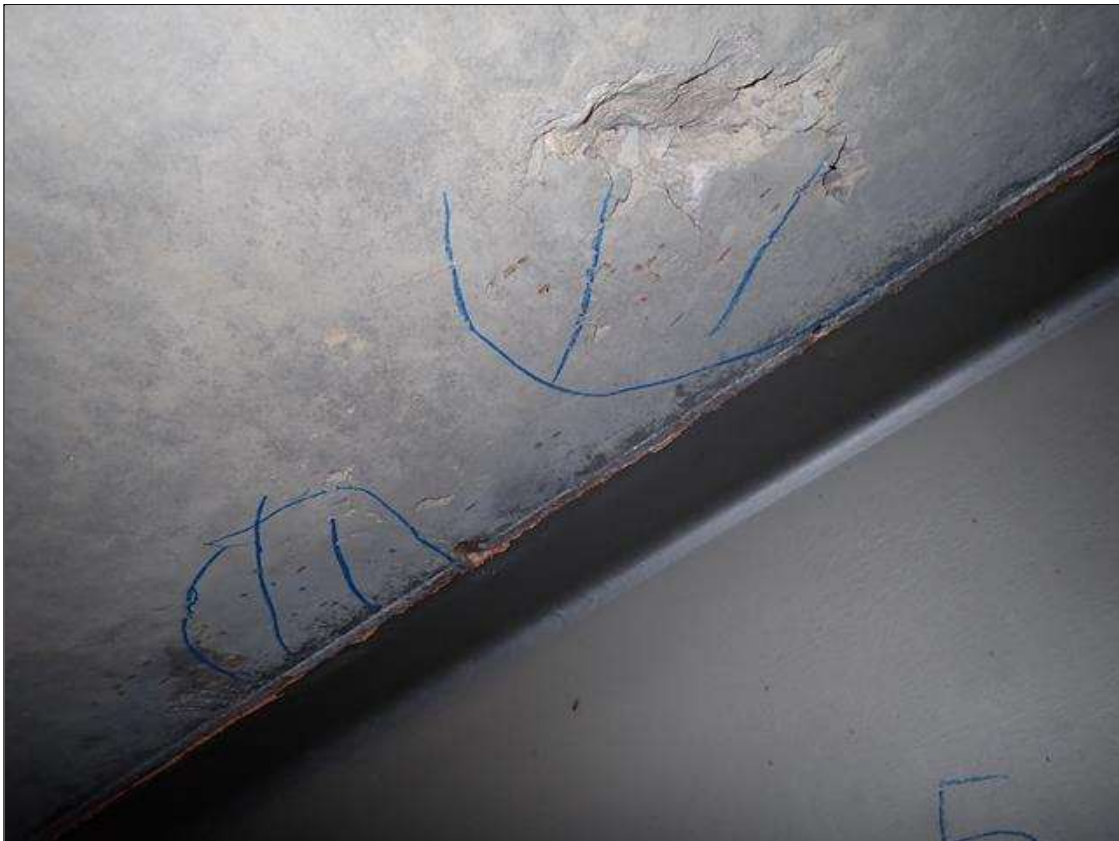
Span 4 Deck: 2 - 7" DIAMETER DELAMINATIONS NEXT TO GIRDER 5 IN BAY 4 IN UNDERSIDE OF DECK AT 7 FT FROM END BENT 2

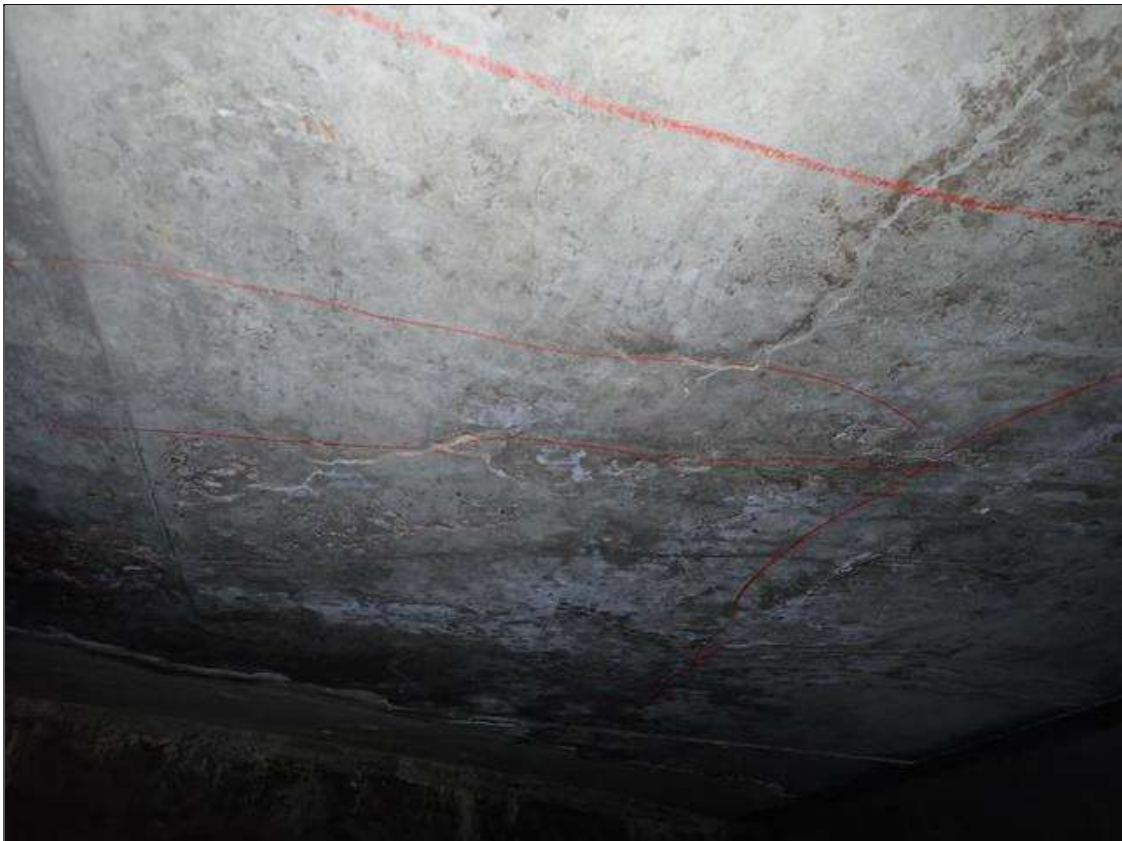
Span 4 Deck: CRACKED DELAMINATION 3 FT x 4 FT LONG, AT END BENT 2 IN BAY 8 UNDERSIDE OF DECK

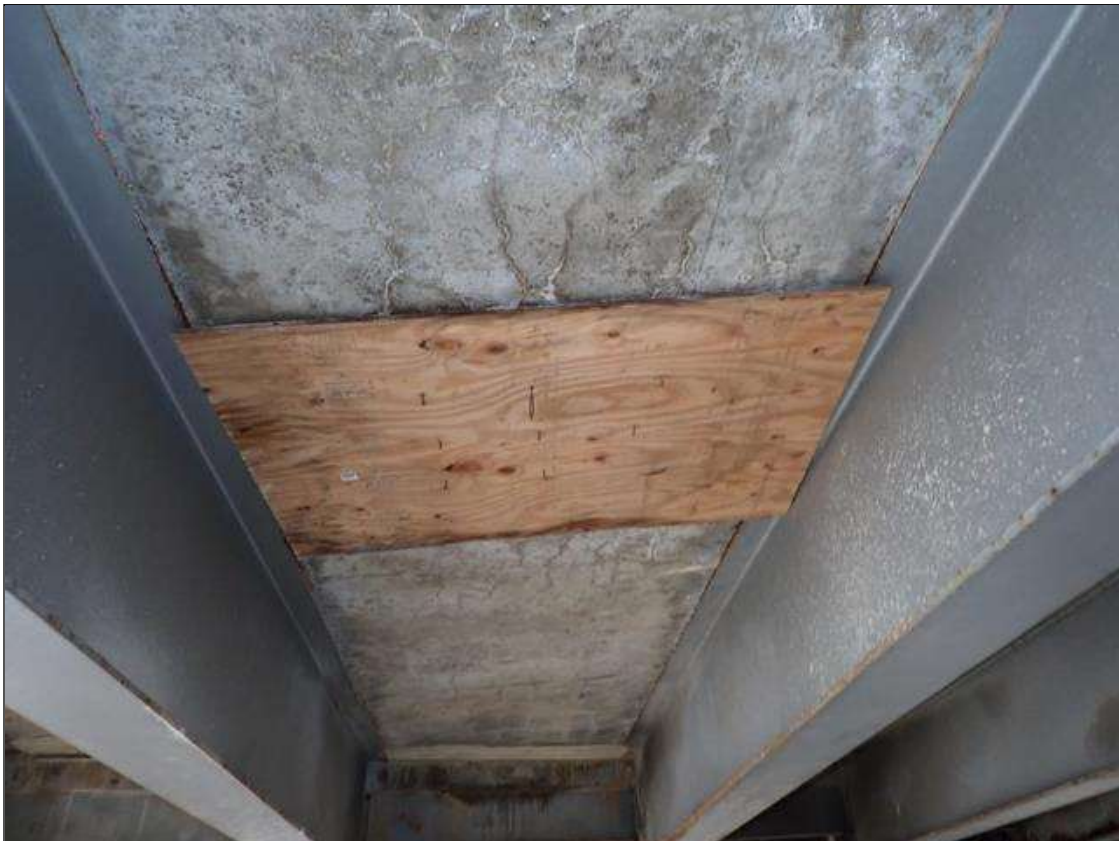
Span 4 Deck: 4 FT x 6 FT PLYWOOD ATTACHED TO BOTTOM DECK IN BAY 8 AT 17 FT FROM BENT 3

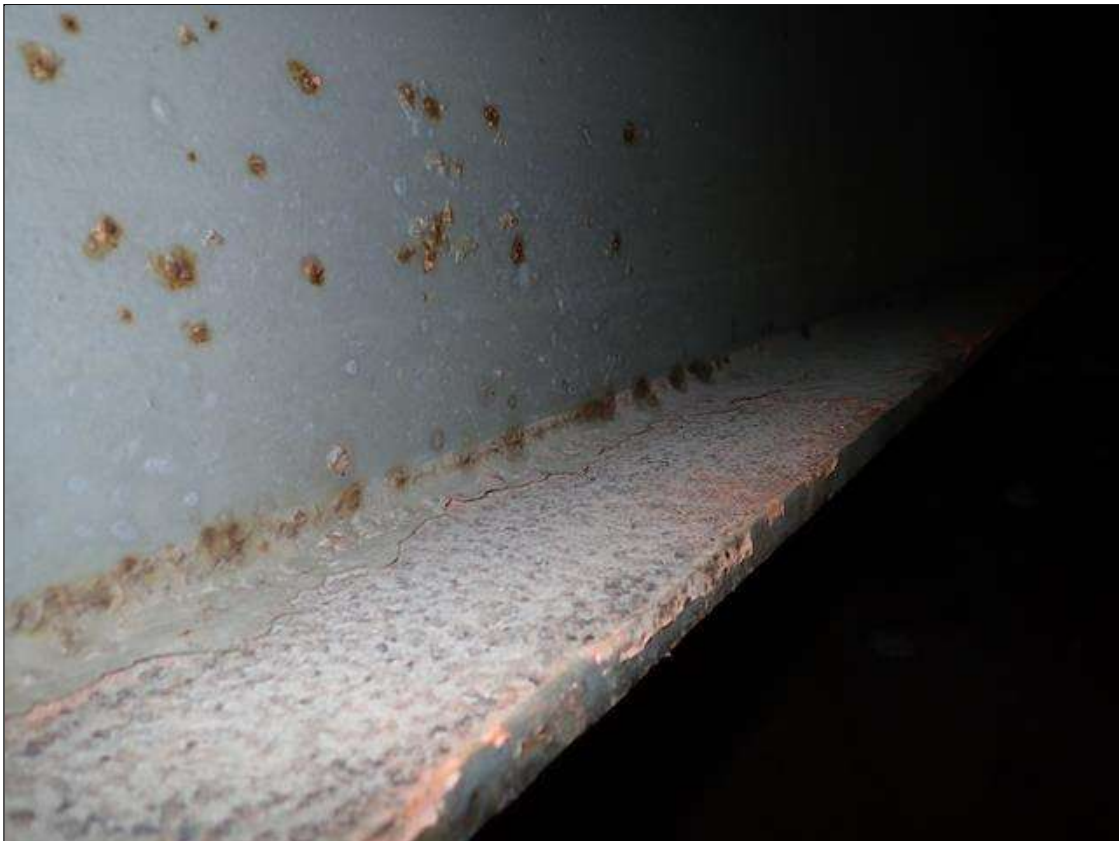
Span 4 Beam 7: SURFACE CORROSION ON BOTTOM FLANGE THROUGHOUT FULL LENGTH ON BOTH SIDES

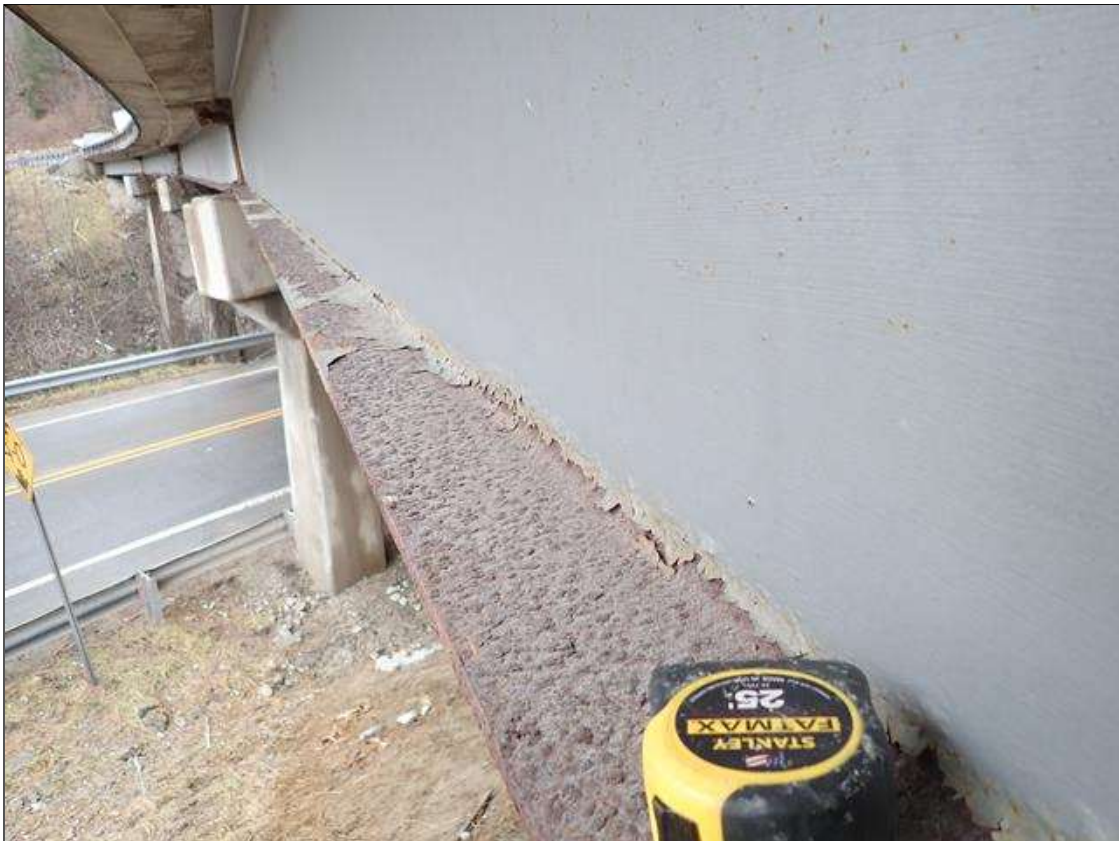
Span 4 Beam 10: SURFACE CORROSION ON BOTH SIDE OF BOTTOM FLANGES THROUGHOUT FULL LENGTH  
OF SPAN, NO MEASURABLE SECTION LOSS

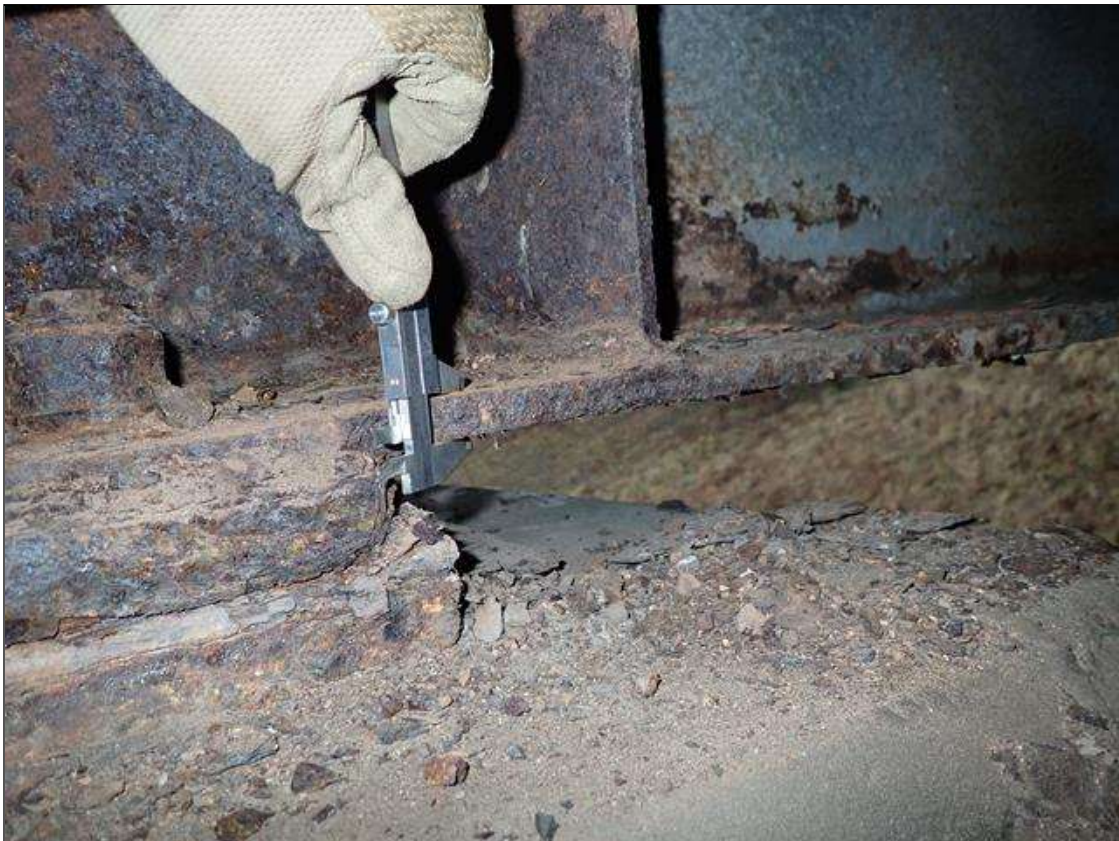
Span 4 Beam 1: 1.5 FT. OF SURFACE CORROSION WITH 1/2" THICKNESS REMAINING SECTION IN BOTTOM FLANGE AT BENT 3

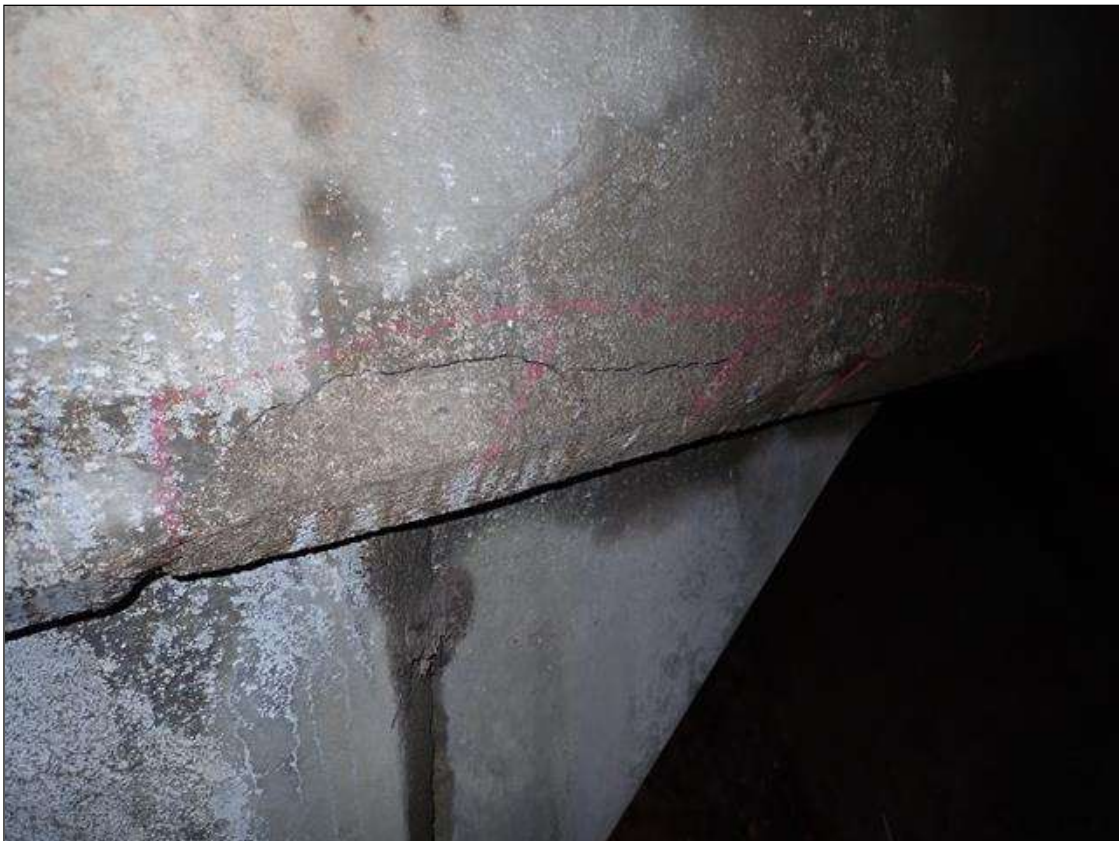
Bent 3 Cap 1: 26" X 4" AREA OF DELAMINATION IN WEST FACE OF BOTTOM CAP UNDER BAY 1

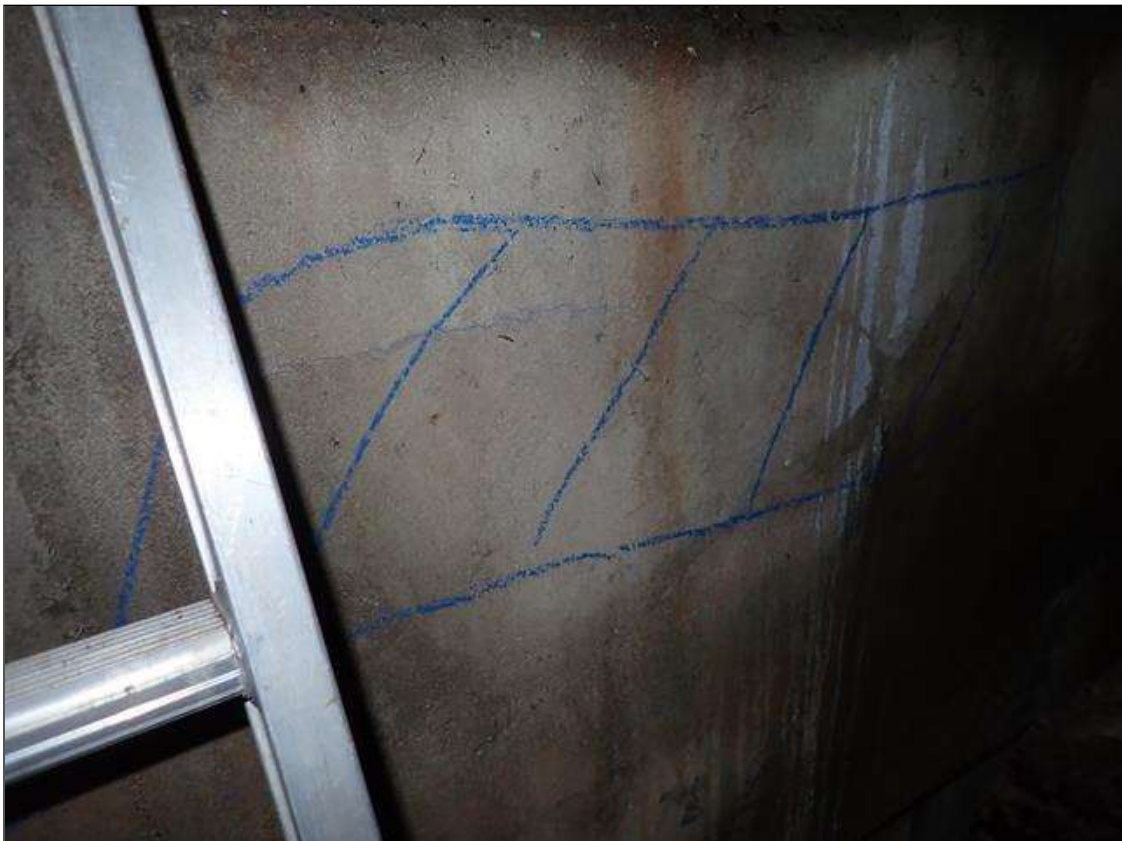
Bent 3 Cap 1: 6 FT x 9" TALL DELAMINATION UNDER BAY 3 IN WEST FACE OF CAP

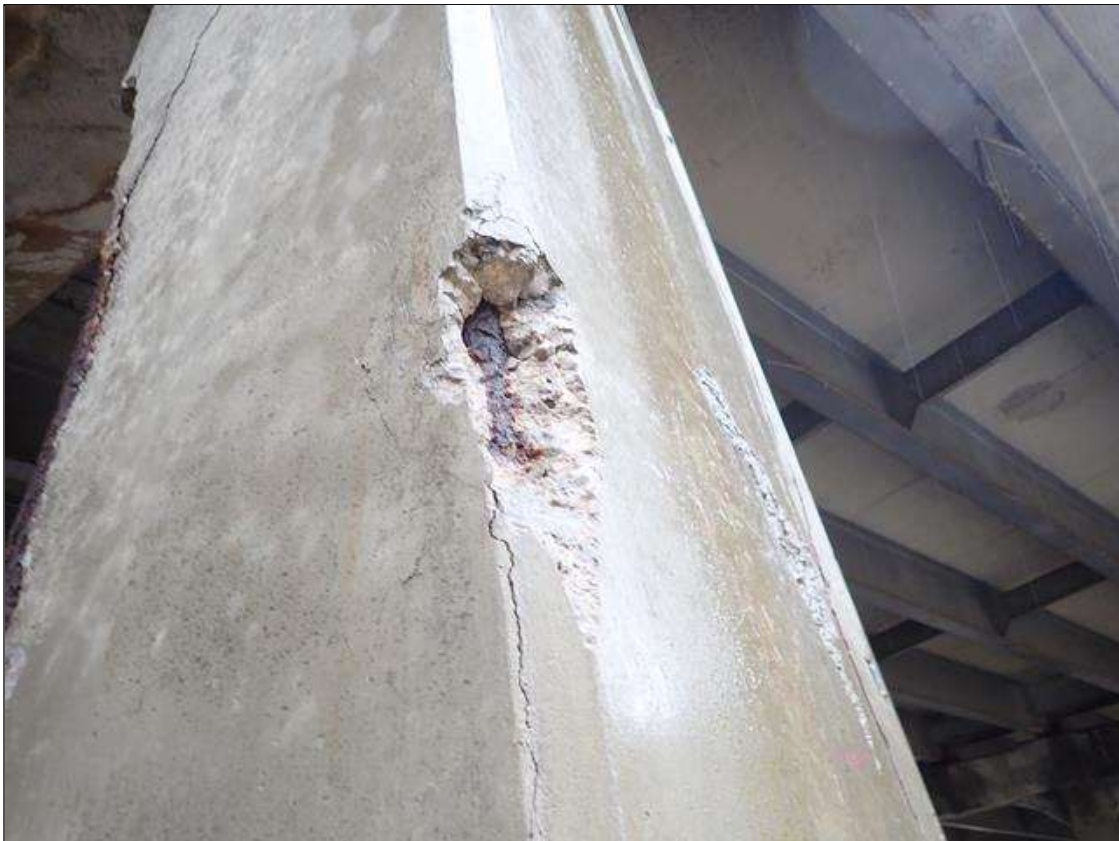
Bent 3 Pile 1: 18" X 6" X 2" DEEP SPALL IN NORTHEAST CORNER

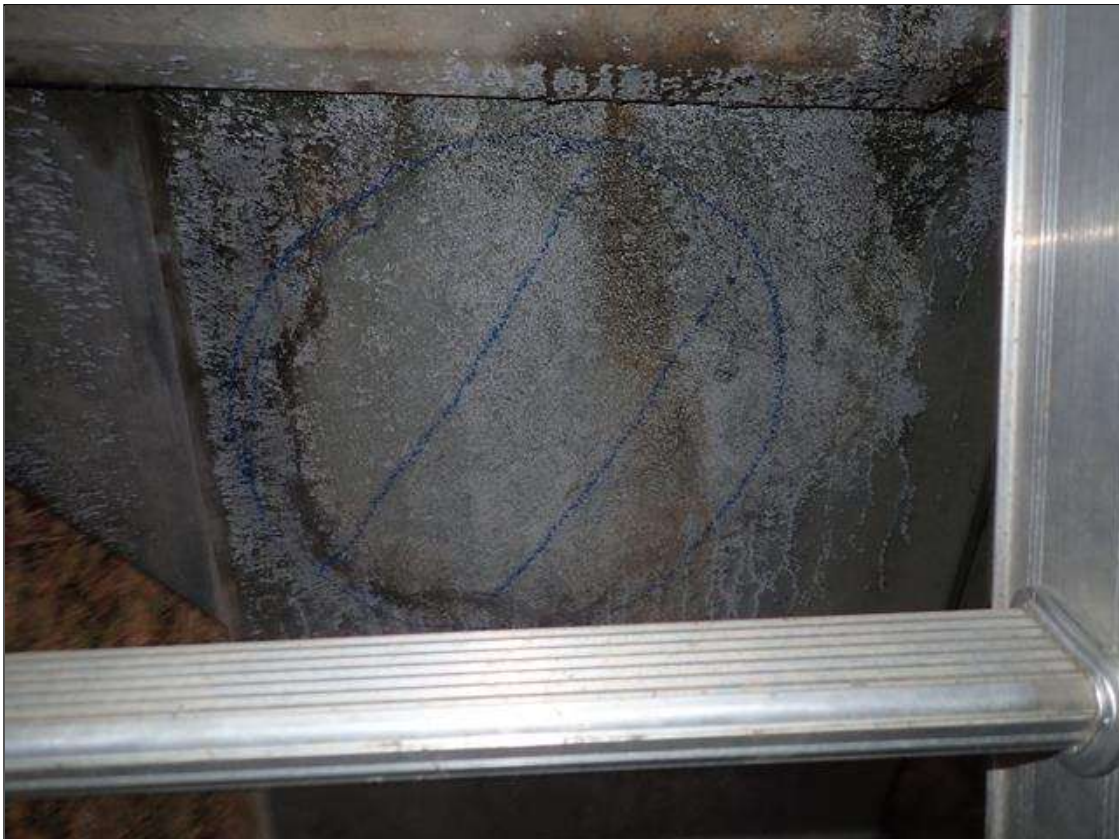
Bent 3 Pile 1: 18" DIAMETER PATCH IN TOP OF COLUMN 1 ON WEST FACE OF CAP

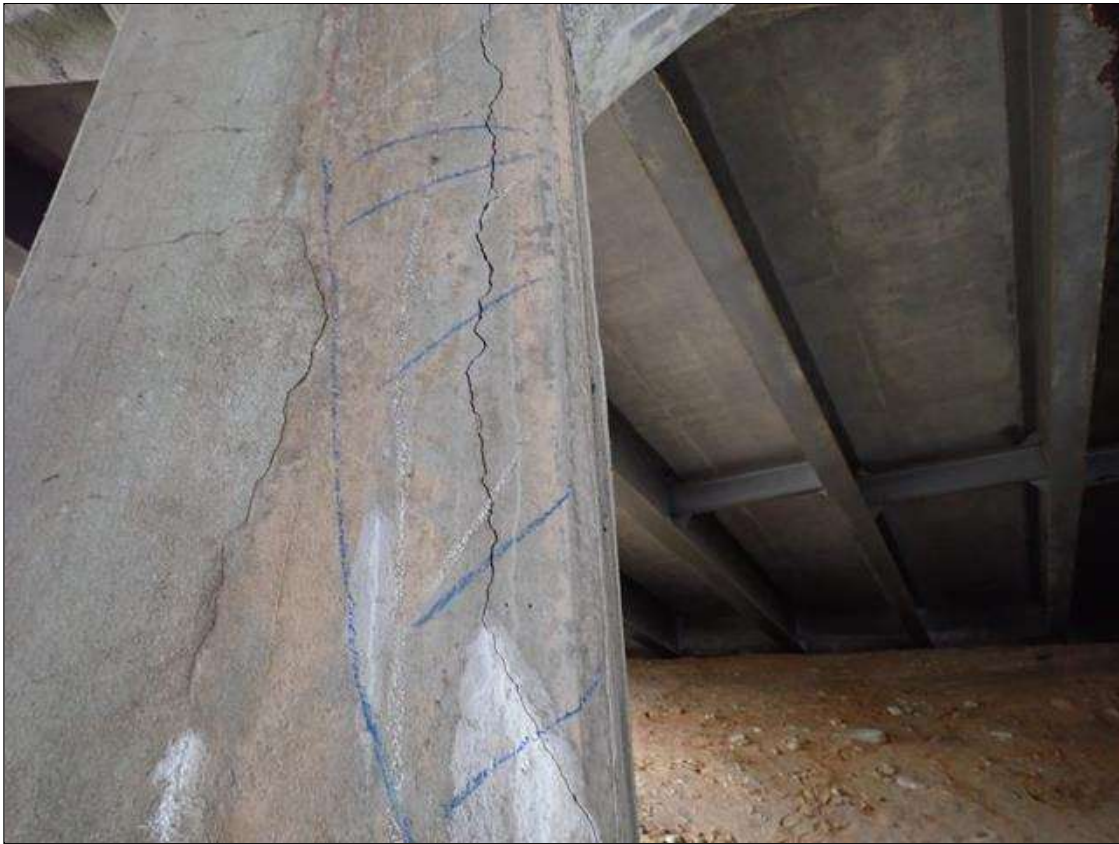
Bent 3 Pile 2: 7.5 FT X 14" x 5" AREA OF DELAMINATION IN SOUTHWEST CORNER OF COLUMN 2 WITH EFFLORESCENCE

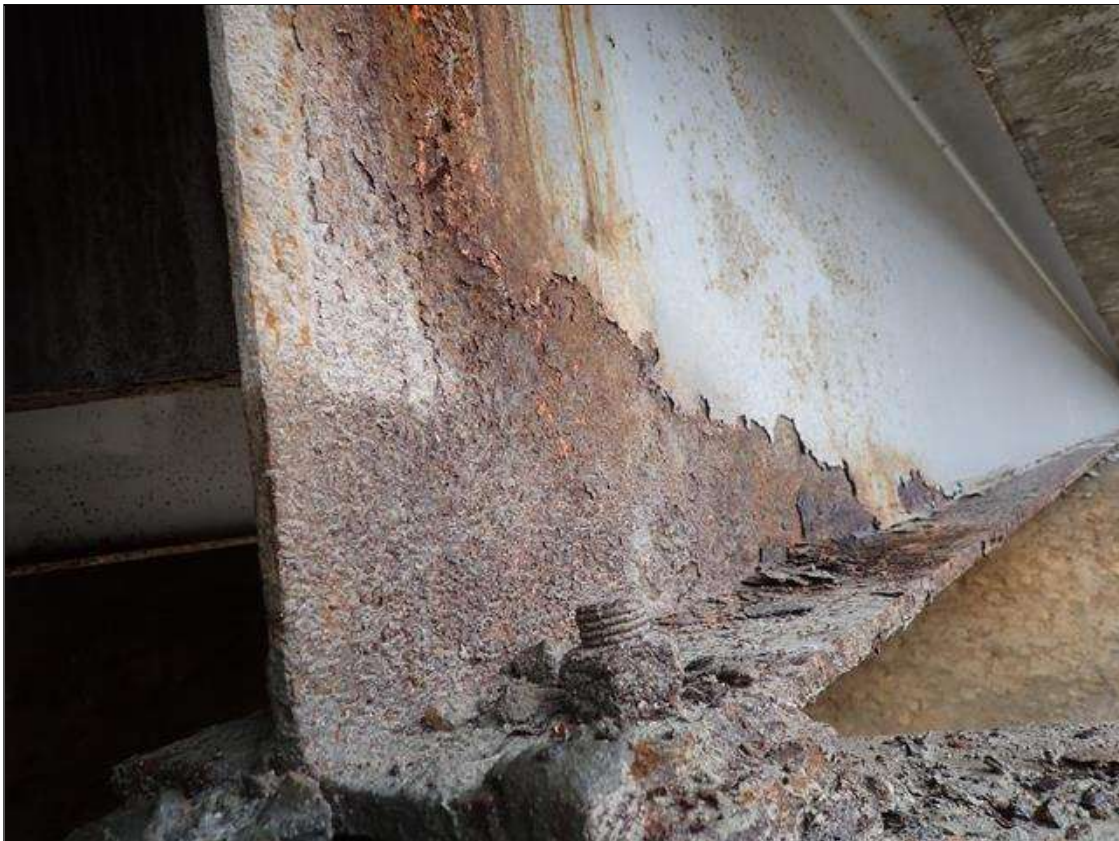
Span 4 Beam 10: SURFACE CORROSION AT BENT 3, 4 FT LONG x FULL HEIGHT OF WEB ON OUTSIDE FACE OF BEAM 10

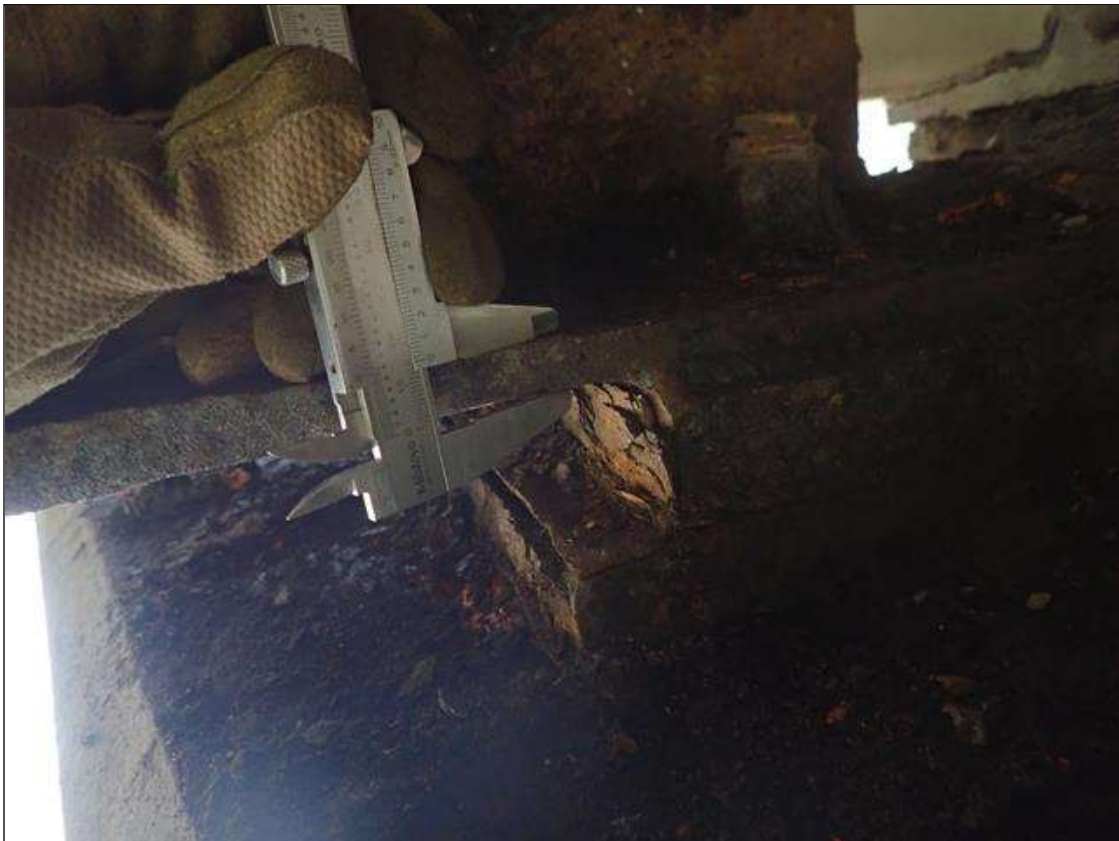
Span 3 Beam 2: 1 FT LONG SURFACE CORROSION ON BOTTOM FLANGE AT BENT 3, 0.5" REMAINING THICKNESS IN BOTTOM FLANGE

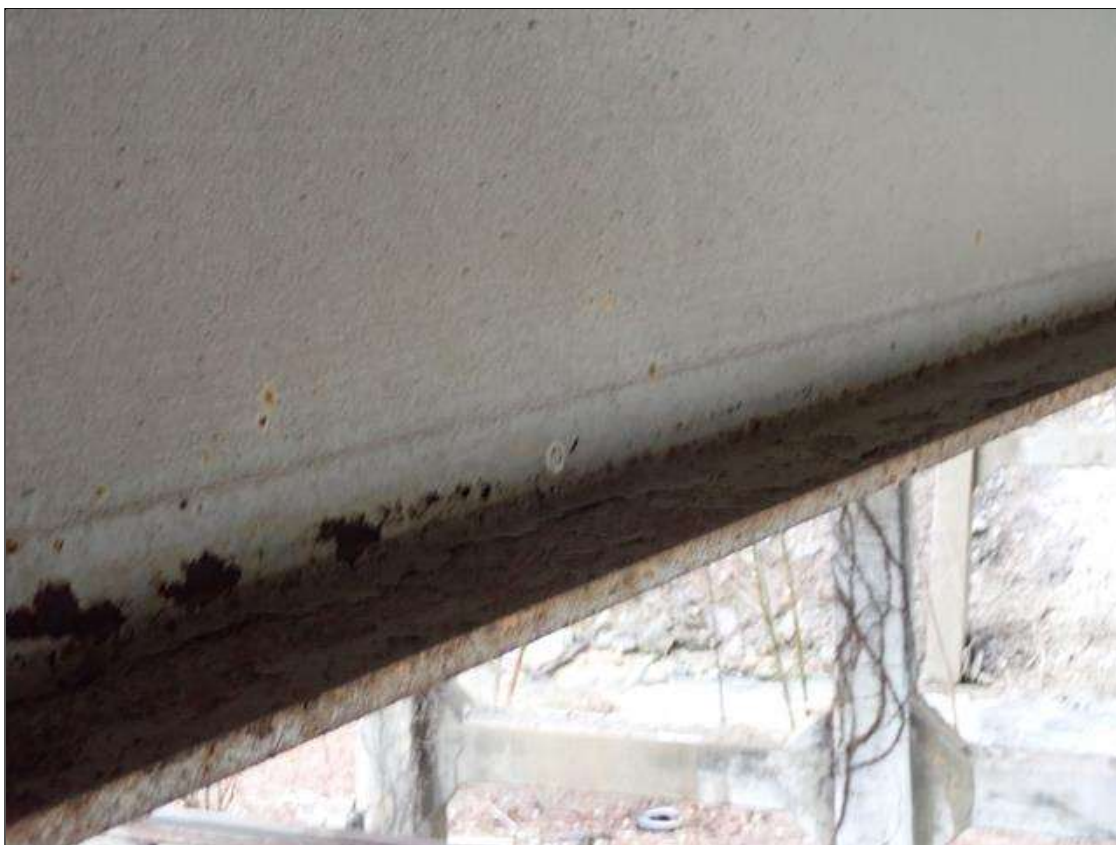
Span 3 Beam 3: SCATTERED SURFACE CORROSION ON BOTTOM FLANGE THROUGHOUT FULL LENGTH

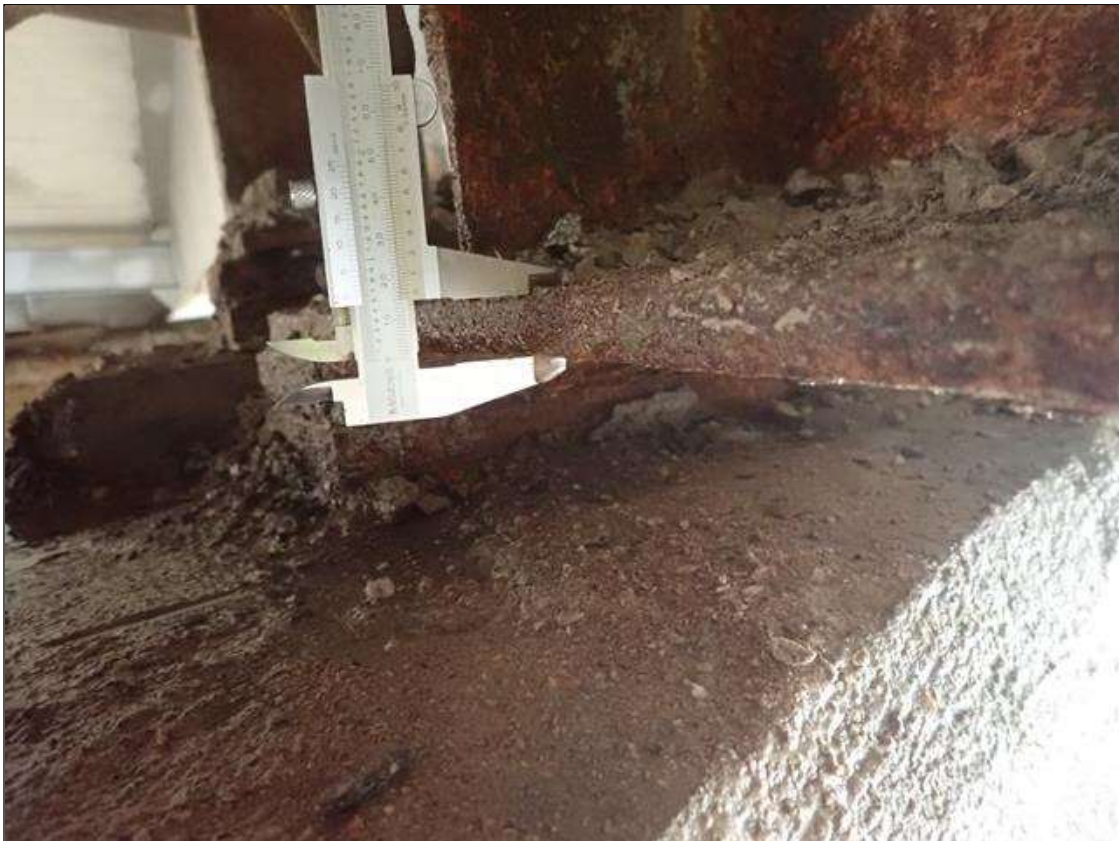
Span 3 Beam 7: 1 FT. OF CORROSION WITH 0.65" REMAINING THICKNESS IN BOTTOM FLANGE AT BENT 3

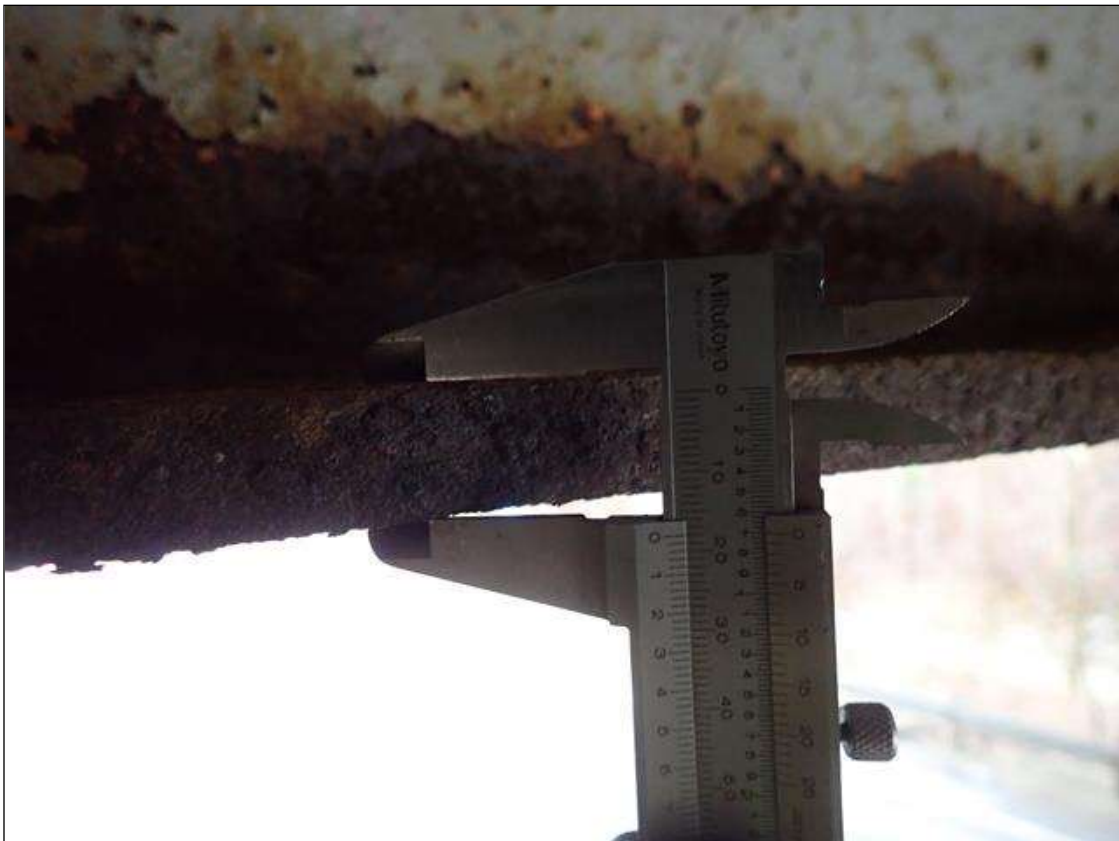
Span 3 Beam 5: 2 FT CORROSION WITH SECTION LOSS ON BOTTOM FLANGE, 0.6" THICKNESS REMAINS AT BENT 3

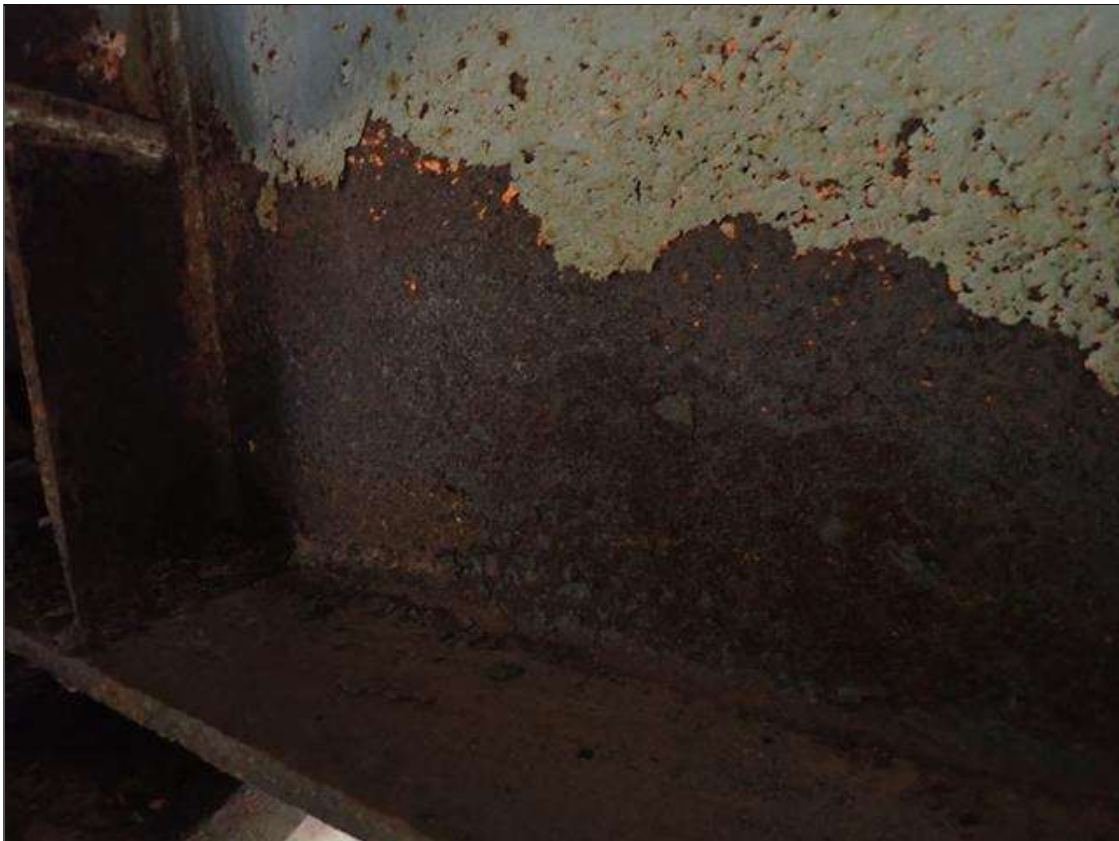
Span 3 Beam 5: BEARING STIFFNER HAS SECTION LOSS FOR 5" TALL x FULL WIDTH, 0.1" THICKNESS REMAINS AT BENT 3. PRIORITY MAINTENANCE ISSUED

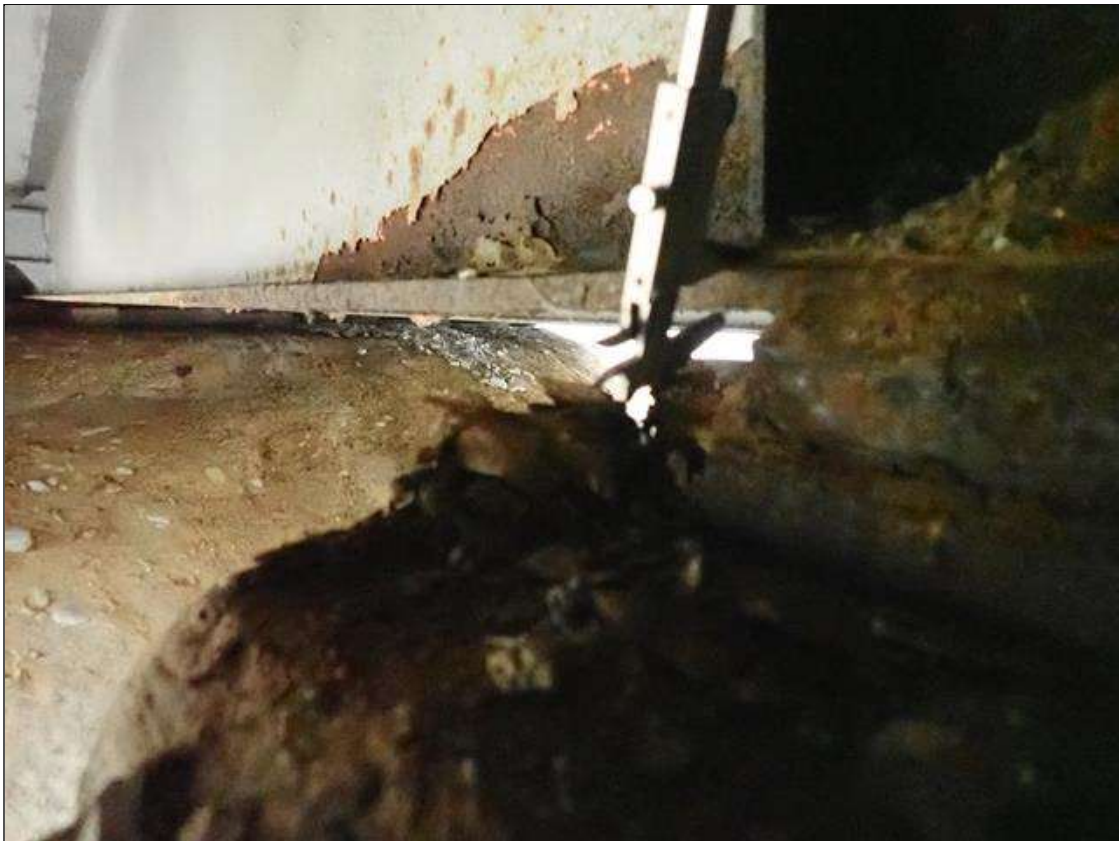
Span 4 Beam 3: 1 FT. OF CORROSION WITH 0.4" REMAINING THICKNESS IN BOTTOM FLANGE AT BENT 3  
(PRIORITY MAINTENANCE ISSUED)

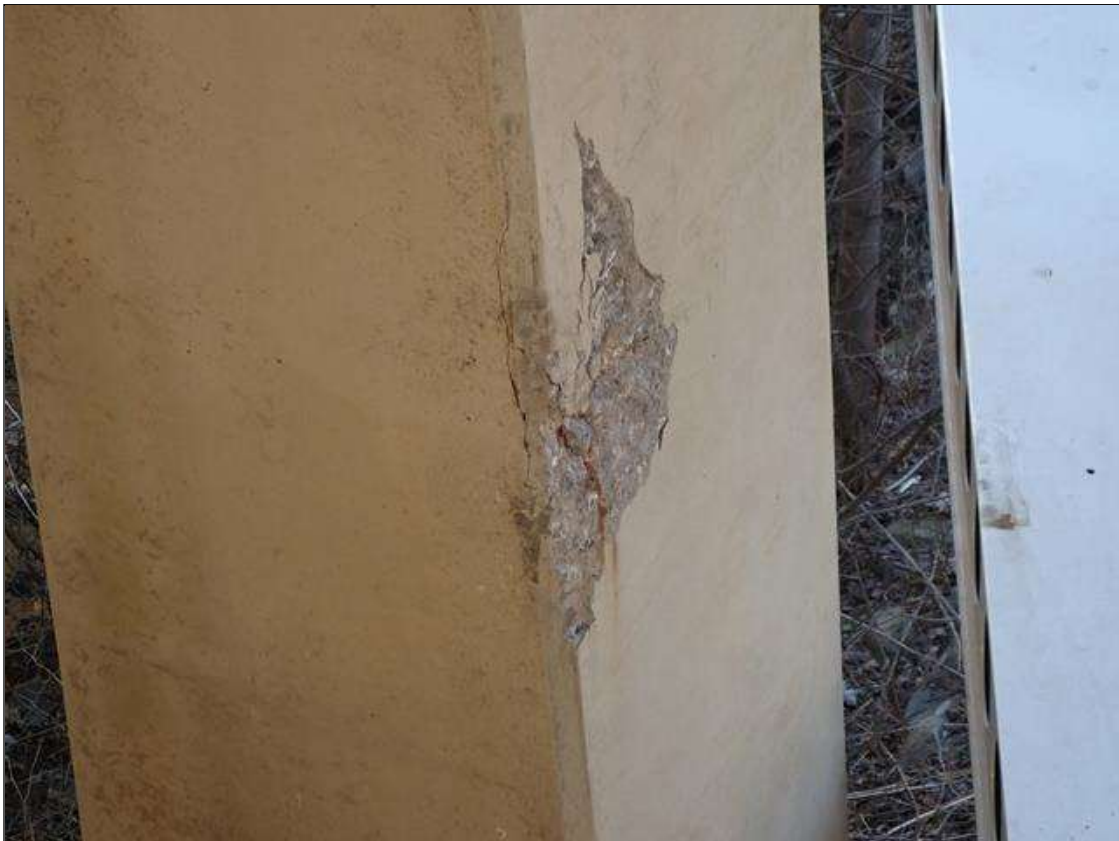
Bent 2 Cap 1: 18" x 7" x 2" SPALL IN TOP OF CAP UNDER BAY 6 AT THE SEAT STEP WITH EXPOSED REBAR, NO SECTION LOSS

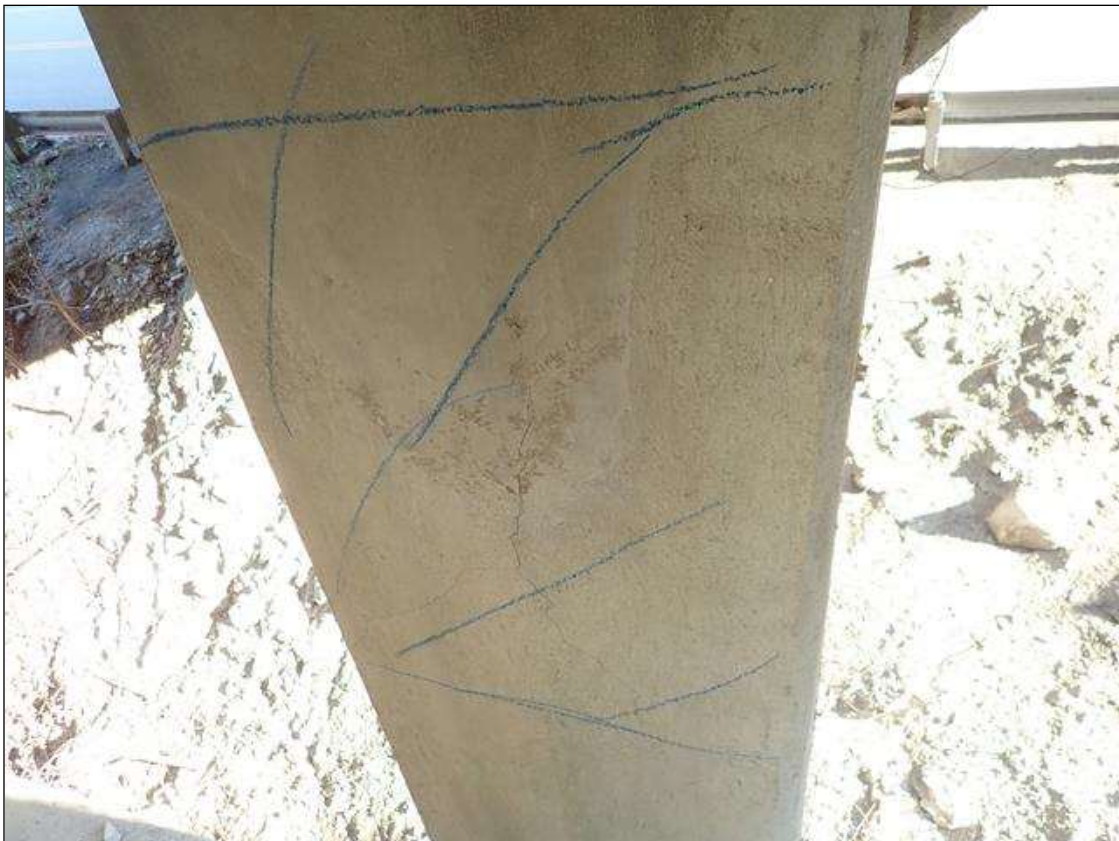
Bent 2 Pile 1: 16" DIAMETER X 1/2" DEEP SPALL WITH EXPOSED REBAR IN SOUTH FACE

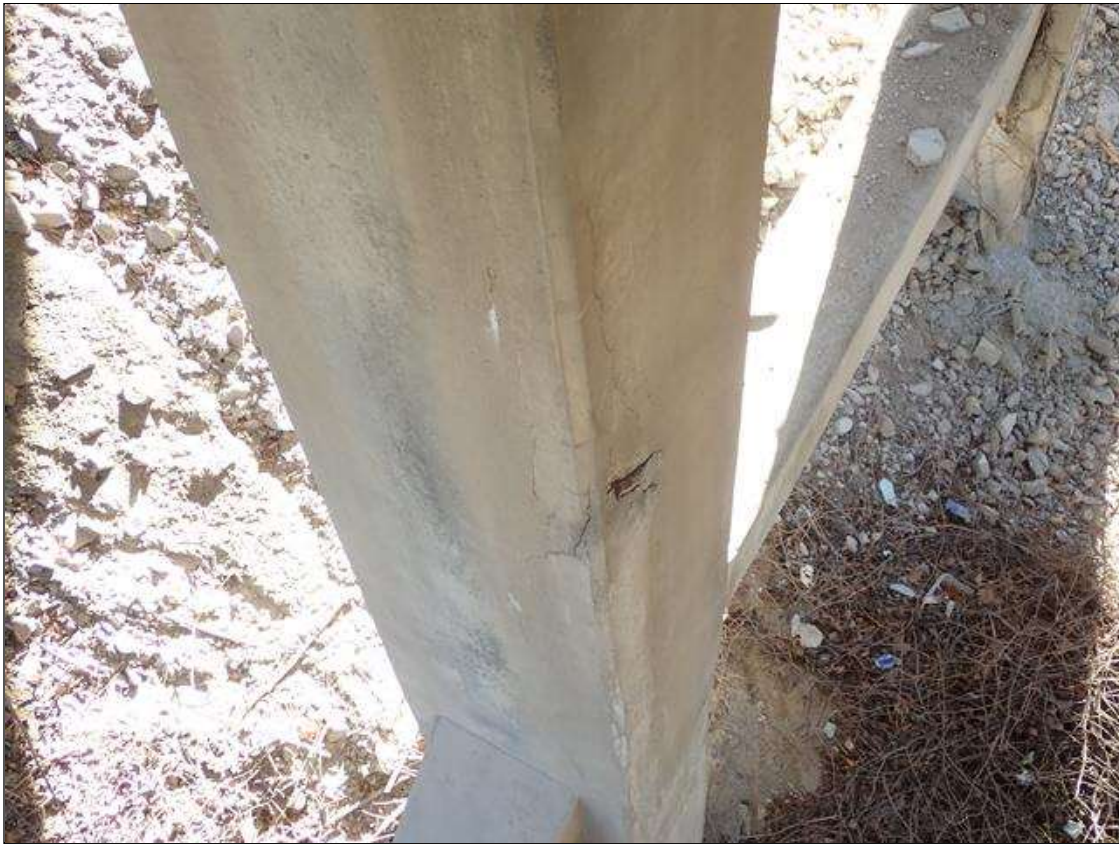
Bent 2 Pile 3: 39" TALL x 30" WIDE DELAMINATION IN WEST FACE OF COLUMN 3

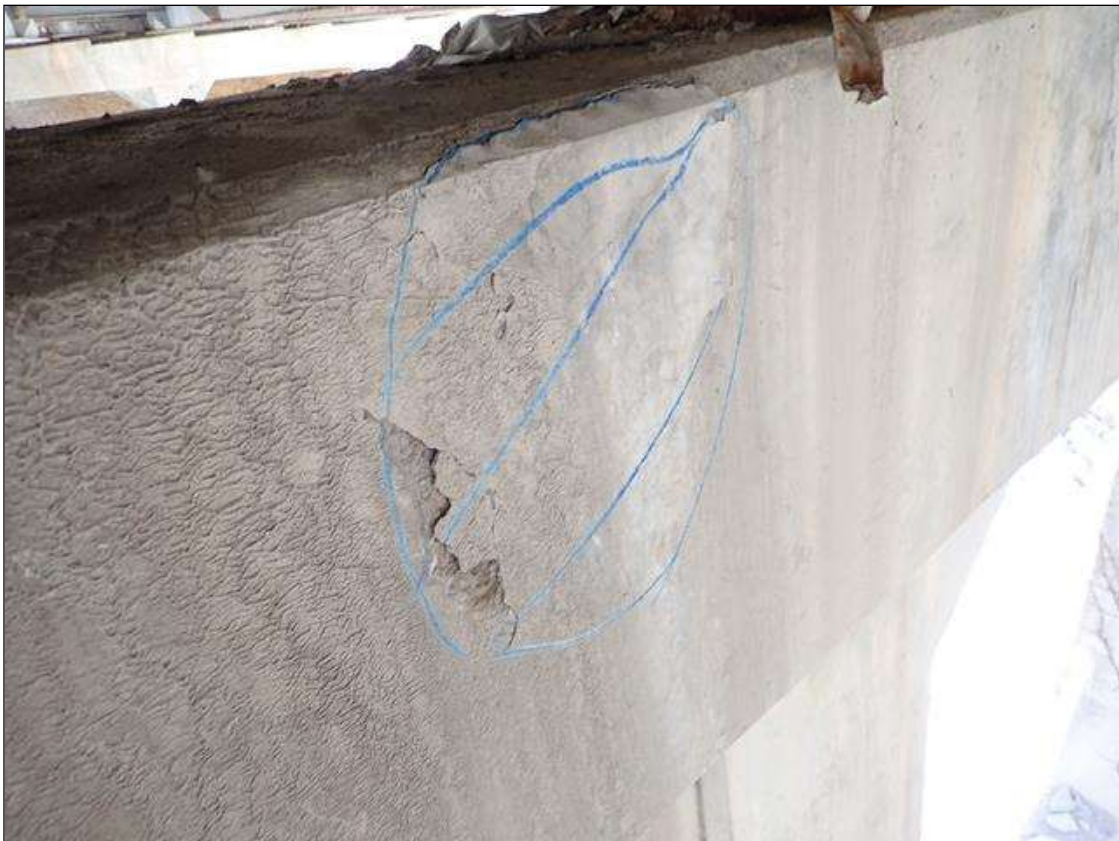
Bent 2 Pile 2: 5FT X 1 FT x 1 FT AREA OF DELAMINATION IN NORTHWEST CORNER NEAR TOP OF COLUMN

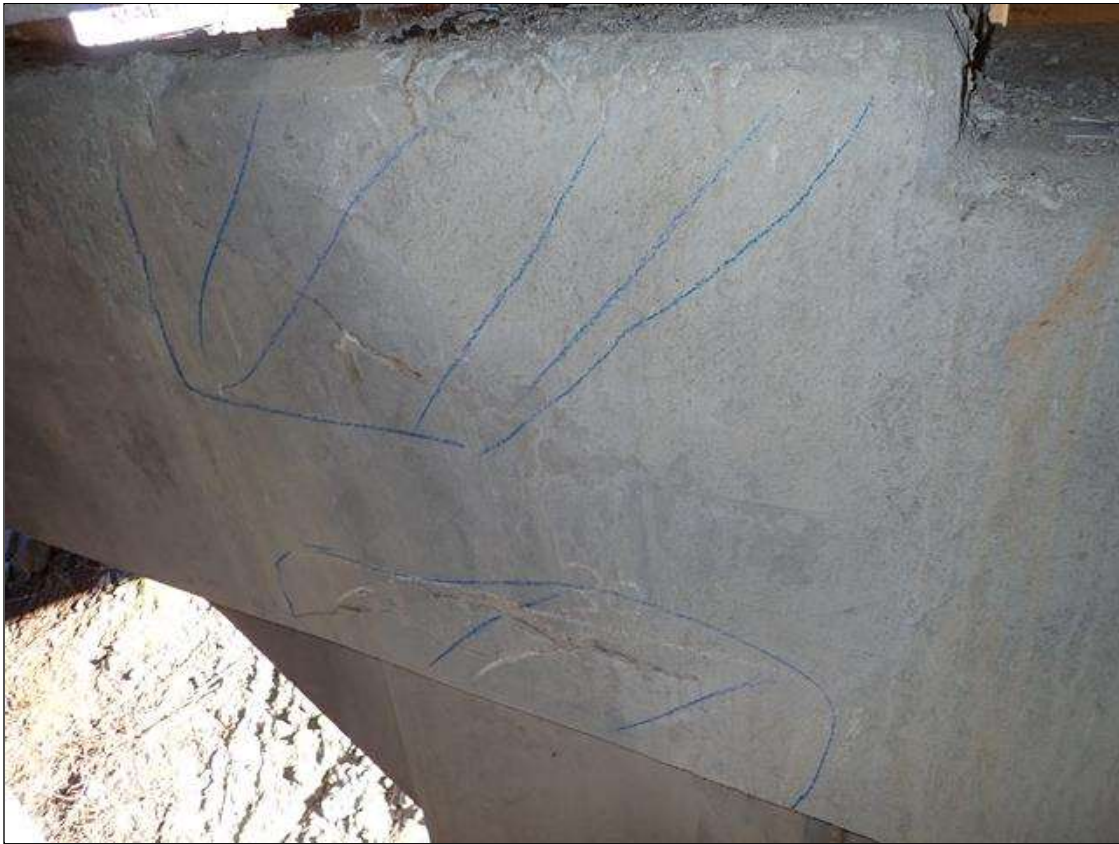
Bent 2 Cap 1: 20" x 20" DELAMINATION IN WEST FACE OF CAP UNDER BAY 3

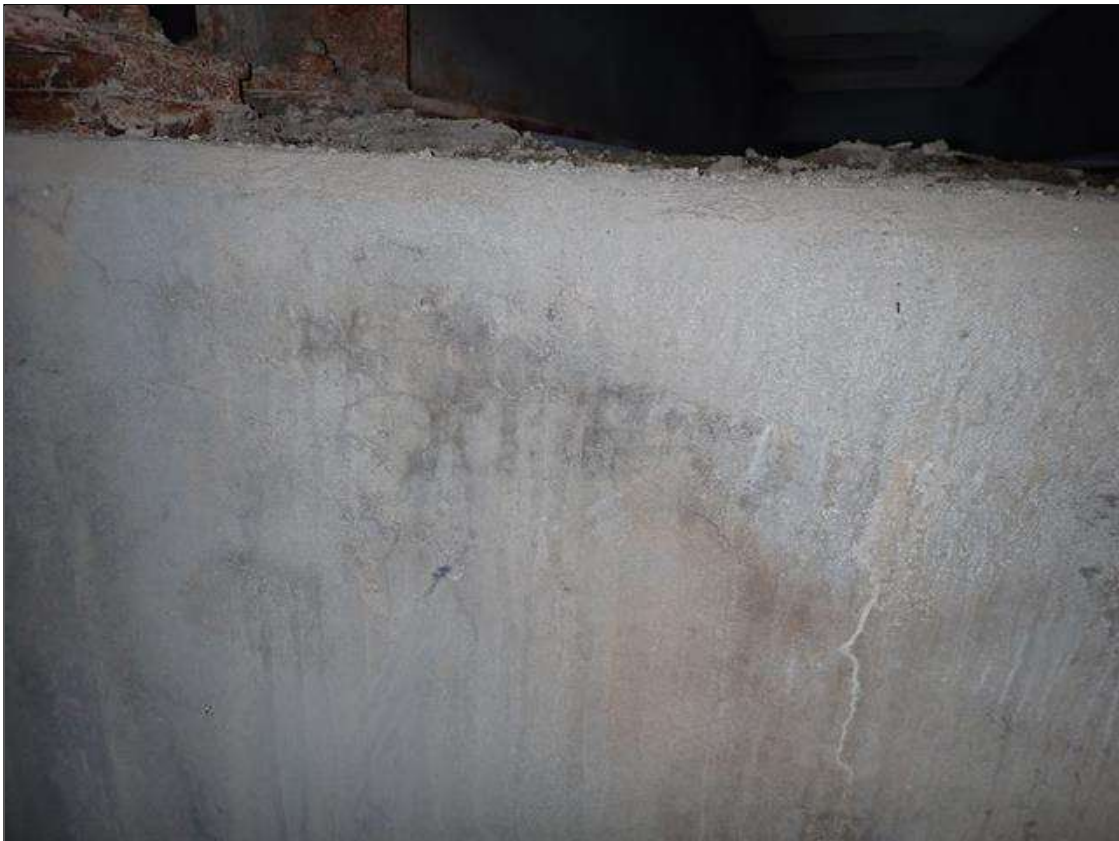
Bent 2 Cap 1: 2 DELAMINATION UNDER GIRDER 7 IN WEST FACE OP CAP, FIRST DELAMINATION AREA IS 3 FT x 18" AND SECOND AREA IS 3 FT x 1 FT
