NC DEPARTMENT OF TRANSPORTATION  
DIVISION OF HIGHWAYS  
STRUCTURE MANAGEMENT UNIT

## Structure Safety Report

### Routine Element Inspection - Contract

DIVISION: 14 COUNTY: HAYWOOD STRUCTURE NUMBER: 430057 FREQUENCY: 24 MONTHS

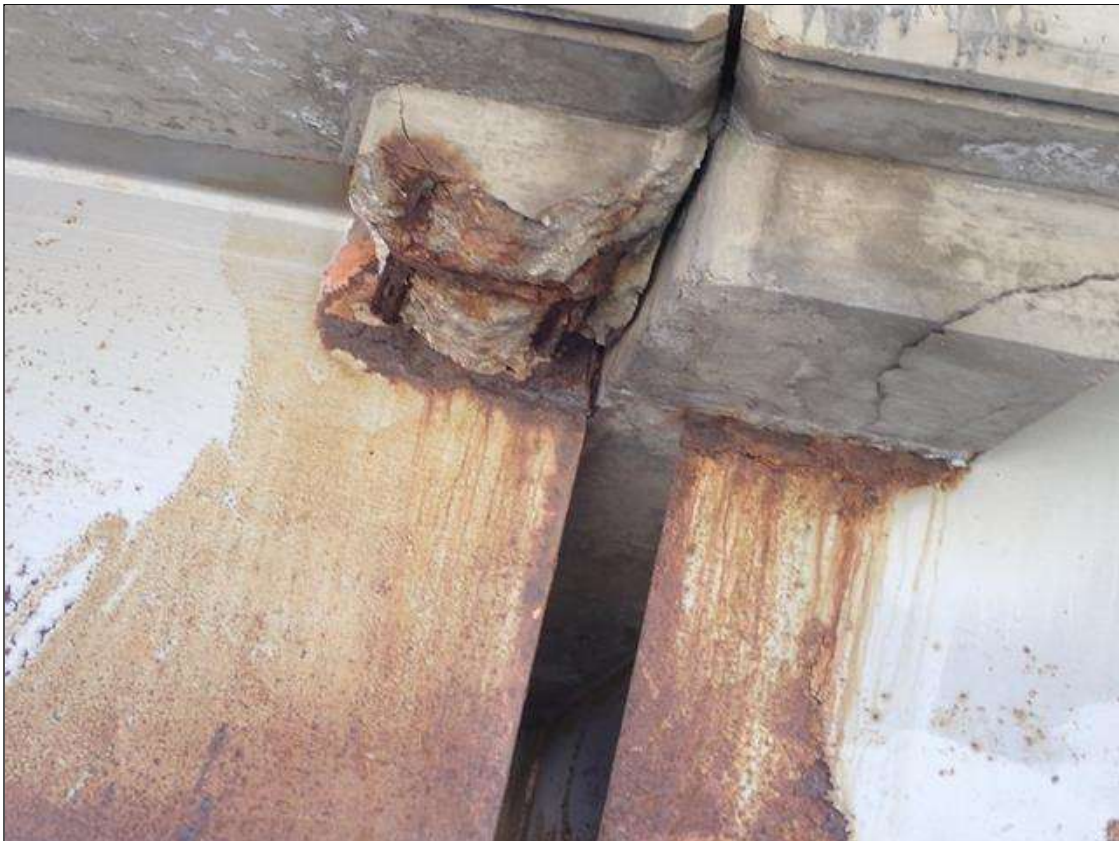
Bent 1 Cap 1: 2.5 FT x 1 FT AREA OF DELAMINATION/SPALL UNDER BAY 4 IN EAST FACE OF CAP AT THE STEP

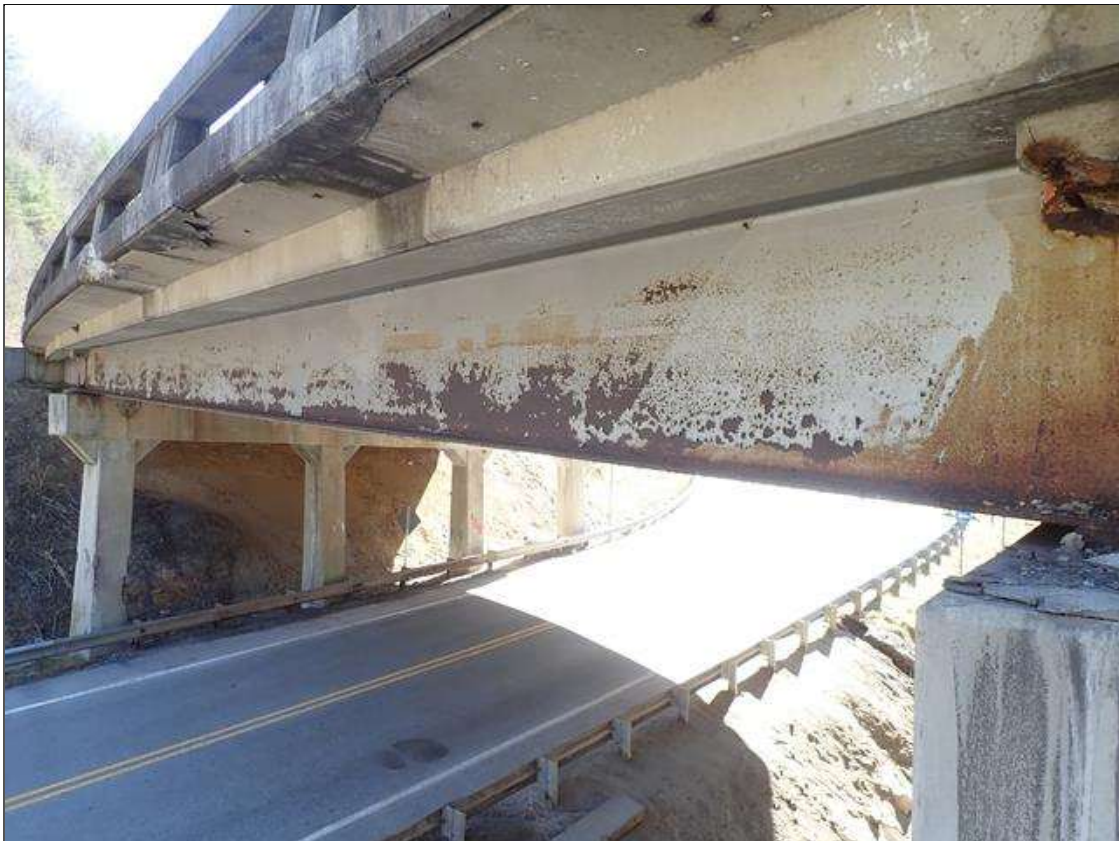
Span 3 Deck: 2.5 FT x 10" x 6" SPALL IN UNDERSIDE OF DECK NEAR GIRDER 1 AT BENT 2 WITH EXPOSED REBAR, NO MEASURABLE SECTION LOSS

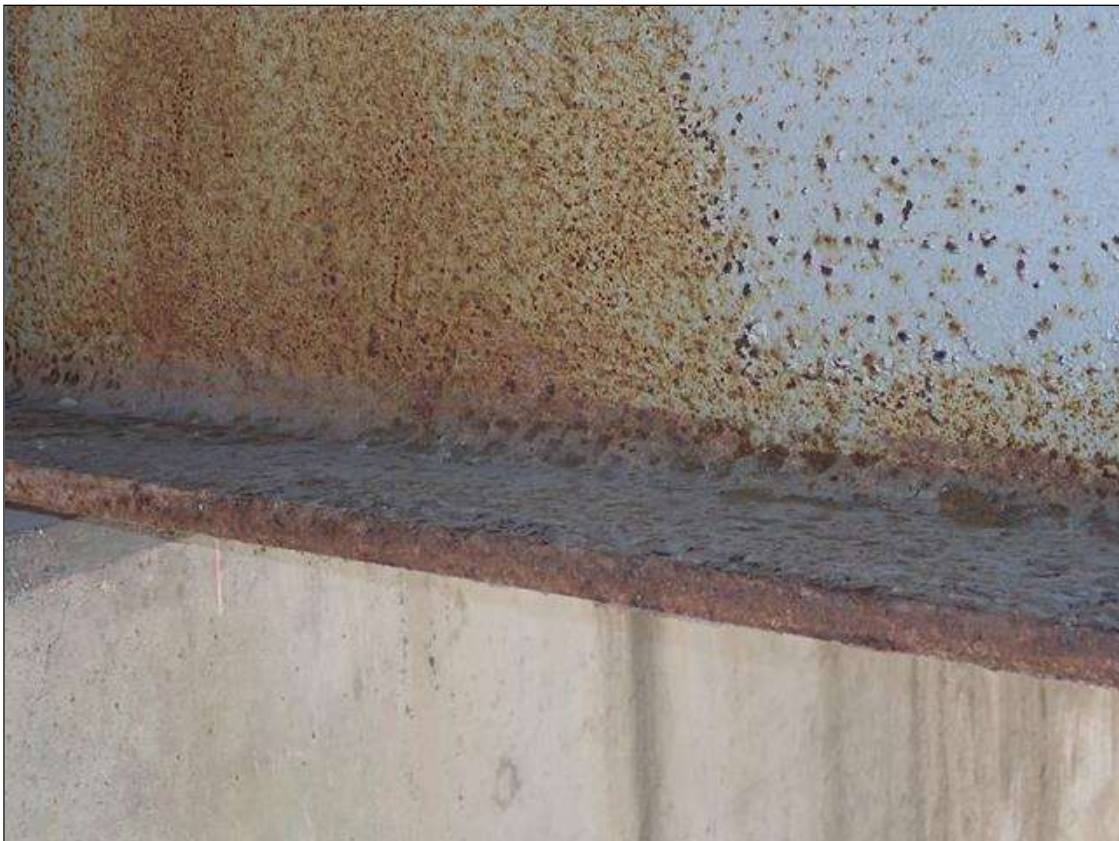
Span 2 Beam 1: SURFACE CORROSION ON BOTTOM FLANGE ALONG FULL LENGTH

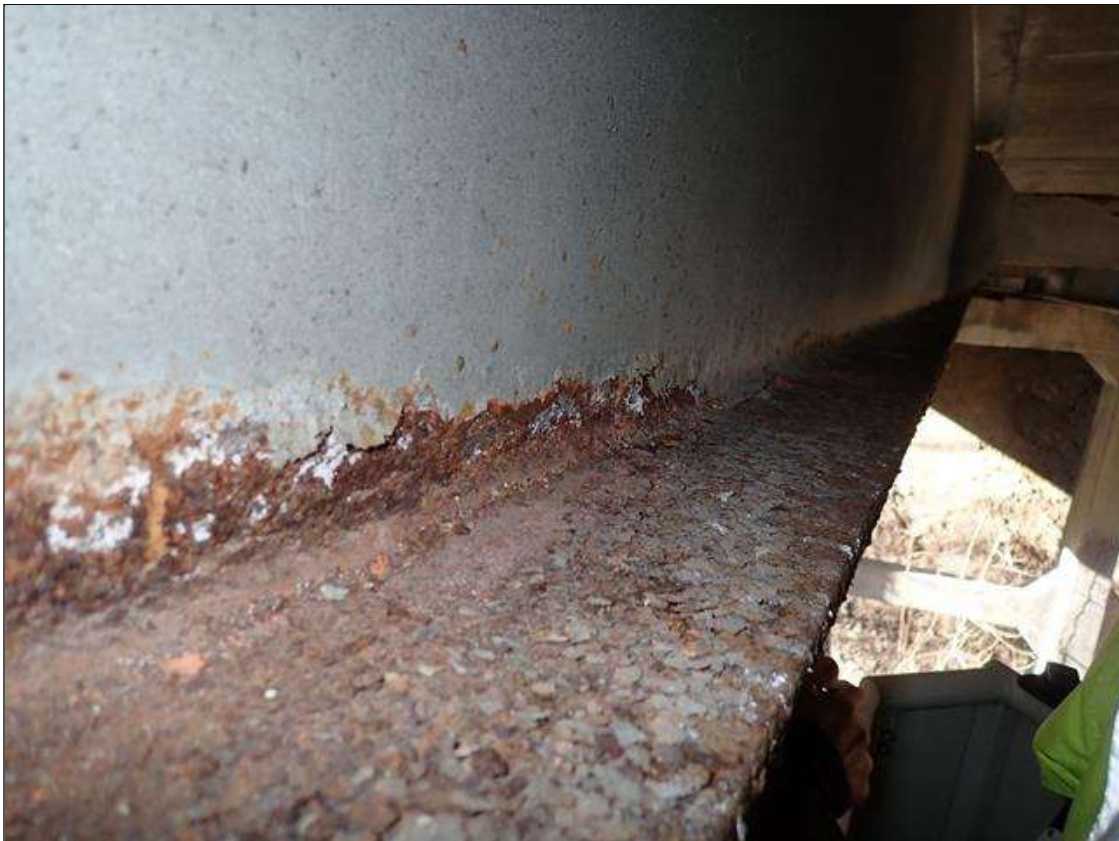
Span 2 Beam 3: SCATTERED SURFACE CORROSION ON BOTTOM FLANGE THROUGHOUT FULL SPAN LENGTH. SCATTERED FRECKLED SURFACE CORROSION IN LOWER 18" OF WEB FOR 6 FT LONG AT BENT 2.

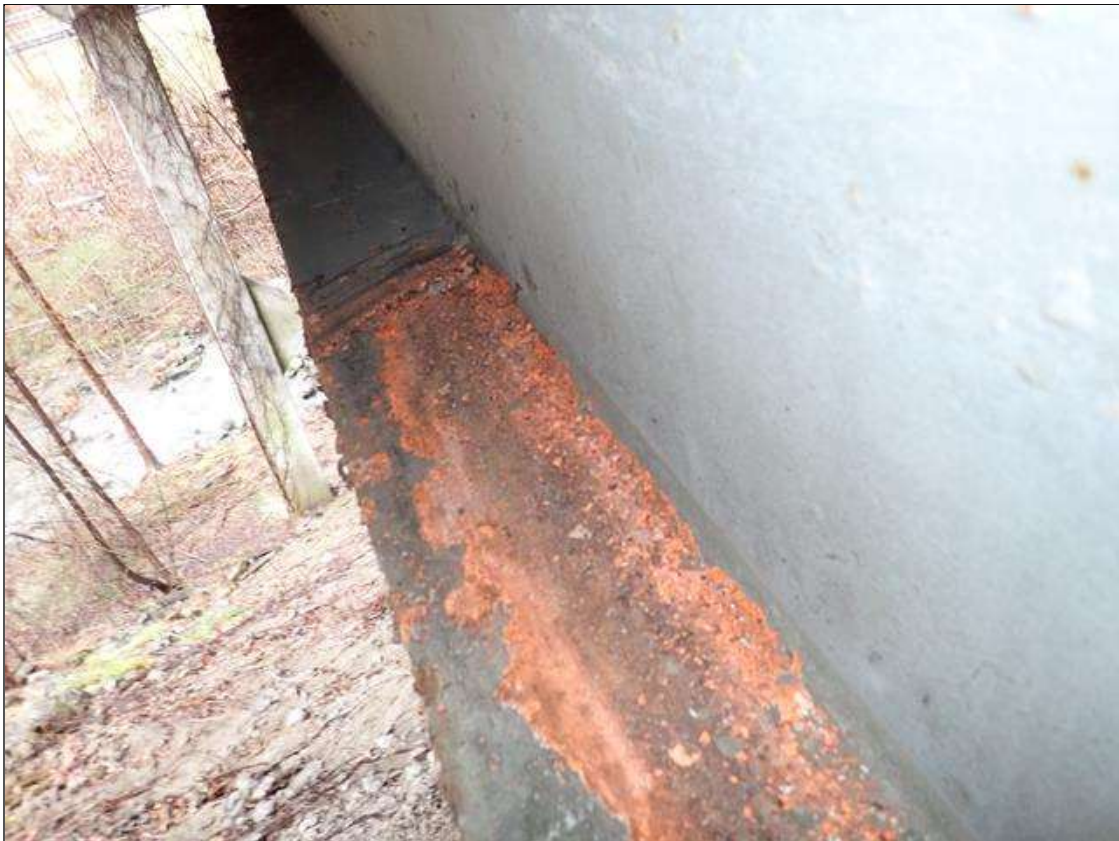
Span 2 Beam 5: SURFACE CORROSION ON TOP FLANGE FOR 15 FT LONG AT MIDSPAN EDGE WITH NO MEASURABLE SECTION LOSS

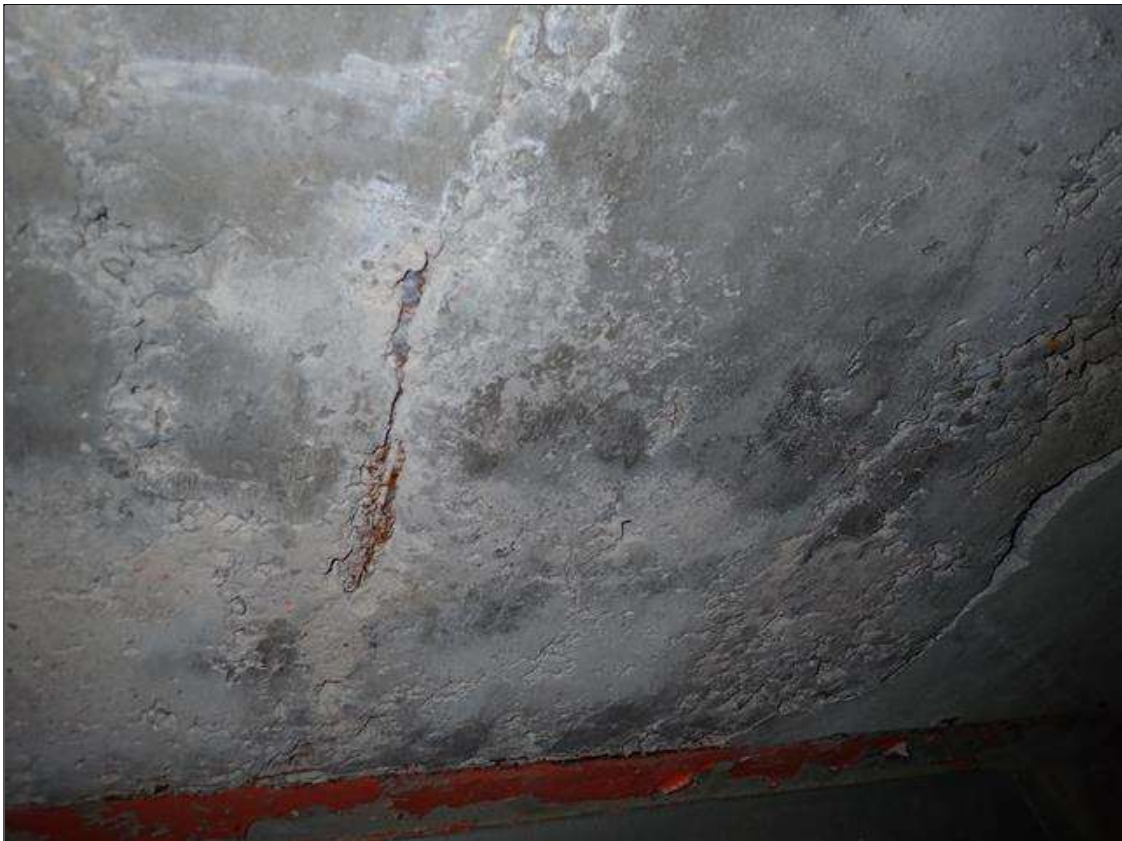
Span 1 Deck: 6" x 6" x 1" SPALL AT MIDSPAN WITH EXPOSED REBAR, NO MEASURABLE SECTION LOSS, AT MIDSPAN IN BAY 7 IN UNDERSIDE OF DECK

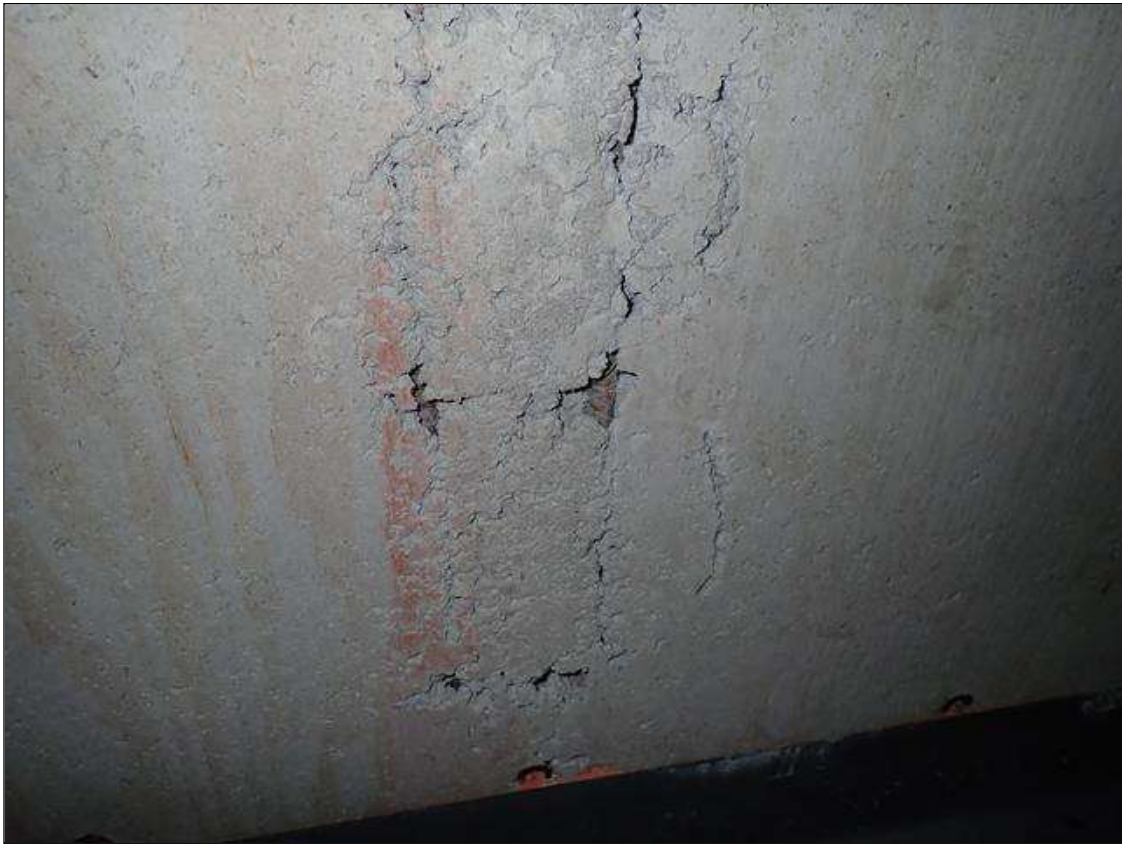
Span 1 Deck: 2 - 2 FT x 6.5 FT WIDE AREA OF HONEYCOMING WITH EXPOSED REBAR IN UNDERSIDE OF DECK IN BAY 8 AT BENT 1

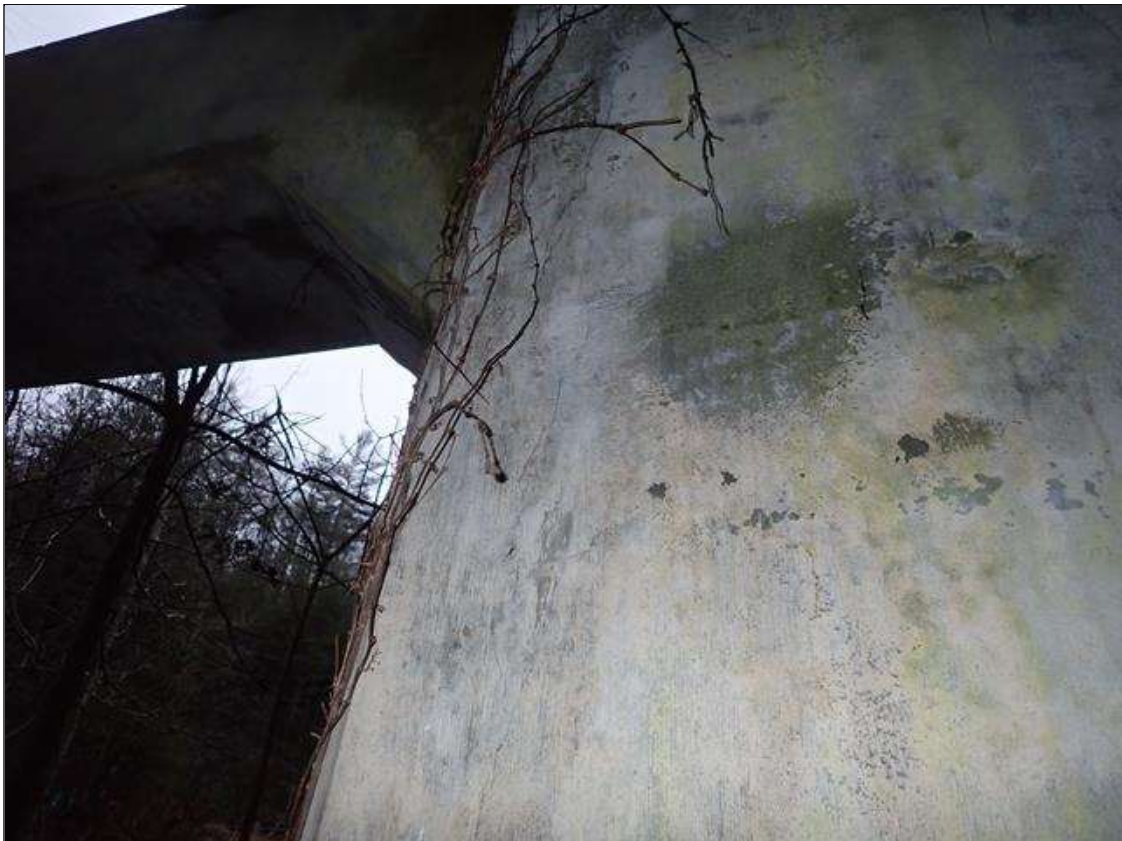
Span 1 Deck: 5 FT x 3 FT AREA OF HONEYCOMBING NEAR MIDSPAN OF UNDERSIDE OF BAY 9 WITH EXPOSED REBAR, NO MEASURABLE SECTION LOSS

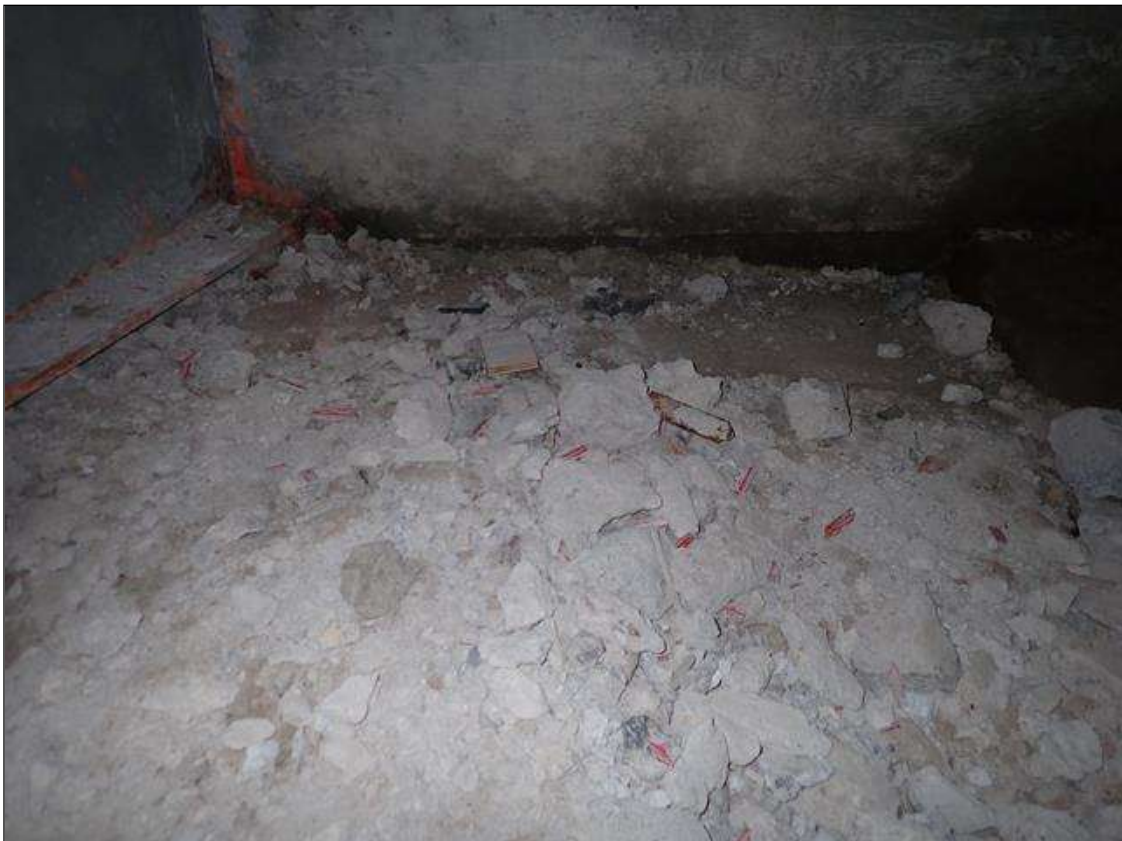
End Bent 1 Cap 1: 1 FT VERTICAL HAIRLINE CRACK UNDER BAY 3 IN CAP

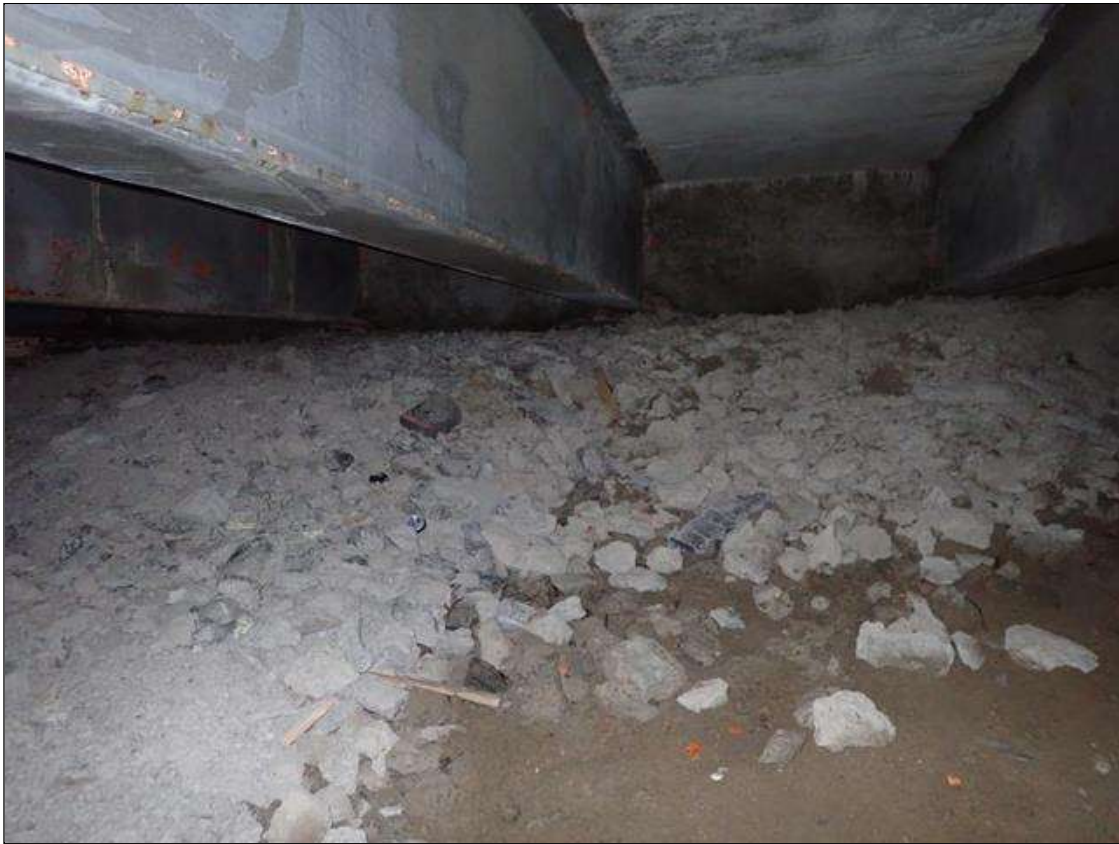
CAP COVERED BY DEBRIS IN BAY 6 AT END BENT 1

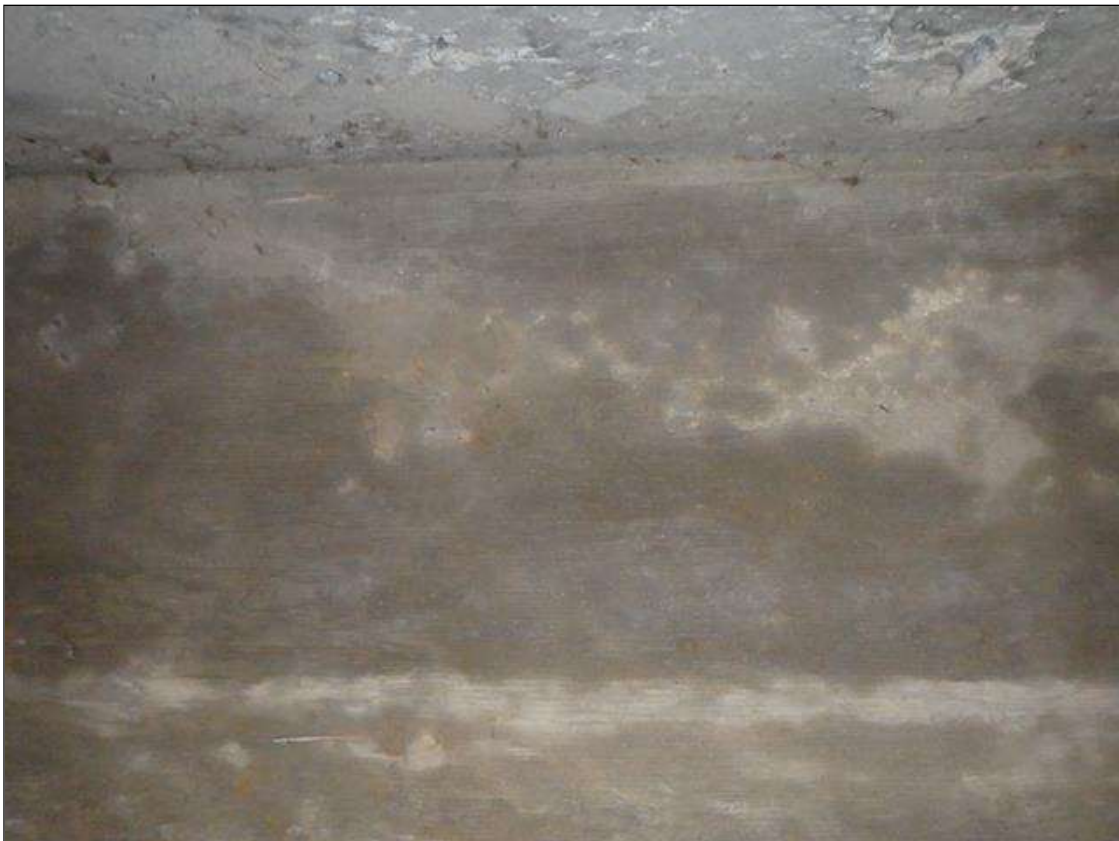
CAP COVERED BY DEBRIS AT END BENT 1 IN BAY 7 UNTIL SOUTH END OF CAP

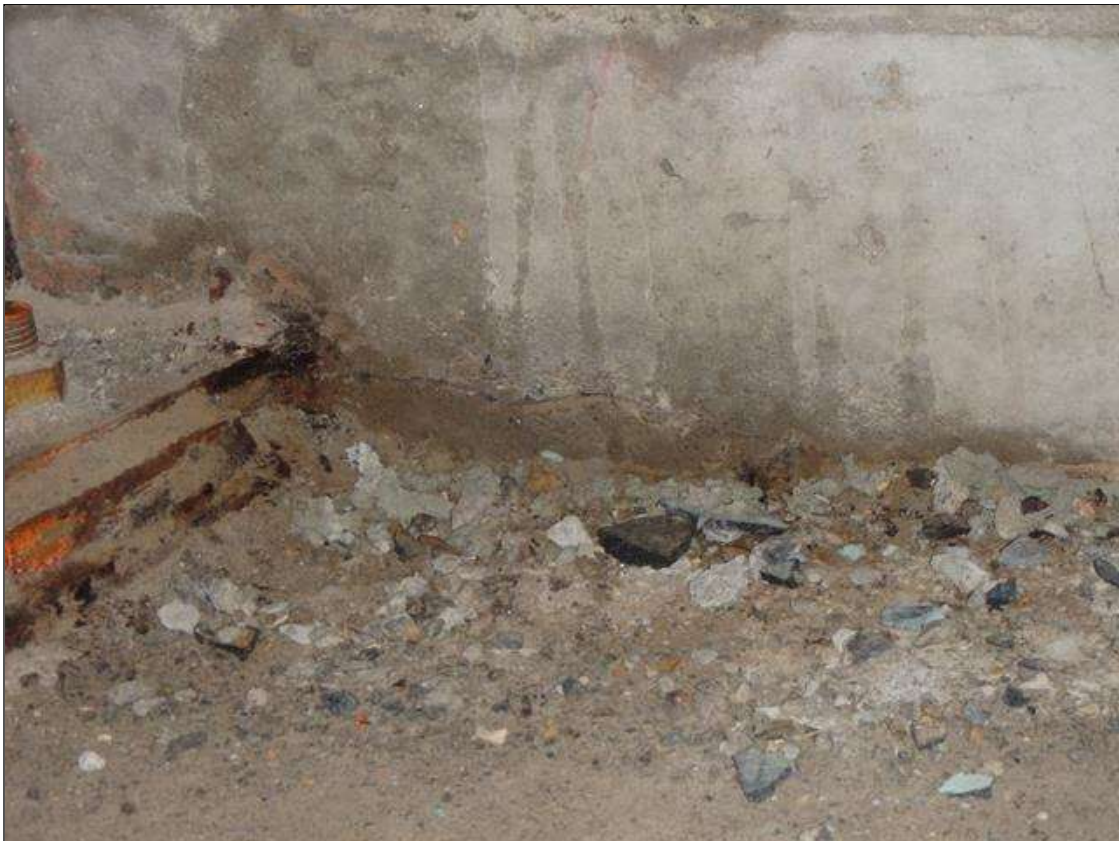
End Bent 2 Abutment/Backwall : 3 - 12" LONG VERTICAL HAIRLINE CRACKS IN CAP IN BAY 4, 1 SIMILAR IN BAY 5

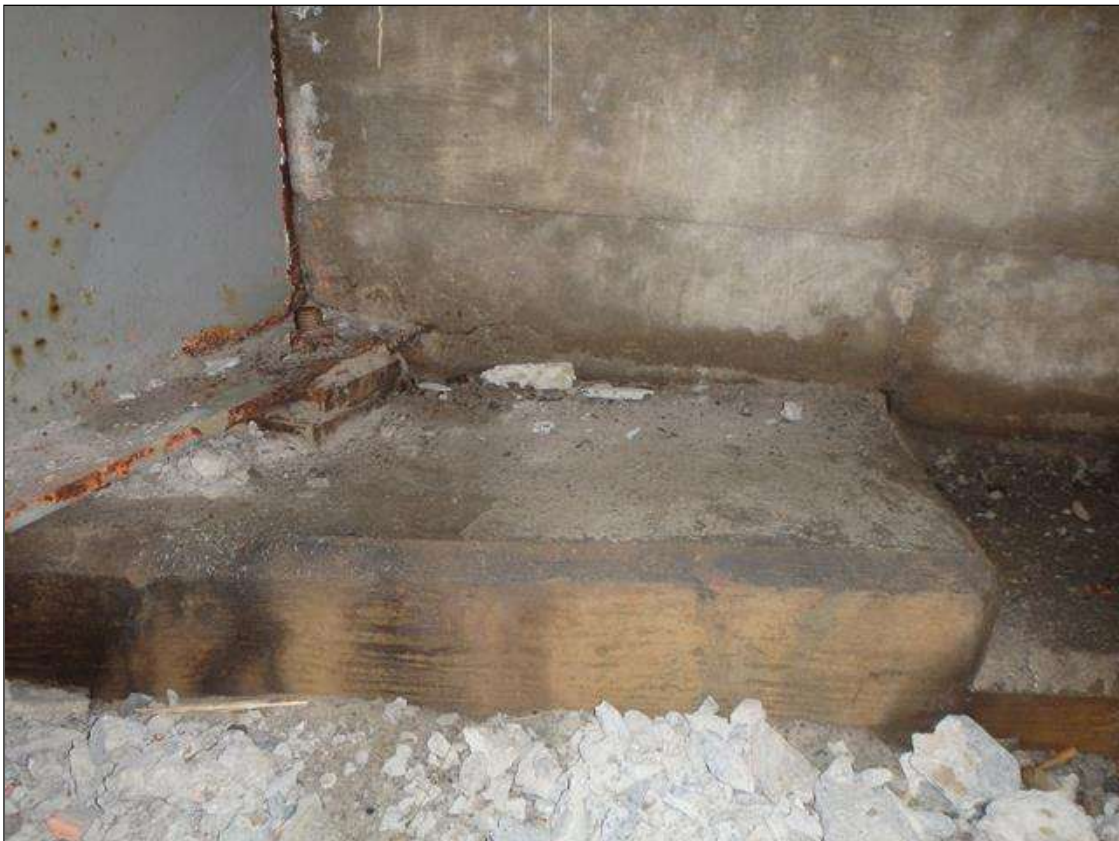
End Bent 2 Abutment/Backwall : 3" x 3" x 1/2" SPALL IN BACKWALL IN BAY 8 NEAR GIRDER 8

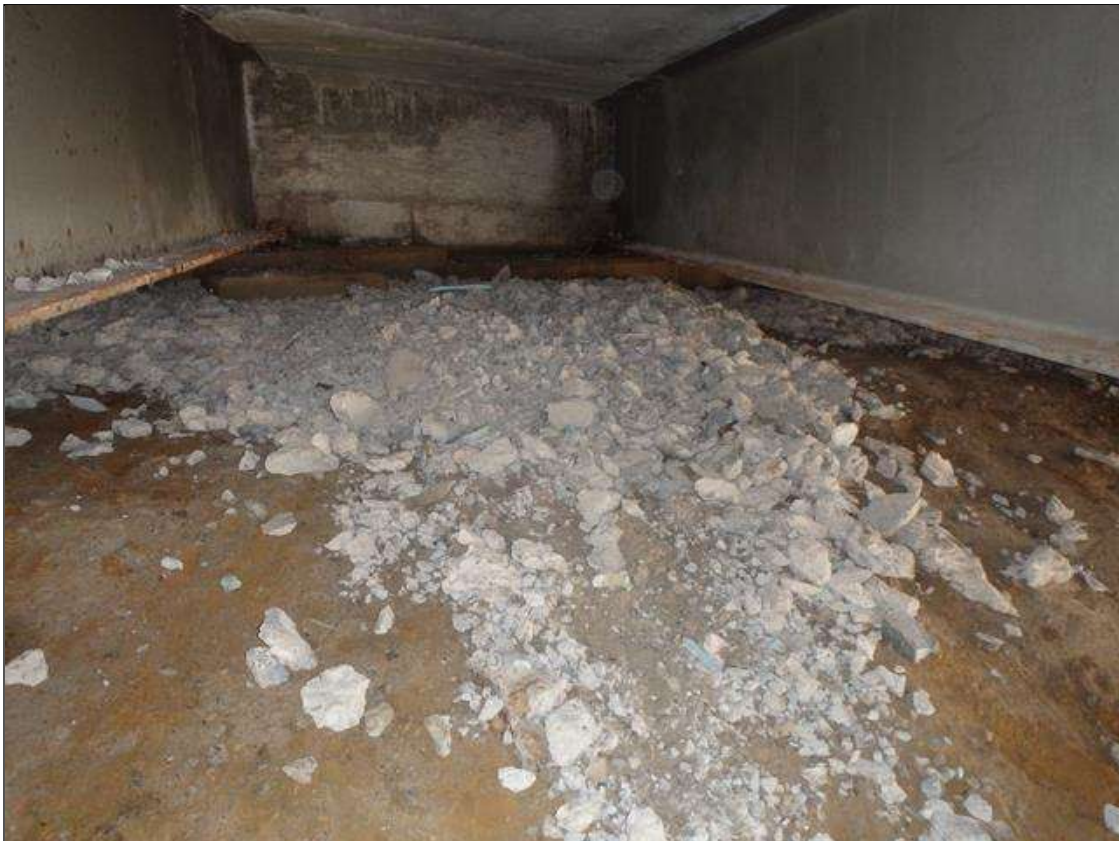
End Bent 2 Cap 1: 12" VERTICAL HAIRLINE CRACK IN CAP, 1 AT GIRDER 1 BEARING, 1 IN CAP UNDER BAY 1 AND 1 IN CAP AT BEARING OF GIRDER 2.

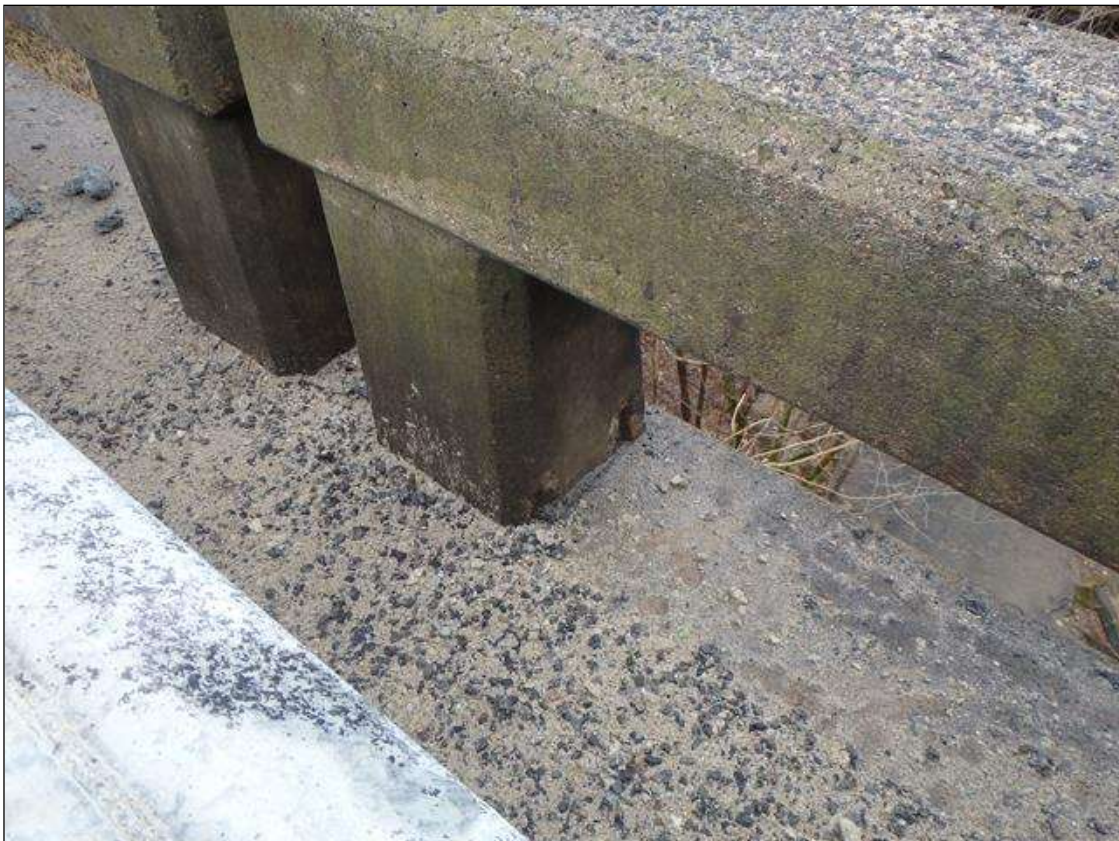
Span 2 Right Bridge Rail: 4 FT LONG IMPACT DAMAGE AT 6 FT FROM BENT 1

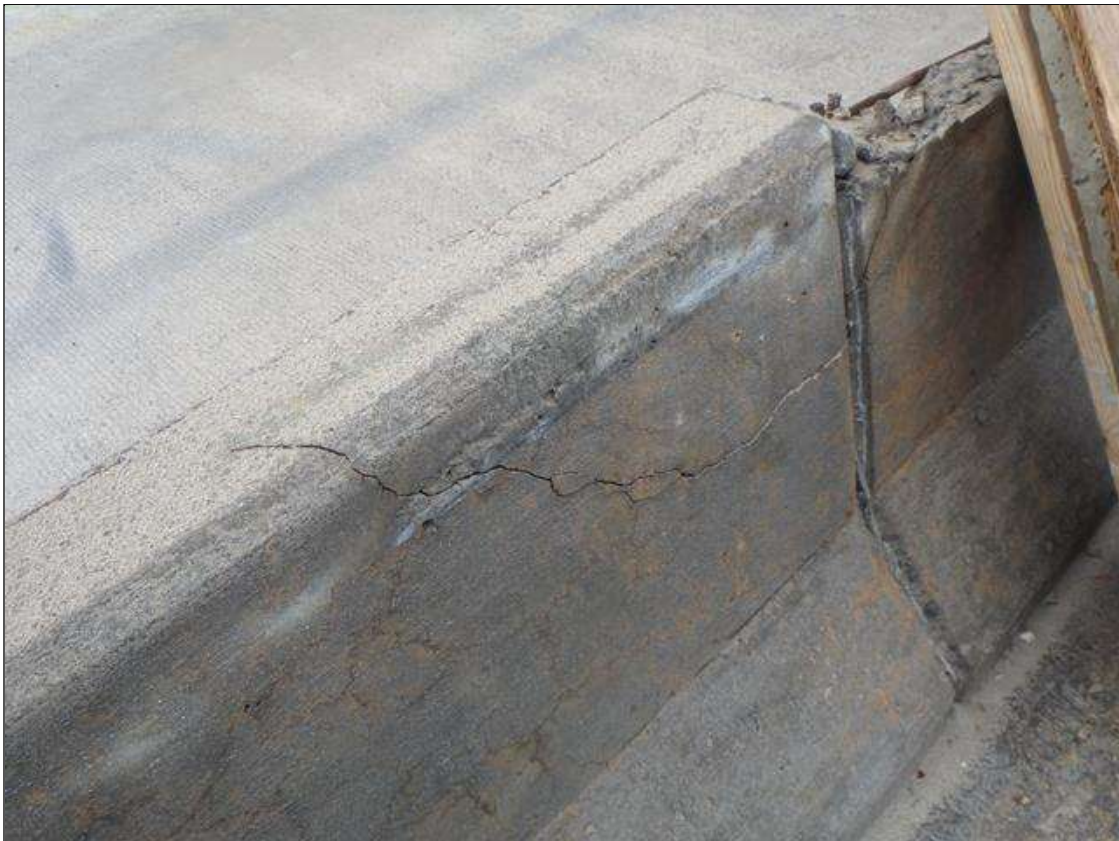
Span 2 Right Bridge Rail: 17 FT OF RAIL WITH SCATTERED SPALLS UP TO 4" x 4" x 3/4" WITH EXPOSED REBARS BUT NO SECTION LOSS AT 49 FT FROM END BENT 1

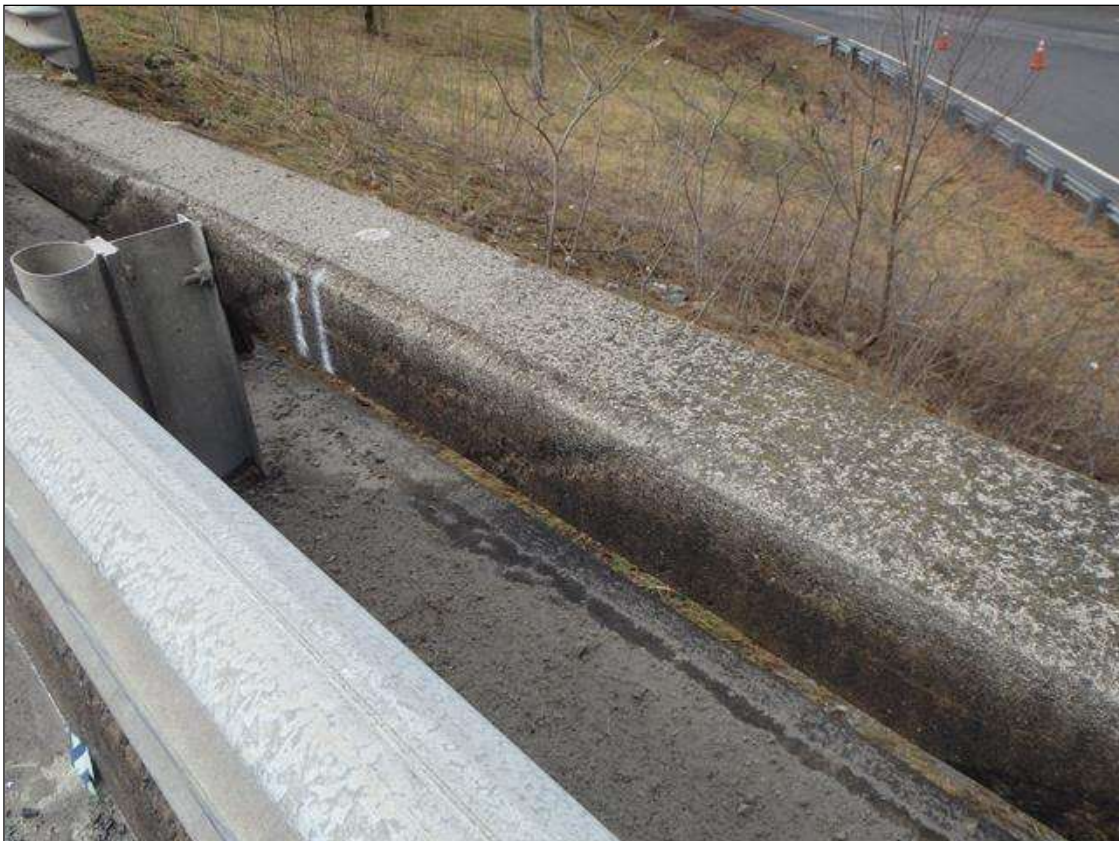
Expansion Joint : JOINT AT BENT 3 EASTBOUND LANES UNDER REPAIR

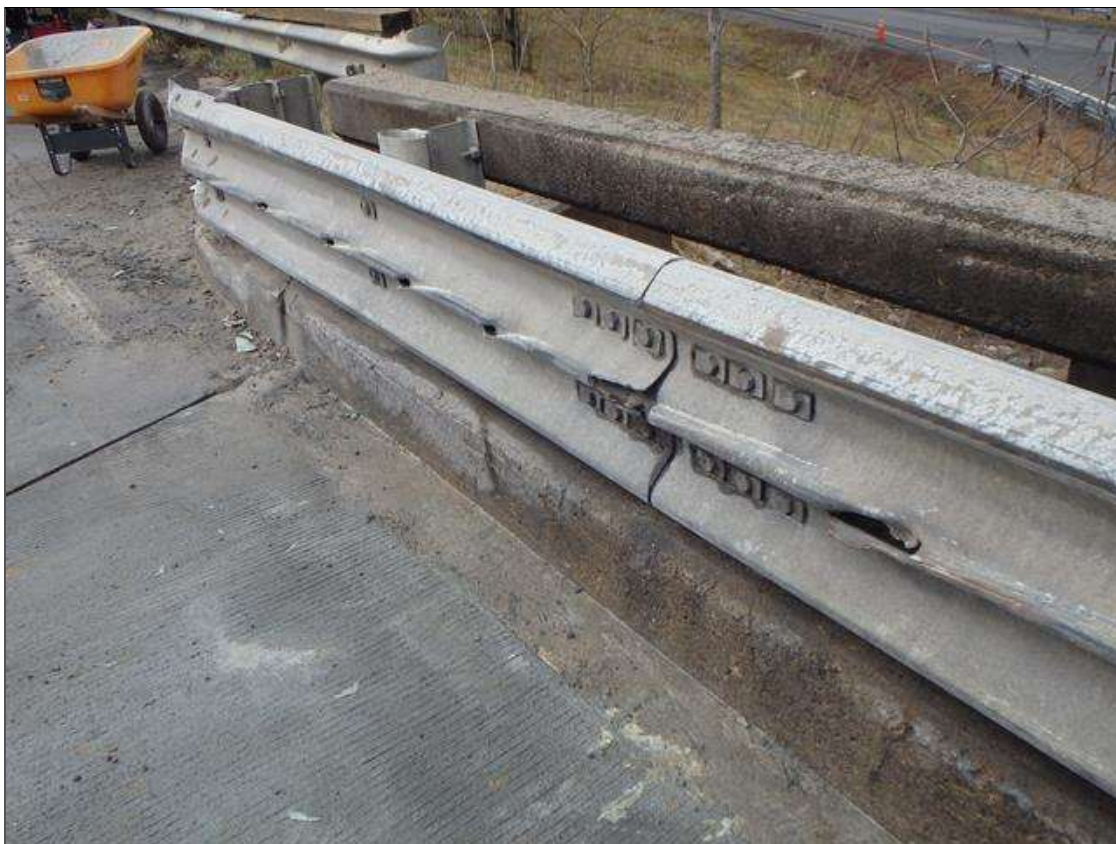
Span 4 Right Bridge Rail: 4 FT OF 1/2" DEEP IMPACT GOUGES TO CONCRETE RAIL AT 9 FT FROM END BENT 2

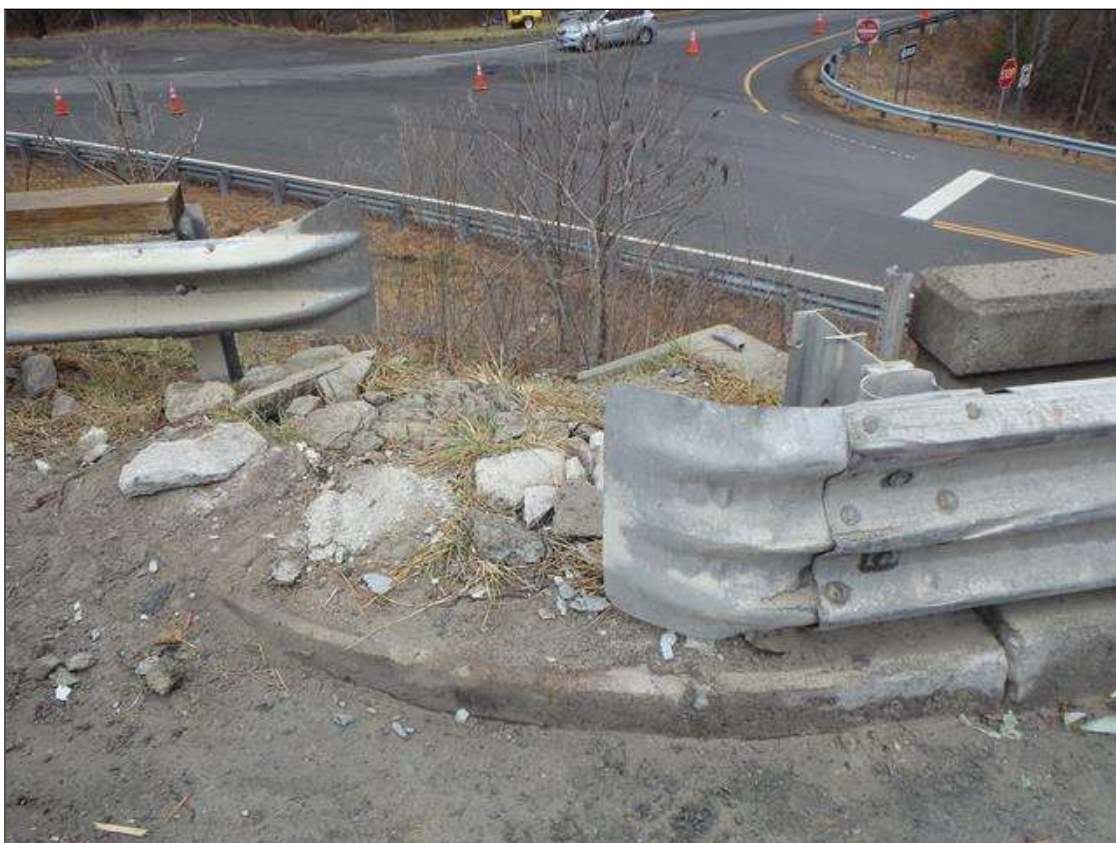
Span 4 Right Bridge Rail: 9 FT OF IMPACT DAMAGE TO GUARDRAIL AT END BENT 2

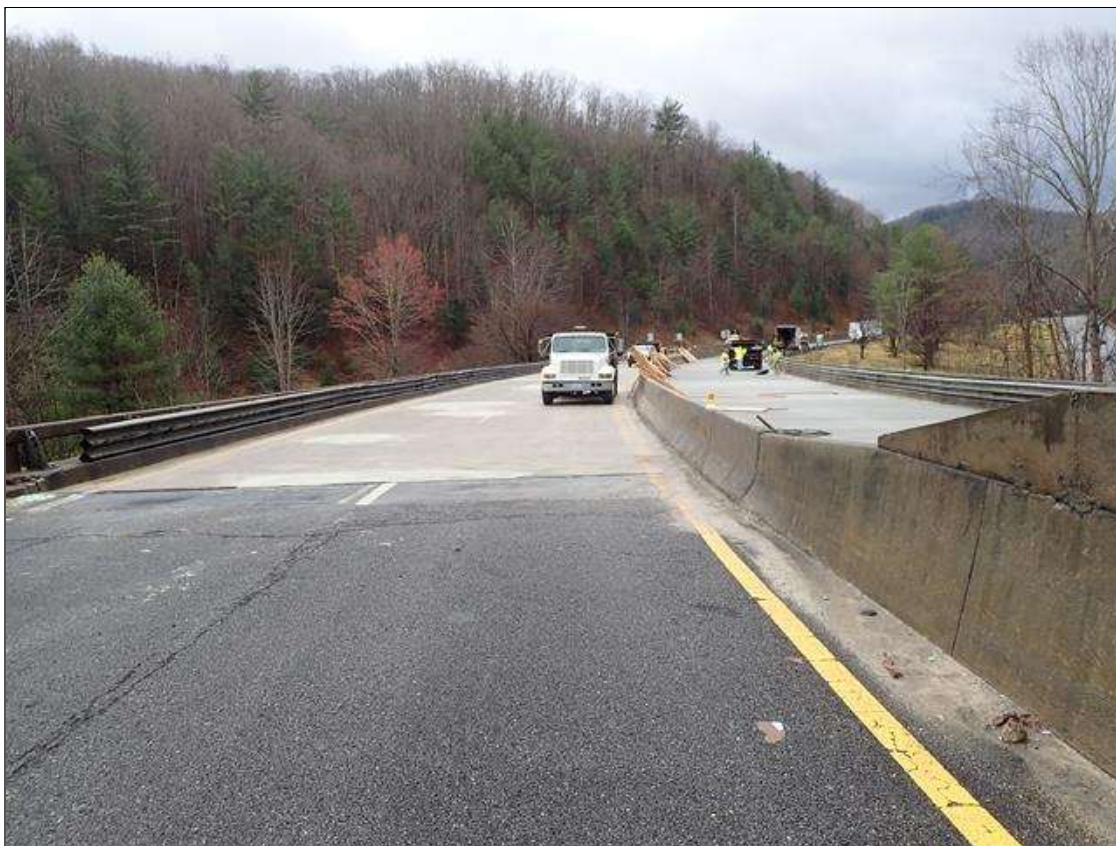
Approach 2: ASPHALT WEARING SURFACE CRACKED AT END OF BRIDGE, FULL WIDTH x UP TO 1/8" WIDE  
WITH 1/2" DIVOTS

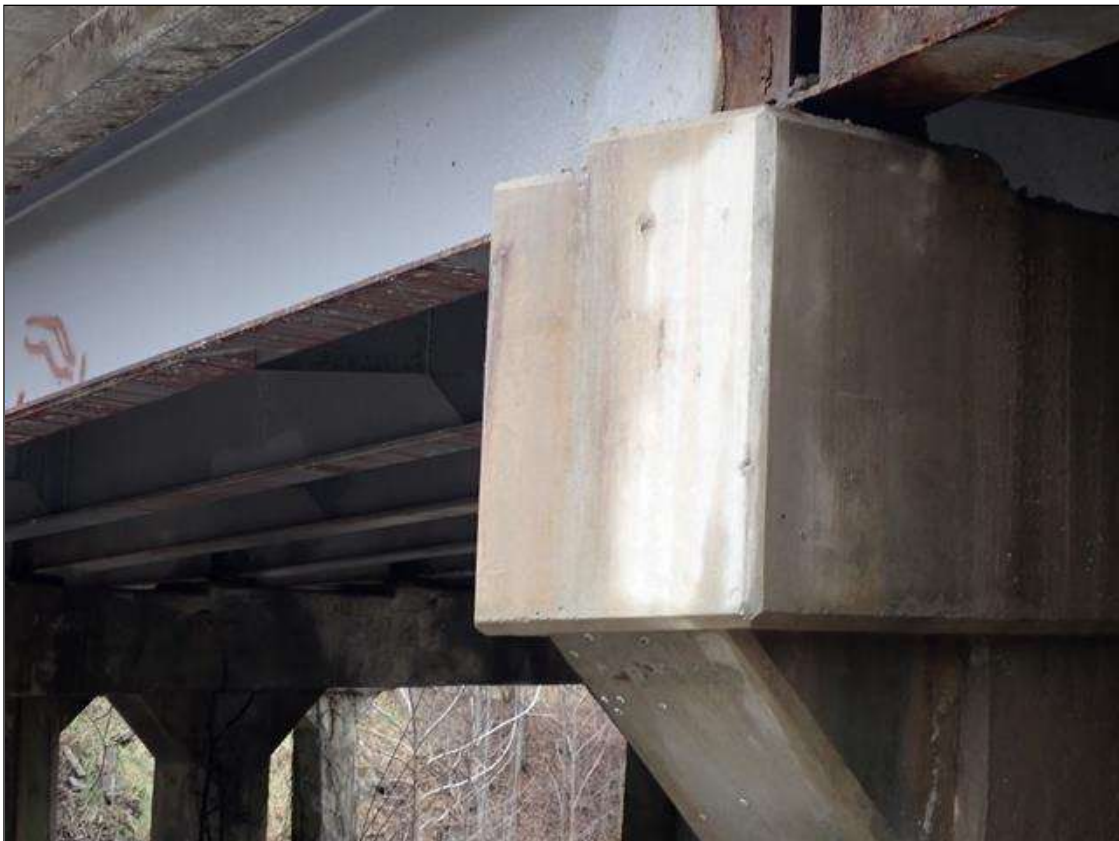
END OF BENT CAP AT BENT 3, TYPICAL

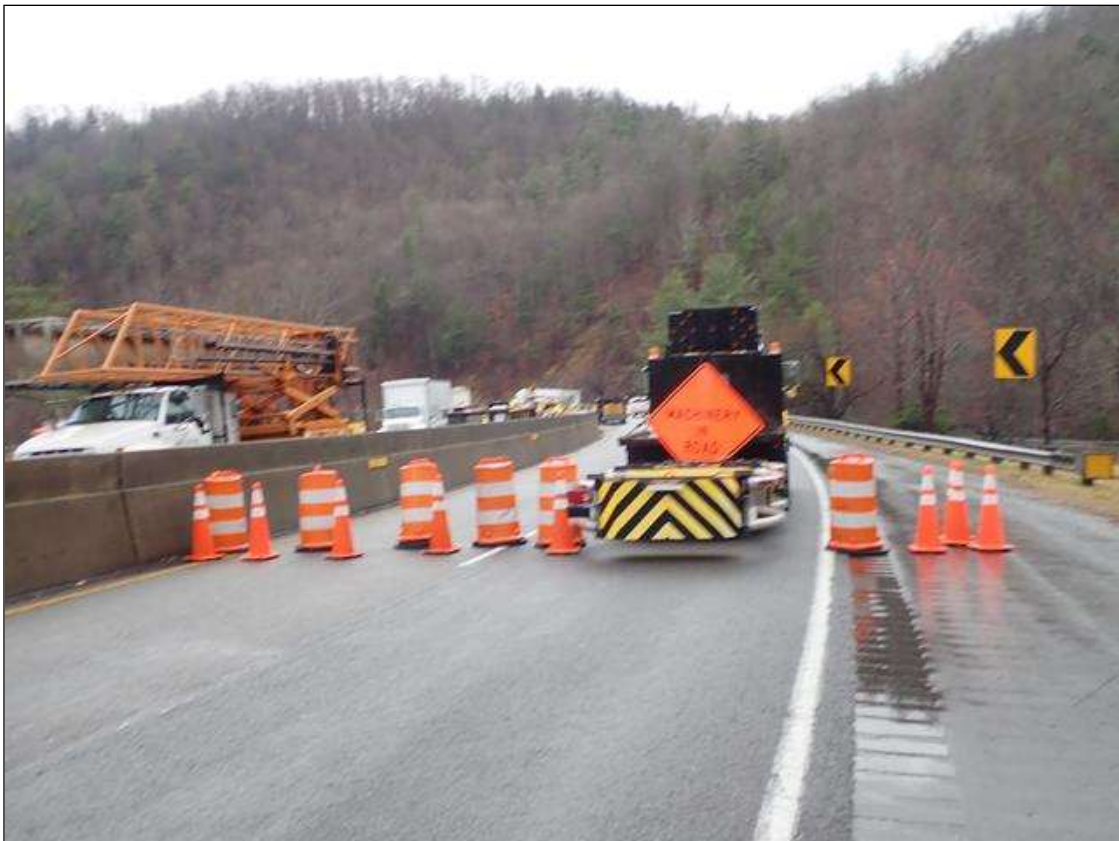
TRAFFIC CONTROL LOOKING WEST AT WEST BOUND LANE, BRIDGE CLOSED FOR REPAIR

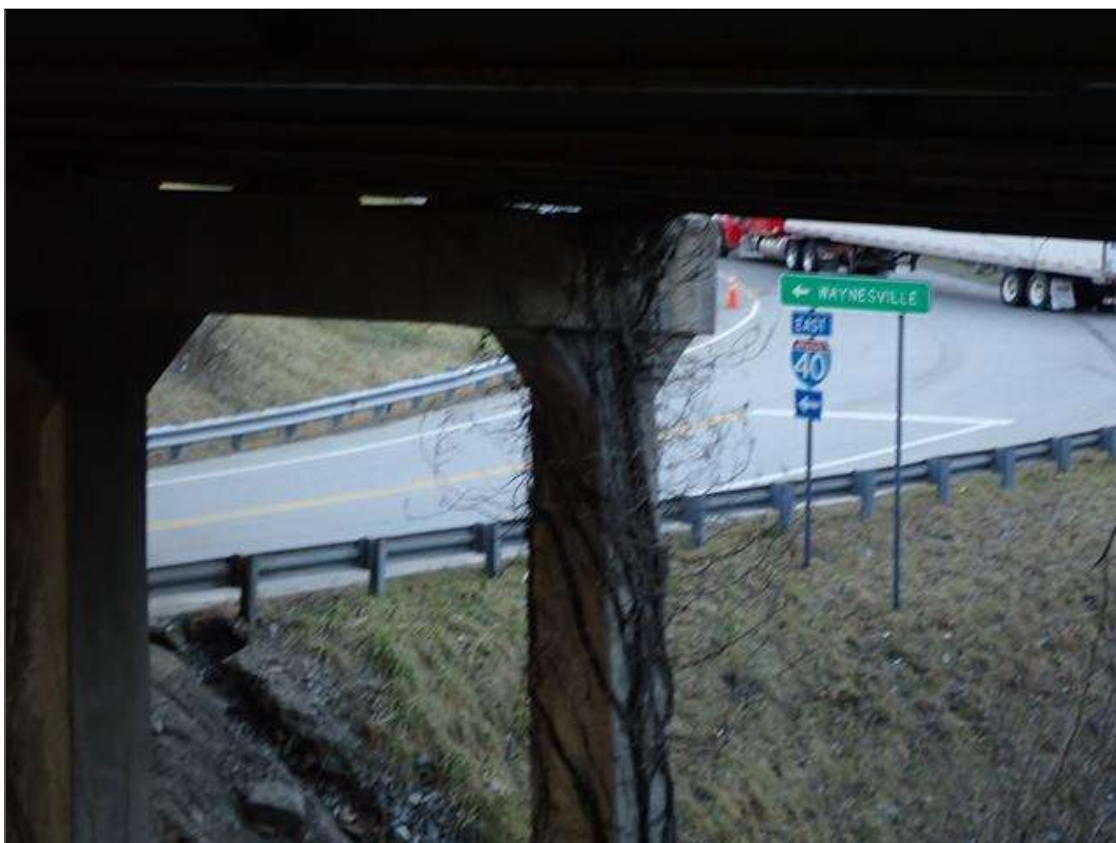
VEGETATION OVERGROWING ON CAP AND COLUMN 4 OF BENT 2
