NC DEPARTMENT OF TRANSPORTATION  
DIVISION OF HIGHWAYS  
STRUCTURE MANAGEMENT UNIT

## Structure Safety Report

### Routine Element Inspection - Contract

DIVISION: 14 COUNTY: HAYWOOD STRUCTURE NUMBER: 430124 FREQUENCY: 24 MONTHS

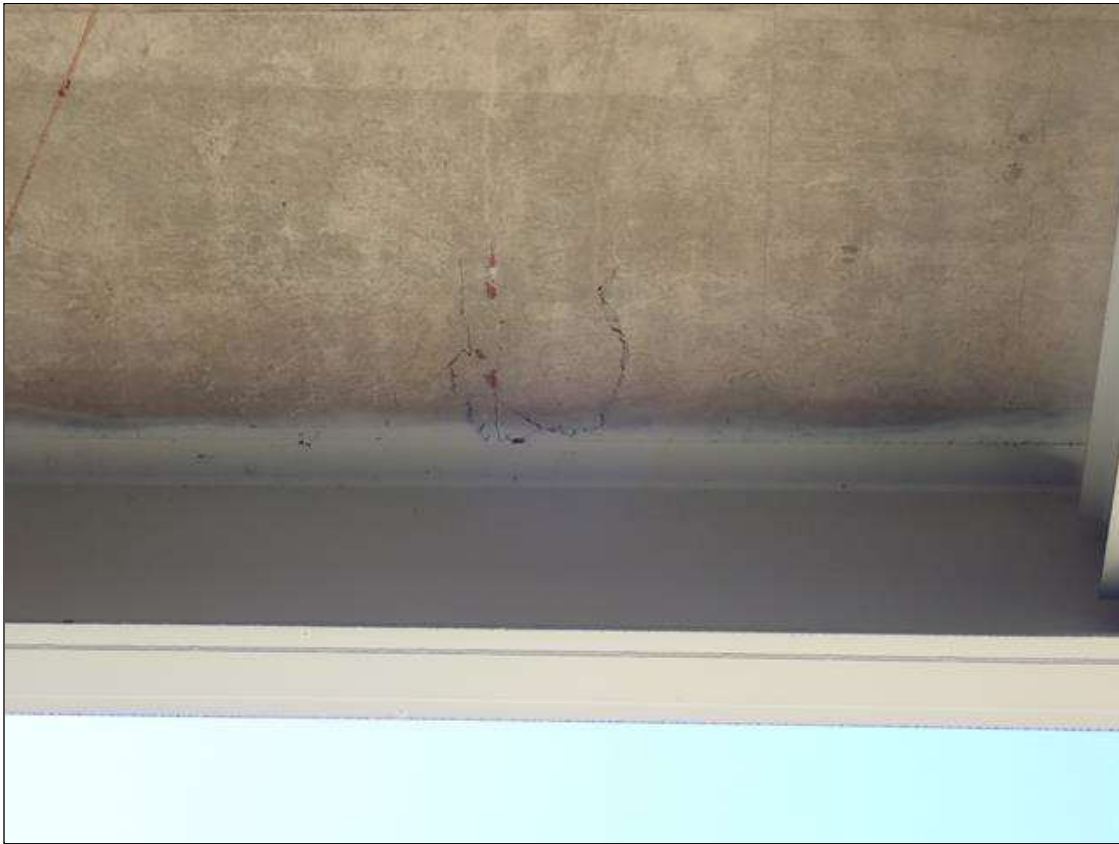
SPAN 2 DECK: 3 FT X 1 FT DELAMINATION IN UNDERSIDE OF DECK IN BAY 9 AT GIRDER 10 ABOVE TRAVEL LANES (PRIORITY MAINTENANCE)

Span 2 Deck: 3 FT X 1 FT DELAMINATION IN UNDERSIDE OF DECK IN BAY 9 AT GIRDER 10 ABOVE TRAVEL LANES (PRIORITY MAINTENANCE)

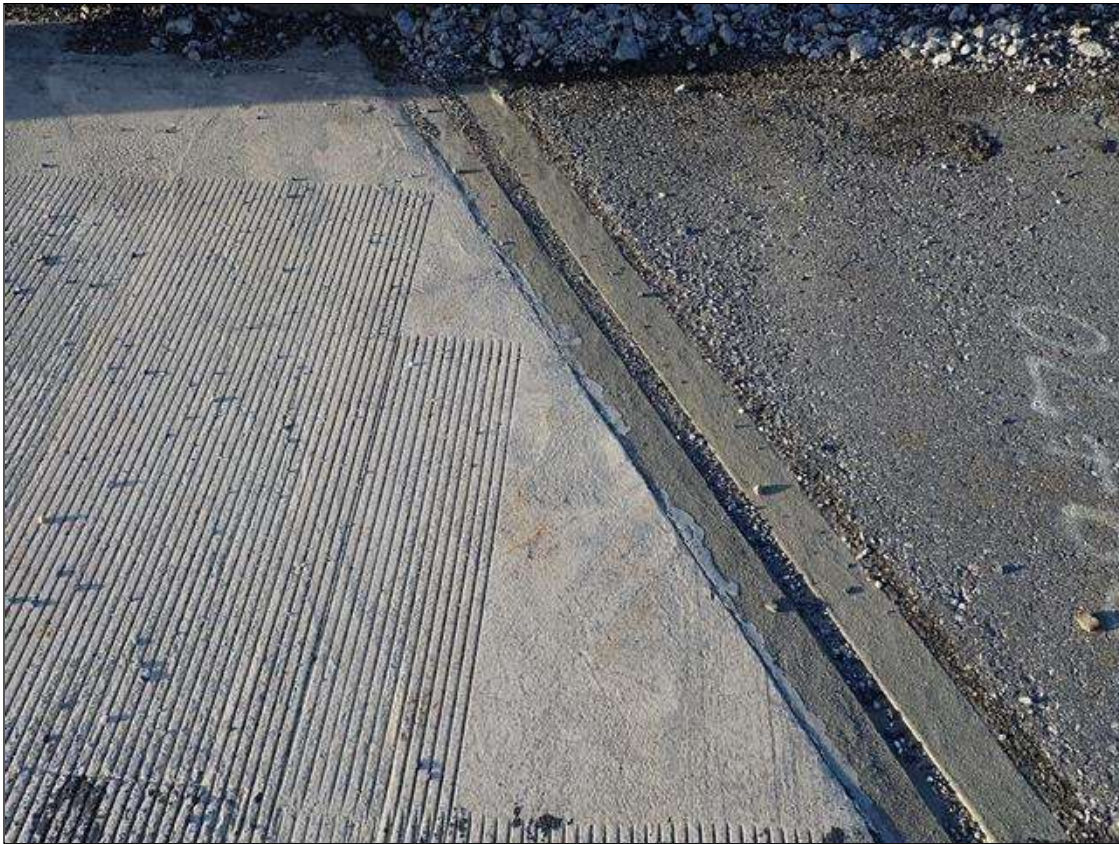
End Bent 1 Expansion Joint : 6 FT OF DEBRIS IMPACTION IN RIGHT SHOULDER OF EASTBOUND LANES, JOINT MOVEMENT UNAFFECTED.

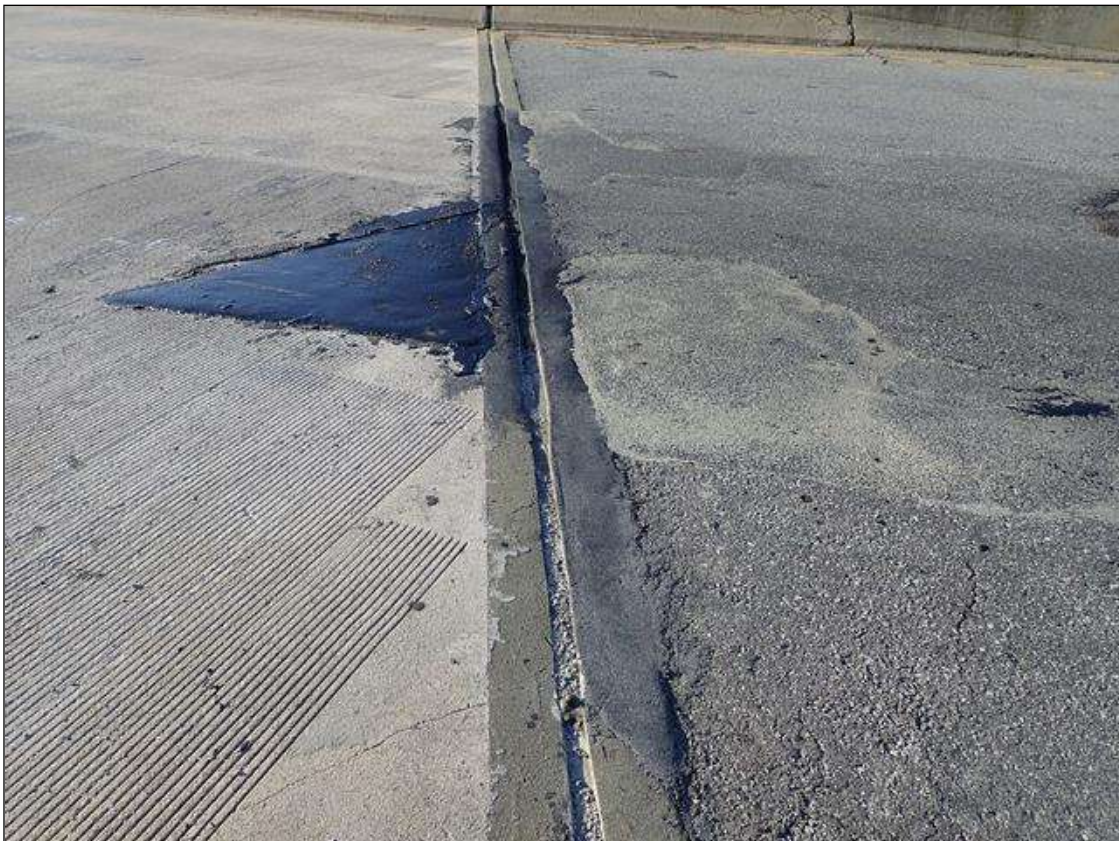
End Bent 1 Expansion Joint : 18 FT OF SOUND PATCHES TO CONCRETE HEADER IN WESTBUOND TRAVEL LANES.

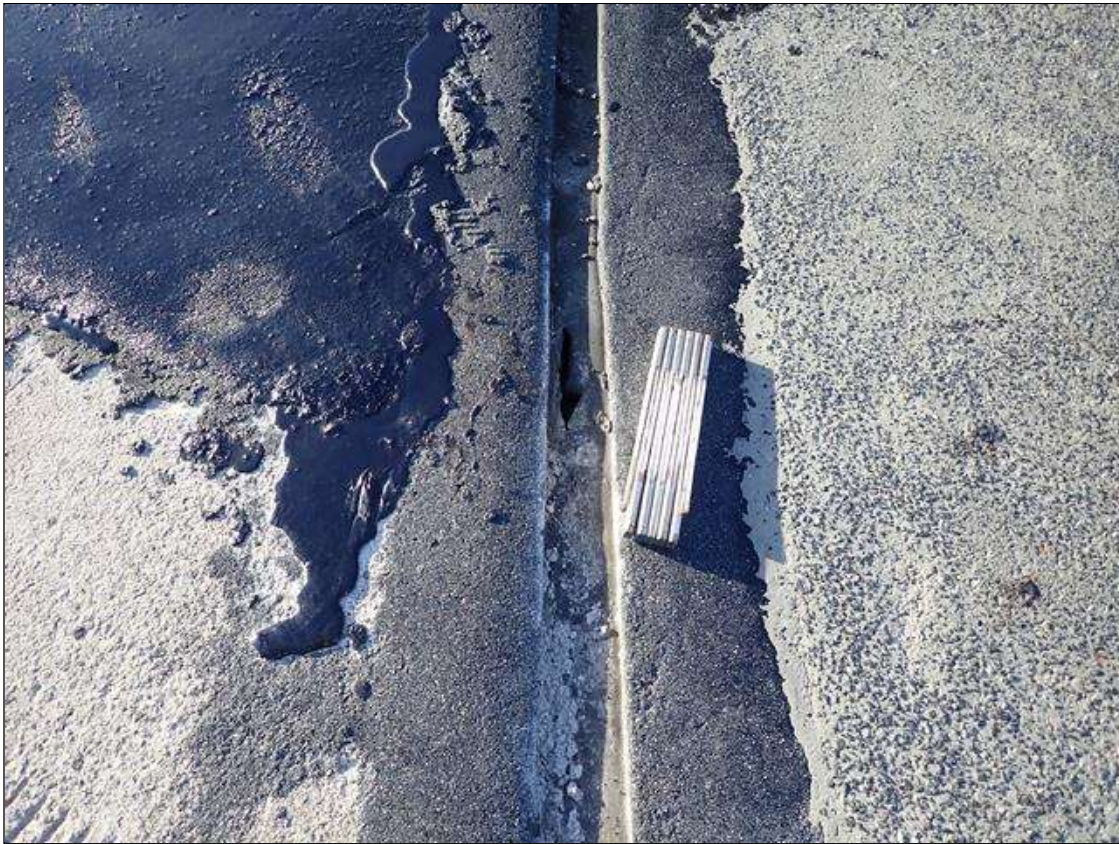
End Bent 1 Expansion Joint : 4" X 1" TEAR IN JOINT MATERIAL IN WESTBOUND LANES AT RIGHT SHOULDER.

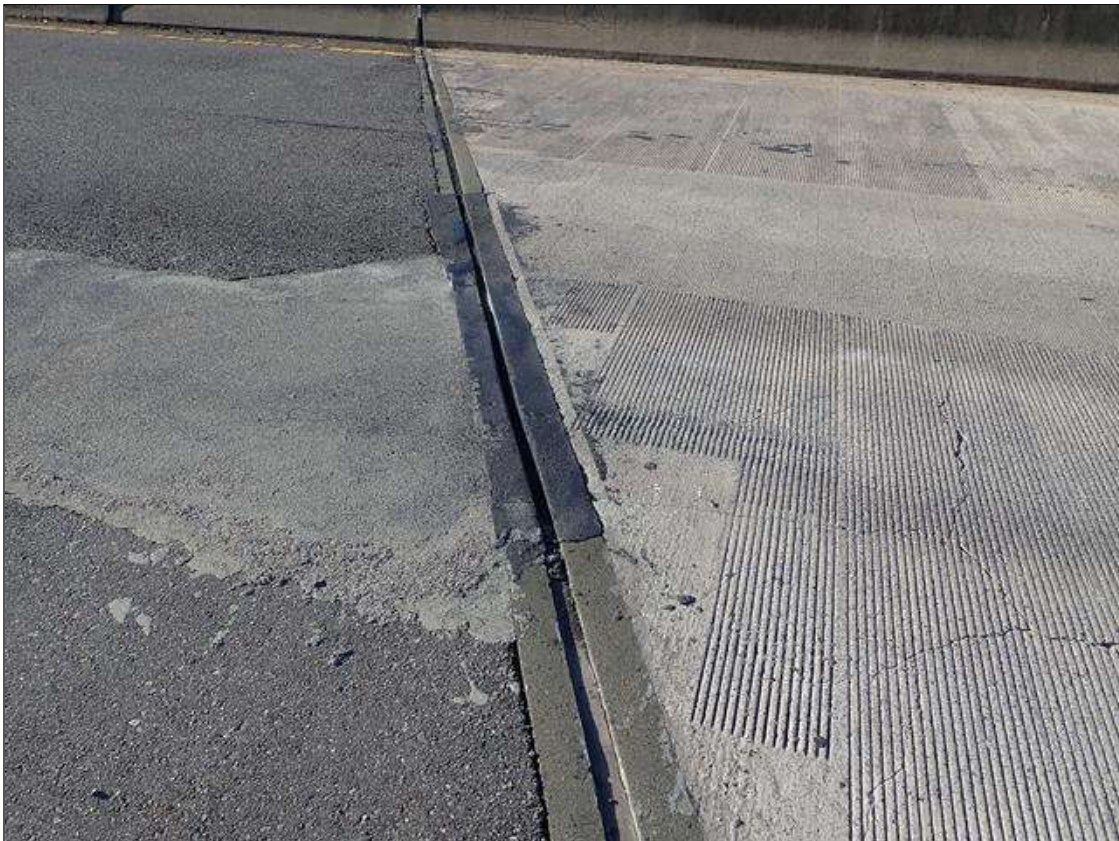
End Bent 2 Expansion Joint : 10 FT OF SOUND PATCHES IN ADJACENT CONCRETE HEADER IN WESTBOUND TRAVEL LANES.

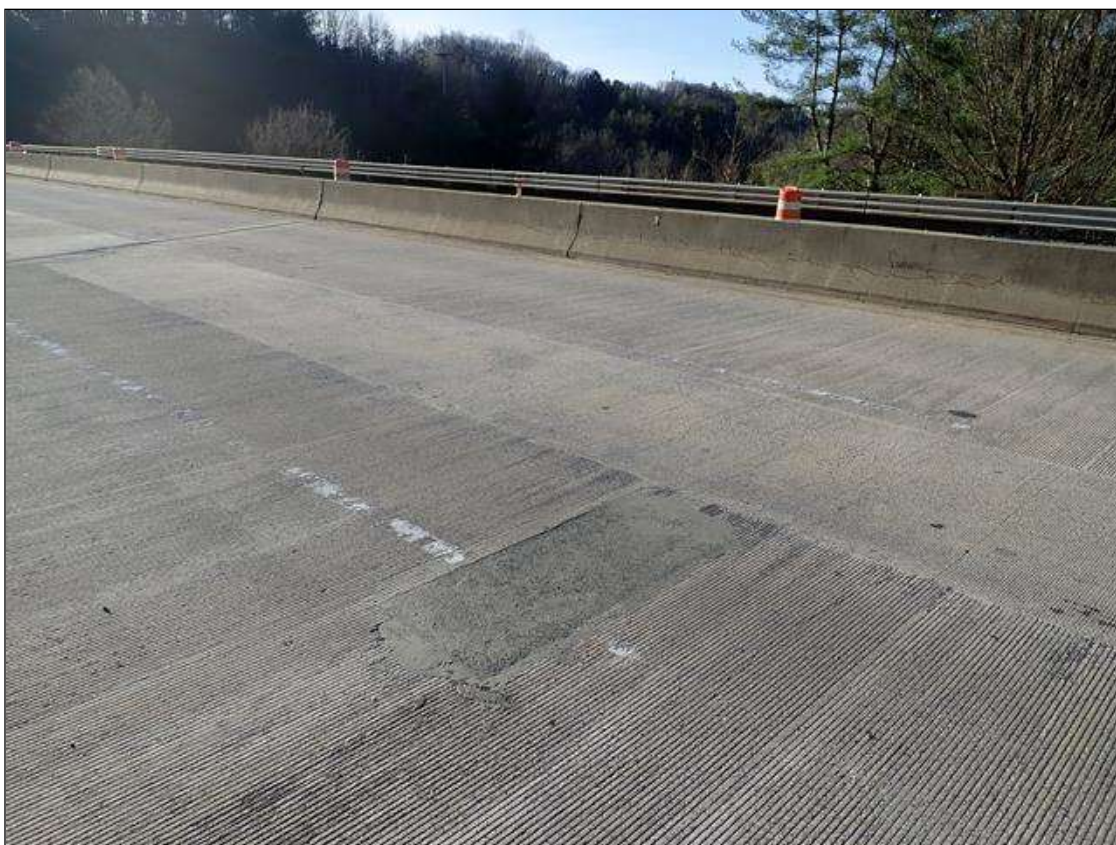
Span 1 Deck: PATCHED AREA 4' WIDE X 2' LONG IN LEFT WEST BOUND LANE 16' FROM END BENT 1 END.

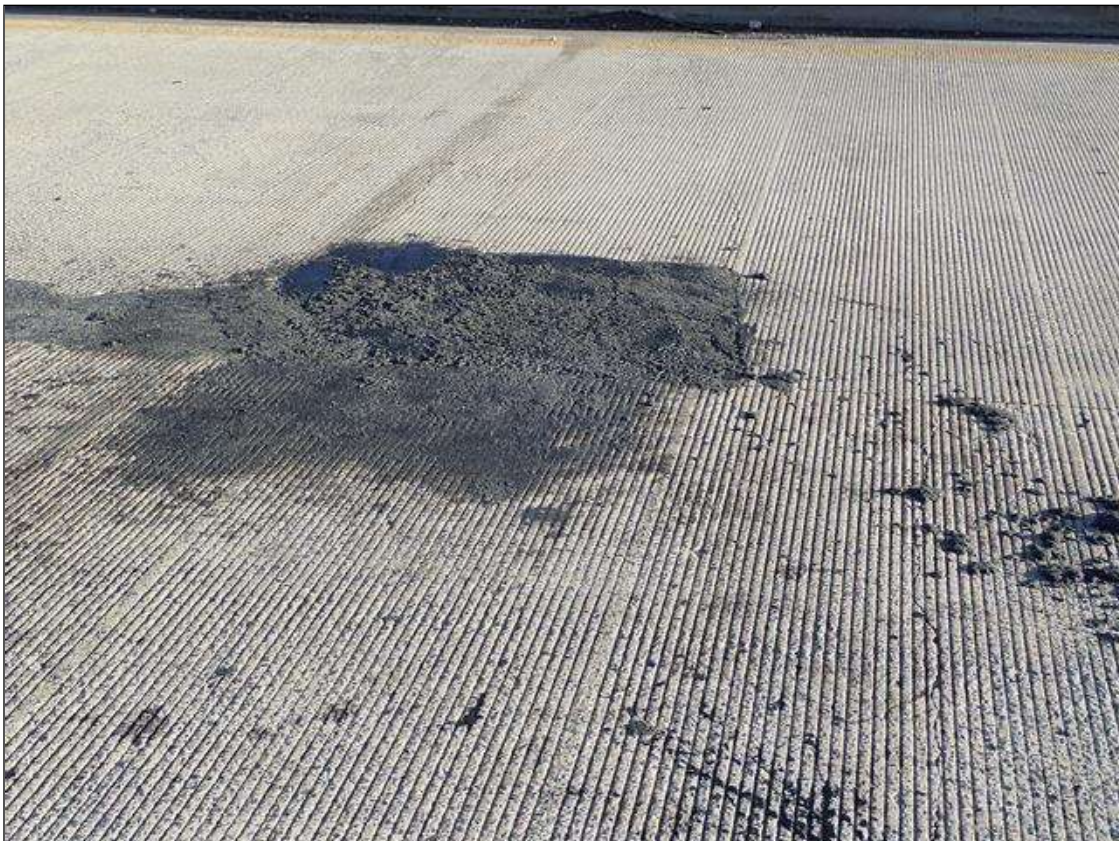
Span 2 Deck: SURFACE ABRASION UP TO 1/4" DEEP IN SOUND ASPHALT PATCH, 15 FT FROM BENT 1 JOINT IN EASTBOUND TRAVEL LANES, AGGREGATE SECURE.

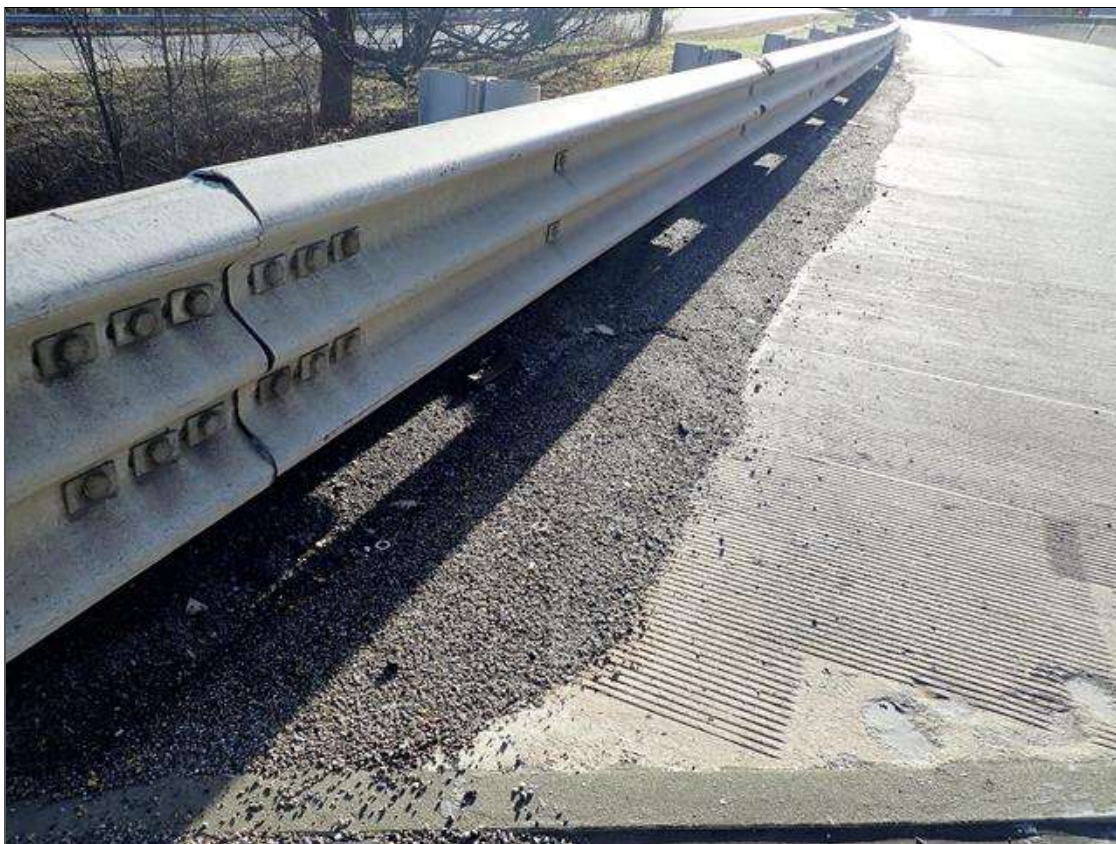
DEBRIS UP TO 3 FT WIDE ALONG LEFT BRIDGE RAIL IN WESTBOUND LANES THROUGHOUT SPAN.

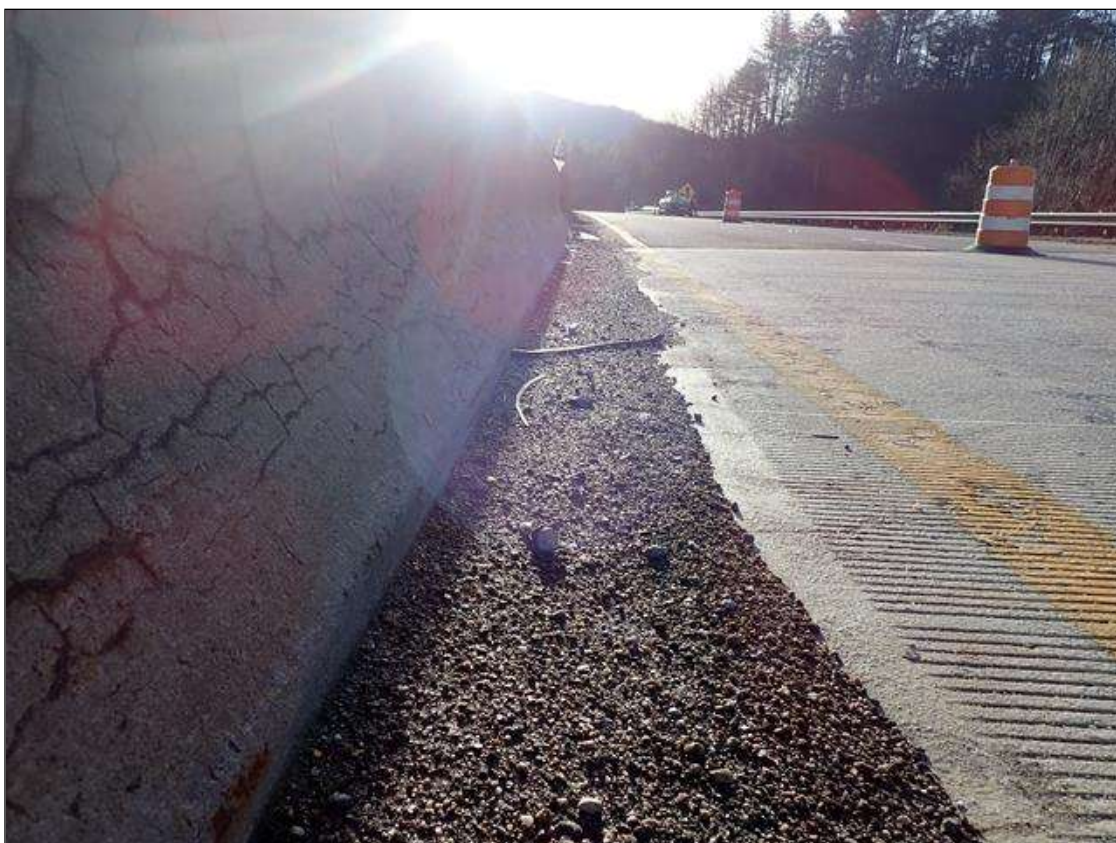
DEBRIS SCATTERED ALONG MEDIAN BARRER THROUGHOUT SPAN IN EASTBOUND LANES, UP TO 4" DEEP.

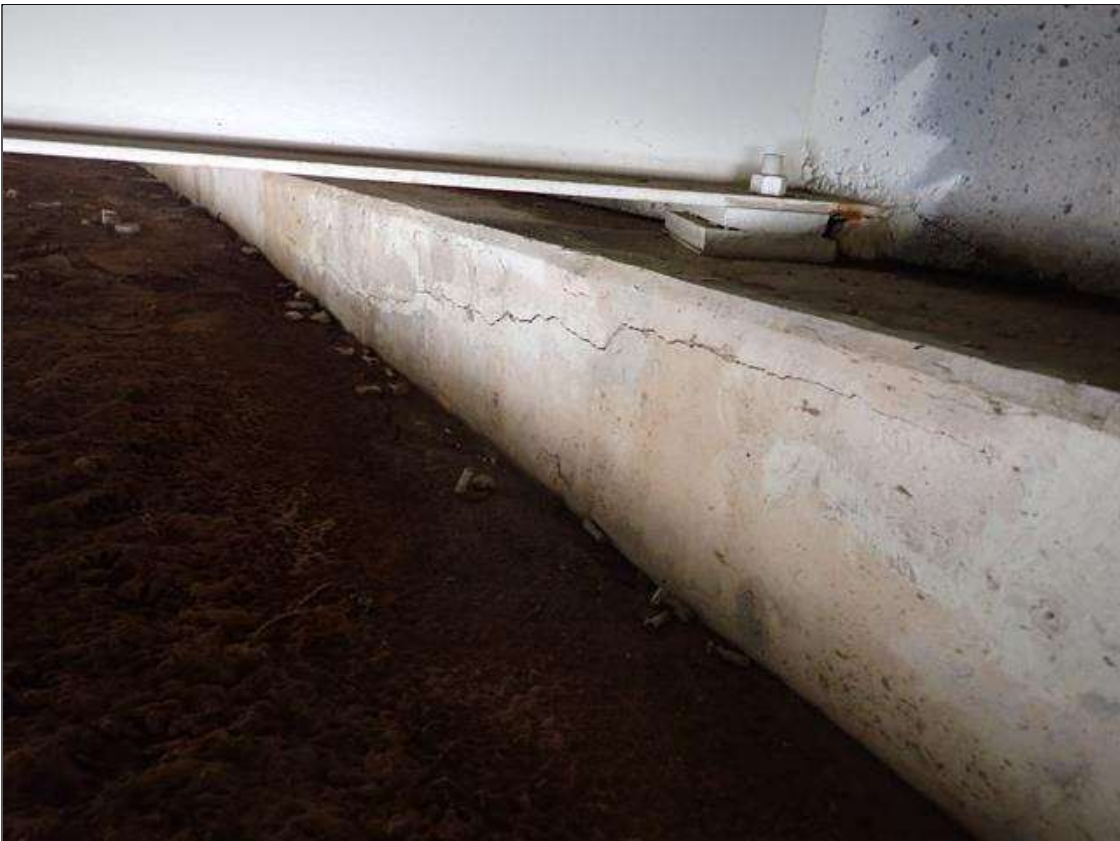
End Bent 1 Cap 1: FULL WIDTH DELAMINATION IN TOP OF CAP BELOW BAY 6, BAY 7, BAY 8, EXTENDING 4" INTO FRONT OF CAP.

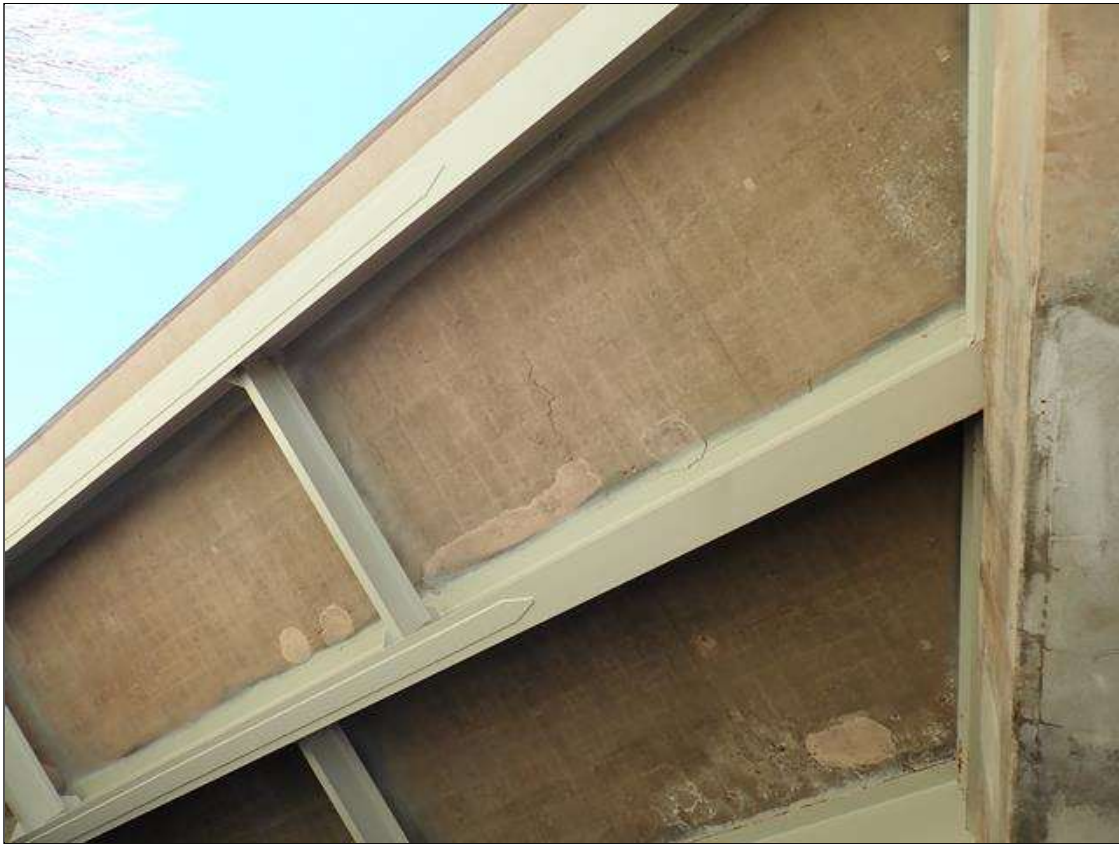
Span 1 Deck: PATCHED AREAS: 4 AT 12" DIAMETER, 12" WIDE X 6' LONG AND 12" DIAMETER AT BAY 9 ALONG BEAM 9.

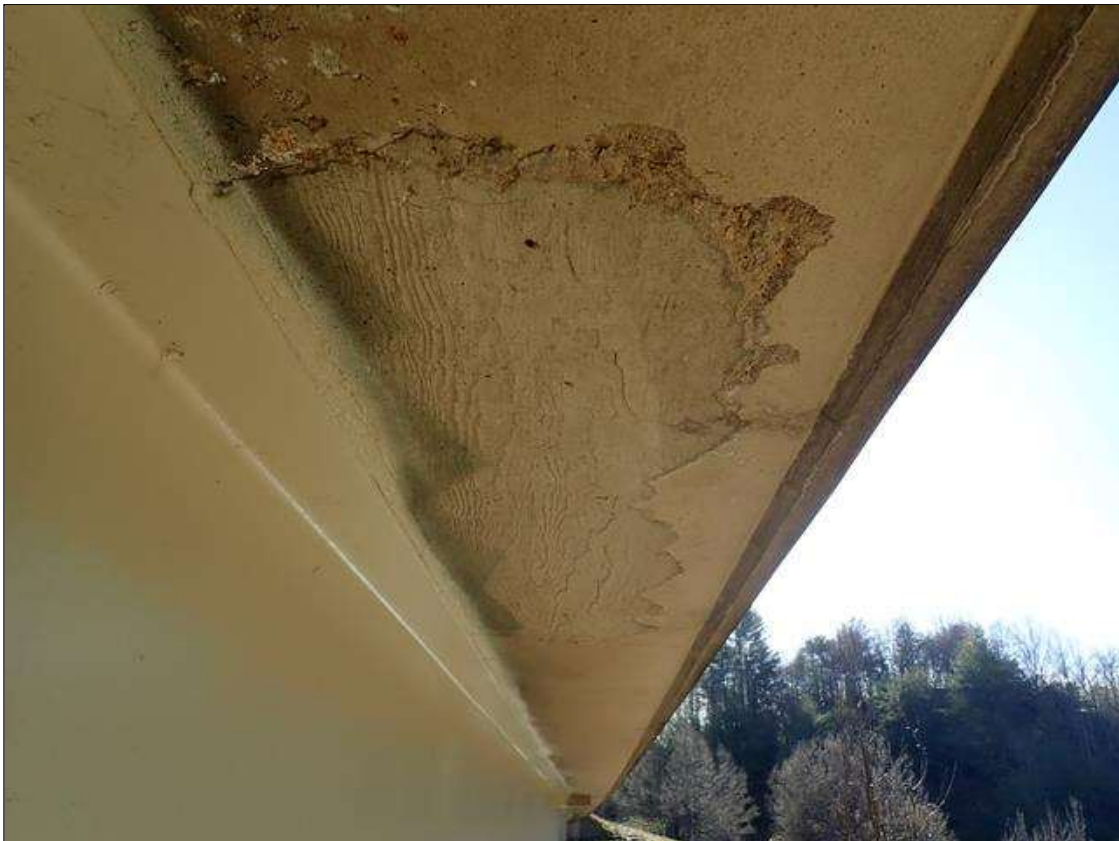
Span 1 Deck: 6 FT X 2 FT PATCH, SOUND, IN UNDERSIDE OF RIGHT OVERHANG NEAR END BENT 1

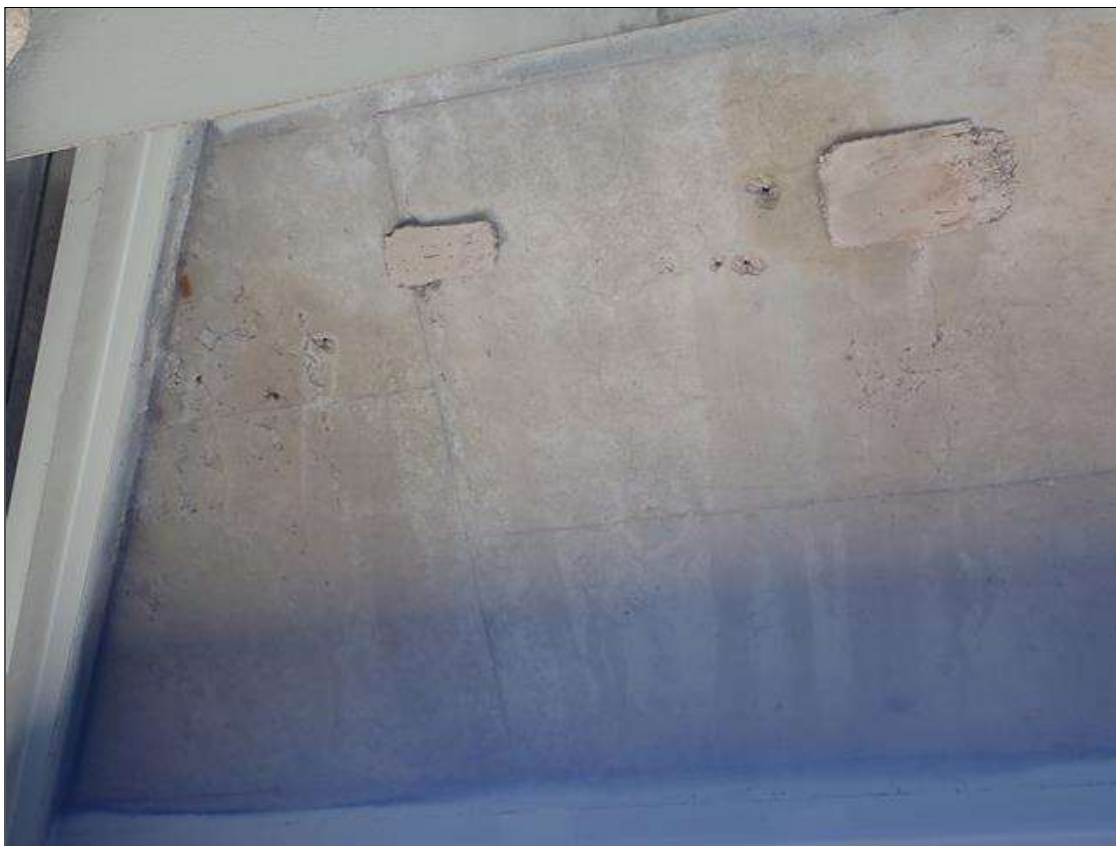
Span 2 Deck: 2 PATCHES UP TO 16" X 10" IN UNDERSIDE OF DECK IN BAY 1 NEAR BENT 1

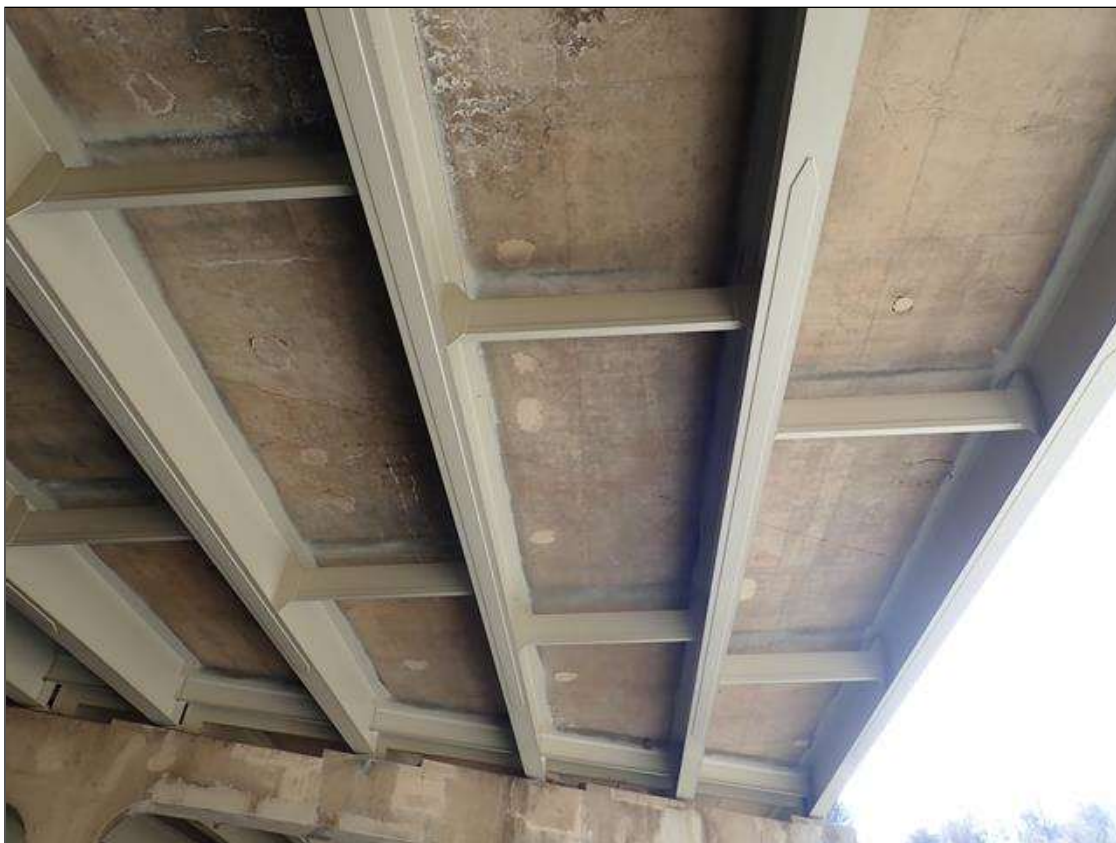
Span 2 Deck: 8 PATCHES UP TO 2" X 1" SOUND, IN UNDERSIDE OF DECK SCATTERED THROUGHOUT BAY 7, 8, 9, AND 6

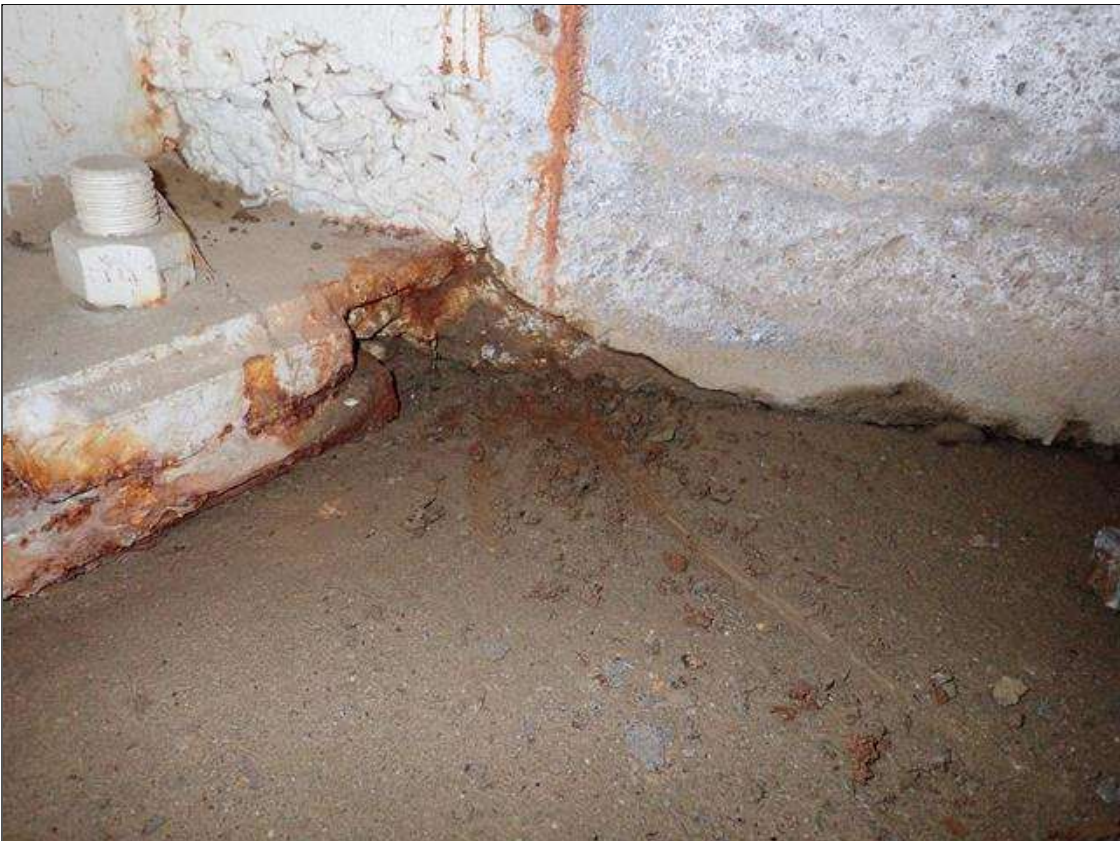
End Bent 2 Abutment/Backwall : 6" WIDE x 3" HIGH DELAMINATION AT GIRDER 6 NEAR BOTTOM FLANGE IN BACKWALL UNDER BAY 6

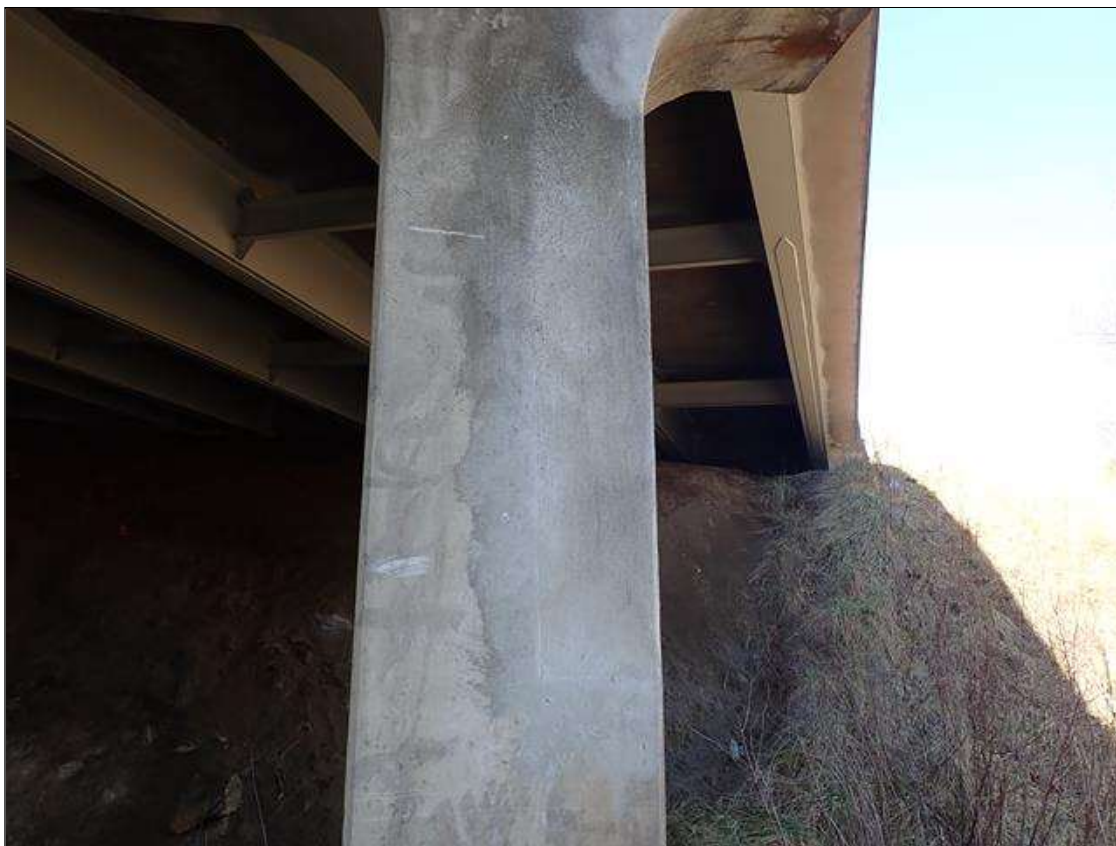
Bent 1 Pile 1: 8 FT x 2 FT WIDE SOUND PATCH IN EAST FACE OF COLUMN

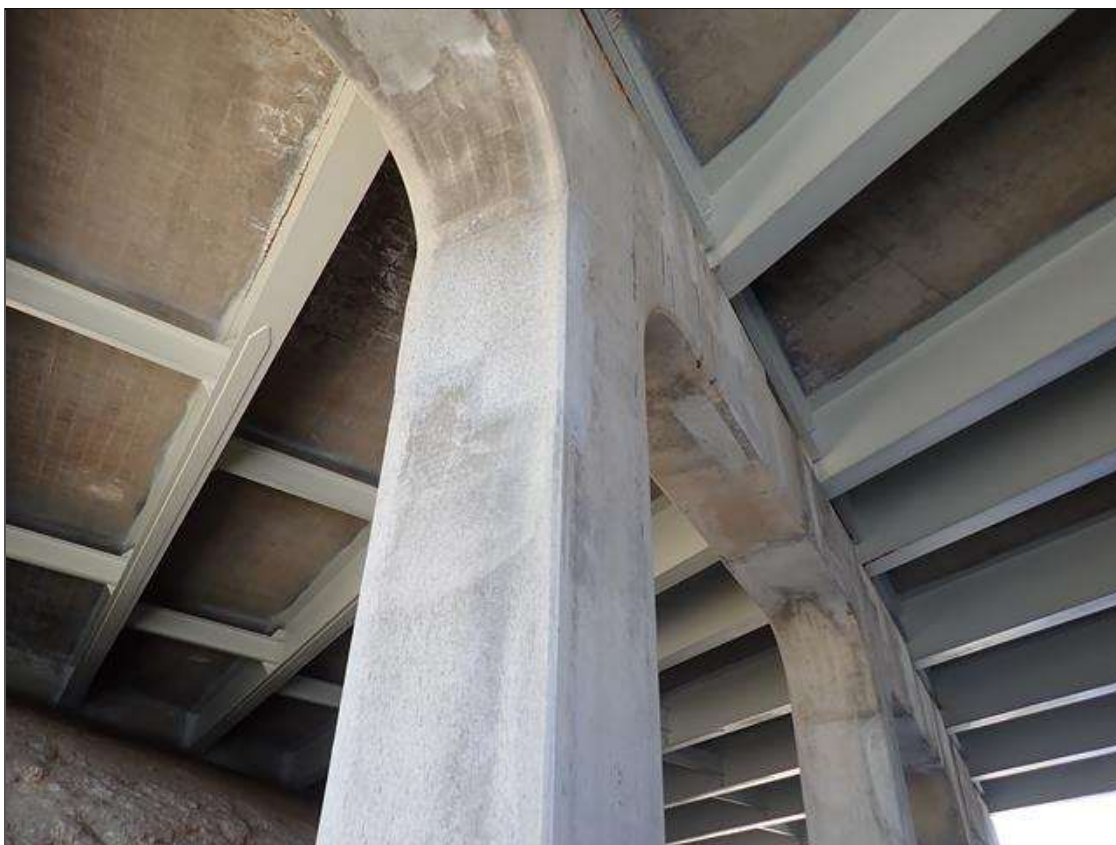
Bent 1 Pile 4: PATCHWORK 4 FT HIGH x FULL WIDTH OF COLUMN ON SOUTHWEST FACE NEAR BOTTOM OF CAP

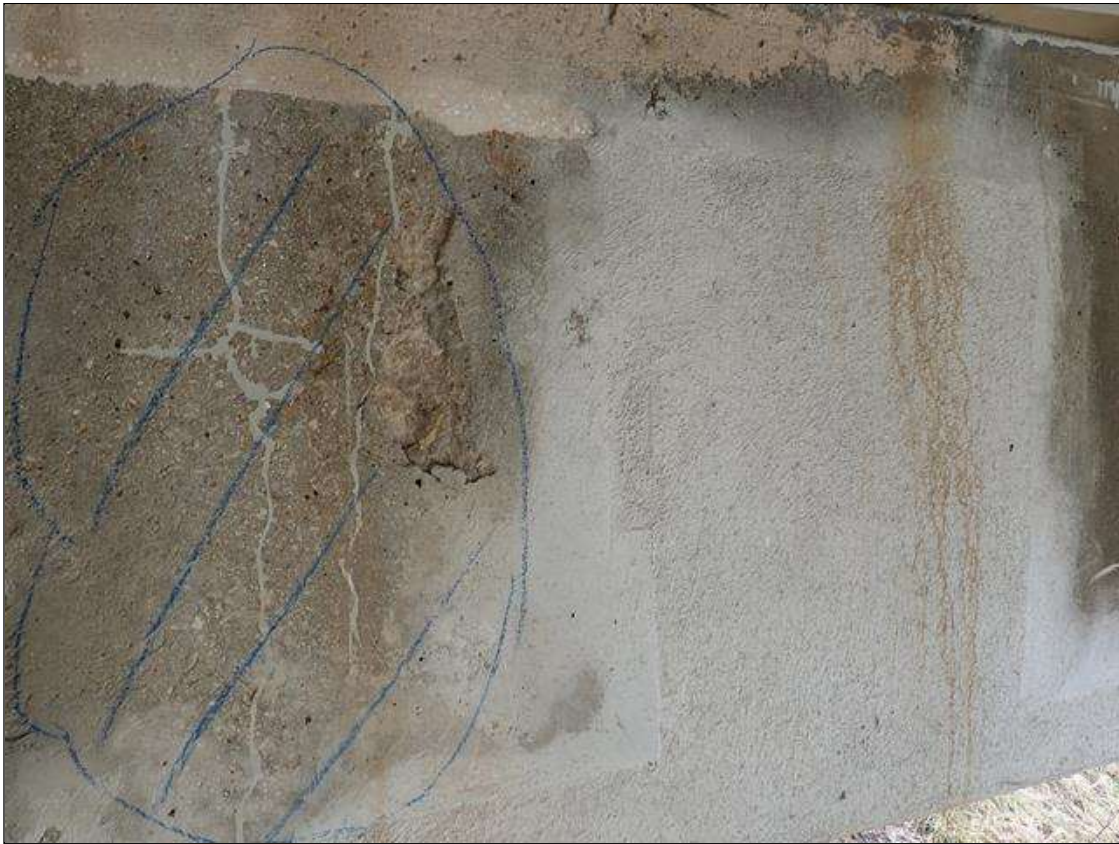
Bent 2 Cap 1: 32" x 18" DELAMINATION UNDER GIRDER 9 IN EAST FACE OF CAP

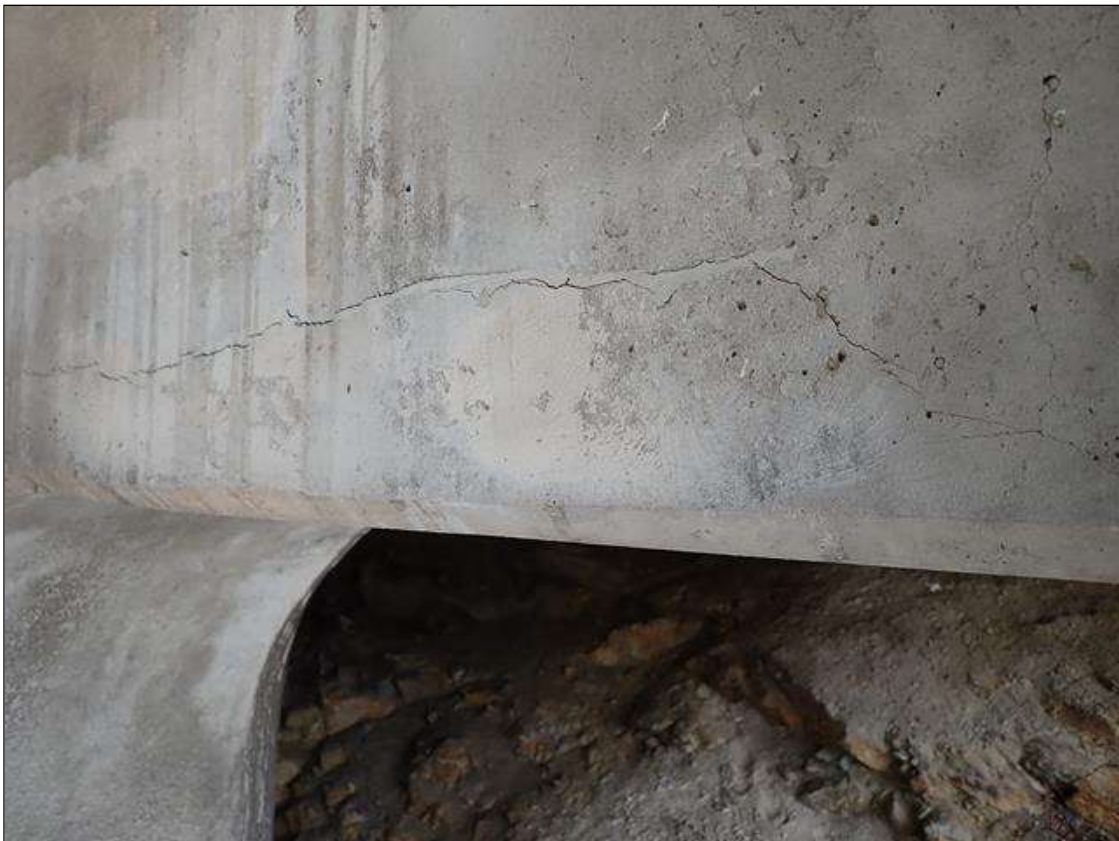
Bent 2 Cap 1: 42" x 6" x 4" DELAMINATION IN BOTTOM CORNER OF EAST FACE OF CAP UNDER BAY 8

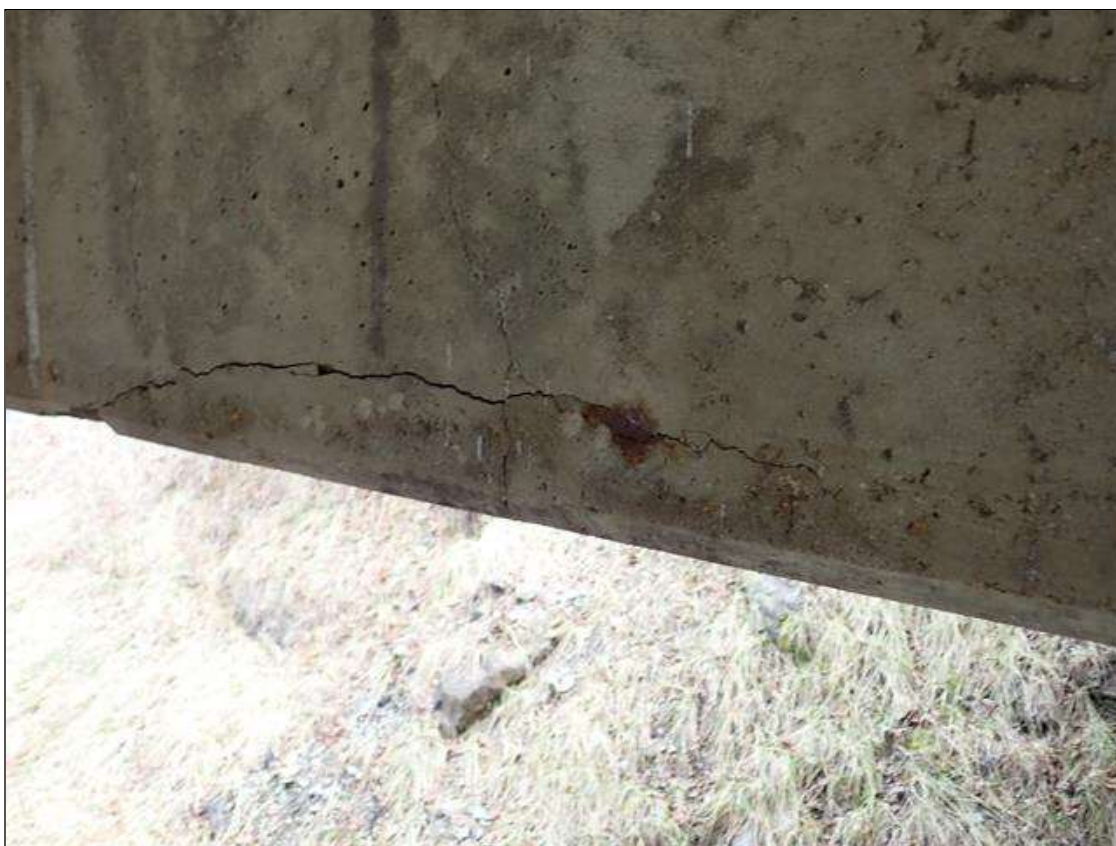
Bent 2 Cap 1: 38" LONG x 4" HIGH x 7" DELAMINATION IN BOTTOM CORNER OF EAST FACE OF CAP BELOW BAY 2

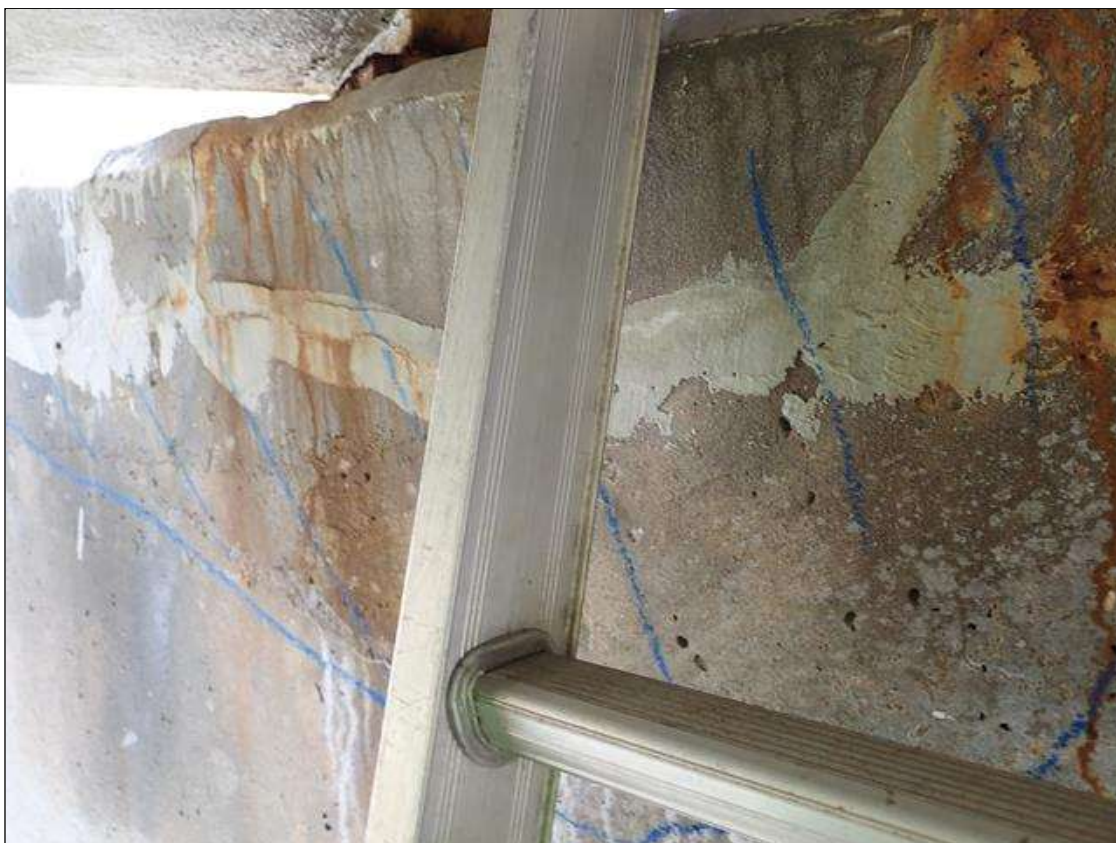
Bent 2 Cap 1: 44" x 15" x 5" DELAMINATION IN TOP CORNER OF EAST FACE OF CAP BELOW GIRDER 1

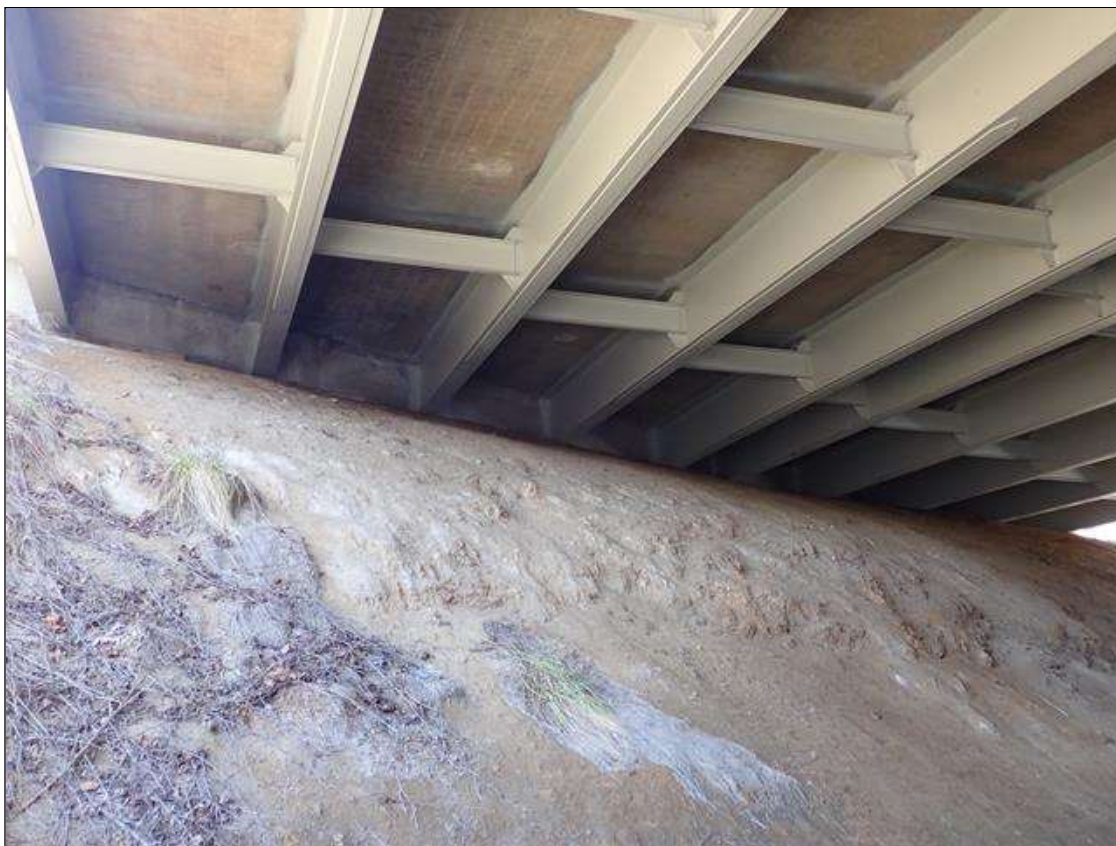
END BENT 1, END BENT 2 SIMILAR.

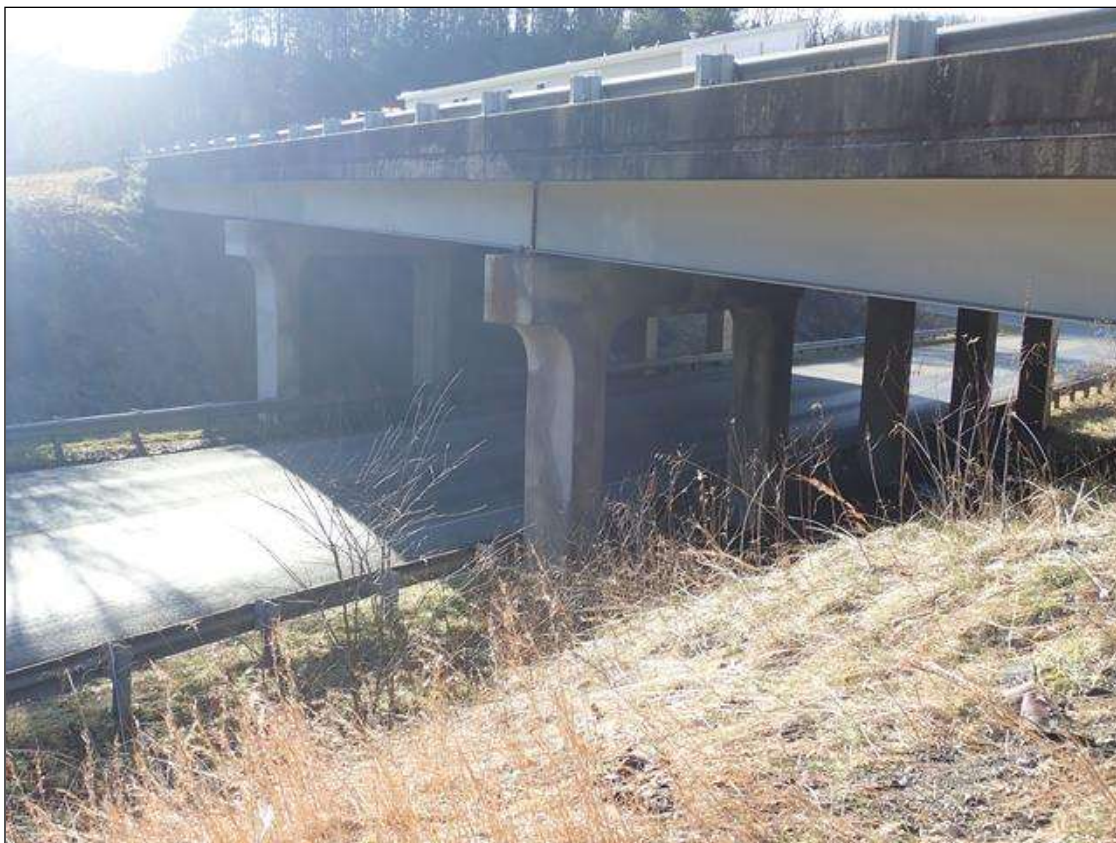
NORTH PROFILE.

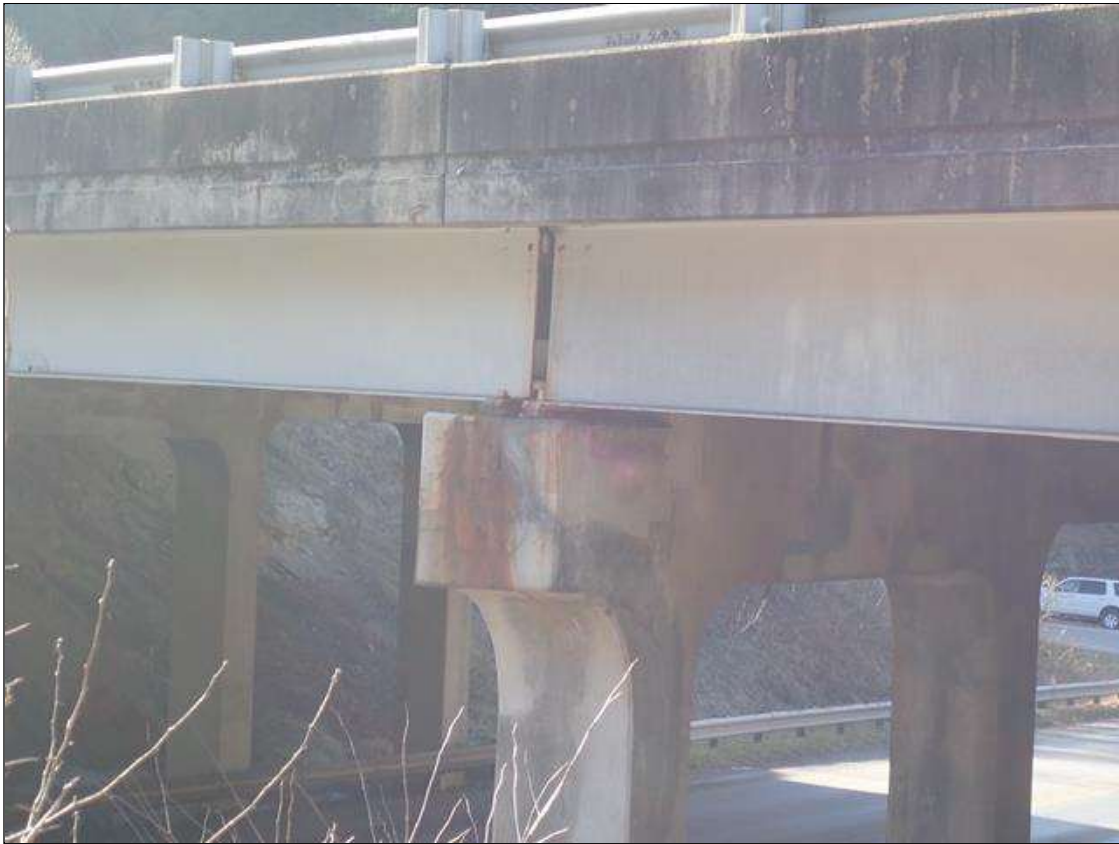
BENT 1, END OF CAP. TYPICAL.
