NC DEPARTMENT OF TRANSPORTATION  
DIVISION OF HIGHWAYS  
STRUCTURE MANAGEMENT UNIT

## Structure Safety Report

### Routine Element Inspection - Contract

DIVISION: 14 COUNTY: HAYWOOD STRUCTURE NUMBER: 430124 FREQUENCY: 24 MONTHS

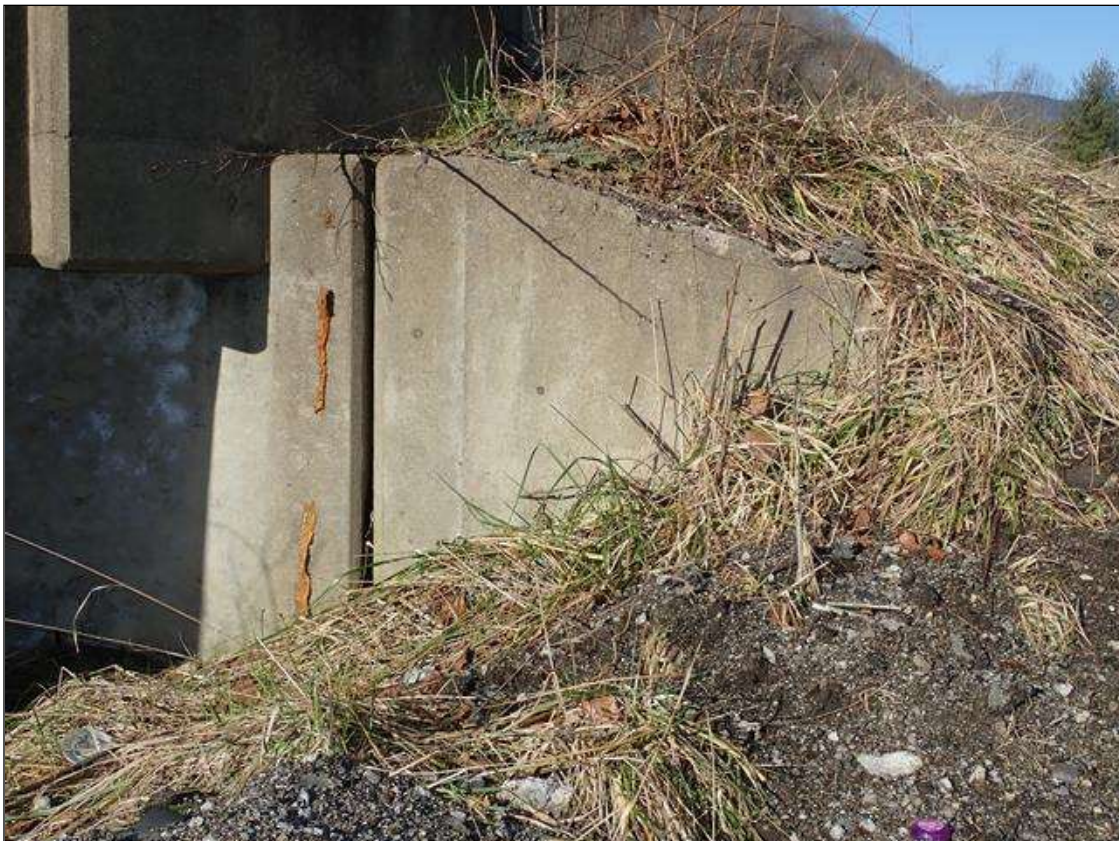
NORTHWEST WINGWALL, TYPICAL.

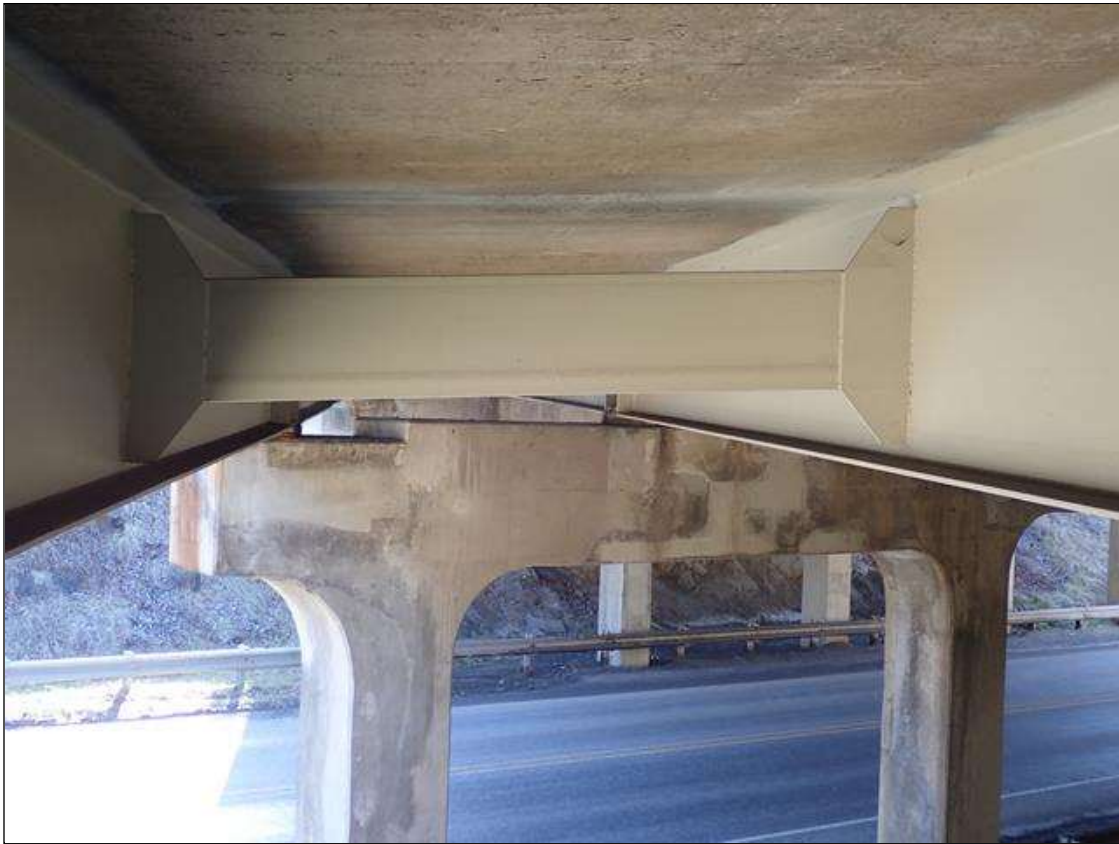
INTERMEDIATE DIAPHRAGM, SPAN 1. TYPICAL.

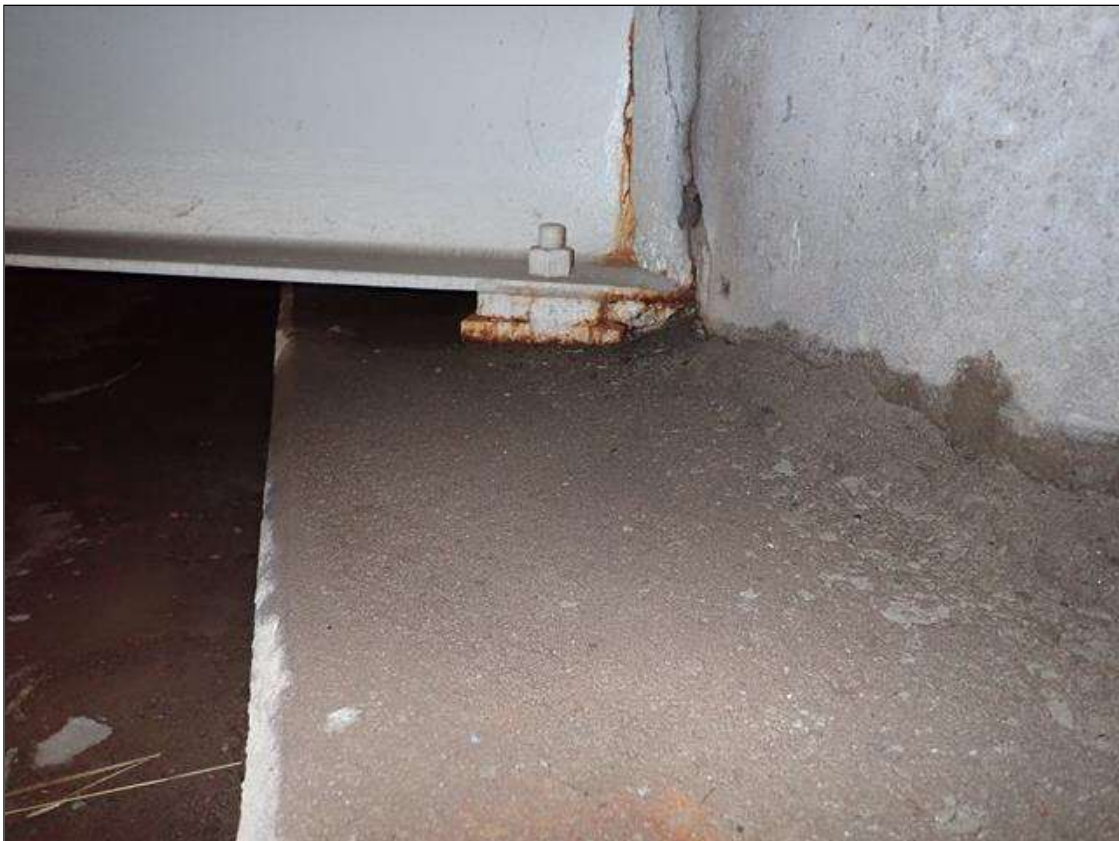
GIRDER 3 BEARING AT END BENT 1. TYPICAL END BENT BEARING.

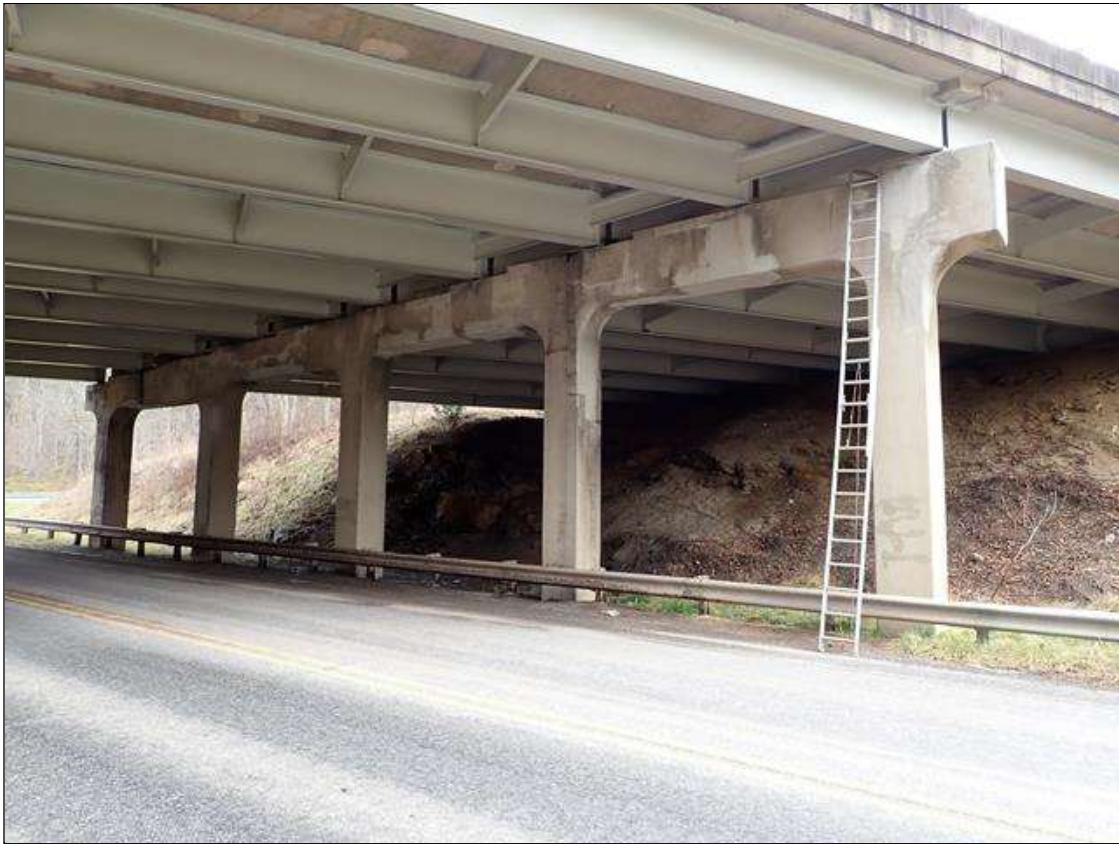
BENT 2, TYPICAL

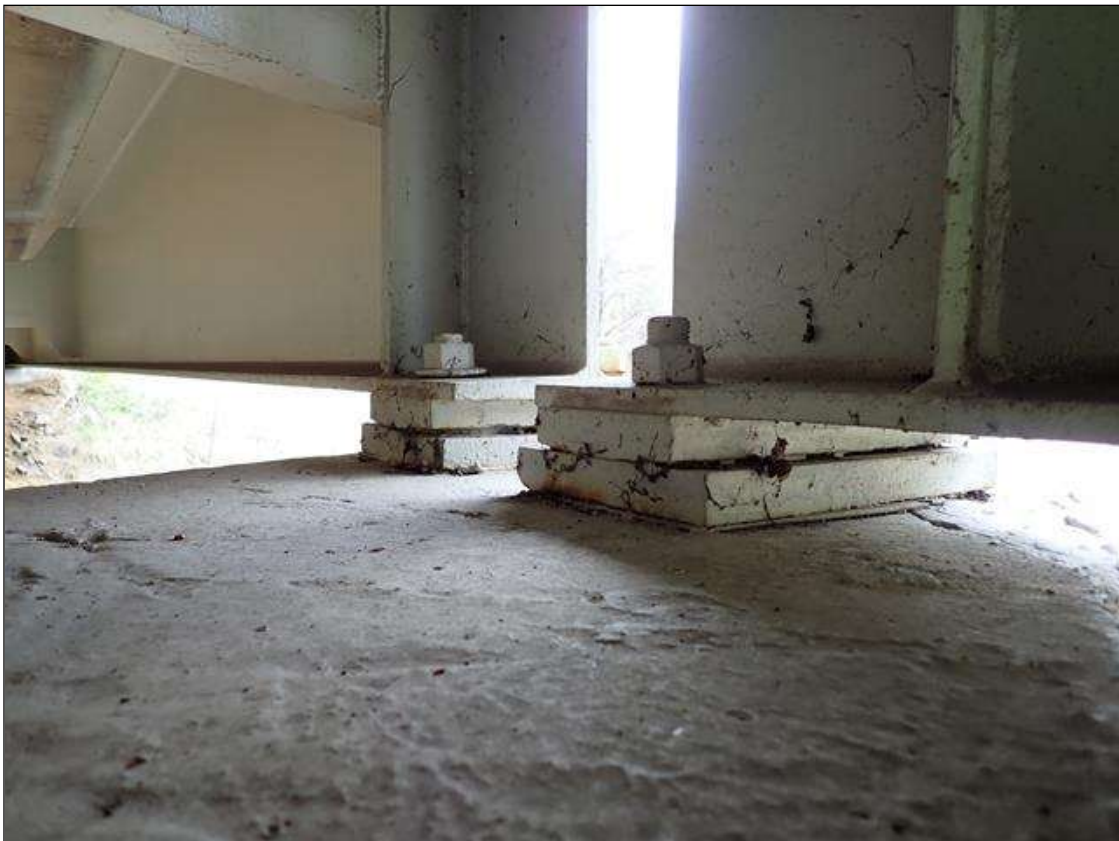
TYPICAL BENT BEARING, BEARING 10 AT BENT 2
