NC DEPARTMENT OF TRANSPORTATION  
DIVISION OF HIGHWAYS  
STRUCTURE MANAGEMENT UNIT

## Structure Safety Report

### Routine Element Inspection - Contract

COUNTY: HAYWOOD STRUCTURE NUMBER: 430124 FREQUENCY: 24 MONTHS  
FACILITY CARRIED: I-40 MILE POST: 14.9  
LOCATION: 5 MI.W.JCT.US276  
FEATURE INTERSECTED: SR1338  
LATITUDE: 35° 40' 3.95" LONGITUDE: 82° 59' 40.3"  
SUPERSTRUCTURE: REINFORCED CONCRETE FLOOR ON I-BEAMS  
SUBSTRUCTURE: E.BT1:RC CAP/H-PILES;ABUT.2:RC CAP/ROCK;INT.BTS:RCP&BEAM  
SPANS: 2 @ 53'-2;1 @ 57'-8.5  
☐ FRACTURE CRITICAL ☐ TEMPORARY SHORING ☐ SCOUR CRITICAL ☐ SCOUR PLAN OF ACTION  
PRESENT CONDITION: Fair INSPECTION DATE: 05/08/2017  
POSTED SV: Not Posted POSTED TTST: Not Posted  
OTHER SIGNS PRESENT: NONE

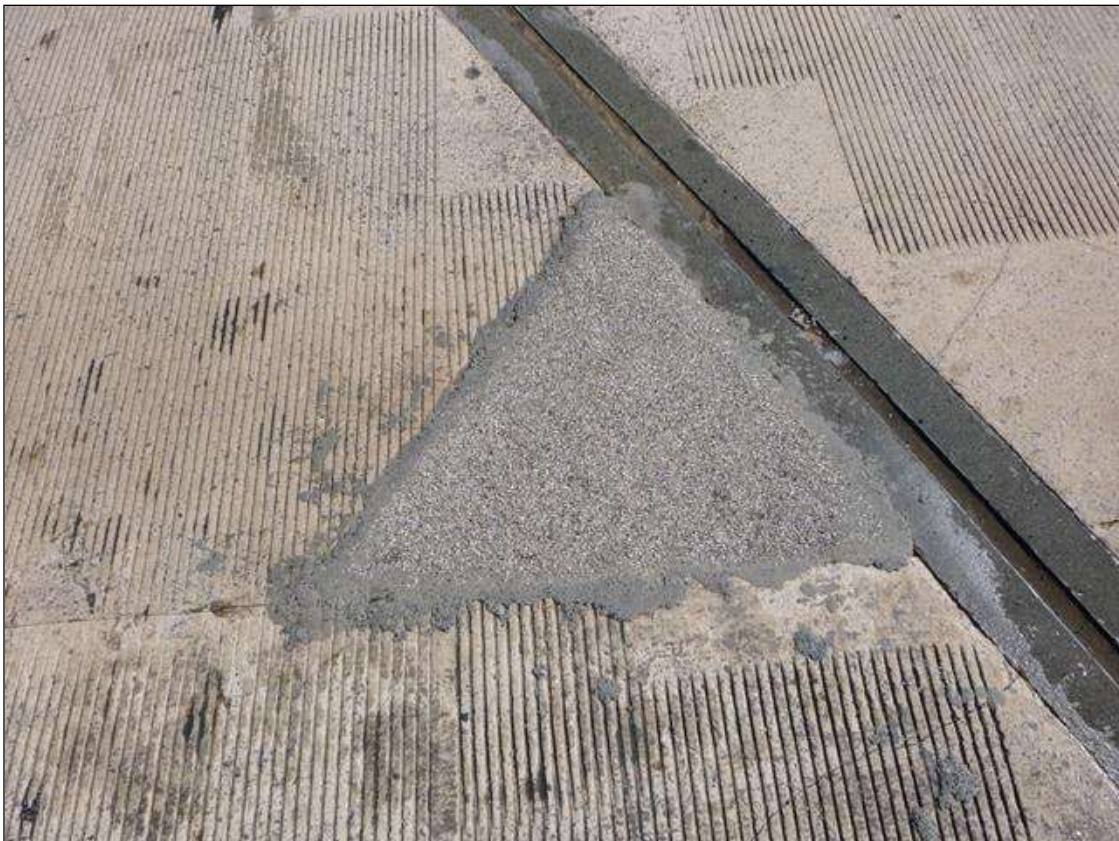
Span 2 Deck: PATCHED AREA 3' X 3' RIGHT EAST BOUND LANE AT BENT 2 END.

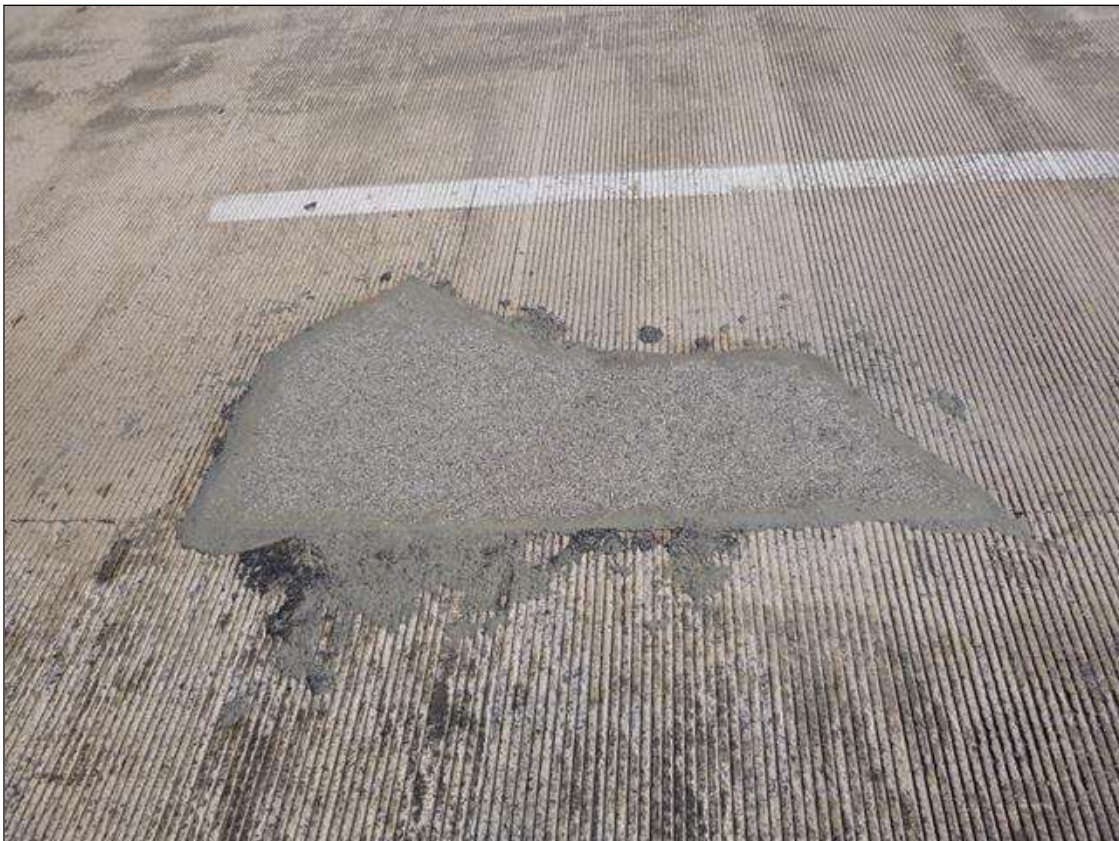
Span 1 Deck: PATCHED AREA 3' X 4' IN RIGHT EAST BOUND LANE 8' FROM BENT 1 END.

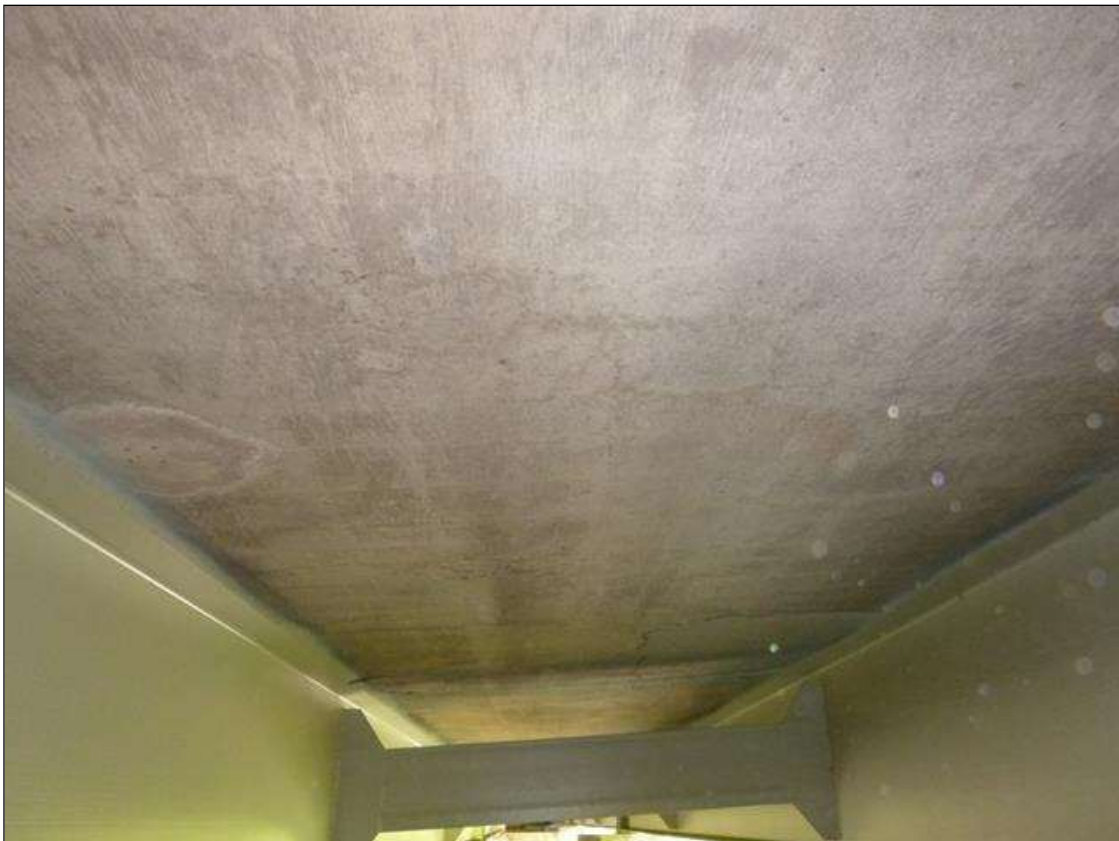
Span 1 Deck: PATCHED AREAS: 4 AT 12" DIAMETER, 12" WIDE X 6' LONG AND 12" DIAMETER AT BAY 9 ALONG BEAM 9.

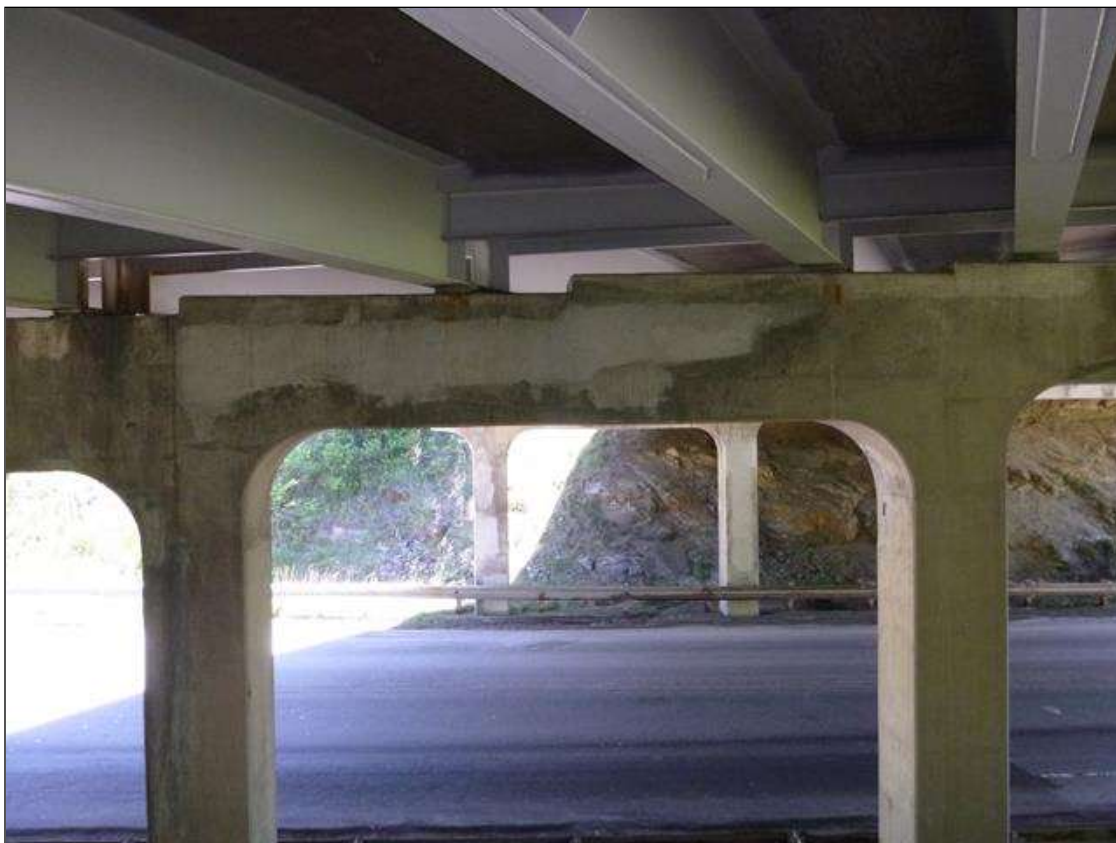
Bent 1 Cap 1: PATCHWORK COLUMN 2 TO COLUMN 3 WEST FACE.

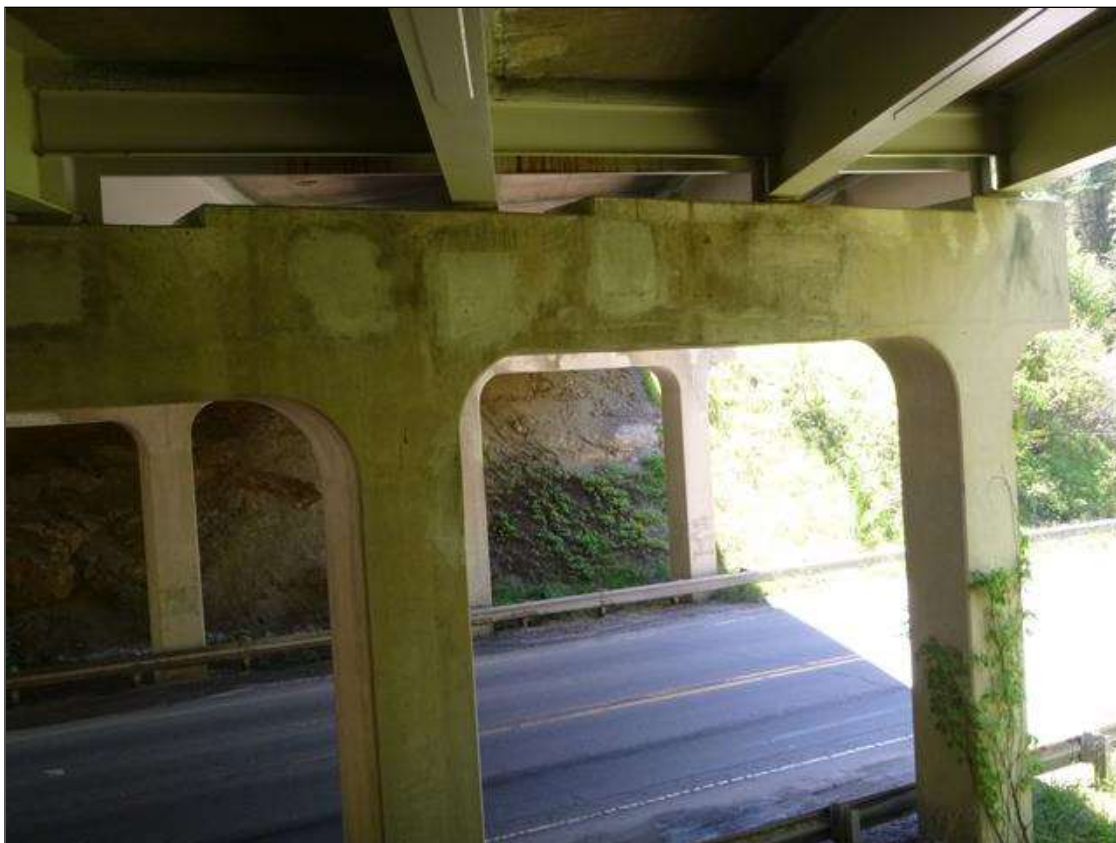
Bent 1 Cap 1: PATCHWORK COLUMN 4 TO RIGHT END WEST FACE.

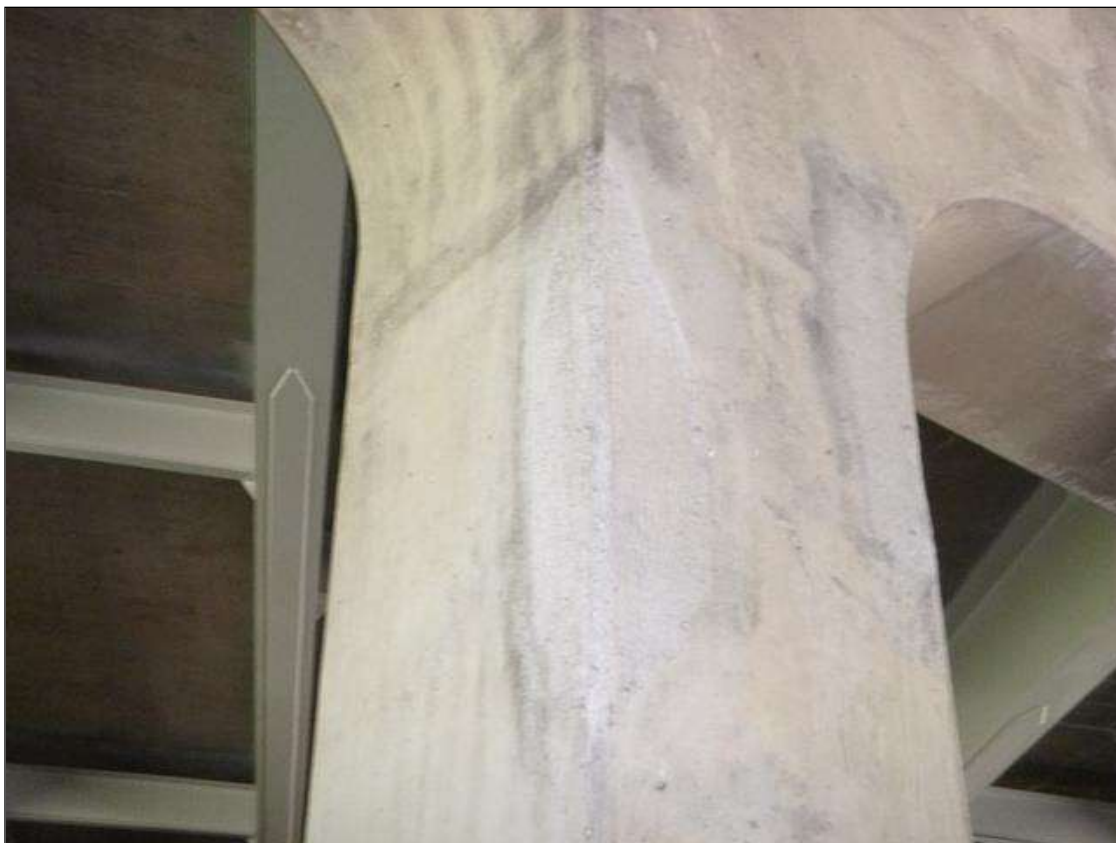
Bent 1 Pile 3: PATCHWORK 6" WIDE X 30" HIGH ON SOUTH AND EAST FACES.

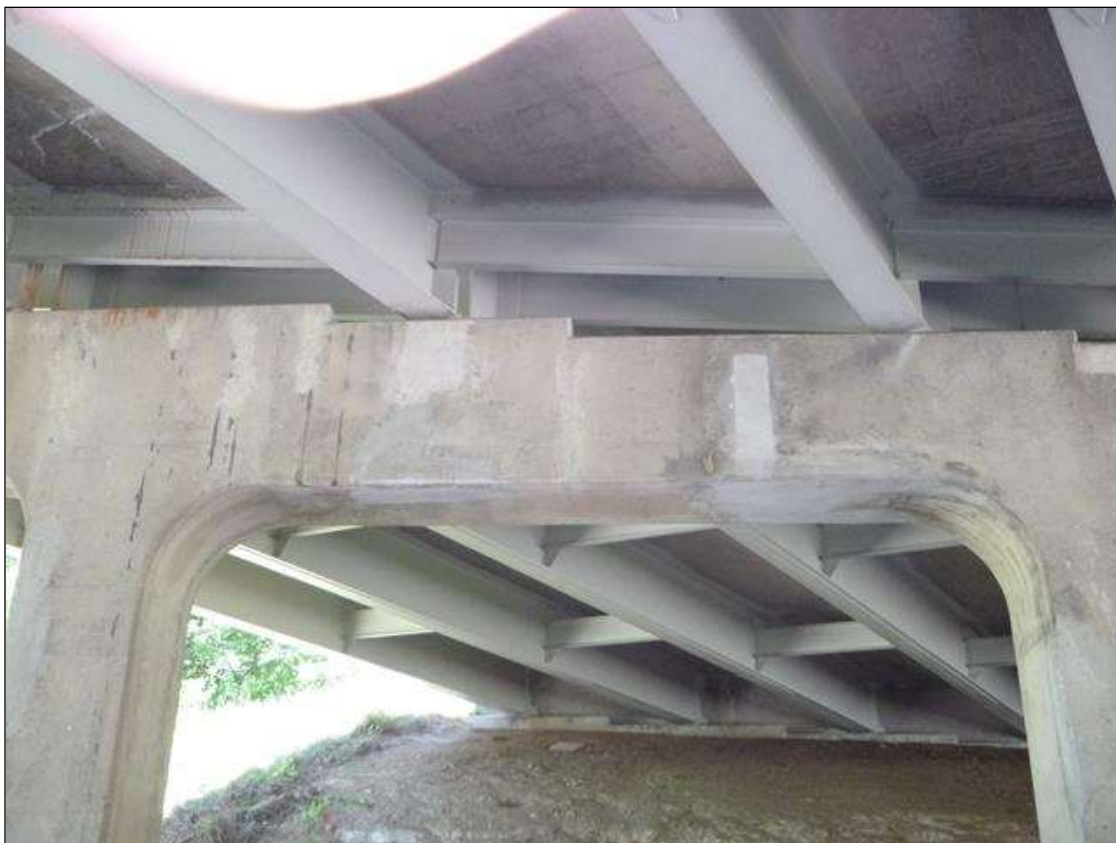
Bent 1 Cap 1: PATCHWORK COLUMN 3 TO COLUMN 4 ON EAST FACE.

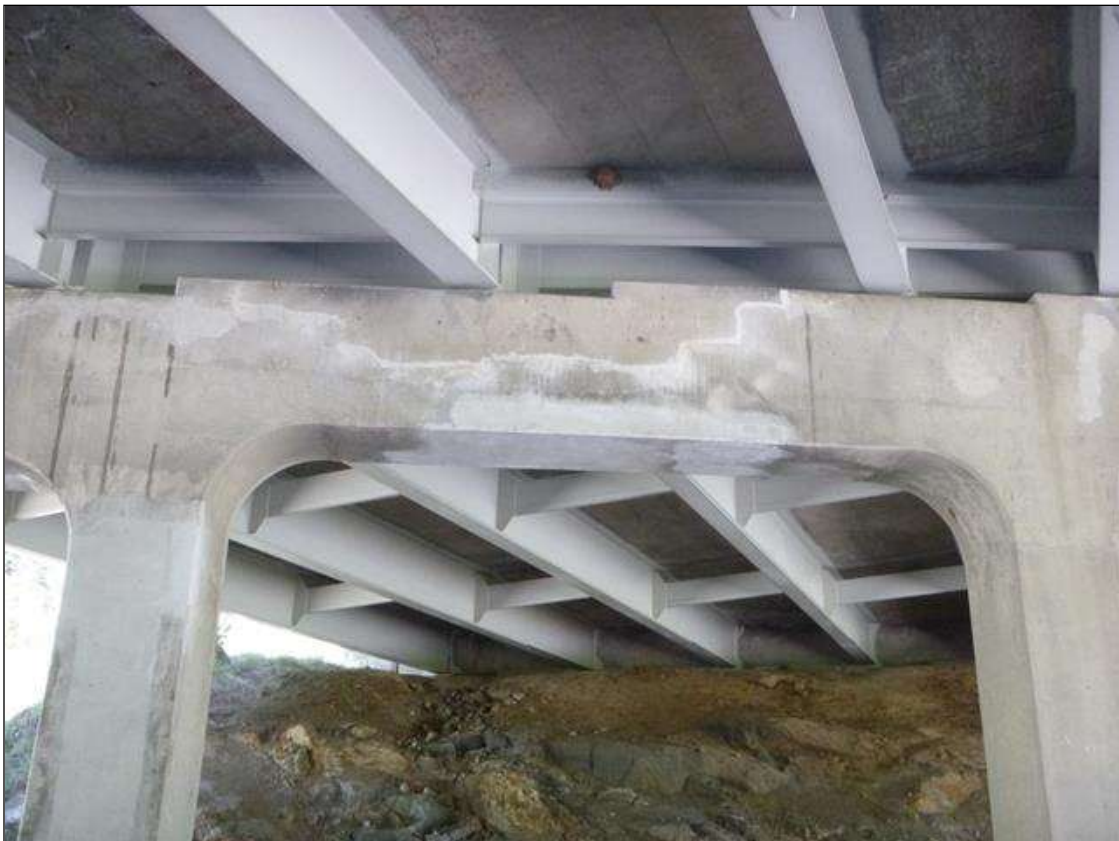
Bent 2 Cap 1: PATCHWORK COLUMN 2 TO COLUMN 3 ON WEST FACE.

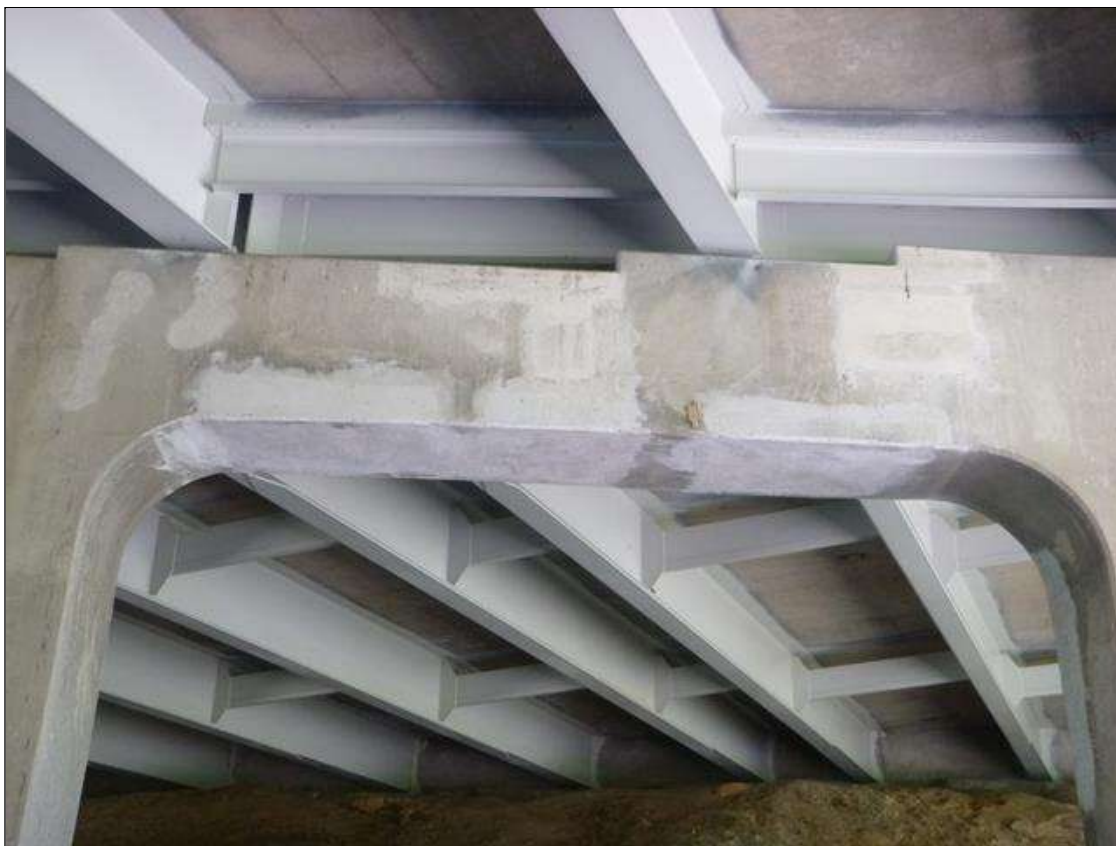
Bent 2 Cap 1: PATCHWORK COLUMN 3 TO COLUMN 4 WEST FACE.

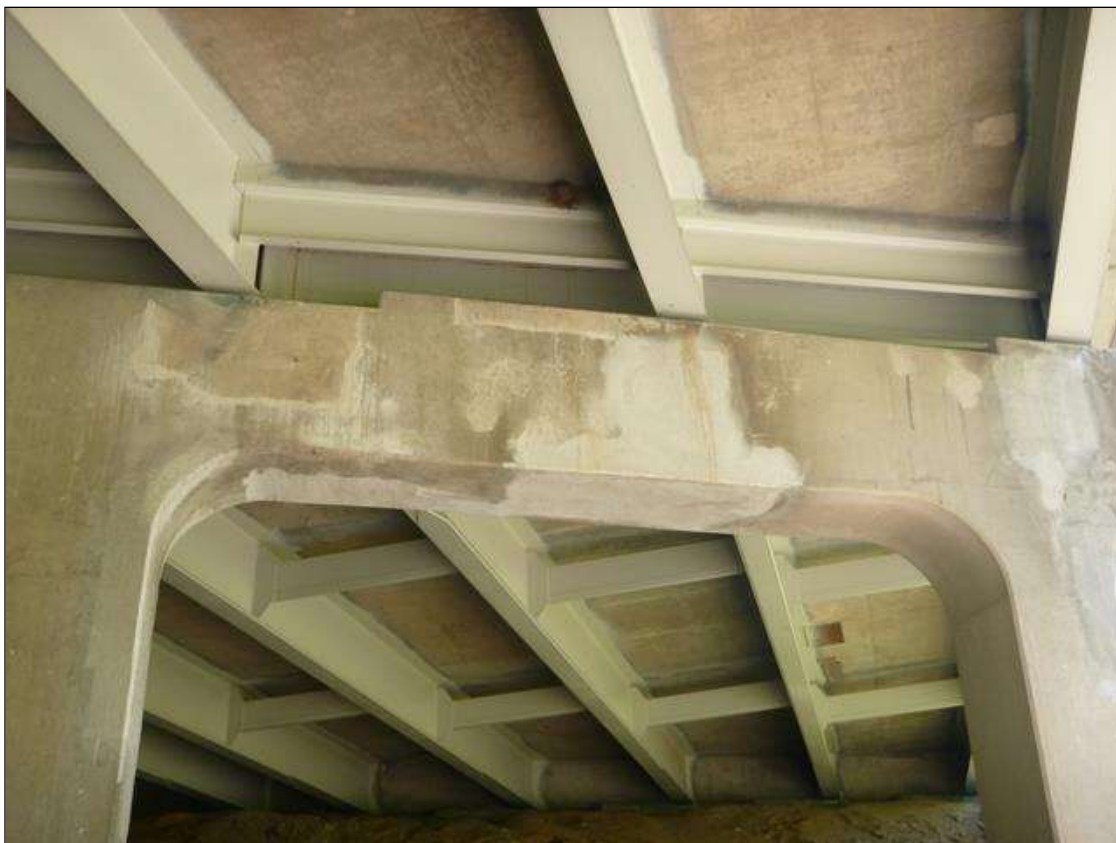
Bent 2 Cap 1: PATCHWORK COLUMN 4 TO RIGHT END.

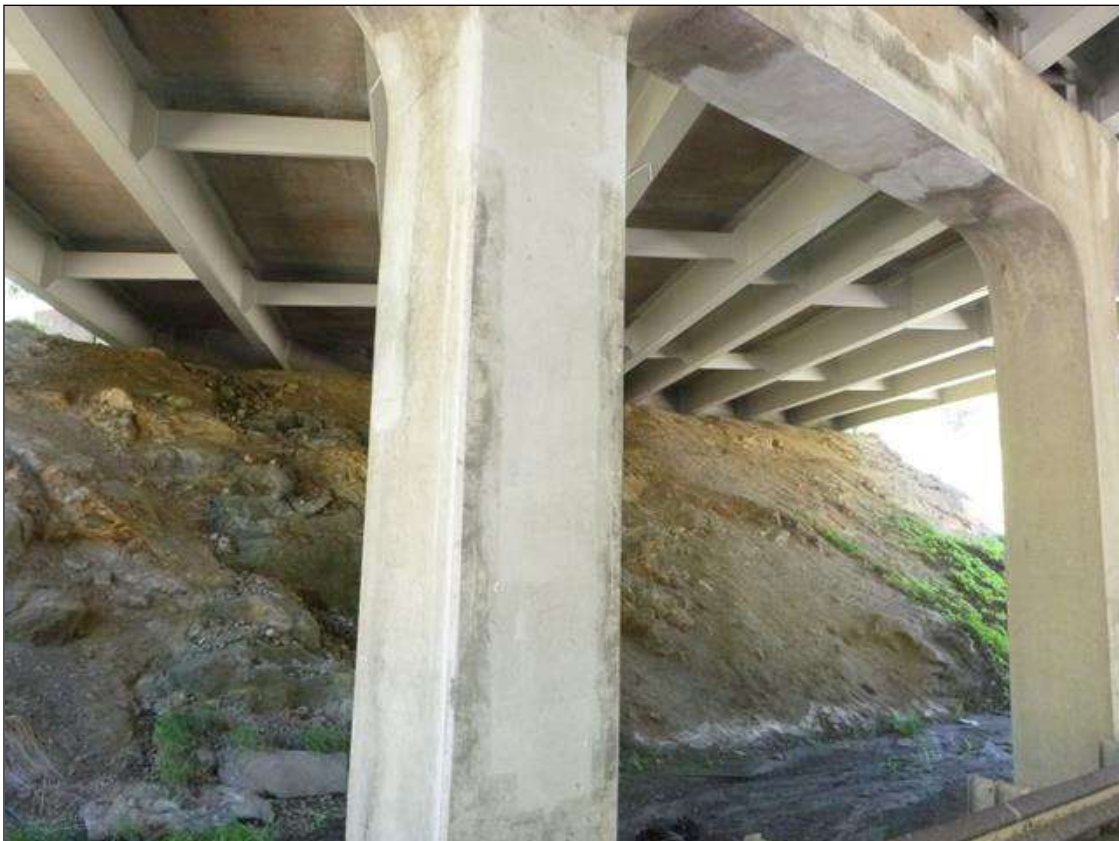
Bent 2 Pile 2: PATCHWORK FULL HEIGHT NORTH AND WEST FACES.

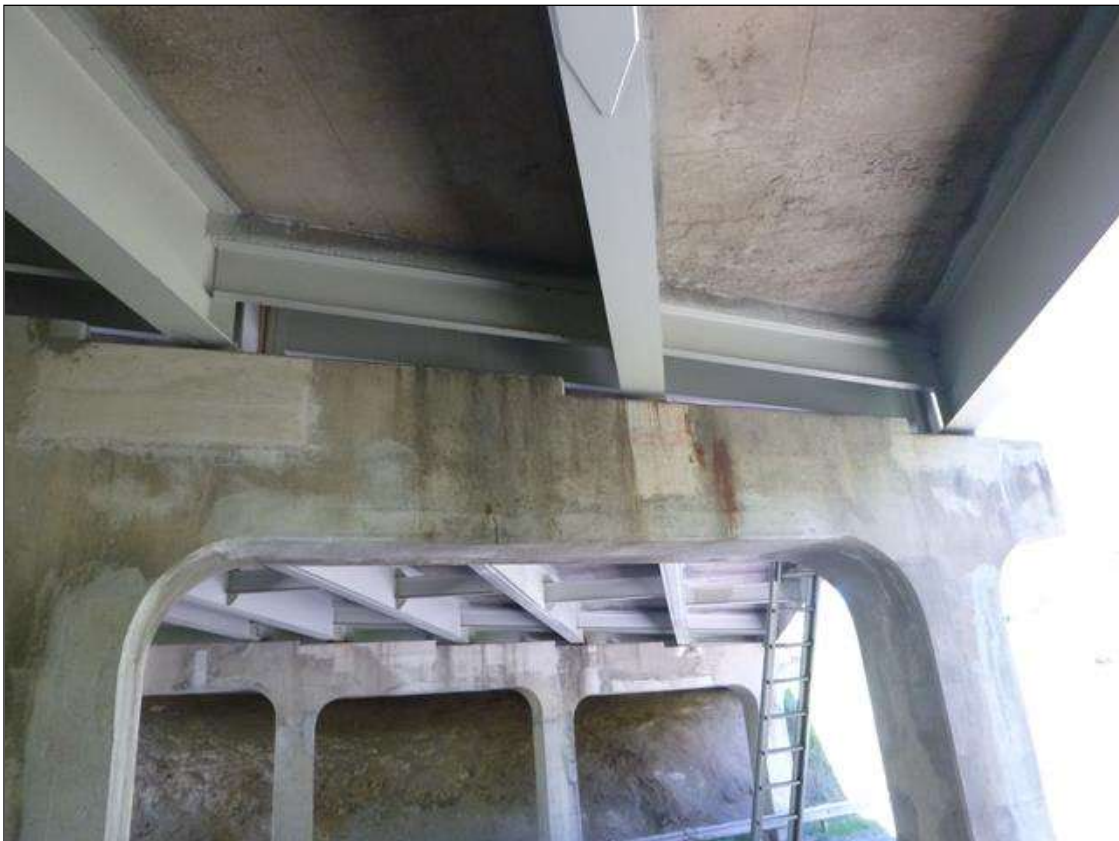
Bent 2 Cap 1: PATCHWORK LEFT END TO COLUMN 2 EAST FACE.

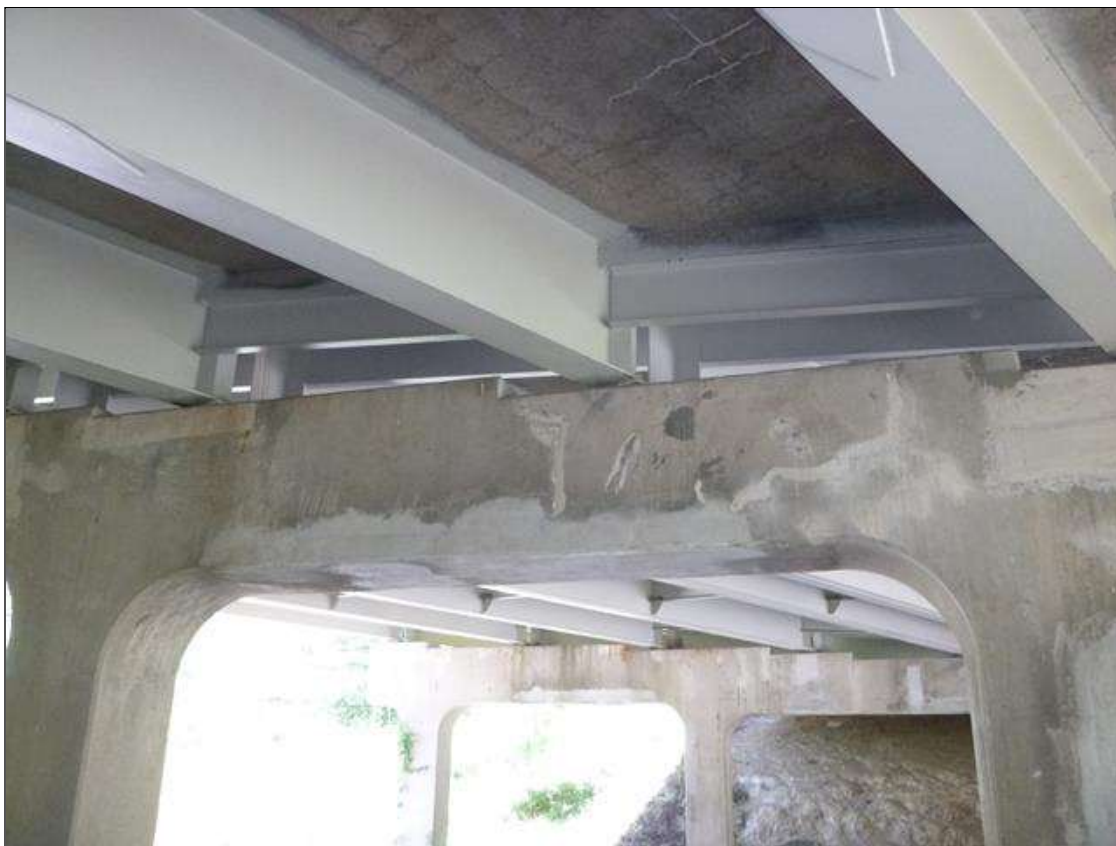
Bent 2 Cap 1: PATCHWORK COLUMN 2 TO COLUMN 3 ON EAST FACE.

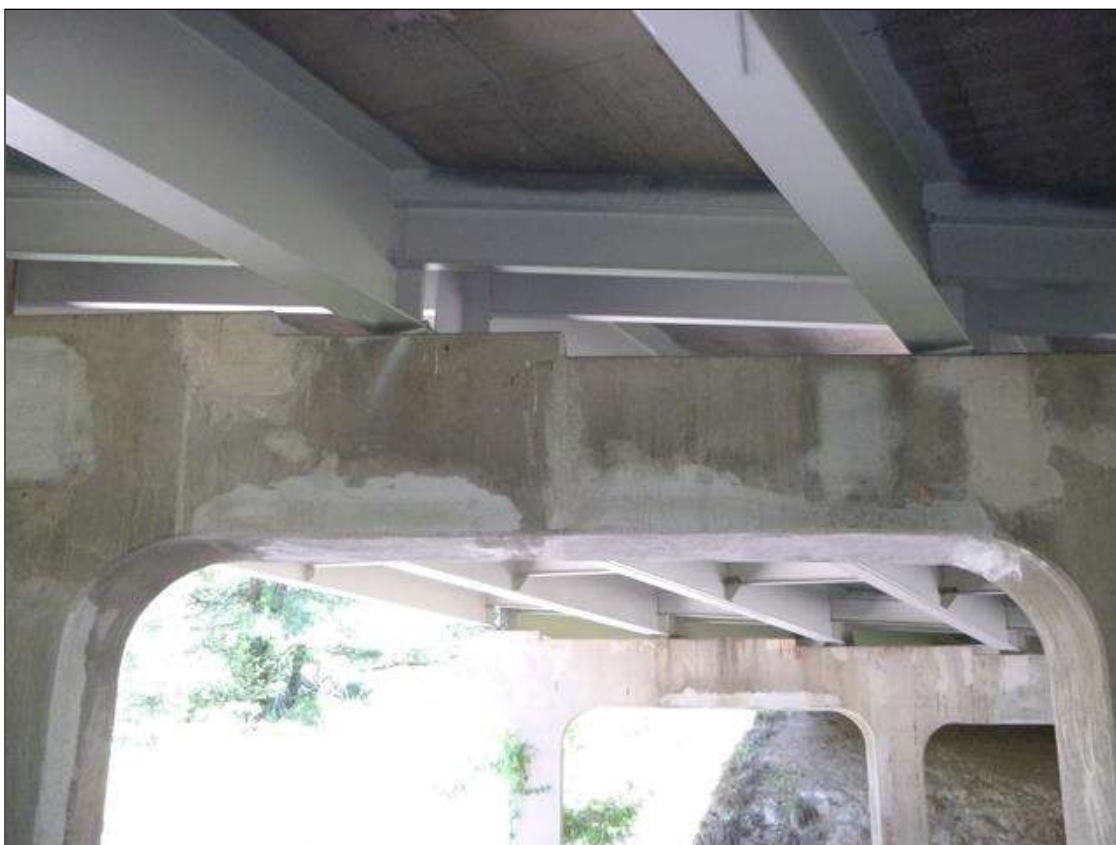
Bent 2 Cap 1: PATCHWORK COLUMN 3 TO COLUMN 4 EAST FACE.

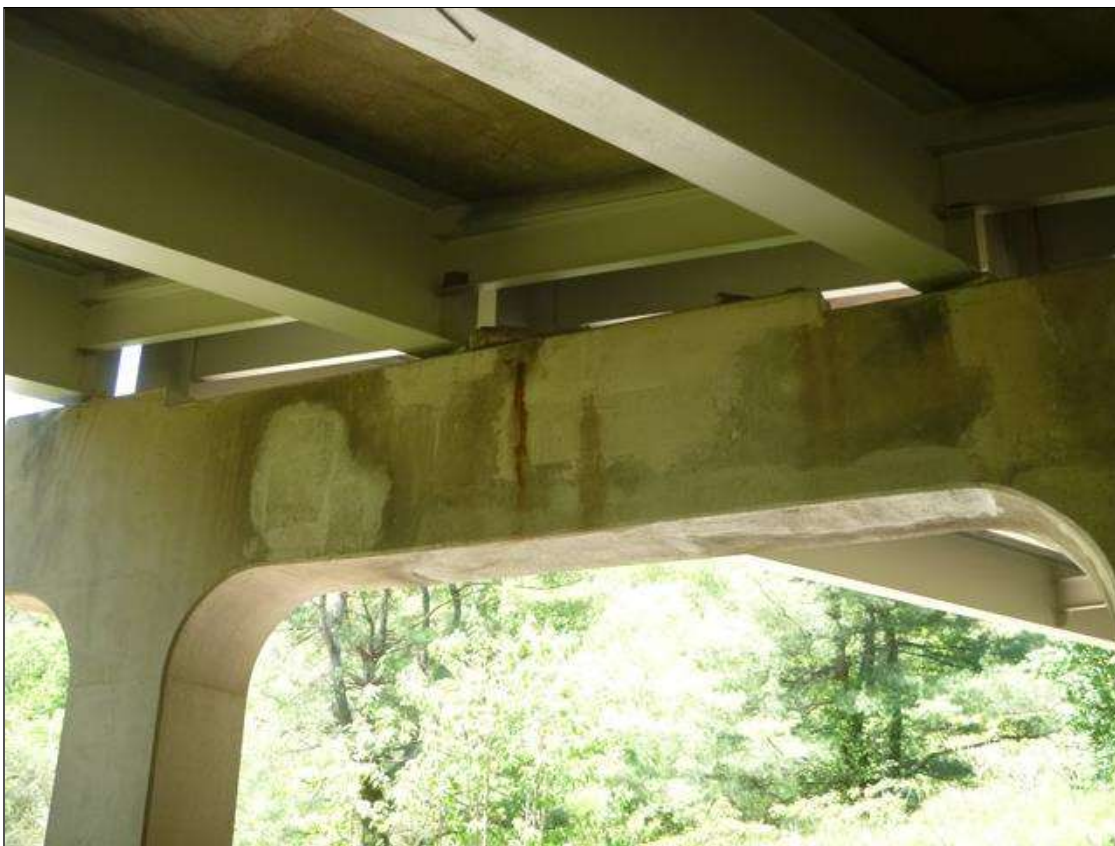
Bent 2 Cap 1: PATCHWORK COLUMN 4 TO RIGHT END EAST FACE.

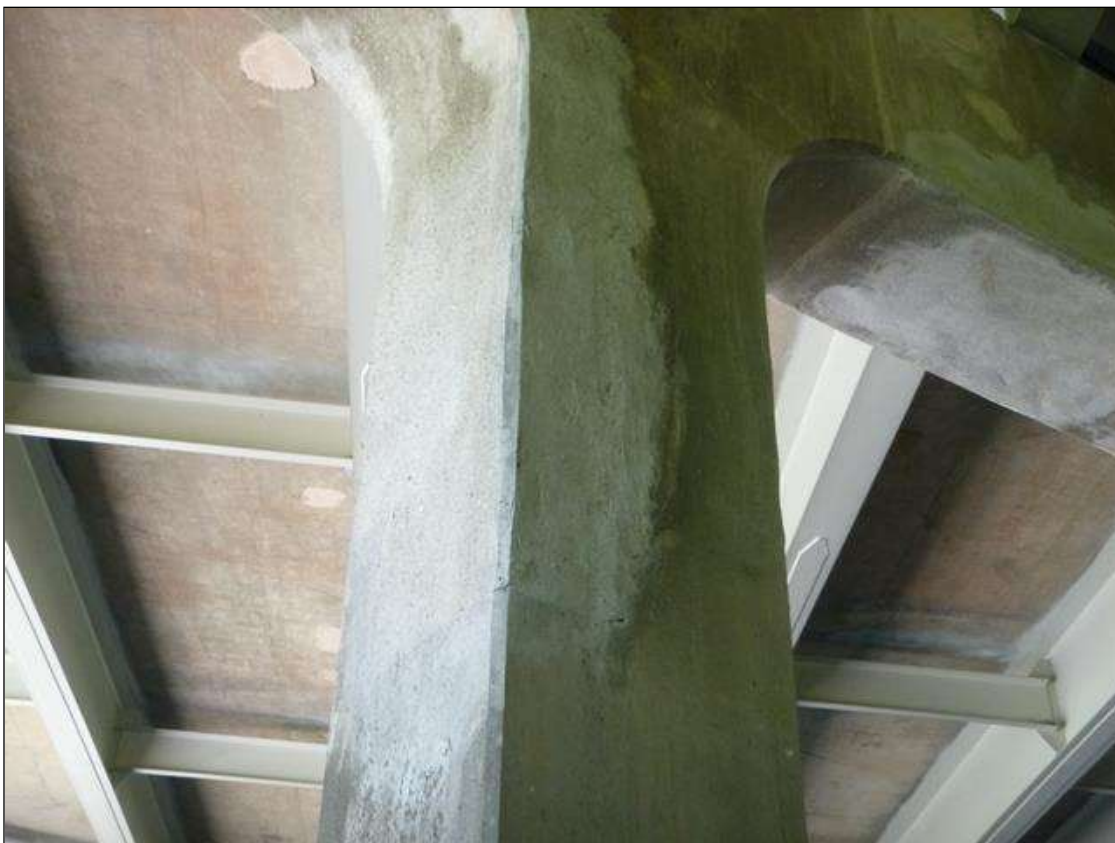
Bent 2 Pile 4: PATCHWORK ALONG TOP 6' ON SOUTH AND EAST FACE.

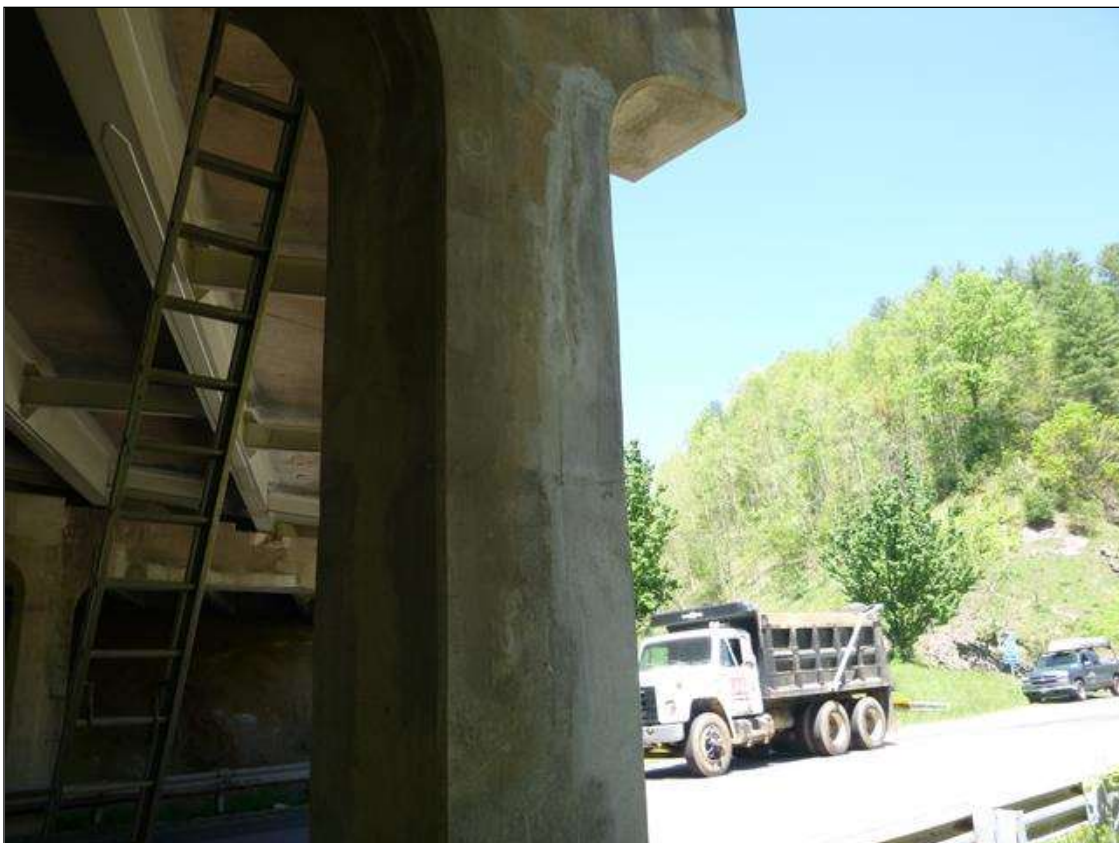
Bent 2 Pile 1: PATCHWORK ALONG TOP 9' ON EAST FACE.

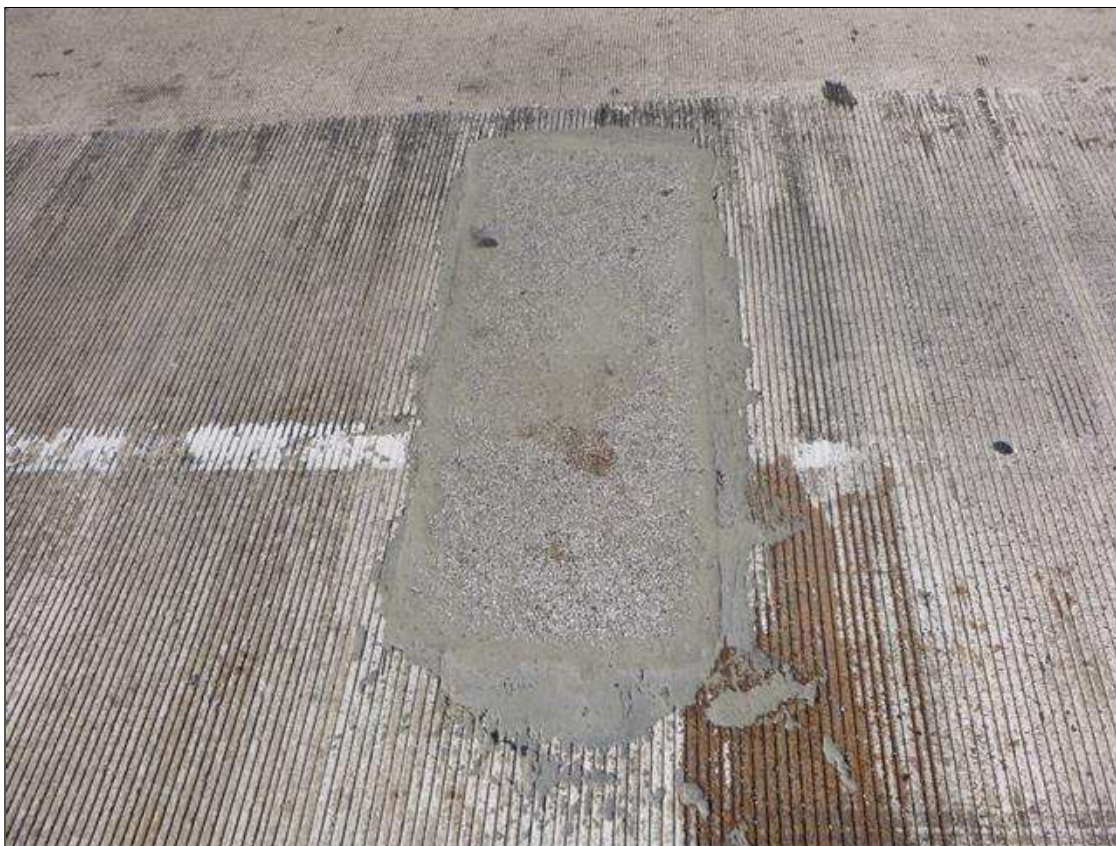
Span 1 Deck: PATCHED AREA 4' WIDE X 2' LONG IN LEFT WEST BOUND LANE 16' FROM END BENT 1 END.

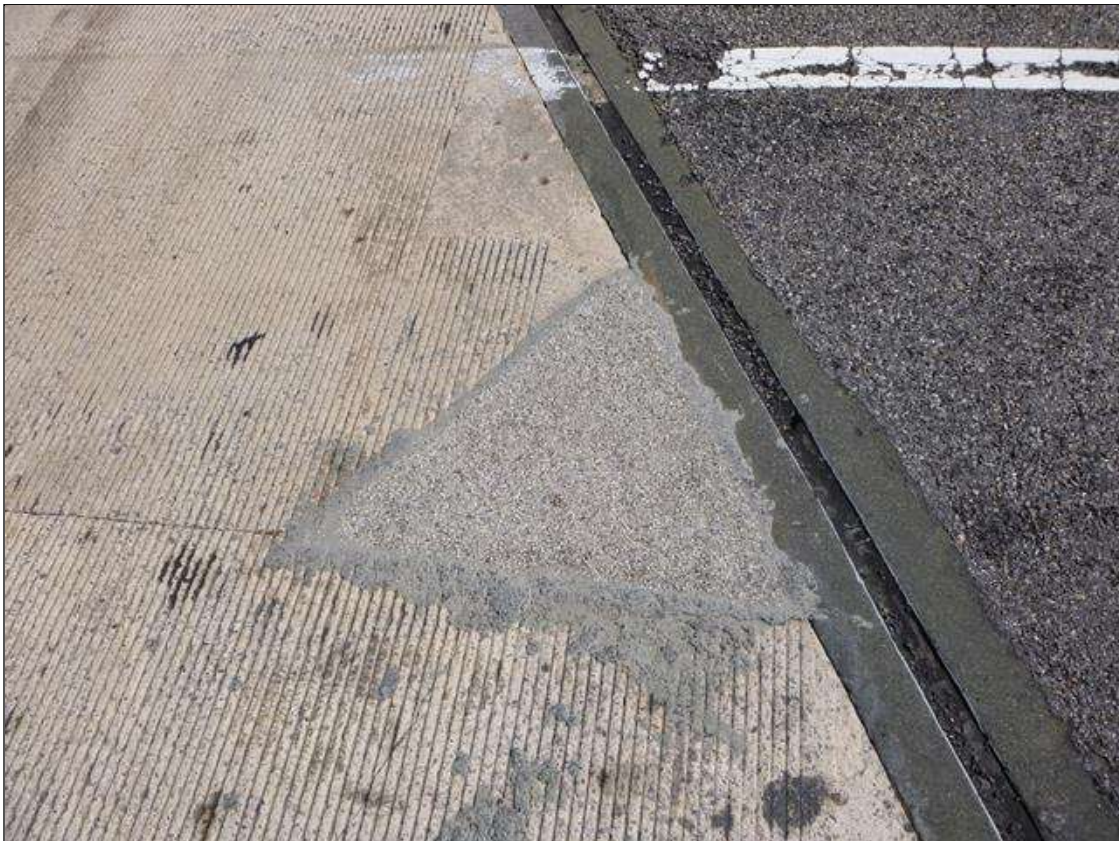
Span 3 Deck: PATCHED AREA 2' X 2' IN EAST BOUND LANE AT CENTERLINE, END BENT 2 END.

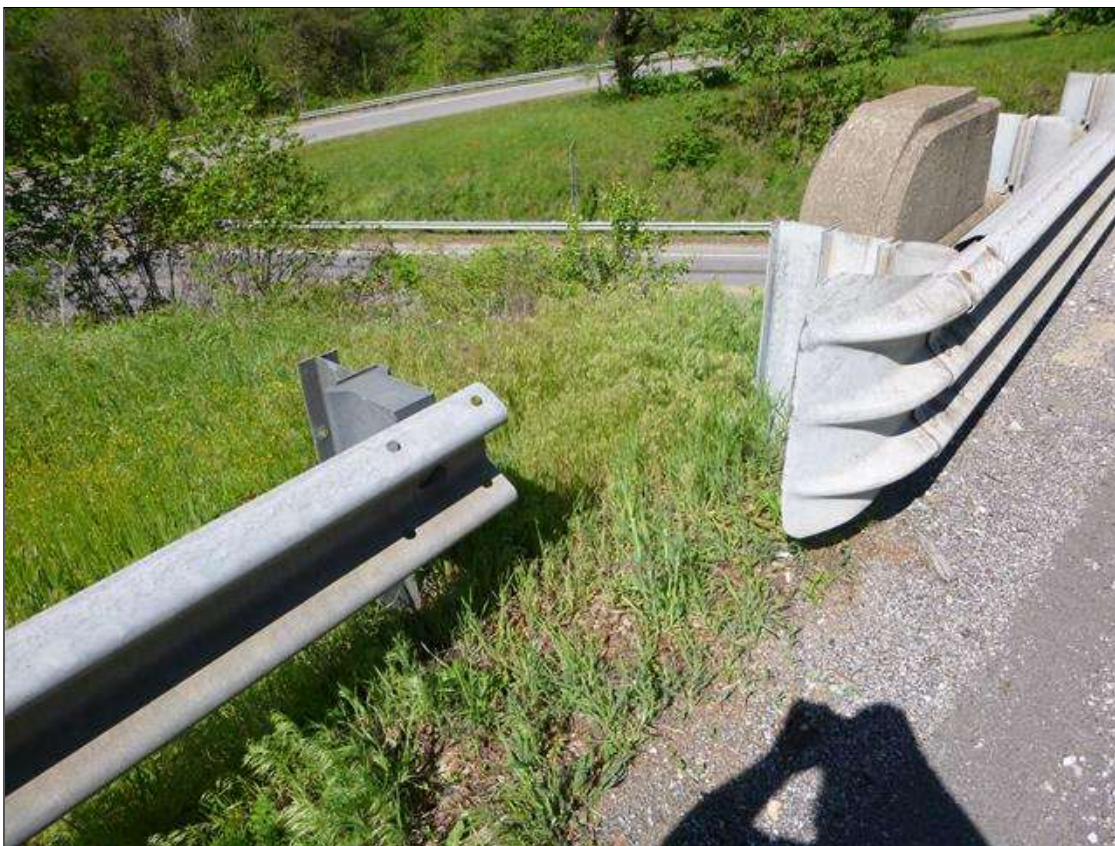
RAIL / GUARDRAIL SEPARATION AT SOUTHEAST CORNER
