NC DEPARTMENT OF TRANSPORTATION  
DIVISION OF HIGHWAYS  
STRUCTURE MANAGEMENT UNIT

## Structure Safety Report

### Routine Element Inspection - Contract

COUNTY: HAYWOOD STRUCTURE NUMBER: 430171 FREQUENCY: 24 MONTHS

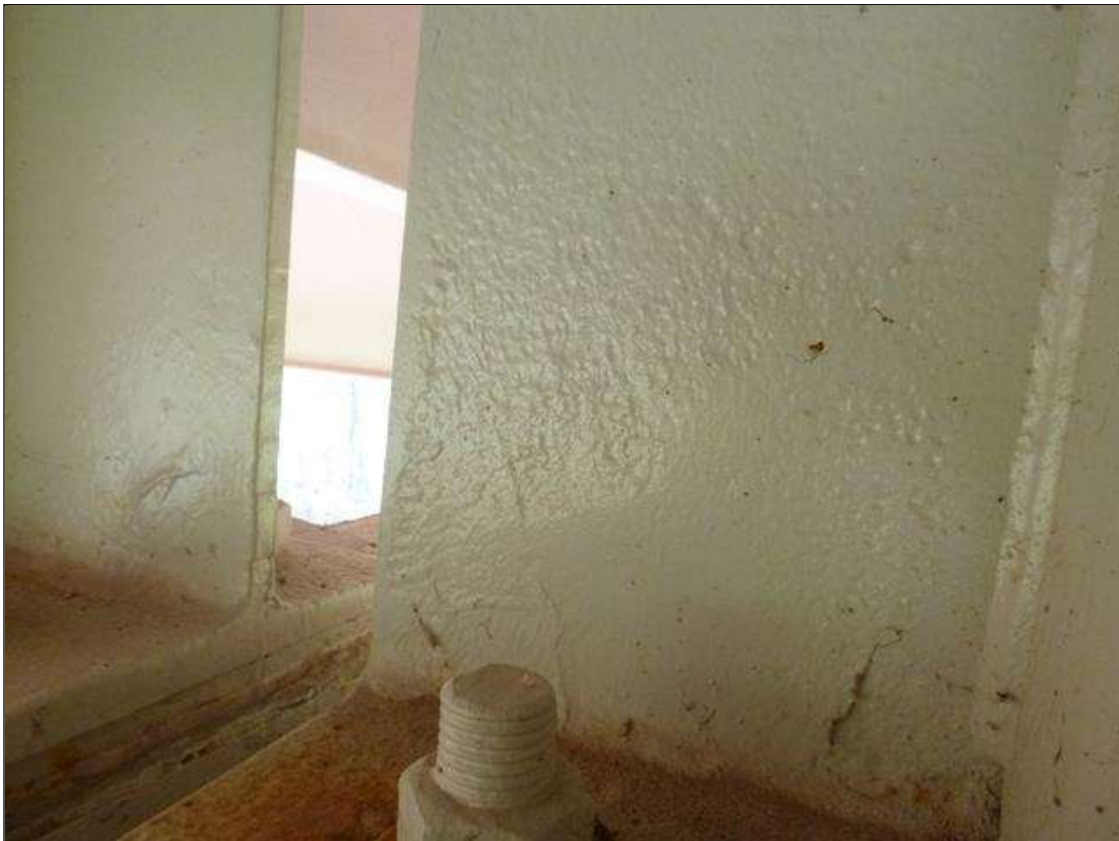
Span 6 Beam 4: SPAN 6, BEAM 4 AT BENT 5 HAS 1/16 INCH SECTION IN THE WEB FROM THE BEAM END OUT 10 INCHES X 12 INCHES HIGH WITH 9/16 INCH REMAINING, PAINTED OVER

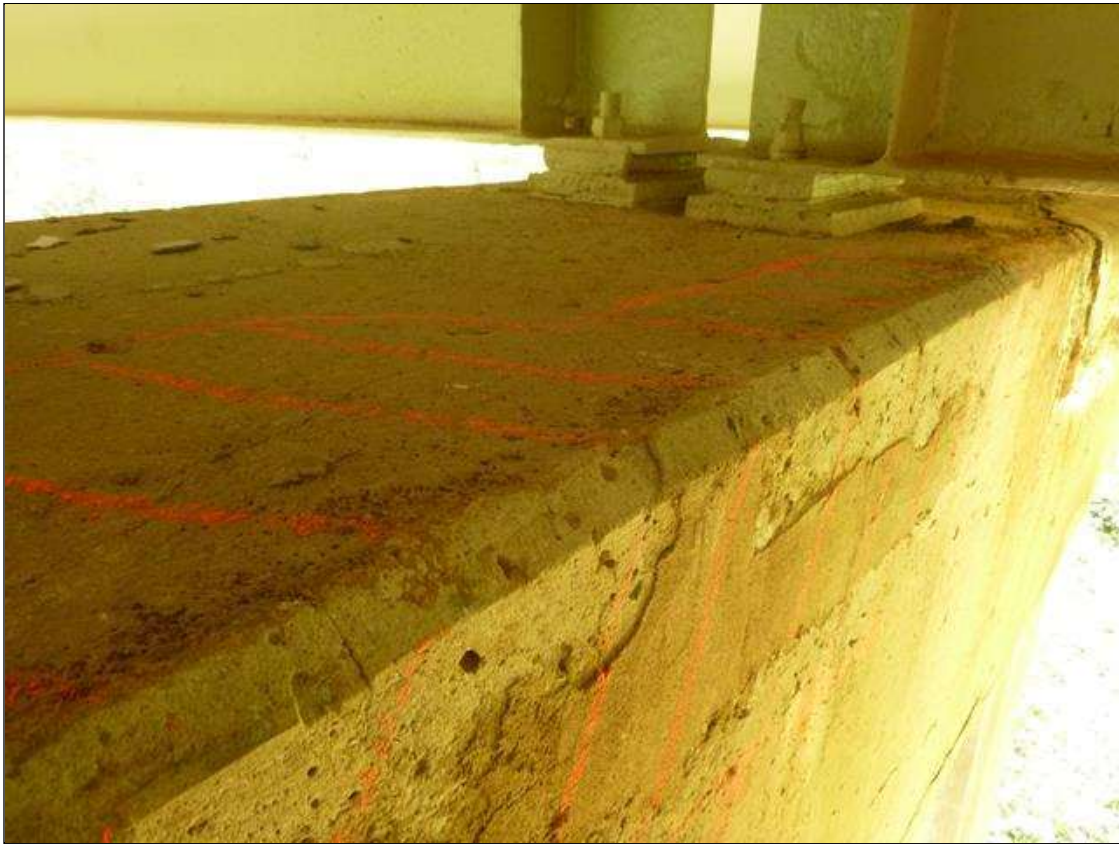
Span 6 Beam 3: SPAN 6, BEAM 3 AT BENT 5 HAS 1/16 INCH SECTION IN THE WEB FROM THE BEAM END OUT 10 INCHES X 12 INCHES HIGH WITH 9/16 INCH REMAINING, PAINTED OVER

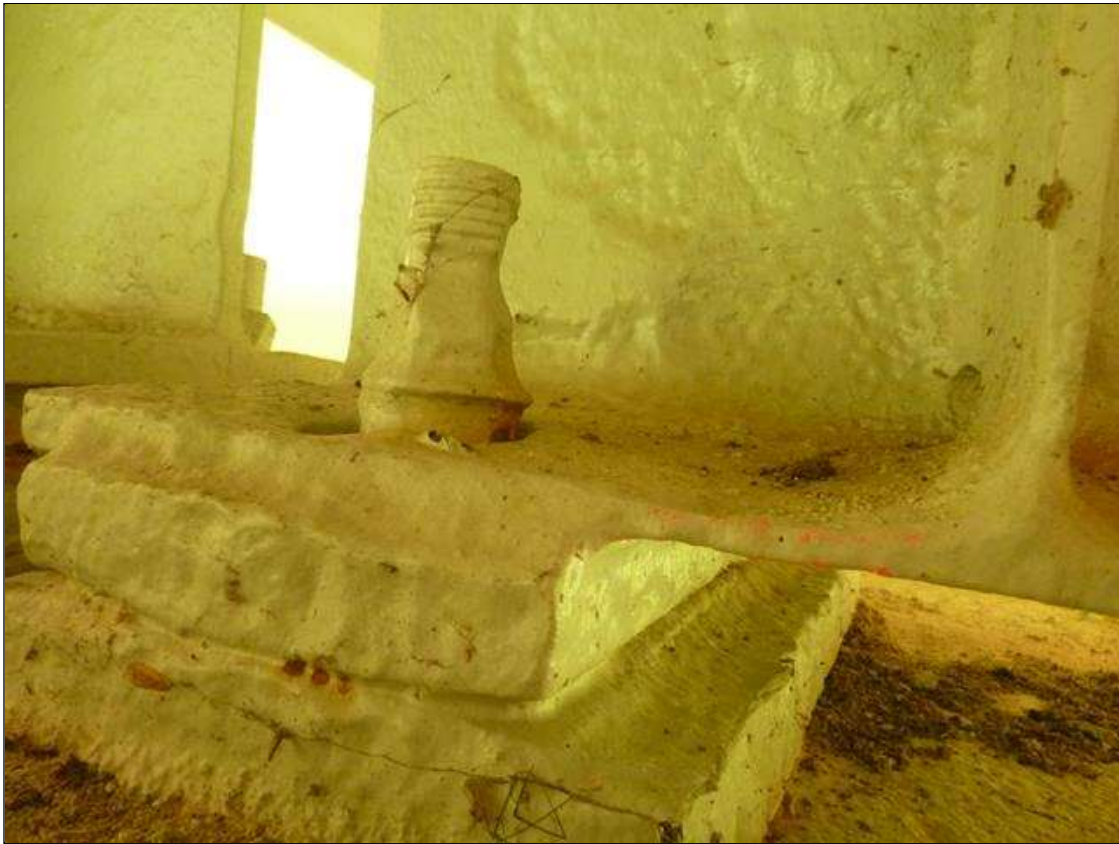
Bent 5 Cap 1: BENT 5 CAP, SPAN 6 SIDE HAS AN AREA OF DELAMINATION IN THE FACE OF THE CAP, IN BAY 2 AT TOP EDGE, 52 INCHES LONG X 10 INCHES DOWN THE FACE OF THE CAP AND UP TO 12 INCHES ACROSS THE TOP, NEAR BEAM 2 WITH 1/16 INCH SEPARATION, BEAM 2 BEARING AREA IS SOUND

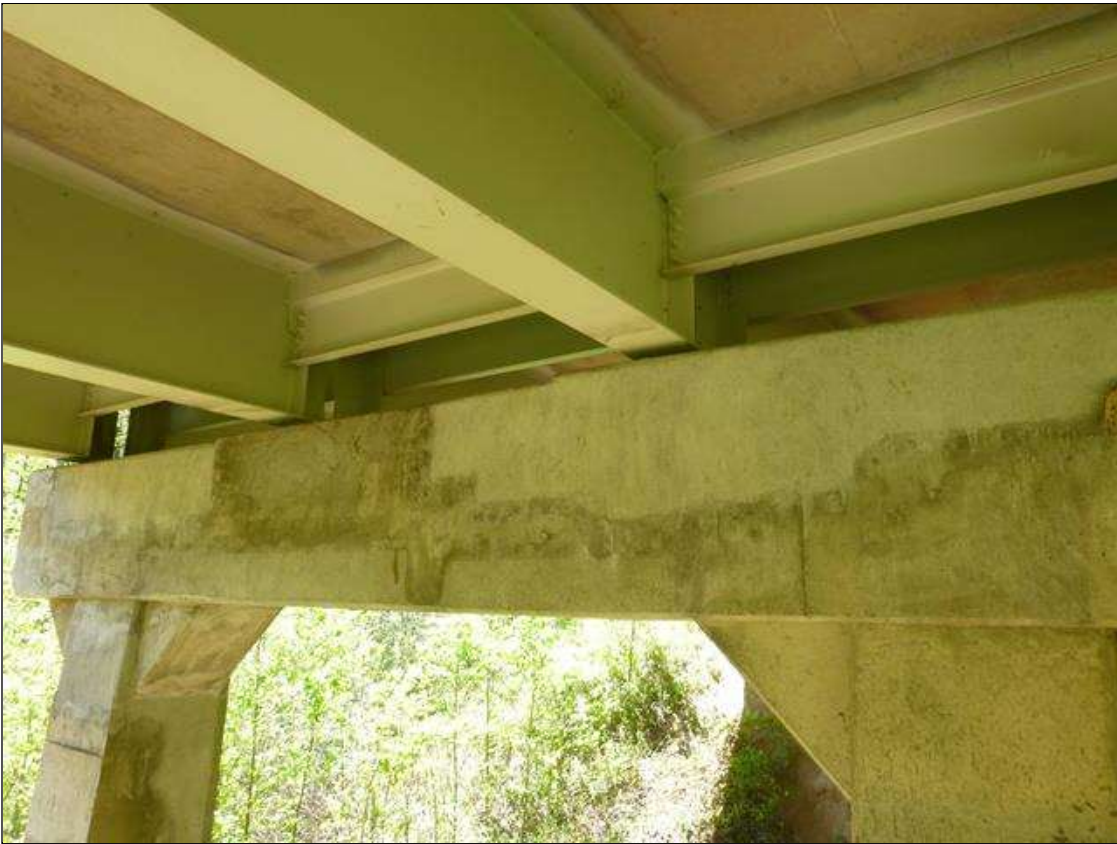
SPAN 5, BOTTOM OF LEFT OVERHANG, 5 FT. FROM BENT 5 HAS A 8 INCH DIAMETER X 2 INCH DEEP SPALL WITH REBAR EXPOSED, FOR A TOTAL OF 3 SQ. FT. OF SPALLS WITH REBAR EXPOSED IN THE LEFT OVERHANG

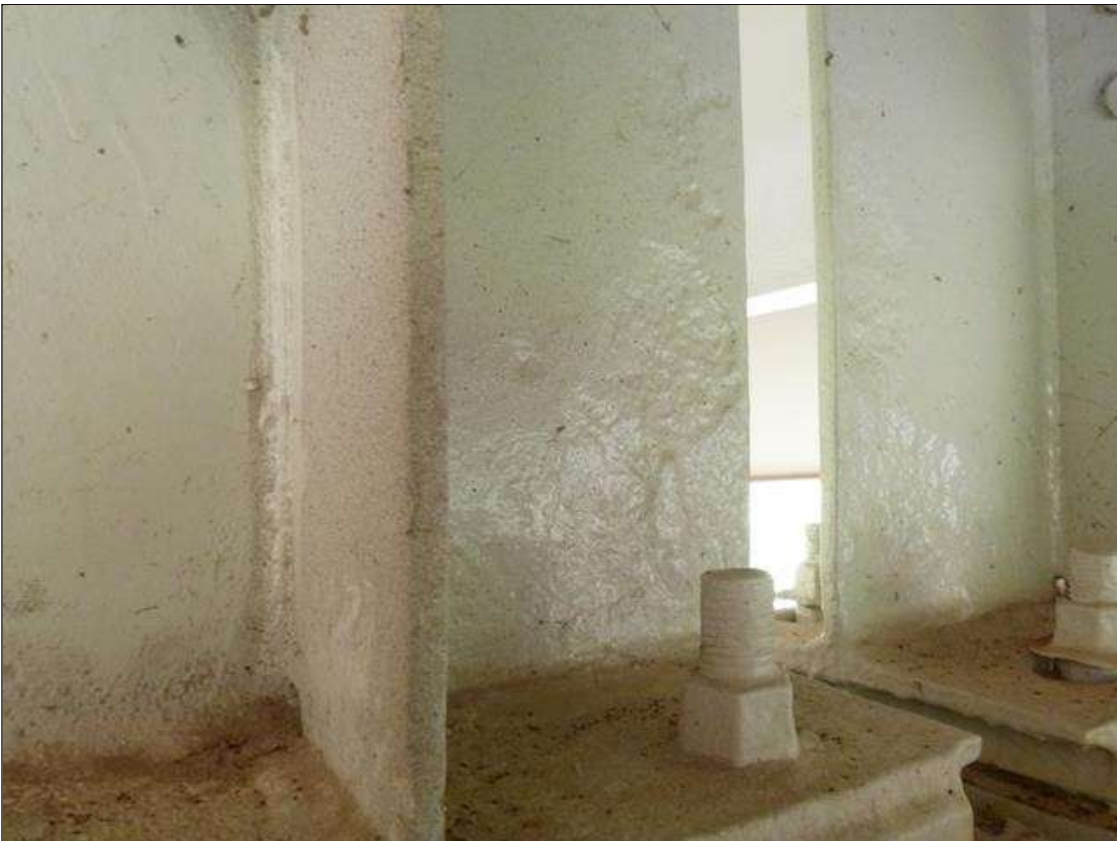
Bent 5 Cap 1: BENT 5 CAP, SPAN 5 SIDE HAS RANDOM PATCHED AREAS IN THE FACE OF THE CAP, PHOTO TAKEN AT LEFT SIDE

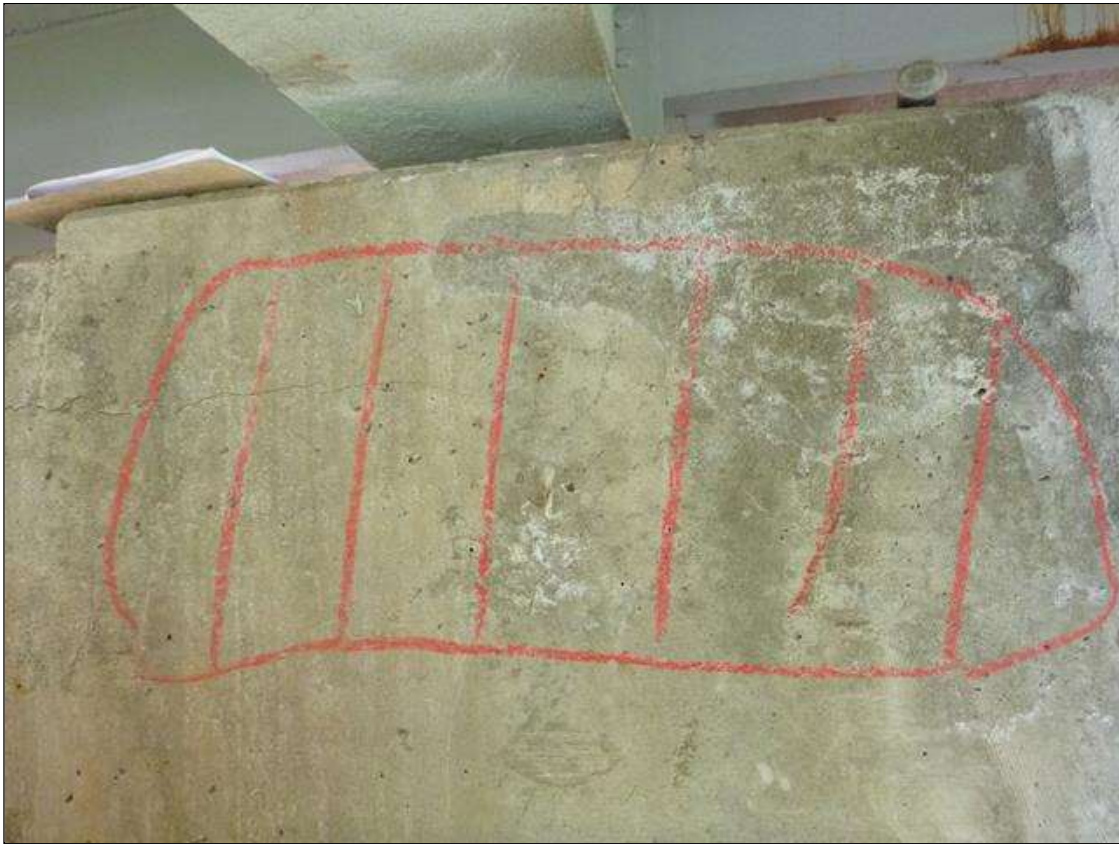
Span 5 Beam 4: SPAN 5, BEAM 4 AT BENT 5 HAS 1/16 INCH SECTION IN THE WEB FROM THE BEAM END OUT 10 INCHES X 12 INCHES HIGH WITH 9/16 INCH REMAINING, PAINTED OVER

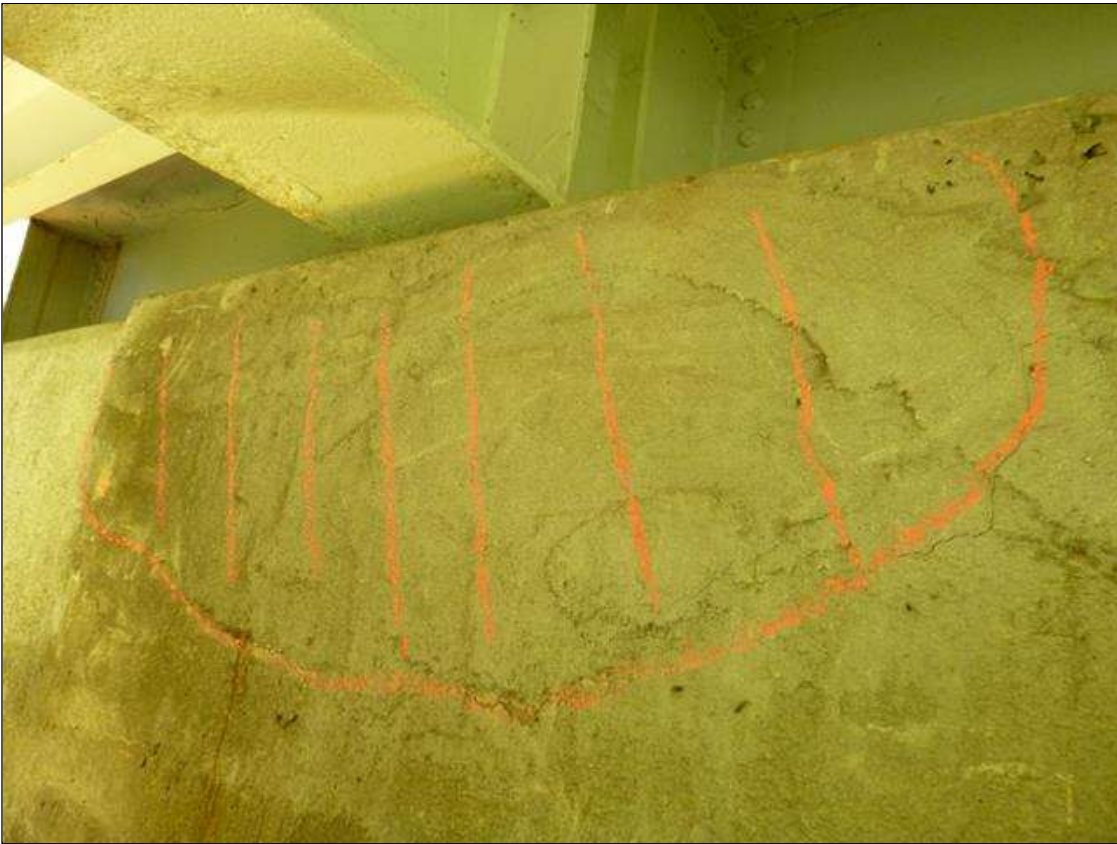
Span 5 Beam 2: SPAN 5, BEAM 2 AT BENT 5 HAS A 1 INCH DIAMETER HOLE RUSTED THRU THE WEB, 7.5 INCHES FROM THE END OF THE BEAM AND 1 INCH ABOVE THE BOTTOM FLANGE, THE BOTTOM FLANGE HAS 3/8 INCH SECTION LOSS FROM FACE OF BEARING OUT 2 INCHES X FULL WIDTH WITH 1/4 INCH REMAINING, PREVIOUS SECTION LOSS TO BEAM HAS BEEN PAINTED OVER

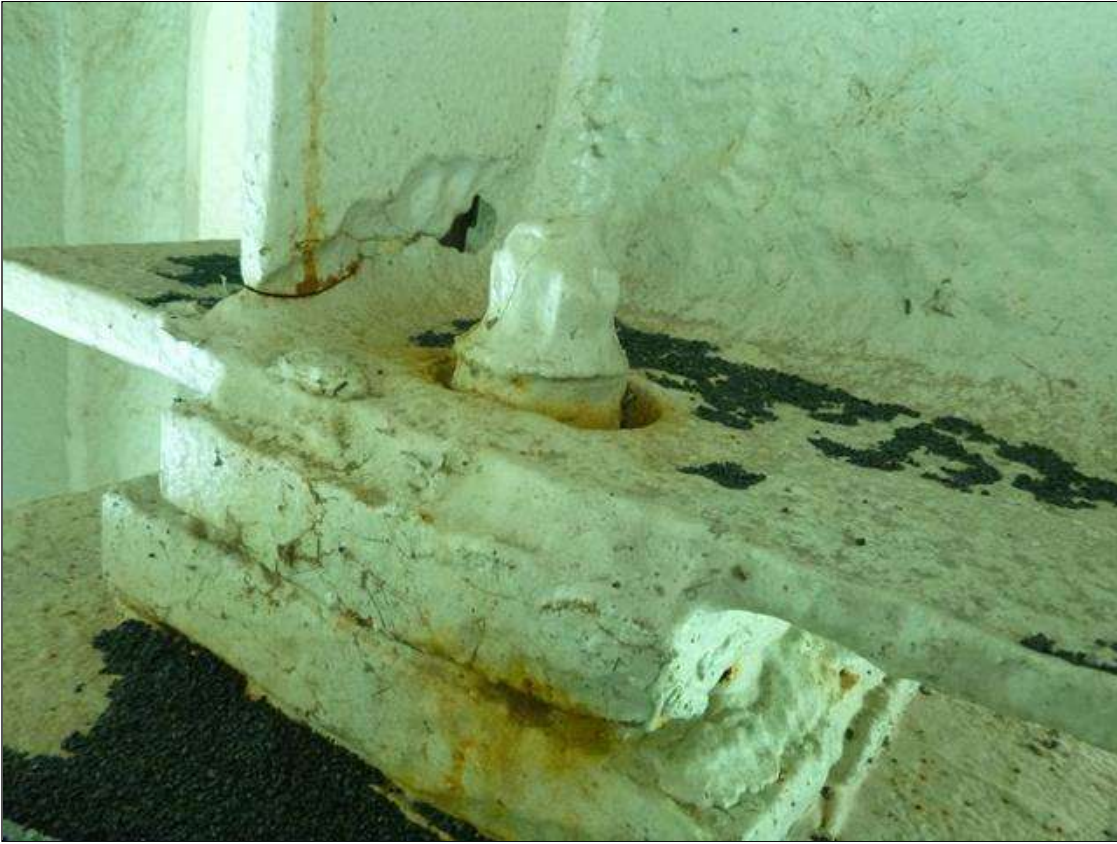
Bent 4 Cap 1: BENT 4 CAP, SPAN 5 SIDE HAS AN AREA OF DELAMINATED PATCHED AREA IN THE FACE OF THE CAP, 6 FT. UNDER BEAM 2, 10 INCHES X 12 INCHES

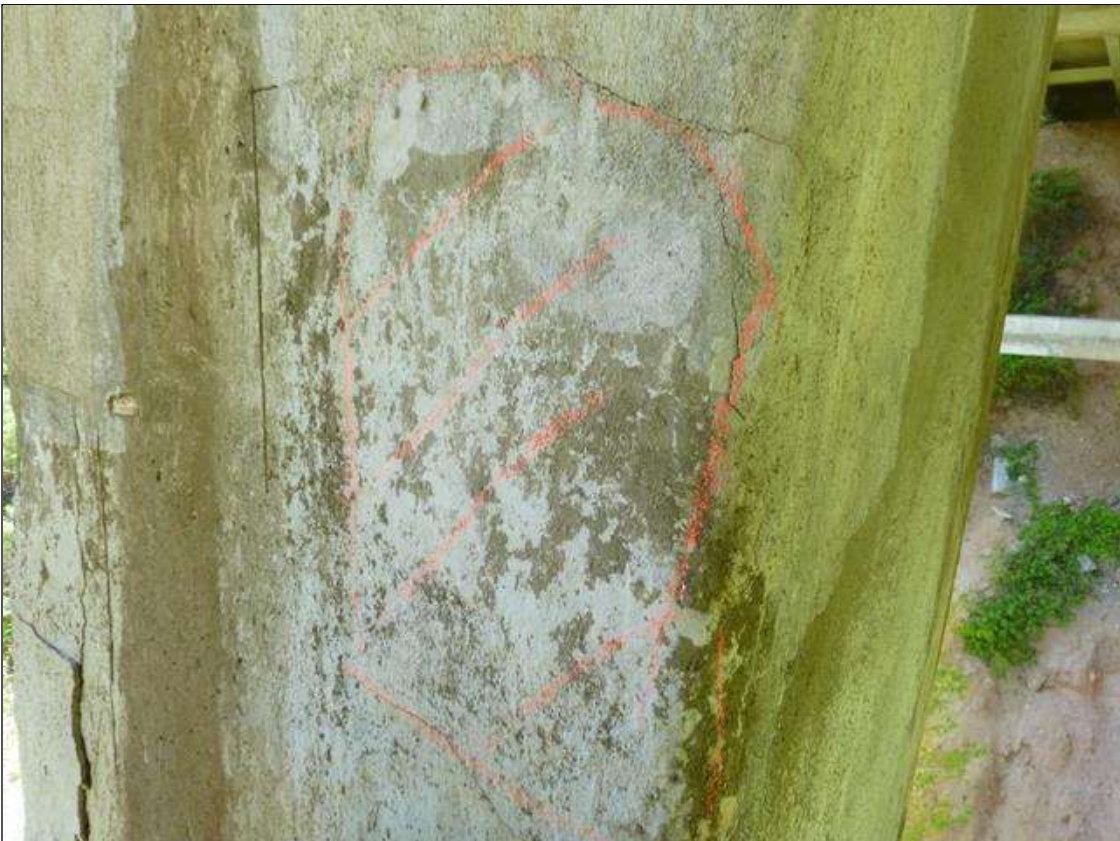
Bent 4 Pile 1: BENT 4, PILE 1 HAS A DELAMINATED PATCHED AREA ON THE NORTHWEST CORNER, 24 INCHES X 60 INCHES, 9 FT. FROM THE BOTTOM OF THE CAP WITH 1/2 INCH SEPARATION

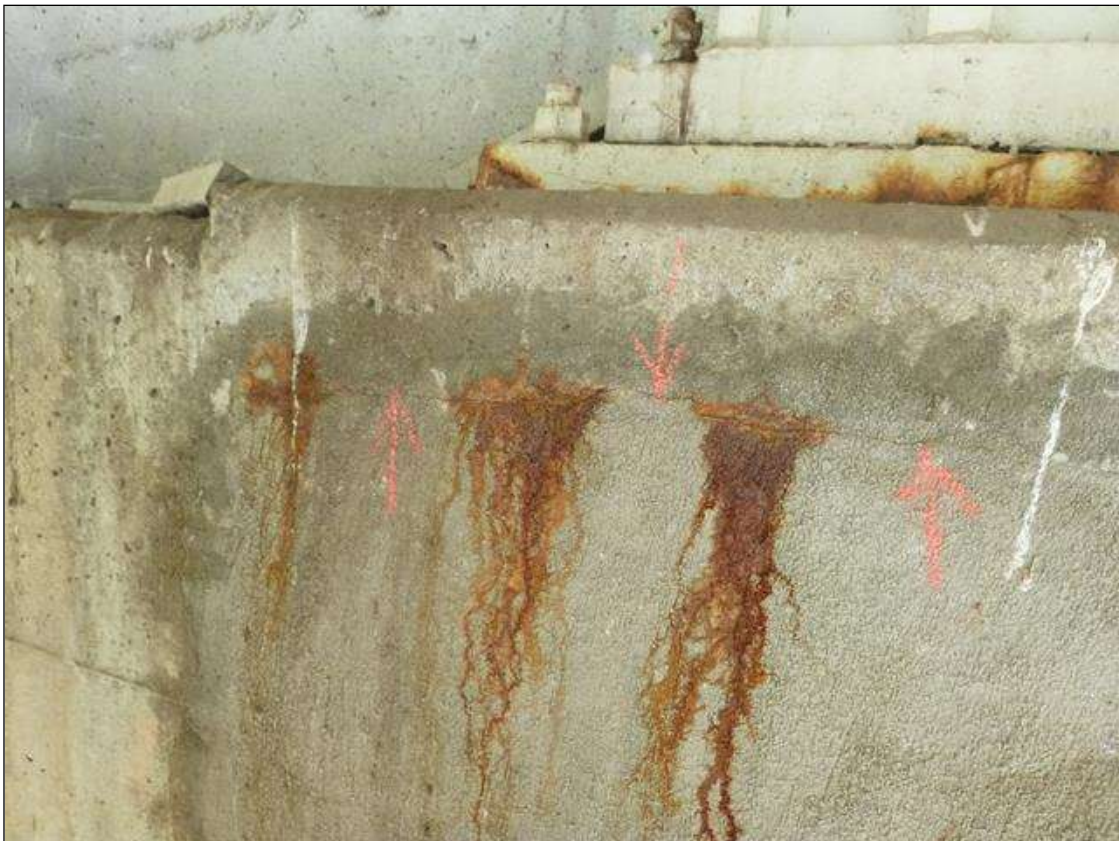
Span 2 Beam 4 Far Bearing: SPAN 2, BEAM 4 FAR BEARING HAS FRECKLED RUST

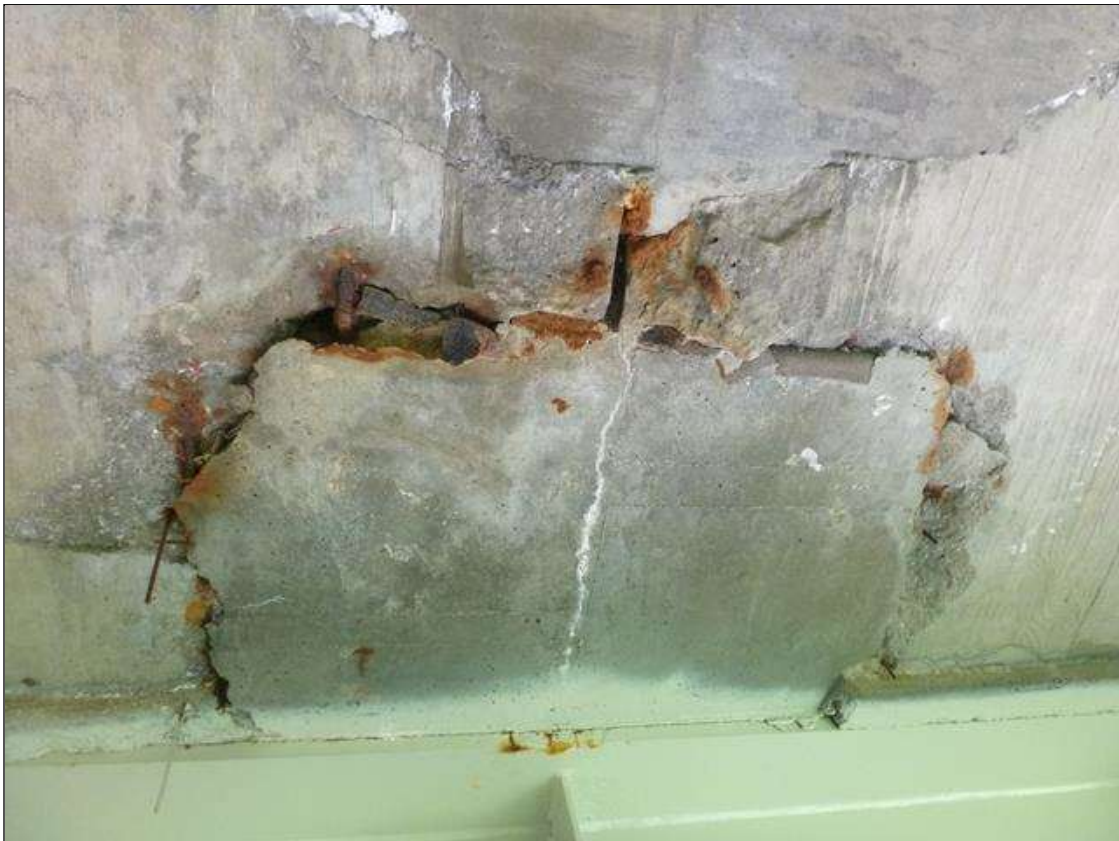
Span 4 Deck: SPAN 4, BAY 4, BOTTOM OF DECK HAS A PATCHED AREA THAT HAS FAILED, 30 FT. FROM BENT 4, 15 INCHES IN DIAMETER X 4 INCHES DEEP WITH REBAR EXPOSED

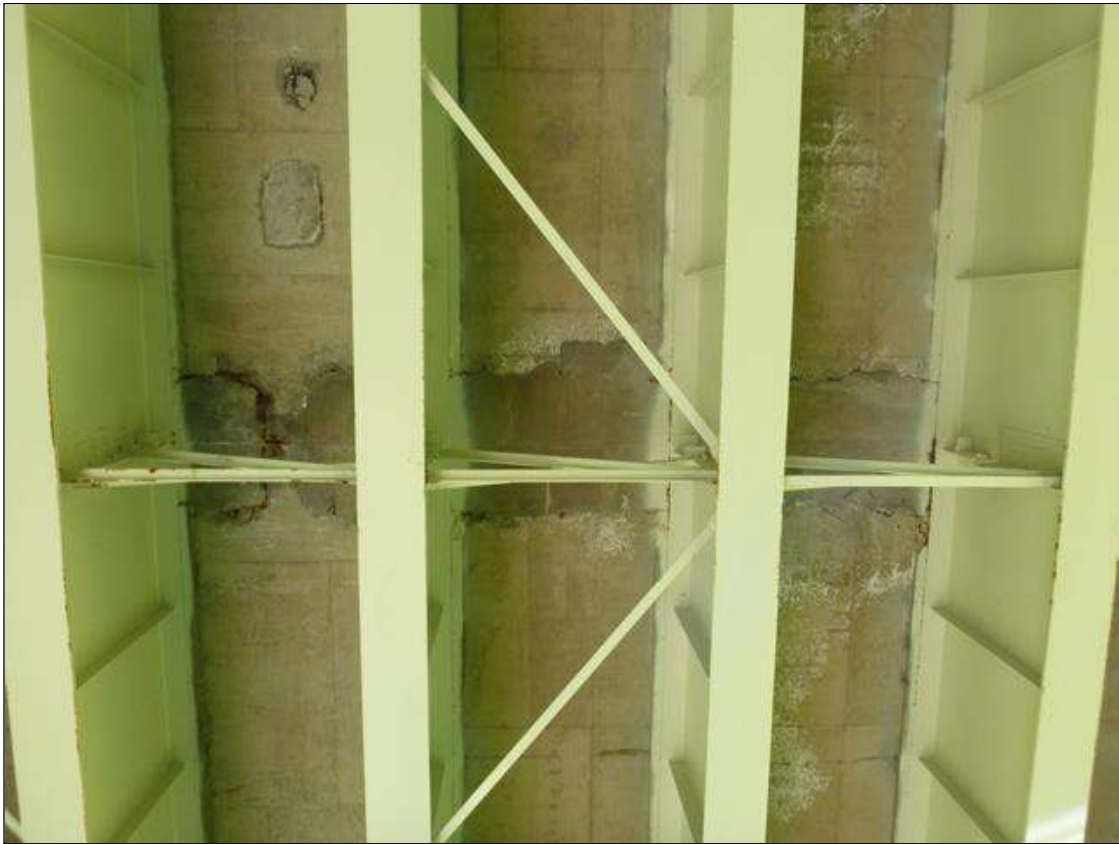
Span 4 Deck: SPAN 4, BAY 4, BOTTOM OF DECK, 40 FT. FROM BENT 4 HAS A UNSOUND PATCHED AREA WITH EXPOSED REBAR, 5 FT. X 3 FT.

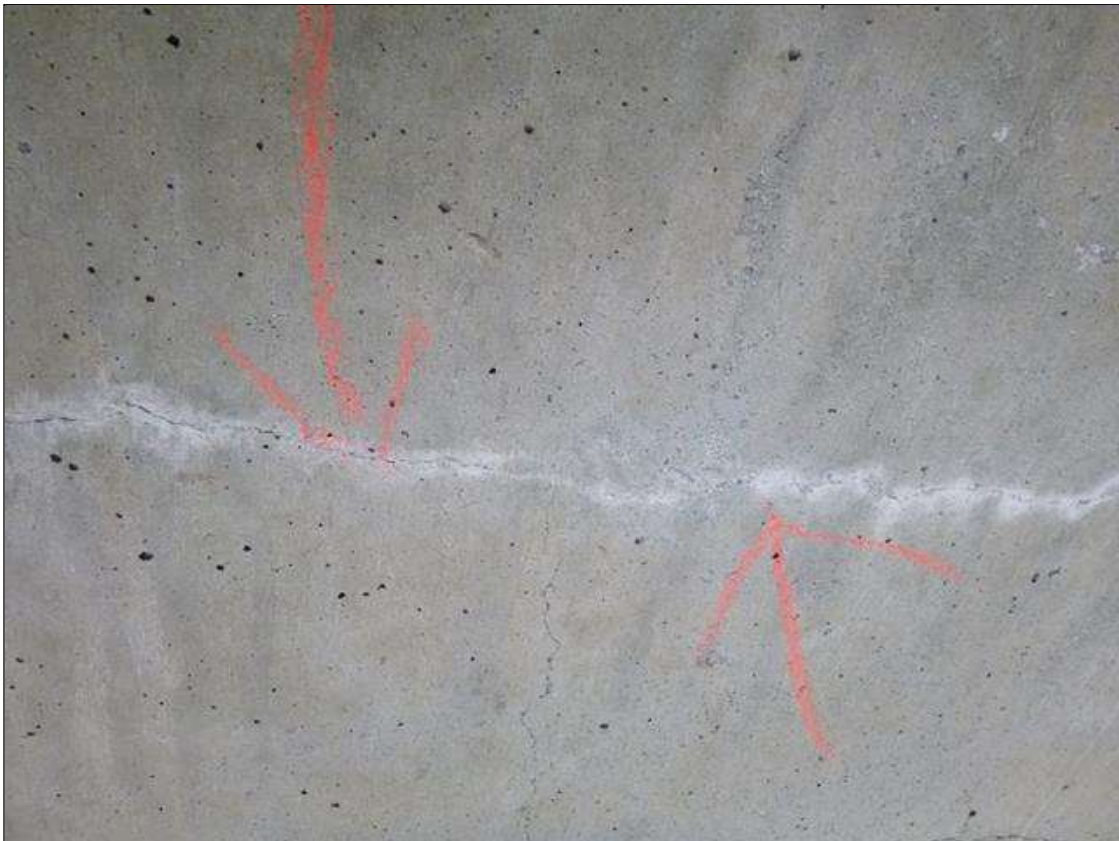
Span 4 Deck: SPAN 4, BOTTOM OF THE DECK HAS 5 FT. WIDE TRANSVERSE PATCHED AREAS IN ALL BAYS AT MID-SPAN

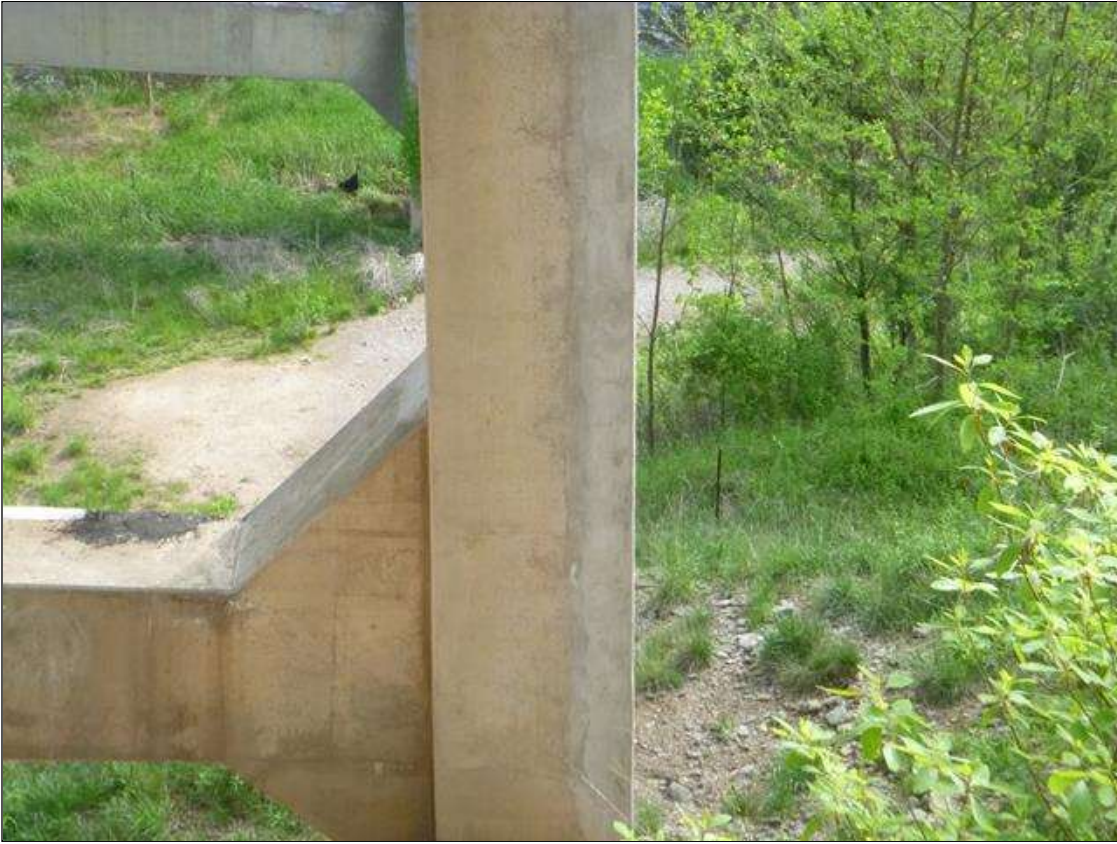
Bent 5 Pile 1: BENT 5, PILE 1 HAS A PATCH ON THE NORTHEAST CORNER, 2 FT. WIDE X 8 FT. HIGH, STARTING 1 FT. BELOW THE BOTTOM OF THE CAP

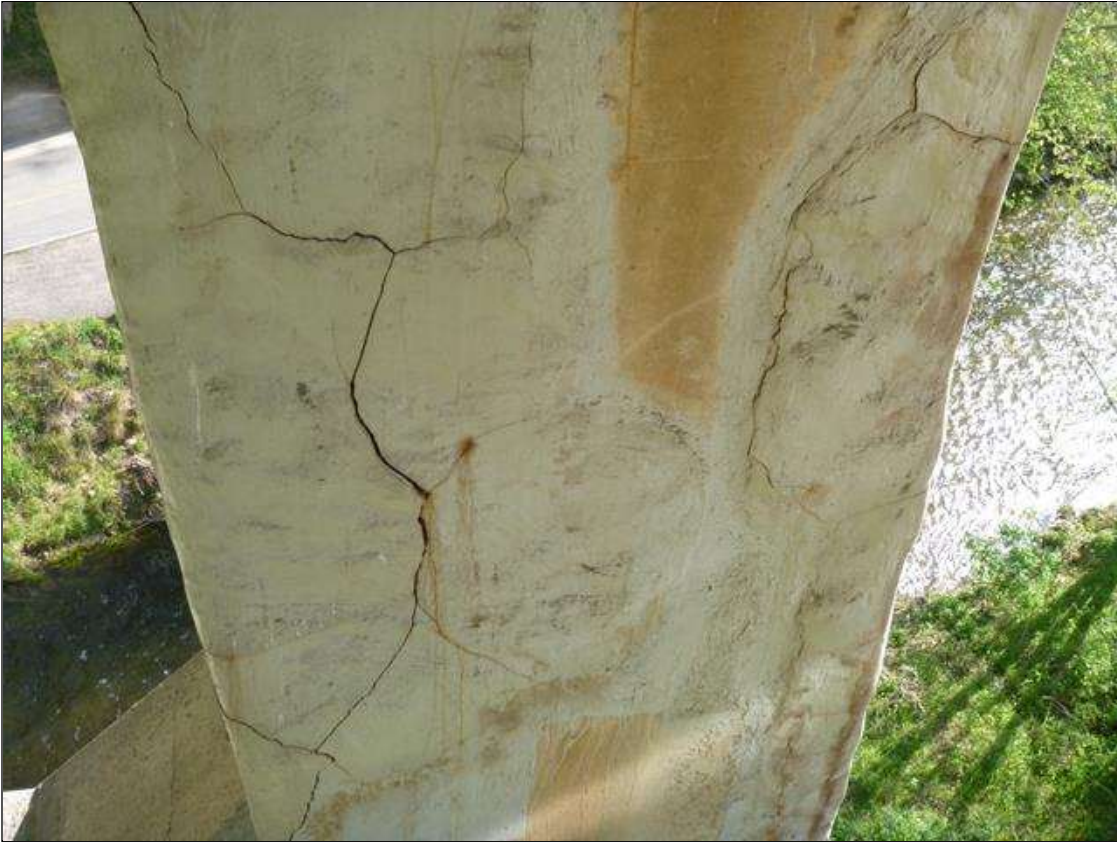
Span 2 Beam 2: SPAN 2, BEAM 1 HAS 100 FT. OF FRECKLED RUST ON THE EDGES OF THE FLANGES THRU OUT THE LENGTH OF THE BEAM

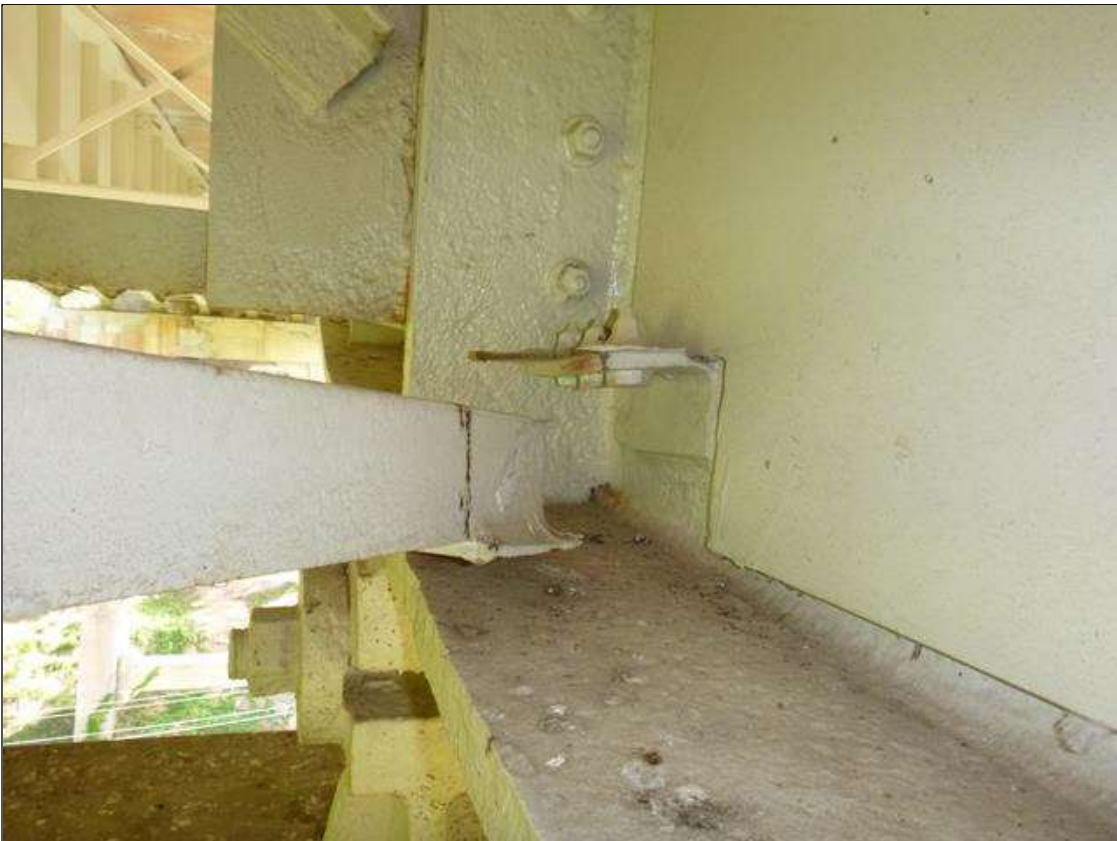
Bent 3 Pile 1: BENT 3, PILE 1 HAS AN UNSOUND PATCHED AREA ON THE EAST FACE, STARTING AT THE BOTTOM OF THE CAP, 35 FT. LONG WITH UP TO 1 INCH SEPARATION

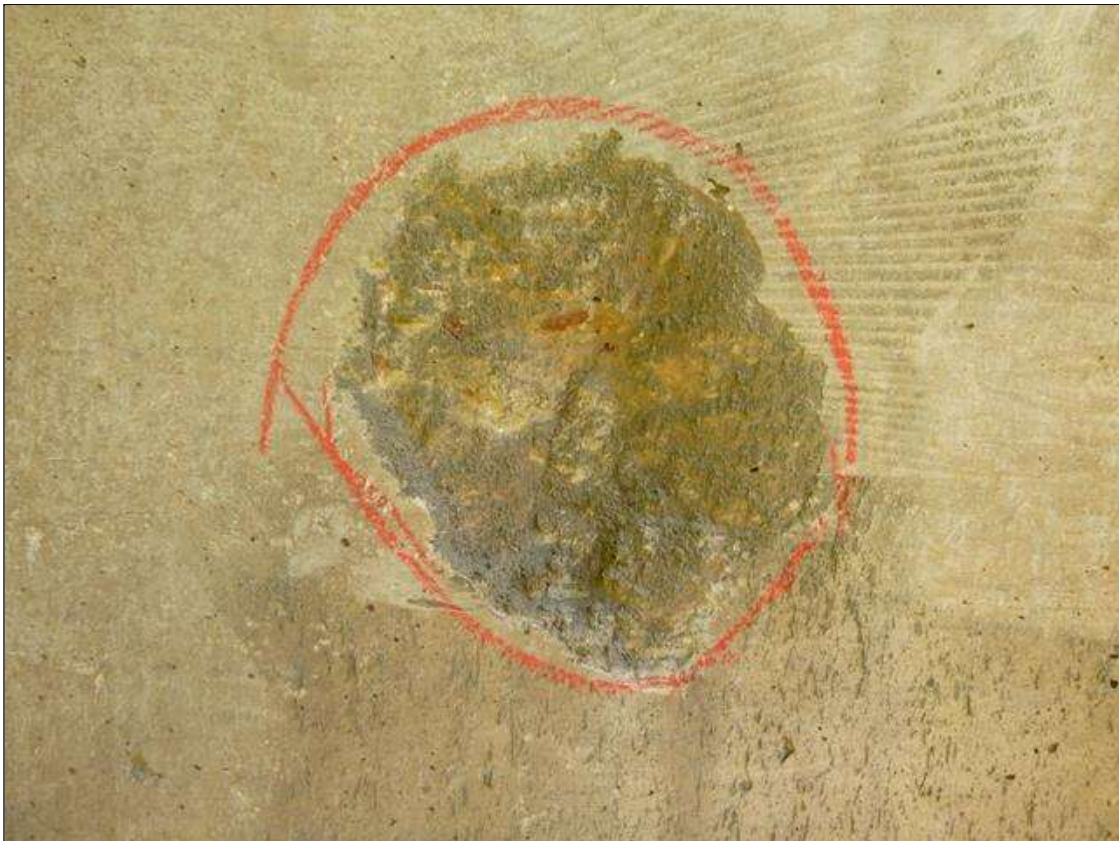
Bent 3 Cap 1: BENT 3 CAP, SPAN 4 SIDE HAS AN AREA OF DELAMINATION IN THE FACE OF THE CAP, IN BAY 1 AT BOTTOM EDGE, 7 FT. LONG X 5 INCHES WIDE WITH 1/8 INCH SEPARATION

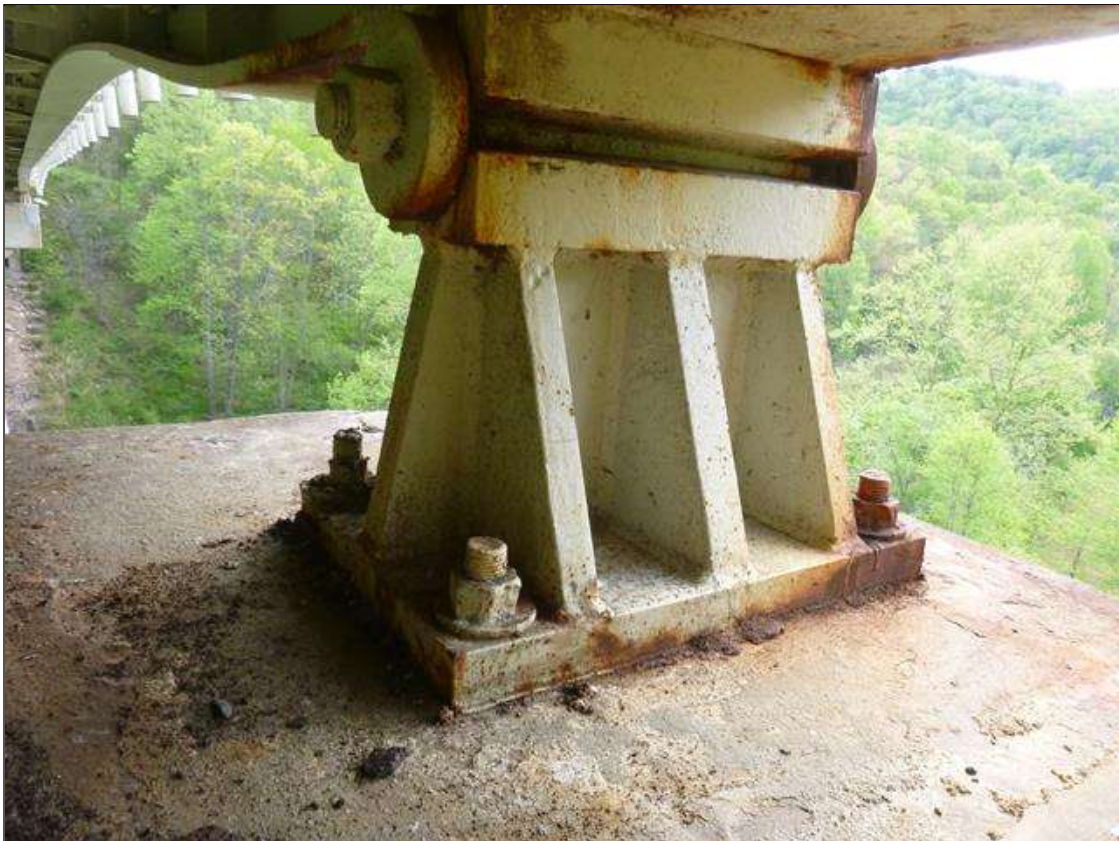
Bent 3 Cap 1: BENT 3 CAP, SPAN 4 SIDE HAS AN AREA OF DELAMINATION IN THE FACE OF THE CAP, UNDER BEAM 1, NEAR BOTTOM EDGE, 20 INCHES IN DIAMETER WITH 1/2 INCH DEEP SPALLING

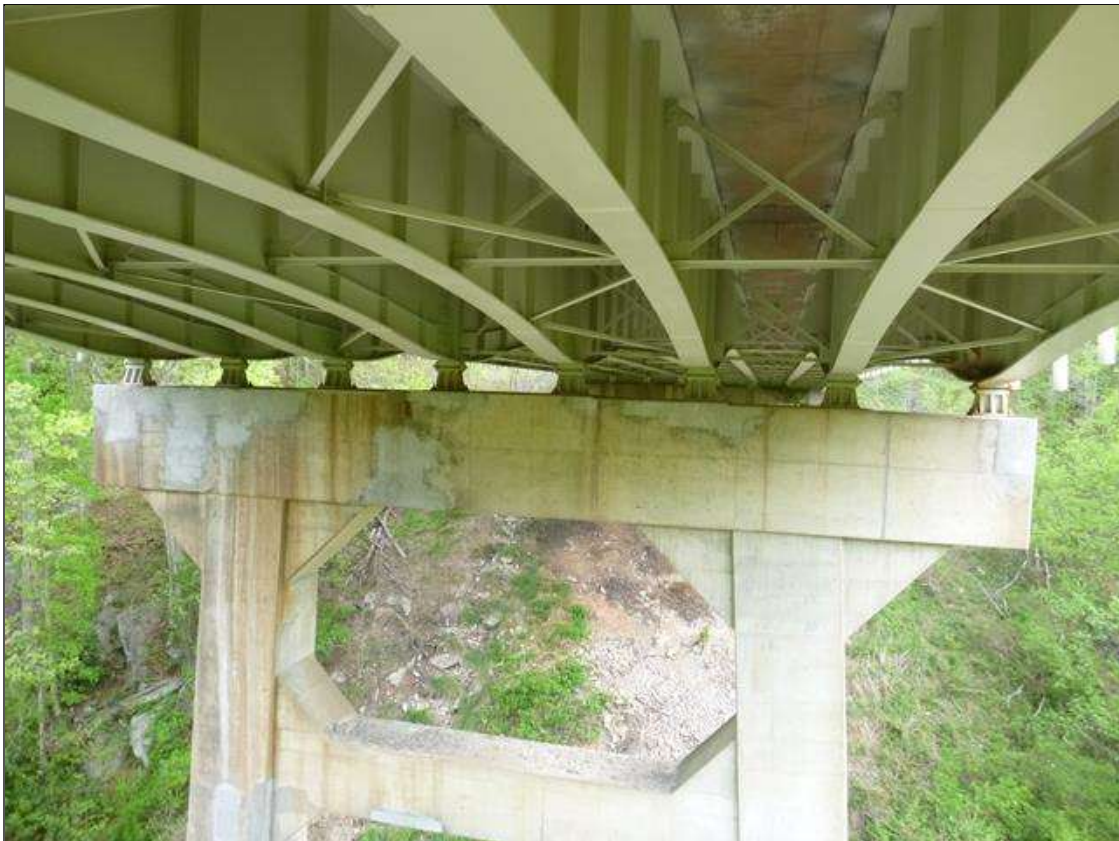
Span 4 Deck: SPAN 4, BOTTOM OF LEFT OVERHANG AT BENT 3 HAS A SPALL, 14 INCHES X 14 INCHES X 4 INCHES DEEP WITH EXPOSED REBAR

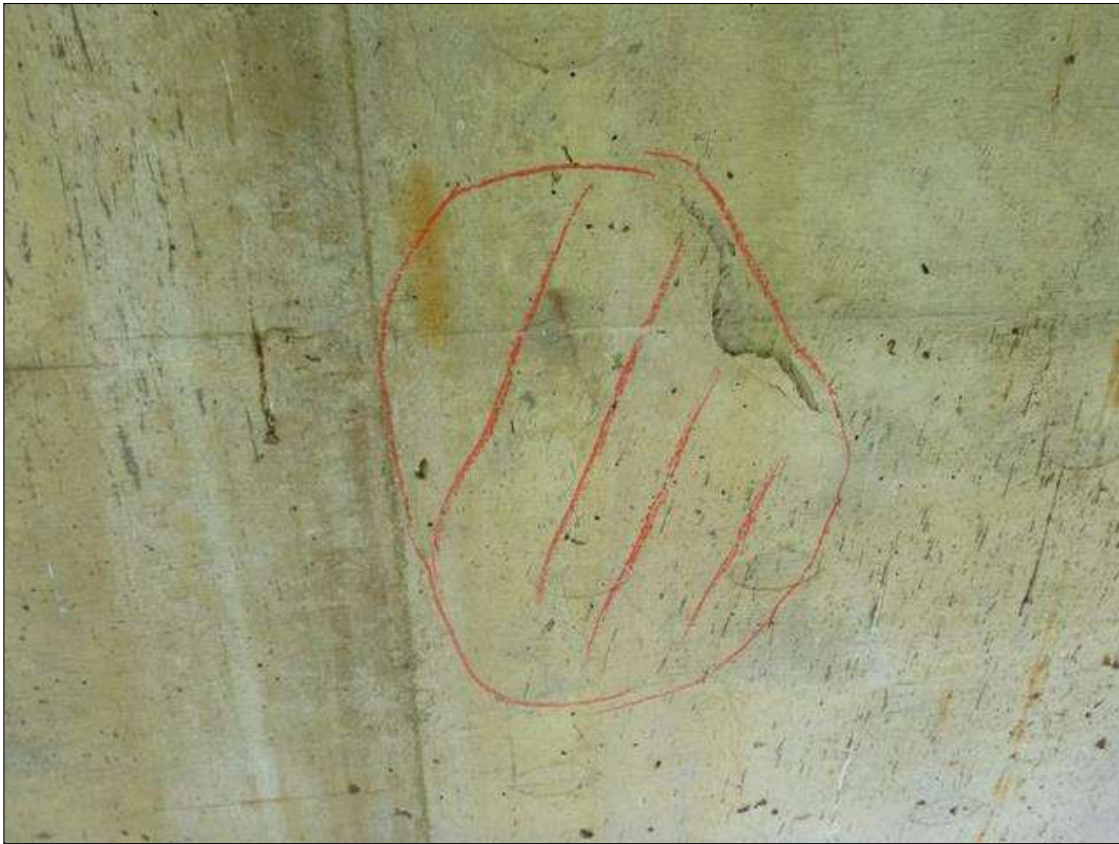
Bent 2 Cap 1: BENT 2 CAP, SPAN 3 SIDE HAS 30 FT. OF PATCHES IN THE FACE OF THE CAP THAT ARE SOUND

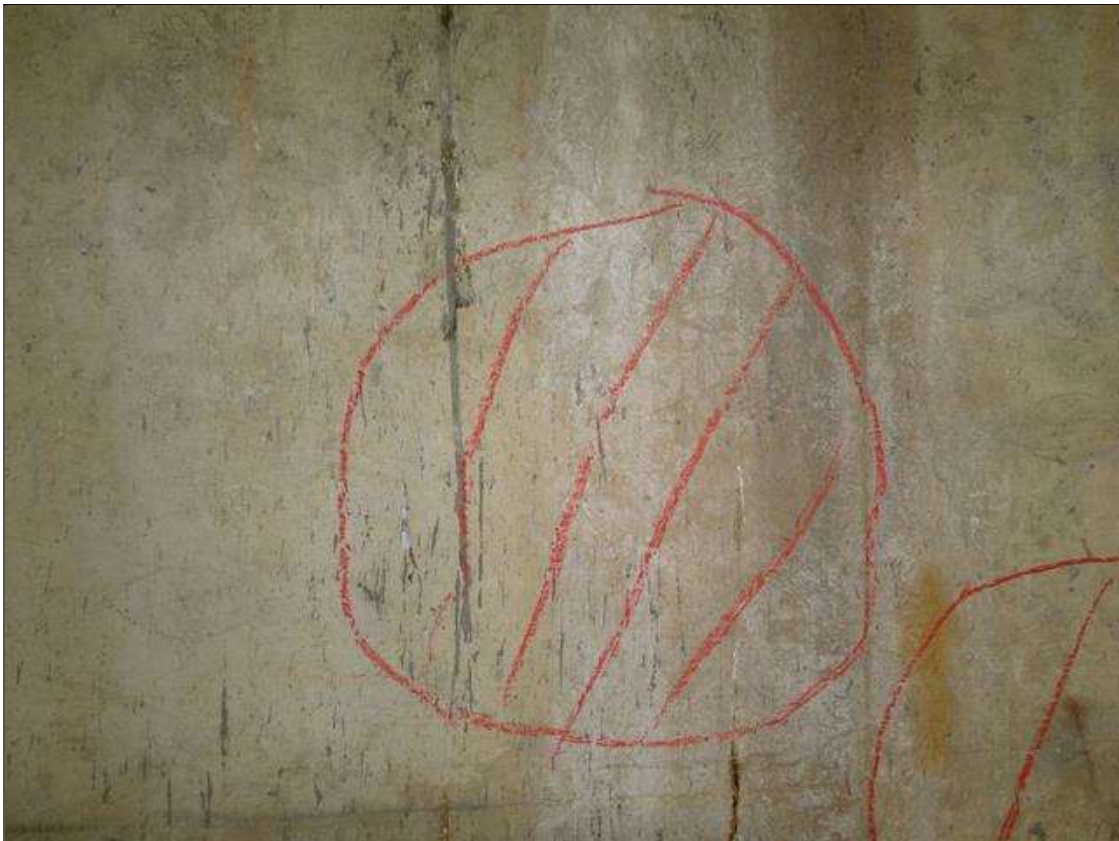
Bent 2 Cap 1: BENT 2 CAP, SPAN 3 SIDE HAS AN AREA OF DELAMINATION IN THE FACE OF THE CAP IN BAY 3, 18 INCHES X 24 INCHES WITH 1/8 INCH SEPARATION

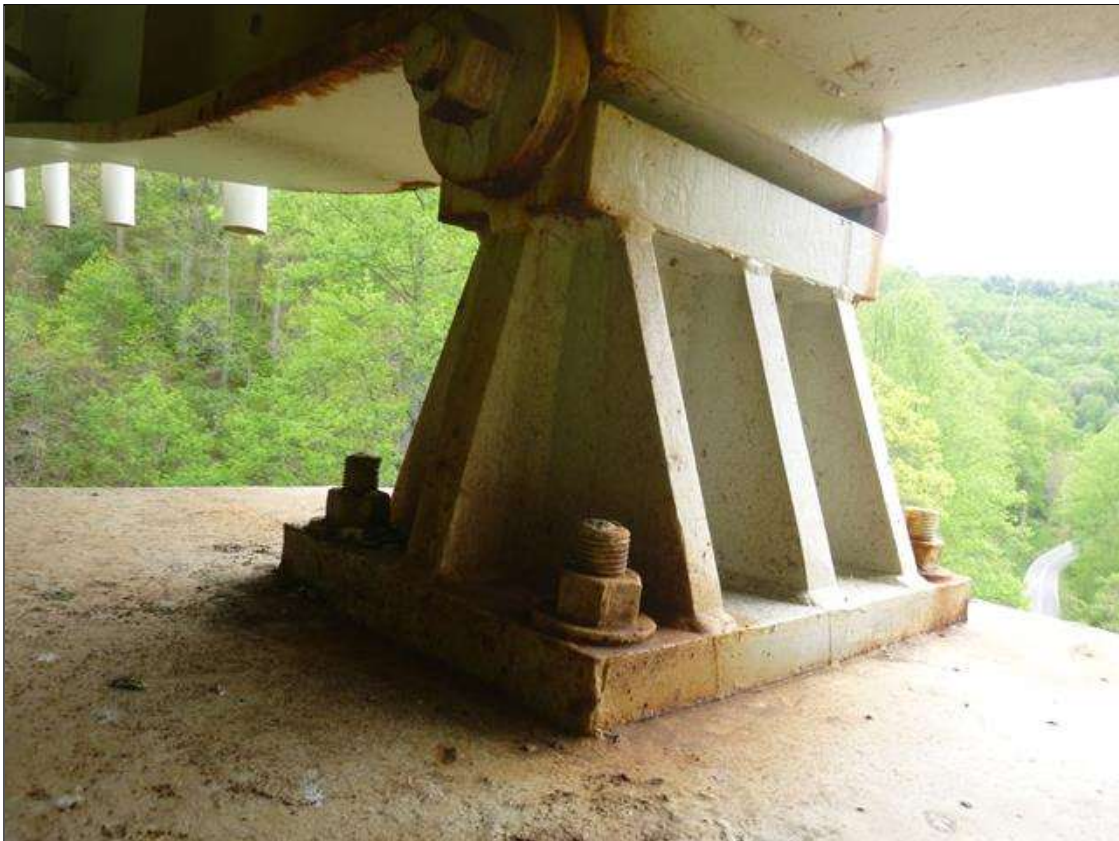
Bent 2 Cap 1: BENT 2 CAP, SPAN 3 SIDE HAS A HAIRLINE VERTICAL CRACK UNDER BEAM 2 IN THE FACE OF THE CAP, 4 FT. LONG

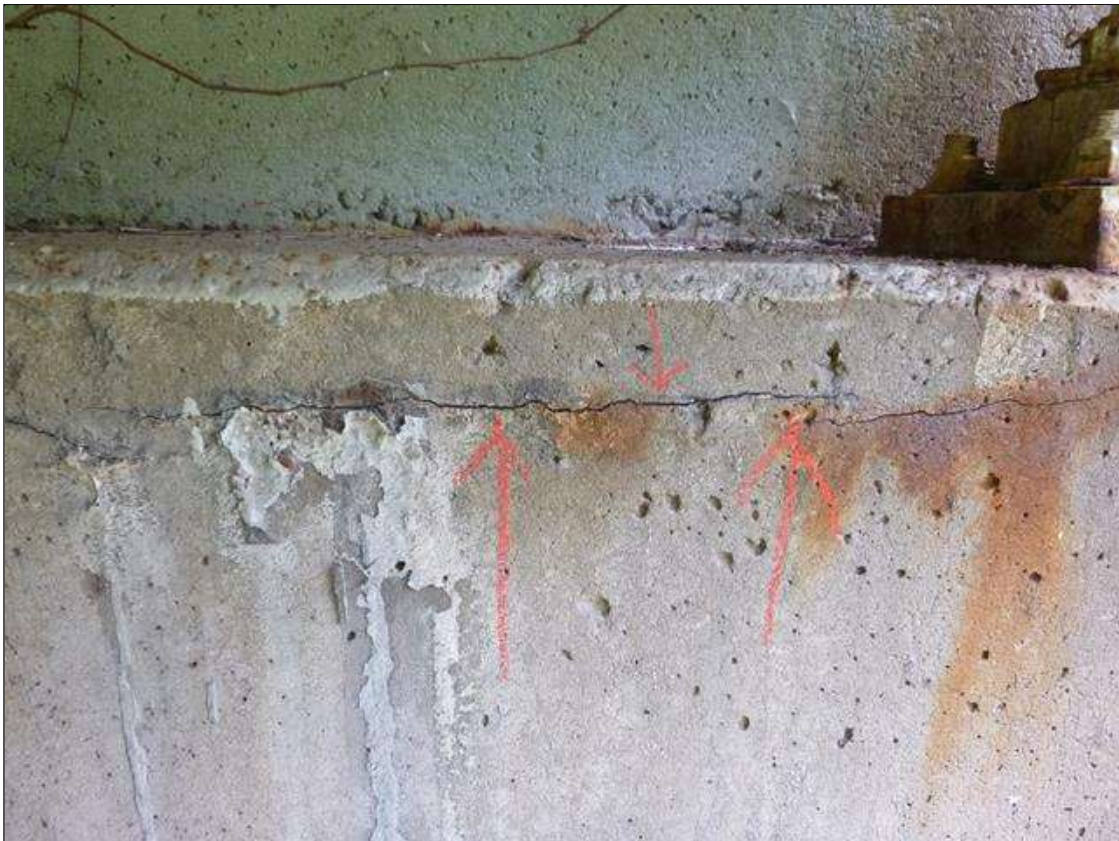
Bent 1 Cap 1: BENT 1 CAP, SPAN 2 SIDE HAS A SPALL IN THE FACE OF THE CAP UNDER BEAM 3, 7 INCHES IN DIAMETER X 3/4 INCH DEEP WITH REBAR EXPOSED
