NC DEPARTMENT OF TRANSPORTATION  
DIVISION OF HIGHWAYS  
STRUCTURE MANAGEMENT UNIT

## Structure Safety Report

### Routine Element Inspection - Contract

COUNTY: HAYWOOD STRUCTURE NUMBER: 430171 FREQUENCY: 24 MONTHS

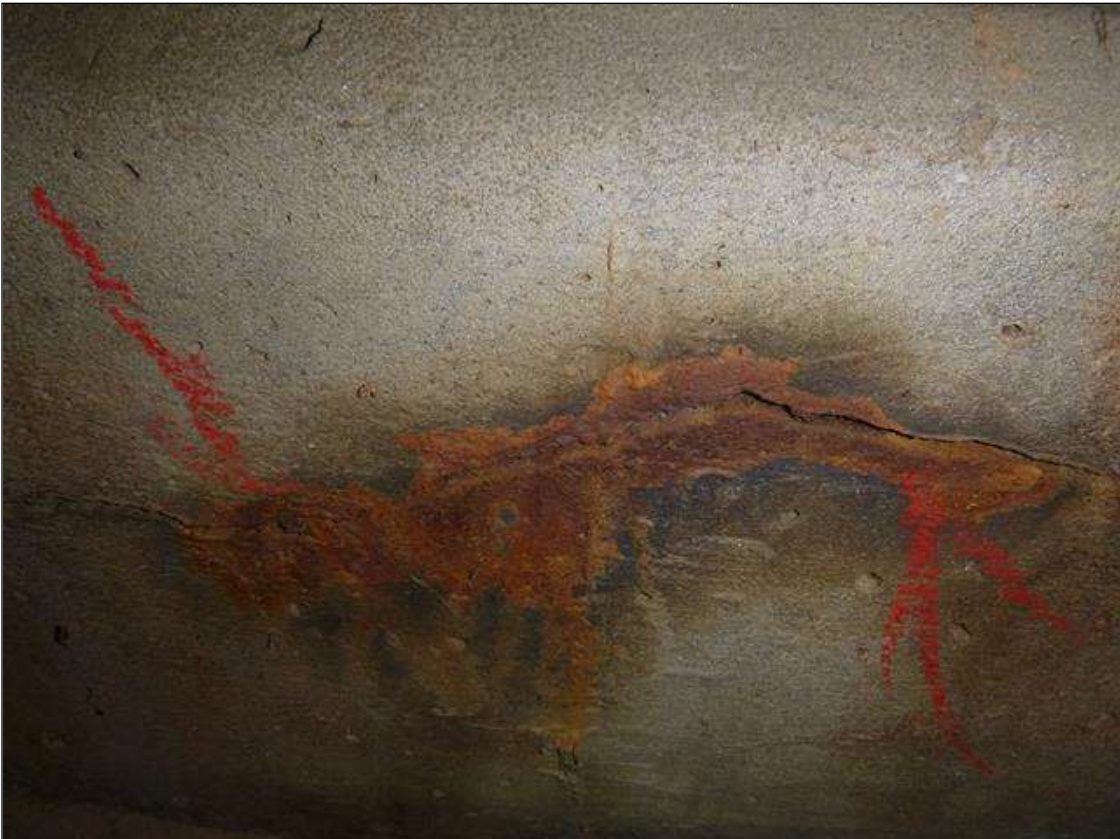
End Bent 1 Cap 1: END BENT 1, FACE OF CAP HAS A SPALL IN BAY 1, 8 INCHES IN DIAMETER X 1 INCH DEEP

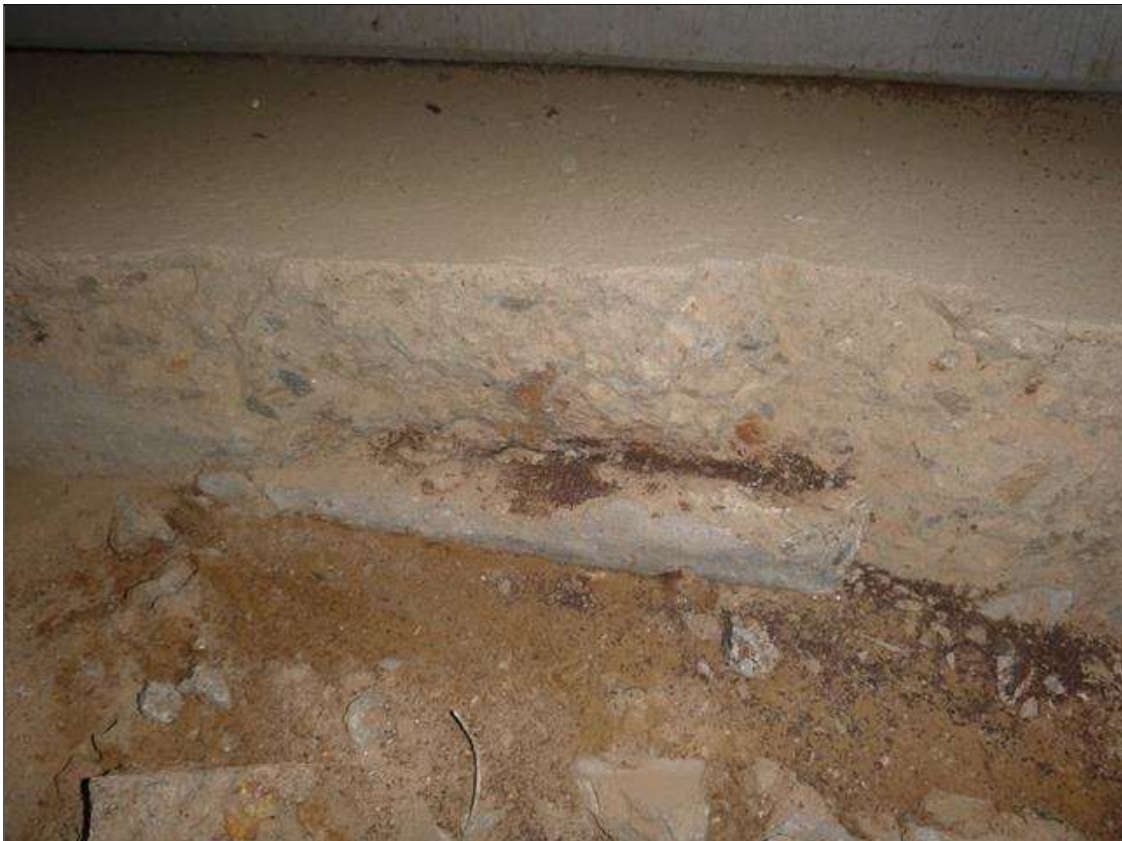
End Bent 1 Cap 1: END BENT 1, FACE OF CAP HAS A SPALL IN BAY 2, 6 FT. LONG X 11 INCHES WIDE X 3 INCHES DEEP WITH EXPOSED REBAR

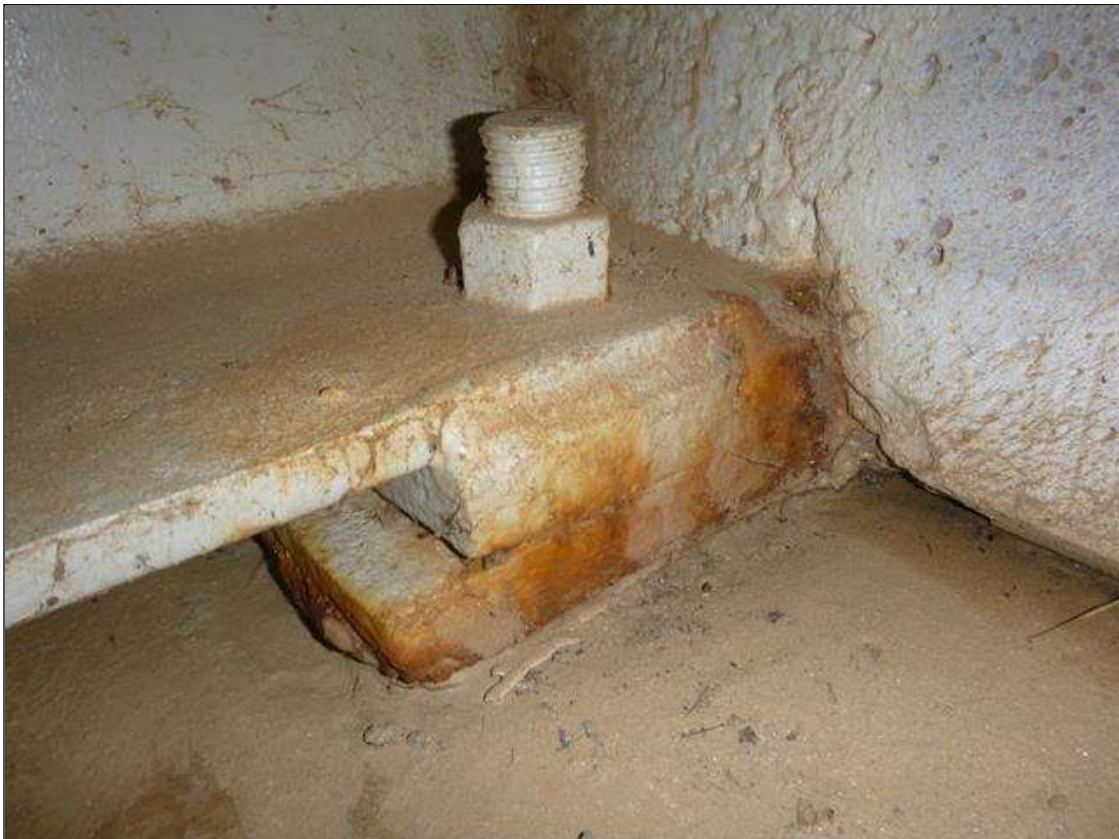
End Bent 1 Abutment/Backwall : END BENT 1 ABUTMENT HAS A 1/16 INCH WIDE X 3 FT. LONG DIAGONAL CRACK IN BAY 7

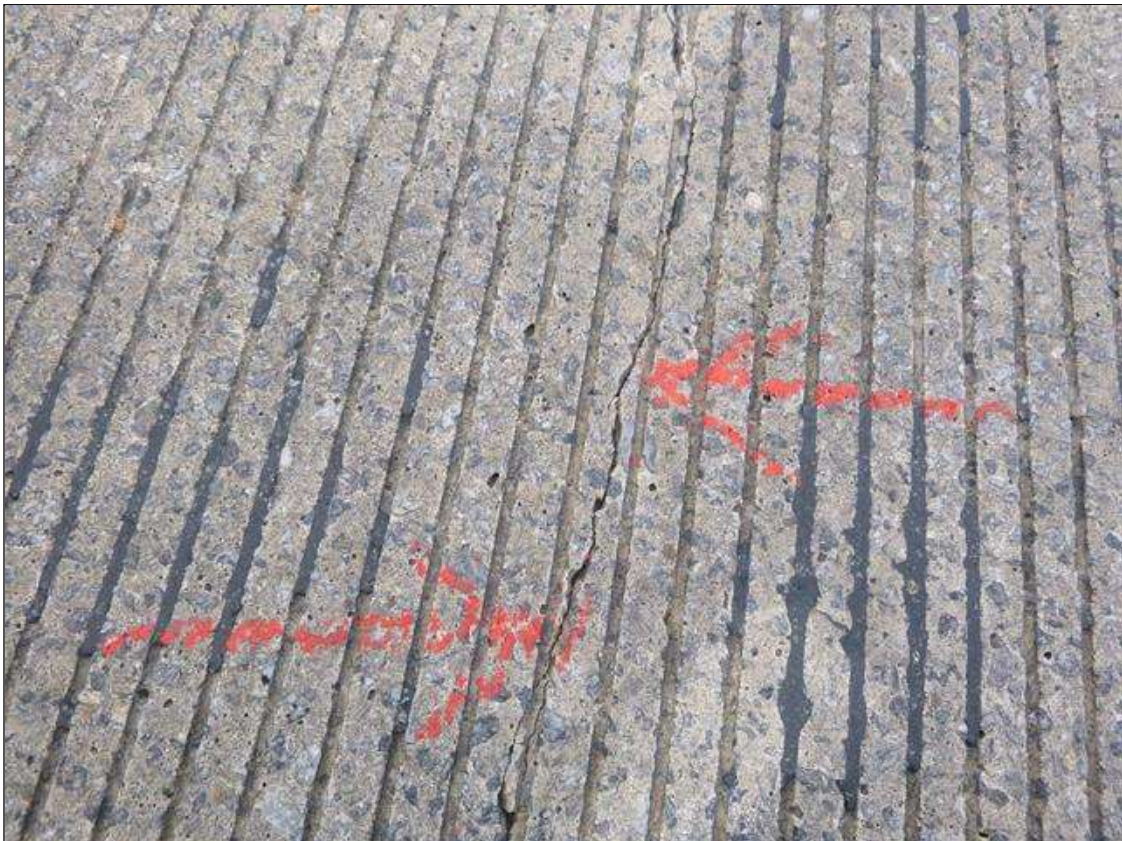
Span 5 Deck: SPAN 5 TOP OF THE DECK HAS A 1/16 INCH WIDE DIAGONAL CRACK, 10 FT. LONG, STARTING AT BENT 4, FOR A TOTAL OF 100 FT. OF CRACKING THRU OUT THE WEST AND EAST BOUND LANES

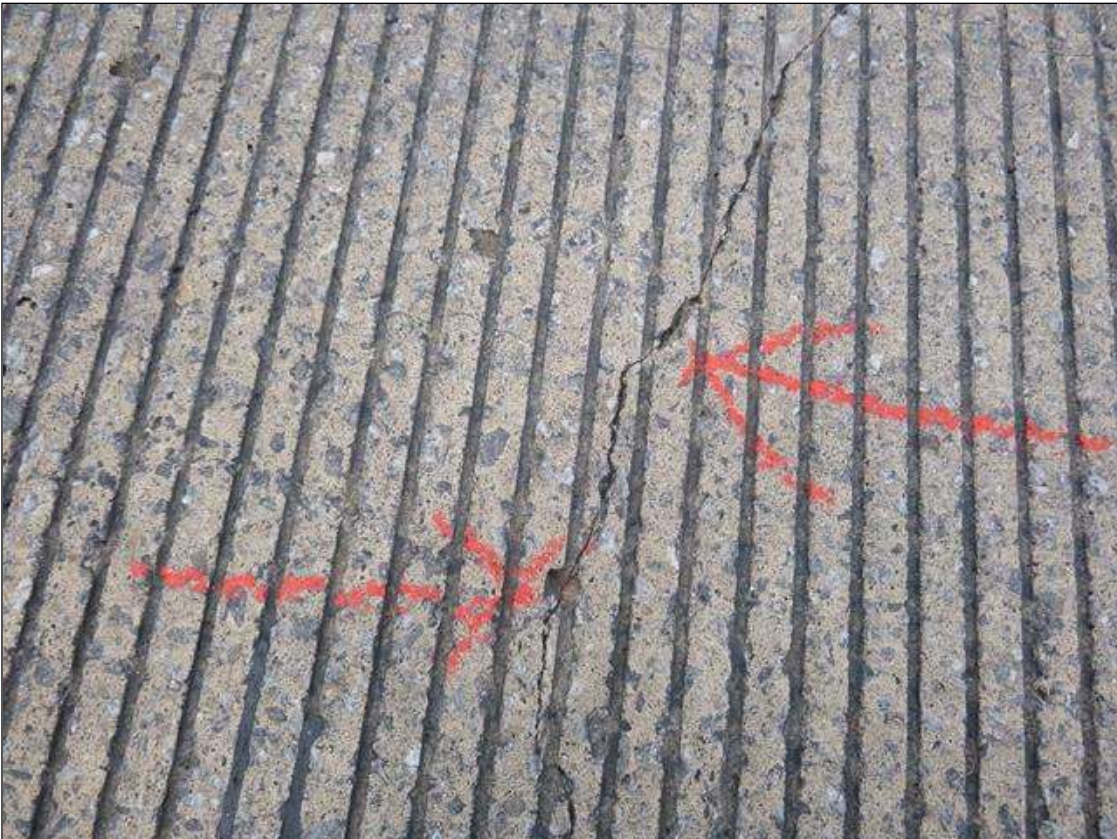
Span 6 Left Bridge Rail: SPAN 6, LEFT BRIDGE RAIL HAS 12 FT. 0F 2 INCH WIDE TEARS THRU OUT THE SPAN

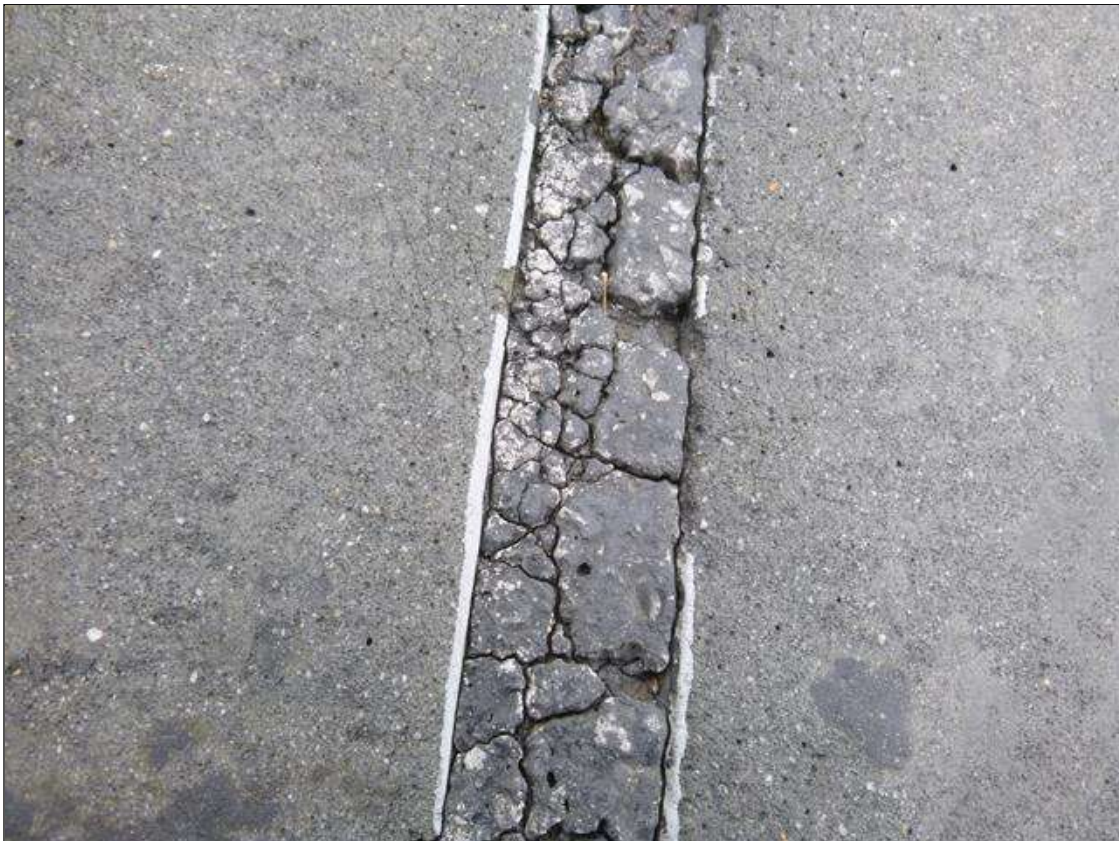
Span 6 Deck: SPAN 6, TOP OF THE DECK HAS 1/16 INCH WIDE X 12 FT. LONG DIAGONAL CRACK AT END BENT 2, FOR A TOTAL OF 150 SQ. FT. THRU OUT THE WEST AND EAST BOUND LANES

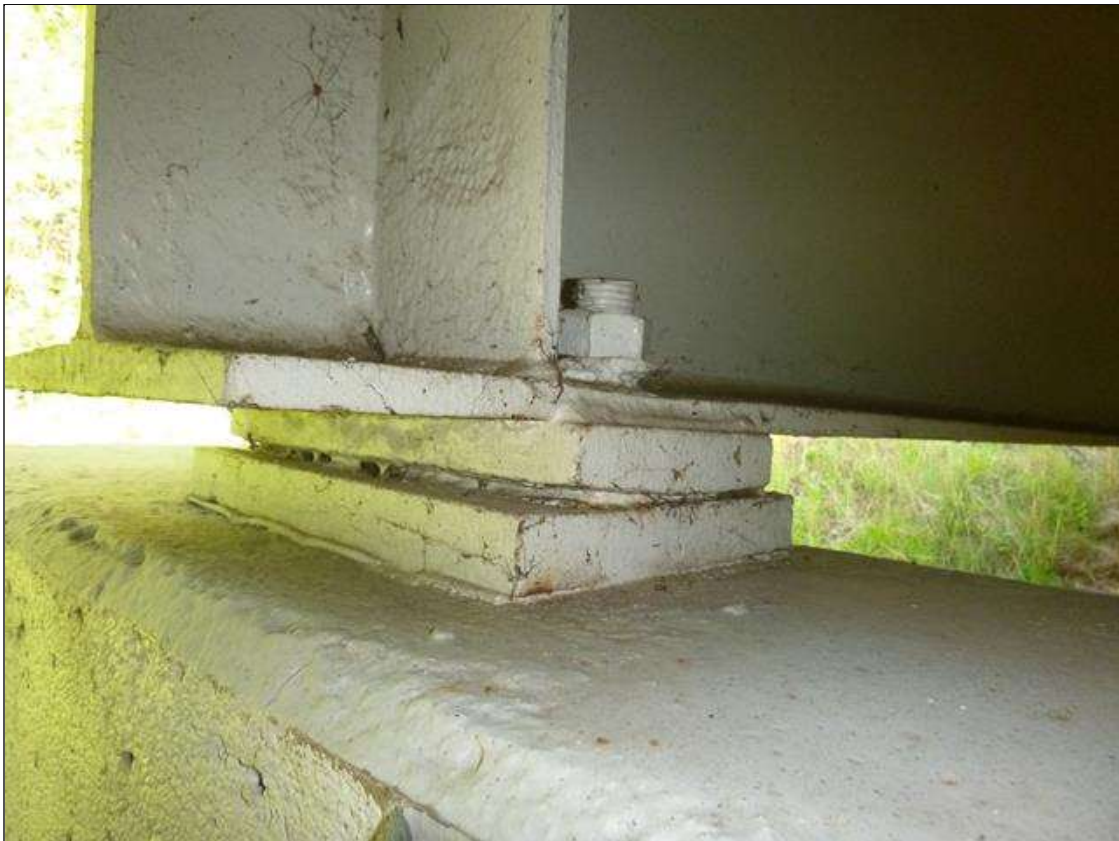
END BENT 2 ASPHALT WEARING SURFACE APPROACH HAS A 8 INCH X 5 INCH X 2` INCH DEEP VOID AT CENTERLINE OF ROADWAY AT END BENT 2 JOINT, WEST BOUND LANES

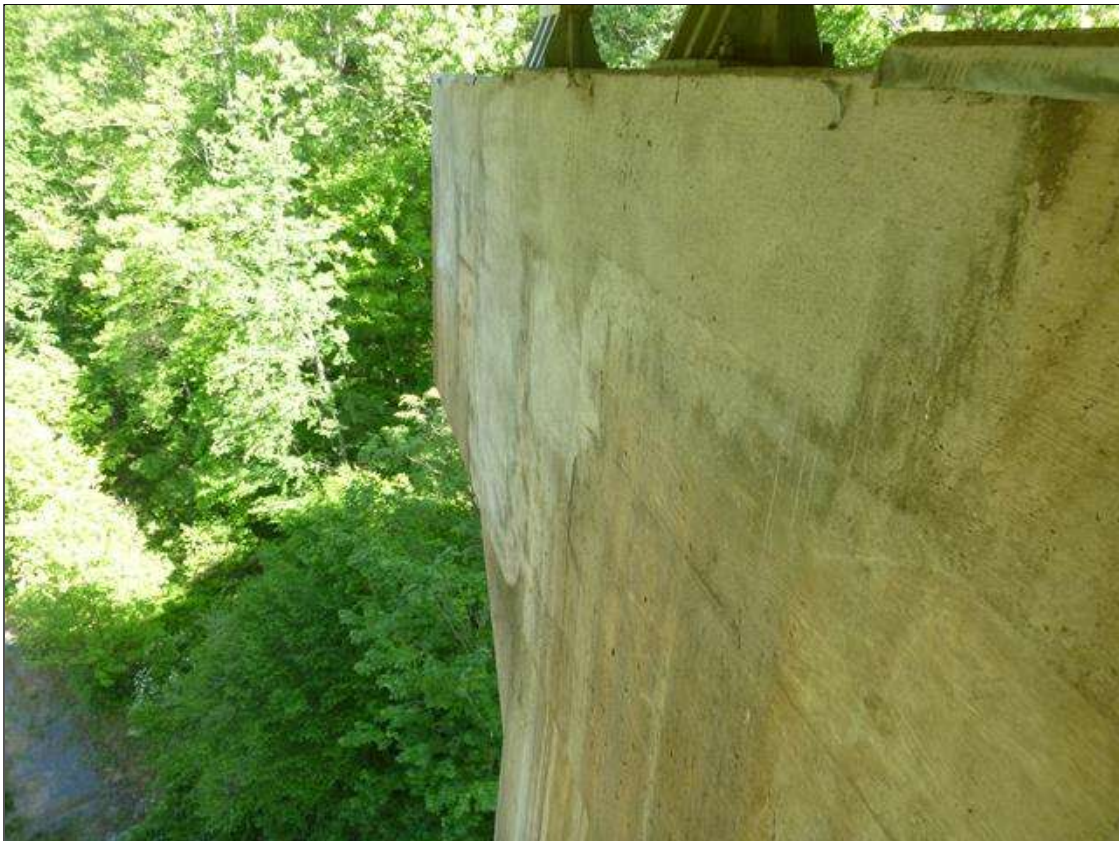
Bent 2 Cap 1: BENT 2 CAP, SPAN 3 SIDE HAS A 1/32 INCH WIDE LONGITUDINAL CRACK IN THE FACE OF THE CAP, NEAR TOP EDGE, UNDER BEAM 5, 6 FT. LONG

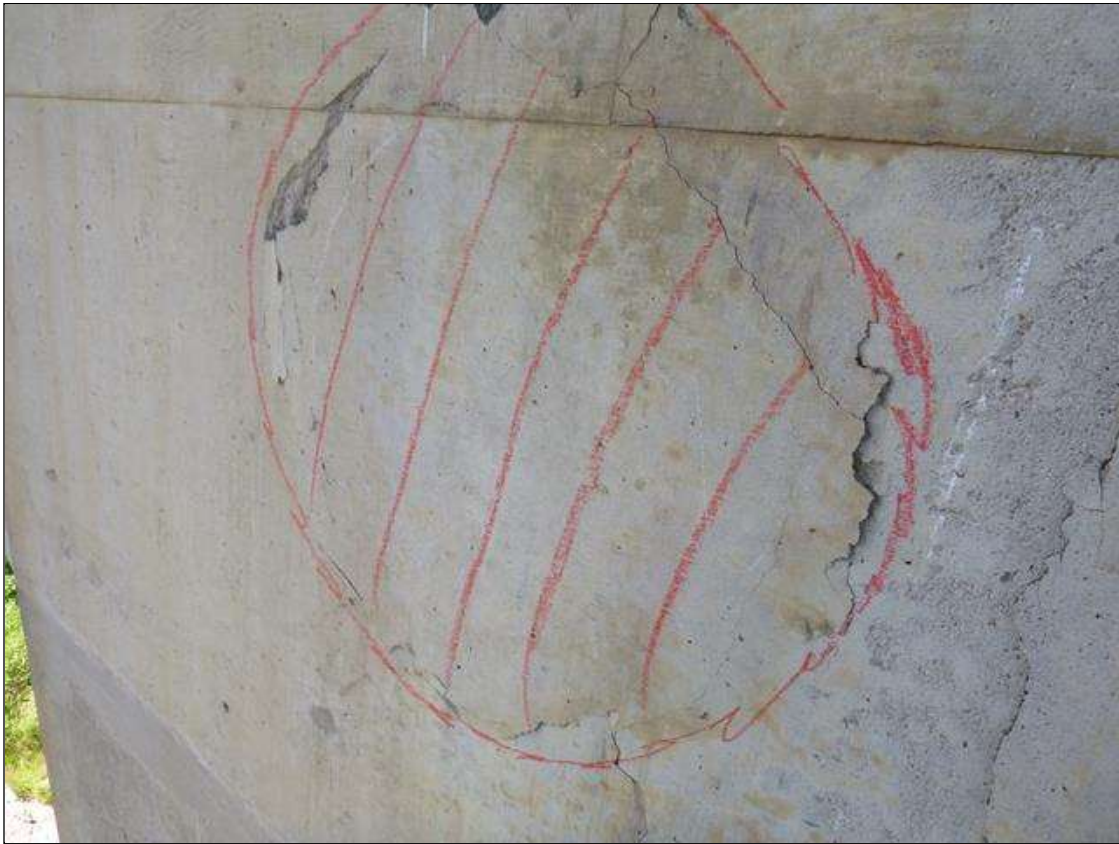
Bent 3 Pile 2: BENT 3, PILE 2 HAS AN AREA OF DELAMINATION ON THE SOUTHWEST CORNER, 20 FT. HIGH X 20 INCHES WIDE WITH UP TO 3/4 INCH WIDE SEPARATION, STARTING 6 FT. BELOW THE BOTTOM OF THE CAP

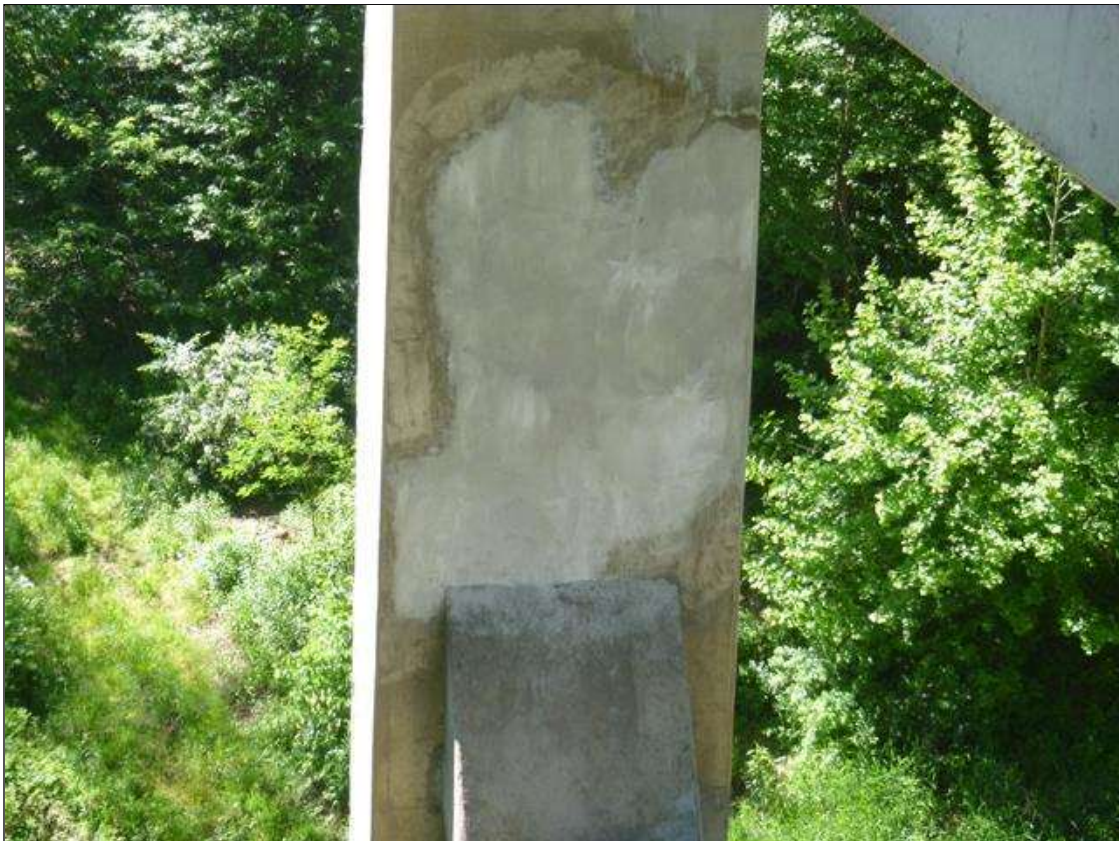
Bent 3 Pile 2: BENT 3, PILE 2 HAS AN AREA OF DELAMINATION ON THE WEST FACE, 20 FT. BELOW THE BOTTOM OF THE CAP, 24 INCHES IN DIAMETER WITH 1/2 INCH SEPARATION

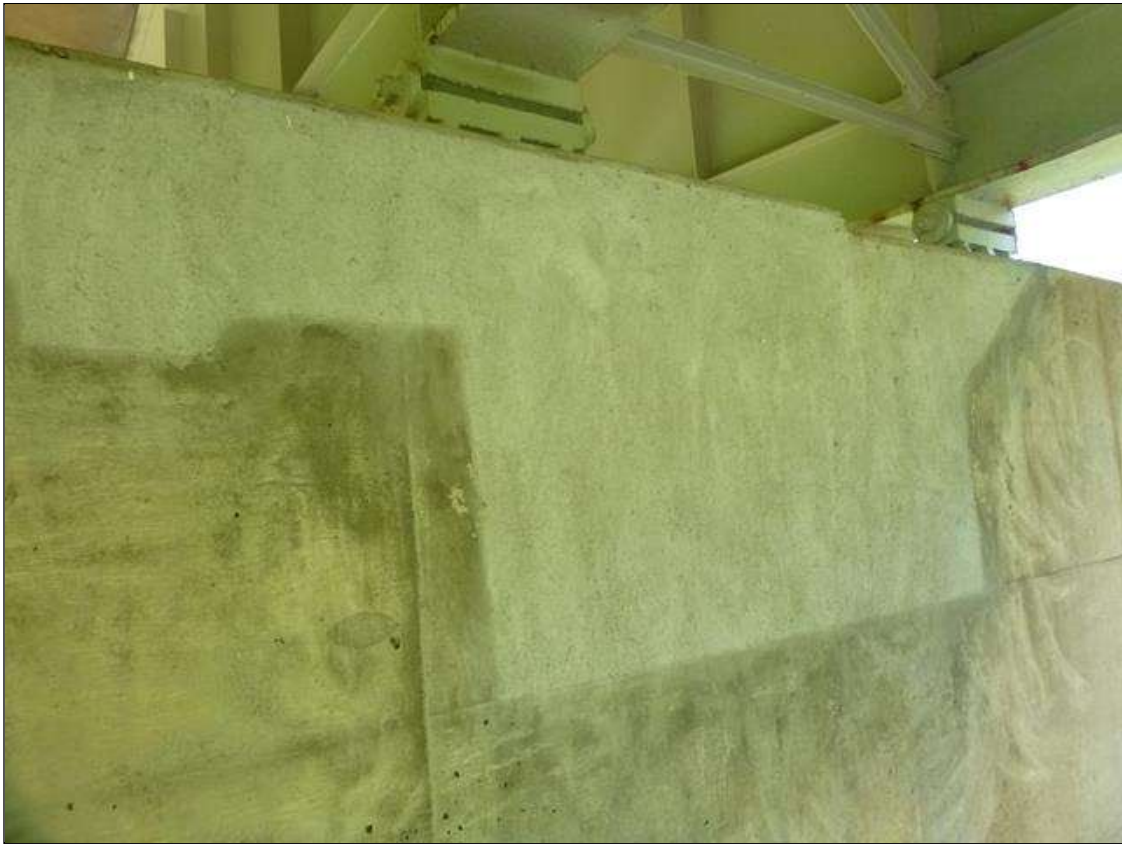
Bent 3 Pile 1: BENT 3, PILE 1 HAS SEVERAL PATCHED AREAS THE ARE SOUND, PHOTO TAKEN, ON THE SOUTH FACE AT MID-HEIGHT

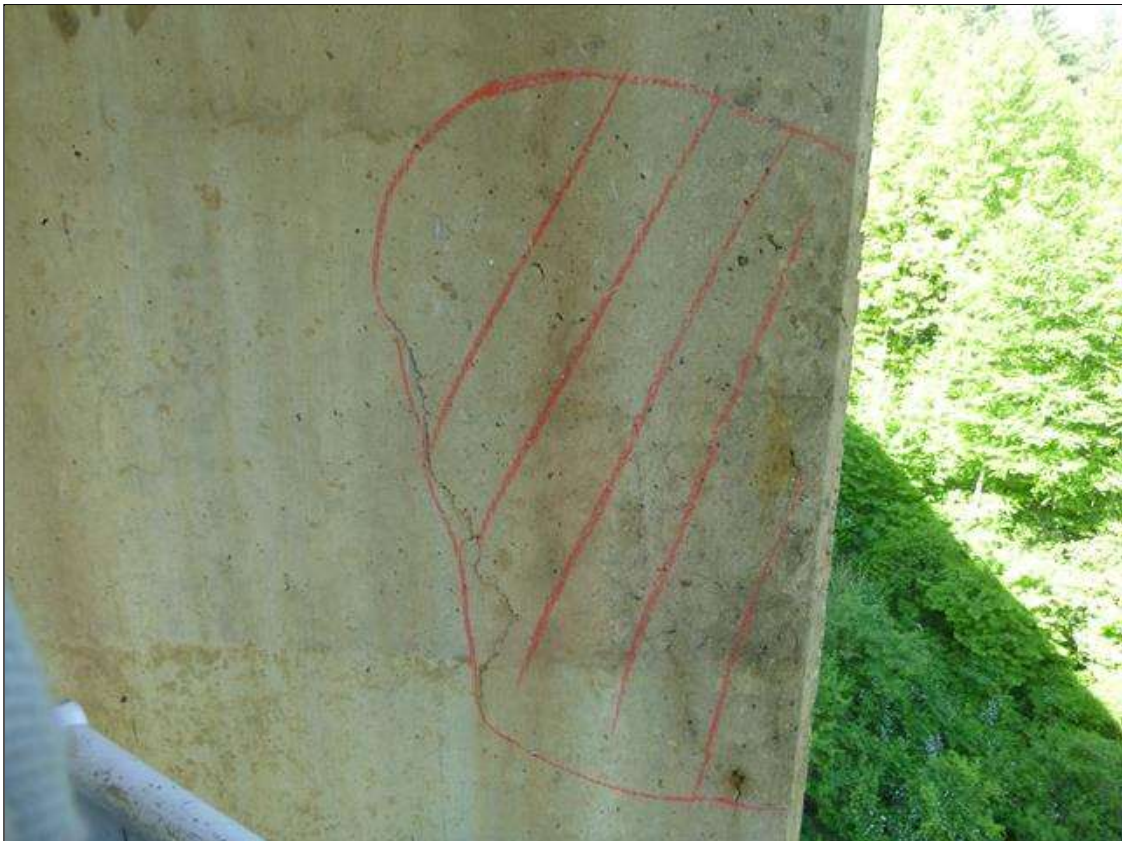
Bent 3 Cap 1: BENT 3 CAP HAS 31 FT. OF SOUND PATCHES AREAS THRU OUT THE LENGTH OF THE CAP, PHOTO TAKEN AT SPAN 3 SIDE AT BEAM 7

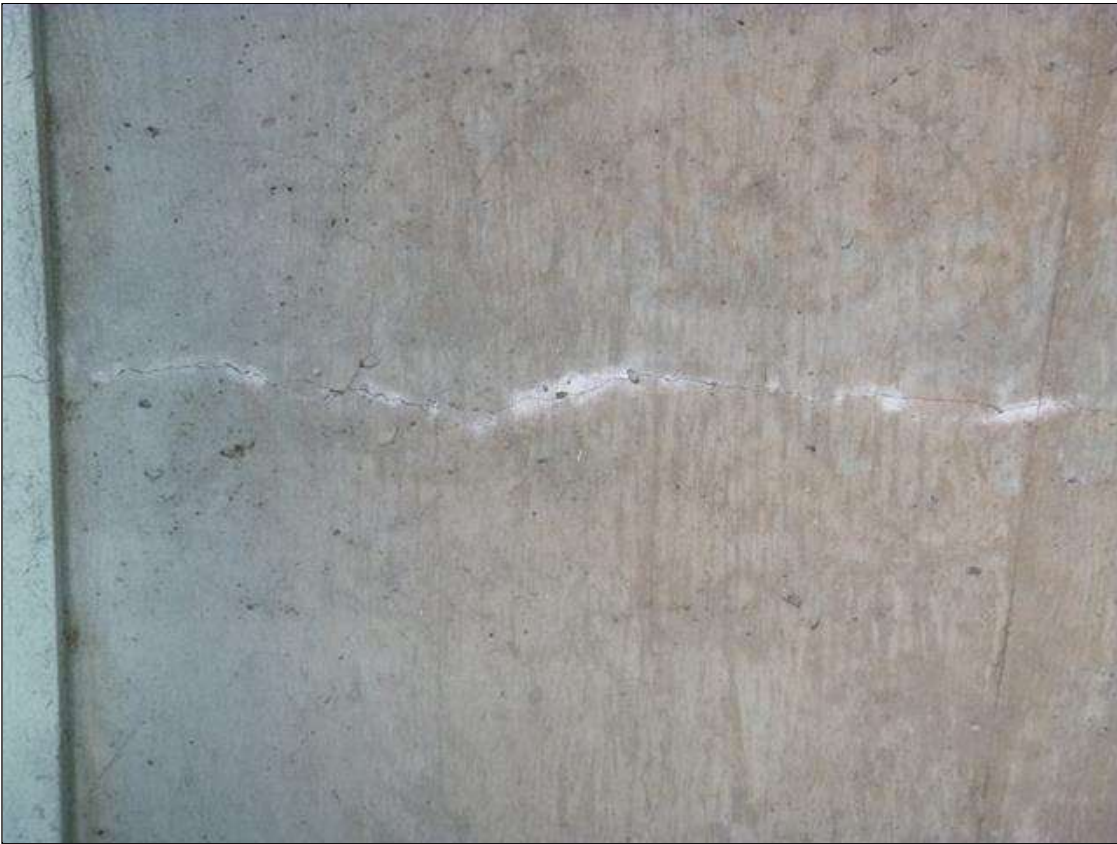
Bent 3 Cap 1: BENT 3 CAP, SPAN 3 SIDE HAS AN AREA OF DELAMINATION IN THE FACE OF THE CAP, RIGHT SIDE UNDER BEAM 8, 16 INCHES X 32 INCHES WITH 1/16 INCH SEPARATION

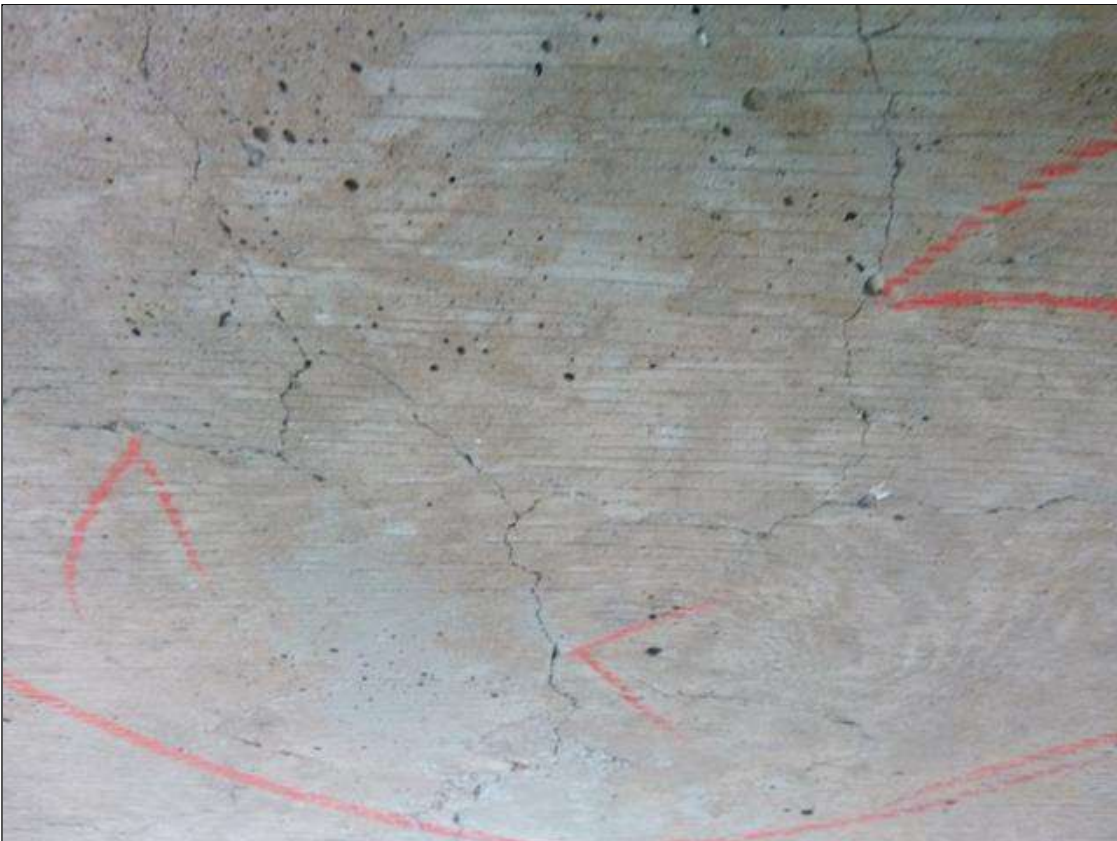
Span 3 Deck: SPAN 3, BAY 7, BOTTOM OF THE DECK HAS A 6 FT. LONG HAIRLINE TRANSVERSE CRACK, 20 FT. FROM BENT 3, FOR A TOTAL OF 2100 SQ. FT. THRU OUT THE BOTTOM OF THE SPAN

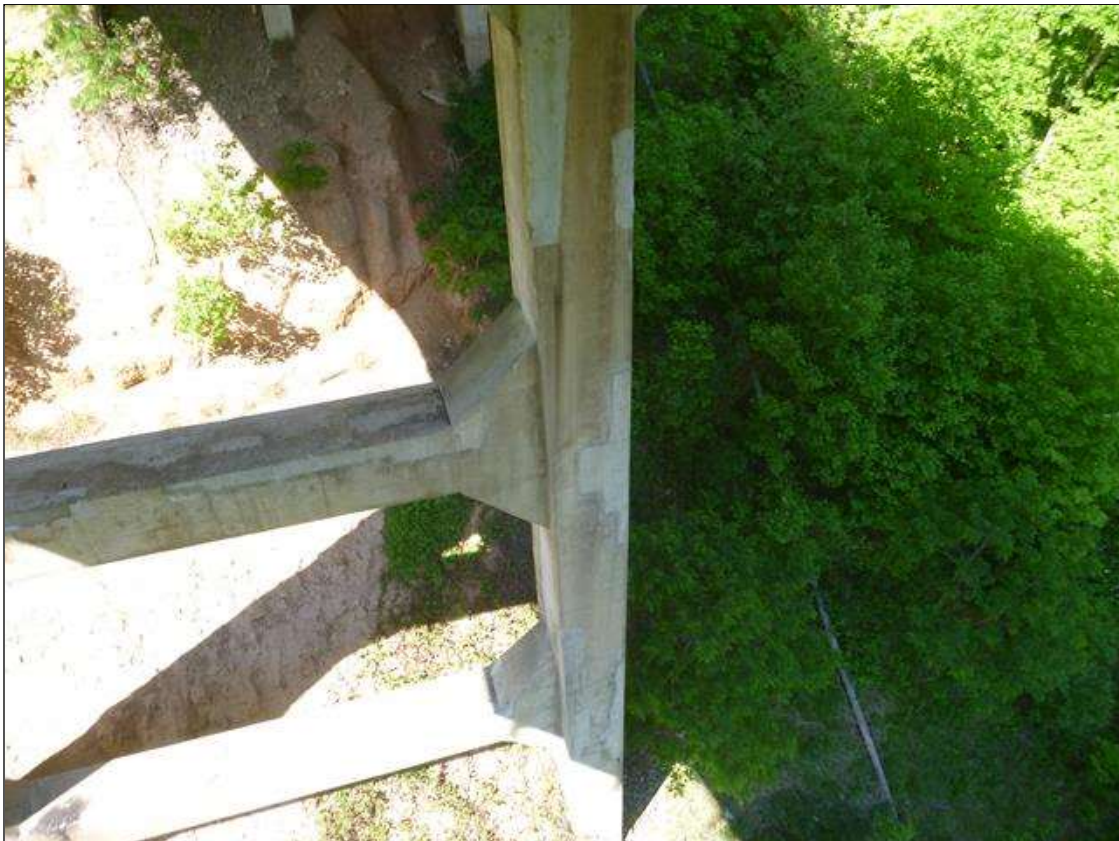
Bent 3 Cap 1: BENT 3 CAP, SPAN 4 SIDE HAS AN AREA OF DELAMINATION IN THE FACE OF THE CAP AT BEAM 6, 16 INCHES IN DIAMETER, WITH RUST STAINS

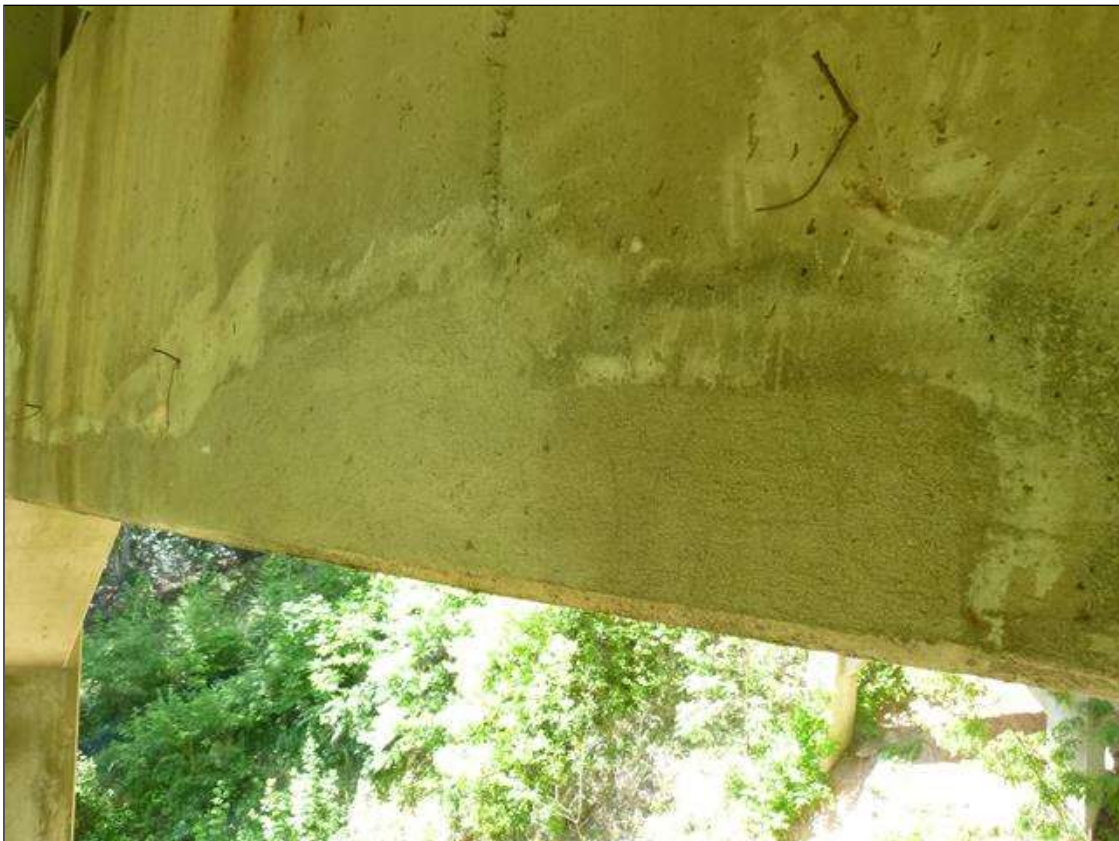
Span 2 Beam 6 Far Bearing: SPAN 2, BEAM 6 FAR BEARING HAS FRECKLED RUST

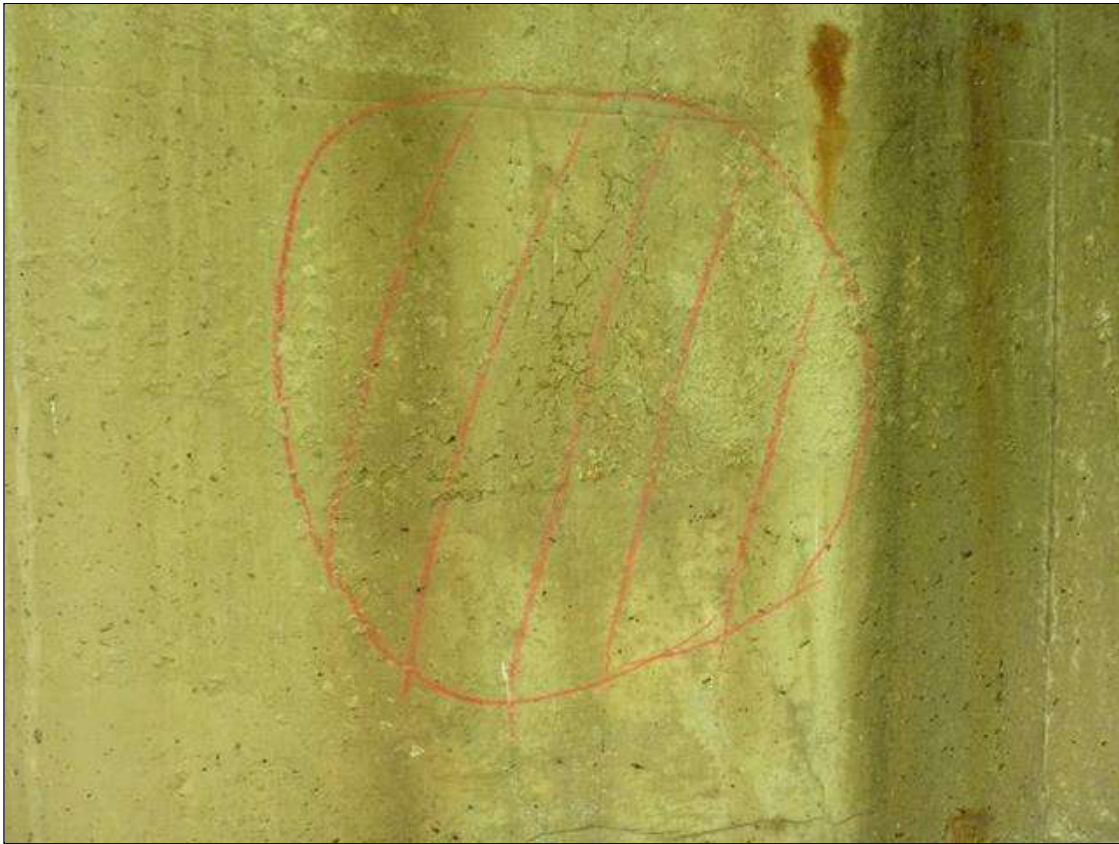
Bent 4 Cap 1: BENT 4 CAP HAS 44 FT. OF SOUND PATCHES THRU OUT THE LENGTH OF THE CAP, PHOTO TAKEN ON SPAN 4 SIDE

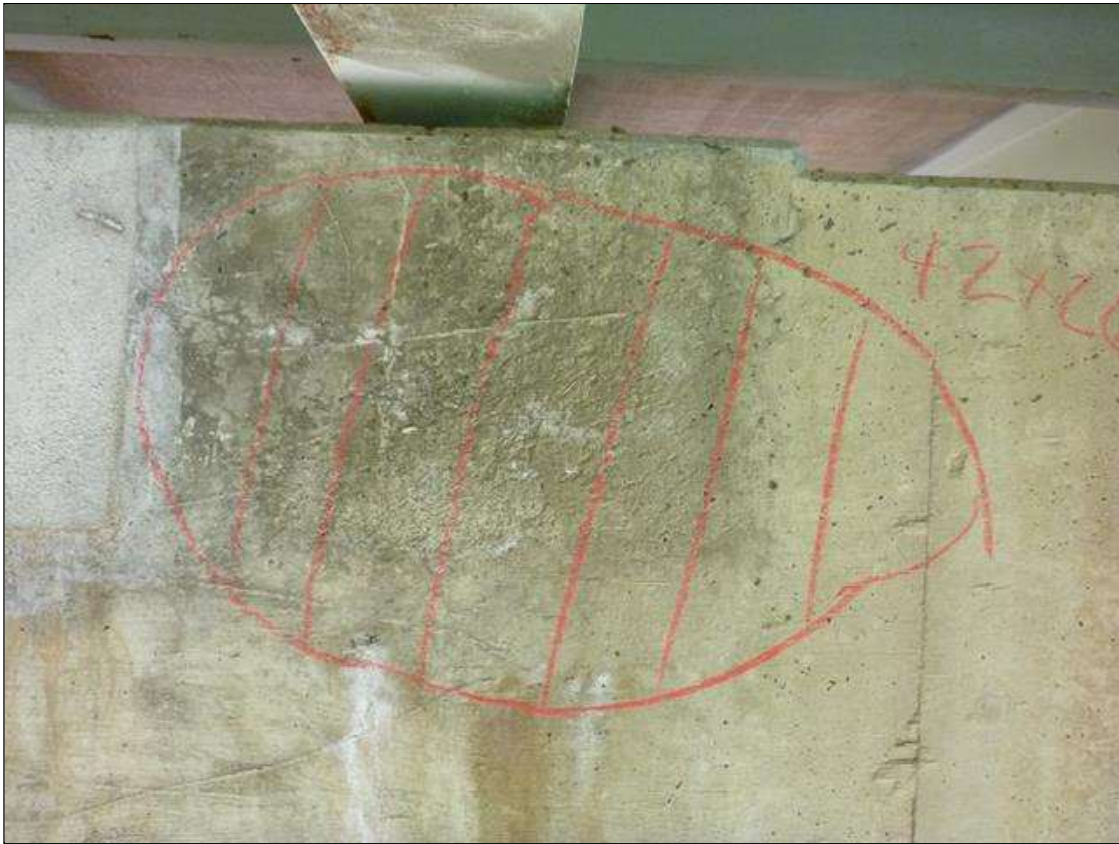
Bent 5 Cap 1: BENT 5 CAP HAS 45 FT. OF SOUND PATCHES THRU OUT THE LENGTH OF THE CAP, PHOTO TAKEN ON SPAN 5 SIDE

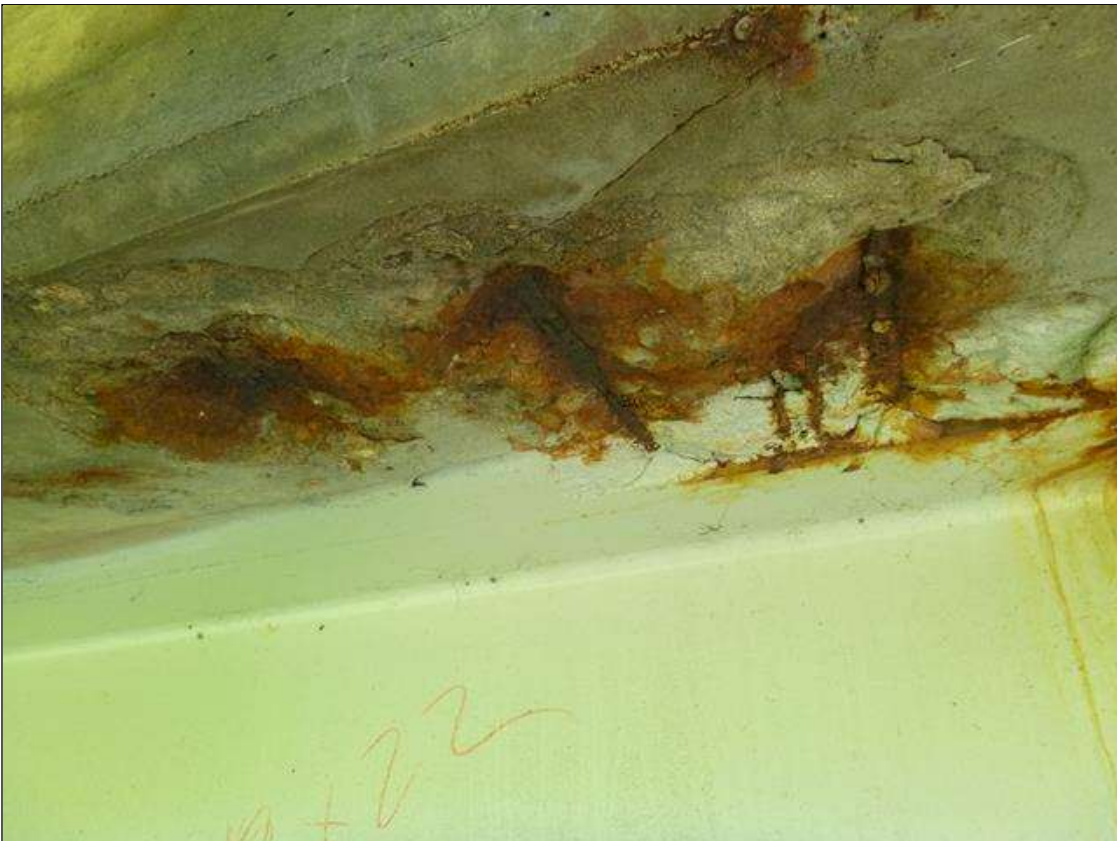
Span 5 Deck: SPAN 5 BOTTOM OF RIGHT OVERHANG, 8 FT. FROM BENT 5 HAS A 12 INCH DIAMETER SPALL X 1 INCH DEEP WITH REBAR EXPOSED

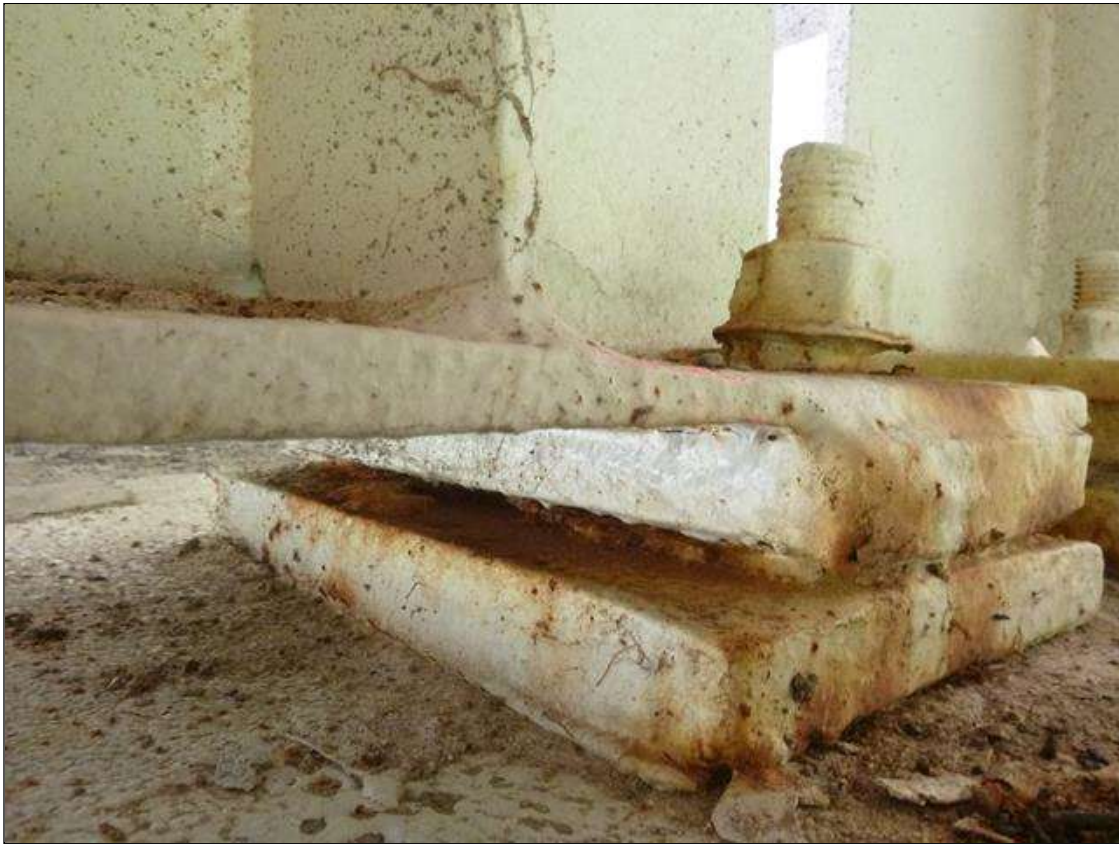
Bent 5 Cap 1: BENT 5 CAP, SPAN 6 SIDE HAS AN AREA OF DELAMINATION IN THE FACE OF THE CAP IN BAY 5  
NEAR BEAM 6, 12 INCHES IN DIAMETER

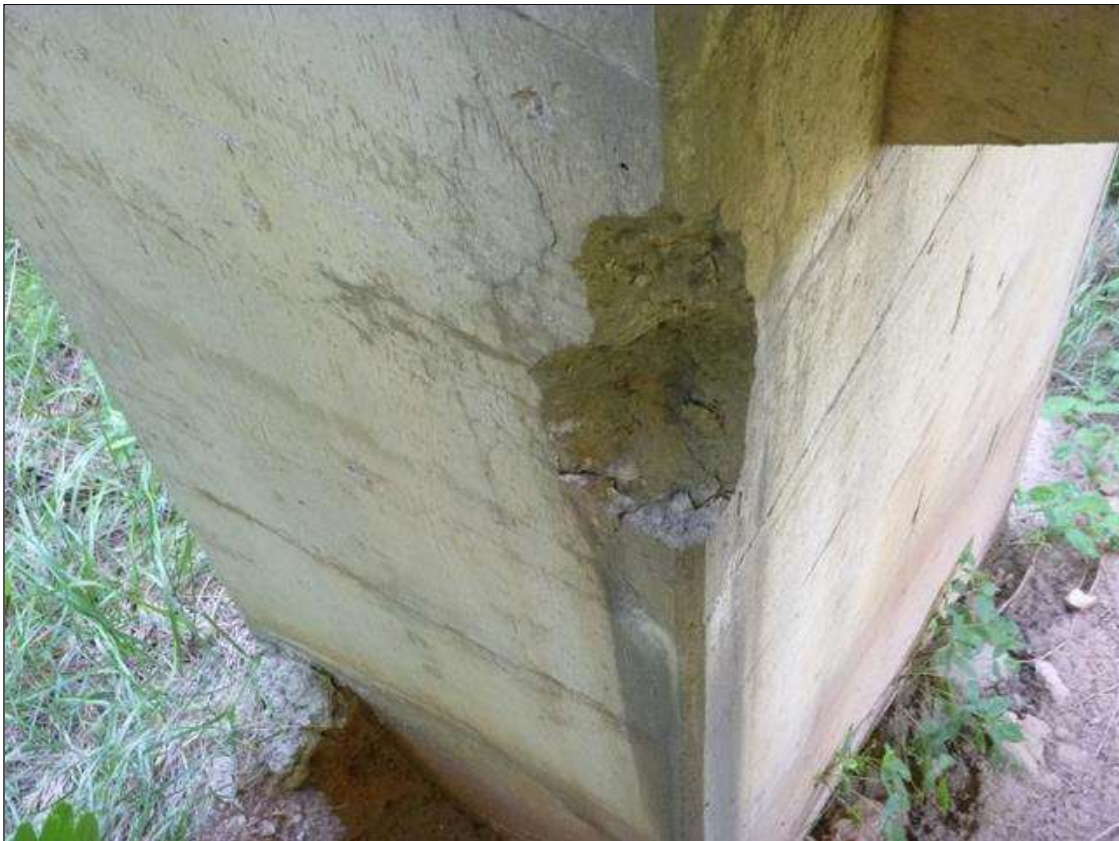
Bent 5 Pile 4: BENT 5, PILE 4 HAS AN AREA OF DELAMINATION ON THE NORTHEAST CORNER, 1 FT. BELOW THE BOTTOM OF THE CAP, 9 INCHES WIDE X 24 INCHES HIGH

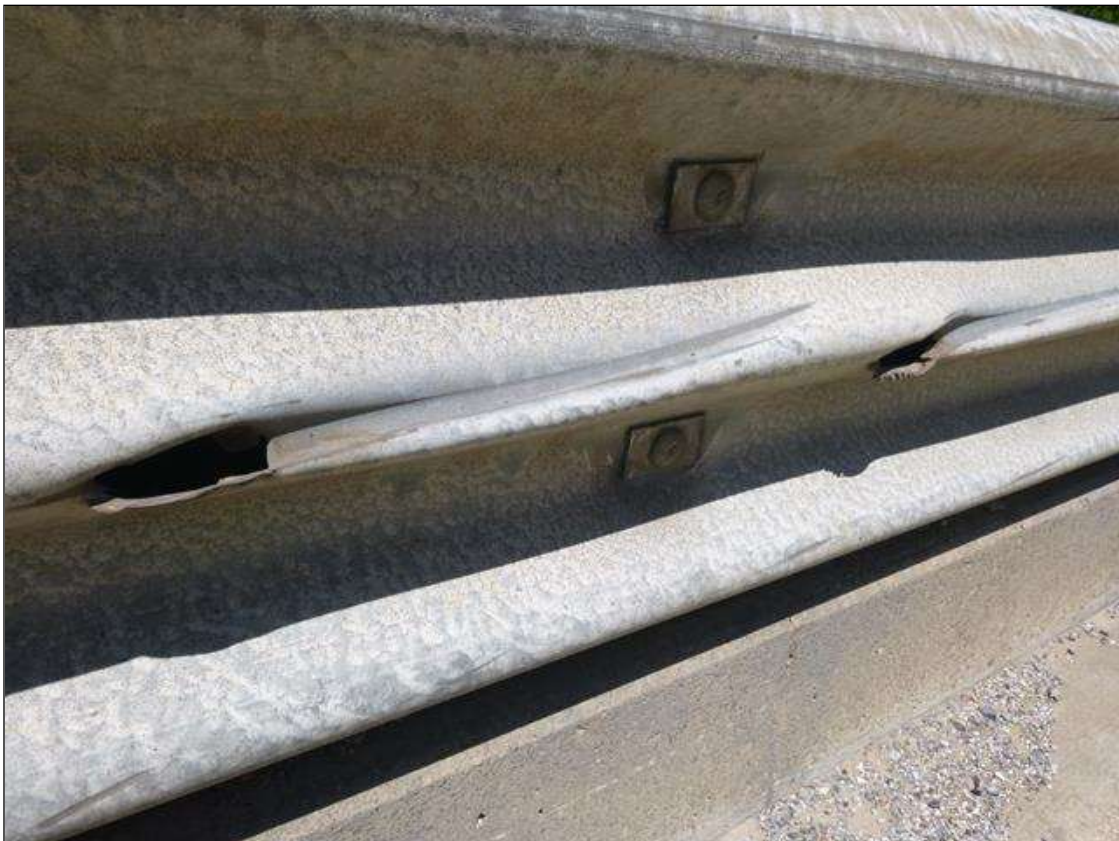
Span 2 Right Bridge Rail: SPAN 2, RIGHT RAIL HAS 25 FT. OF DAMAGE, STARTING 12 FT. FROM BENT 1

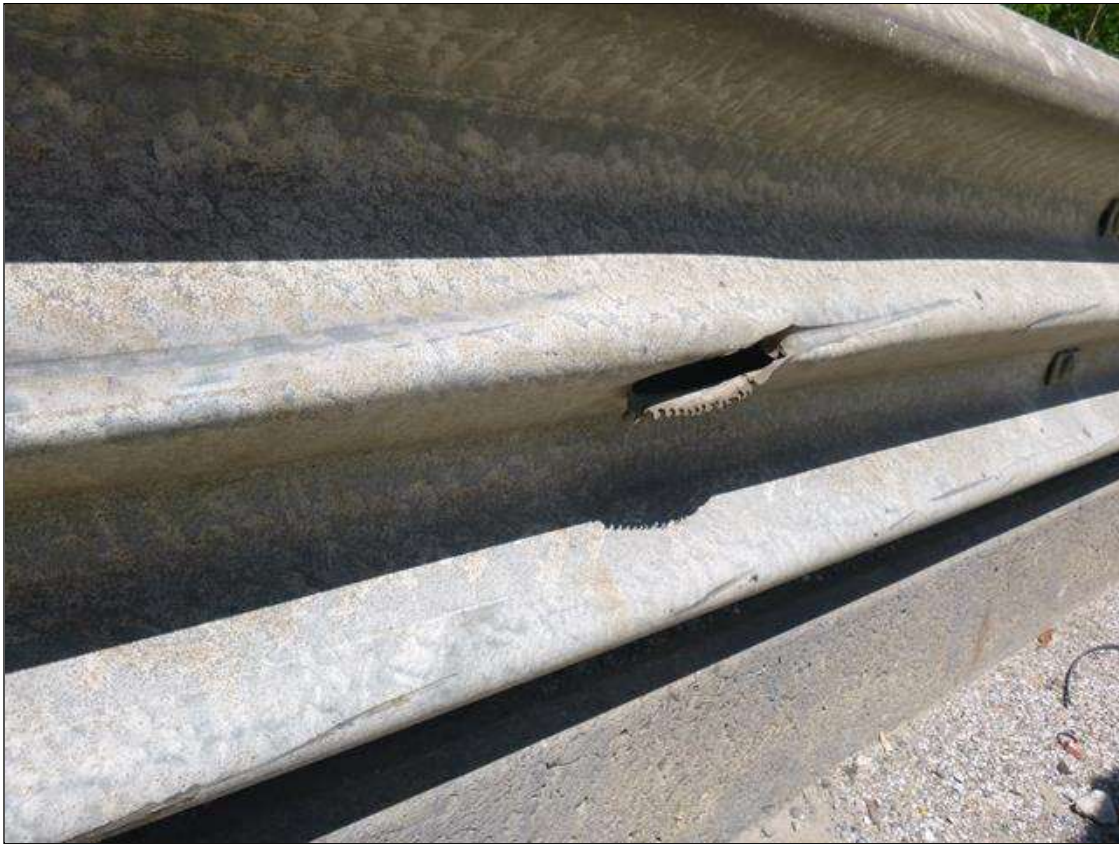
Span 2 Right Bridge Rail: SPAN 2, RIGHT RAIL HAS 20 FT. OF 2 INCH WIDE TEARS THRU OUT THE LENGTH OF THE RAIL
