NC DEPARTMENT OF TRANSPORTATION  
DIVISION OF HIGHWAYS  
STRUCTURE MANAGEMENT UNIT

## Structure Safety Report

### Routine Element Inspection - Contract

COUNTY: HAYWOOD STRUCTURE NUMBER: 430171 FREQUENCY: 24 MONTHS

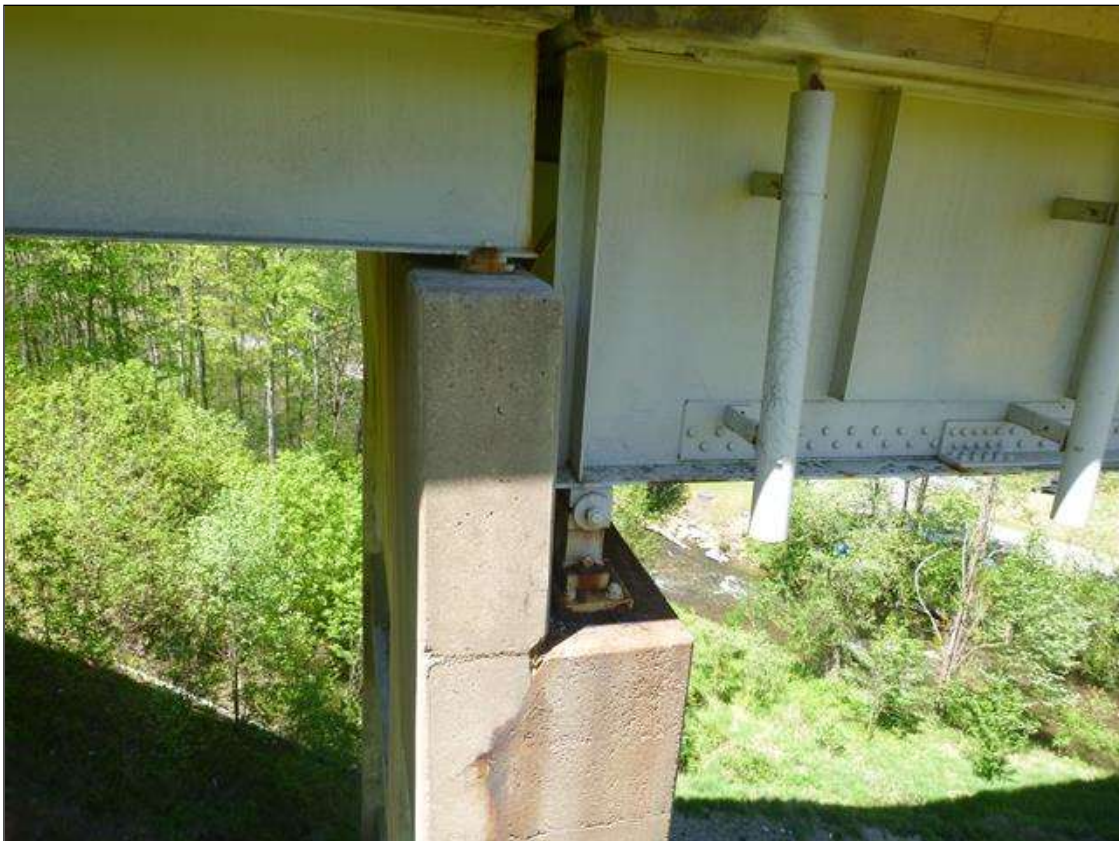
BENT 4, LEFT SIDE SUPERSTRUCTURE

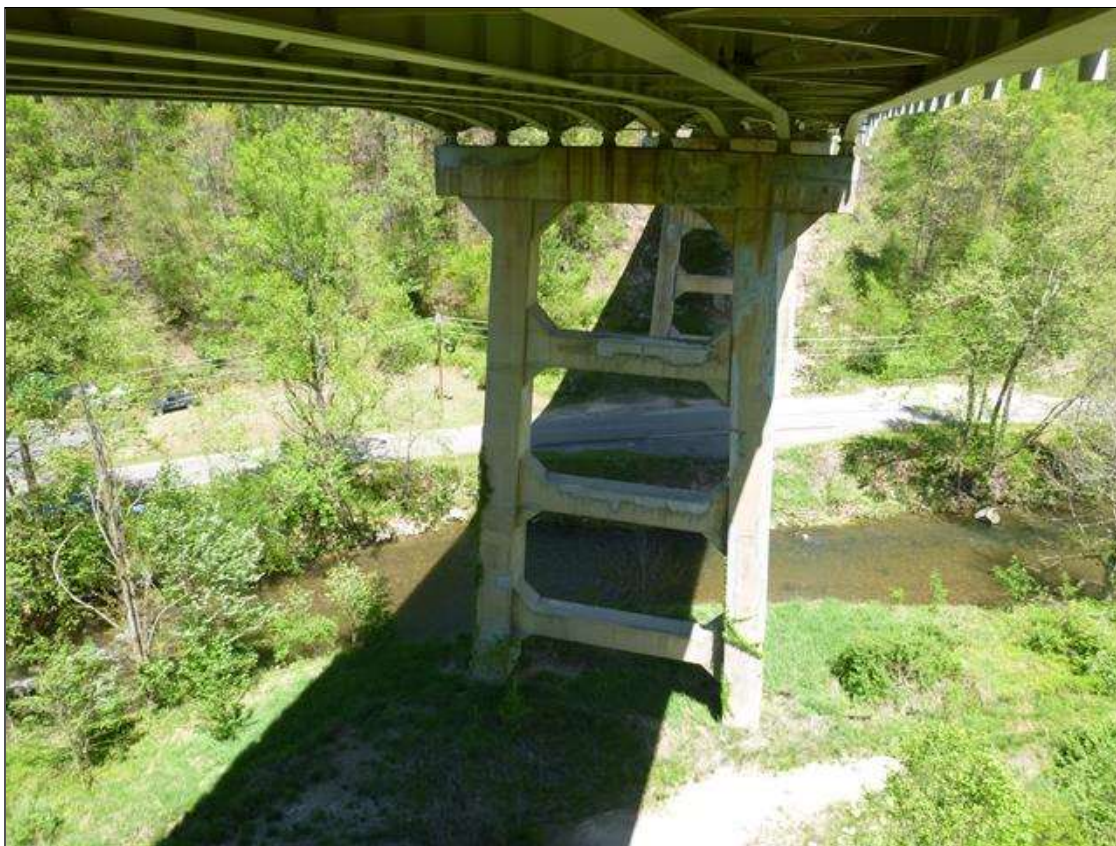
BENT 3, SPAN 4 SIDE

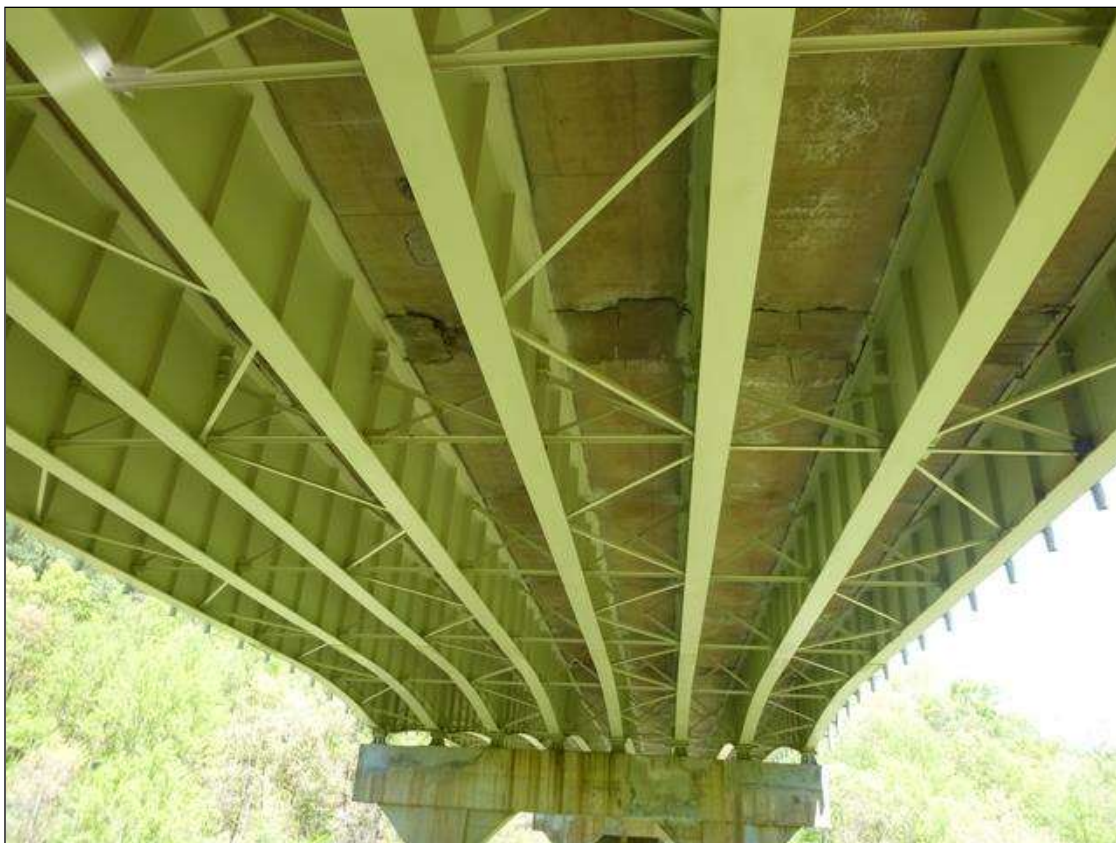
SPAN 4 SUPERSTRUCTURE LOOKING WEST

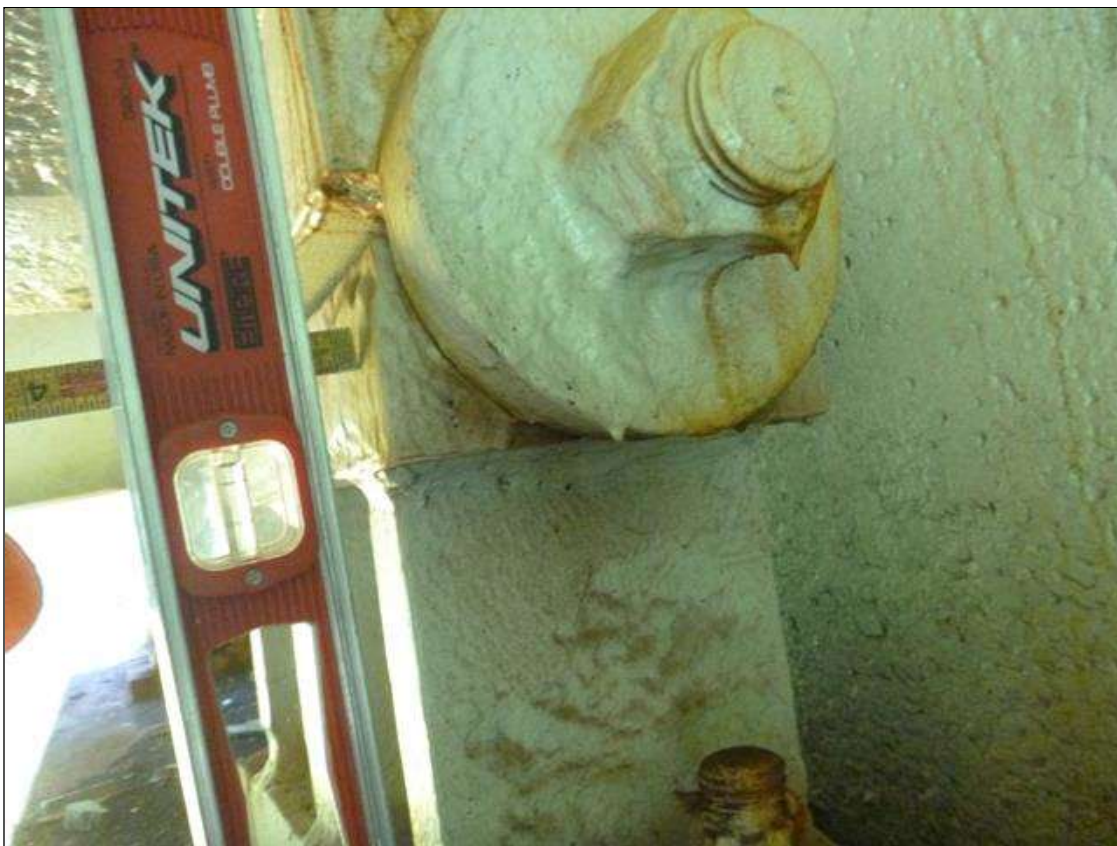
SPAN 4, GIRDER 2 ROCKER BEARING AT BENT 4 LEANING 1 INCH TO THE EAST

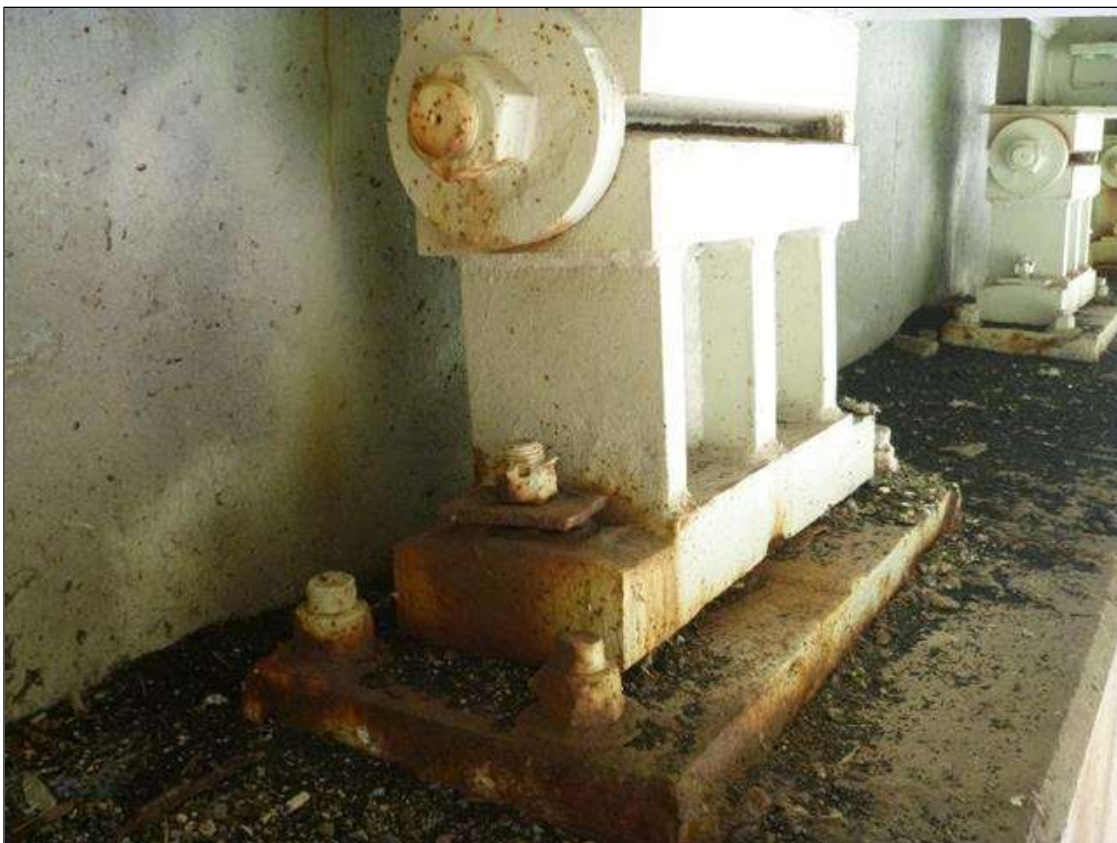
SPAN 4, GIRDER 5 ROCKER BEARING AT BENT 4

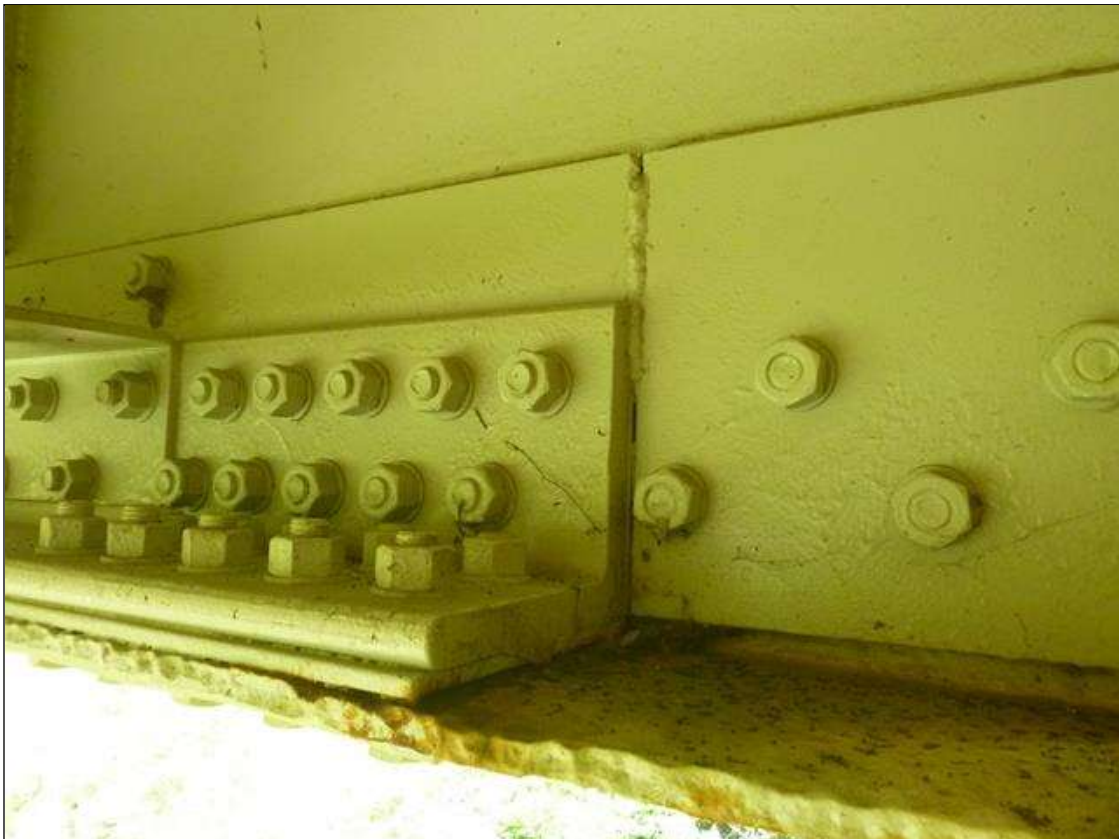
SPAN 4, GIRDER 1, WEB AND BOTTOM FLANGE REPAIR

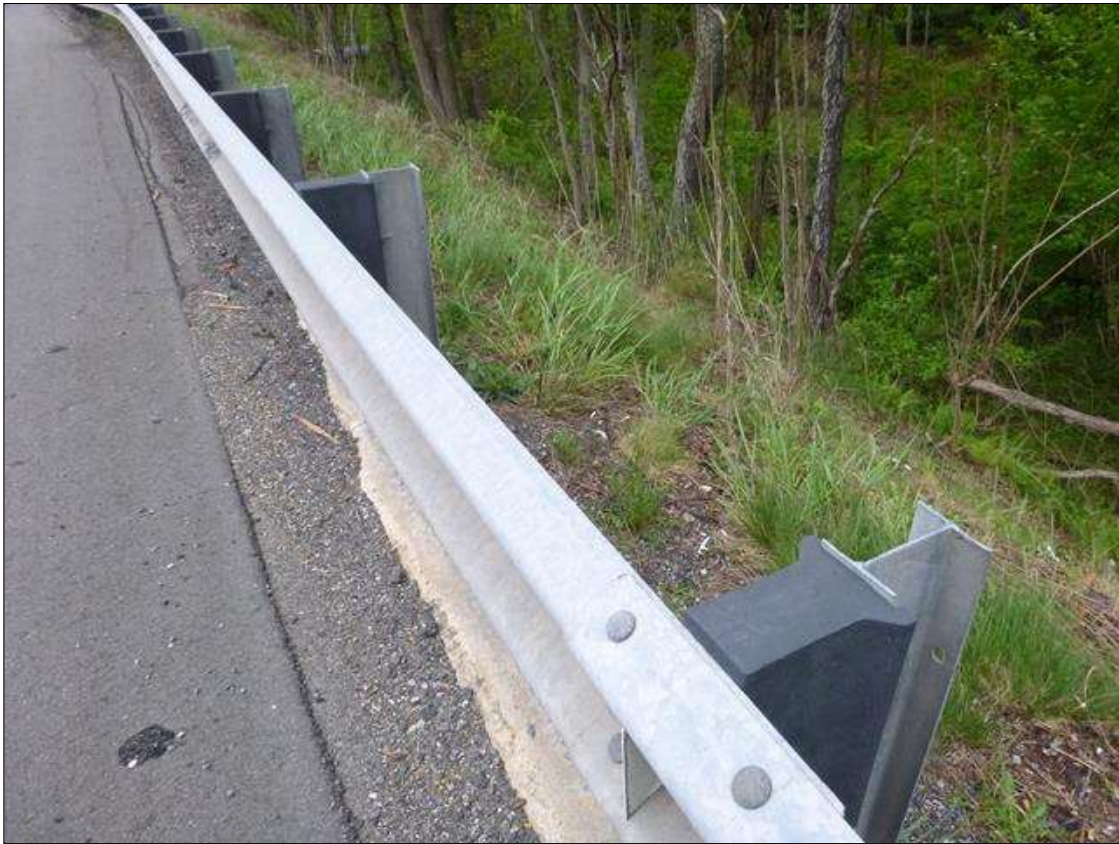
APPROACH GUARDRAIL POST SPACING, 75 INCHES AT THE NORTHEAST CORNER

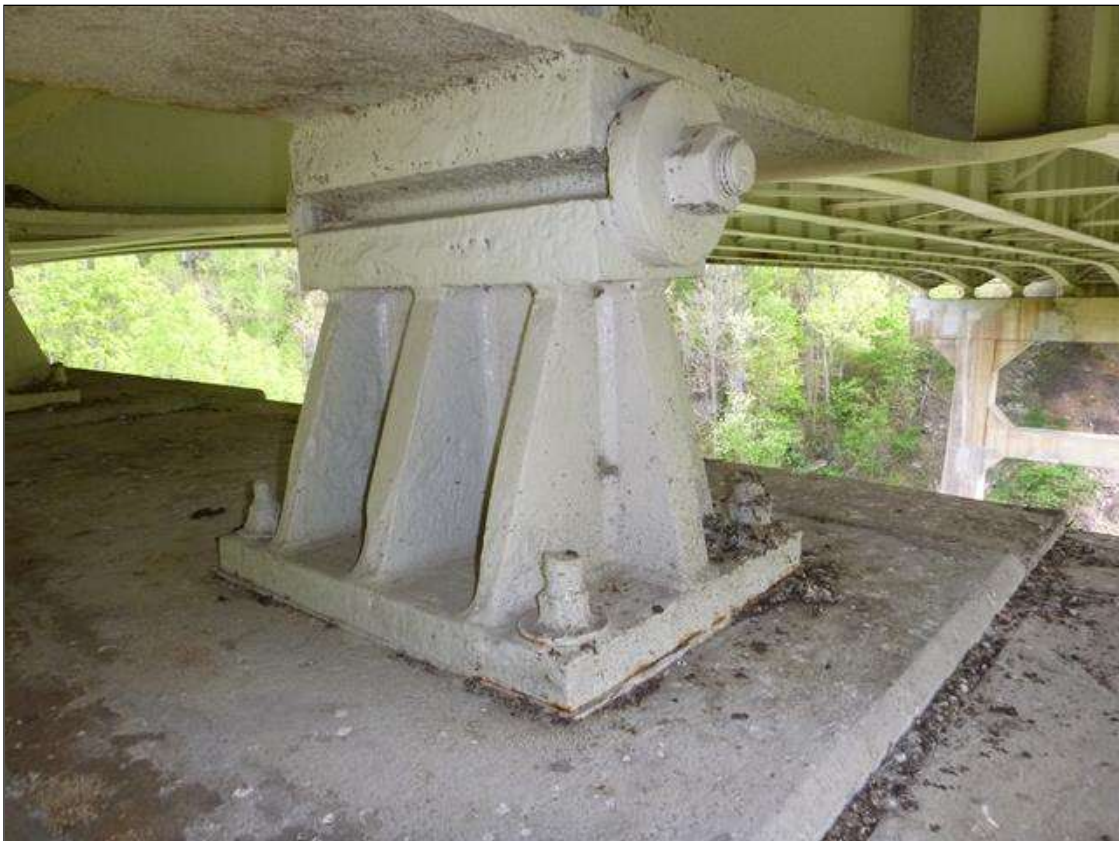
SPAN 2, BEAM 2, INTERMEDIATE BEARING AT BENT 3

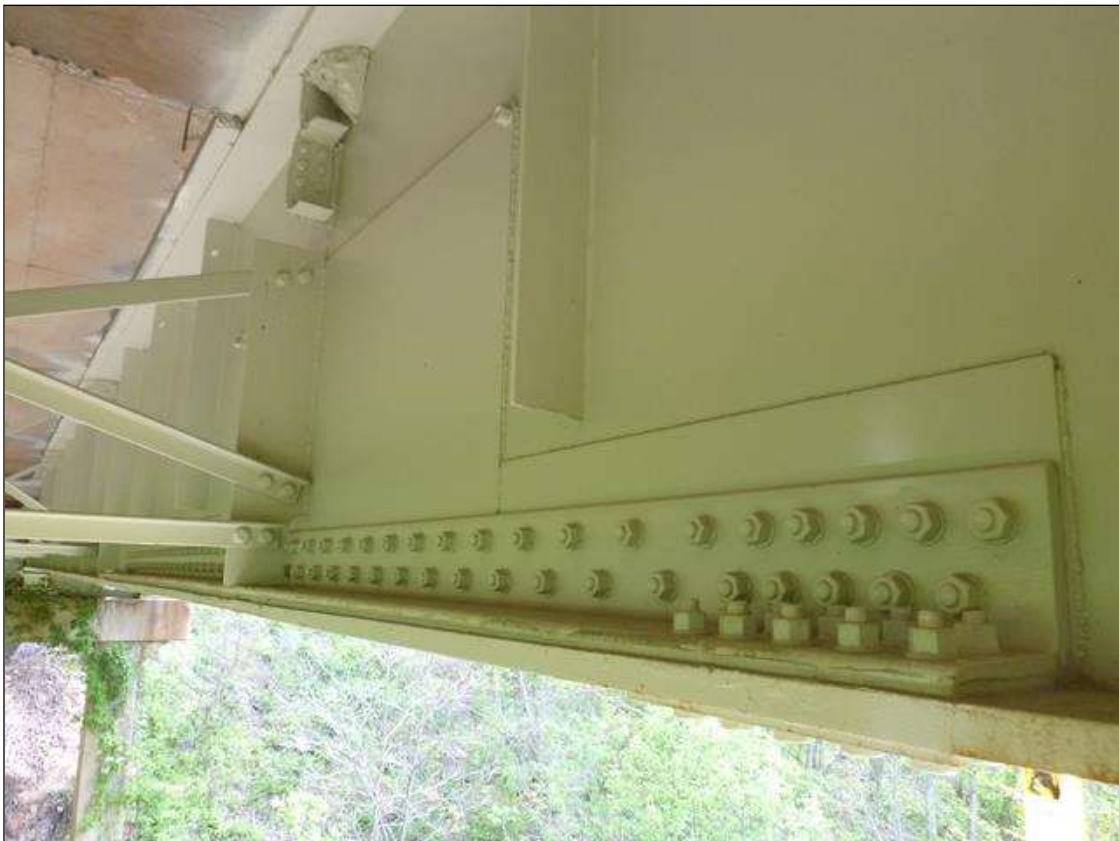
SPAN 2, BEAM 2, BOTTOM FLANGE AND WEB REPAIR, NEAR MID-SPAN

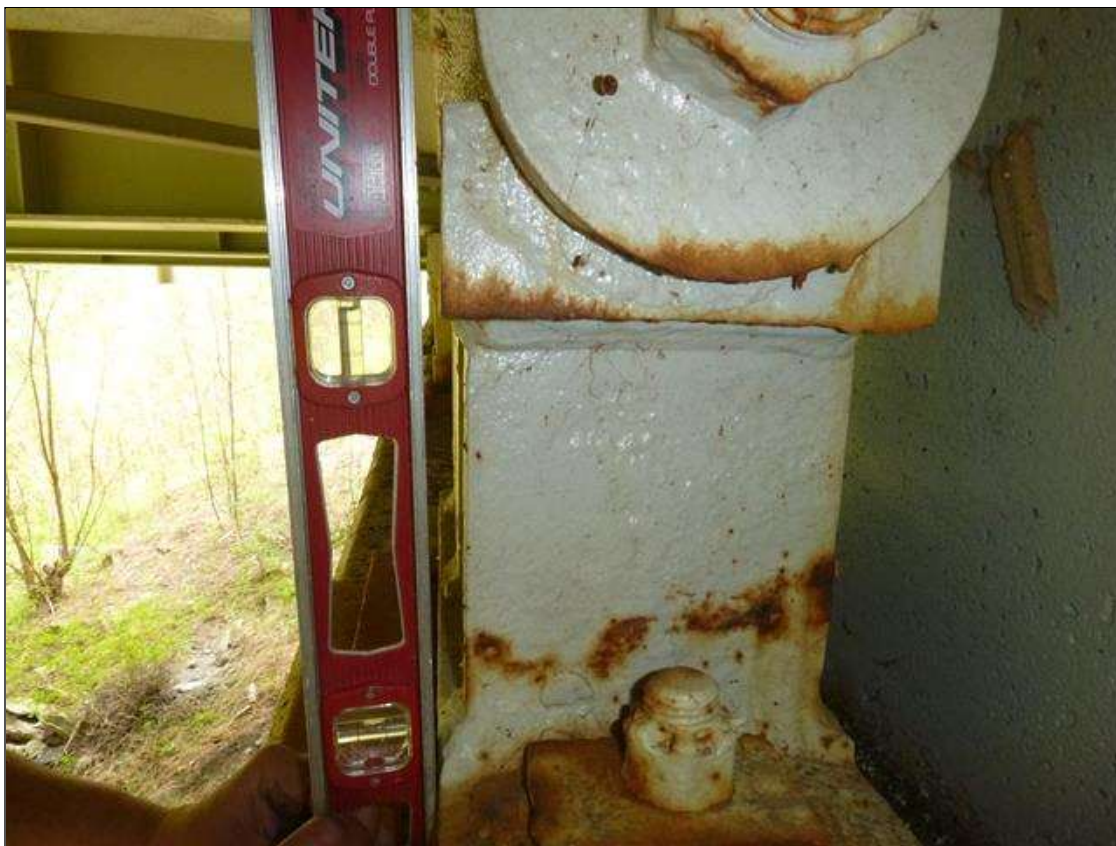
SPAN 2, BEAM 5 NEAR ROCKER BEARING MOVEMENT TO THE WEST

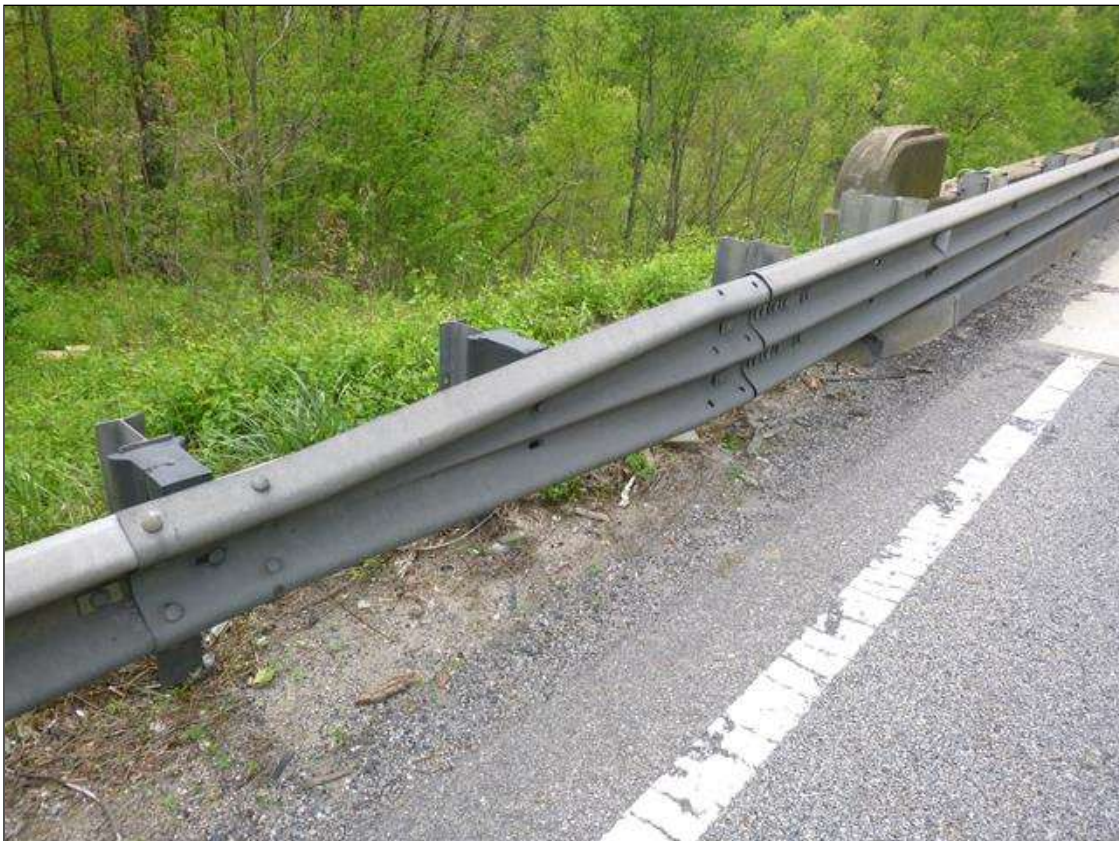
END BENT 1 APPROACH GUARDRAIL TRANSITION, LEFT SIDE

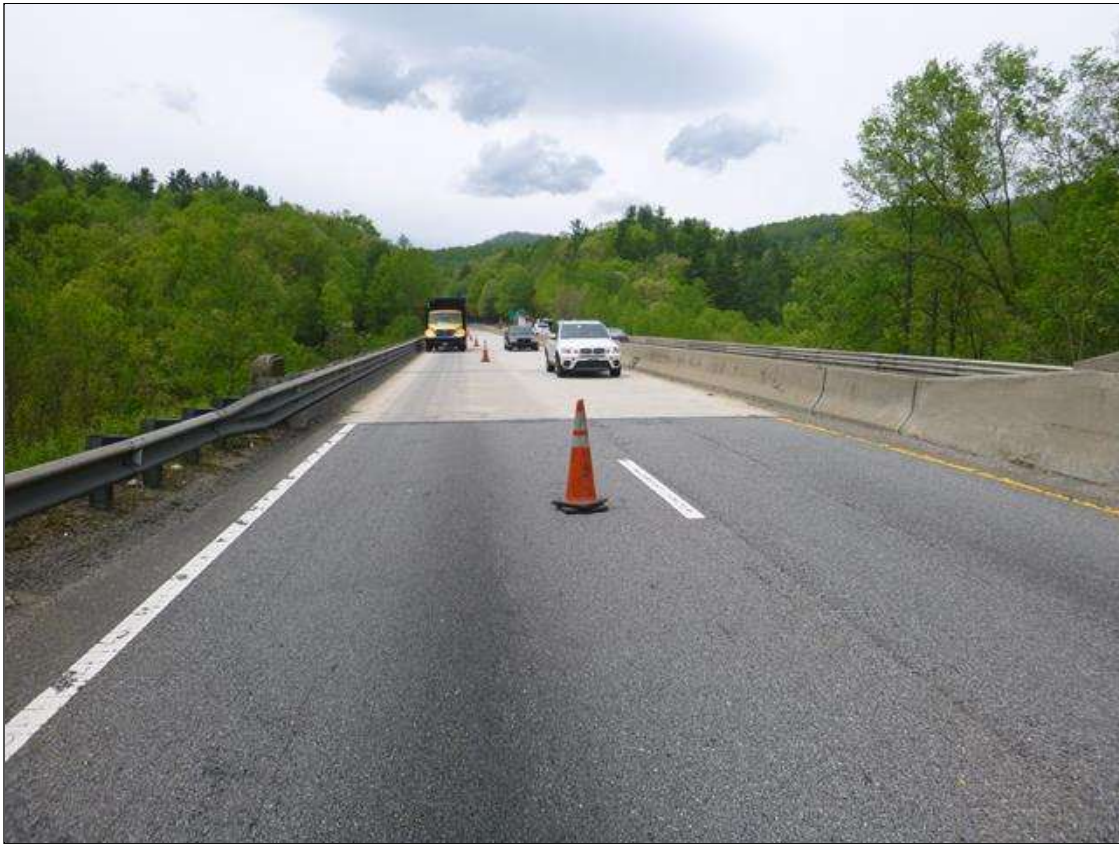
WEST APPROACH LOOKING EAST, WEST BOUND LANE.

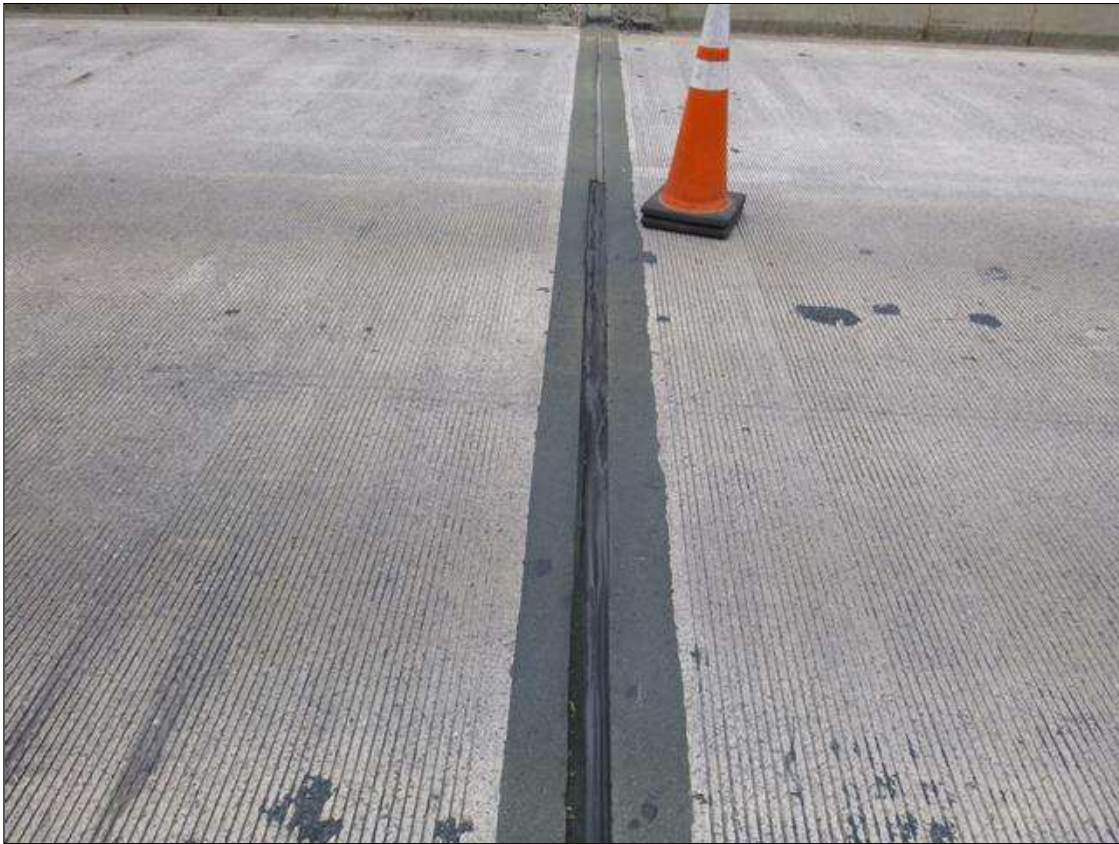
BENT 4 JOINT WEST BOUND LANES

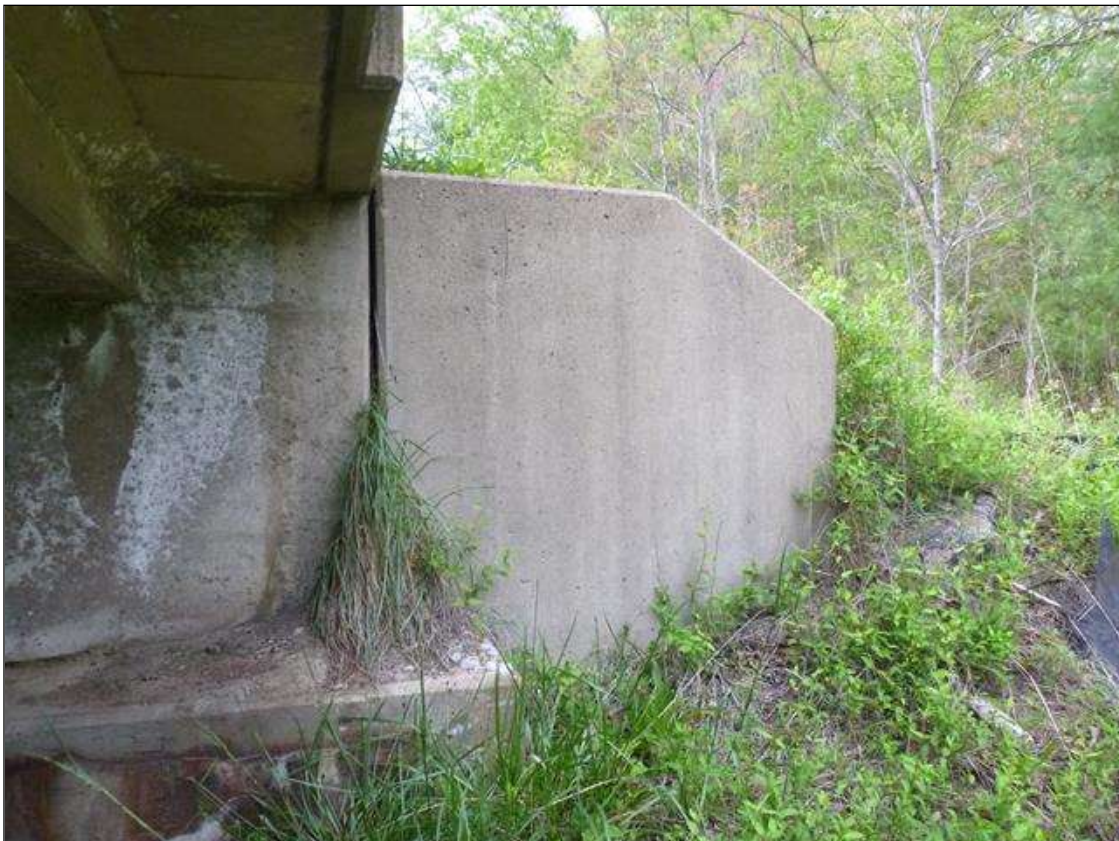
END BENT 1, LEFT WINGWALL

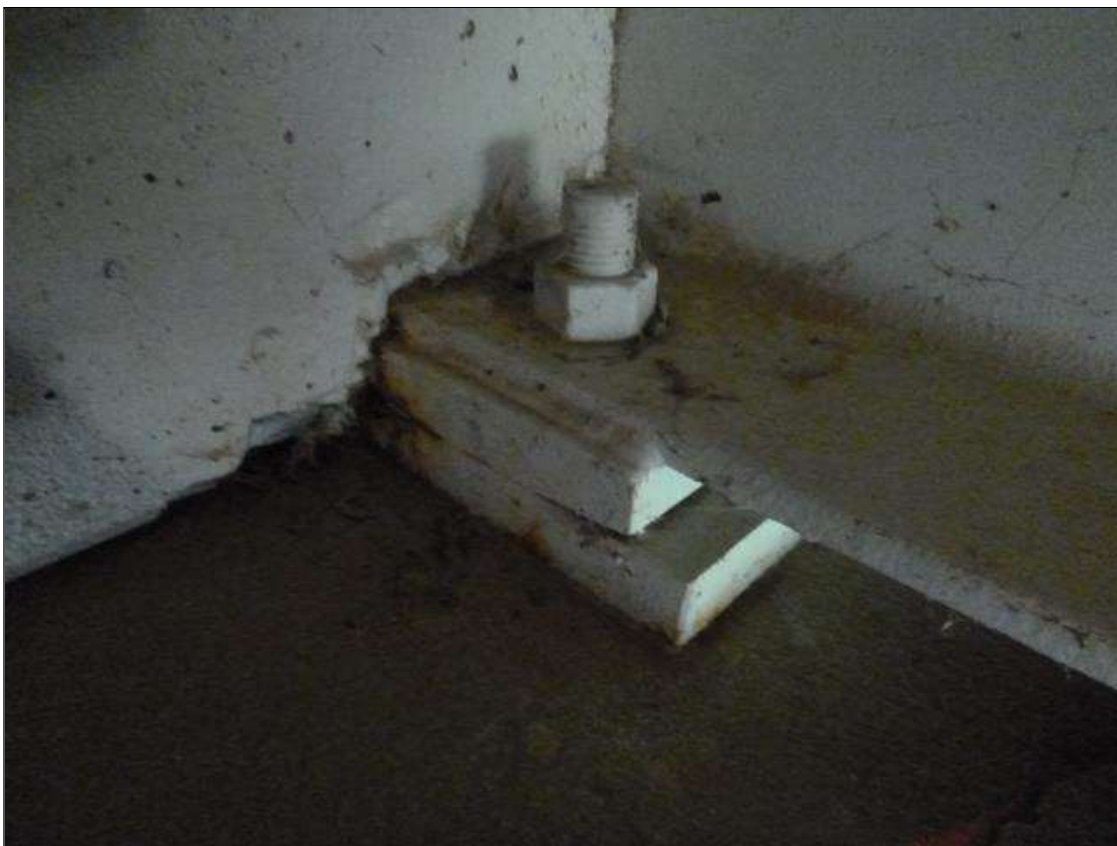
SPAN 1, BEAM 7 NEAR BEARING

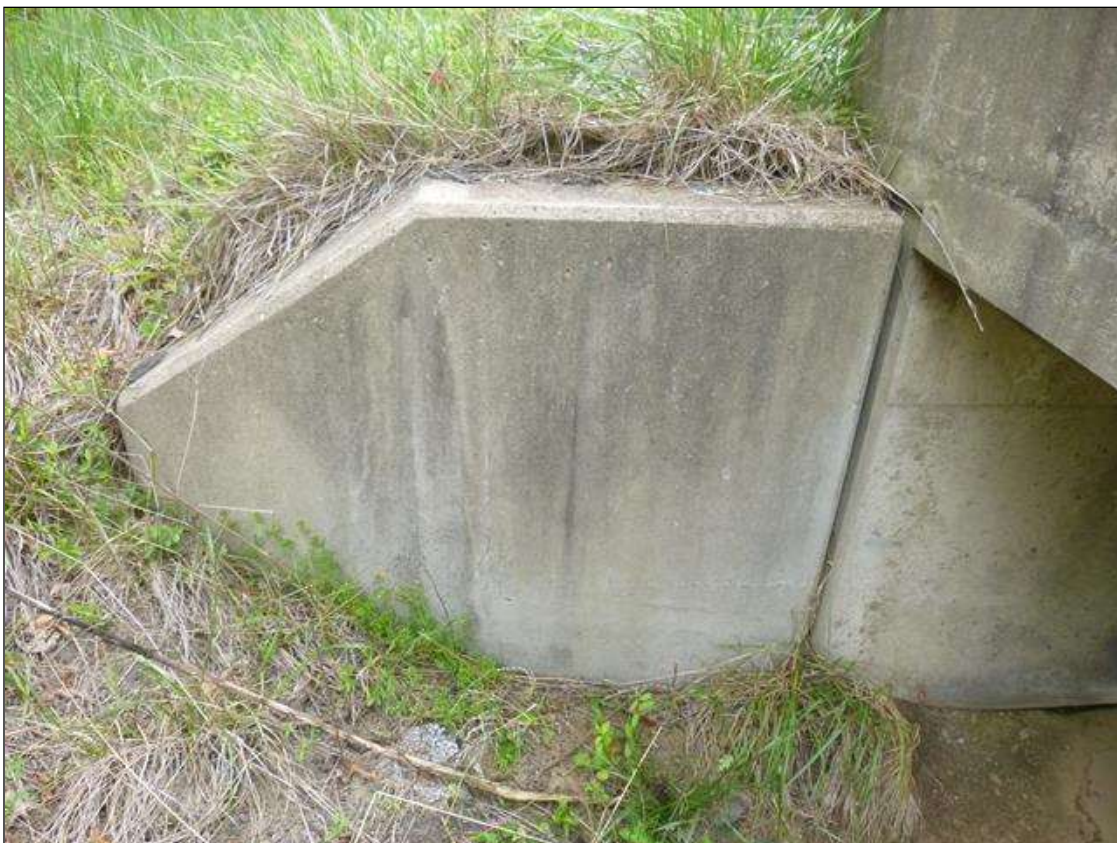
END BENT 1, RIGHT WINGWALL

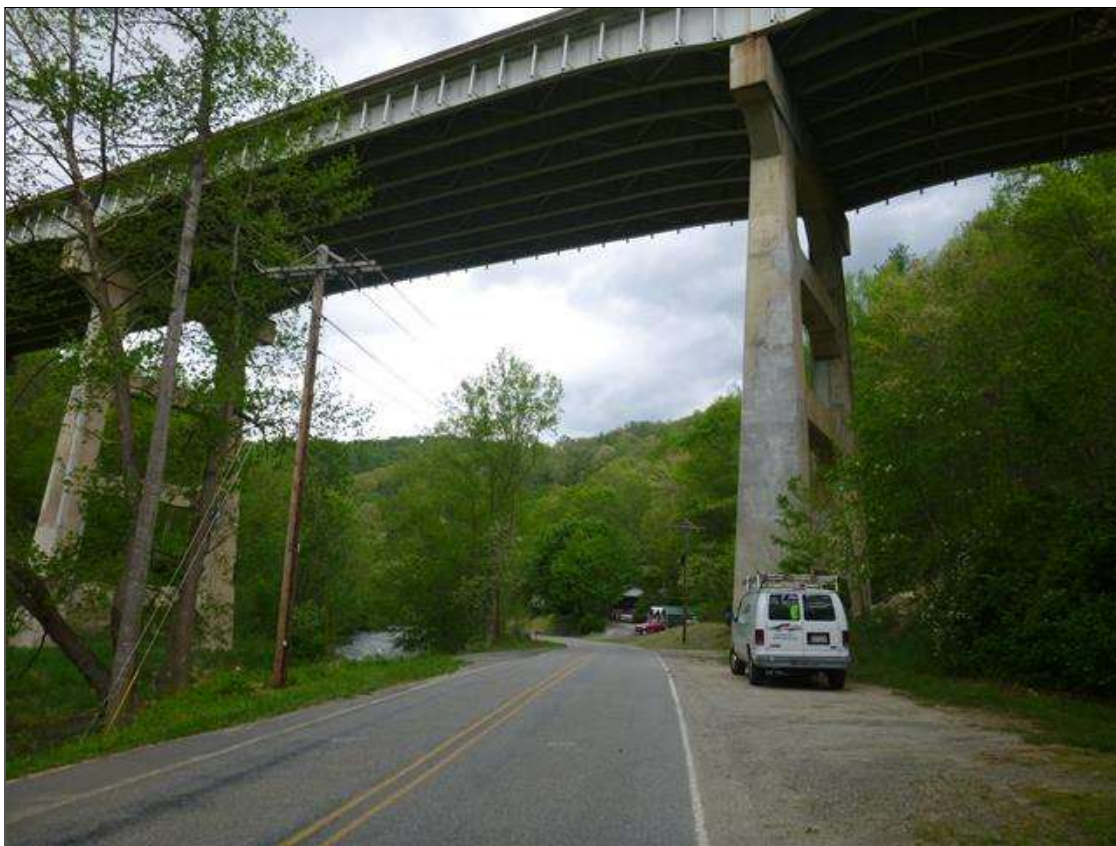
LEFT SIDE OF SPAN 3, LOOKING SOUTH

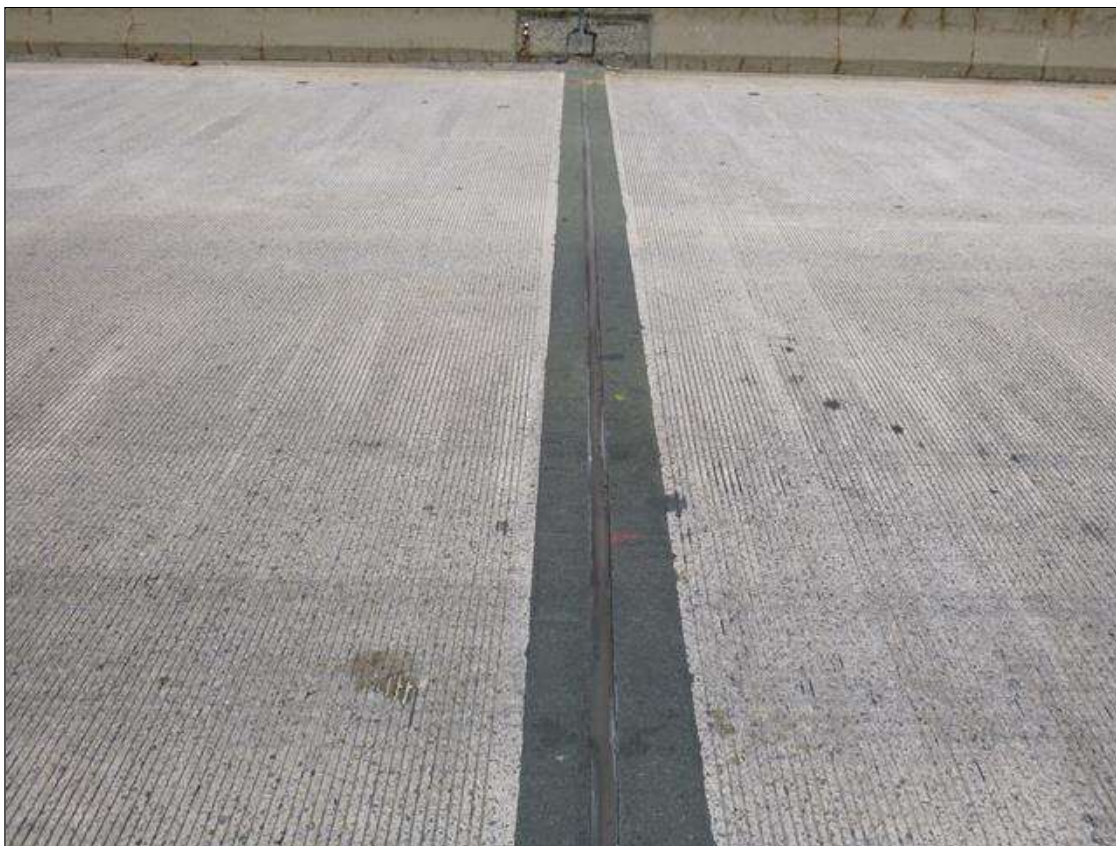
BENT 1 JOINT, WEST BOUND LANES

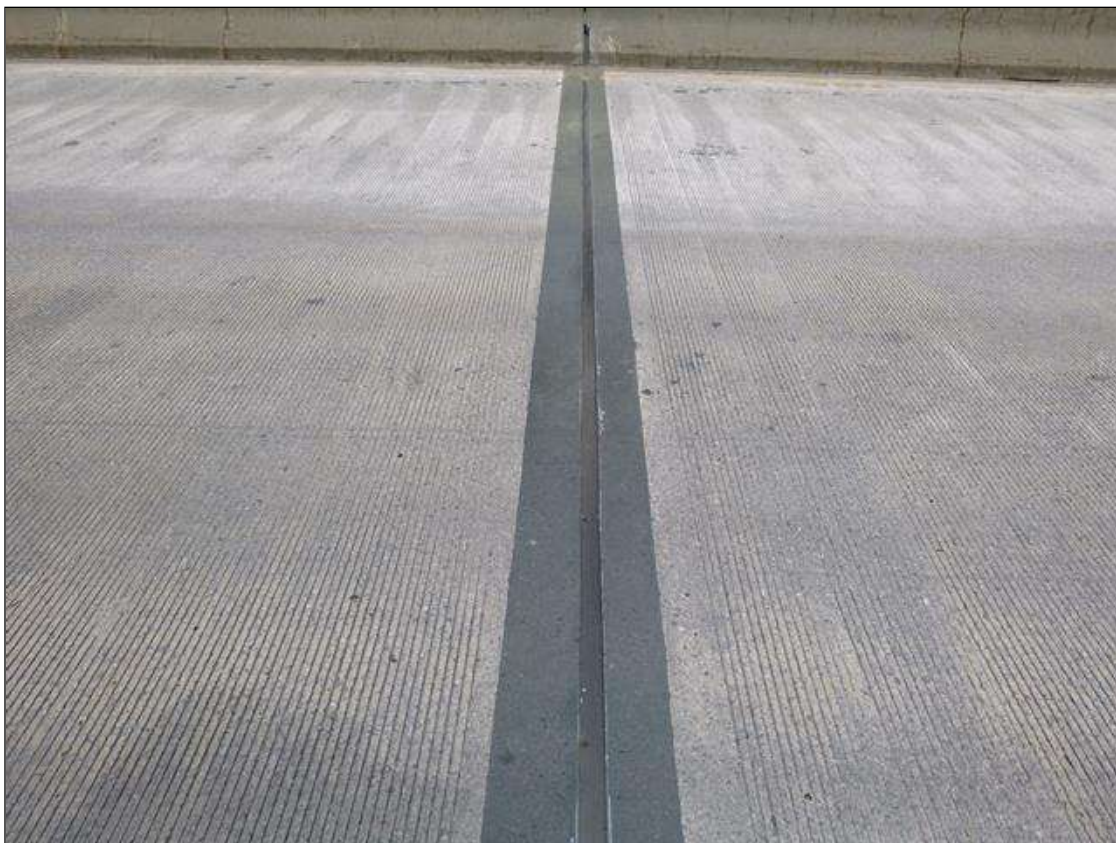
BENT 5 JOINT WEST BOUND LANES

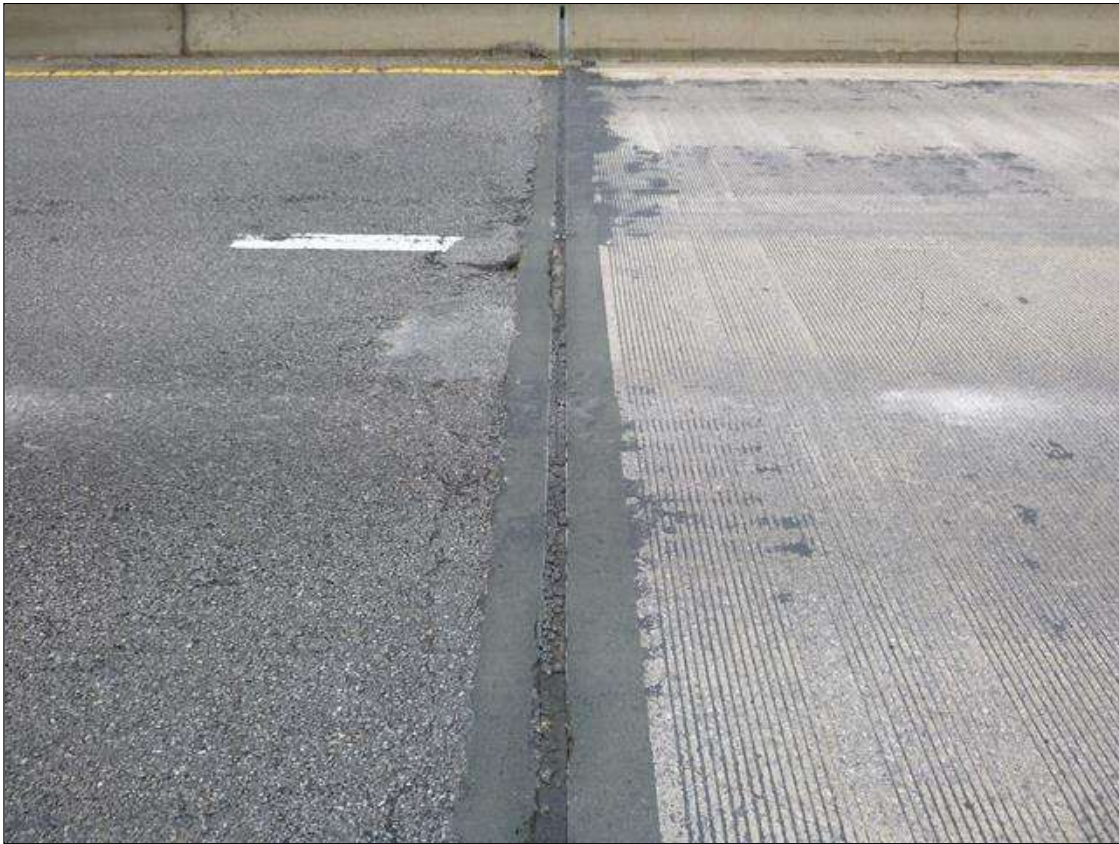
END BENT 2 JOINT WEST BOUND LANES

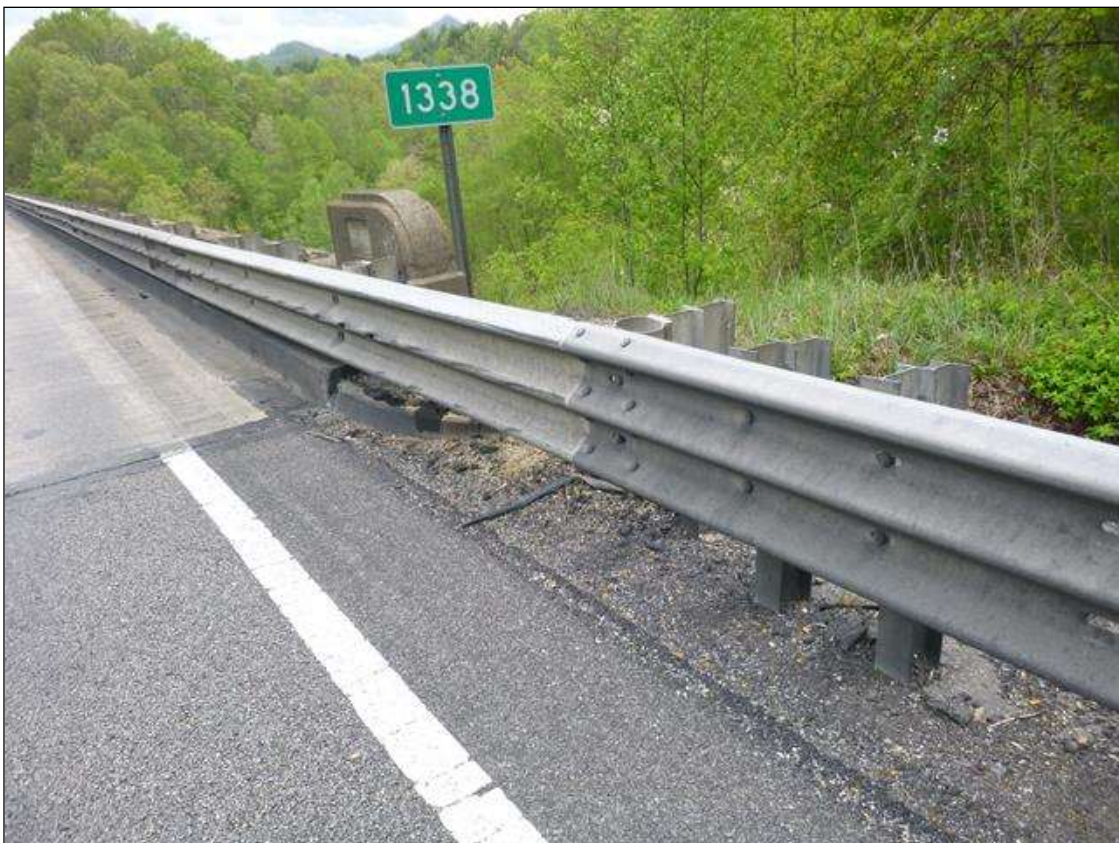
APPROACH GUARDRAIL TRANSITION AT THE LEFT SIDE OF END BENT 2

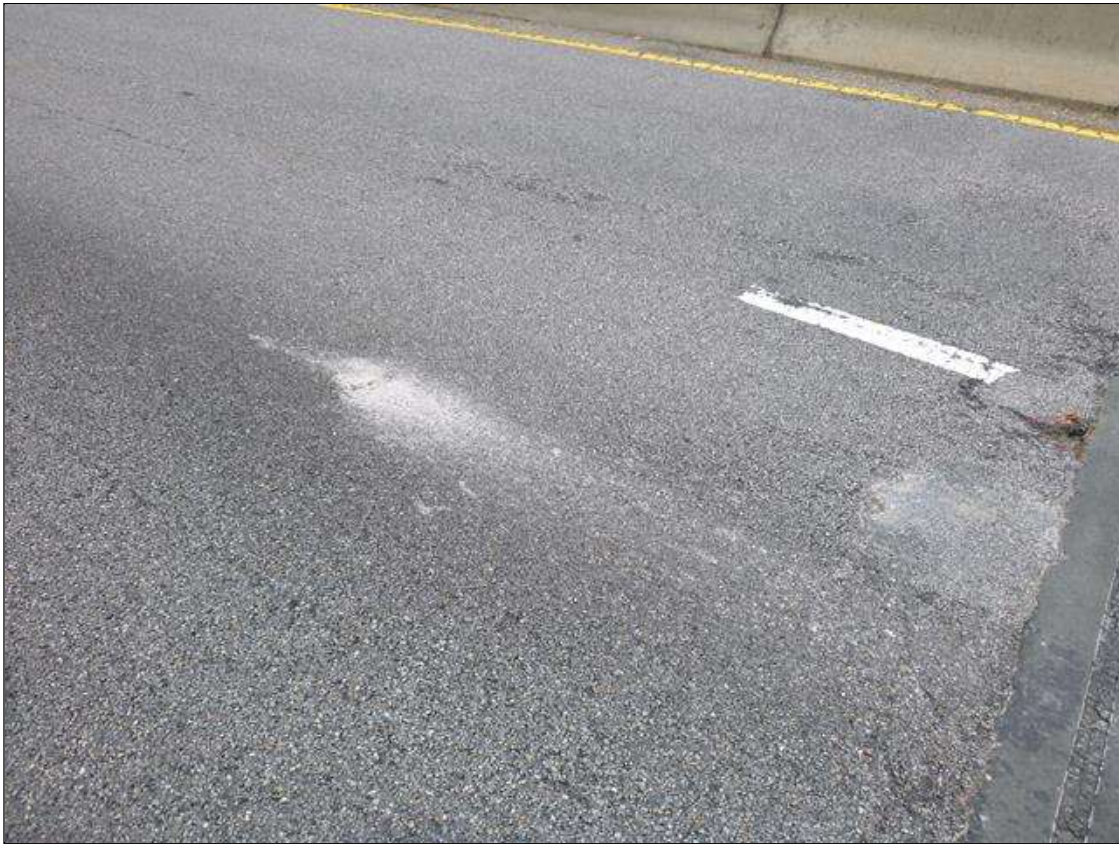
END BENT 2 ASPHALT WEARING SURFACE APPROACH

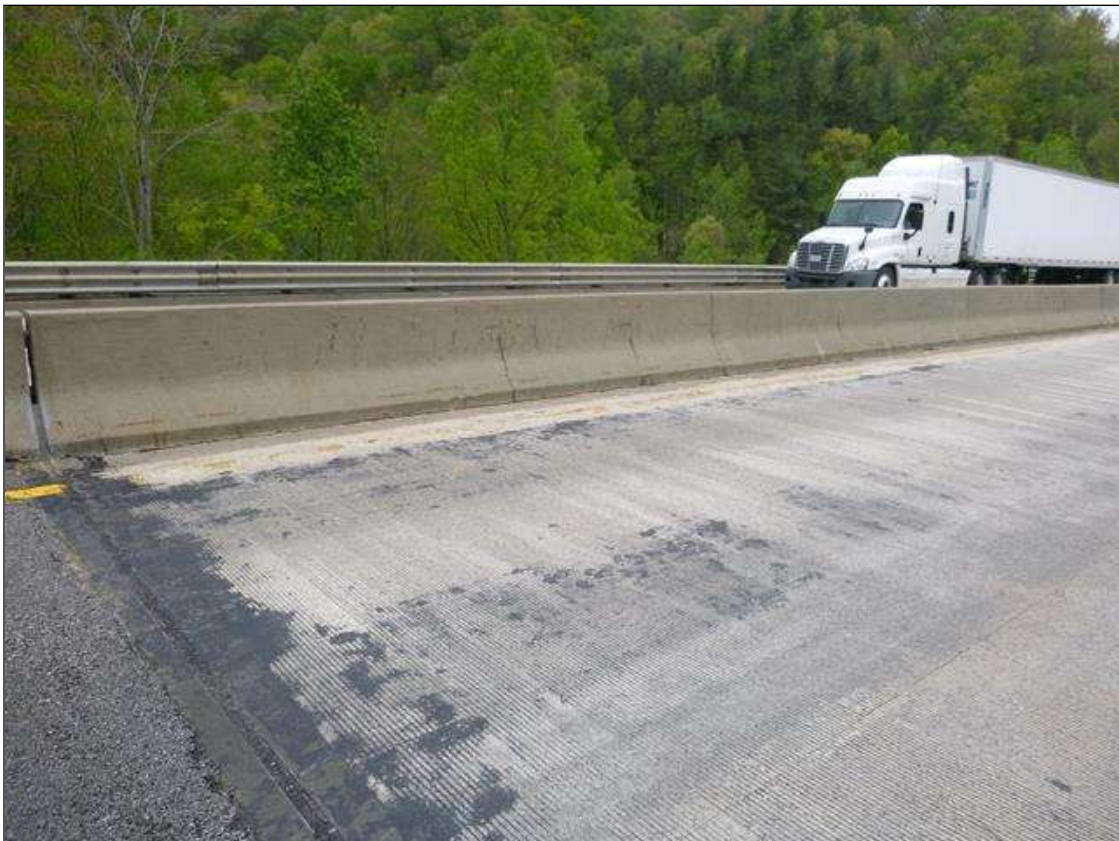
SPAN 6, LEFT SIDE OF THE MEDIAN RAIL

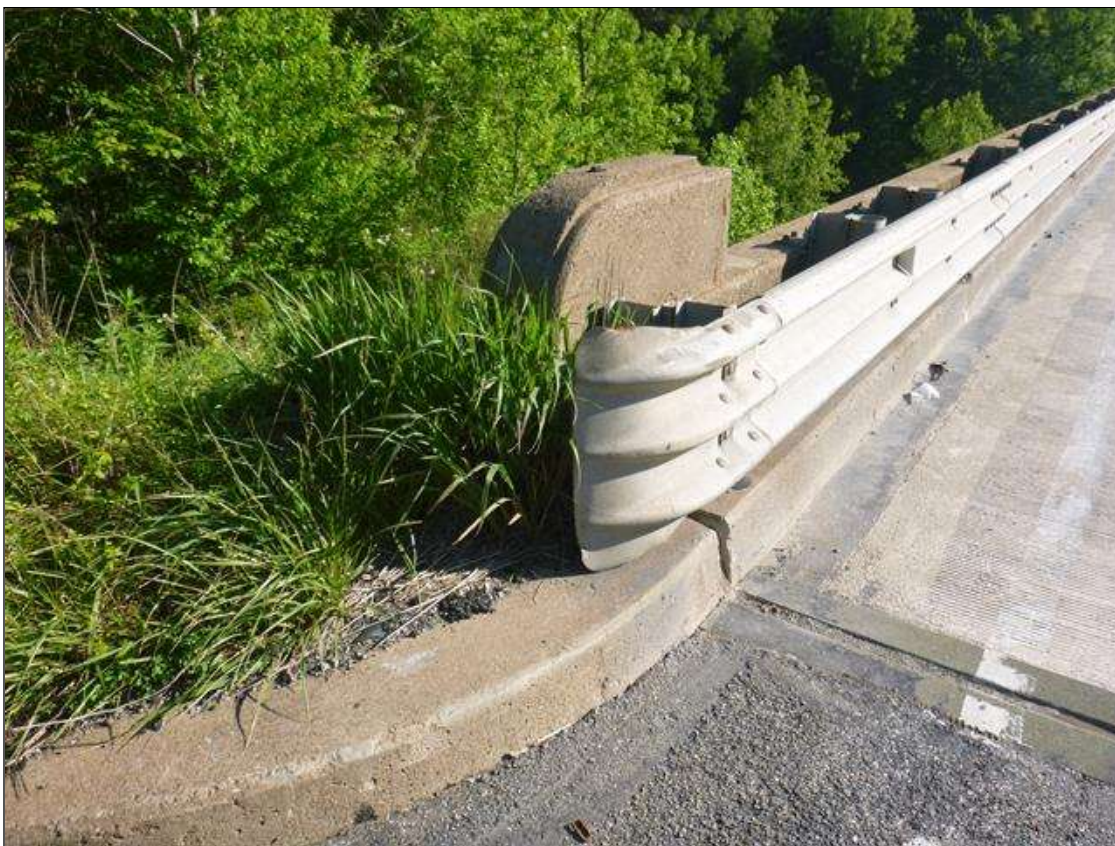
END BENT 2, RIGHT SIDE BRIDGE RAIL END
