NC DEPARTMENT OF TRANSPORTATION  
DIVISION OF HIGHWAYS  
STRUCTURE MANAGEMENT UNIT

## Structure Safety Report

### Routine Element Inspection - Contract

COUNTY: HAYWOOD STRUCTURE NUMBER: 430171 FREQUENCY: 24 MONTHS

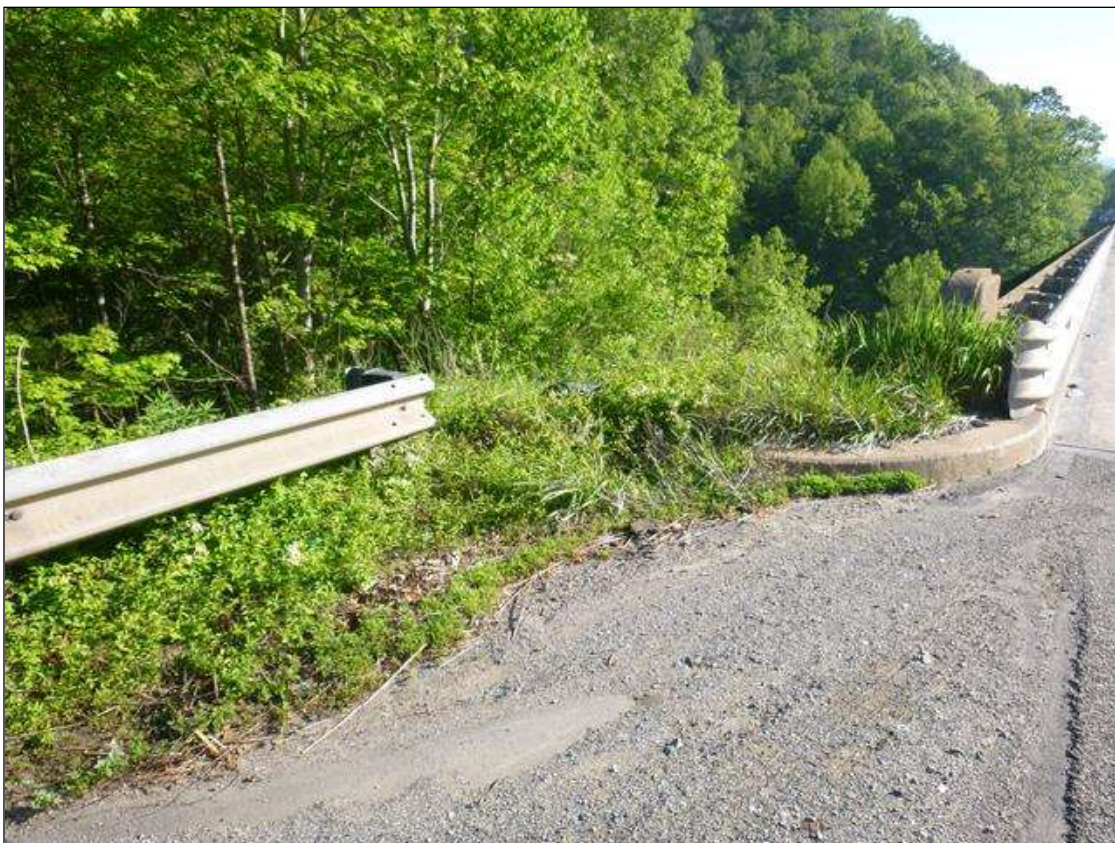
RIGHT SIDE OF END BENT 2

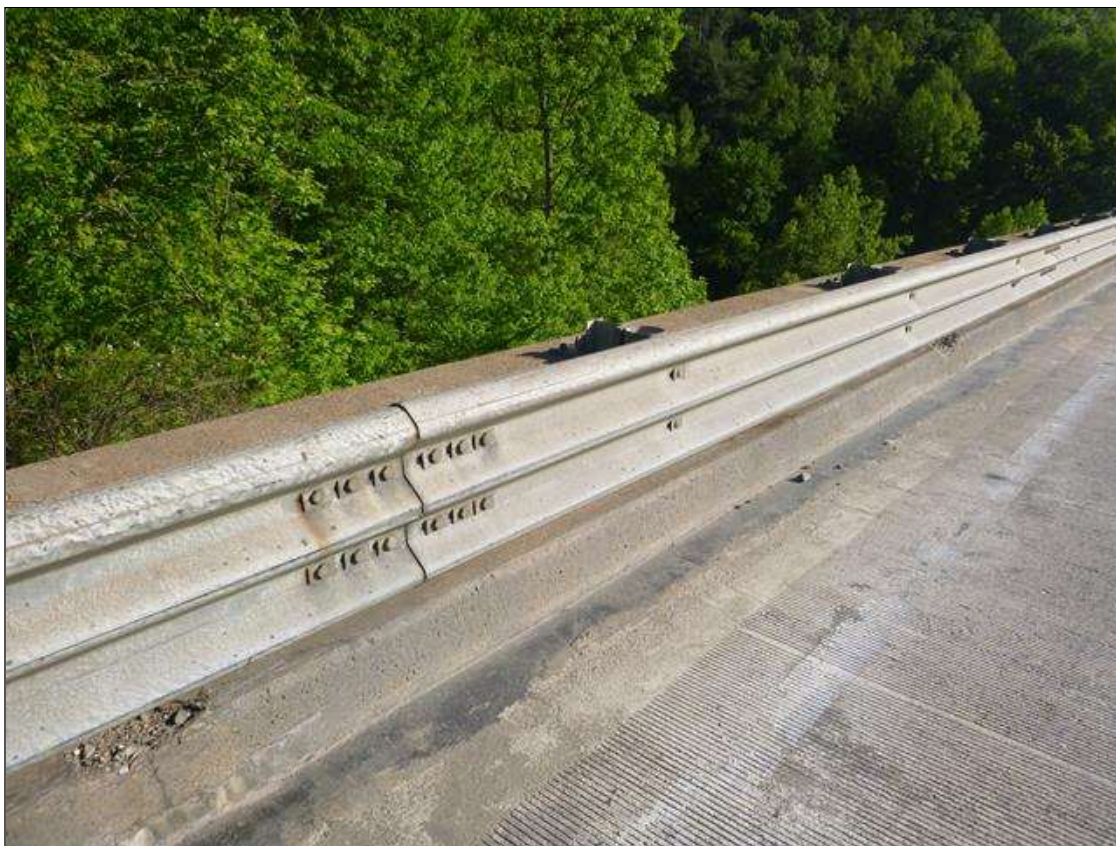
SPAN 6, RIGHT BRIDGE RAIL

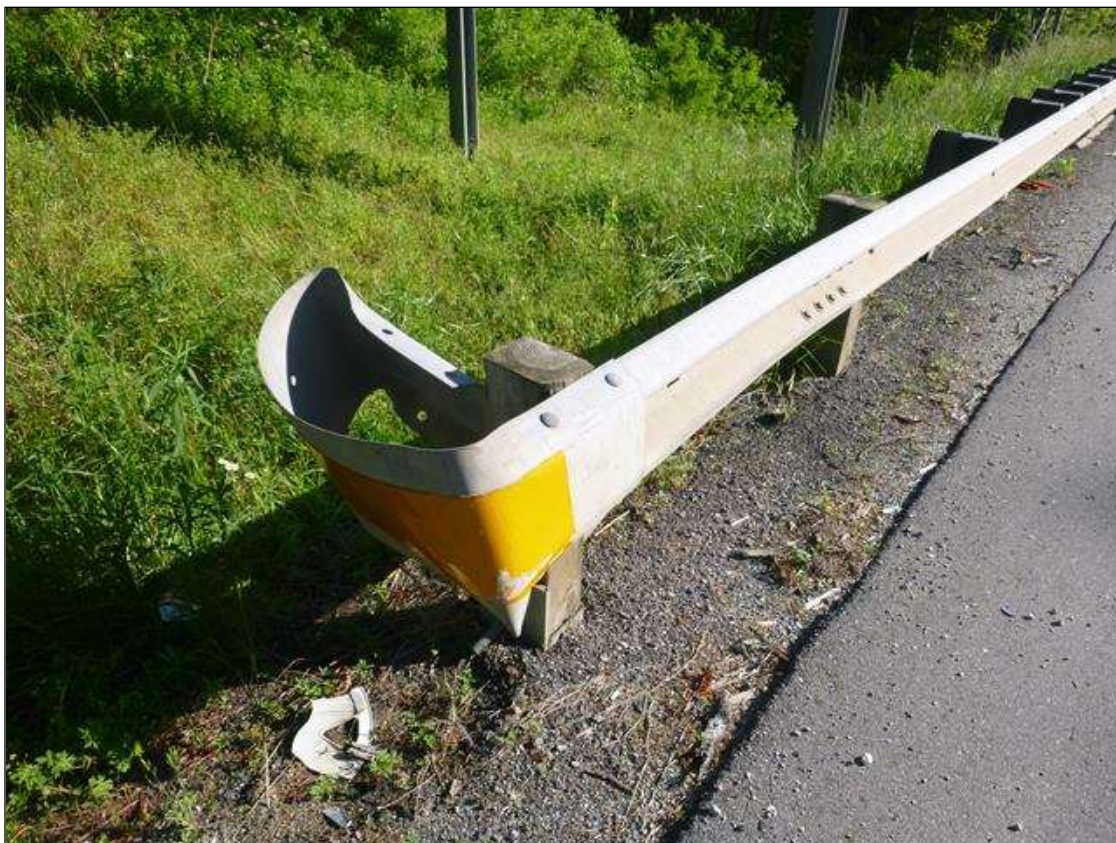
APPROACH GUARDRAIL END AT THE SOUTHEAST CORNER

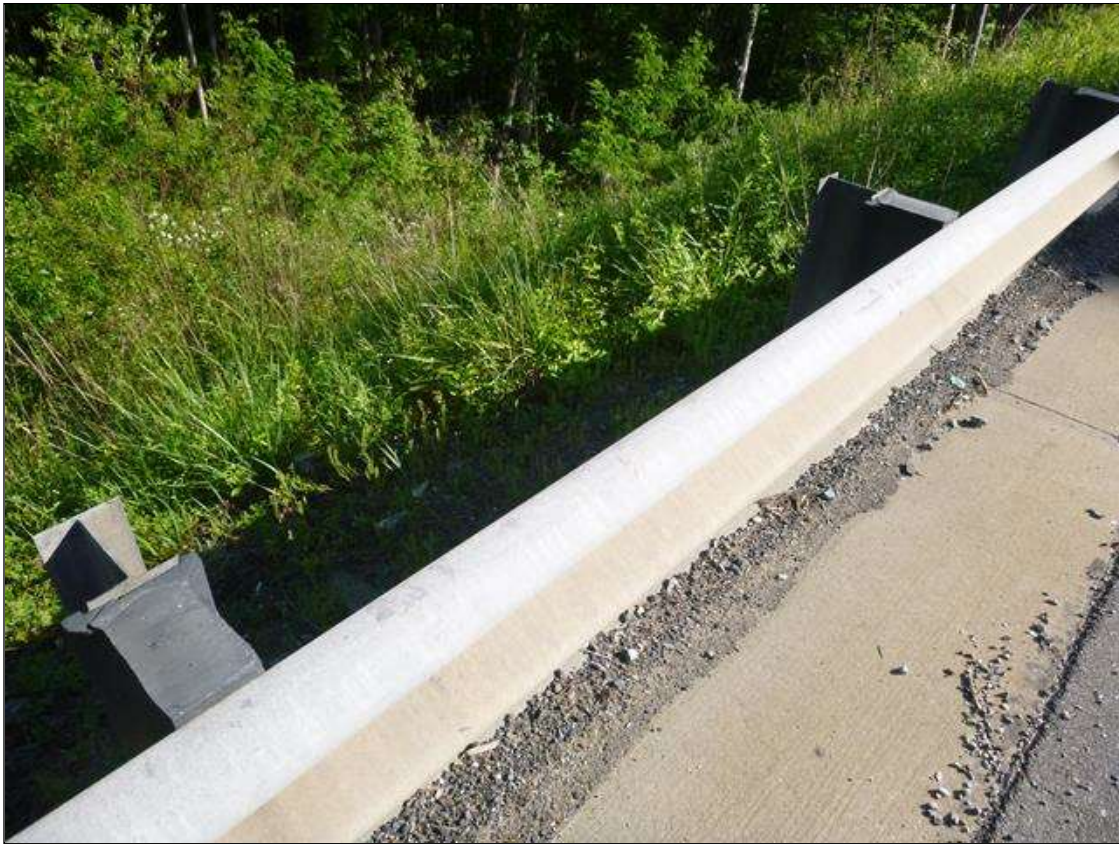
APPROACH GUARDRAIL POST SPACING, 75 INCHES AT THE SOUTHEAST CORNER

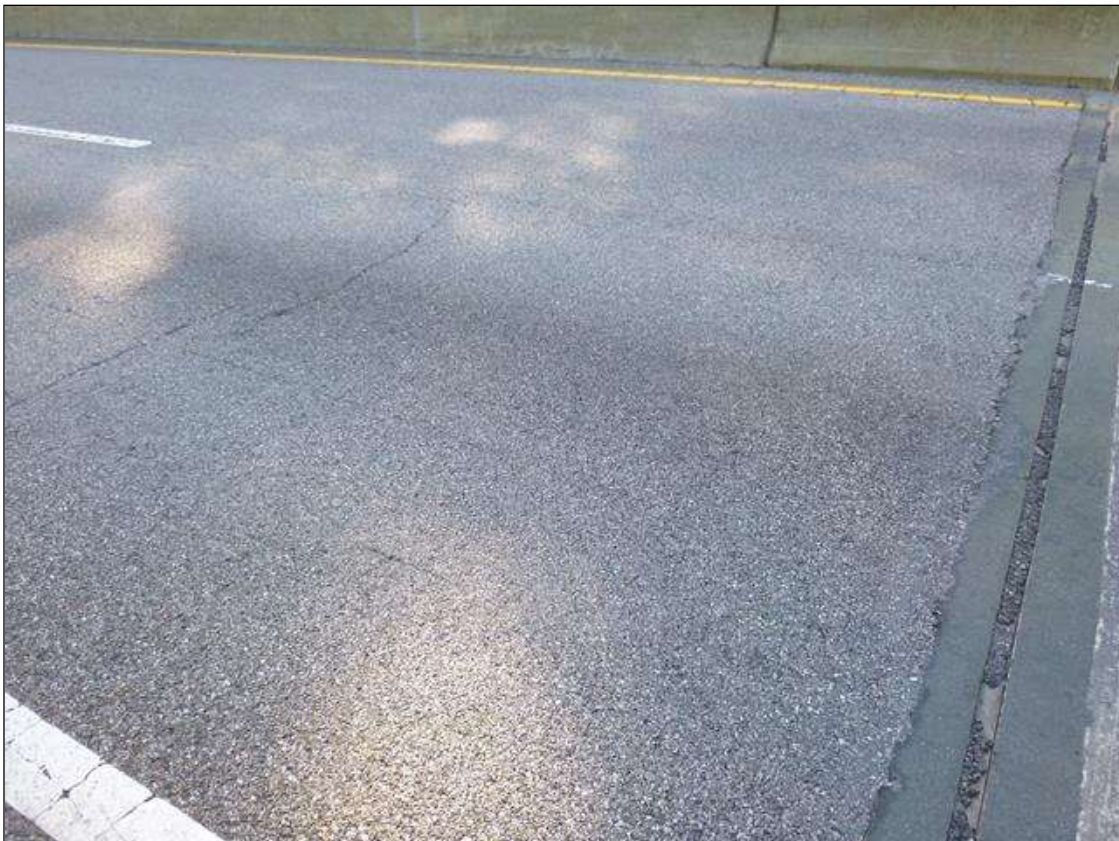
END BENT 1 ASPHALT WEARING SURFACE APPROACH, GOOD CONDITION

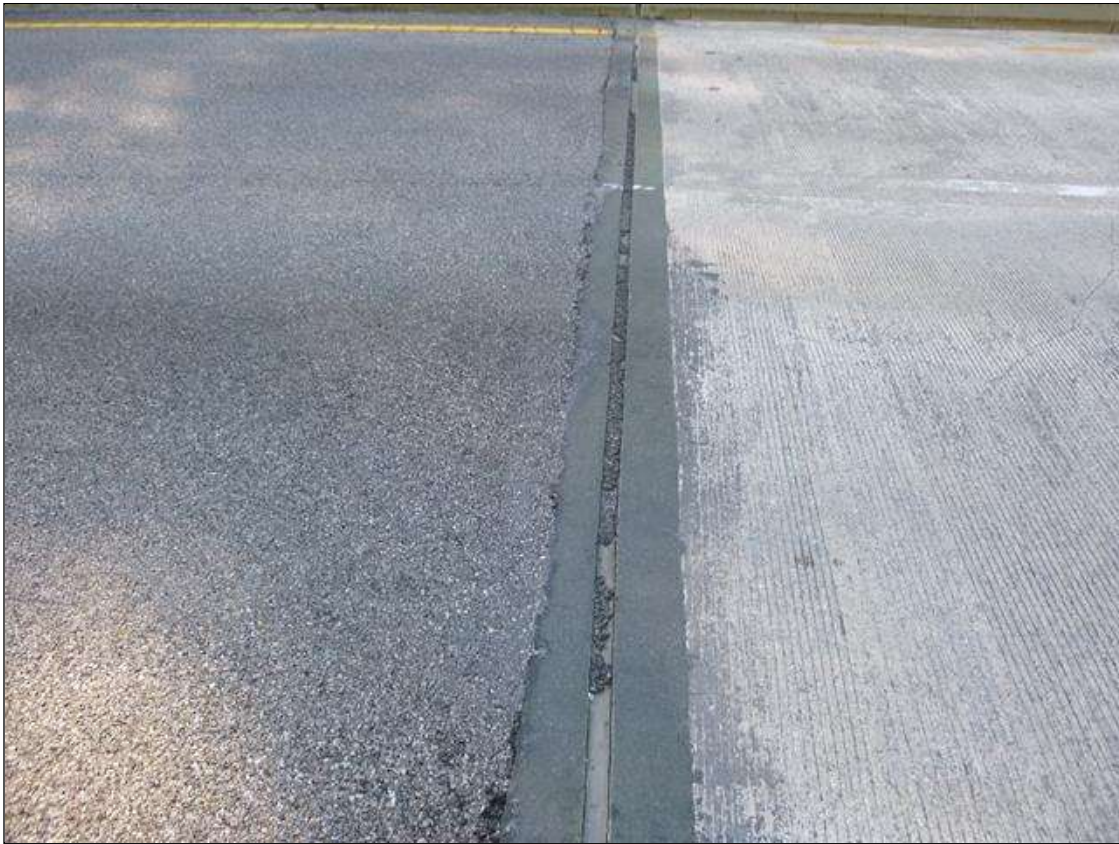
END BENT 1 JOINT, EAST BOUND LANE

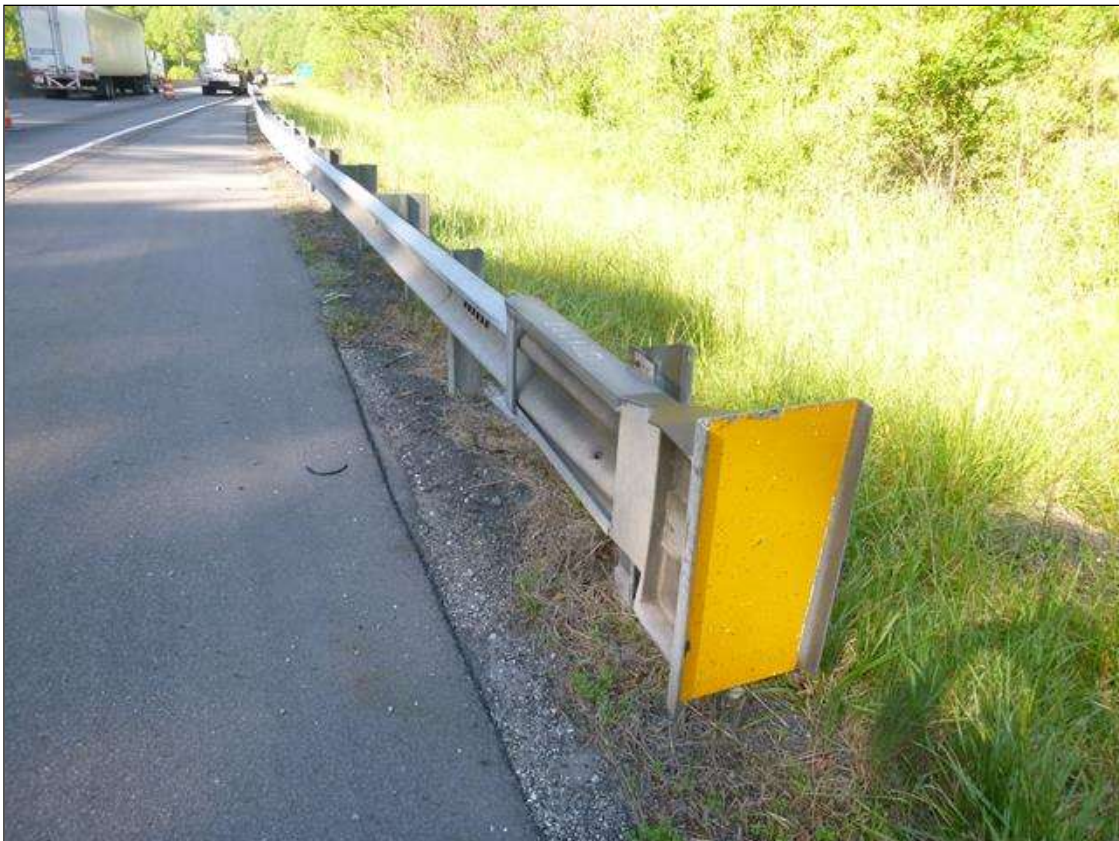
APPROACH GUARDRAIL END AT THE SOUTHWEST CORNER

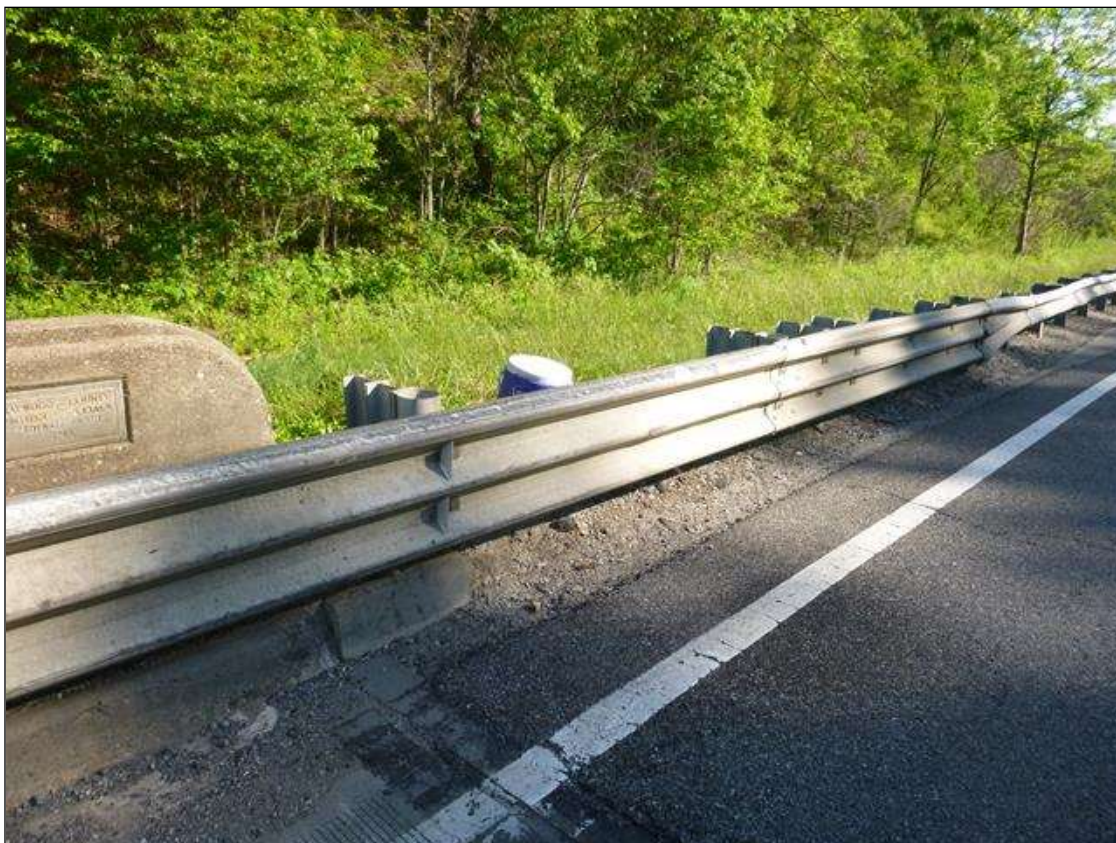
APPROACH GUARDRAIL TRANSITION AT THE RIGHT SIDE OF END BENT 1

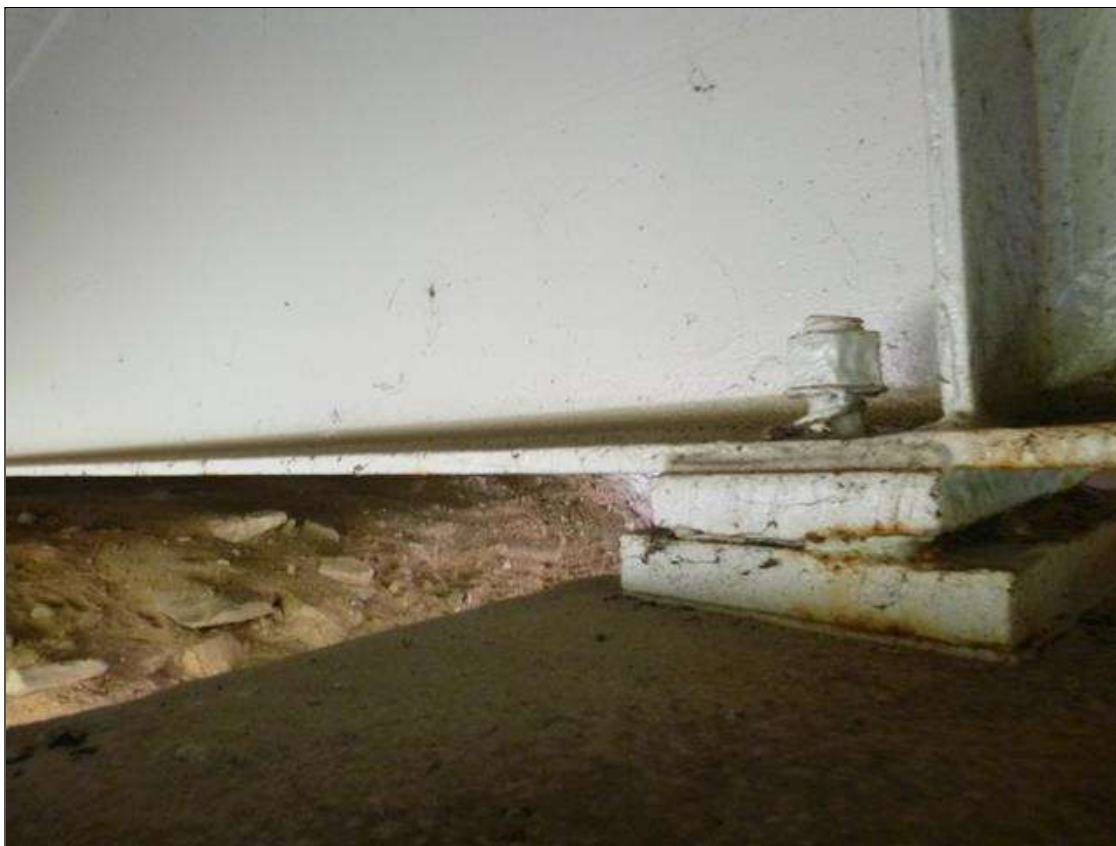
SPAN 1, BEAM 7 FAR BEARING

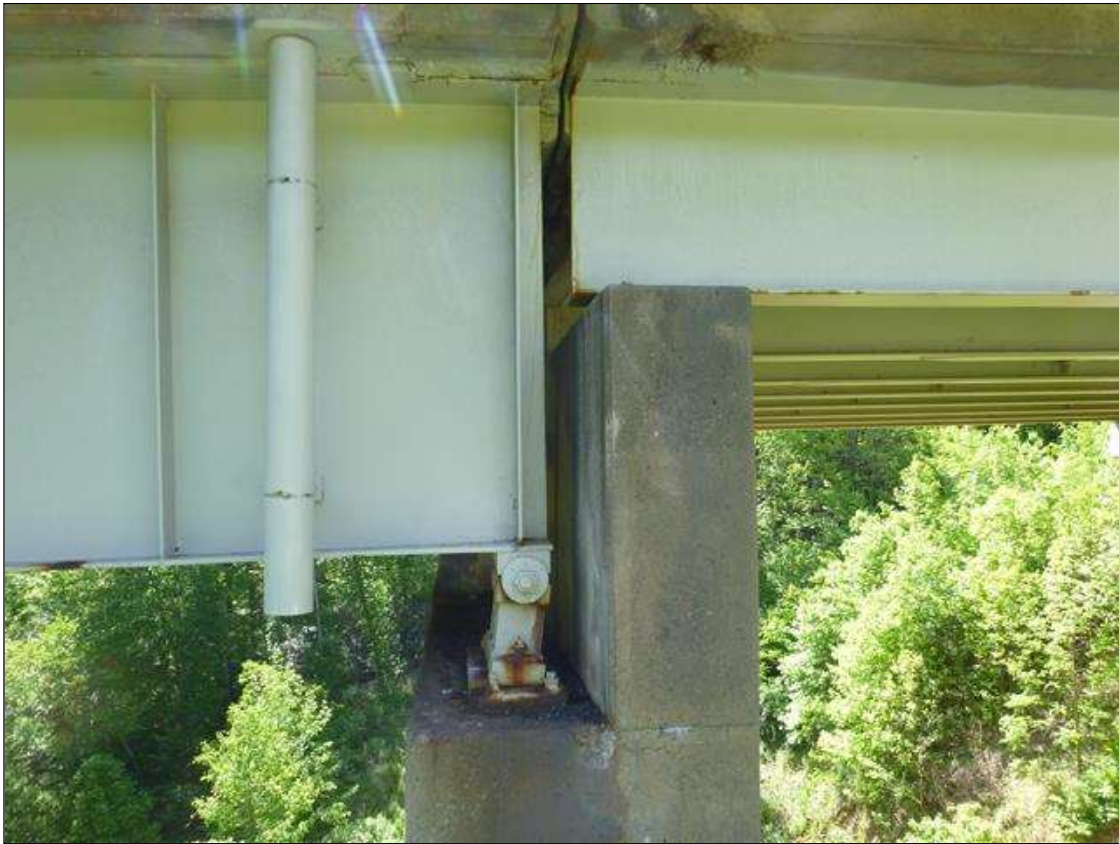
BENT 4, RIGHT END SUPERSTRUCTURE

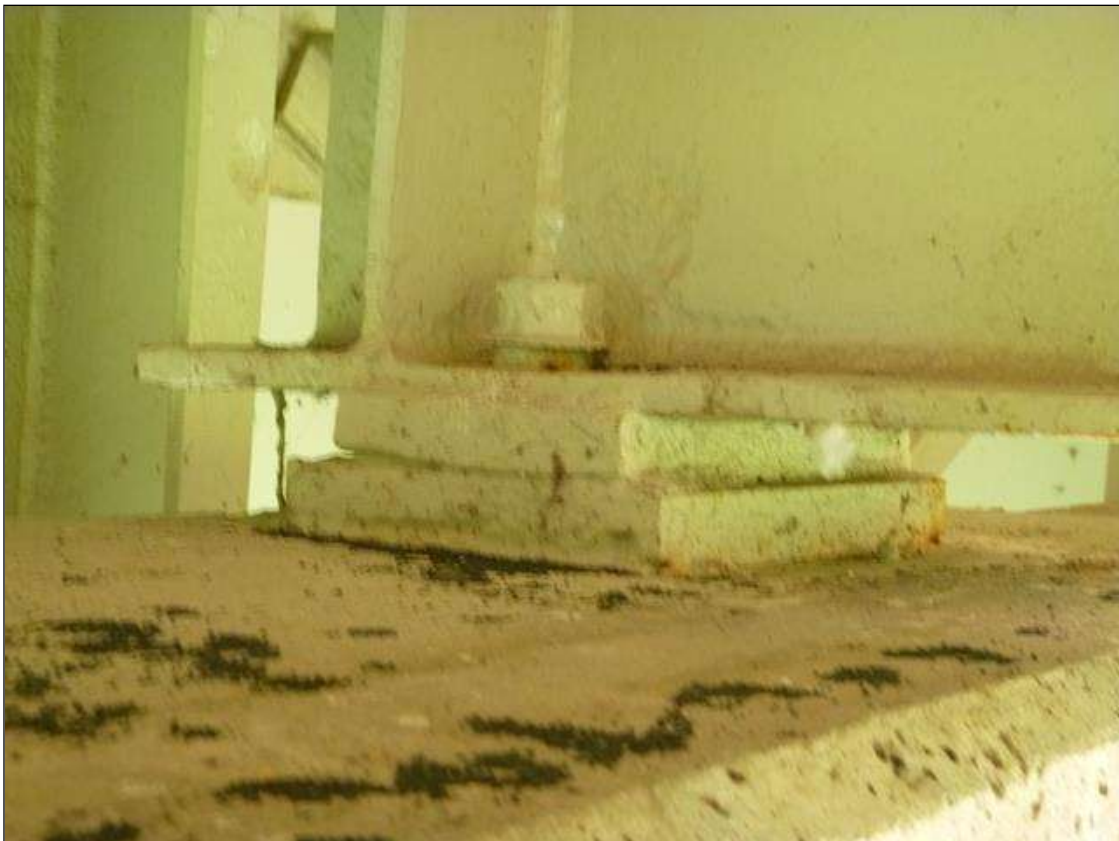
SPAN 5 BEAM 4, NEAR BEARING

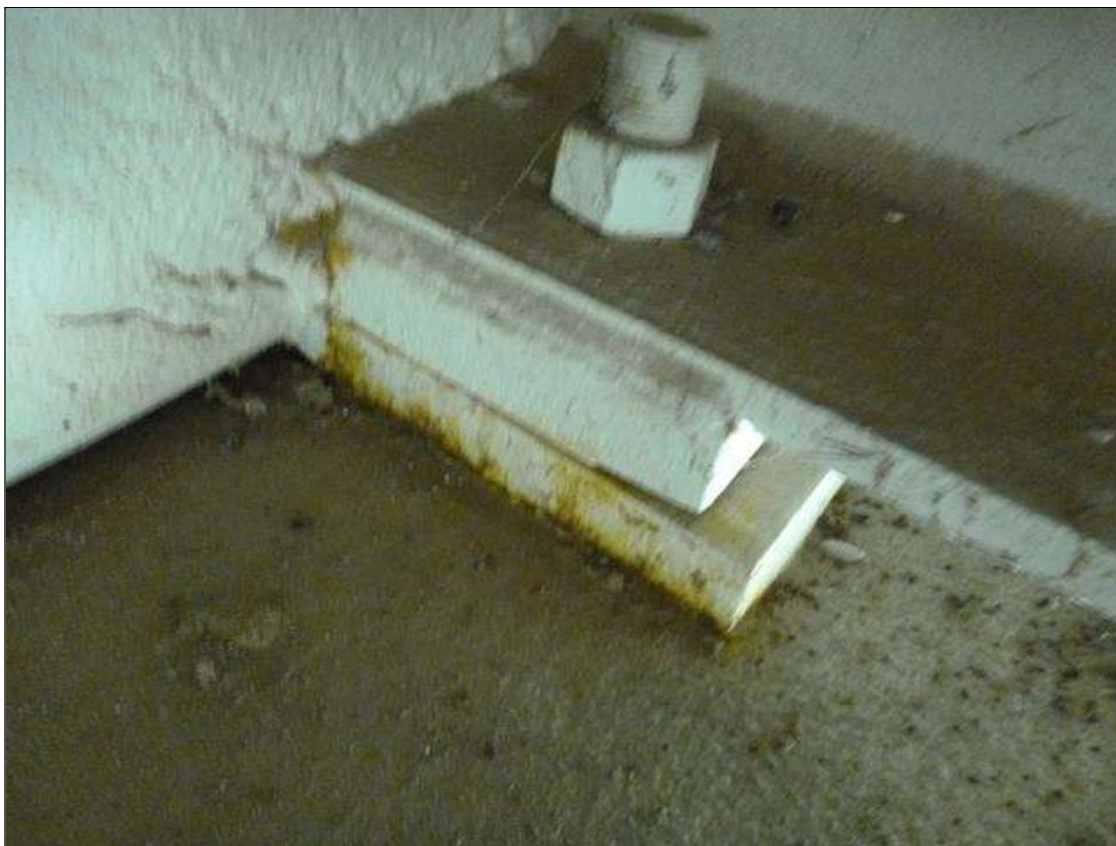
SPAN 1, BEAM 3 NEAR BEARING

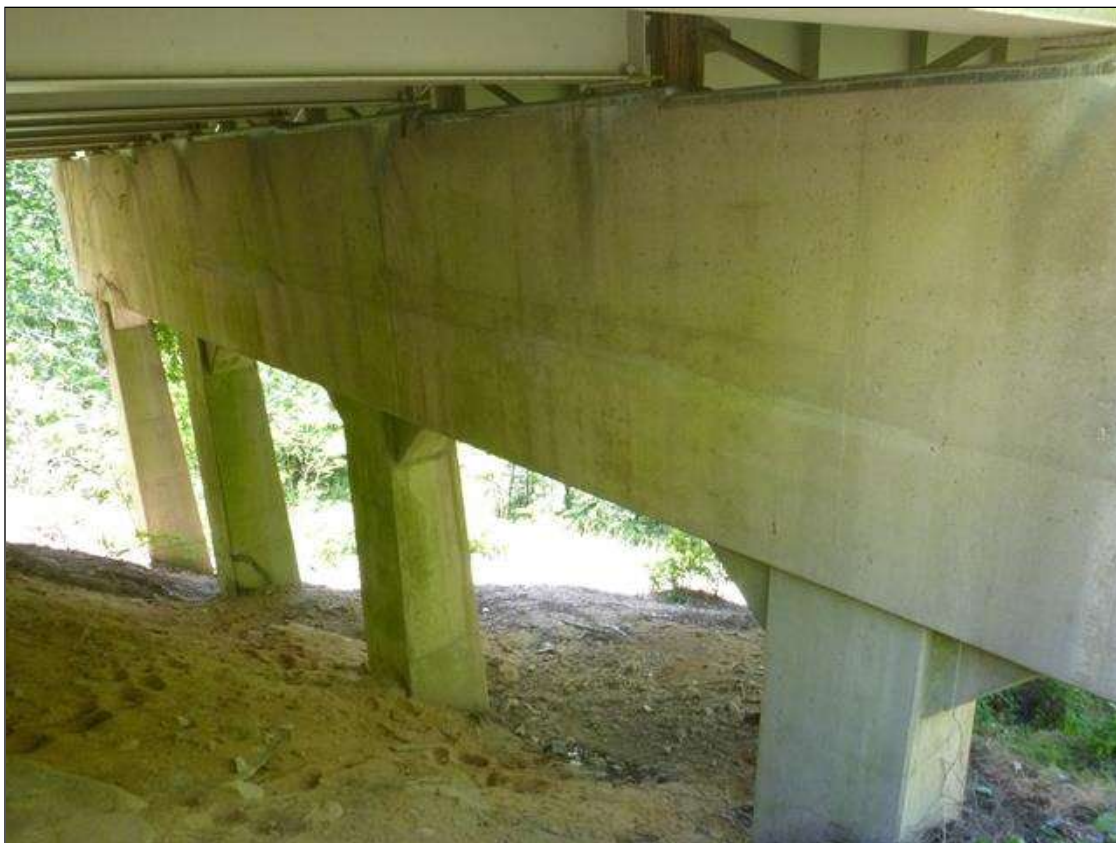
BENT 1, SPAN 1 SIDE

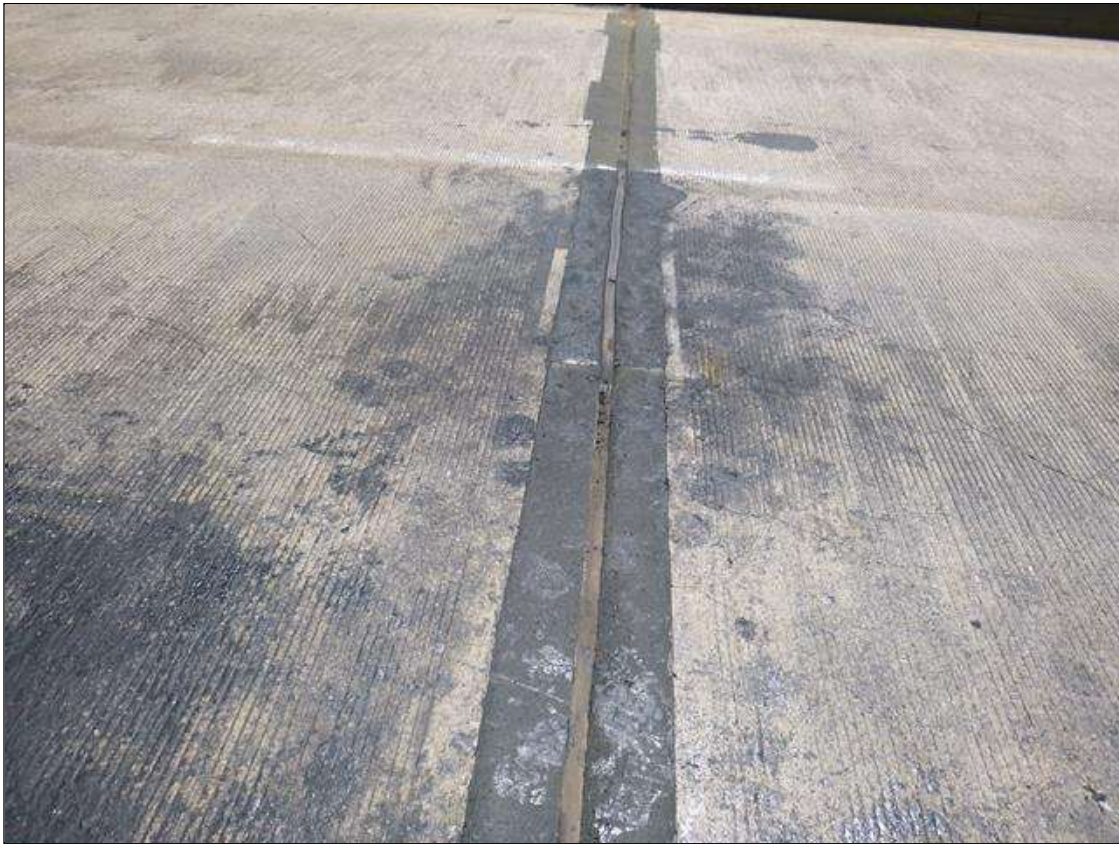
BENT 1 JOINT, EAST BOUND LANES

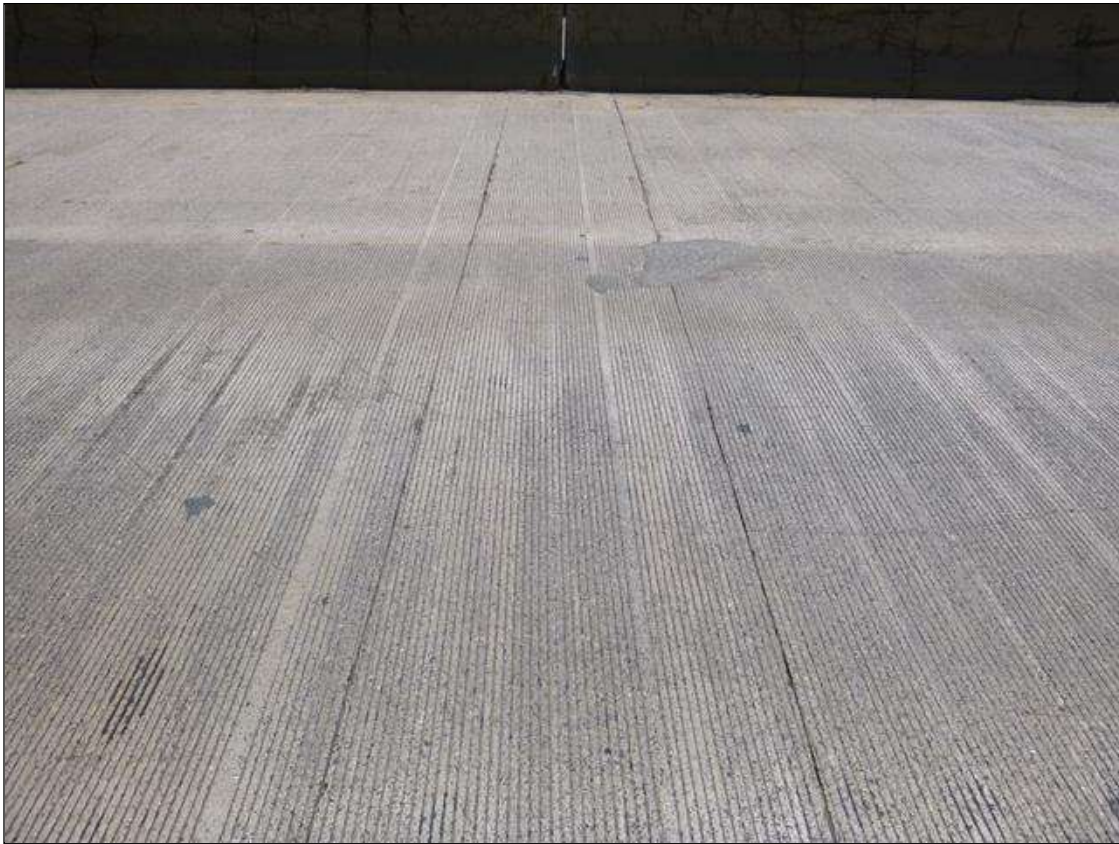
BENT 2 TOP OF DECK, EAST BOUND LANES

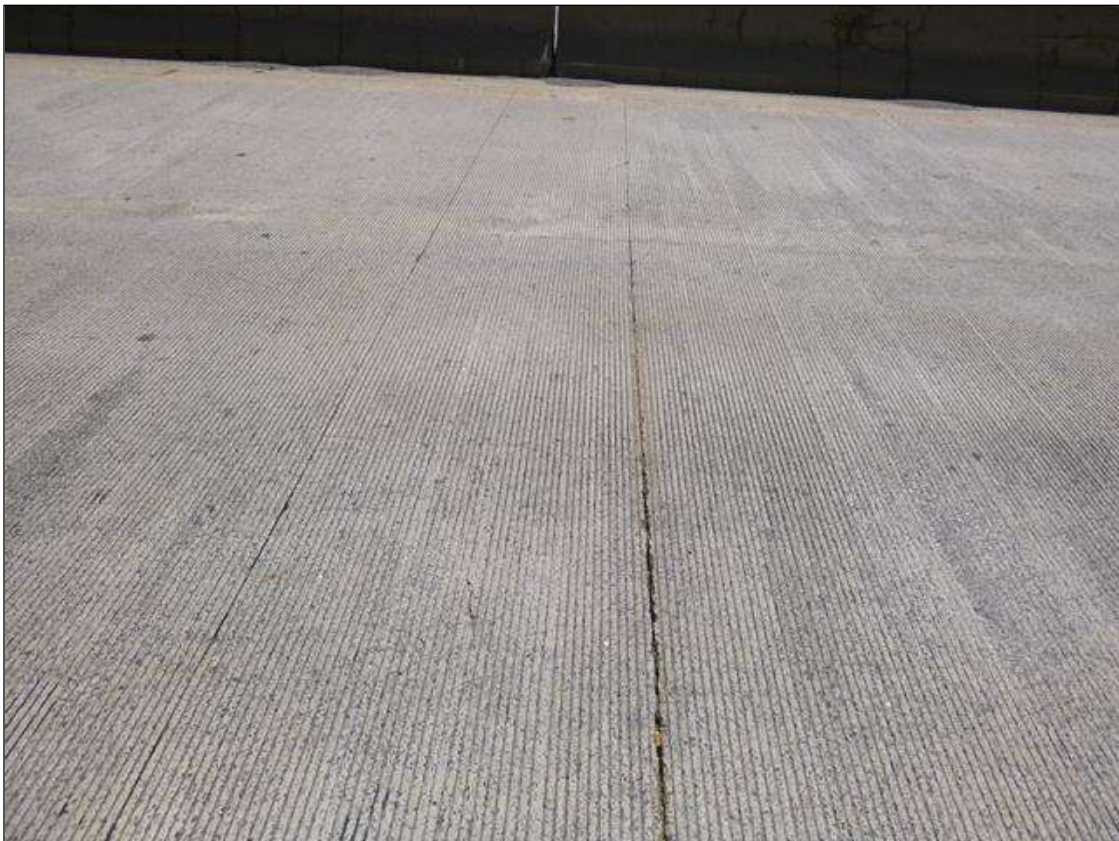
BENT 3 TOP OF THE DECK, EAST BOUND LANES

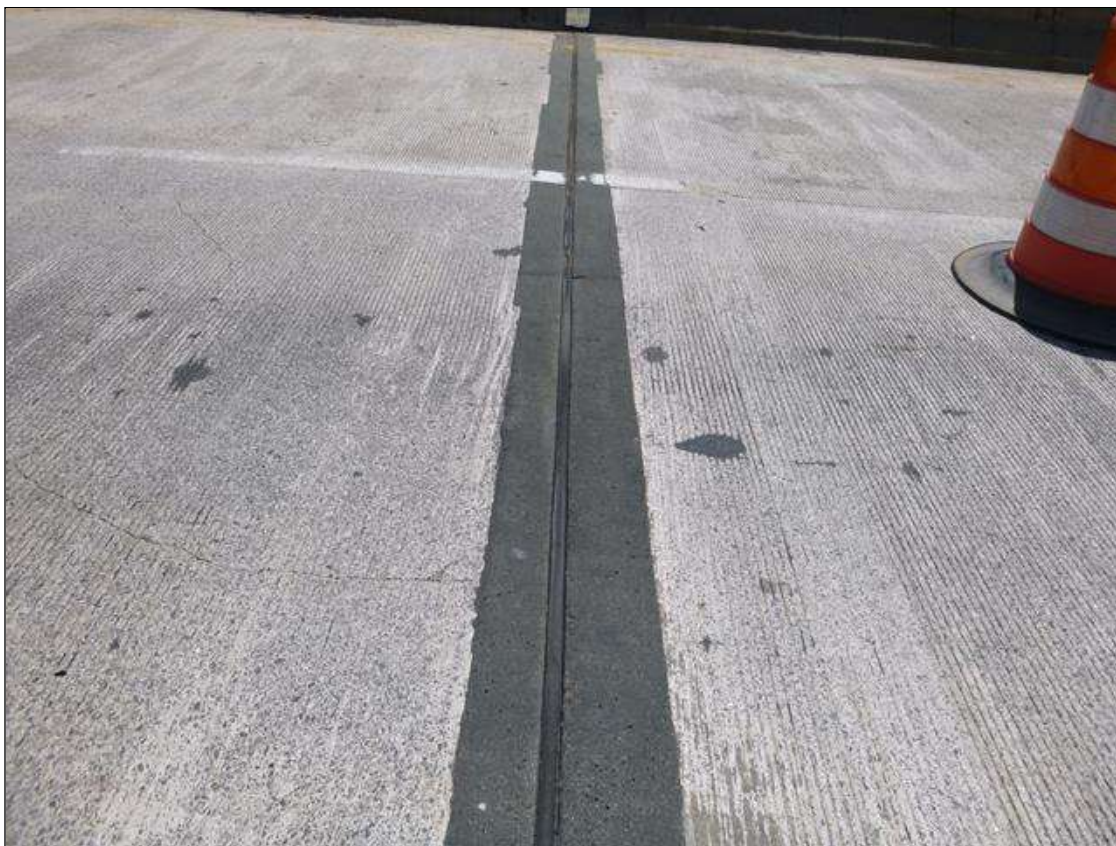
BENT 4 JOINT, EAST BOUND LANES

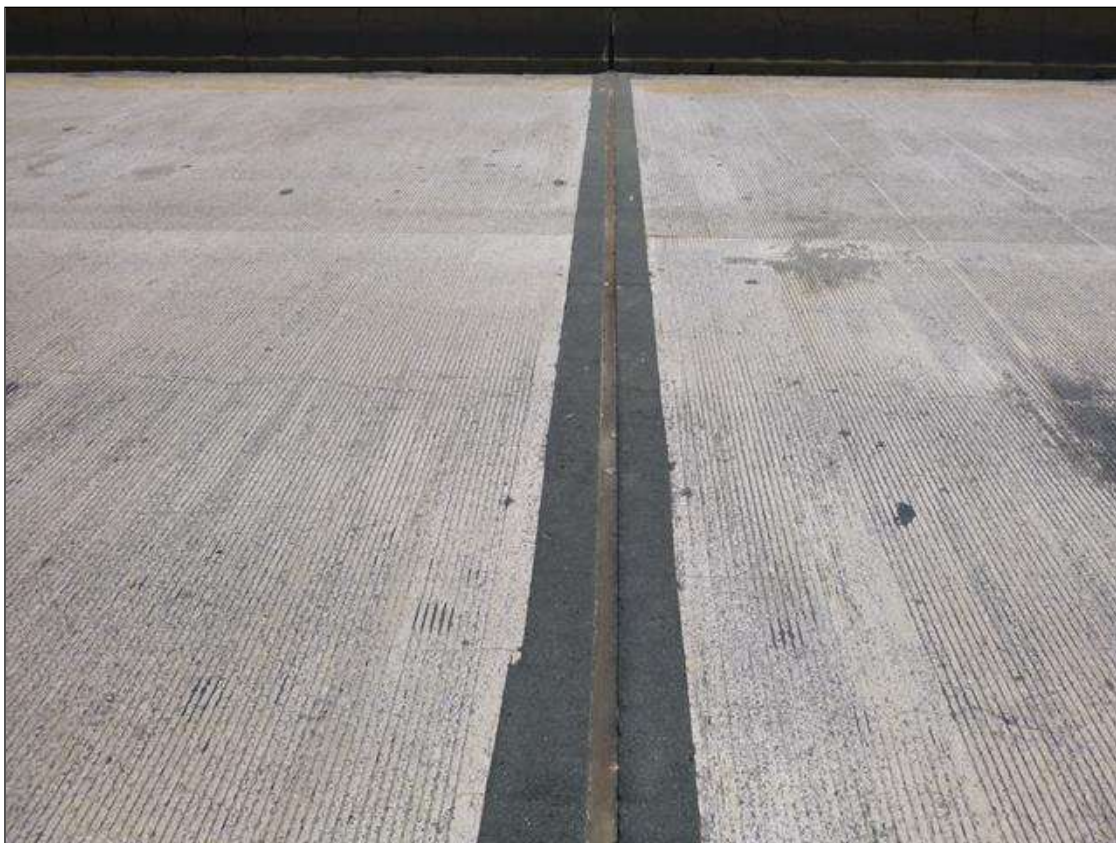
BENT 5 JOINT, EAST BOUND LANES

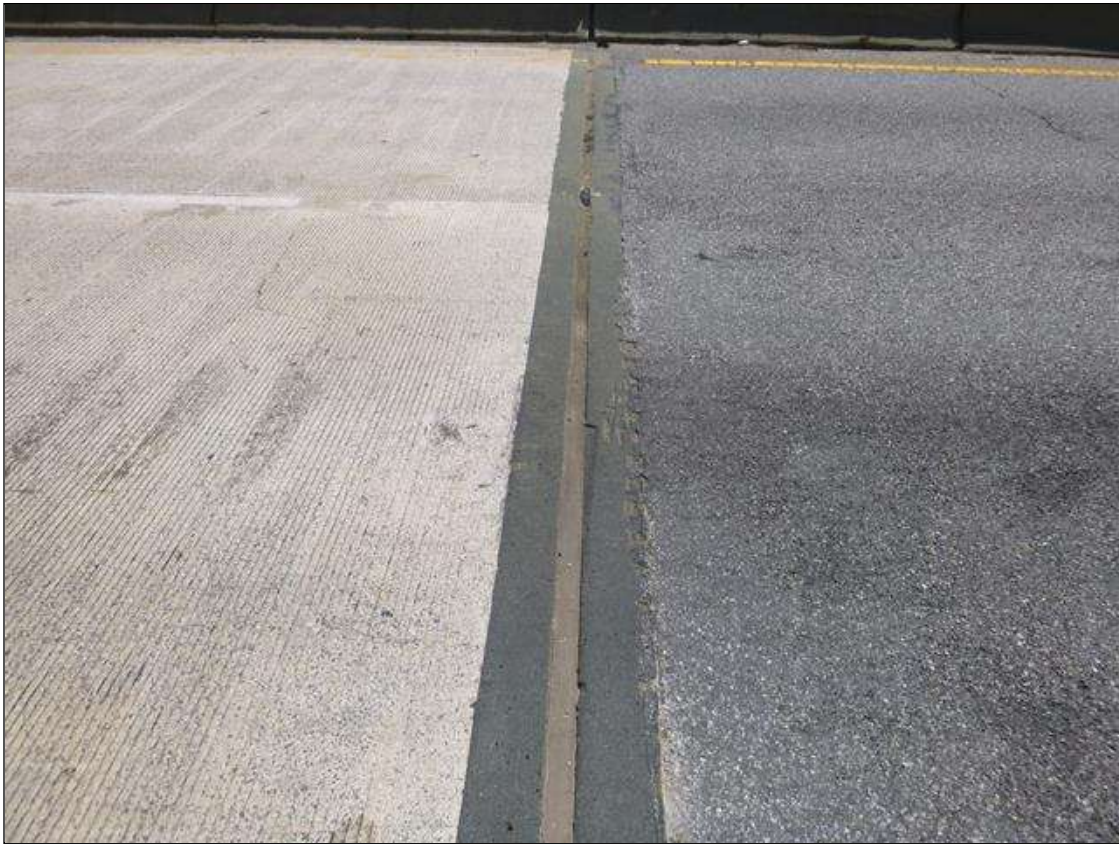
END BENT 2 JOINT, EAST BOUND LANES

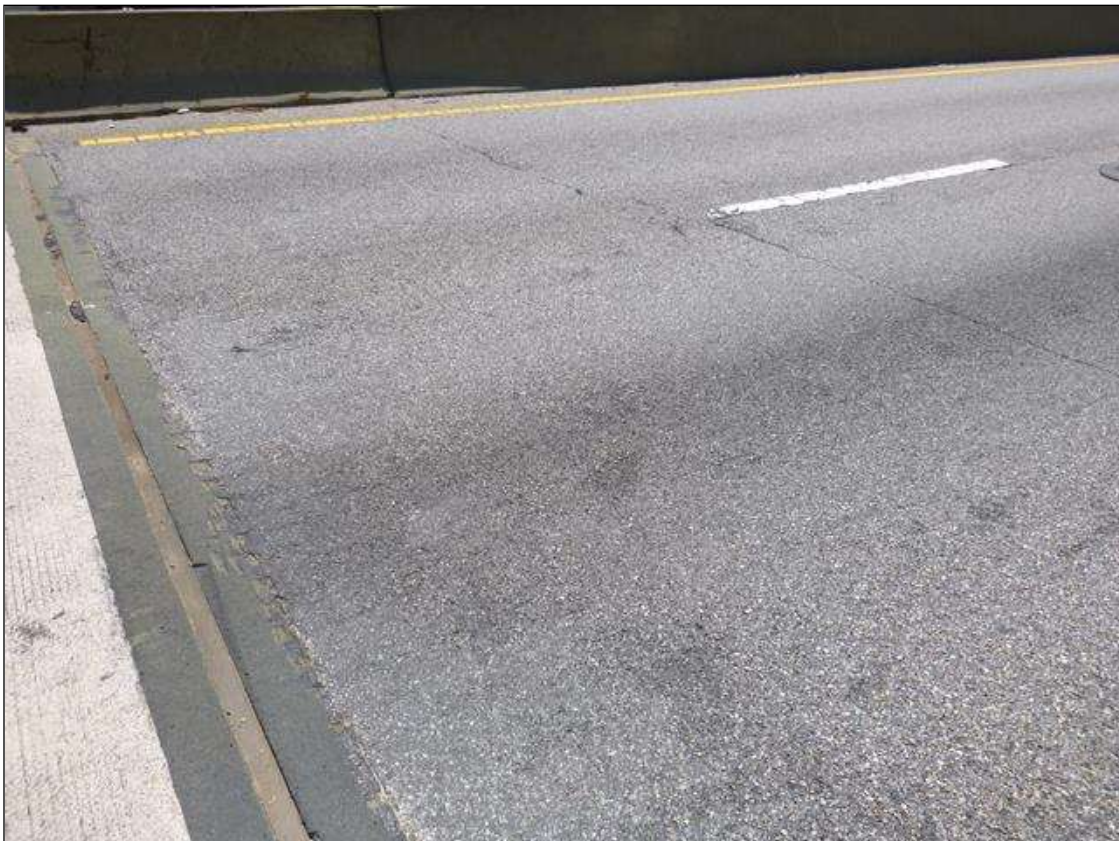
END BENT 2 ASPHALT WEARING SURFACE APPROACH, GOOD CONDITION

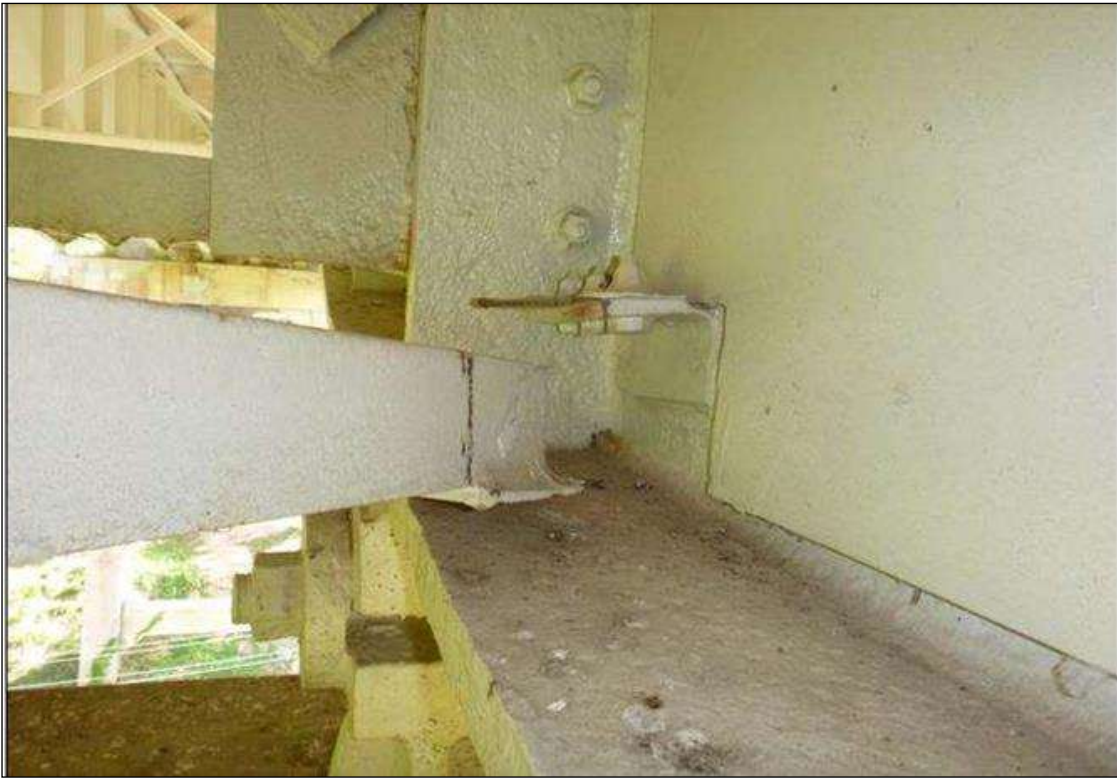
| MMS Code | Description of Function | Unit | Quantity | Remarks | Est. Cost |
|---|---|---|---|---|---|
| 3314 | Maintain Steel Superstructure Components | LF | 1 | SPAN 4, BAY 3 AT BENT 3, SWAY BRACE CONNECTION TO BEAM 3, AT EAST SIDE OF BEARING BROKE LOOSE | |

| MMS Code | MMS Description | Quantity |
|---|---|---|
| SPAN 4, BAY 3 AT BENT 3, SWAY BRACE CONNECTION TO BEAM 3, AT EAST SIDE OF BEARING BROKE LOOSE | | |

SPAN 4, BAY 3 AT BENT 3, SWAY BRACE CONNECTION TO BEAM 3, AT EAST SIDE OF BEARING BROKE LOOSE
