NC DEPARTMENT OF TRANSPORTATION  
DIVISION OF HIGHWAYS  
STRUCTURE MANAGEMENT UNIT

## Structure Safety Report

### Routine Element Inspection

COUNTY: CUMBERLAND STRUCTURE NUMBER: 250052 FREQUENCY: 24 MONTHS

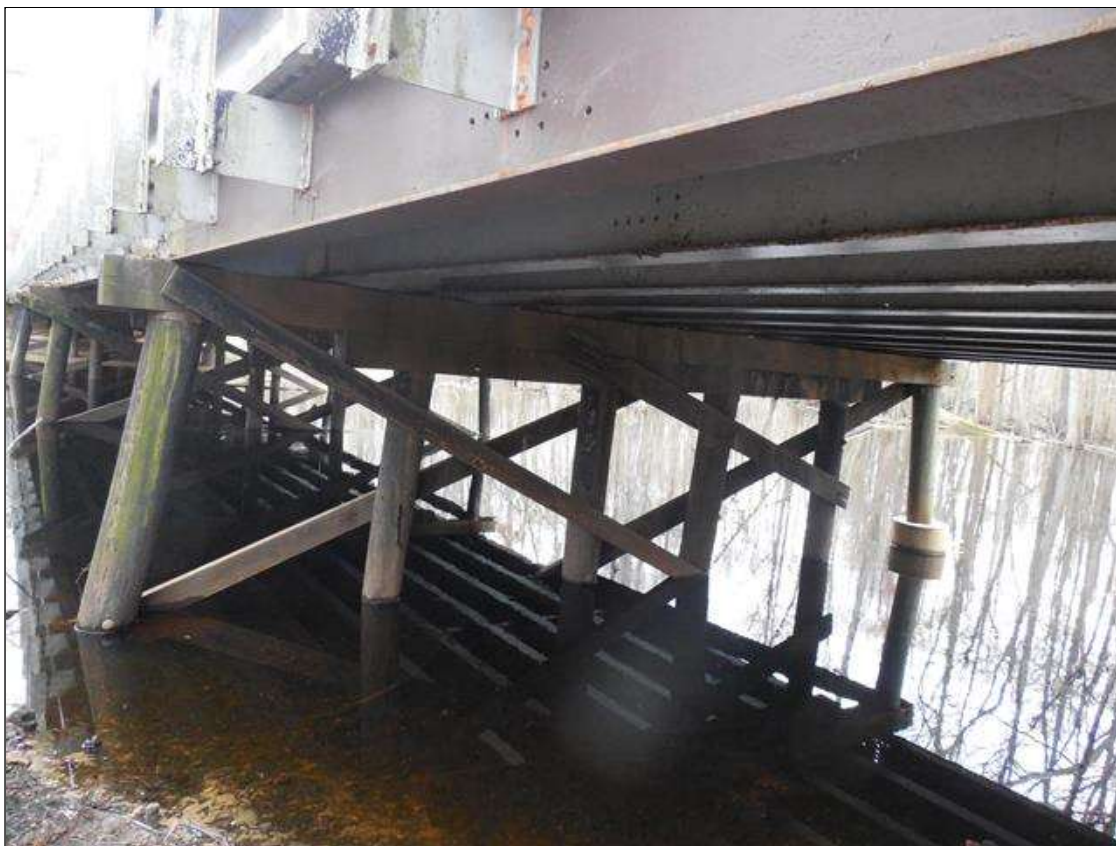
700 Square Feet of Crack (Wearing Surface): Width of more than 0.05 in. or spacing of less than 1.0 ft. MAP CRACKING IN SPAN 1 ASPHALT WEARING SURFACE  
28 Square Feet of Crack (Wearing Surface): Width of more than 0.05 in. or spacing of less than 1.0 ft. 1/2" TRANSVERSE CRACKS OVER BENT 1

2 Feet of Corrosion: Section loss is evident or pack rust is present but does not warrant structural review. RUST WITH SECTION LOSS 1/16" IN FLANGE WITH 7/16" REMAINING AT BENT 1  
2 Square Feet of Effectiveness (Steel Protective Coatings): Limited effectiveness.  
30 Square Feet of Peeling/Bubbling/Cracking (steel Protective Coatings): Finish coats only.  
2 Feet of Corrosion: Section loss is evident or pack rust is present but does not warrant structural review. 1/8" SECTION LOSS IN WEB 3/8" REMAINING AND 1/4" REMAINING IN BOTTOM FLANGE AT END BENT 1, BAY 1 SIDE  
2 Square Feet of Effectiveness (Steel Protective Coatings): Limited effectiveness. 2' AT END BENT 1 END

2 Feet of Corrosion: Section loss is evident or pack rust is present but does not warrant structural review. SECTION LOSS WITH 7/16" REMAINING IN FLANGE AT BENT 1  
2 Square Feet of Effectiveness (Steel Protective Coatings): Limited effectiveness.

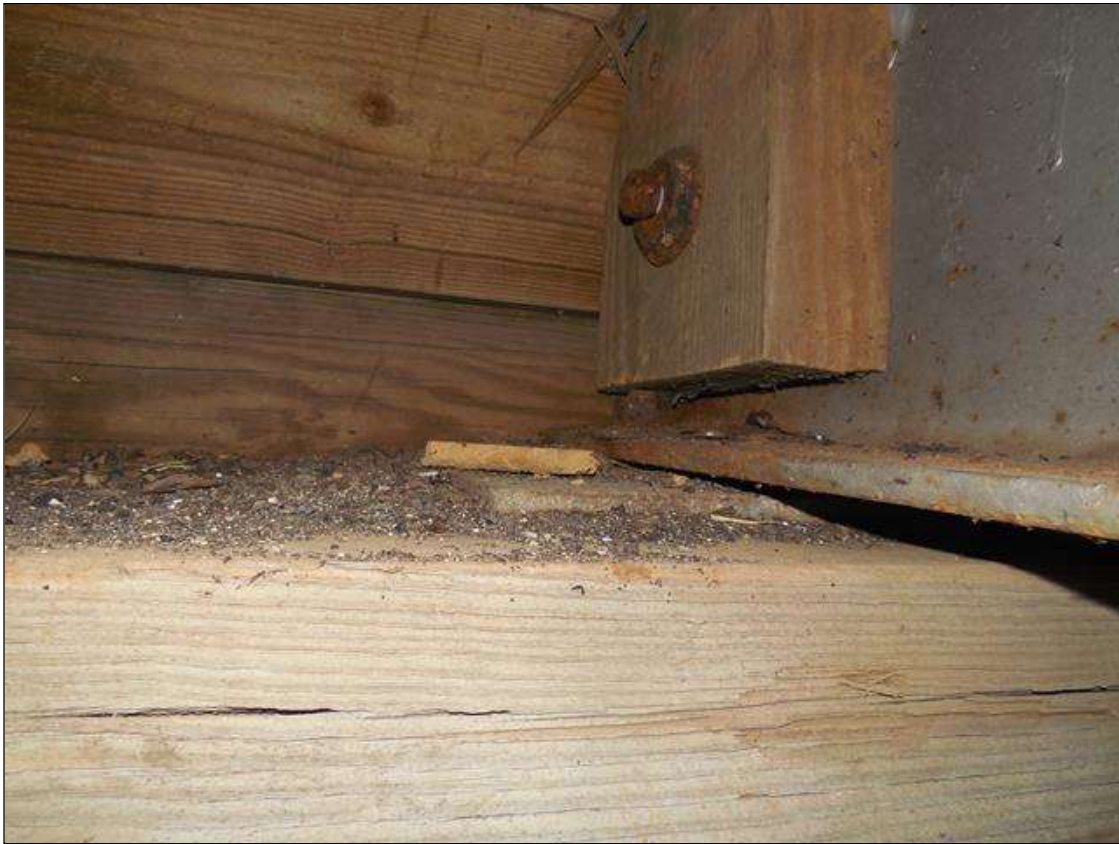
BEAM 9 BEARING AT END BENT 1, ALL BEARINGS ARE SIMILAR
