NC DEPARTMENT OF TRANSPORTATION  
DIVISION OF HIGHWAYS  
STRUCTURE MANAGEMENT UNIT

## Structure Safety Report

### Routine Element Inspection - Contract

COUNTY: CALDWELL STRUCTURE NUMBER: 130262 FREQUENCY: 24 MONTHS

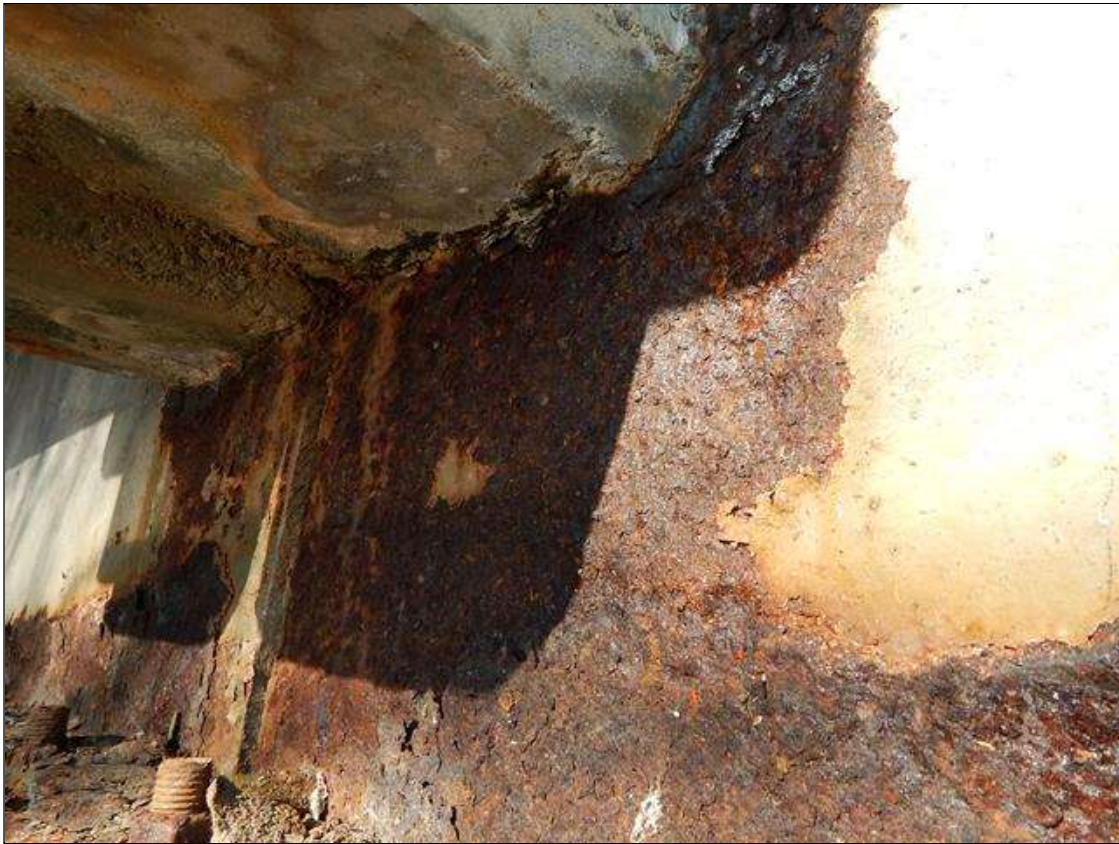
Span 2 Beam 4: 12" x 10" area of 1/8" section loss (3/8" remaining) on web at Bent 1

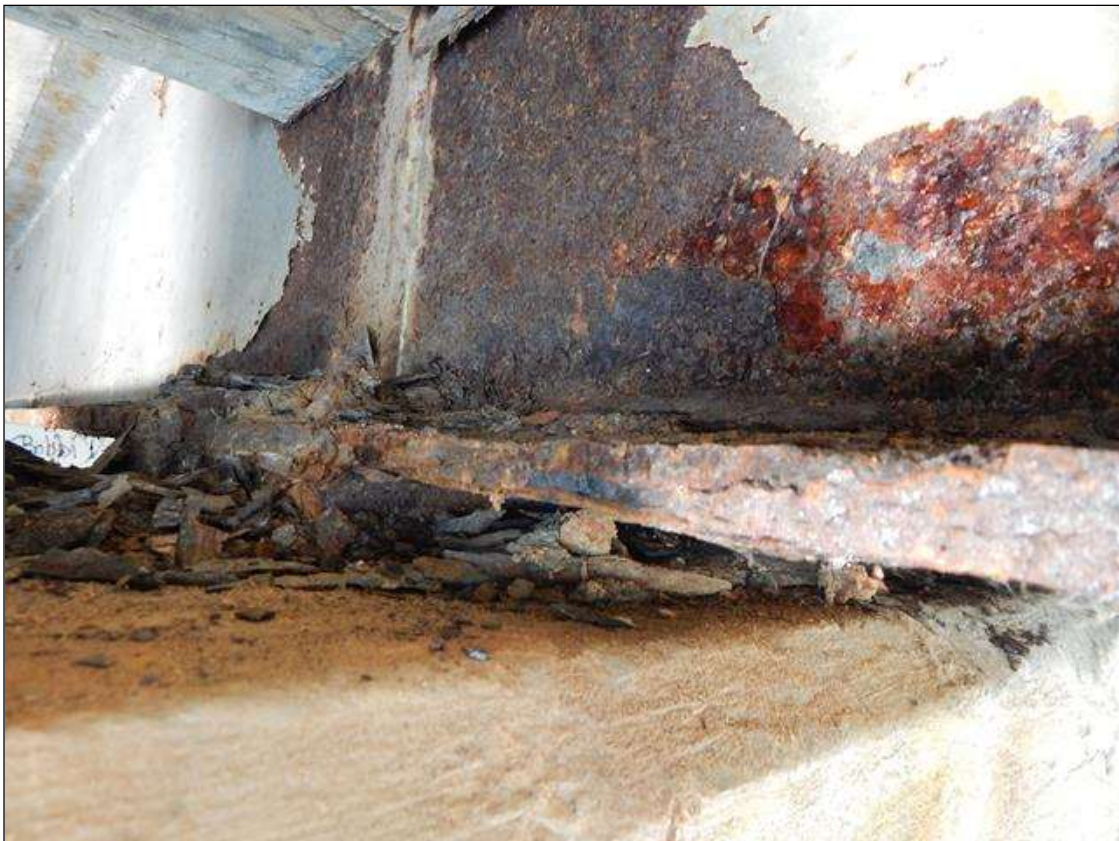
Span 2 Beam 3: 9" x 3" area of 1/4" section loss (1/2" remaining) on both sides of bottom flange at Bent 1

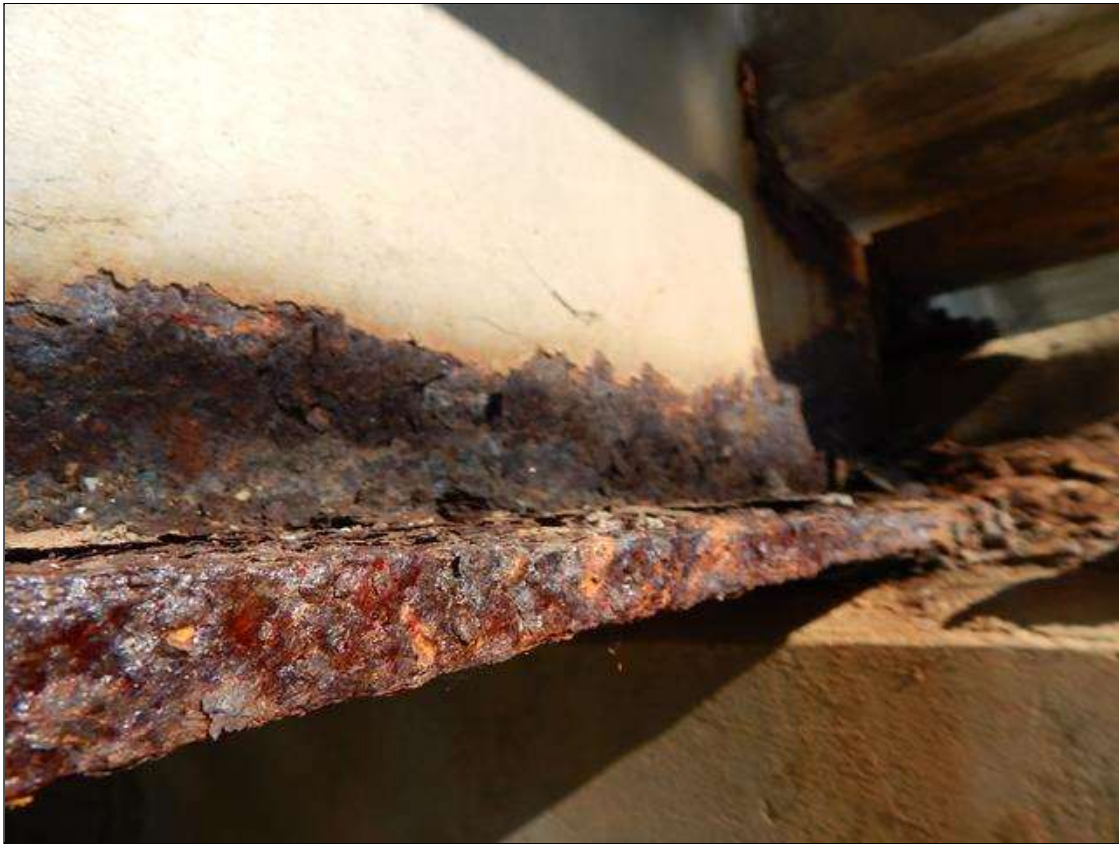
Span 2 Beam 4: 20" x 3" area of 1/4" section loss (1/2" remaining) on both sides of bottom flange at Bent 2

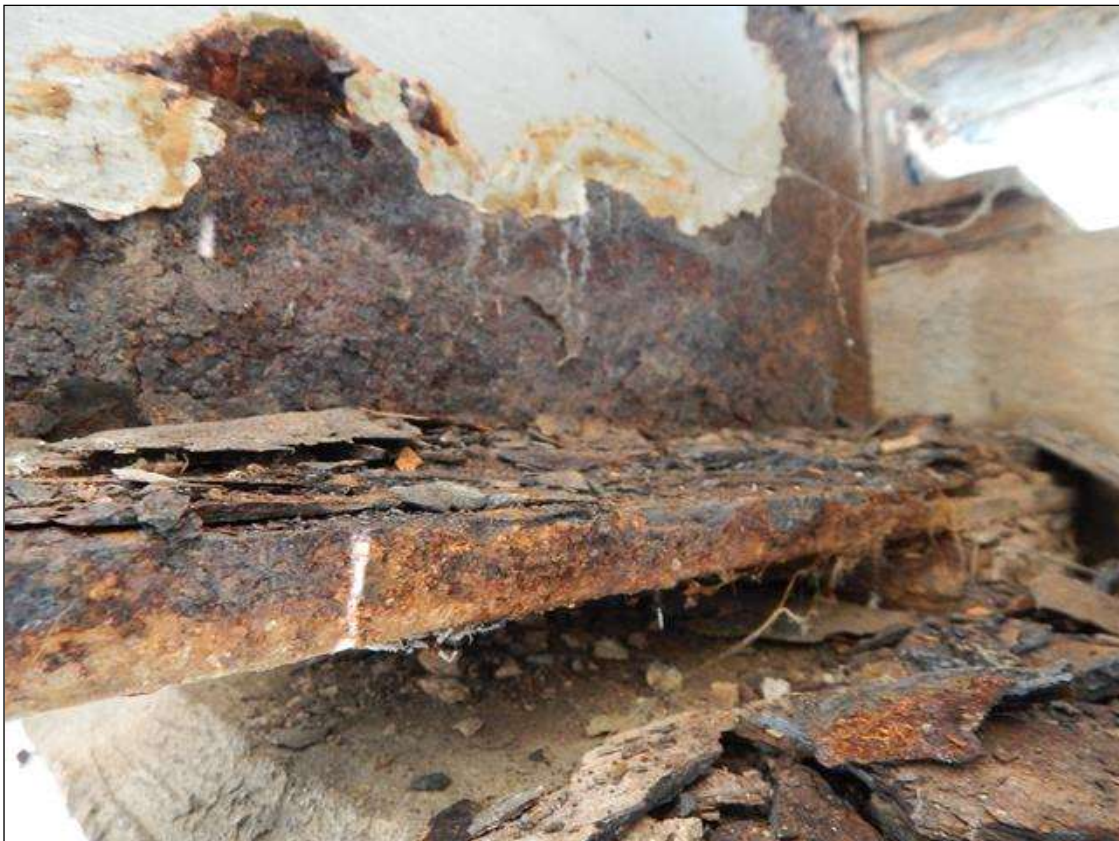
Span 2 Beam 3: 10" x 3" area of 1/8" section loss (5/8" remaining) on right side of bottom flange at Bent 2

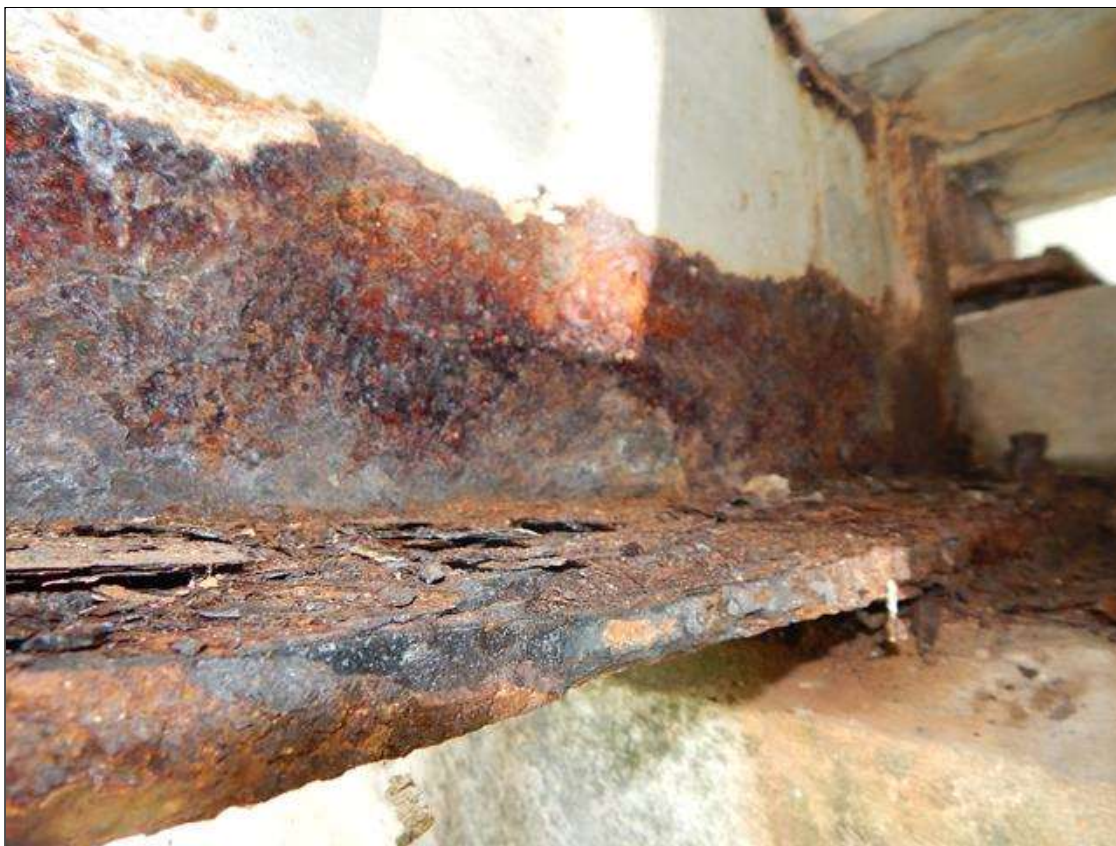
Span 2 Beam 1: 20" x 3" area of 1/4" section loss (1/2" remaining) on both sides of bottom flange at Bent 2

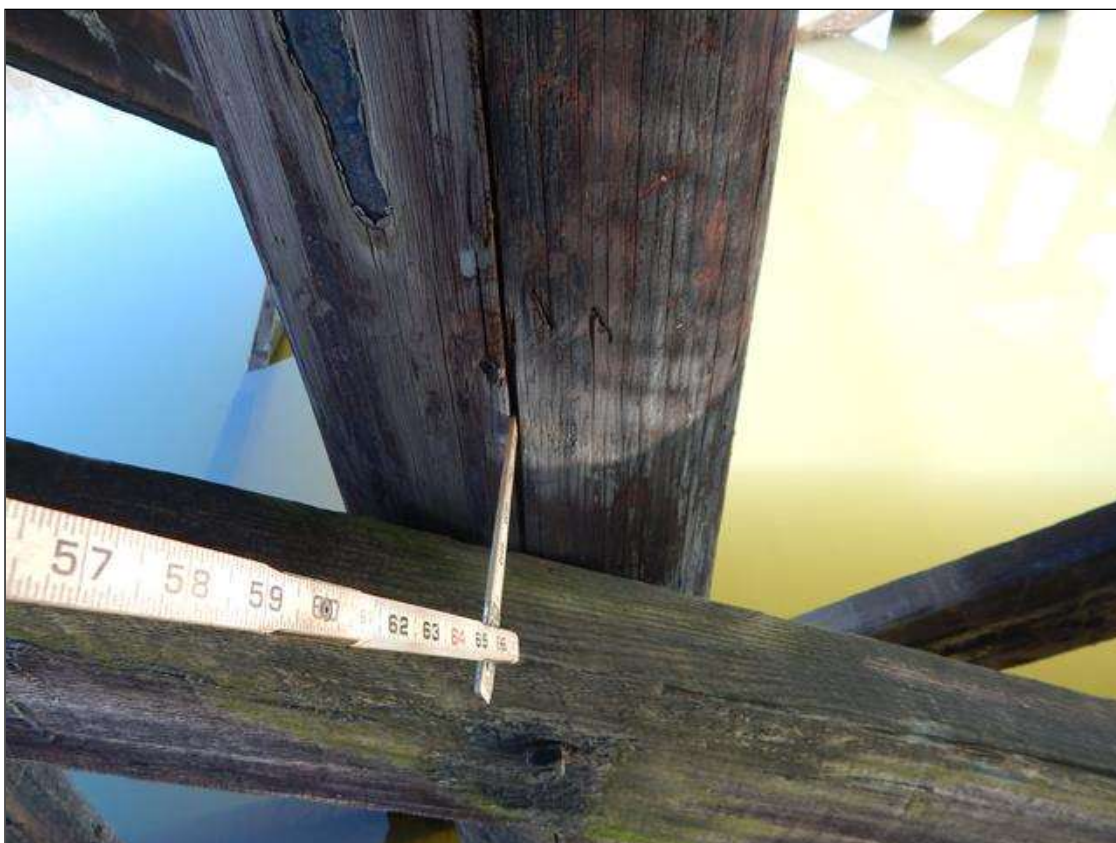
Bent 2 Pile 2: 4" long up to 1" deep check in Span 2 face

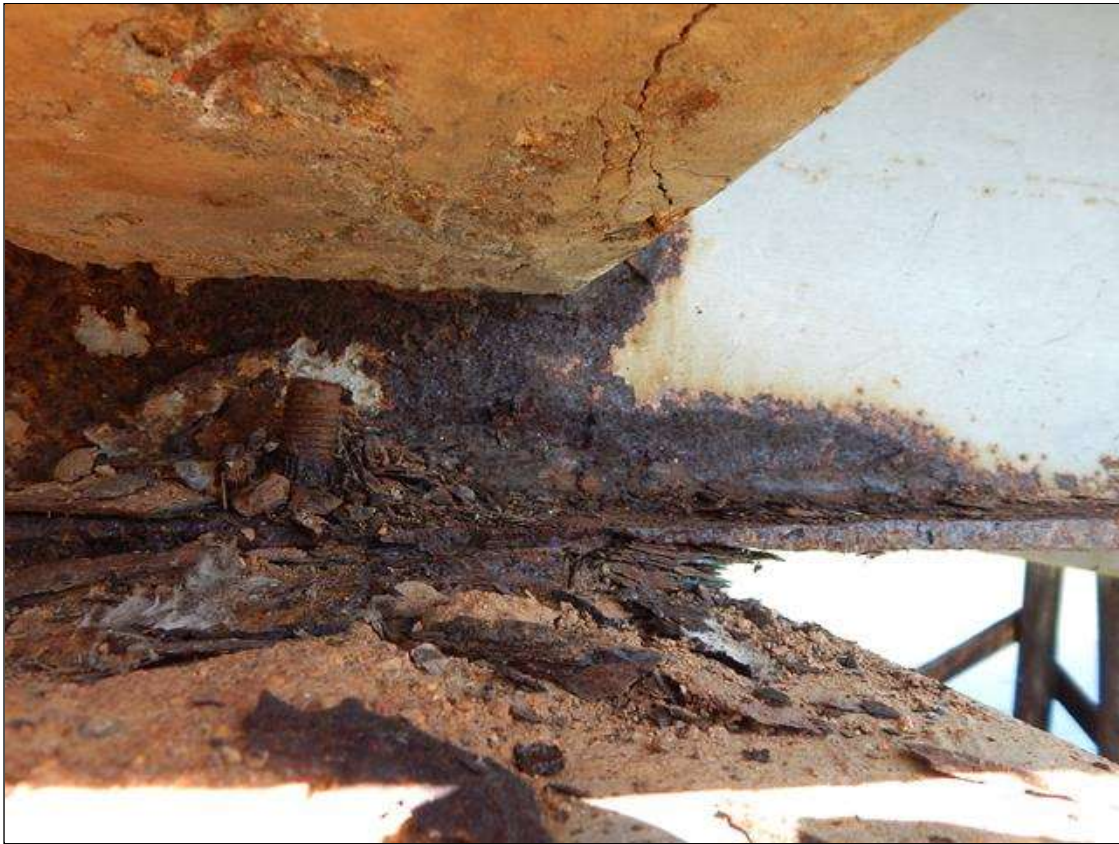
Span 3 Beam 4: 9" x 3" area of 1/4" section loss (1/4" remaining) for right side of bottom flange and web at Bent 2

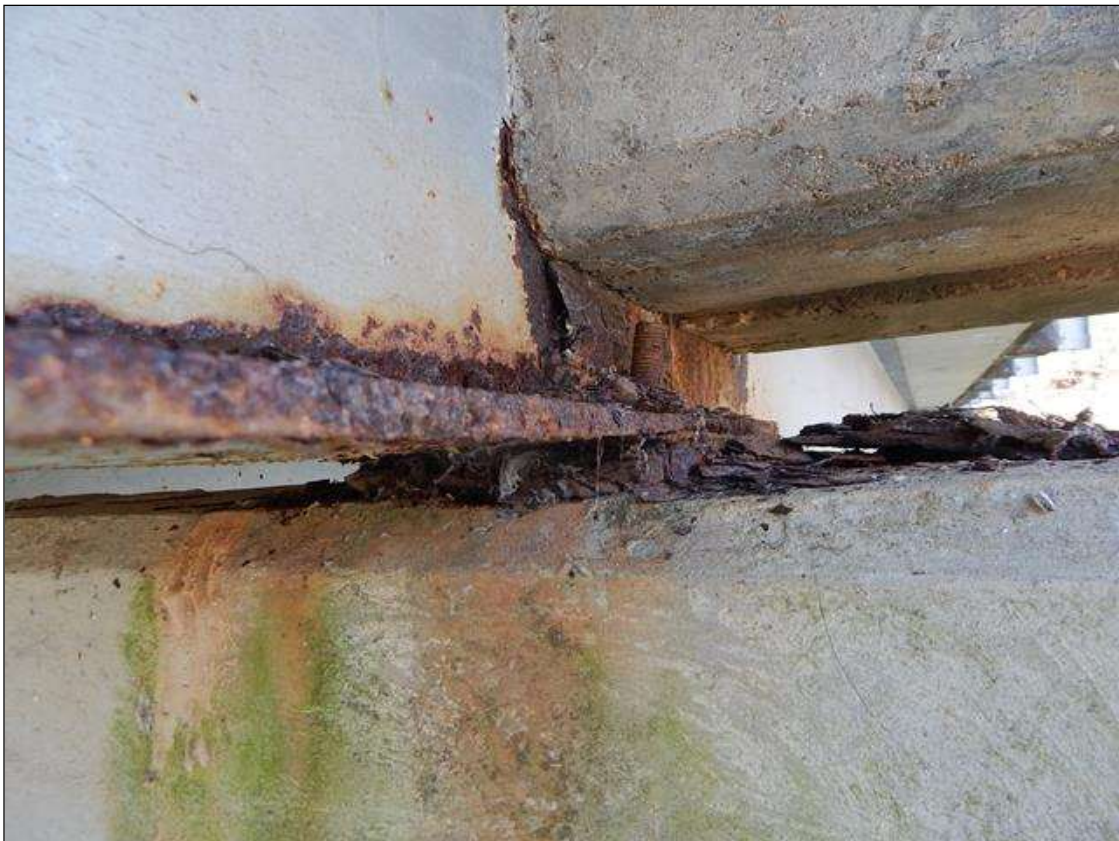
Span 3 Beam 1: 10" x 3" area of 1/4" section loss (1/4" remaining) for both sides of bottom flange at Bent 2

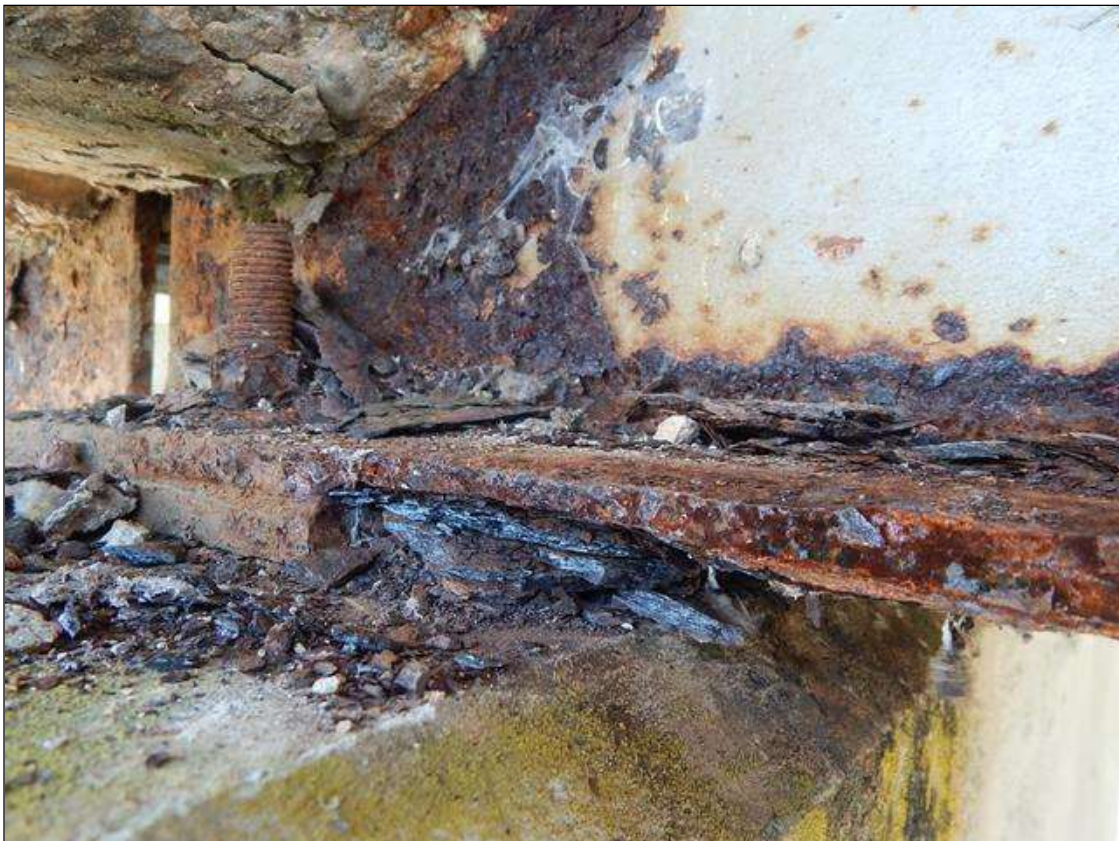
Span 7 Beam 4: 3" x 3" area of 1/4" section loss (1/4" remaining) on both sides of bottom flange at Bent 6

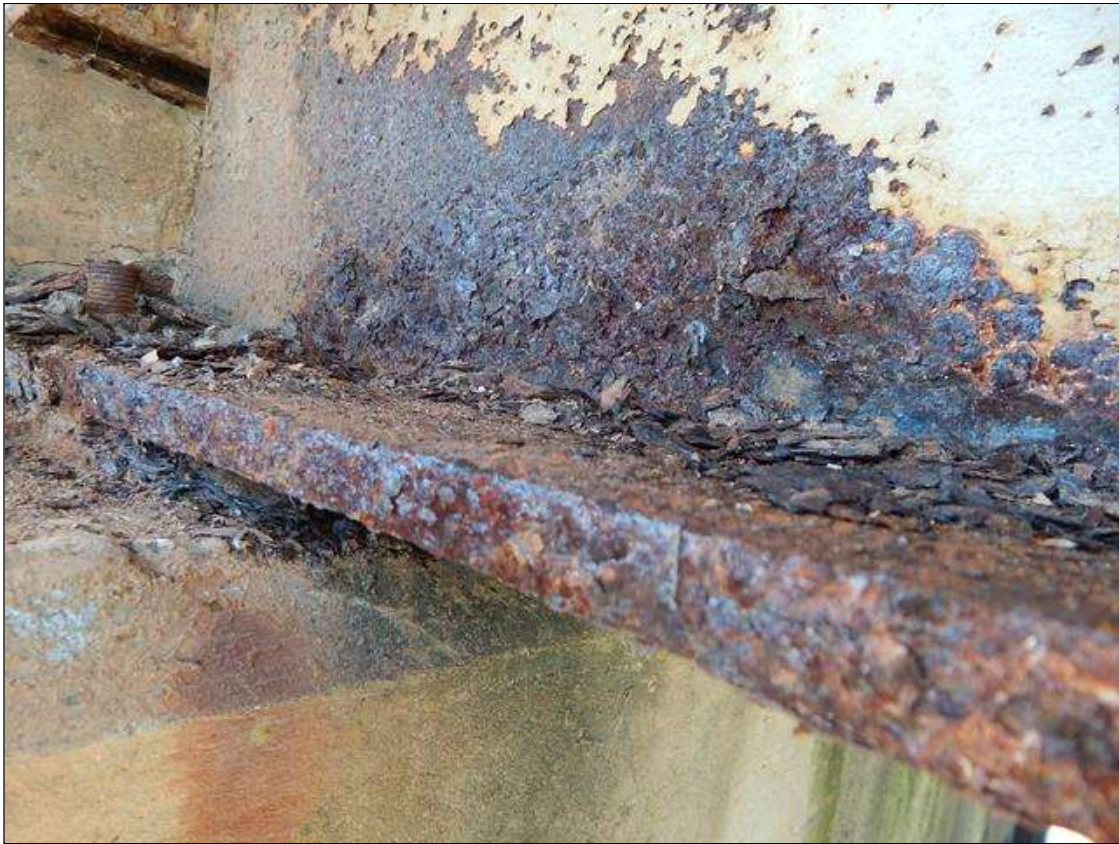
Span 8 Beam 4: 10" x 2" area of 1/8" section loss (5/8" remaining) on both sides of bottom flange at Bent 7

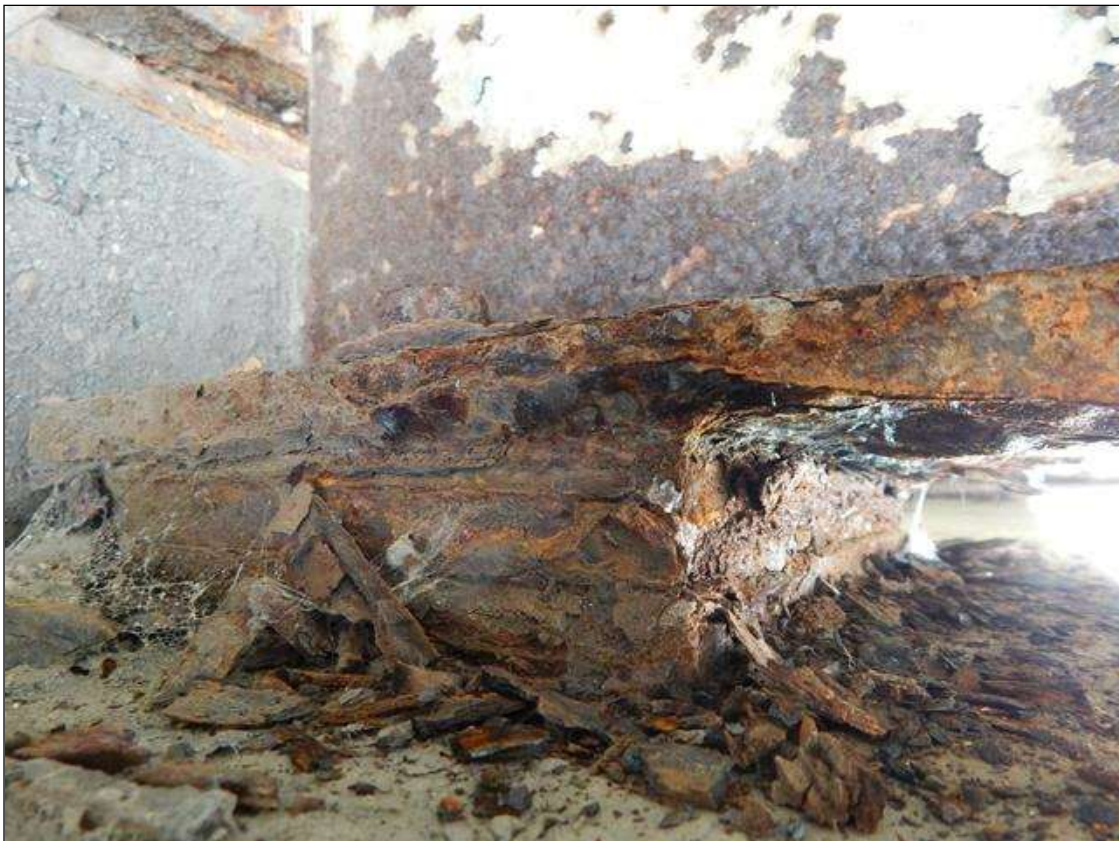
Span 8 Beam 2: 4" x 2" area of 1/4" section loss (1/2" remaining) on both sides of bottom flange at Bent 7

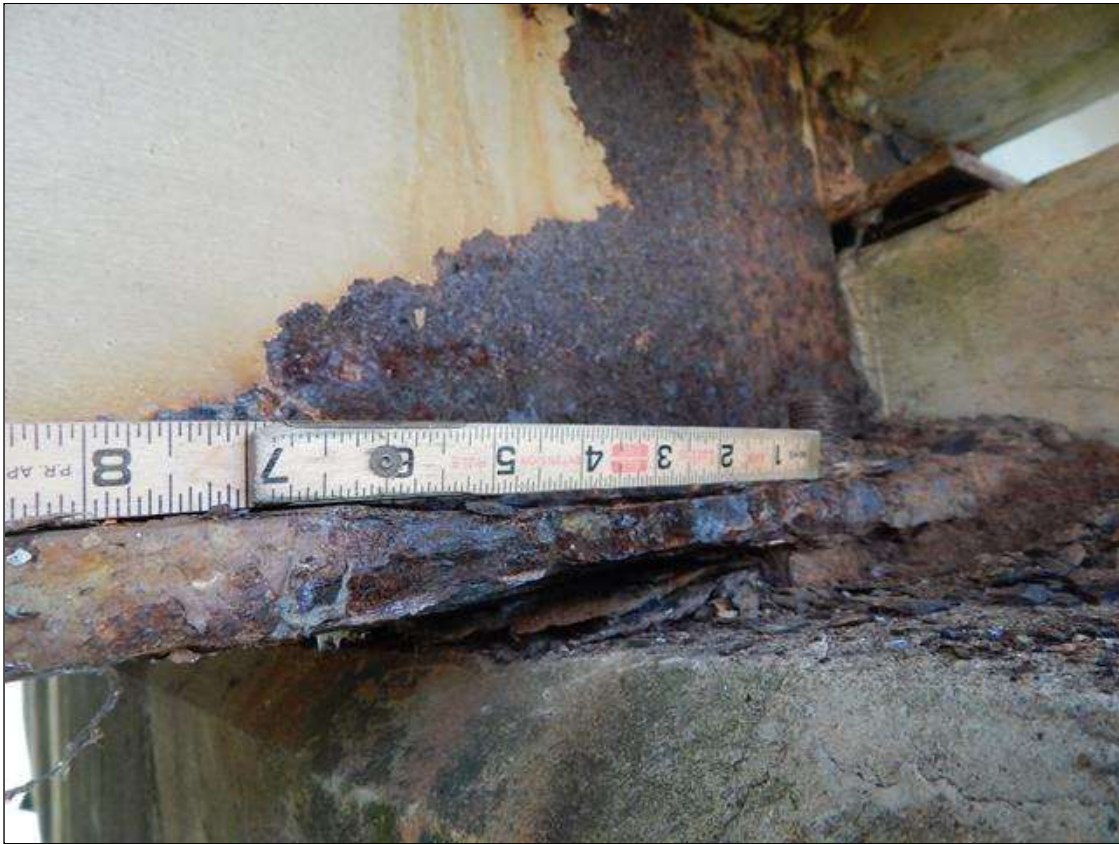
Span 8 Beam 1: 5" x 2" area of 1/4" section loss (1/2" remaining) on left side of bottom flange at Bent 7

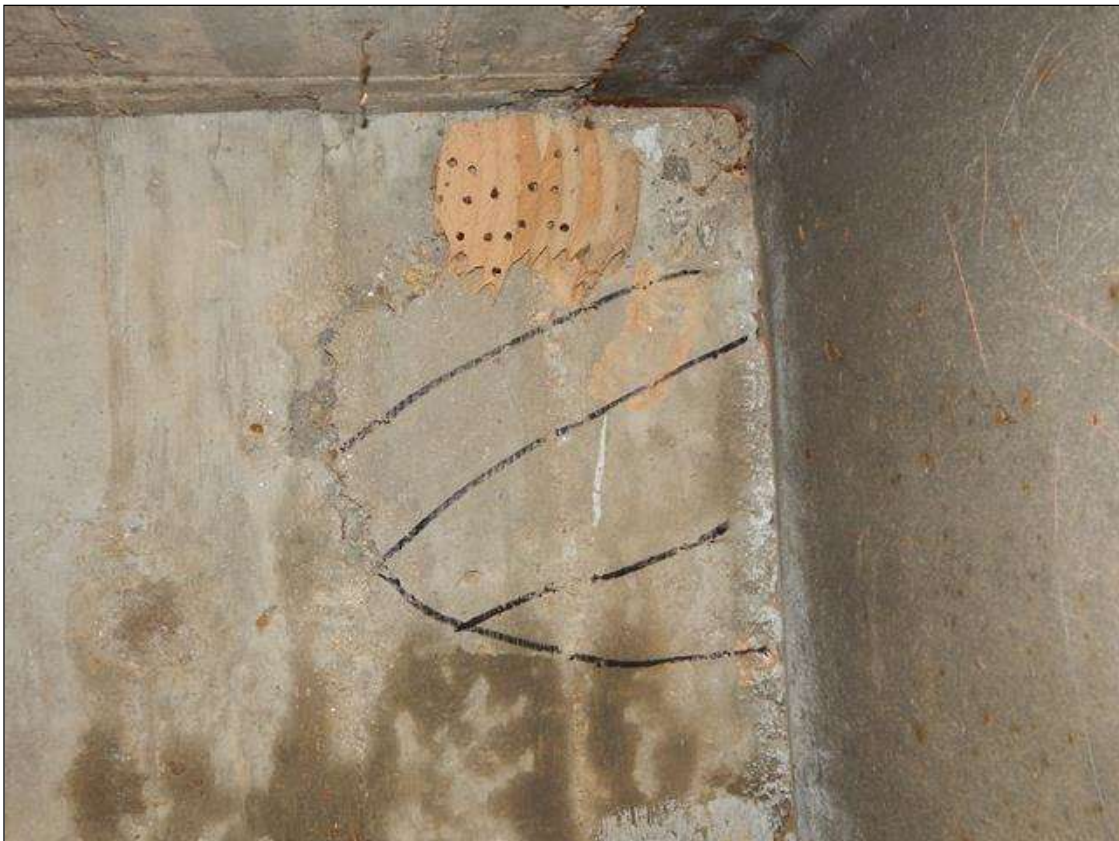
End Bent 2 Abutment/Backwall : 11" x 14" area of delamination in Bay 2 adjacent to Beam 3

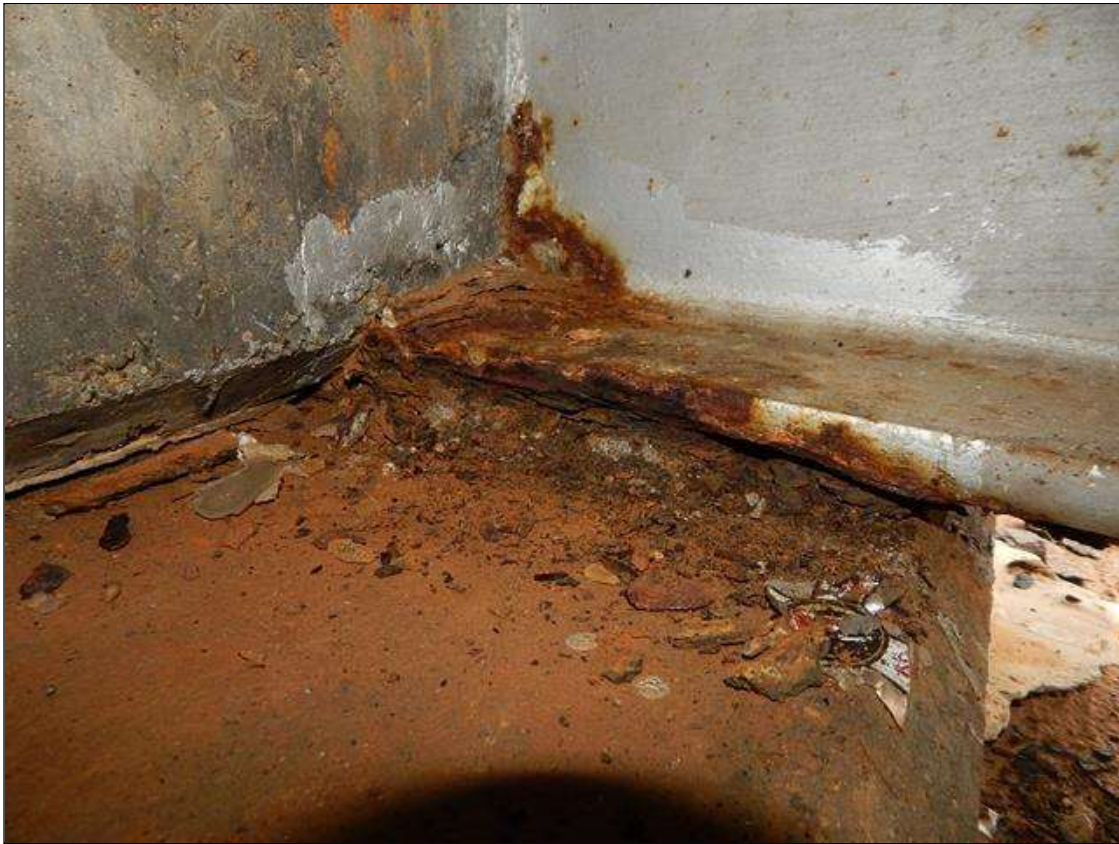
Span 12 Beam 4: 6" x 3" area of 1/4" section loss (1/2" remaining) in left side of bottom flange at End Bent 2

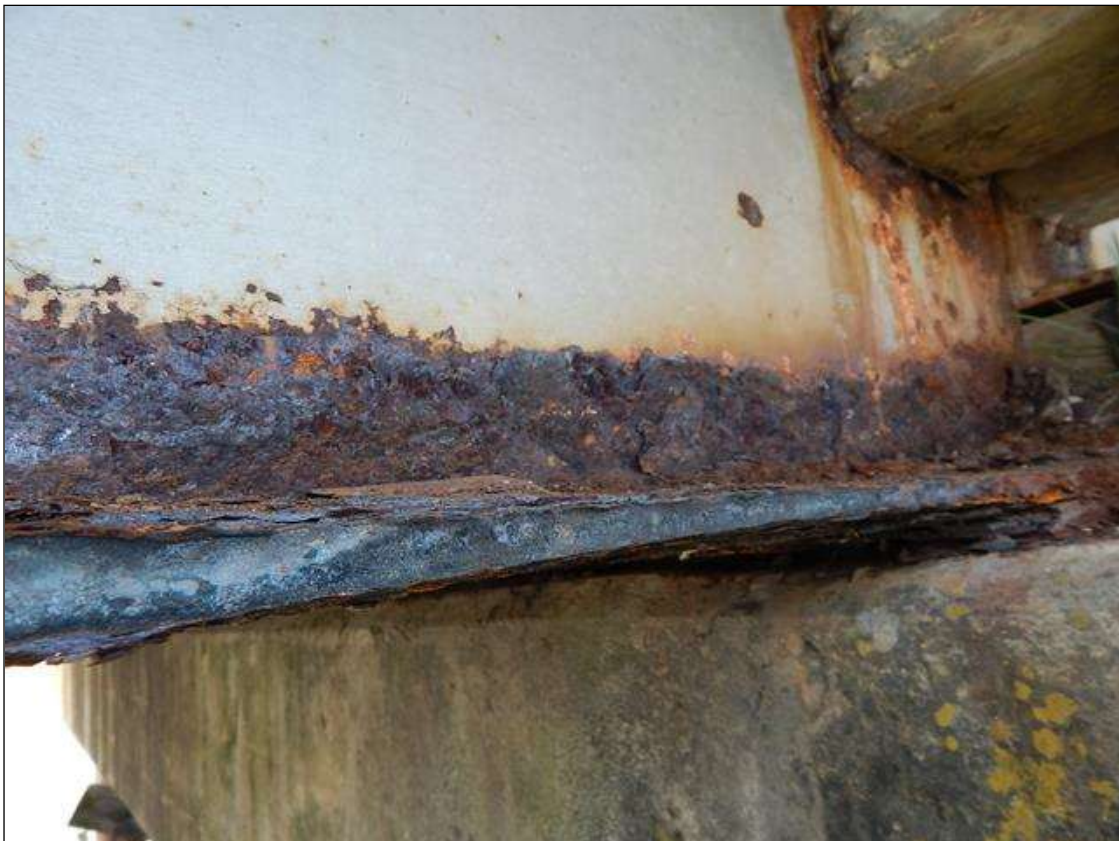
Span 8 Beam 4: 16" x 4" area of 3/8" section loss (3/8" remaining) on right side of bottom flange at Bent 8

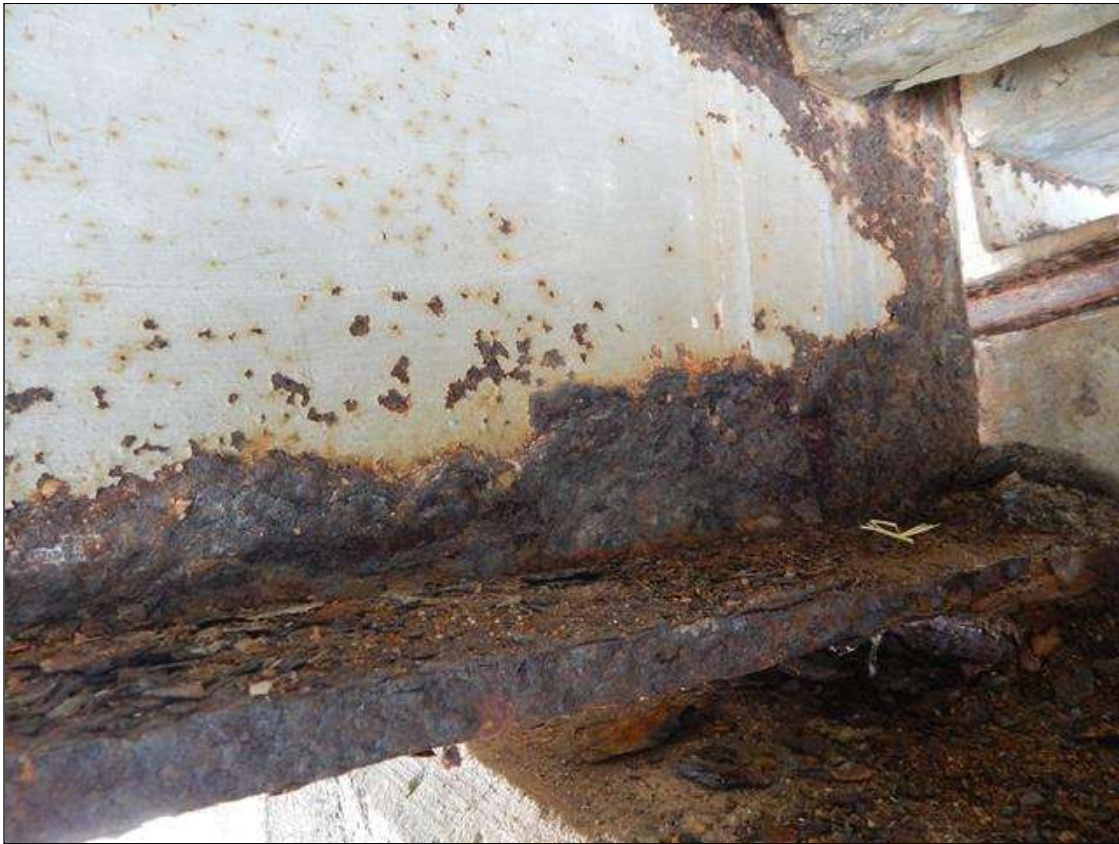
Span 8 Beam 3: 18" x 3" area of 1/4" section loss (1/2" remaining) on right side of web at Bent 8

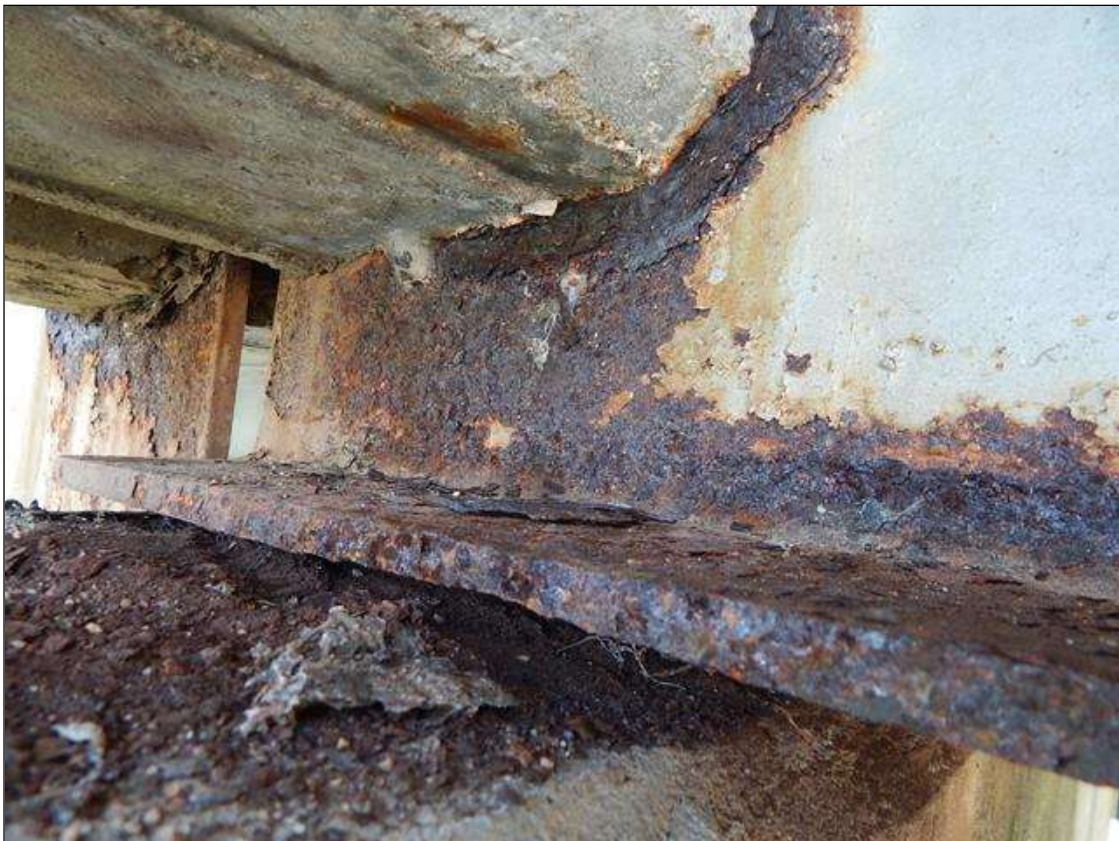
Span 9 Beam 4: 7" x 3" area of 3/16" section loss (5/16" remaining) right side bottom flange at Bent 8

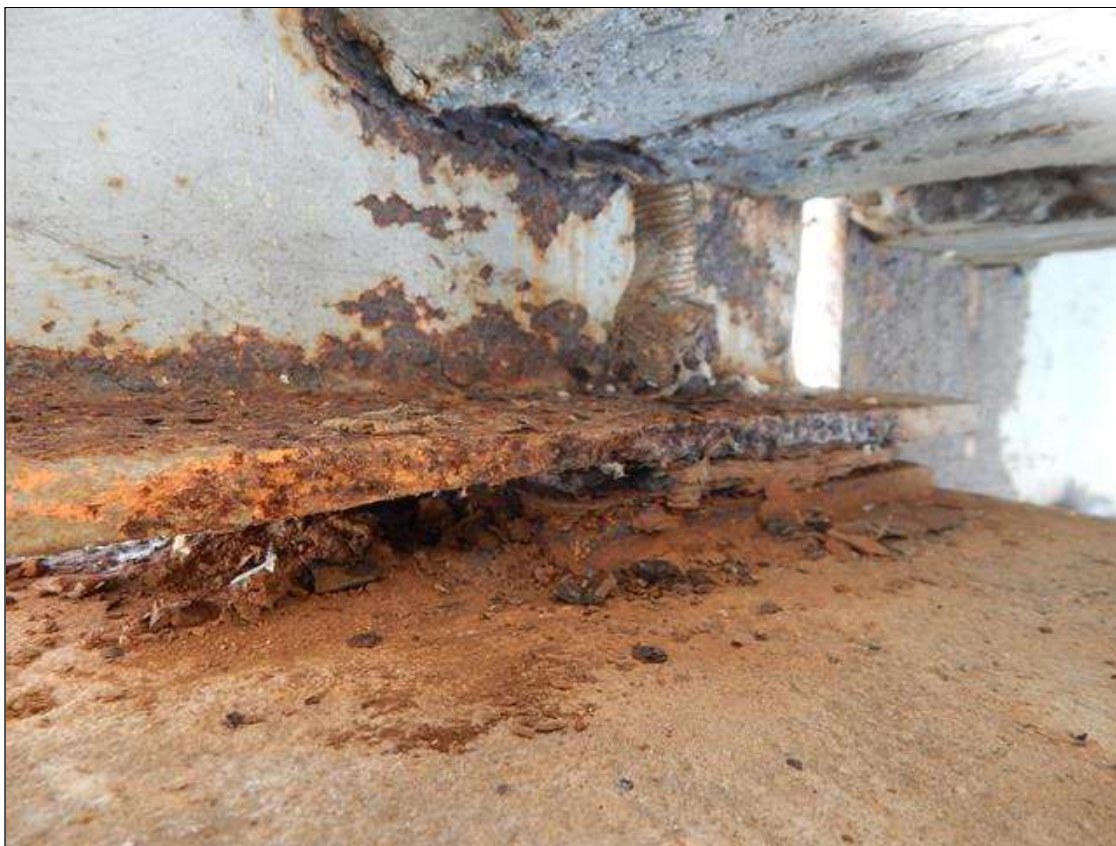
Span 9 Beam 4: 4" x 2" area of 1/16" section loss (7/16" remaining) on both sides of bottom flange at Bent 9

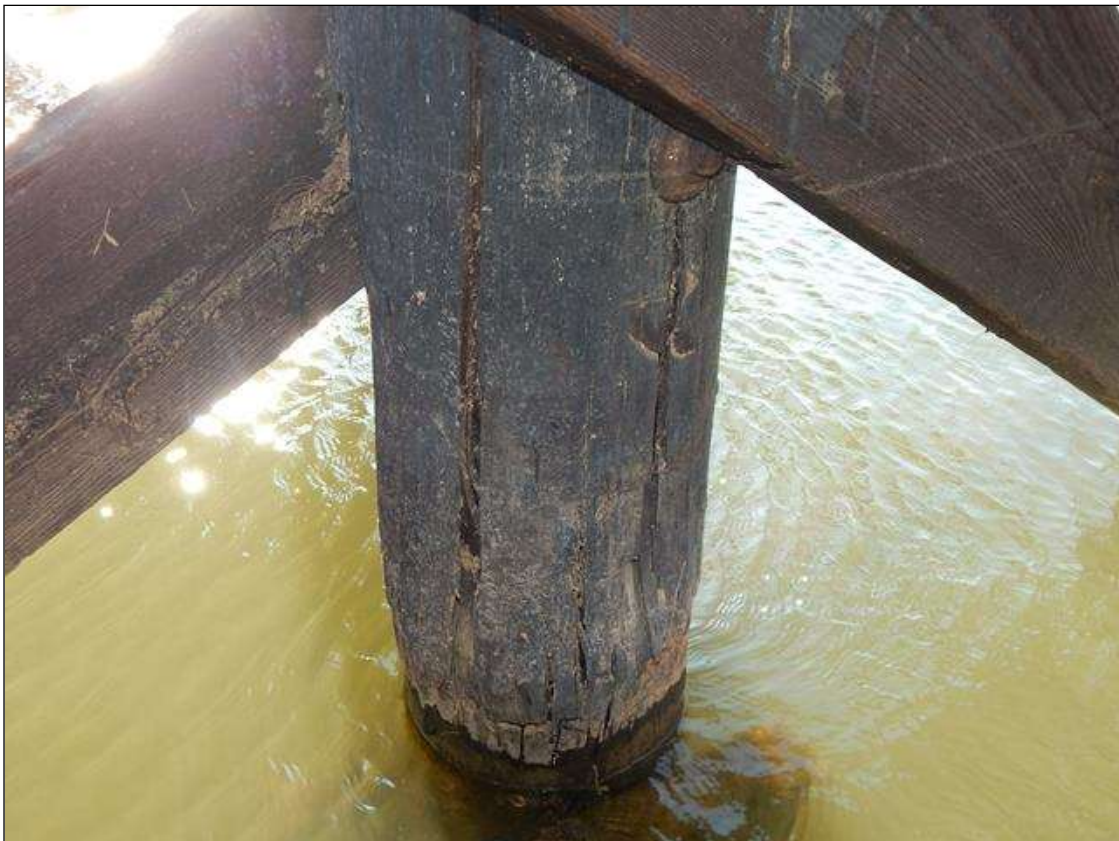
Bent 9 Pile 2: 28" long pile mushrooming

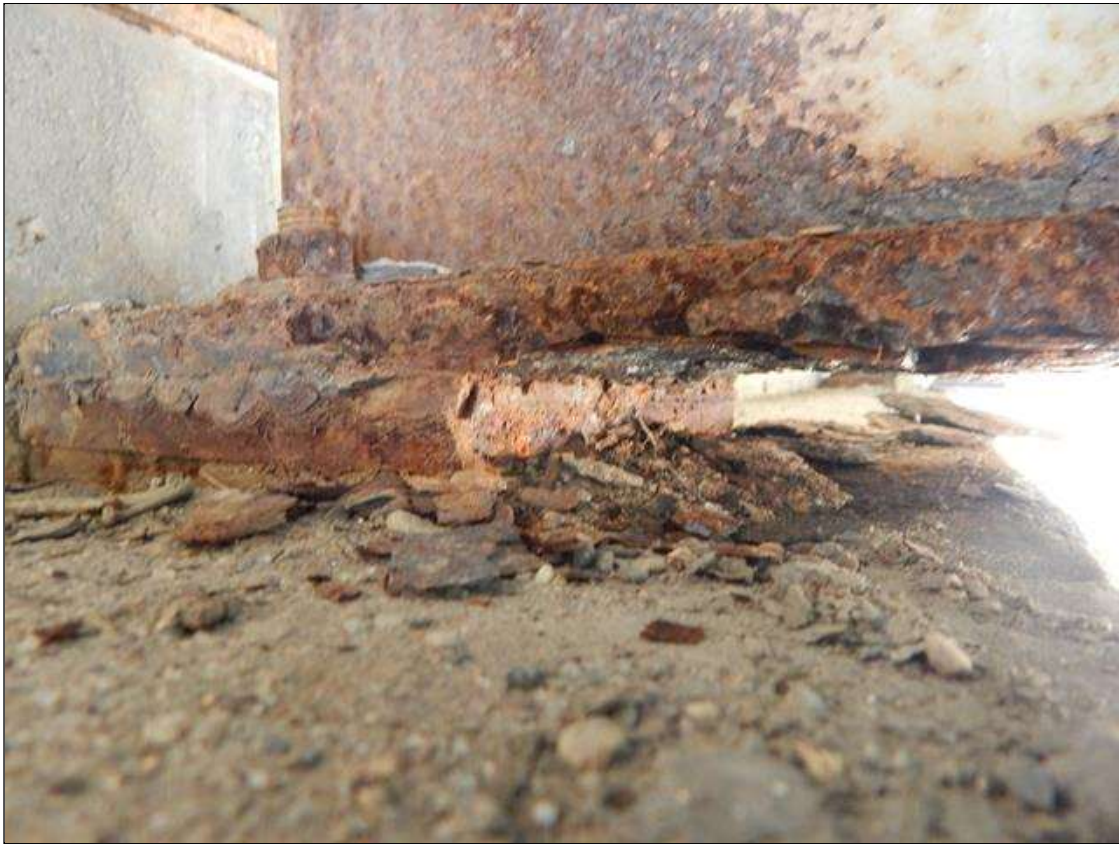
Span 10 Beam 1: 11" x 4" area of 1/16" section loss (11/16" remaining) on both sides of bottom flange at Bent 9

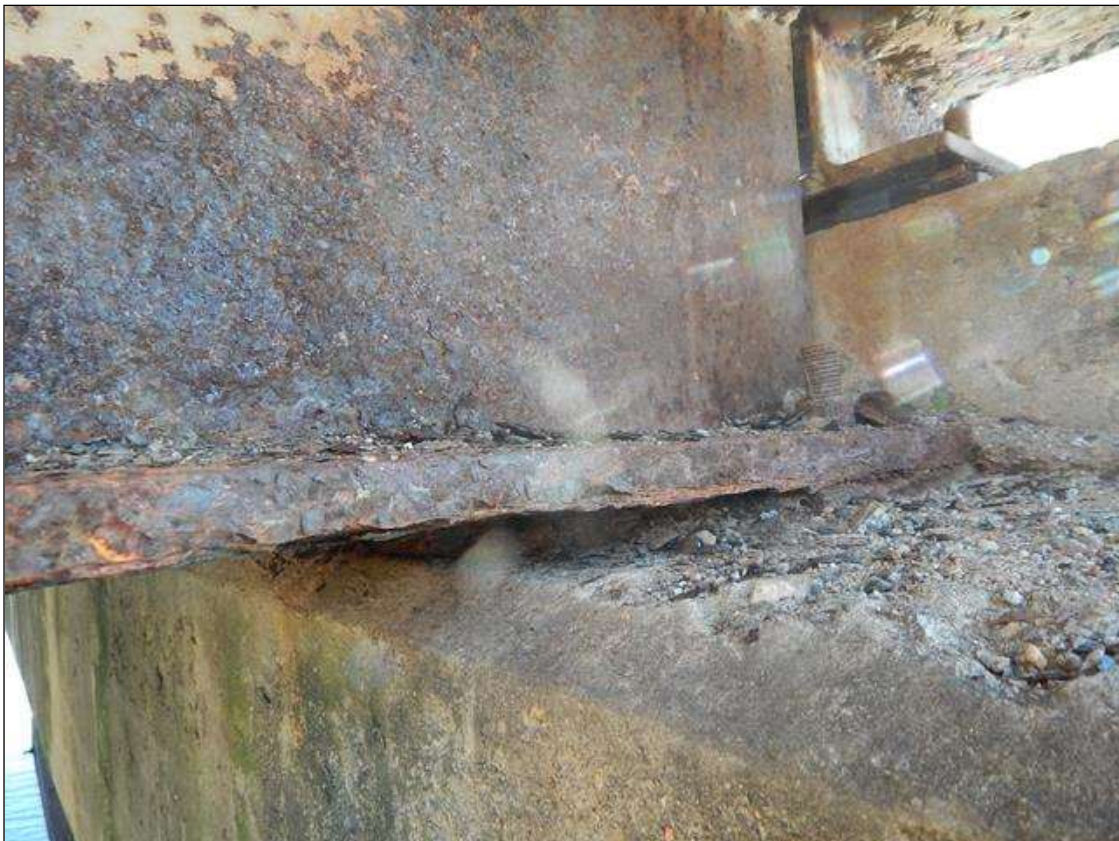
Span 10 Beam 2: 4" x 4" area of 1/16" section loss (11/16" remaining) on both sides of bottom flange at Bent 9

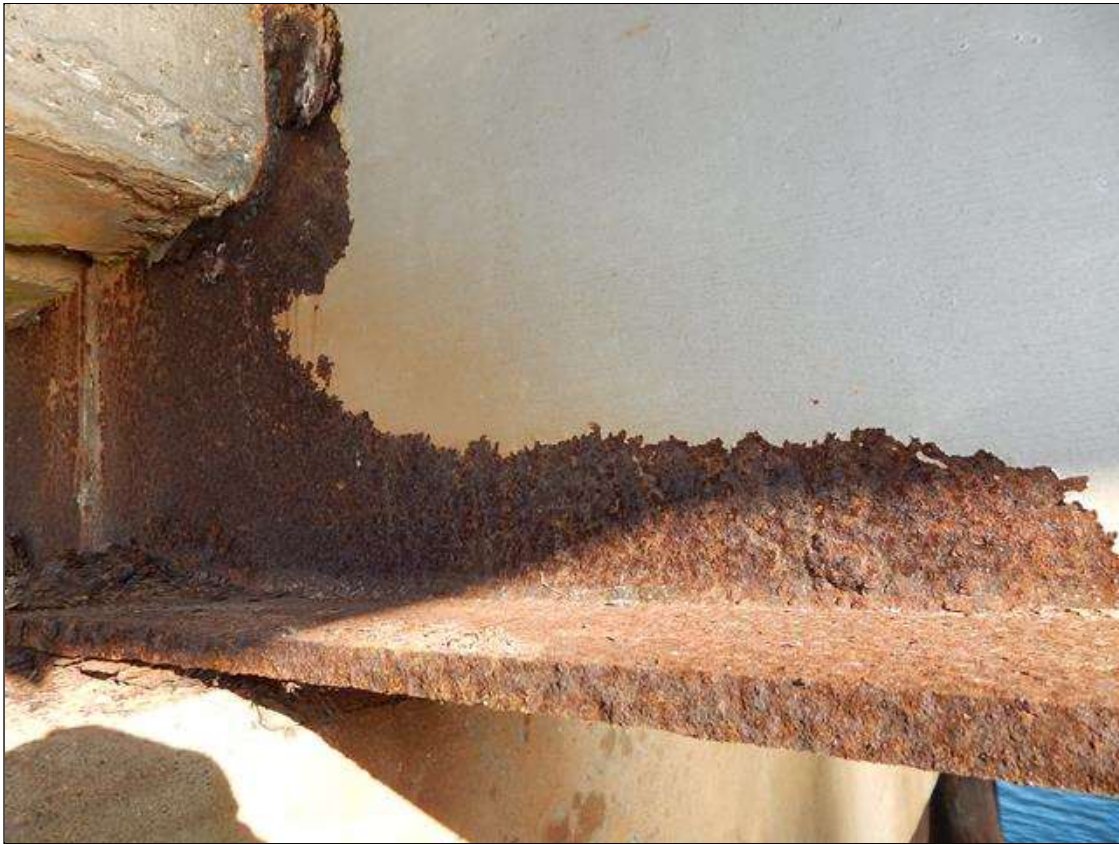
Span 10 Beam 1: 12" x 4" area of 1/16" section loss (11/16 remaining) of both sides of bottom flanges at Bent 10

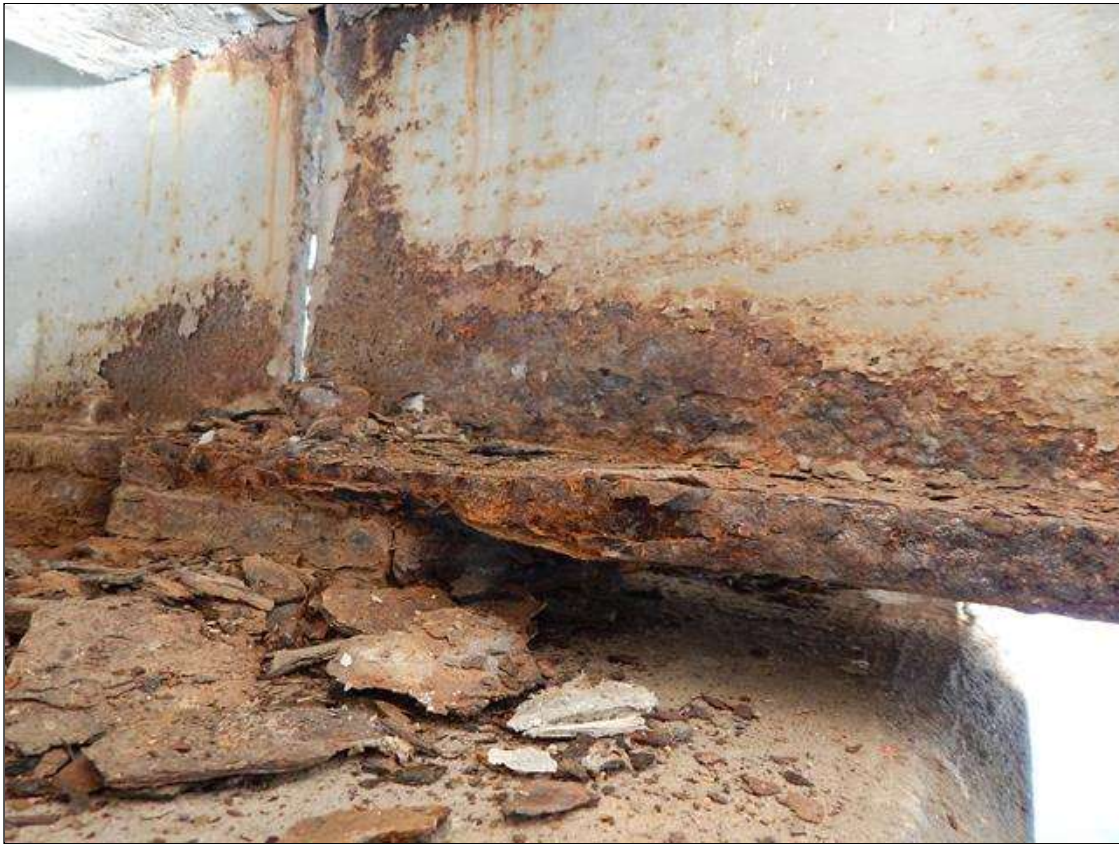
Span 10 Beam 2: 5" x 4" area of 1/8" section loss (5/8" remaining) on both sides of bottom flange at Bent 10

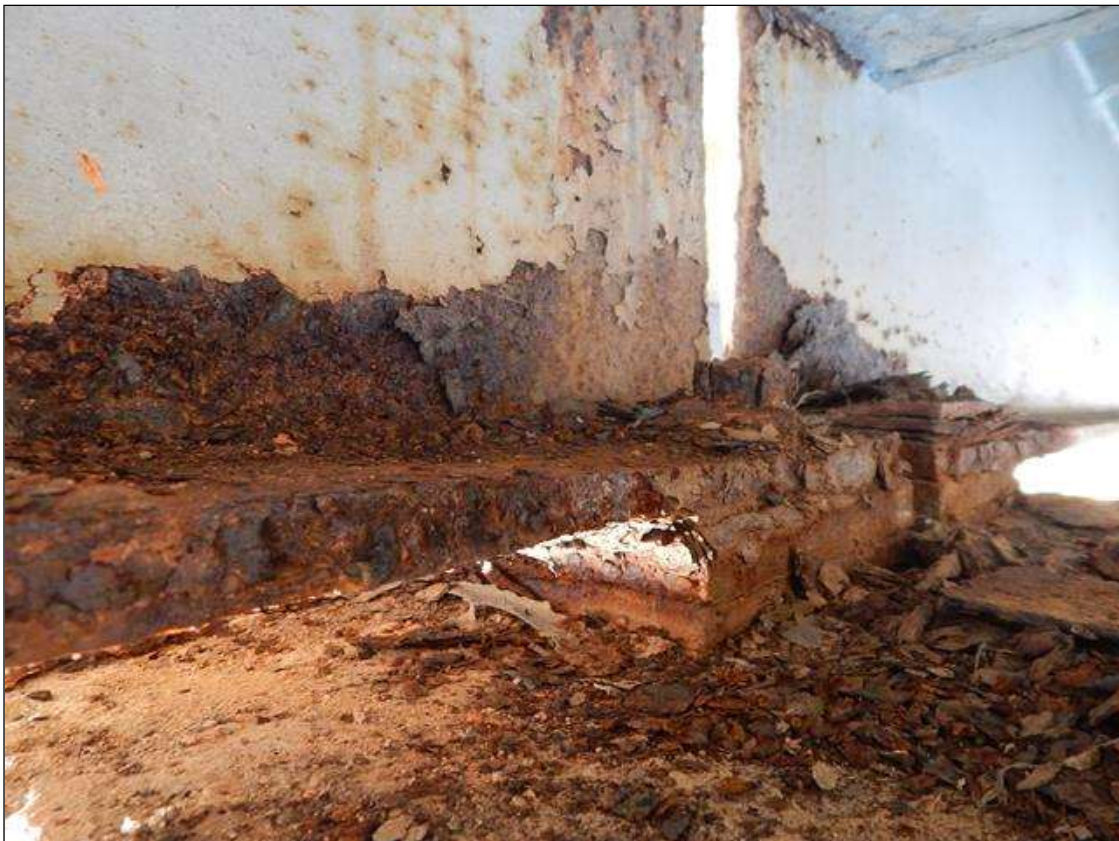
Span 10 Beam 3: 7" x 4" area of 1/4" section loss (1/2" remaining) both sides of bottom flange at Bent 10
